## Interoffice Communication

Subject 1983 Vinyl Chloride Safety Association Meeting Report

## INDEX

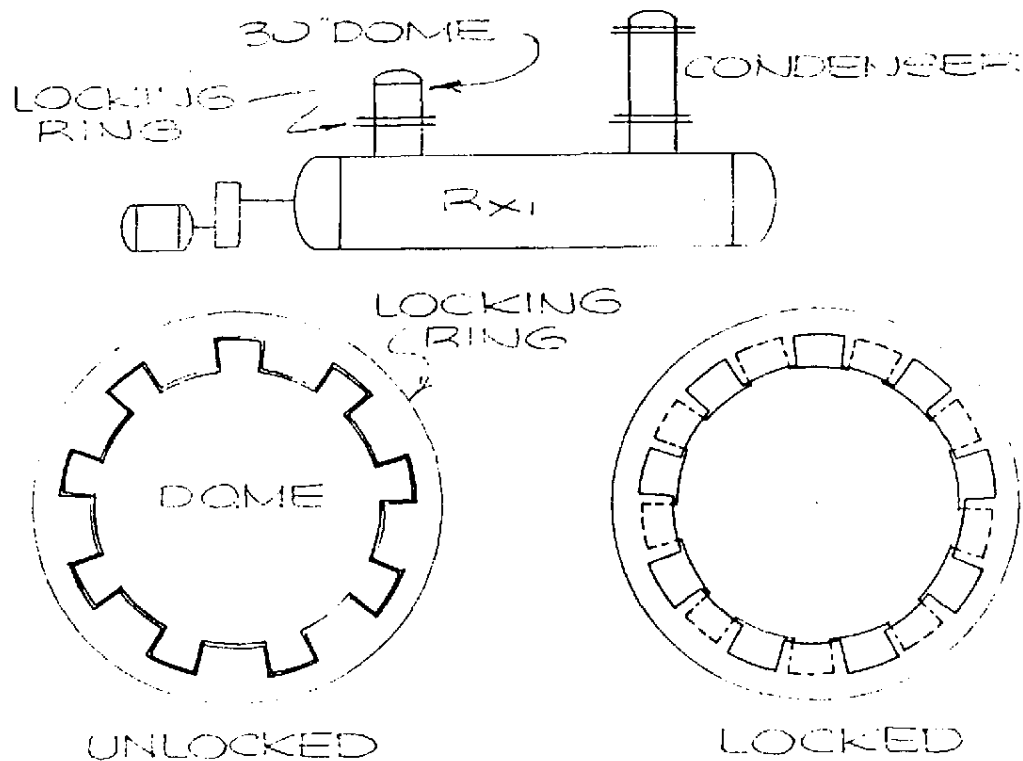
The dome slipped out of the locking ring and broke a three-inch nozzle on the dome (or maybe vice versa). Perhaps the dome had not been tightened completely. Or the broken nozzle could have caused the dome to twist out of the locking ring. They don't know which happened first.

A steel wedge was made to insert in the locked dome flange to prevent it opening accidentally. A proximity switch was installed to confirm that the wedge was in place before charge would start. Alarms sound if the wedge is removed during operation. This has worked well.

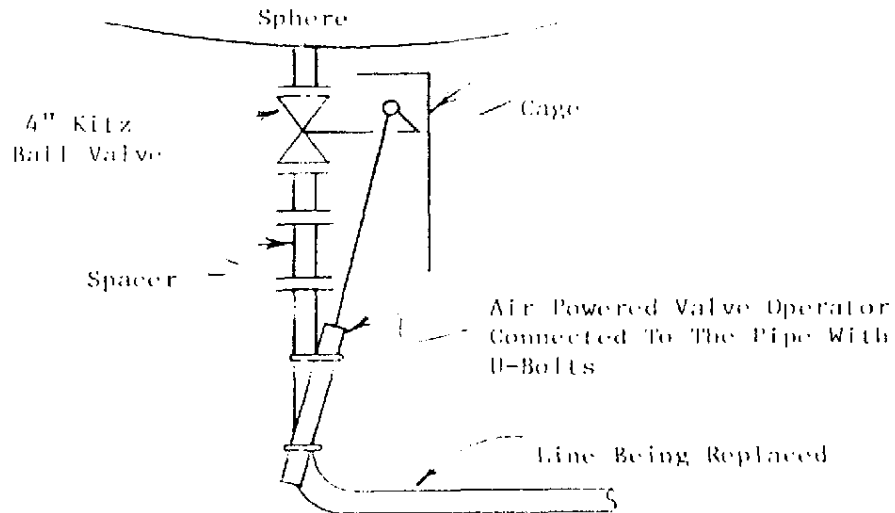
The valve was closed. The pipe fitter was not allowed to remove the expanded mesh cage around the valve or the operator. However, he did remove the operator's U-bolts, freeing it from the pipe. In the process of trying to move the unbolted line the line flange hooked the valve operator, partially opening the valve. Liquid VCM began to blow out. Operations could not close the valve with air pressure because the operator was only connected to the valve stem; it did not have anything to push against. They tried to use a long 2x4 to pry the valve operator and close the valve. However, the 2x4 snapped. Apparently the recoil caused the valve to go wide open. One and one half million pounds of VCM (the entire contents of the tank were lost over a six-hour period. There was no fire or explosion.

This incident was investigated thoroughly by BFG. They concluded that the accident was caused by a breakdown of their maintenance work order procedure. A new companywide maintenance work order standard was prepared (attached) which requires that the release by operations of hazardous equipment must be done at the job site in the presence of the craftsman, among other things. The release is valid for that shift only and must be repeated for the next shift. This helps to insure that both operations and maintenance understand the status and hazards of the work.

- a. Liquid valves must be:
  - 1) Quick opening and closing, fail closed.
  - 2) Remote operated, from two local points outside the dike and one remote (usually the control room).
  - 3) Valve must pass fire testing.
  - 4) Valve must not be top entering. This eliminates plug valves.
- b. Relieving system must be sized correctly. Some of theirs were found to be undersized due to inlet block valve losses.
- c. Automatic deluge sprinkler system is required. Some of their tanks were protected with fire water monitors only.
- d. Continuous LEL monitors are required. When 50 percent of the LEL is reached, all liquid valves on the storage tank are closed.

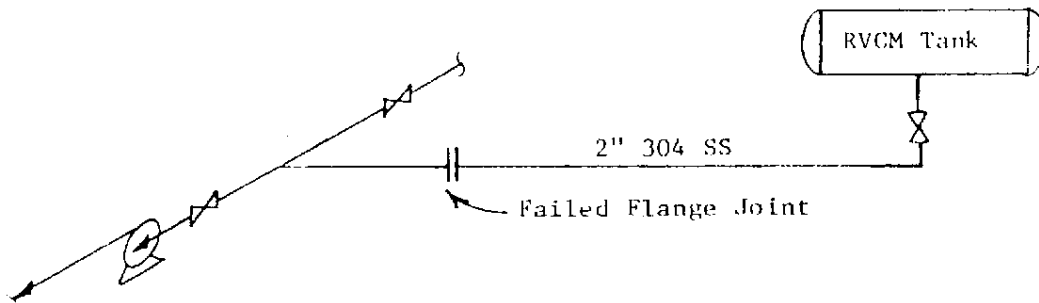
9. Failure of a VCM Line -- Jim Wallace, Exxon Canada

The fixed point monitors indicated a leak. They found the flange to pipe weld was leaking. They blocked in the leaking section of the line quickly. There was no fire or major release.

Afterwards someone kicked the line and the leaking flange to pipe weld completely failed. The flange was monel. The 304 stainless steel line had suffered galvanic corrosion at the weld.

The flange had been installed by a contractor. He did not have a two-inch flange so he used a monel flange figuring that it would be even better than stainless steel.

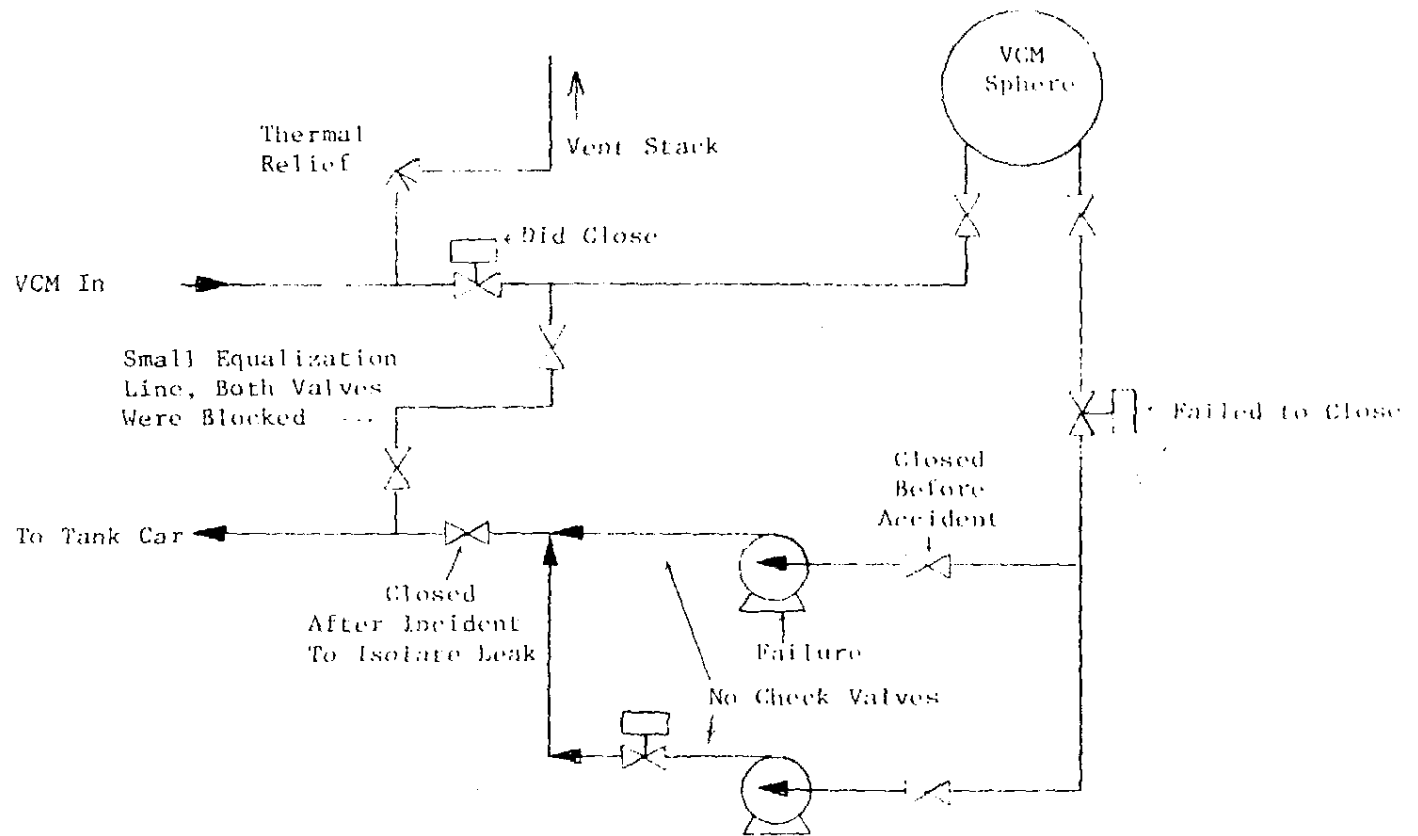
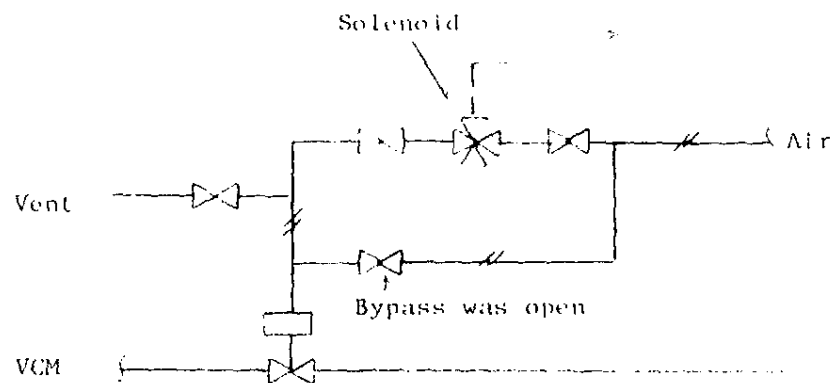
A blocked in loading pump in their VCM tank farm failed due to overpressure from thermal expansion of the VCM. The pump's parts in contact with VCM were steel, but the back of the pump was steel clad cast iron. The back failed 360° around its circumference. The force of the failure sheared the pump base and motor mounting bolts and bent the pump shaft. The pump seal did not blow out.

The pump was not running at the time. Normally the pump and lines are left liquid full but the valves to the sphere are left open. However, the pump suction valve was closed this time.
