# **REPORT OF COMPLIANCE EVALUATION INSPECTION**

**Leon Water Supply  
104 West 1st Street  
Leon, Iowa 50144  
Public Water Supply ID: IA2742076**

**August 19, 2025**

**U.S. ENVIRONMENTAL PROTECTION AGENCY  
Region 7  
Enforcement and Compliance Assurance Division (ECAD)**

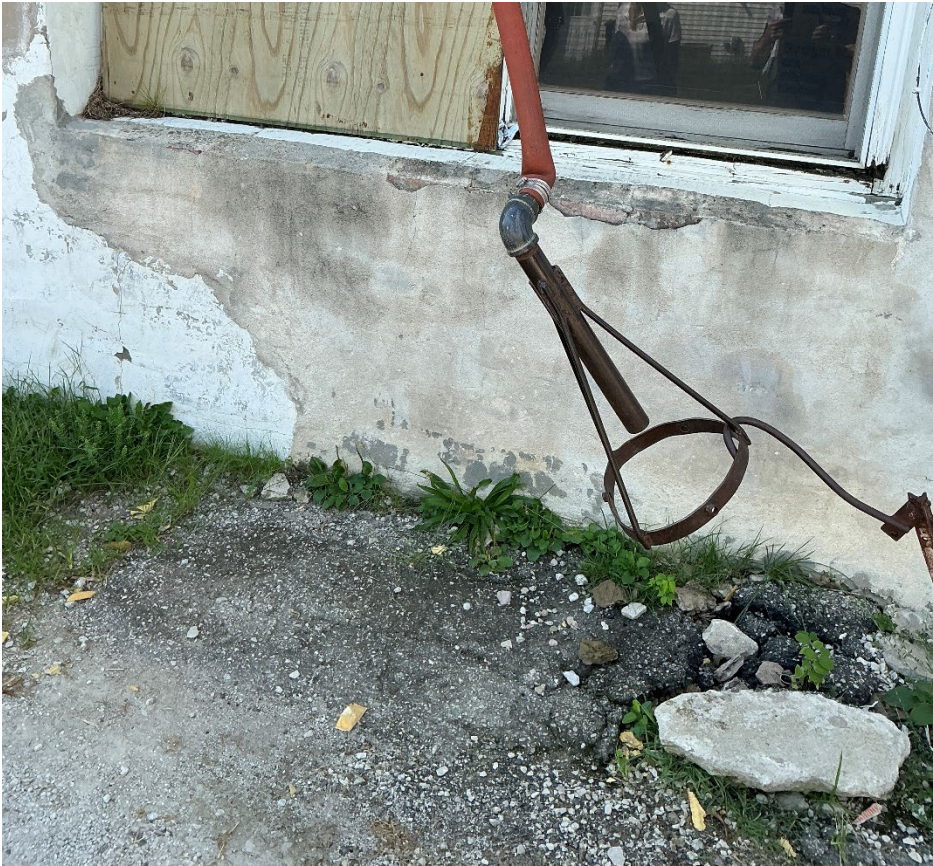
| Number | Photo |
|---|---|
| | Bulk fill station outside WTP. |

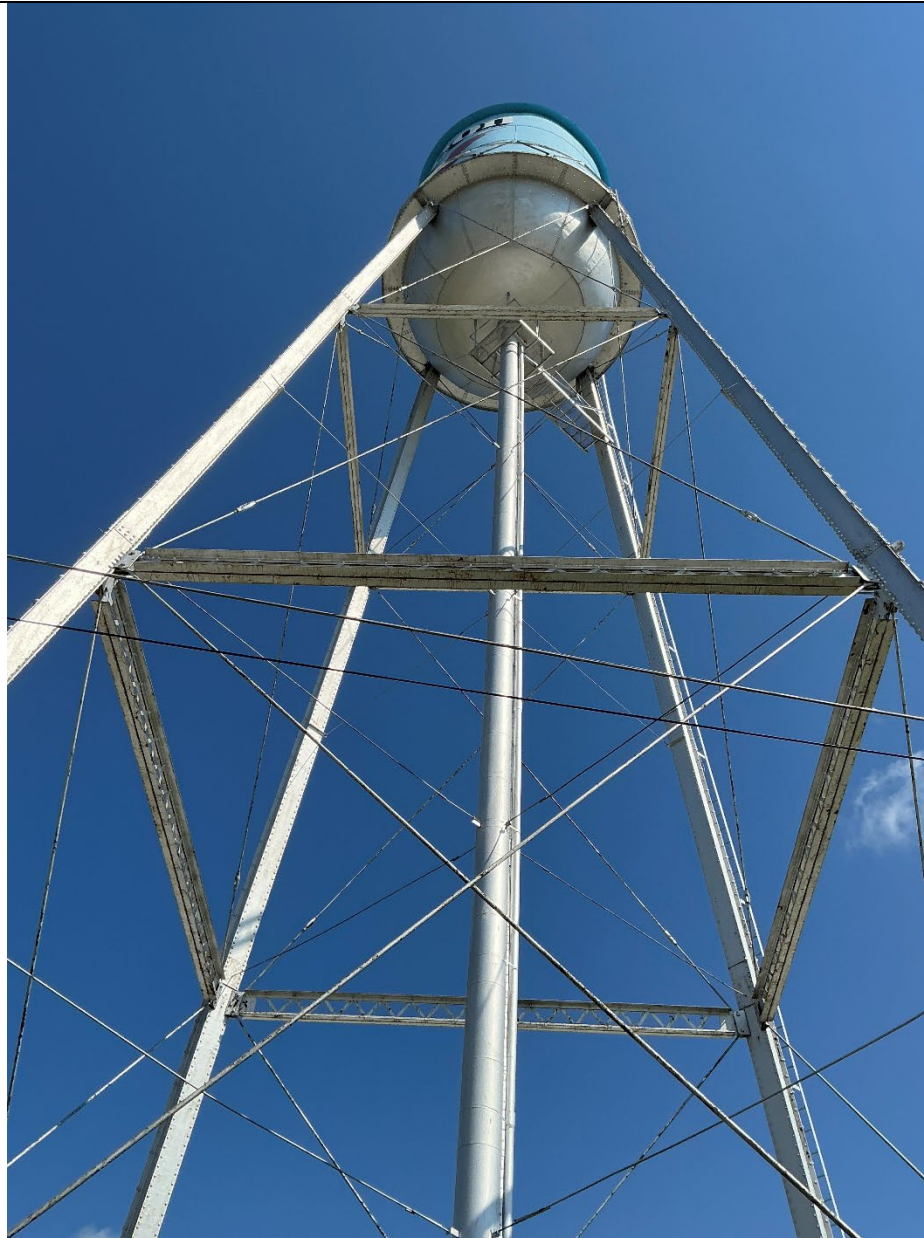
2

The 75,000-gallon Cone Tower was not located inside an area with security fencing (**NOPF 14**). Mr. Sheetz explained that the tower had been painted within the last couple years due to vandalism (photo 2). Security at water towers such as fencing or cameras can help protect water supplies by reducing risk of unauthorized access. I observed the concrete bases of each support leg of the tower and noted one base had deterioration of the concrete base (photo 4). Damage to the tower's foundation can lead to reduced foundational integrity over time. A water tank inspection report conducted on October 19, 2023, identified that the tower is not equipped with a roof vent and vents through air gaps where the roof meets the sidewall of the tower shell. The

report included a picture taken from inside the tank looking up at the roof that documents large gaps with daylight visible along the perimeter of the tower roof, which Mr. Sheetz confirmed was not screened (**NOPF 15**). I discussed this finding with Mr. Sheetz during the inspection and closing conference on August 19, 2025. I asked when he would be able to get this fixed, and he stated it would likely be fixed in a year when the contracted company, Maguire, was expected to visit the tower.

75,000-gallon Cone Tower without a roof vent and venting through unscreened air gaps where the roof meets the sidewall of the tower.

Following the inspection and after discussions with EPA staff, I explained to Mr. Sheetz via phone call and email on August 25, 2025, August 26, 2025, and August 27, 2025, that the unprotected openings of the tower posed a significant issue and needed to be addressed as soon as possible to minimize the potential risk of contamination of water supplied to consumers. On September 2, 2025, Mr. Sheetz provided me with a written plan and schedule to address this finding (Attachment 9). His response specified that measures to address the unprotected openings were expected to be implemented no later than September 30, 2025. The planned measures include using a sealant to close the gaps between the tower walls and the tower roof and adding a vent to the roof.

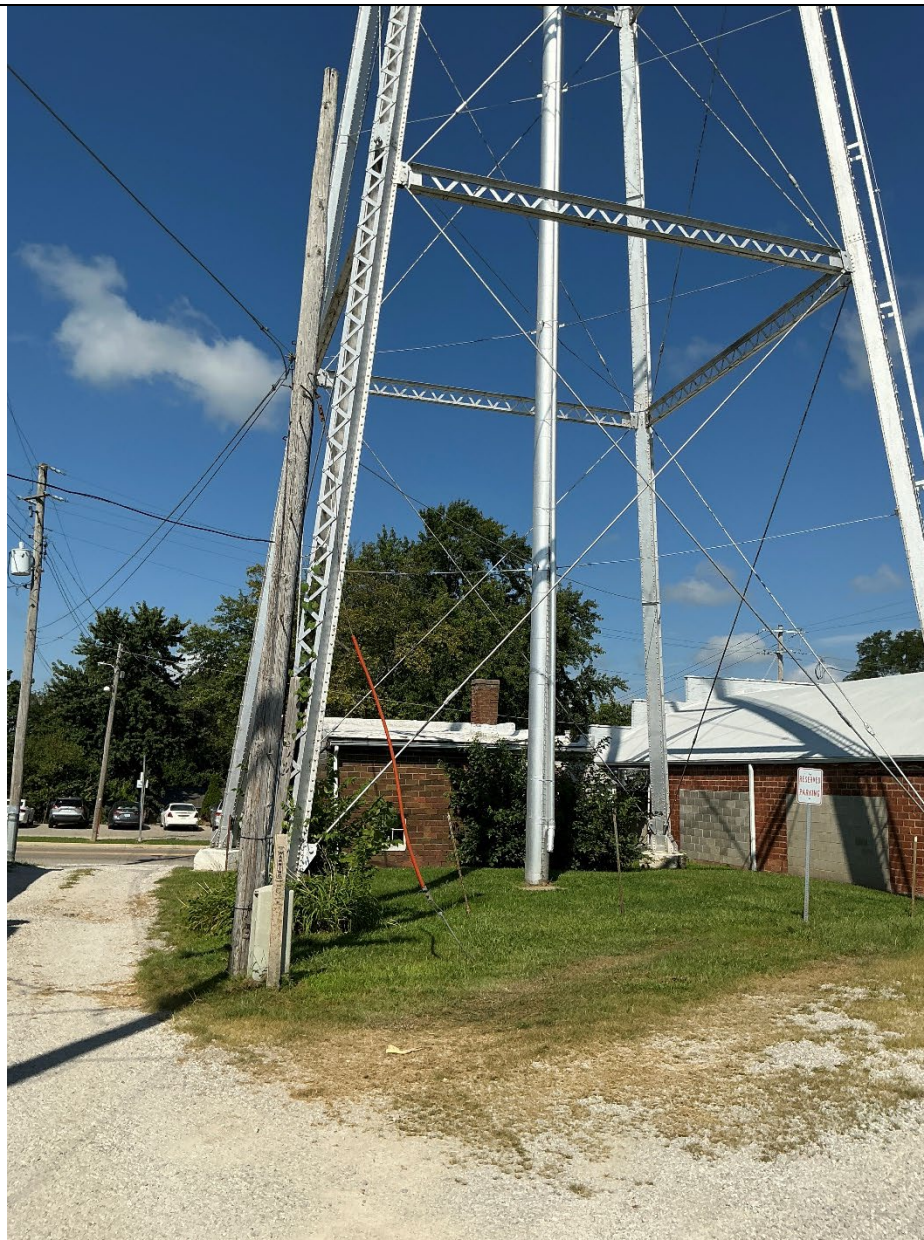
Base of the 75,000-gallon Cone Tower.

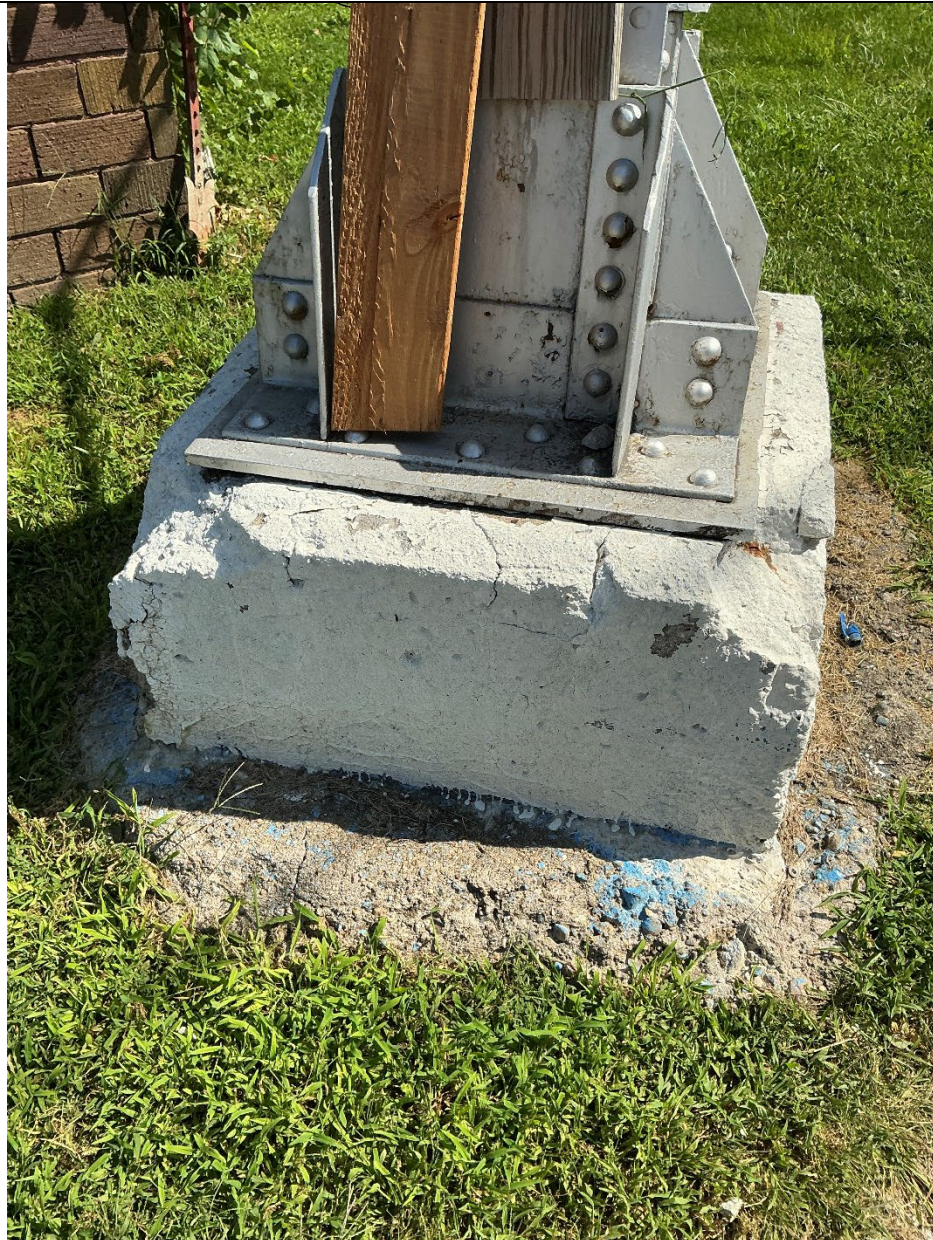
Deterioration of the concrete foundation supporting one of the legs of the 75,000-gallon Cone Tower.

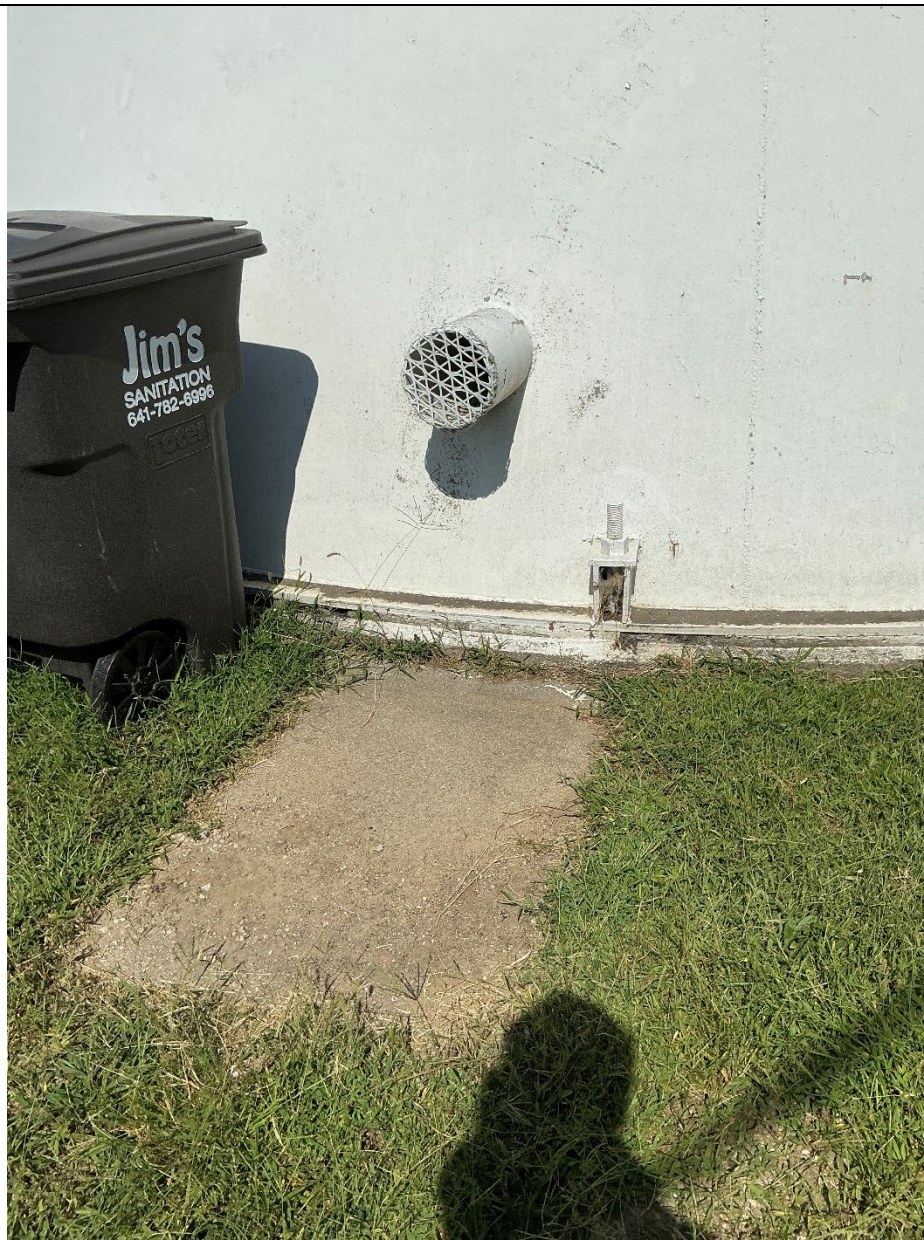
5

200,000-gallon Sphere Tower overflow does not have 24 mesh.

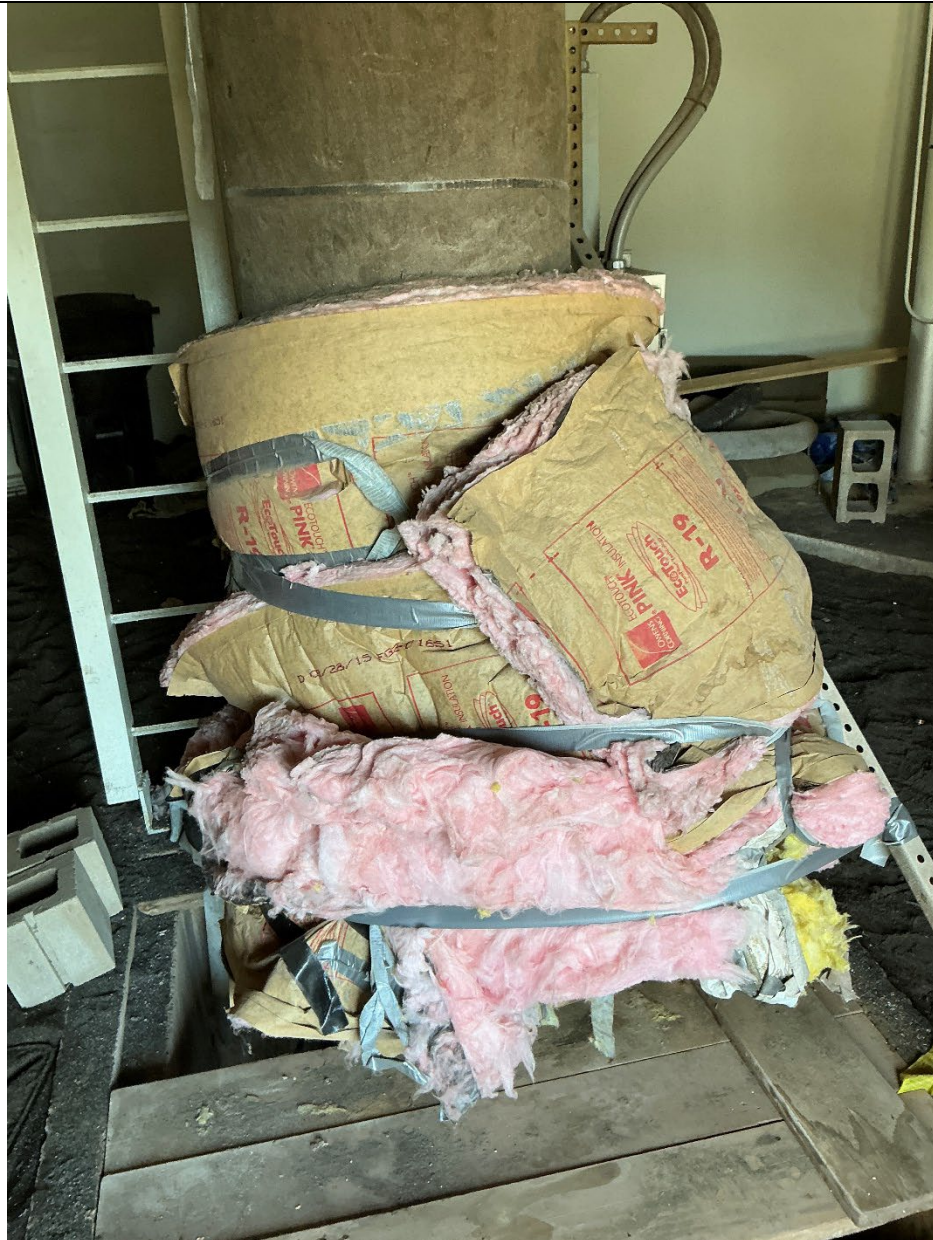
6

200,000-gallon Sphere Tower interior.

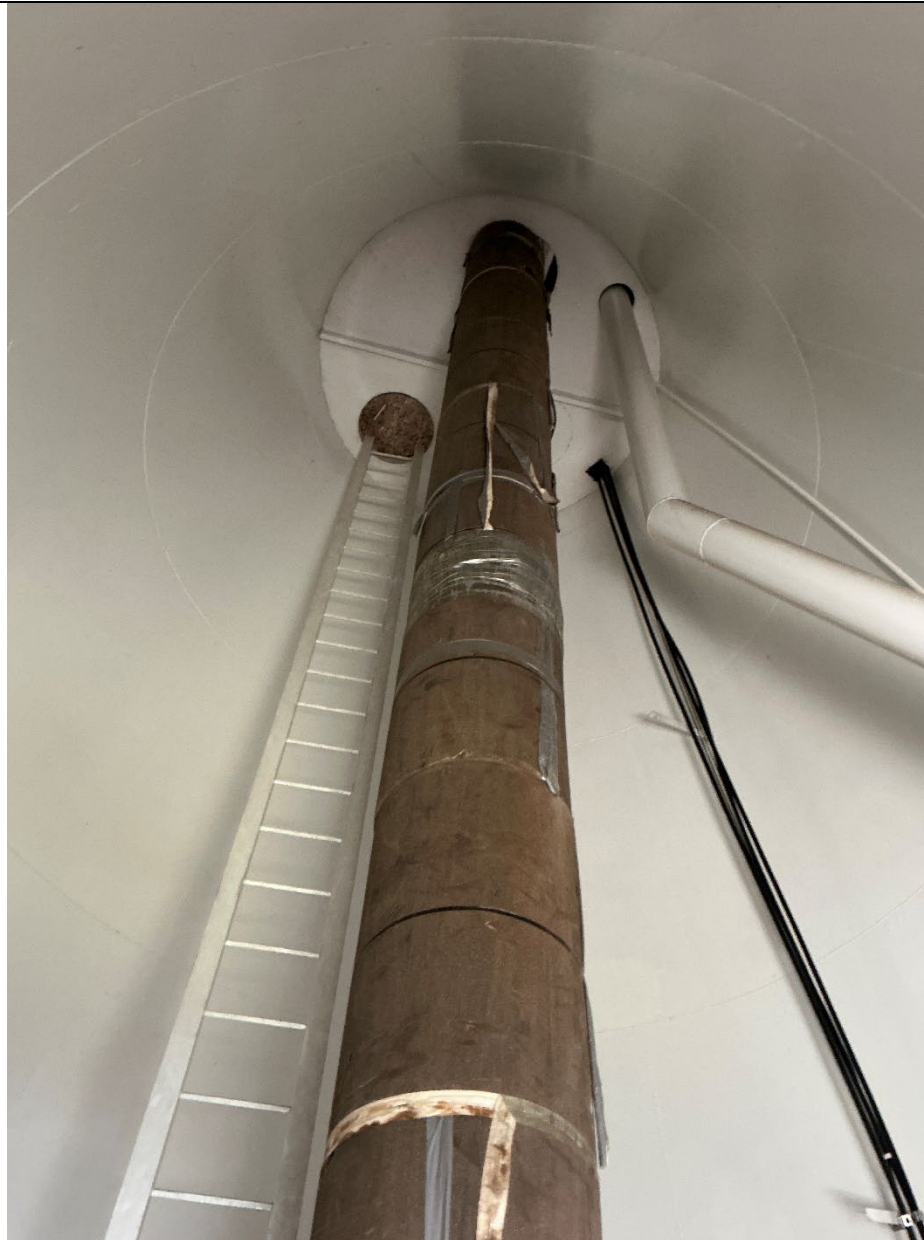
7

200,000-gallon Sphere Tower interior.

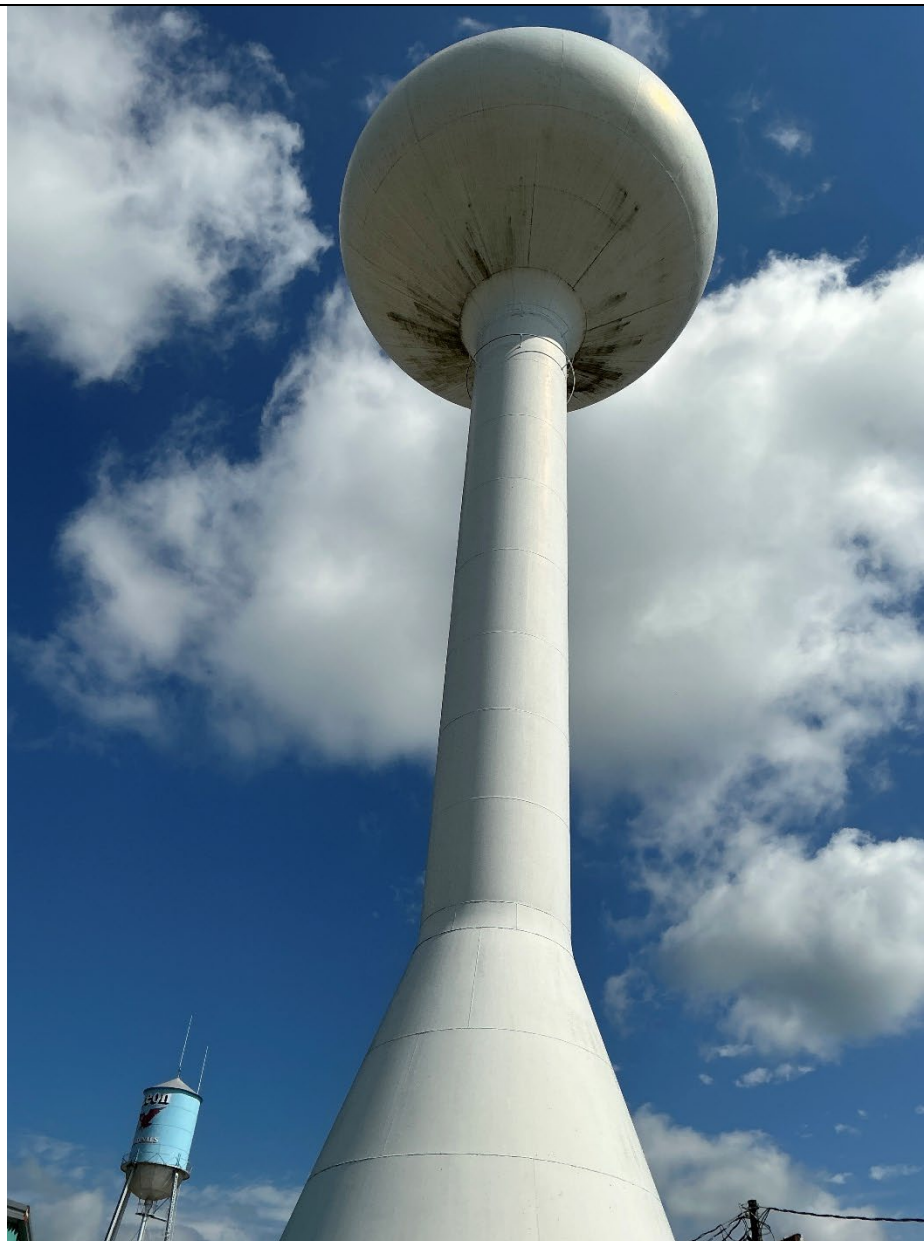
The Sphere Tower was located nearby and was also not located inside an area with security fencing (**NOPF 14**; photo 8). According to the 2025 tower report and Mr. Sheetz, the finished water access hatch also did not have a watertight seal (**NOPF 16**). Watertight seals on finished water storage structures can help keep contaminants such as birds, insects, etc. out of the finished water supply. I observed the overflow mesh was larger than 24 mesh and not downturned (**NOPF 17**; photo 5). 24 mesh screens on finished water overflows can help keep contaminants such as vectors out of the finished water supply. This is a repeated finding from IDNR's 2023 SS. There was a garbage can immediately next to the unprotected overflow (photo 8). I observed mildew on the exterior of the tower (photo 8). Mildew growing on water storage can lead to deterioration of the protective coating and increase repair costs. Following the inspection, Mr. Sheetz stated that Maguire had visited and was beginning the process of painting the Sphere Tower.

200,000-gallon Sphere Tower exterior.

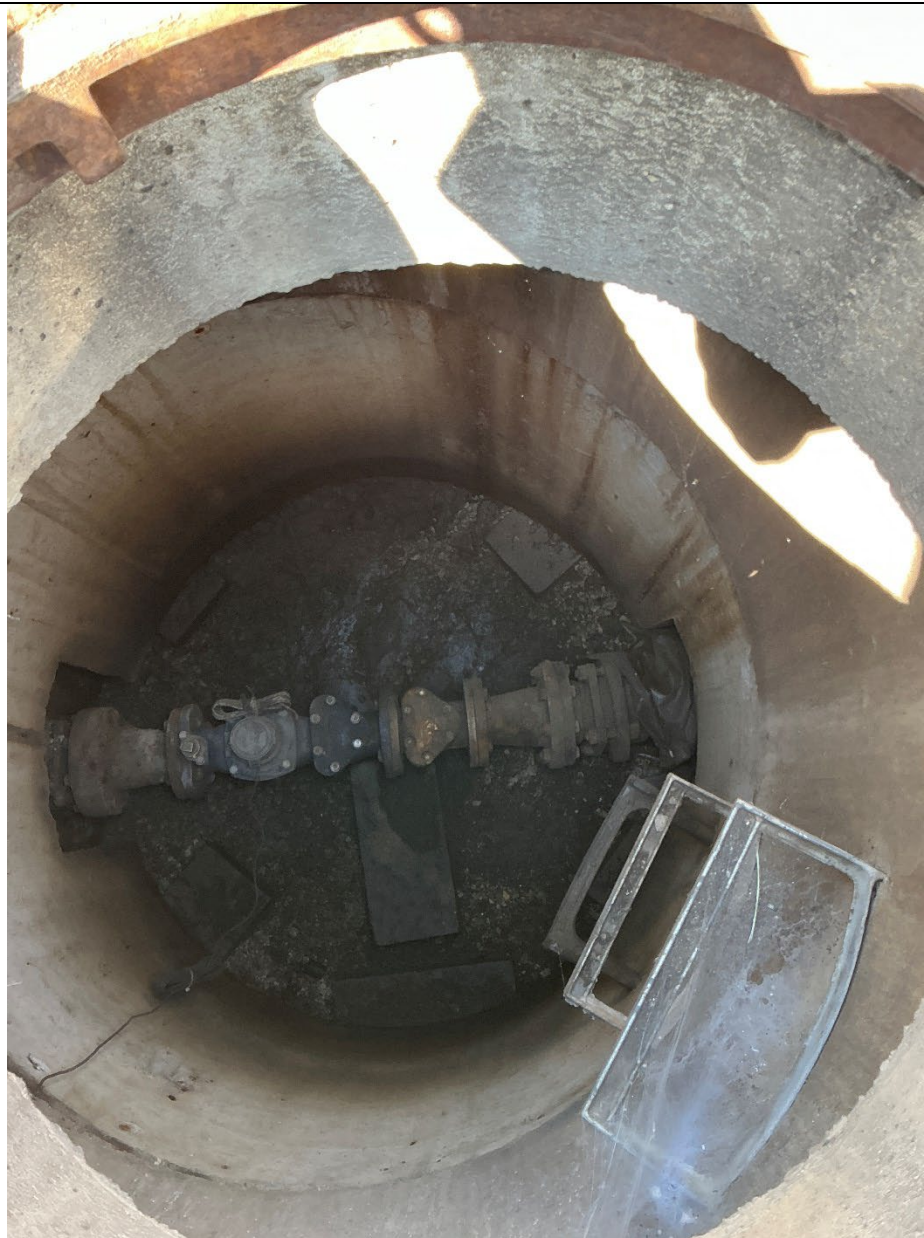
Meter pit connection with the SIRWA system. Owned by SIRWA.

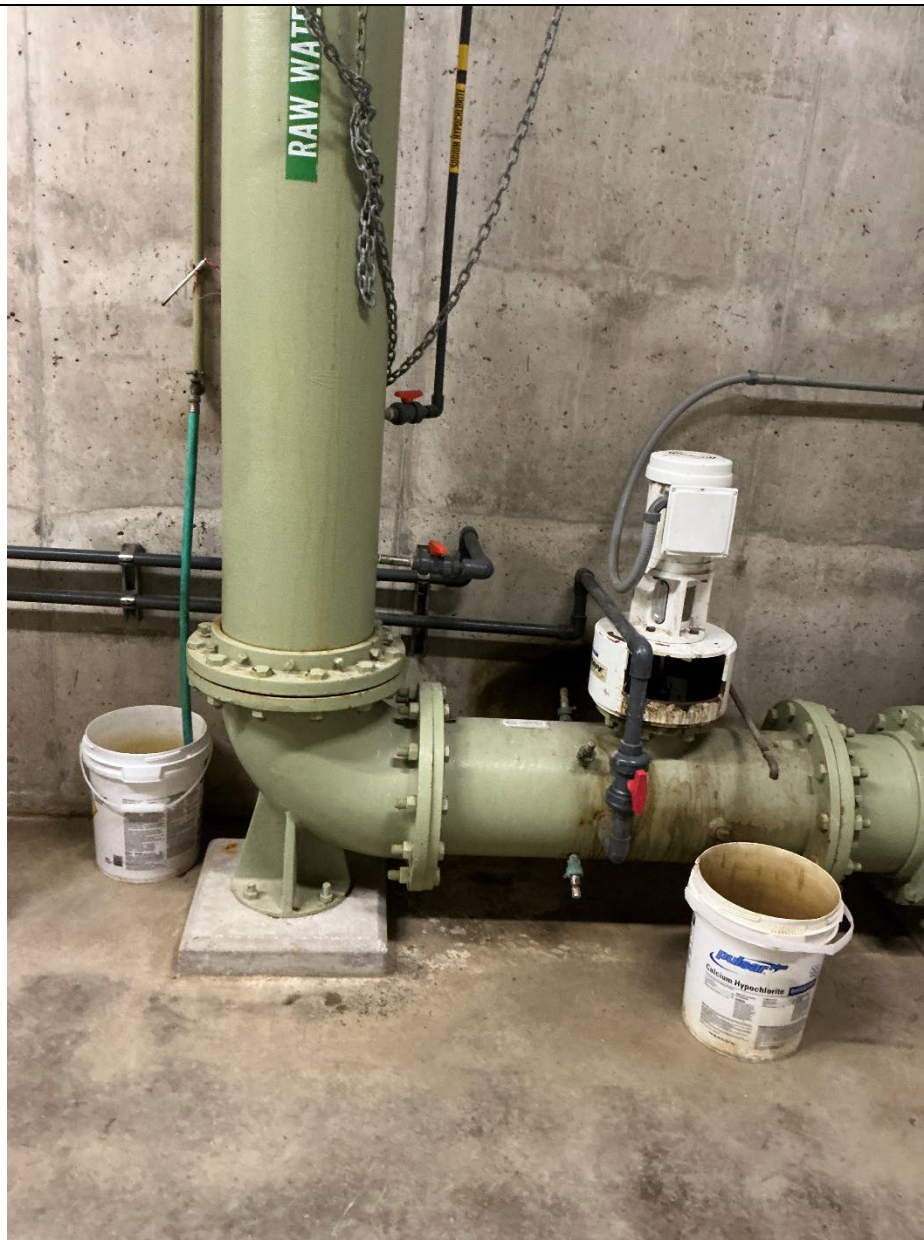
10

Water Treatment Plant raw water entry point and first sampling location.

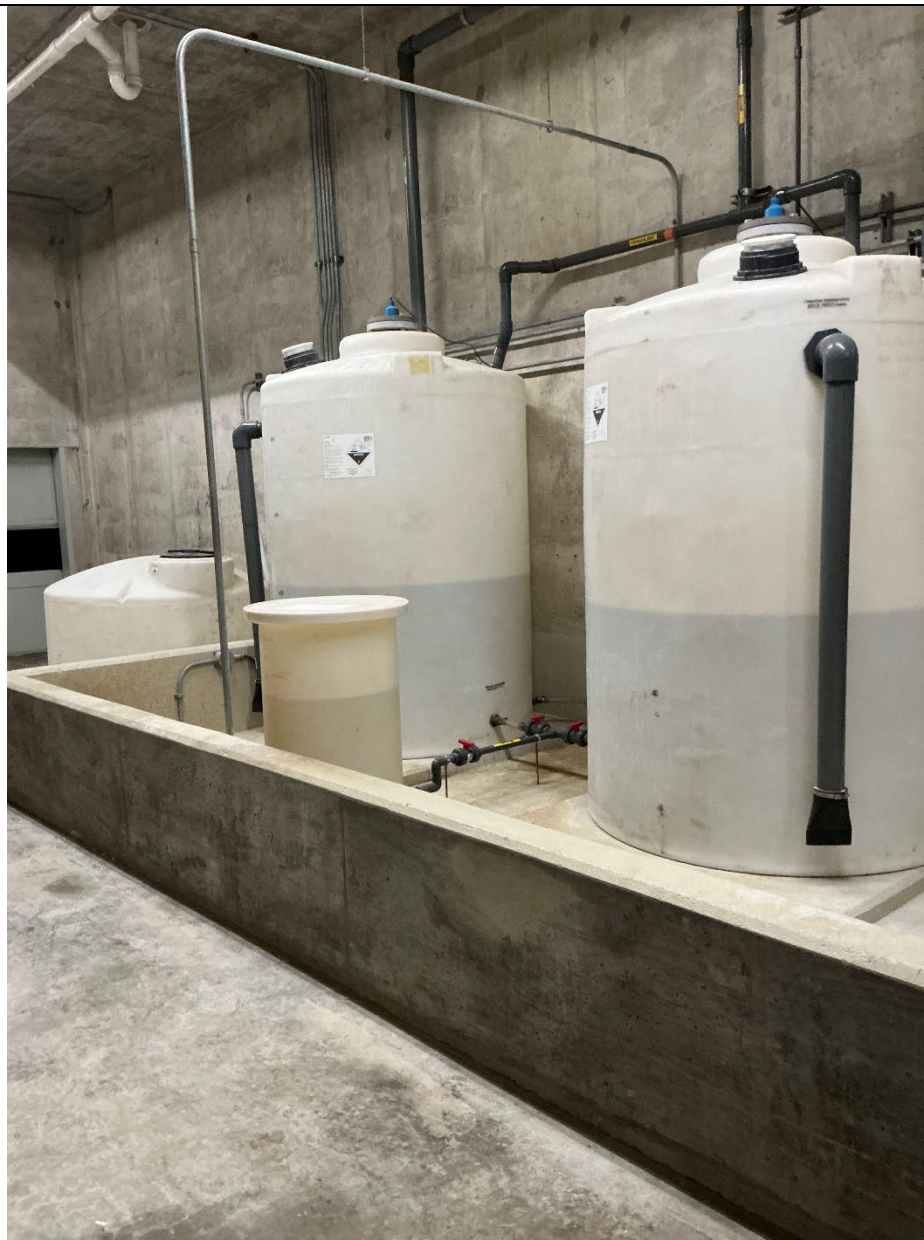
11

Coagulants with secondary containment.

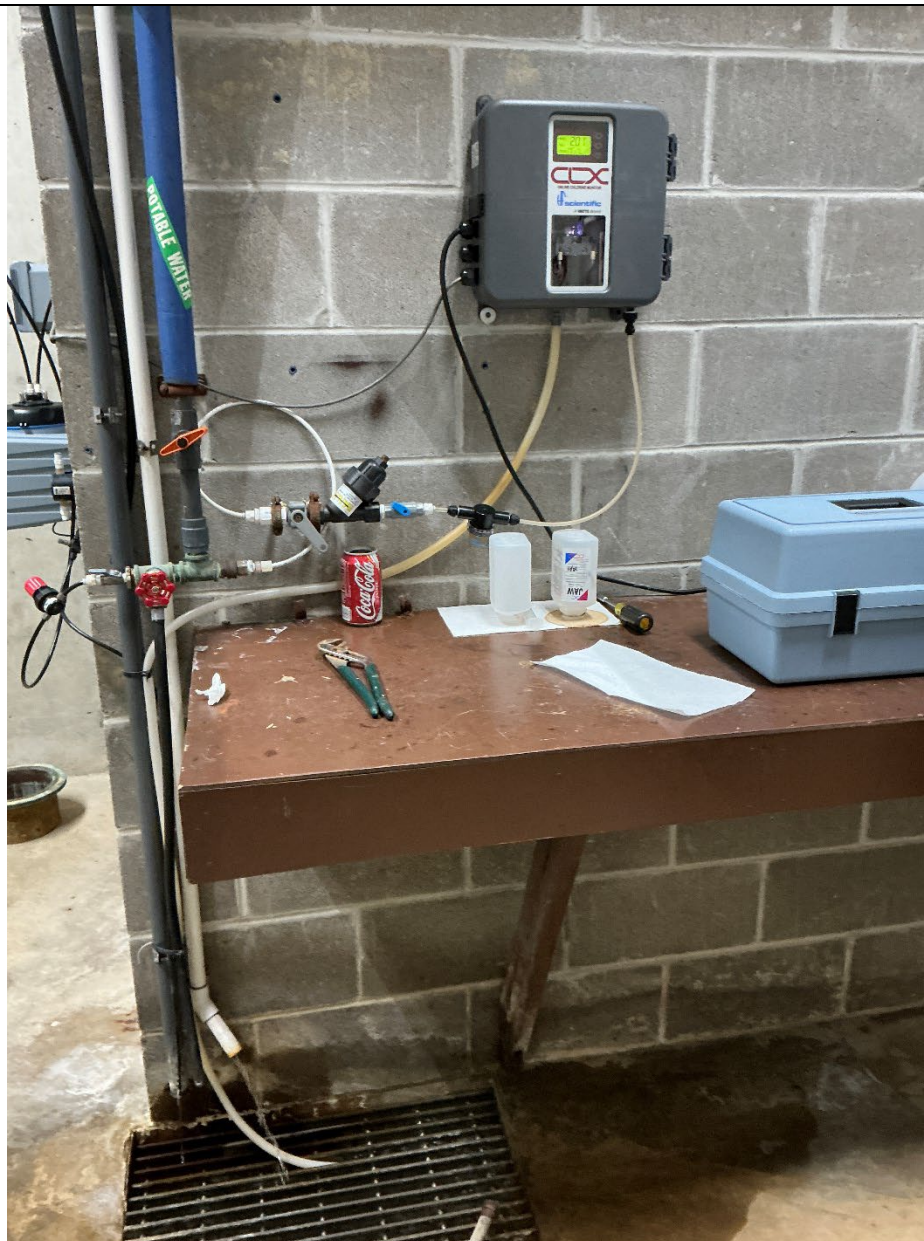
12

Second sampling point in the WTP.

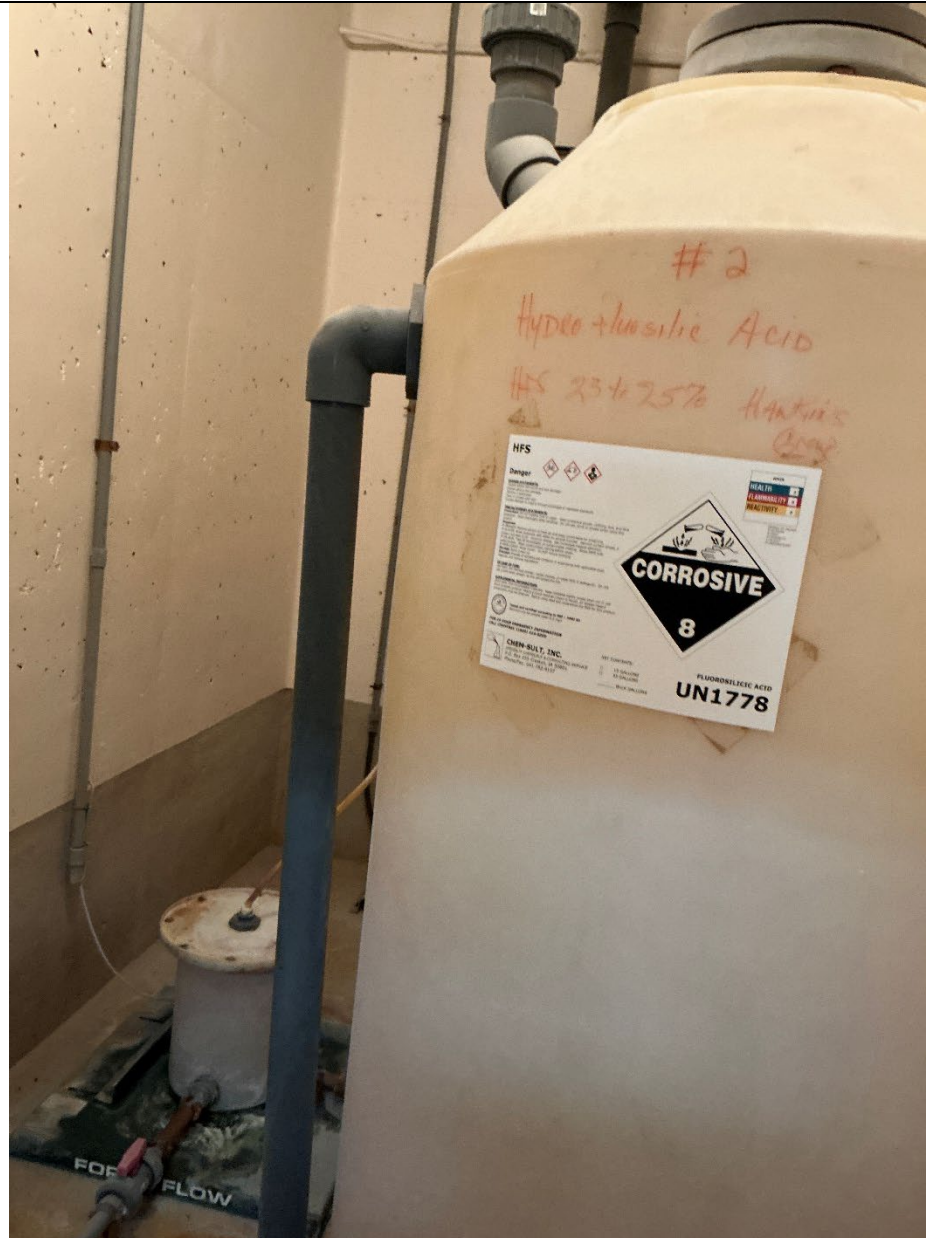
Hydrofluorosilicic acid tank.

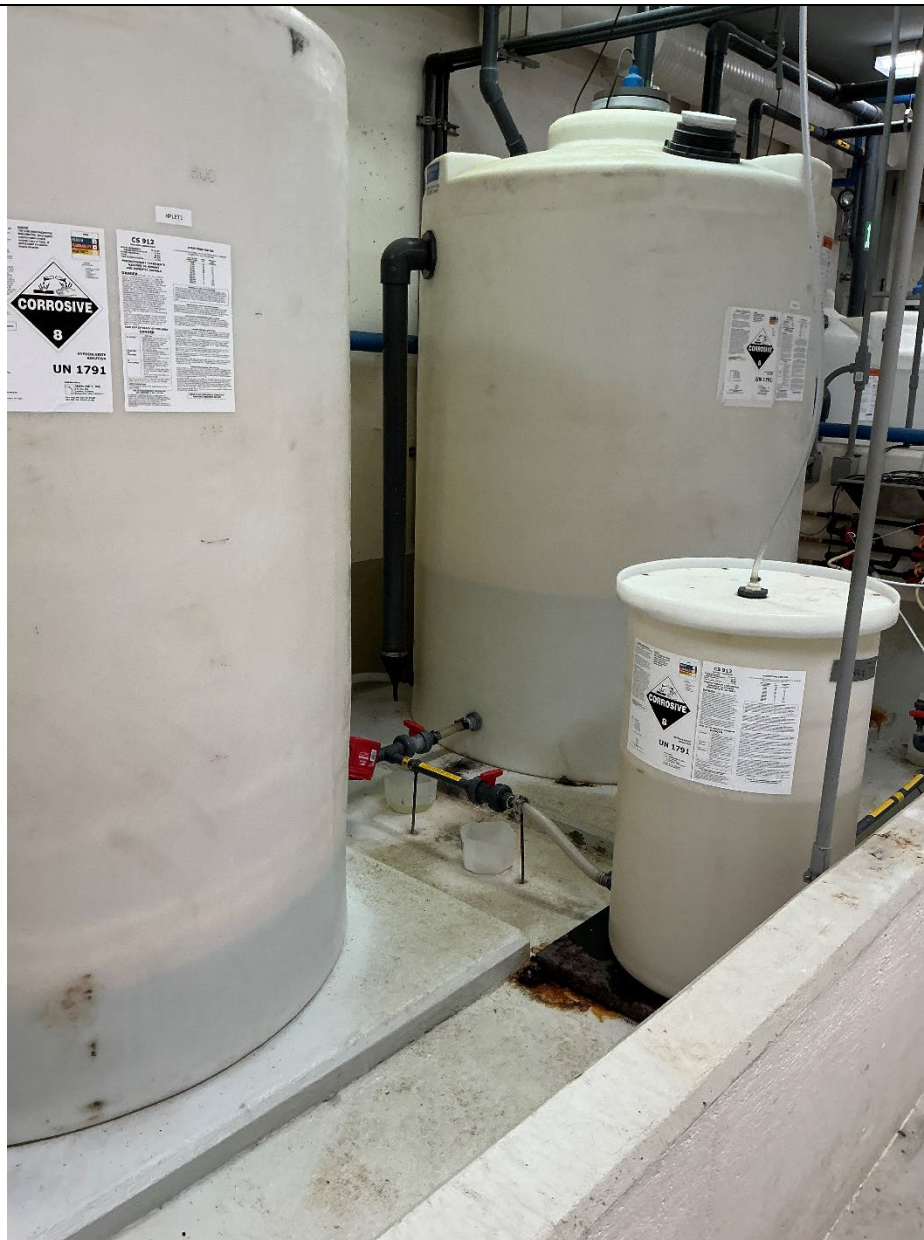
Coagulants with secondary containment.

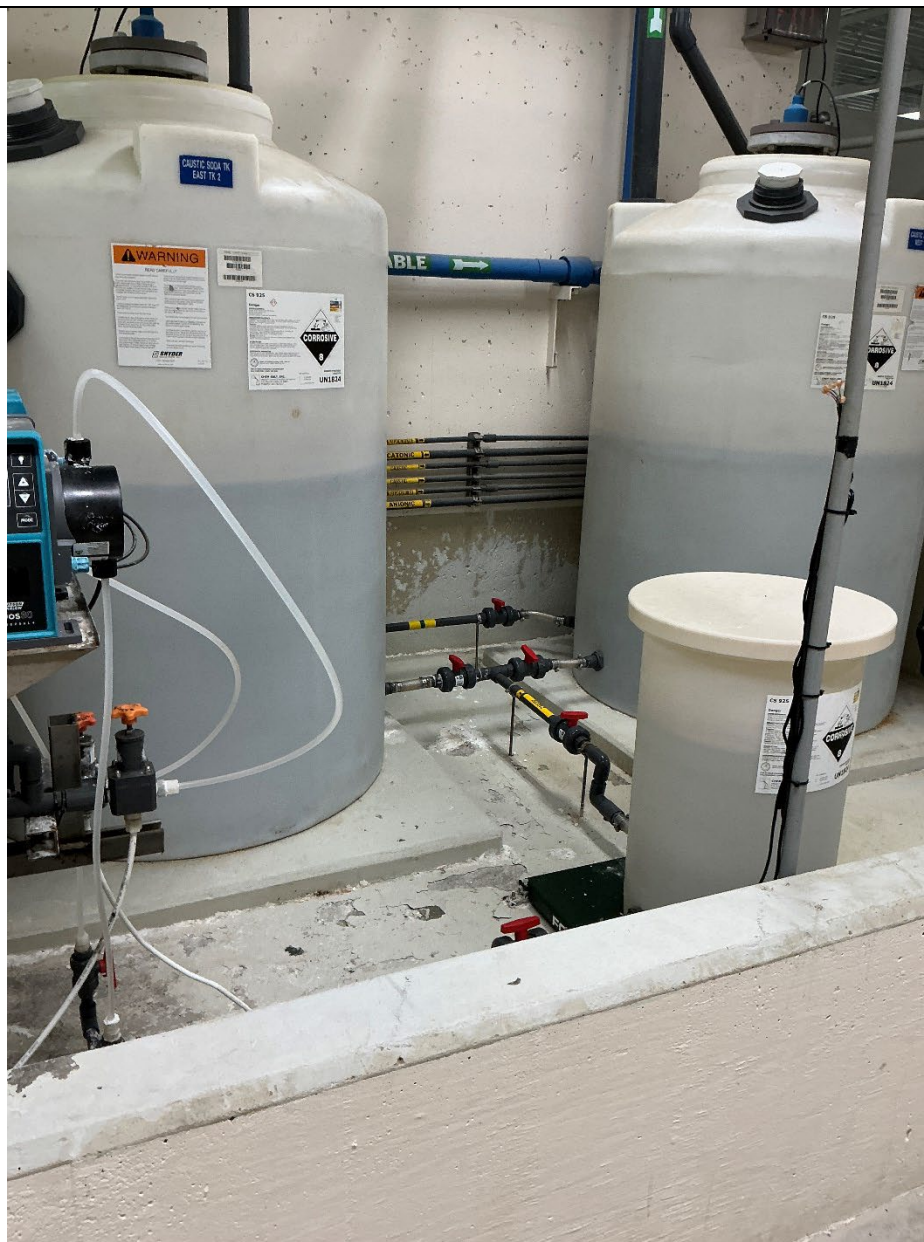
15

Caustic soda with secondary containment.

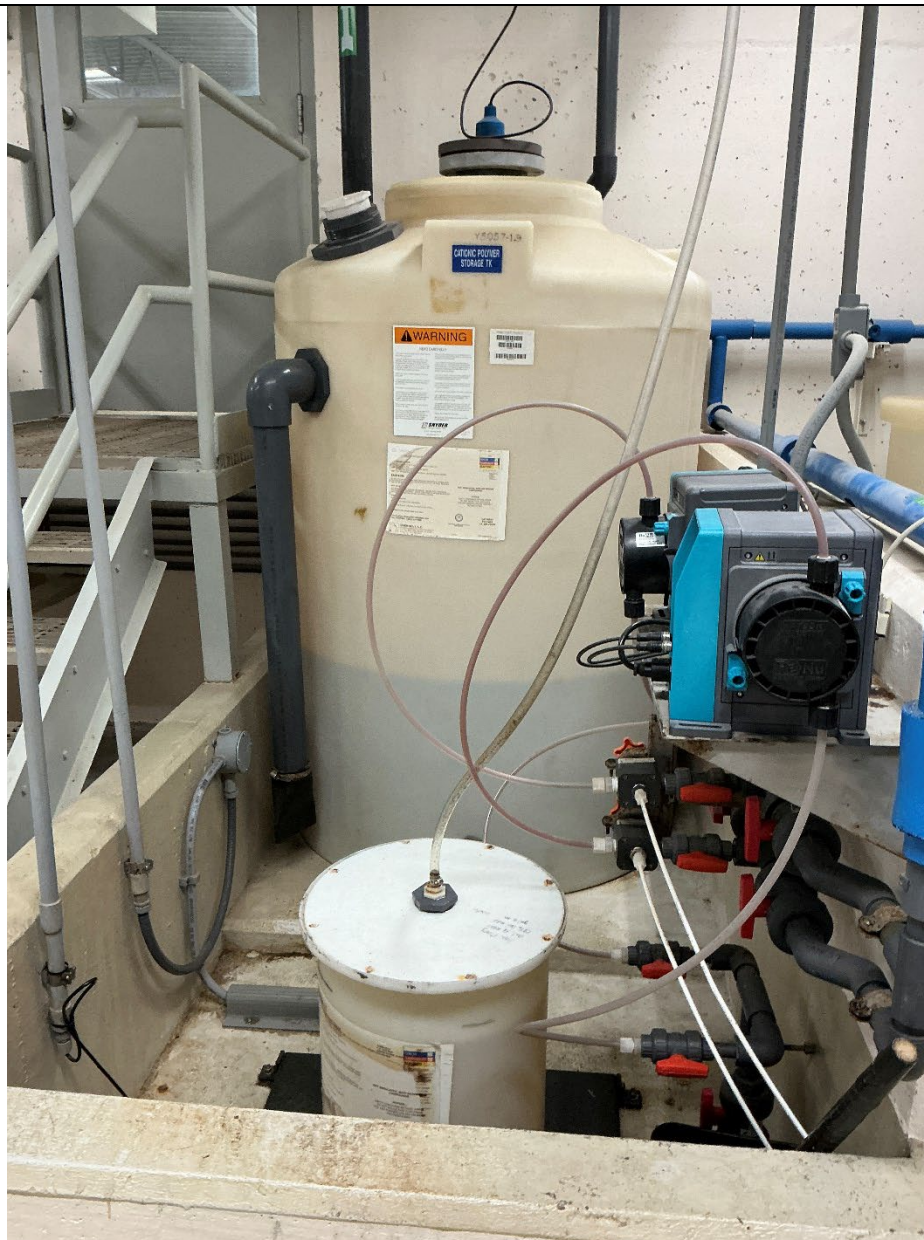
Cationic polymer with secondary containment.

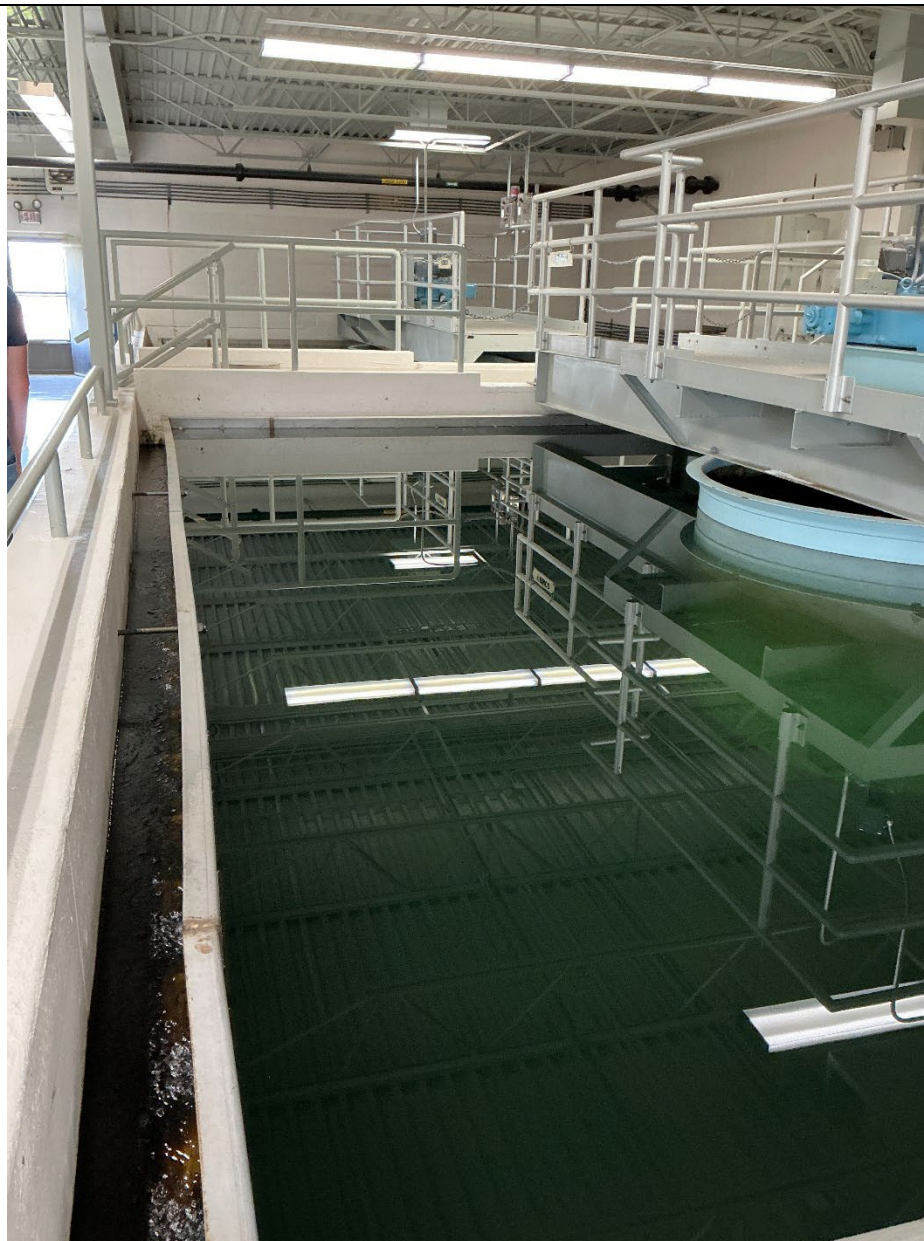
I observed the two 300 GPM clarifiers, which appeared to be free of excess corrosion or buildup (photos 17 and 18). I did not observe any structural issues with the clarifiers, and the weirs appeared to be level. I then observed the 4 filter beds, which Mr. Sheetz said were dual-media gravity filters. Mr. Sheetz explained that they contain granulated activated carbon, gravel, and sand (photo 19). According to IDNR's 2023 SS, the carbon had been replaced on all four filters and the sand and gravel was replaced on two of the filters in 2022. IDNR's 2023 SS also indicates that before 2022, the previous carbon was replaced in 2018. According to the 2023 IDNR SS, Mr. Sheetz explained at that time that he thought that the media should be replaced or replenished more frequently than every 4 years. During the inspection, Mr. Sheetz explained that based on his observations, that the GAC accumulates more manganese after it has been in use for a couple years. However, the system may be due for regular replacement of the GAC based on past replacement history and statements from the 2023 SS. The system did not have a written procedure on when inspections and replacements of filter media should occur (**NOPF 6**). Filter media can be lost over time and mineral deposits and biofouling can cause media to lose its treatment effectiveness. A written procedure can help identify when media concerns need to be evaluated and addressed.

300 GPM clarifier.

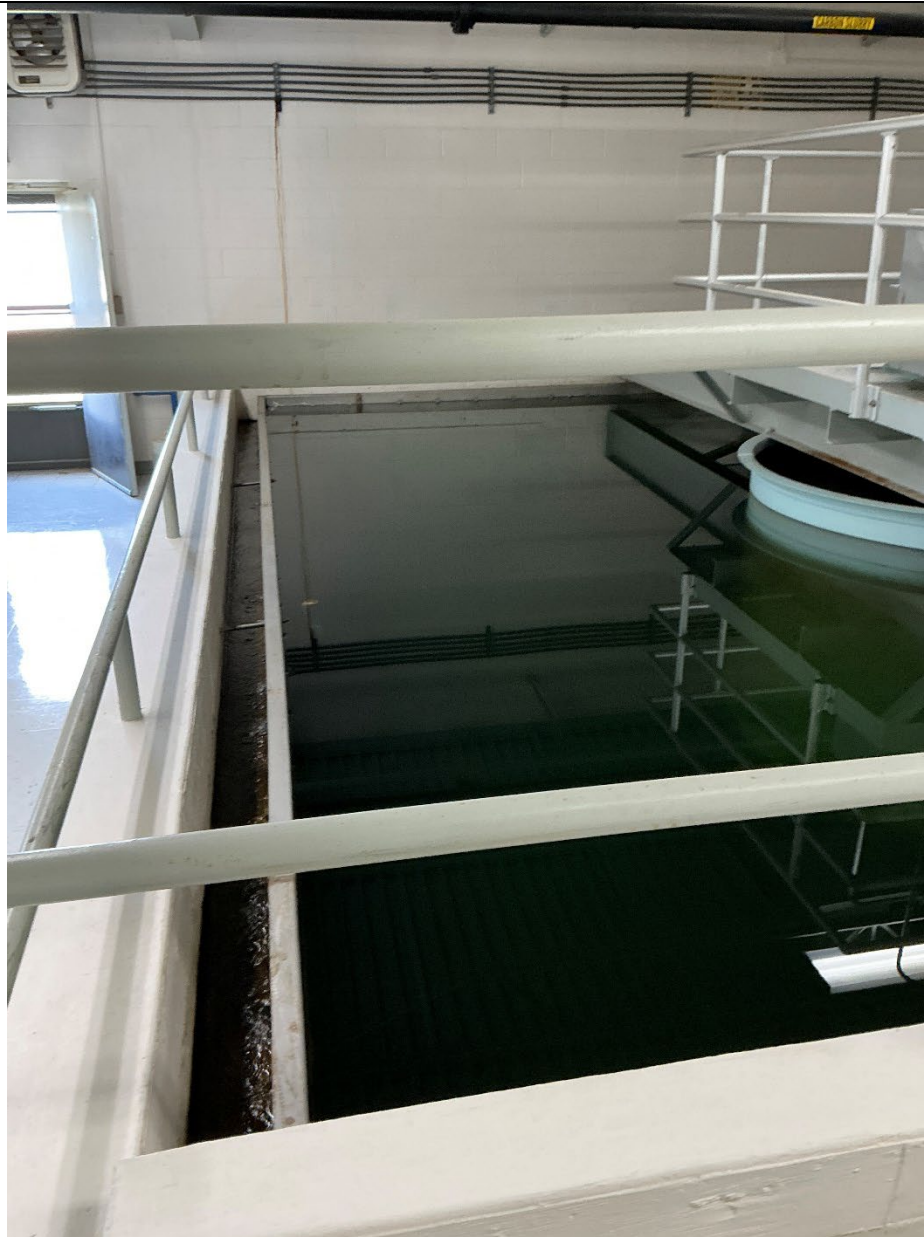
18

300 GPM carifier.

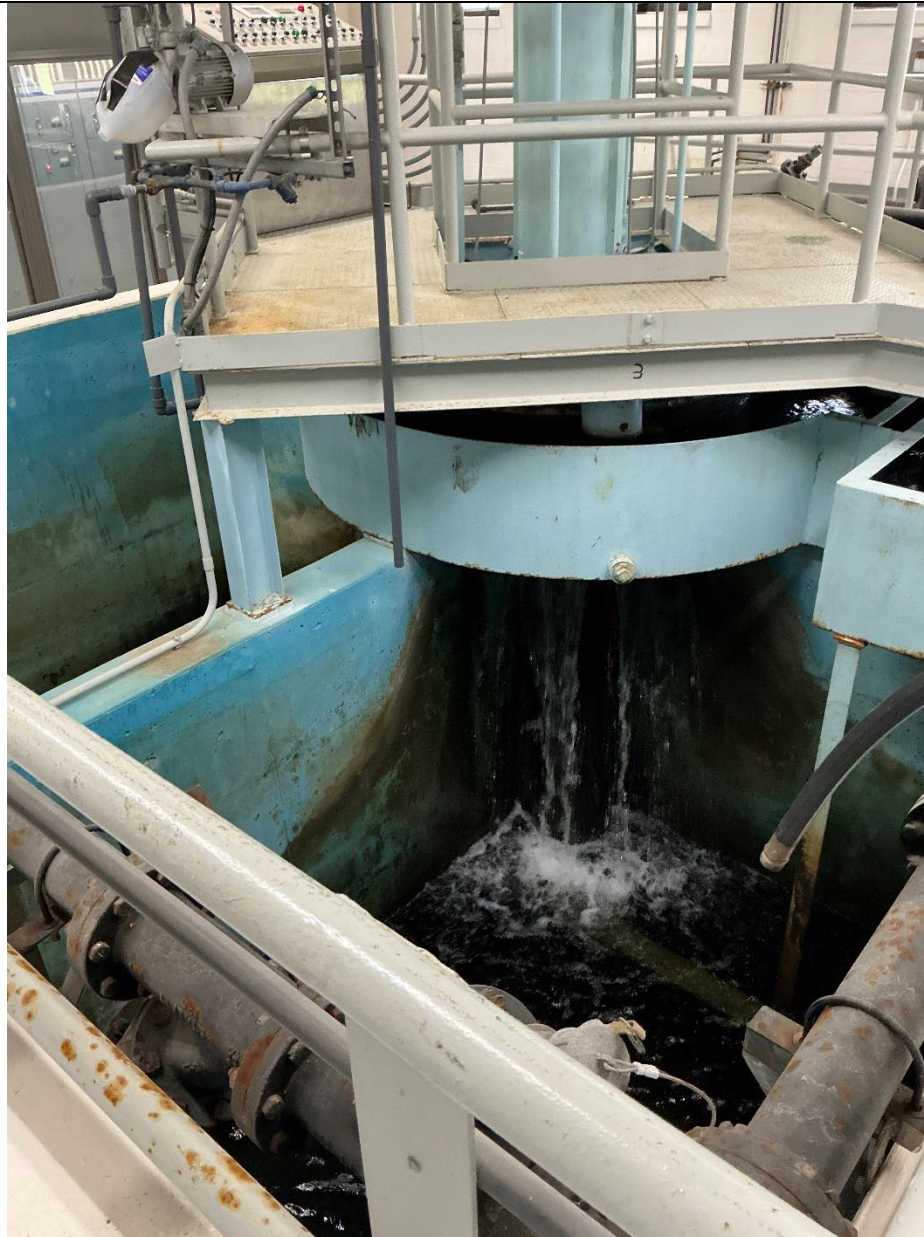
19

GAC, sand, and gravel filters.
