# **REPORT OF COMPLIANCE EVALUATION INSPECTION**

**Leon Water Supply  
104 West 1st Street  
Leon, Iowa 50144  
Public Water Supply ID: IA2742076**

**August 19, 2025**

**U.S. ENVIRONMENTAL PROTECTION AGENCY  
Region 7  
Enforcement and Compliance Assurance Division (ECAD)**

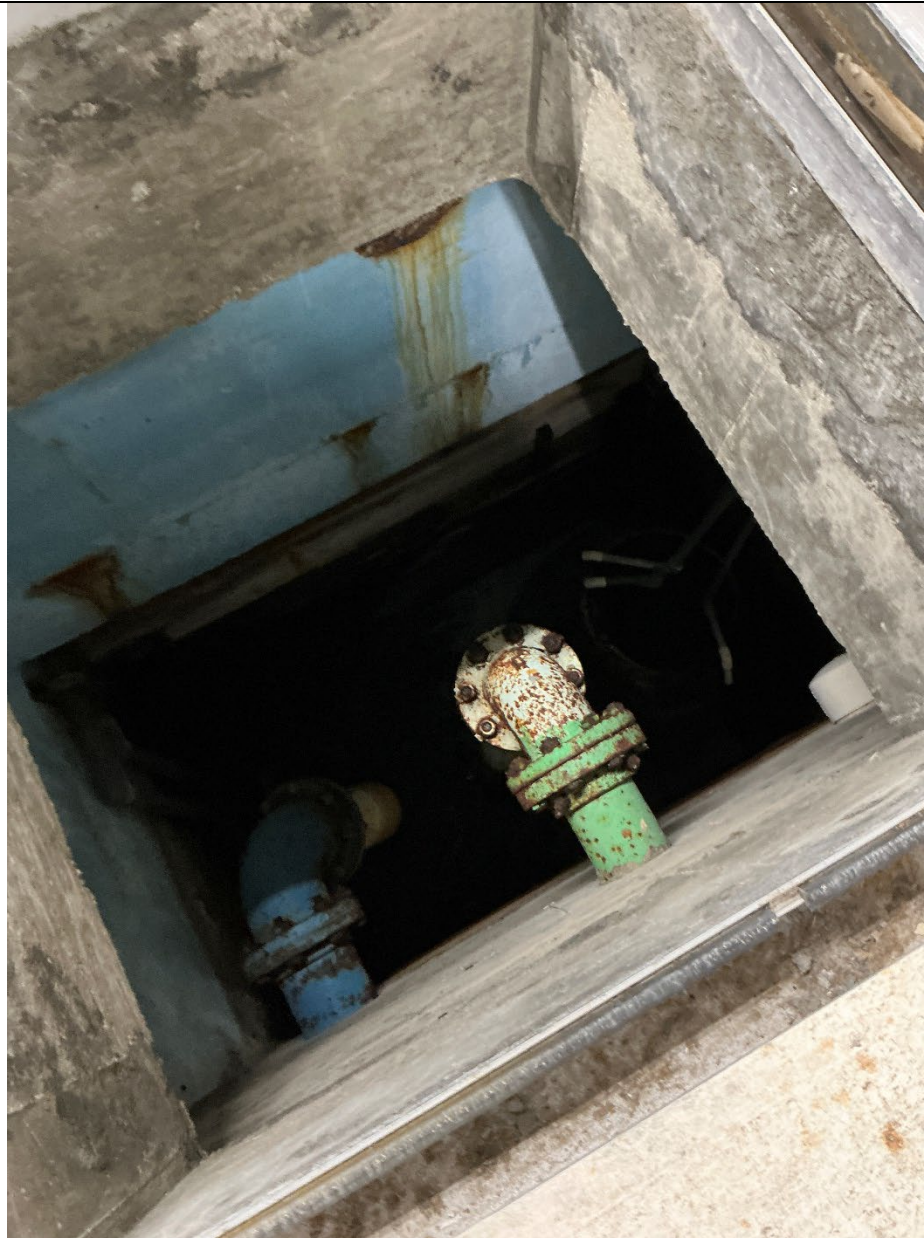
Mr. Scheetz explained that the system has an ammonia injection point that is not in use (photo 20). He said that the pit capable of injecting ammonia has a redwood bottom that needed to be removed and replaced with concrete before an ammonia injection site would be functional for chloramines. He explained that prior to entering the 300,000-gallon clearwell, sodium hypochlorite is added to the flow for disinfection in addition to fluoride.

Basin with redwood bottom that is planned to be replaced with concrete. Ammonia injection point planned to provide distribution system with chloramines under Bilateral Compliance Agreement (BCA) with the State.

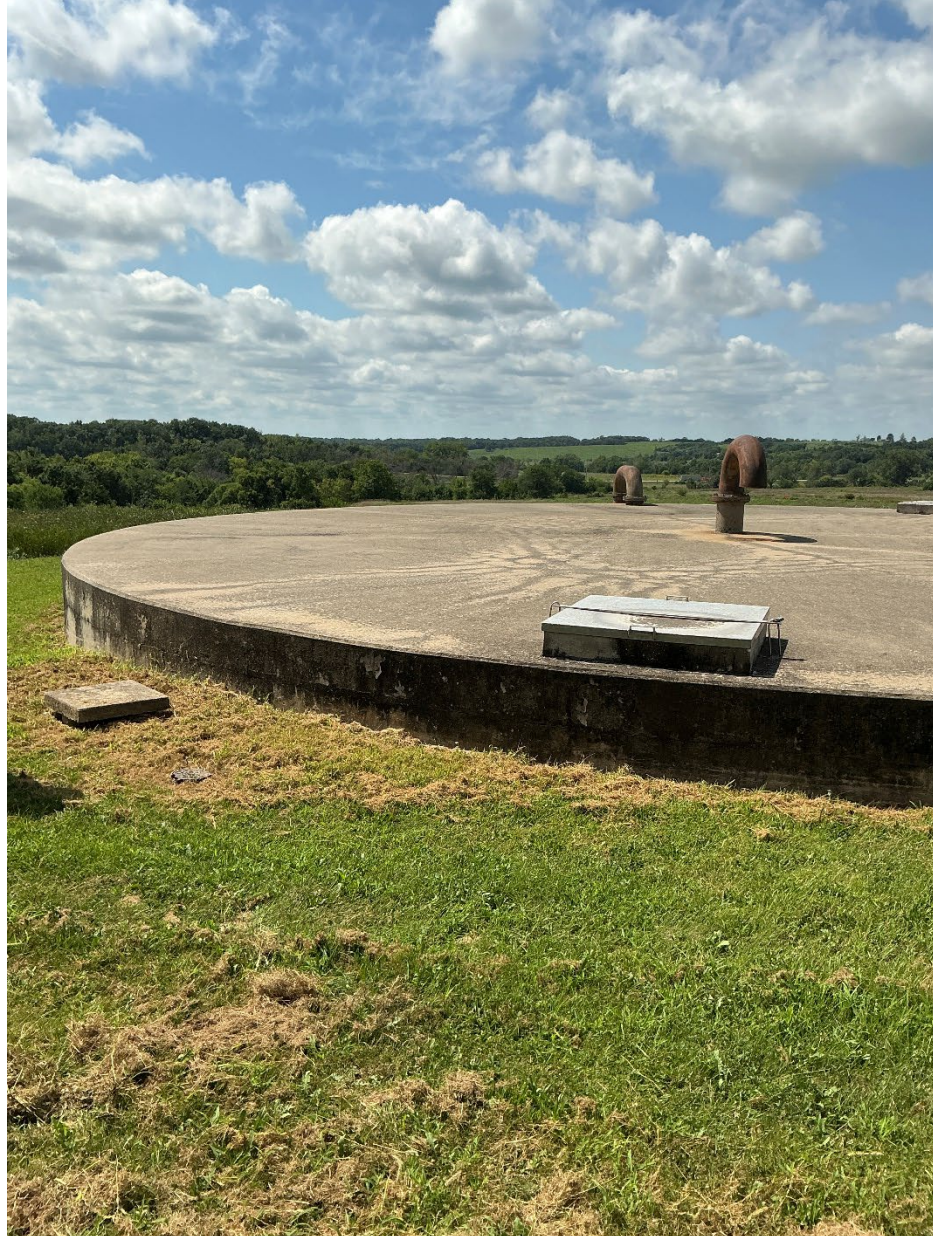
21

The 300,000-gallon clearwell was constructed of concrete and located immediately outside of the WTP (photo 21). Mr. Sheetz stated that the clearwell is used for chlorine contact time. I asked for the last inspection report for this clearwell, and Mr. Sheetz said there were not any available. I asked Mr. Sheetz if he could estimate the last time it had been inspected, and he gave an estimate of about 15 years ago (**NOPF 11**). I observed superficial cracks along the rim of the clearwell, but none on the top. I did not observe any signs of water leaking or burrows in the soil surrounding the clearwell. The clearwell's vent and overflow were both downturned and screened with 24 mesh. Mr. Sheetz opened the access hatch, revealing there was not a gasket or watertight seal (**NOPF 12**; photo 21). Watertight seals help keep contaminants such as vectors from entering the finished water supply.

300,000-gallon clearwell. Finished water access hatch does not have gasket/watertight seal. No inspection report available.

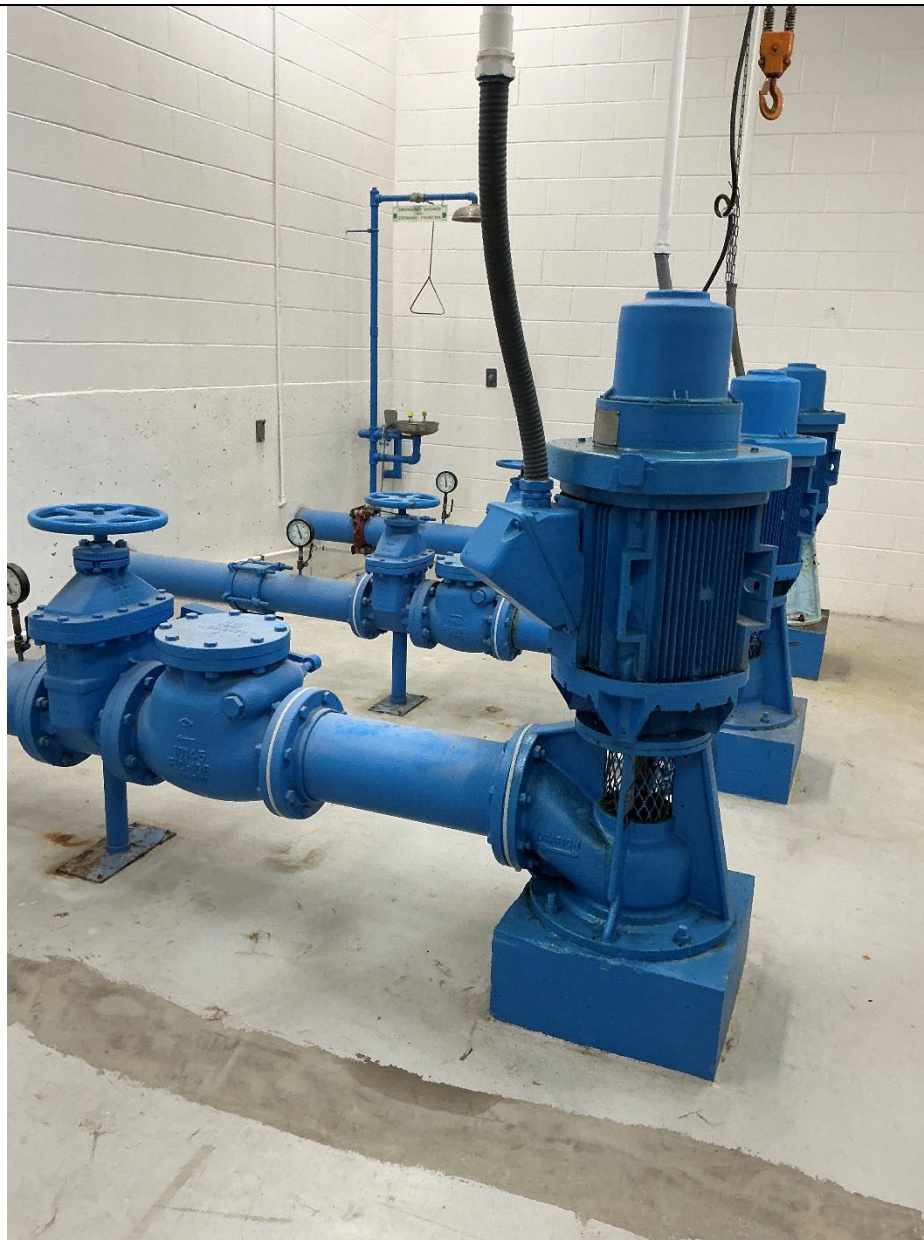
22

WTP high service pumps.

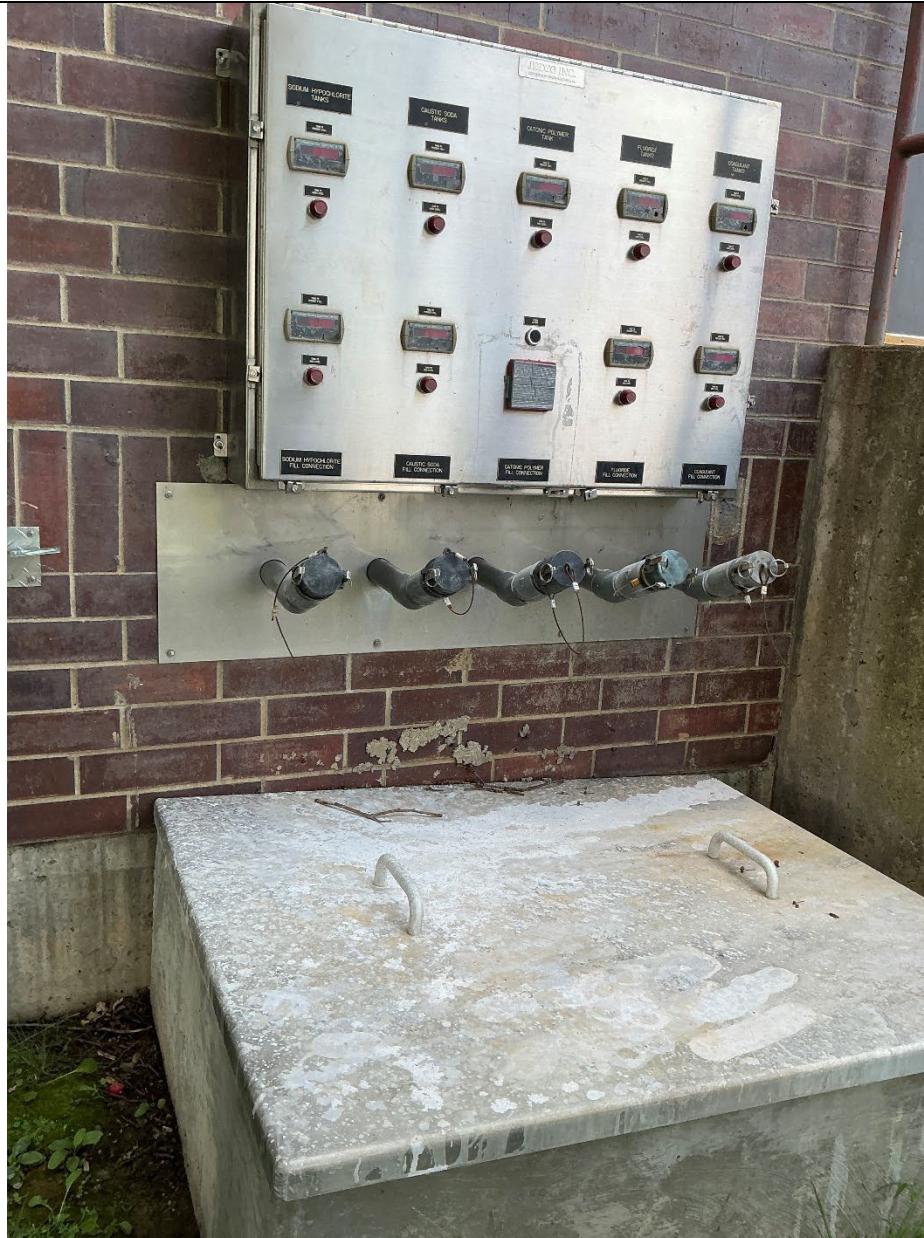
23

Outside the WTP building, the system has a bulk fill station with sodium hypochlorite, caustic soda, cationic polymer, fluoride, and coagulant available for trucks to refill treatment chemicals (photo 23). Each of the connections were unlocked and led directly into the WTP chemical storage/dosage tanks. Mr. Sheetz explained that the company who fills the bulk chemicals will typically call ahead before arriving, but a staff member from the system does not regularly accompany them during chemical filling. The bulk fill stations did not have physical access

restrictions such as locks and were not in a fenced area (photo 23). I noted that the bulk chemical fill station protections and procedures are inadequate to protect against mishandling or tampering (NOPF 9). If chemicals were filled into the wrong chemical storage, there would be significant risk for the system's treatment ability to be disrupted. Bulk fill access restrictions, such as locks with keys held by system personell, can help ensure bulk chemical providers are only able to fill the correct chemical storage.

Bulk fill chemical station with inadequate protections.

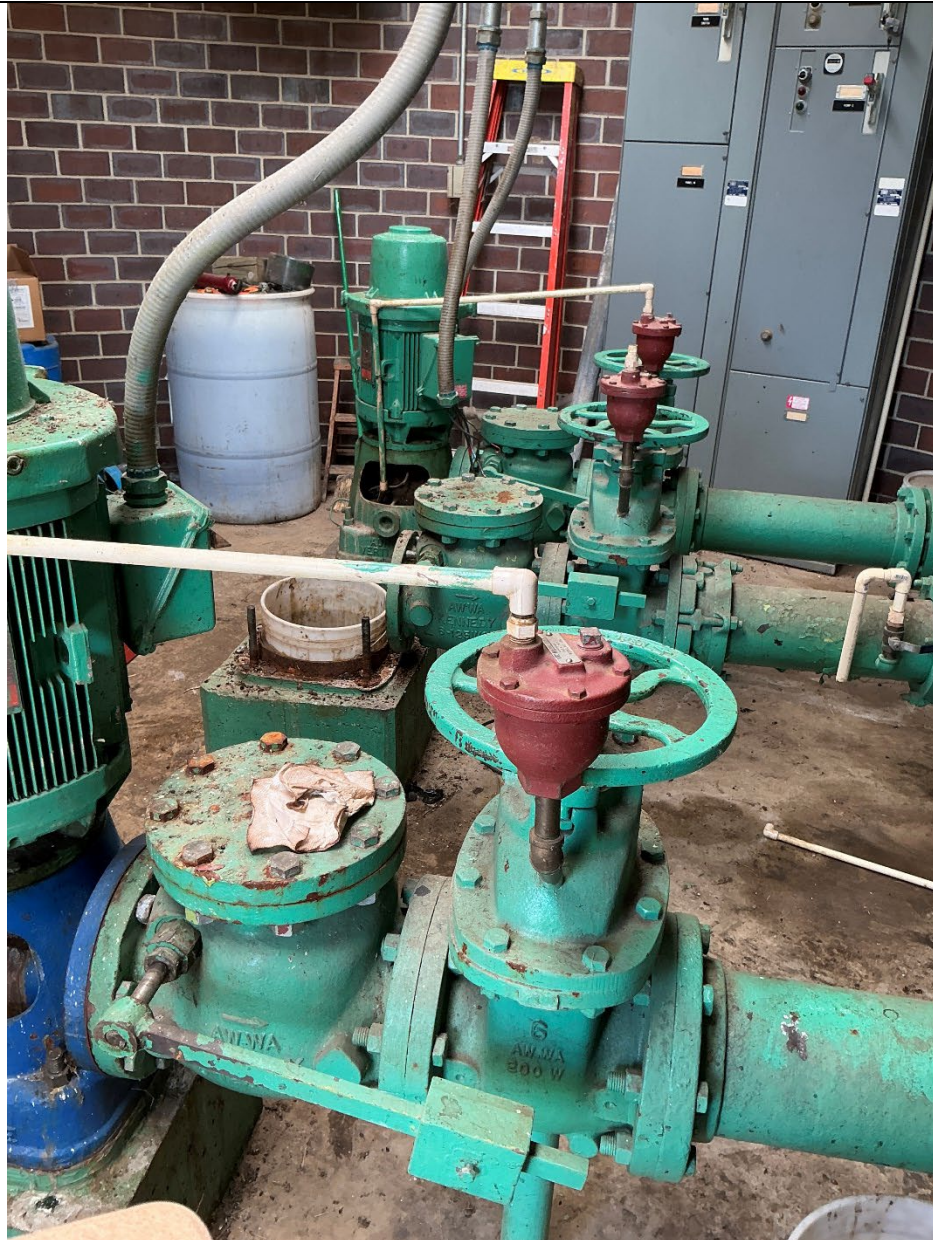
24

Raw water pumps.

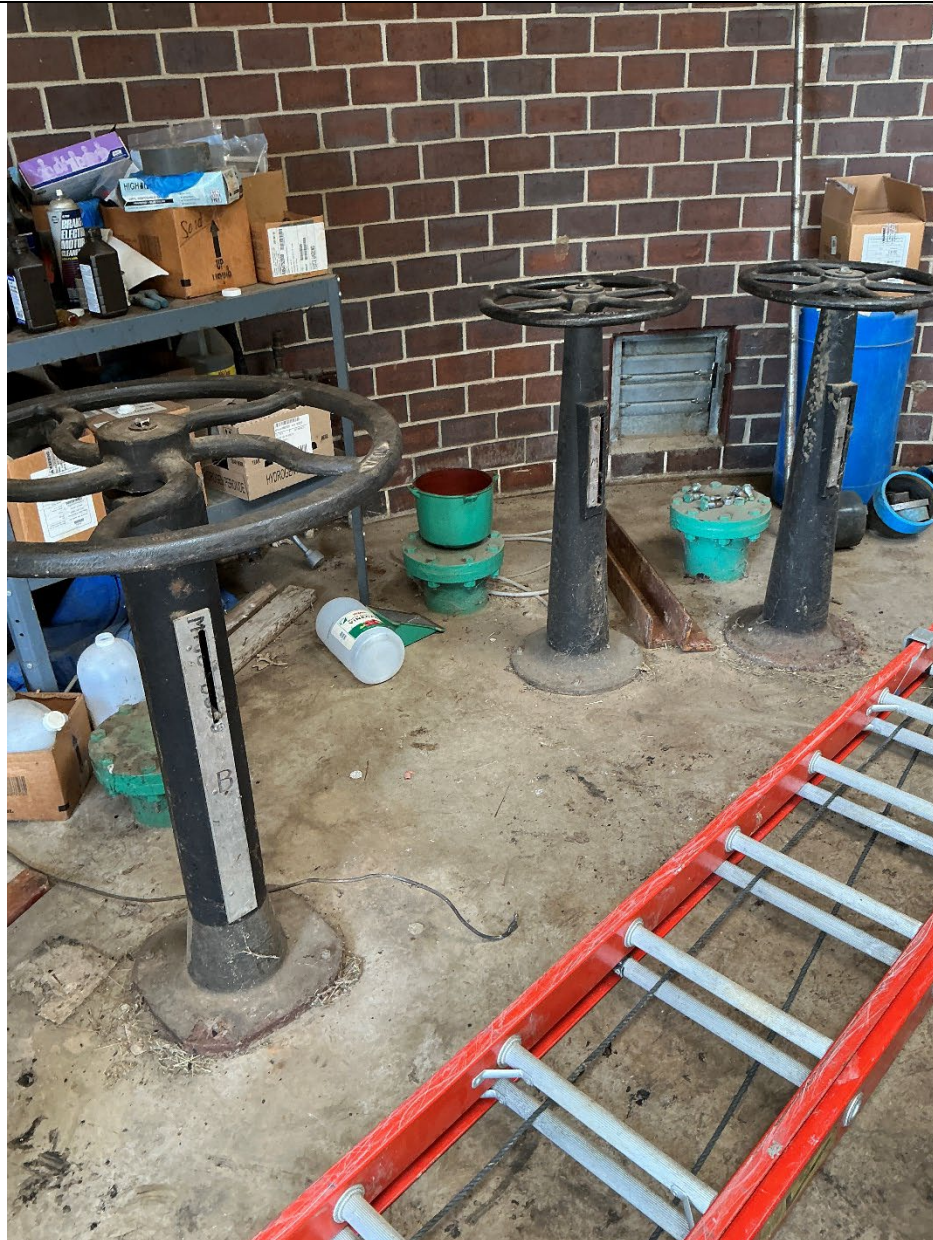
25

During the inspection, I observed the system's raw water pump station, where the system injects sodium permanganate for manganese control, taste, and odor. I observed the sodium permanganate feed, and it appeared to be in working order and free of excess buildup. I observed three manually operated valves that Mr. Sheetz explained can be used to draw water from multiple levels in the lake (photo 25). I did not observe algae on the surface of the lake (photo 26).

Turn wheels to control intakes.

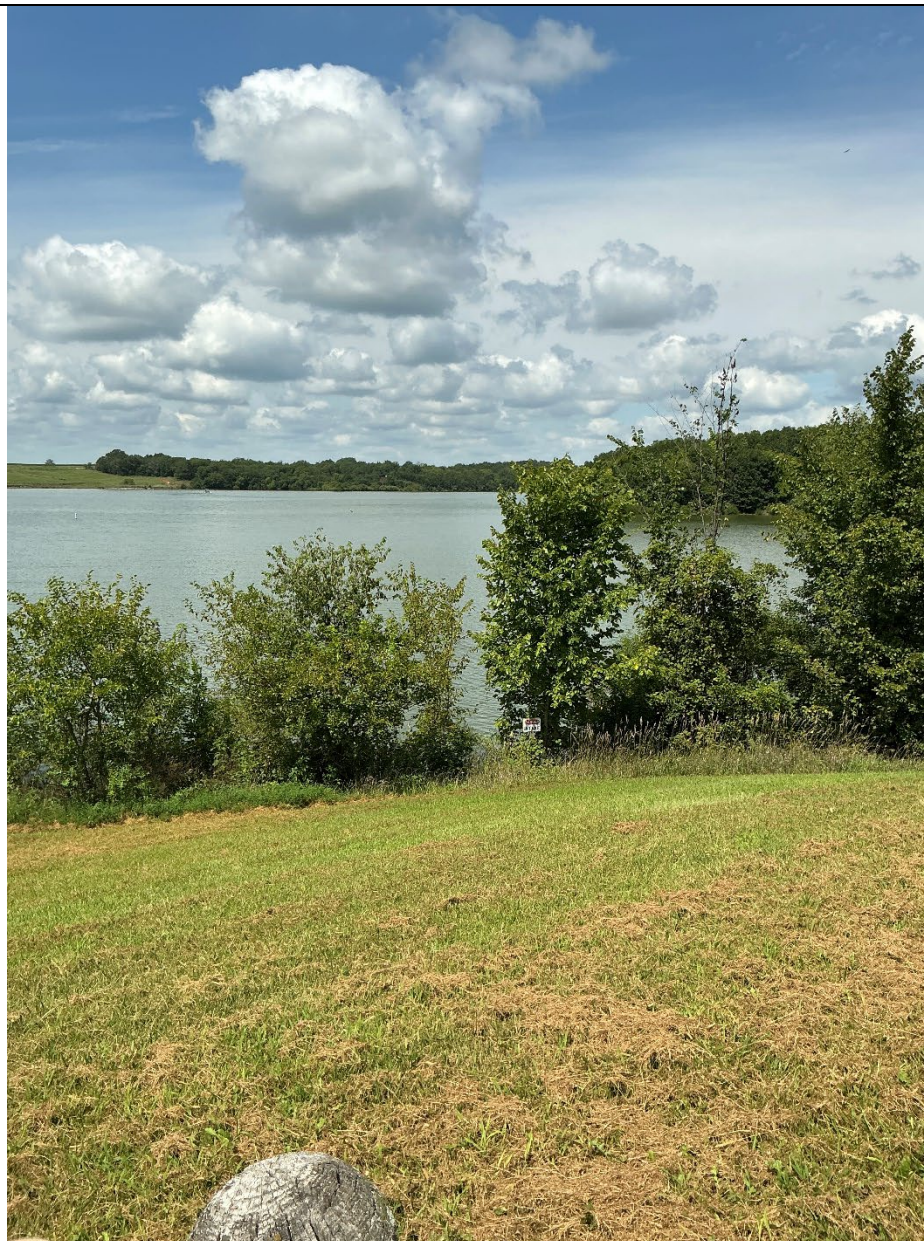
26

Little River Lake.
