**Region 6 - Enforcement & Compliance Assurance Division**  
**INSPECTION REPORT**

| Regulatory Program(s) | Clean Water Act – National Pollution Discharge Elimination System (Brine) | |
| Company Name: | PE-Osage, LLC | |
| Facility Name: | Breene Unit | |

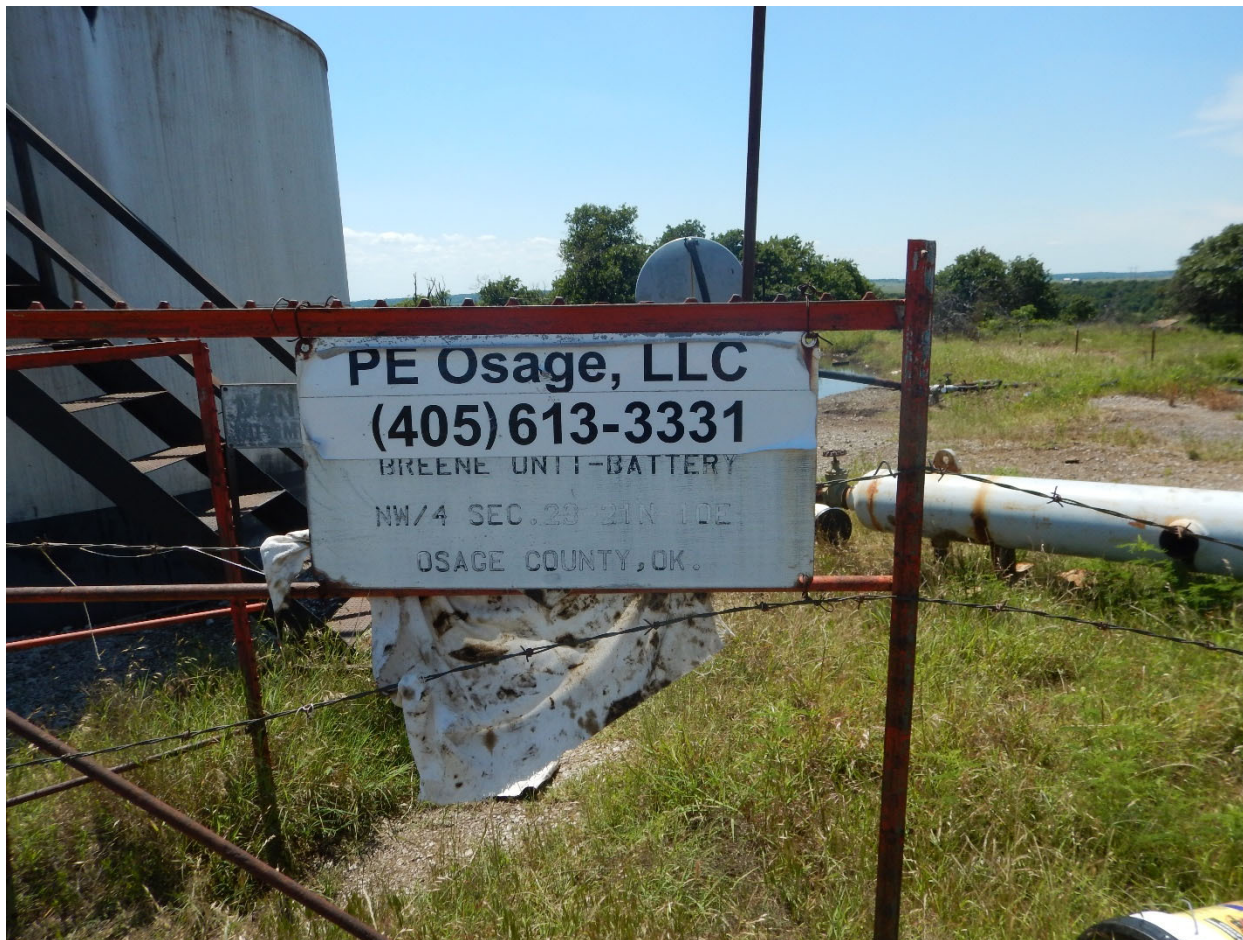
Photo No. 1

**Description:** This was the Breene Unit tank battery sign.

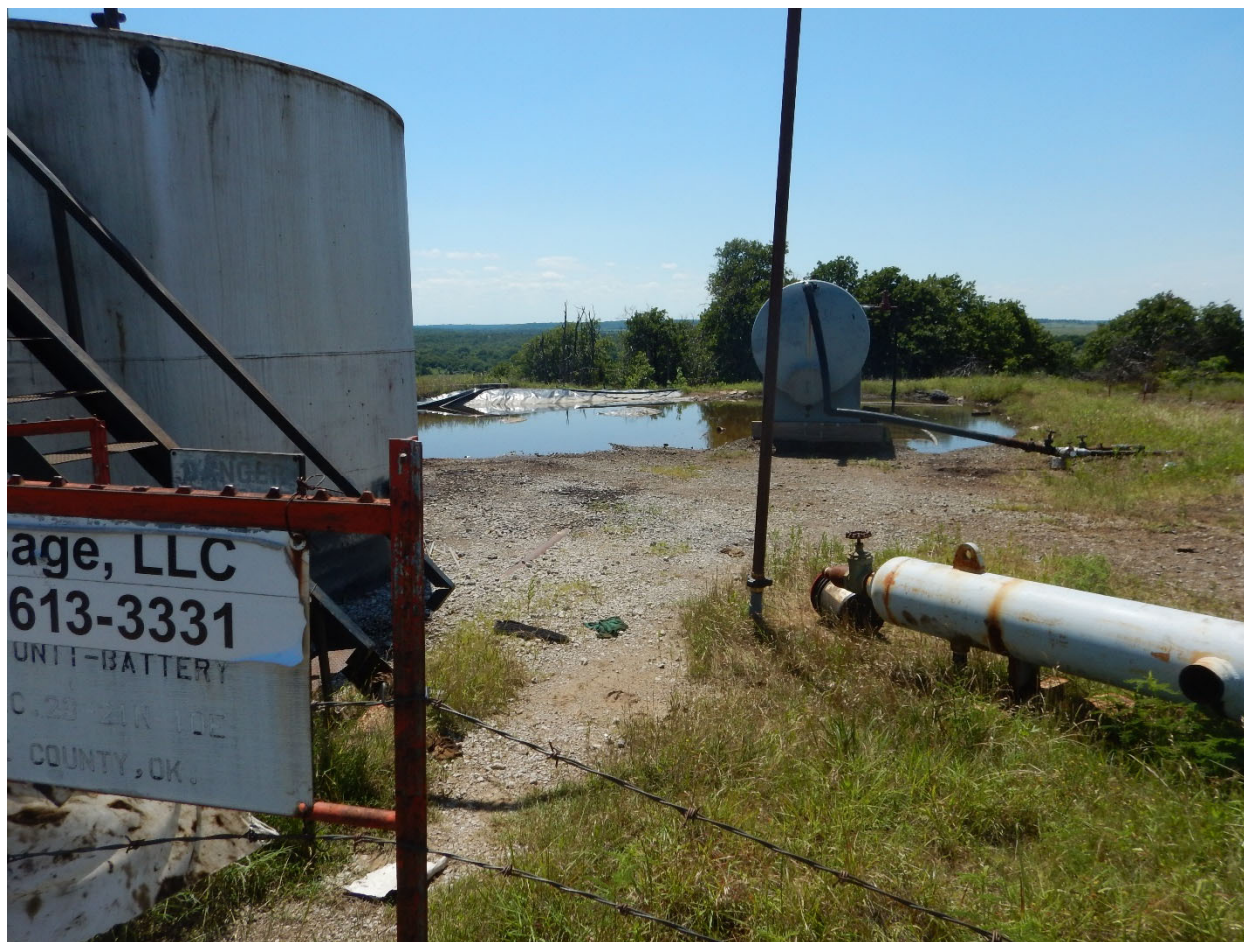
Photo No. 2

I observed the Breene Unit tank battery and sign, this was documented in Appendix 1/Photo Log, photo No. 1. I observed the secondary containment pit inside the Breene Unit tank battery berm, which was full of water at the time of the inspection. The secondary containment pit was documented in photo No. 2. On the south side of the southernmost secondary containment berm of the Breene Unit tank battery, I observed water leaking through the berm and flowing downgradient to the south, this was documented in photo No. 3. I observed the water as it continued south along the flowpath. I observed the impacted land/soil along the flowpath and estimated approximately 80 percent of the impacted area had fully recovered with vegetation.

**Description:** This was a photo showing the secondary containment "pit" located at the Breene Unit tank battery. The pit was full of water at the time of the inspection.

EPA Region 6 inspectors observed water leaking through the secondary containment berm which could allow recurrence of the spill event as the primary area of concern. The secondary containment pit should be emptied, and the secondary containment berm should be repaired to prevent fluid migration through the berm. I also observed moderate soil erosion along the flowpath where brine impacts prevented revegetation, this area of soil erosion should be corrected to prevent additional erosion.

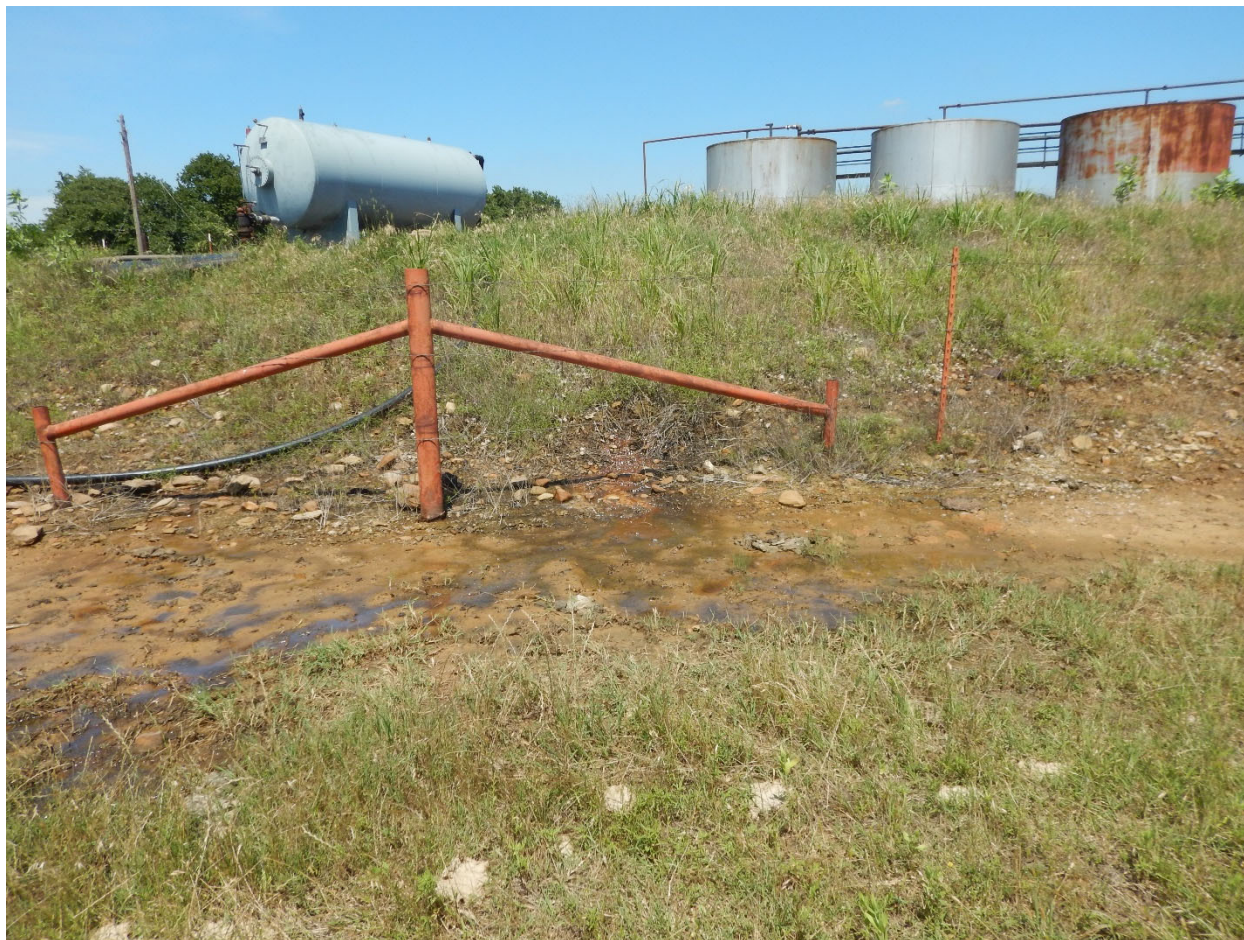
Photo No. 3

**Description:** This was a photo of the south berm of the Breene Unit tank battery. The pit full of water was located on the north side of the berm, inside the tank battery. Water was flowing from inside the tank battery, through the berm, then continuing south downgradient.

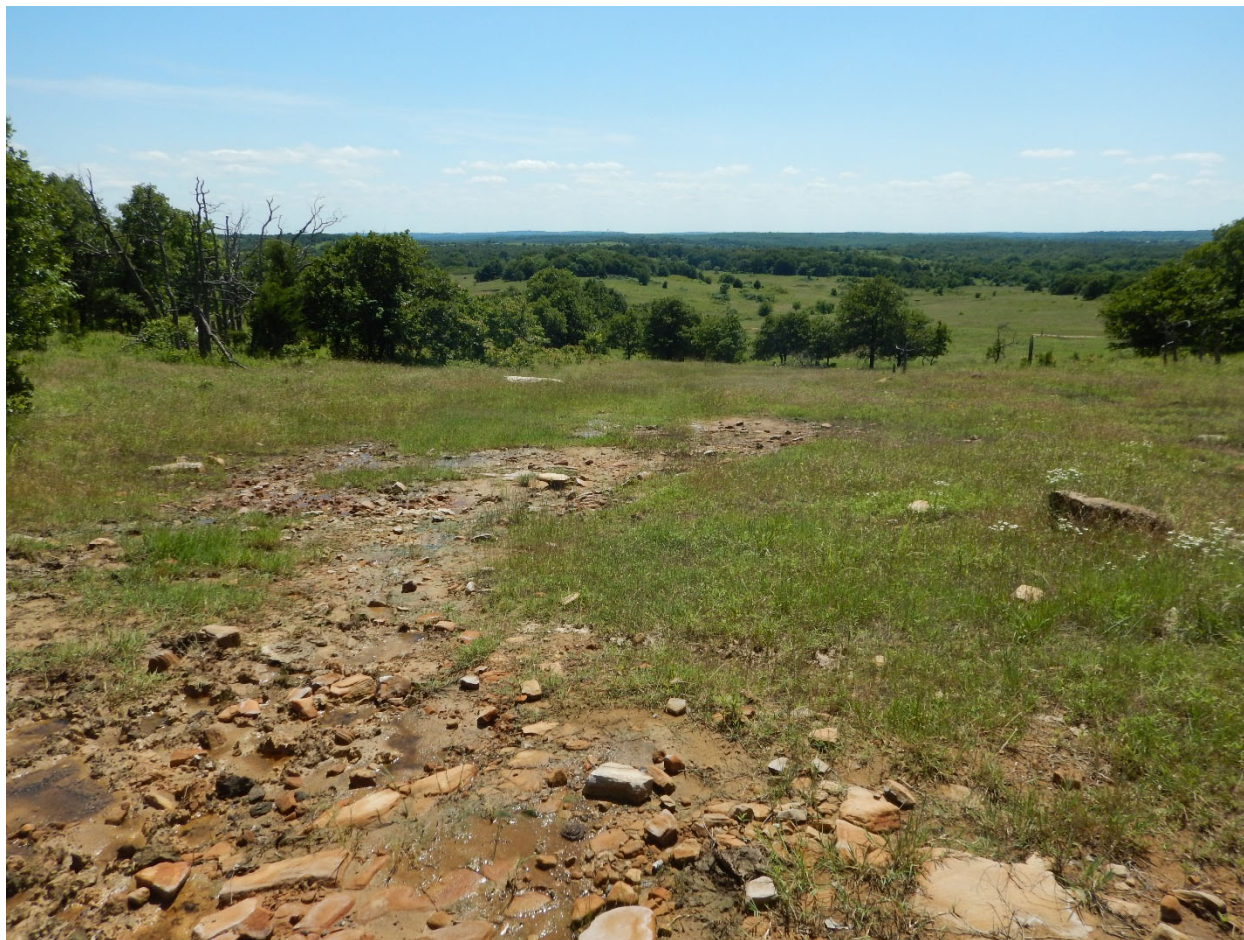
Photo No. 4

**Description:** This was a photo taken standing at the south berm of the Breene Unit tank battery, with a view downgradient/south. The flowpath had not fully recovered from the brine impacts. I estimated the flowpath was approximately 80 percent recovered.
