## MULTI-SECTOR GENERAL PERMIT NON-FILER INSPECTION CHECKLIST

| <b>Inspection Date(s):</b> | 2/6/2023 | |
| <b>Operator Name:</b> | Nolt Services LLC | |

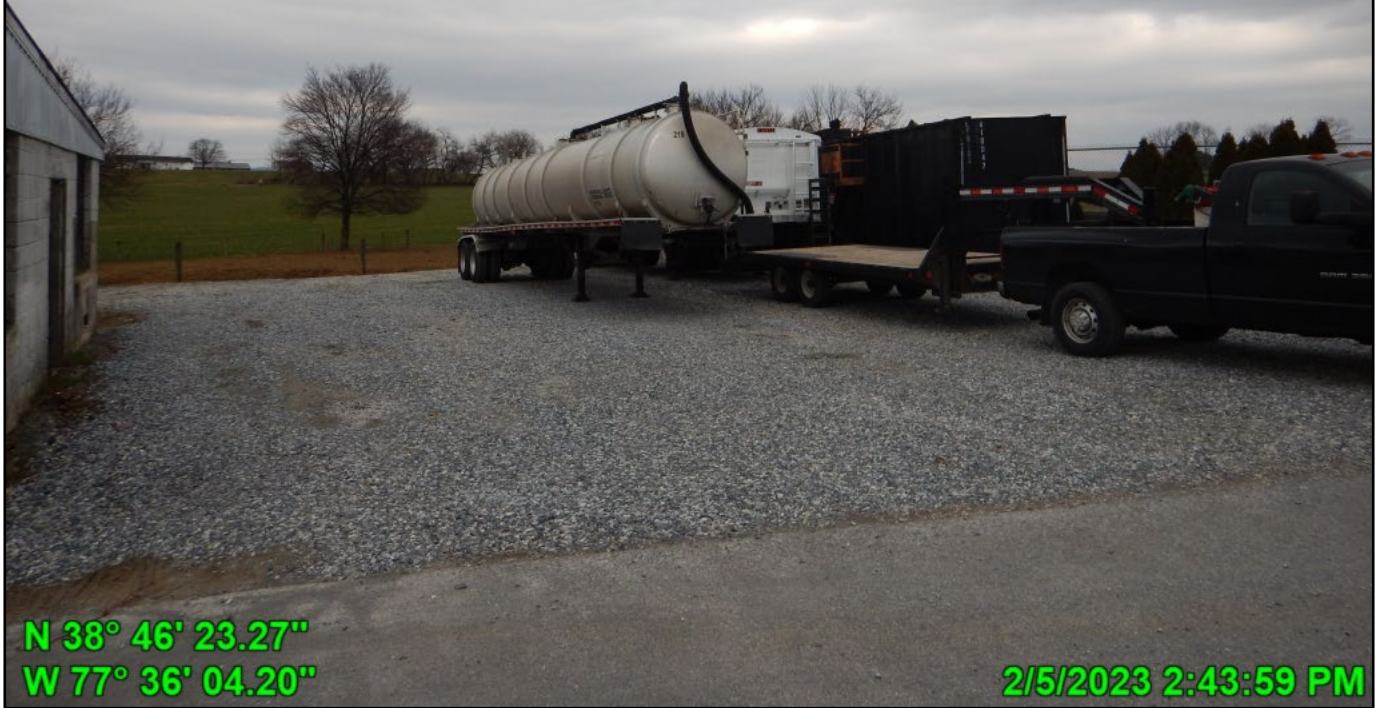
DSCN5017.JPG

| SITE EVALUATION | |
|---|---|
| <b>Industrial Machinery &amp; Equipment Storage</b> | <p>The EPA Inspection Team observed outside uncovered storage areas for vehicles and Facility equipment (refer to <u>Appendix B, Photographs DSCN5017 and DSCN5068</u>). The outside storage areas did not have any cover.</p> <p>The Facility representative stated that the Facility has its own trucks, but also receives septage/biosolids materials directly from customers/contractors via their respective vehicles.</p> |

| Description | Facing northeast of Facility machinery storage with Meadows Run flowing right to left just beyond the gravel lot. |

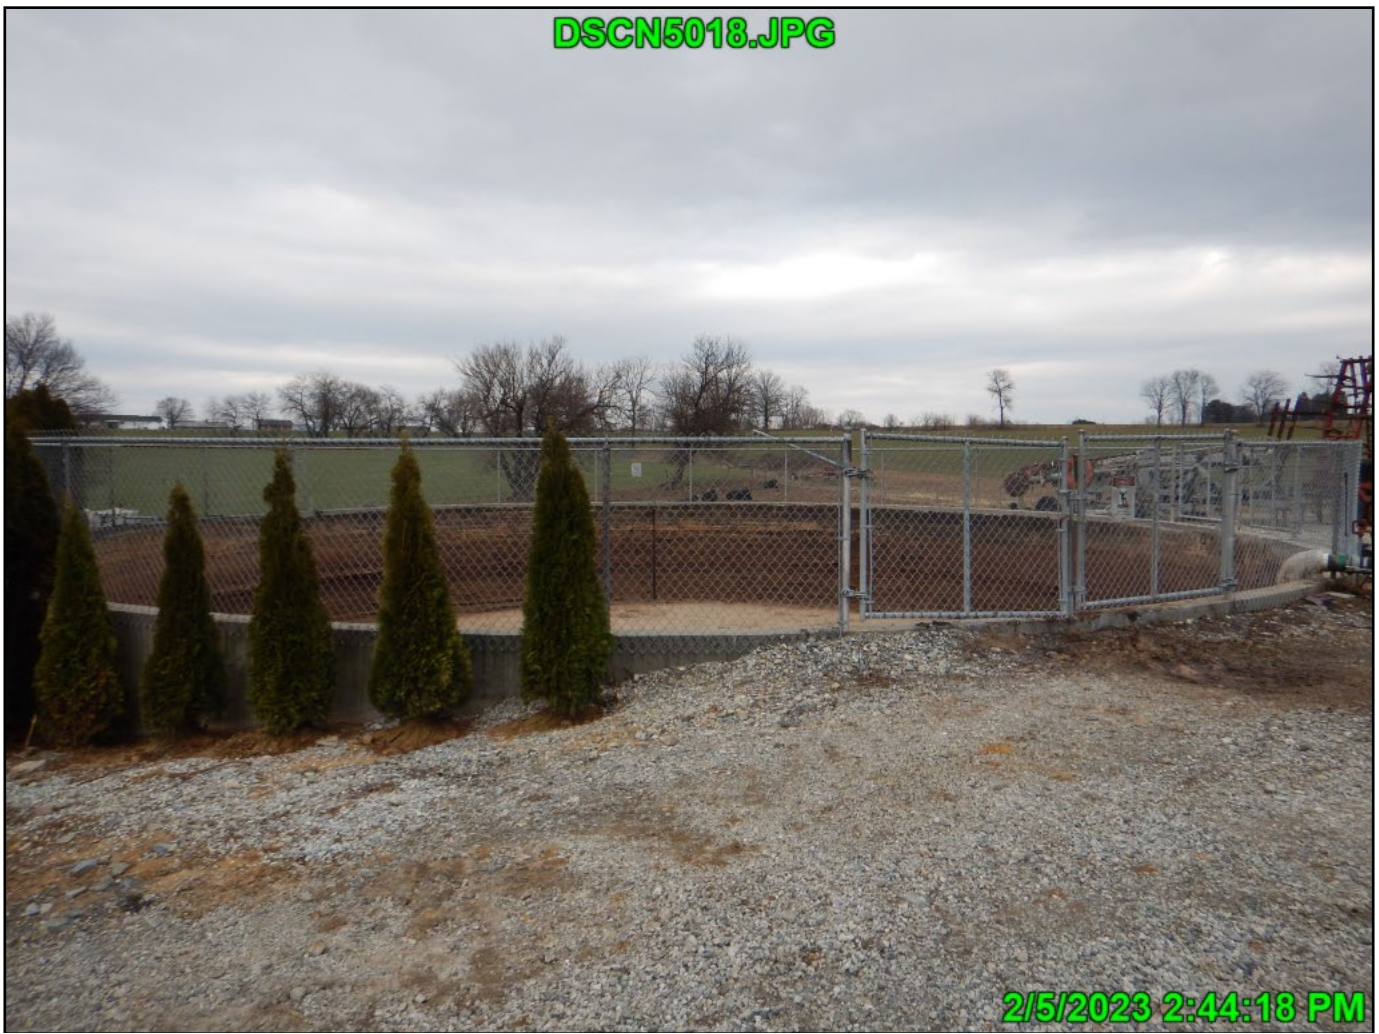
DSCN5018.JPG

| SITE EVALUATION | |
|---|---|
| <b>Storage of Industrial Materials or Products</b> | The industrial products (i.e. septage/biosolids materials) are stored entirely in the three (3) concrete in-ground treatment tanks listed above in the Facility's Operation & Product Description section of this report (refer to <u>Appendix B, Photographs DSCN5018 – DSCN5021</u> ). |

| Description | Facing northeast, of Tank P2, a 252,000 – gallon tank designed to store and treat manure located in the north area of the Facility. |

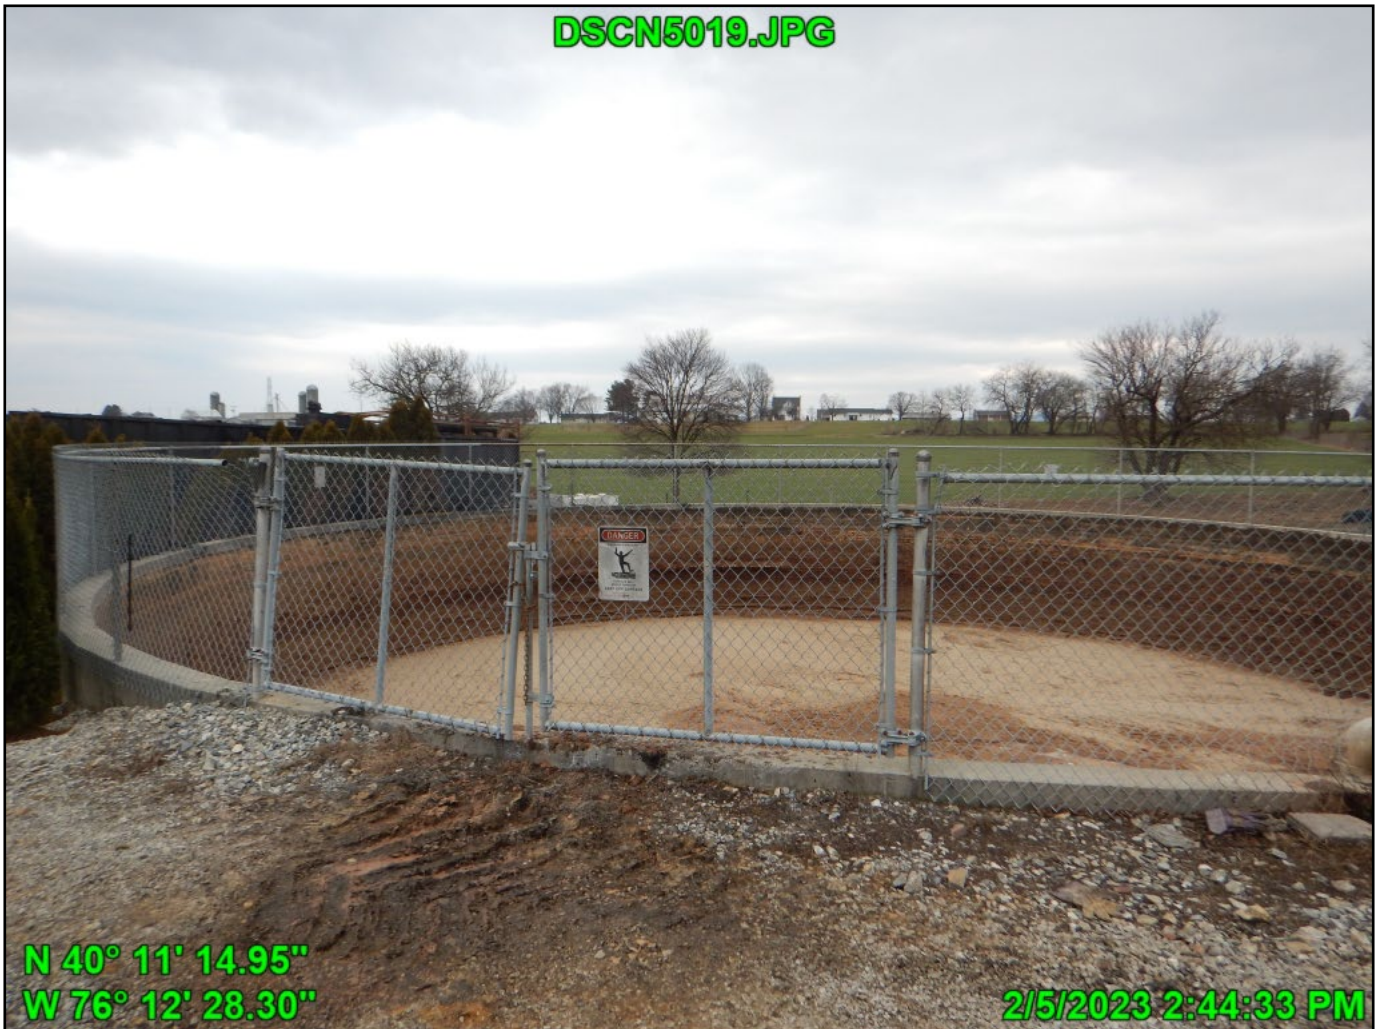
DSCN5019.JPG

| Description | Tank P2, note the spillage in front of the tank. |

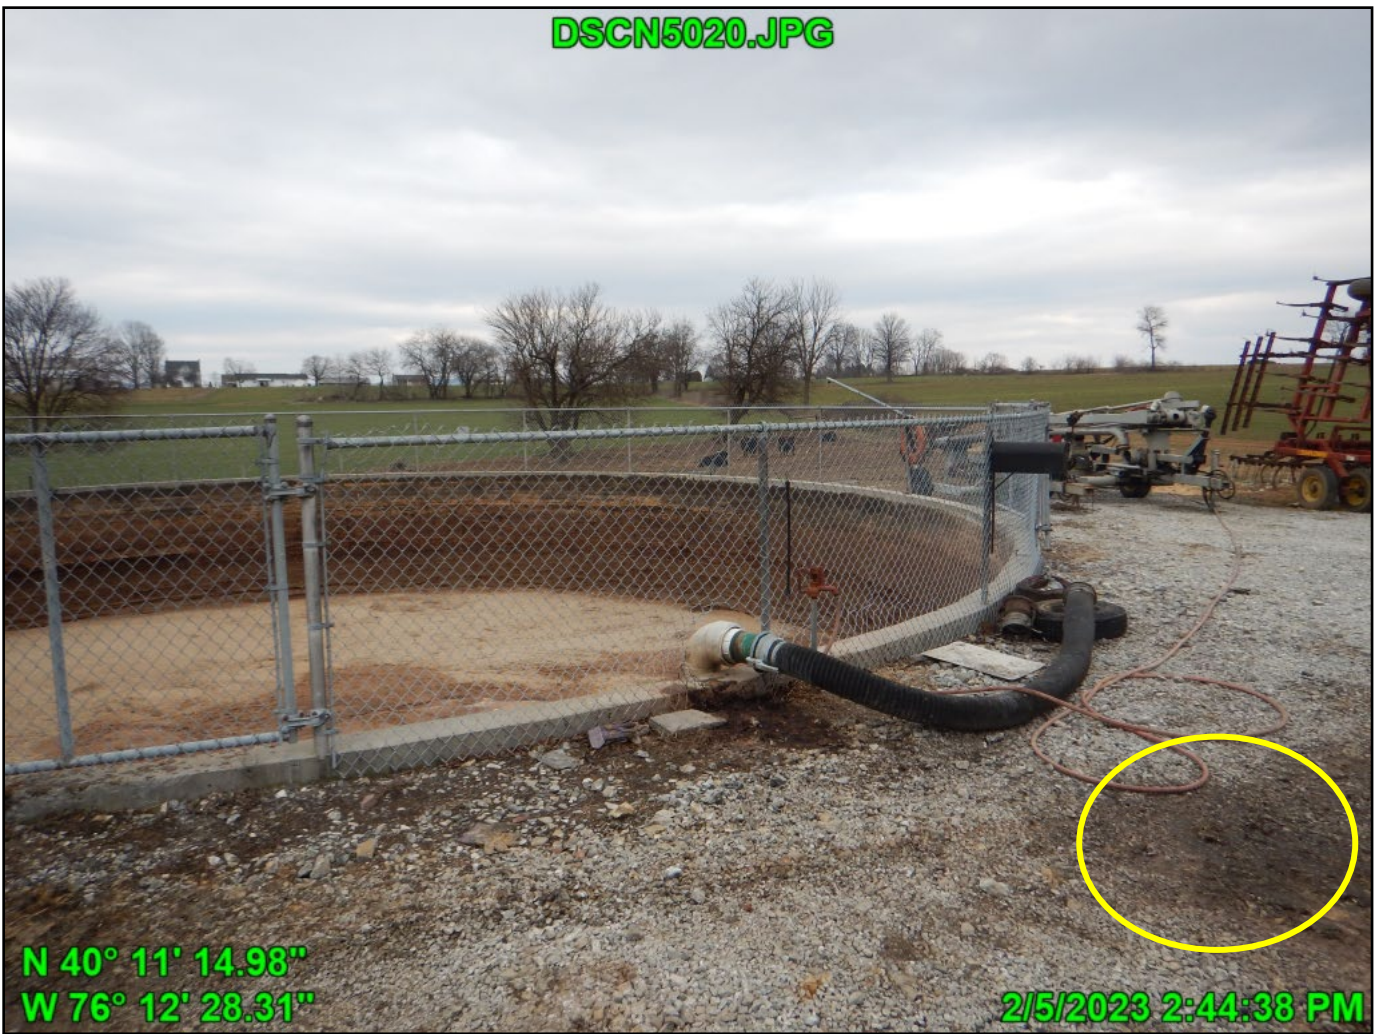
DSCN5020.JPG

| Description | Tank P2, note the additional spillage in front of the tank |

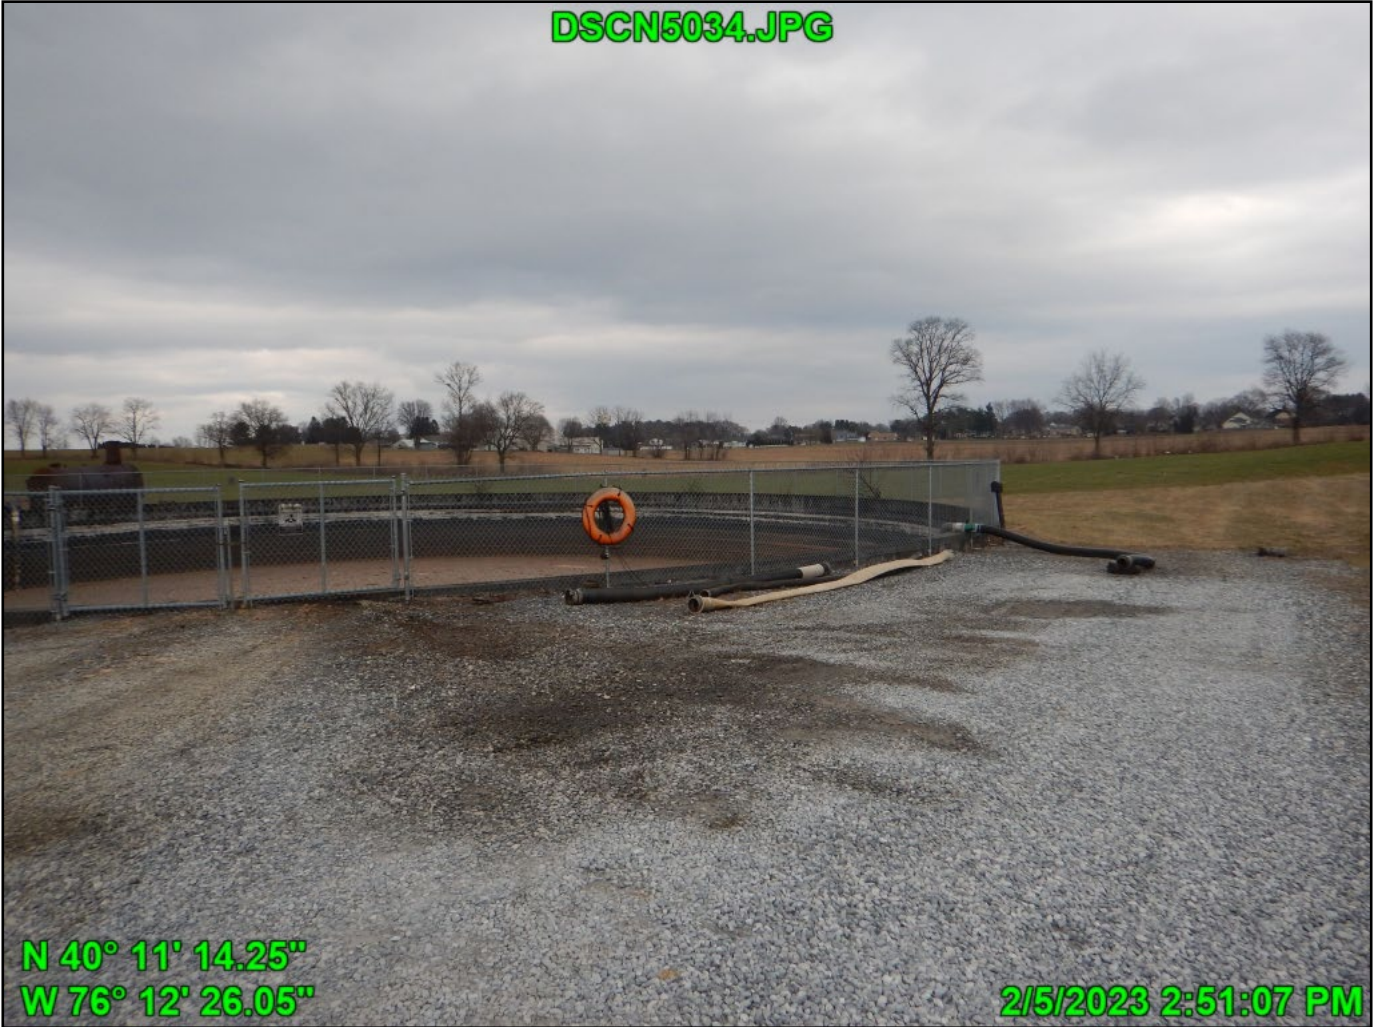
DSCN5034.JPG

| Description | Spillage staining adjacent to Tank P3. |

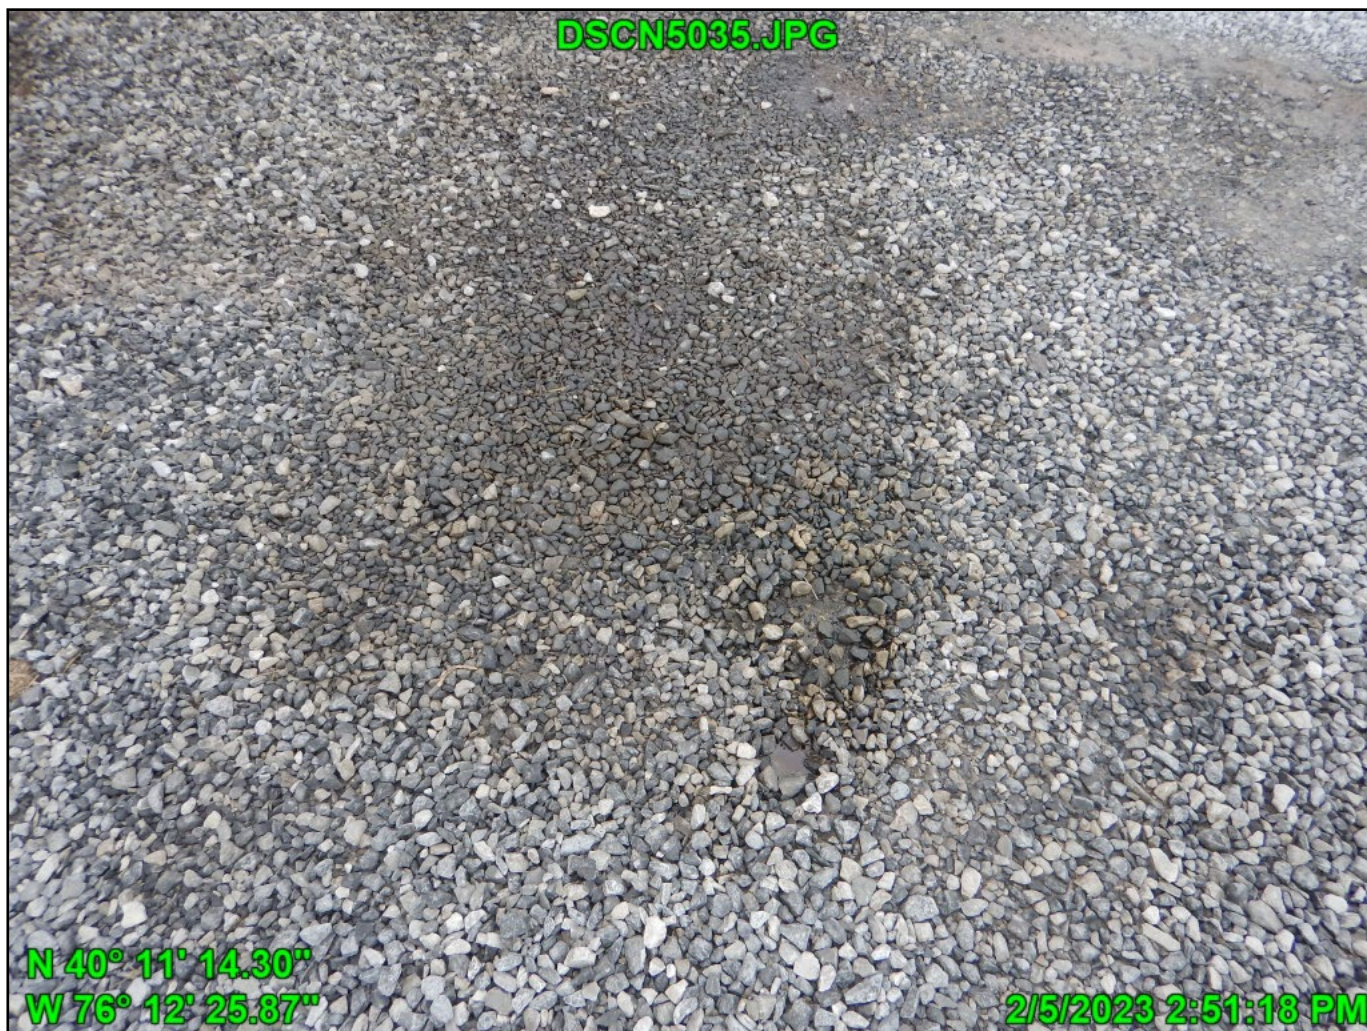
| Description | Closer view of the spillage staining as shown in Photograph DSCN5034. |

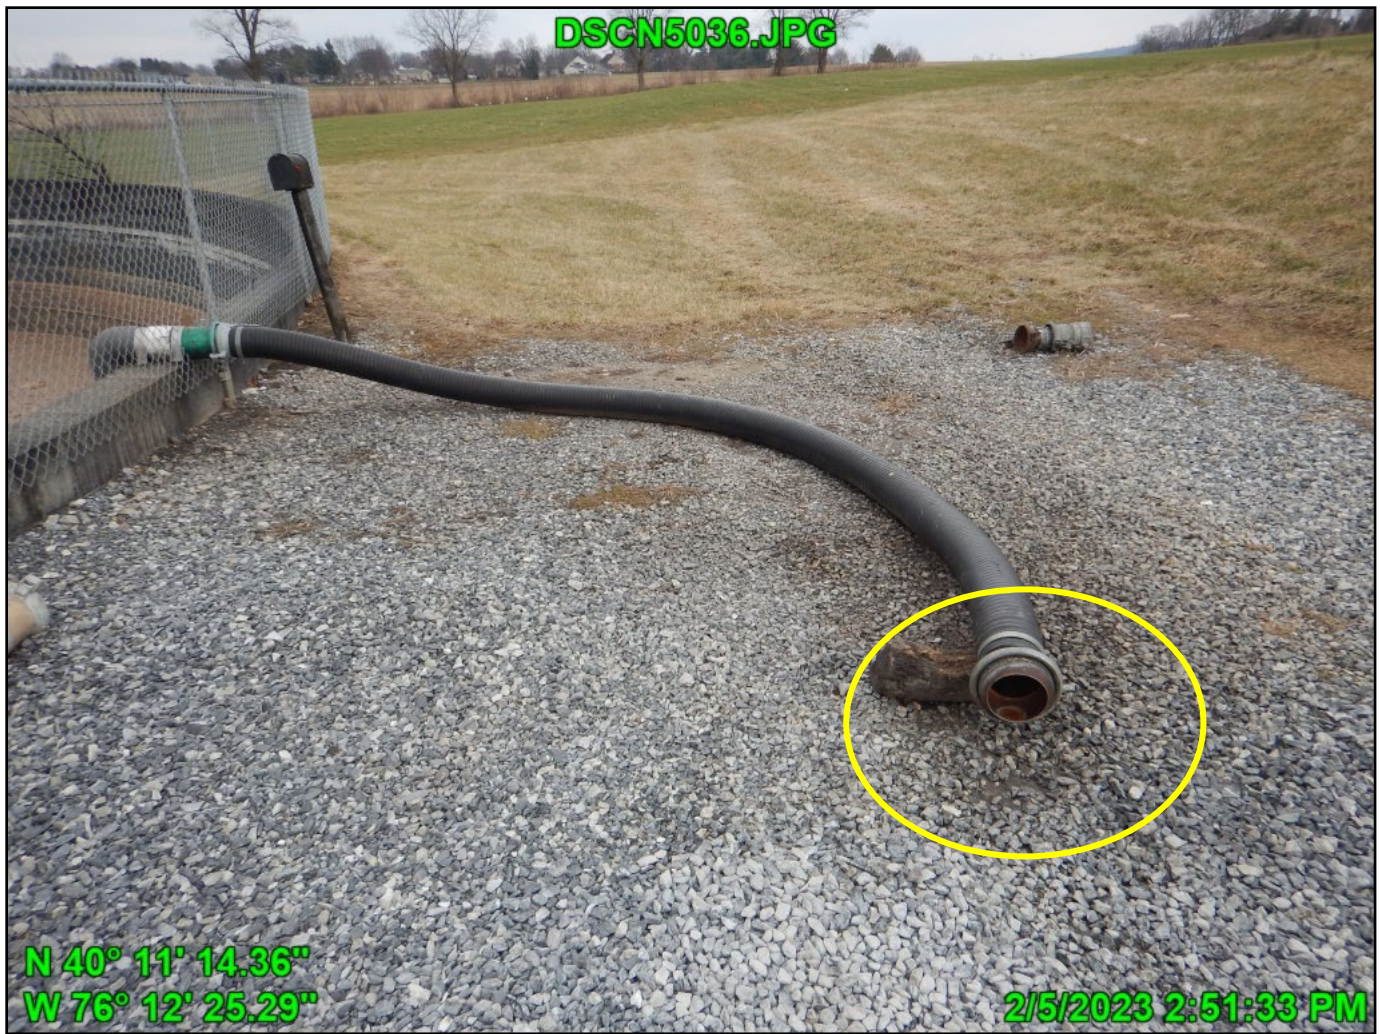
| Description | Spillage staining from the connection pipes to Tank P3. |

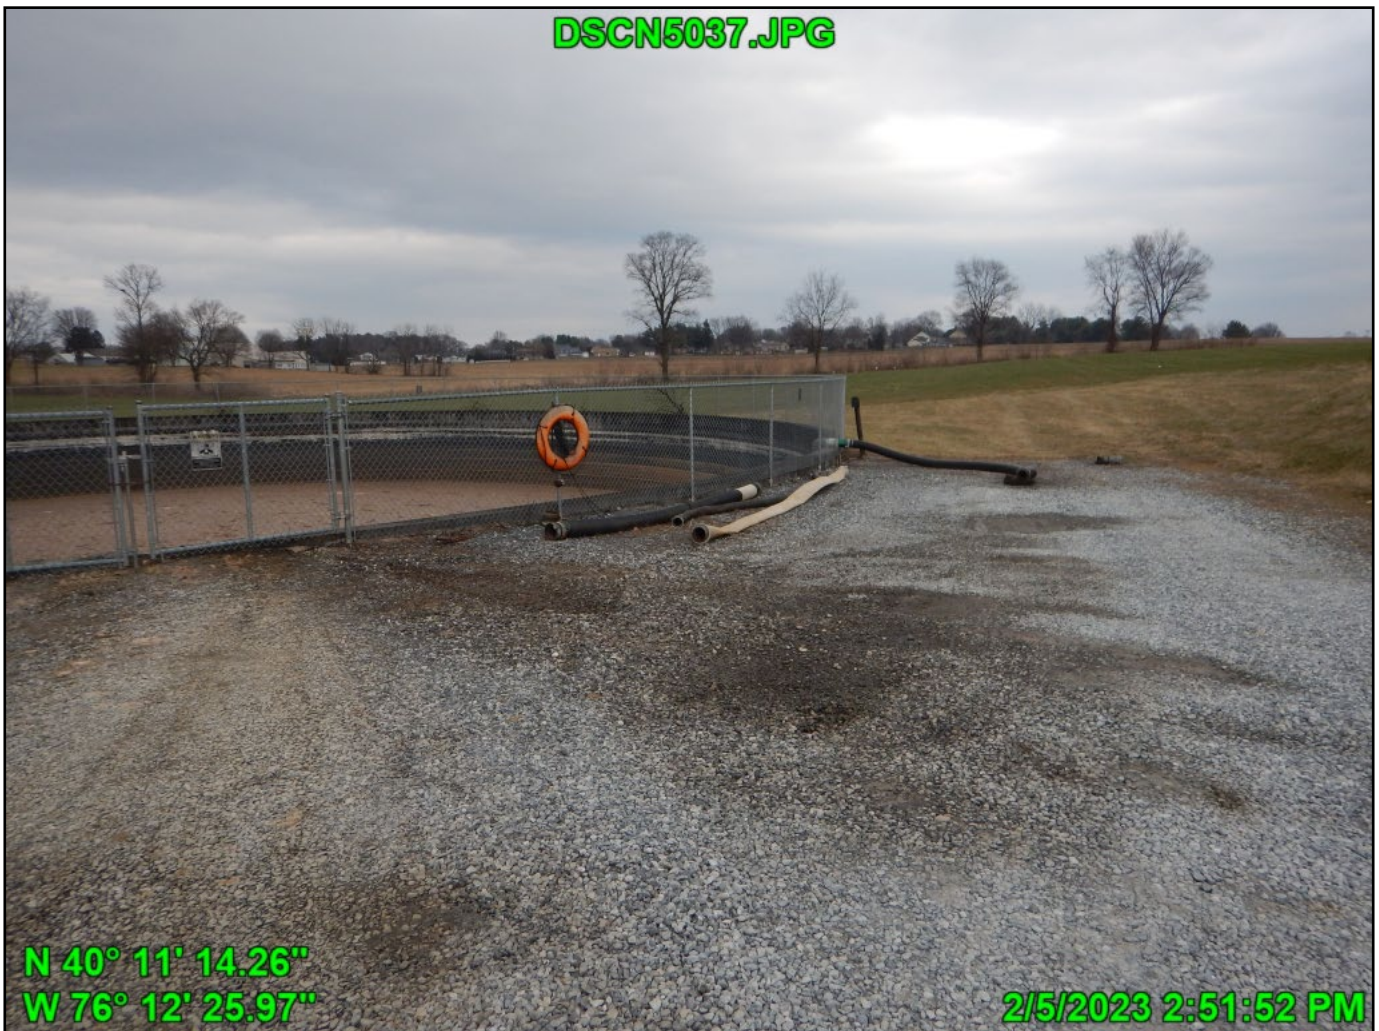
DSCN5037.JPG

| Description | Spillage staining adjacent to Tank P3. |

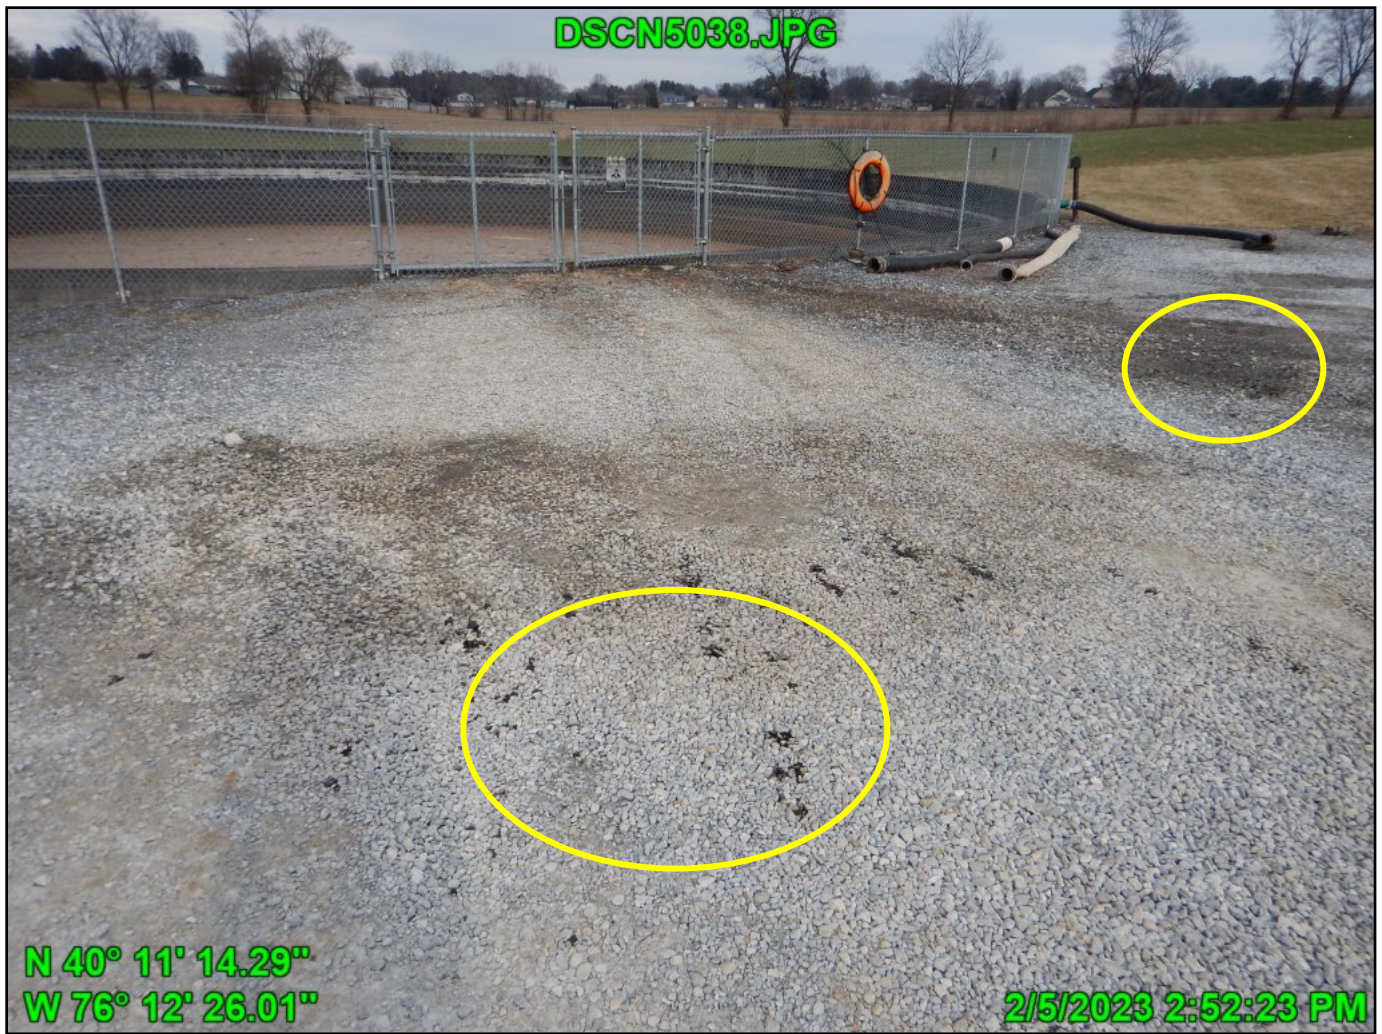
| Description | Spillage staining adjacent to Tank P3. |

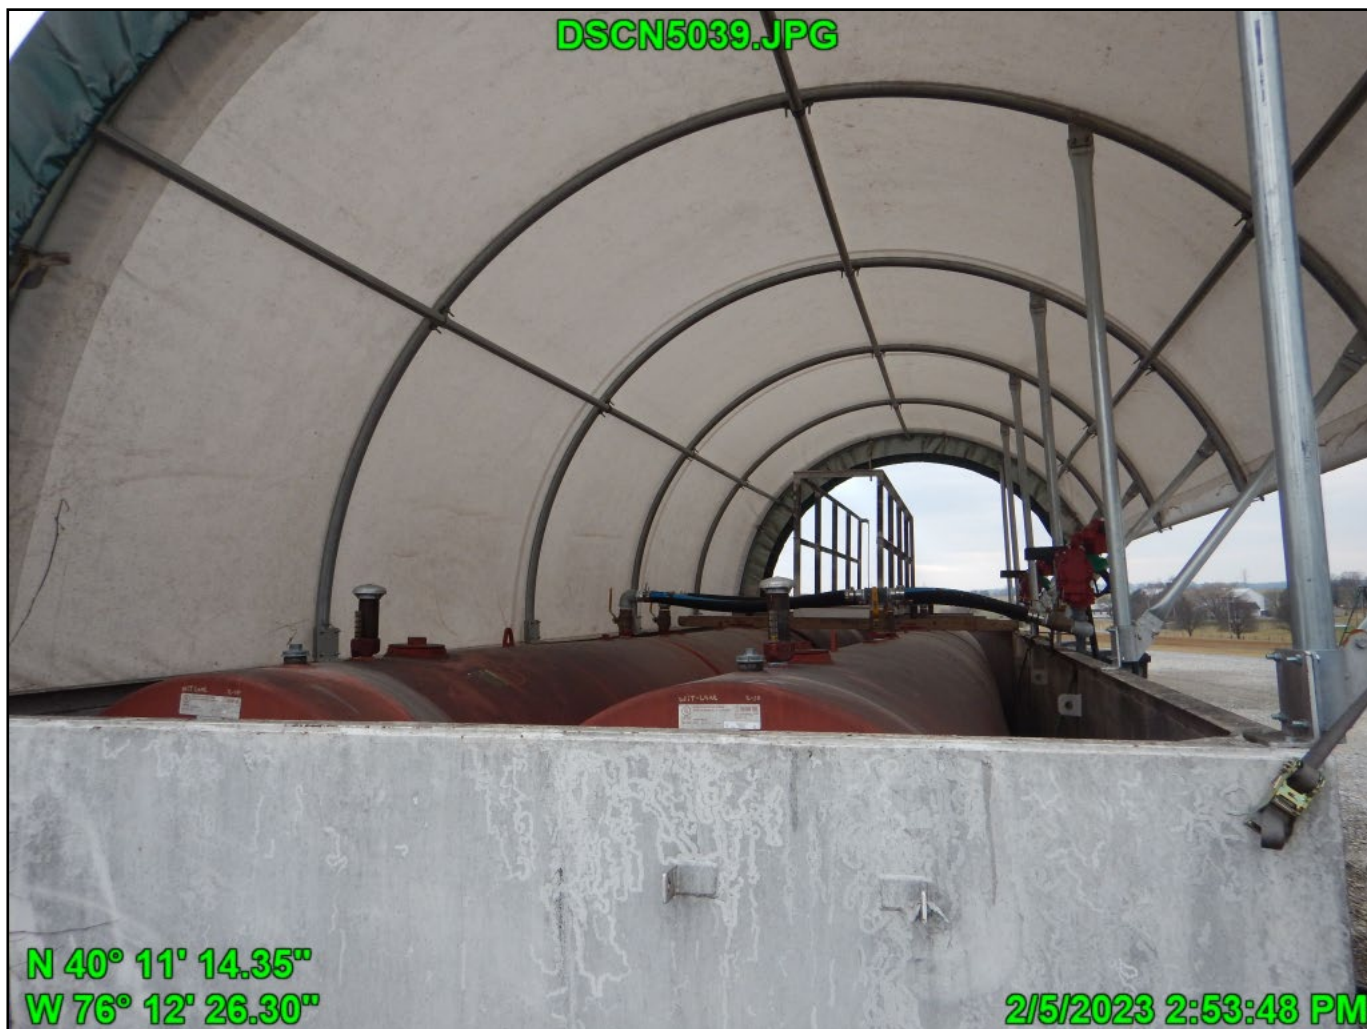
| SITE EVALUATION | |
|---|---|
| <b>Liquid Storage (e.g., Tanks, Liquid Storage Drums)</b> | The EPA Inspection Team observed six (6) 1,000-gallon diesel tanks used for fueling onsite equipment and vehicles (refer to <u>Appendix B, Photographs DSCN5039, DSCN5040, and DSCN5057</u> ). It was unclear if the tanks were double walled, but they were covered by a canvas awning and were within a concrete secondary containment structure. It is unclear whether the secondary containment structure was large enough for the oil stored in that area. |

| Description | Six (6) 1,000-gallon diesel tanks used for fueling onsite equipment and vehicles under a canvas structure. |

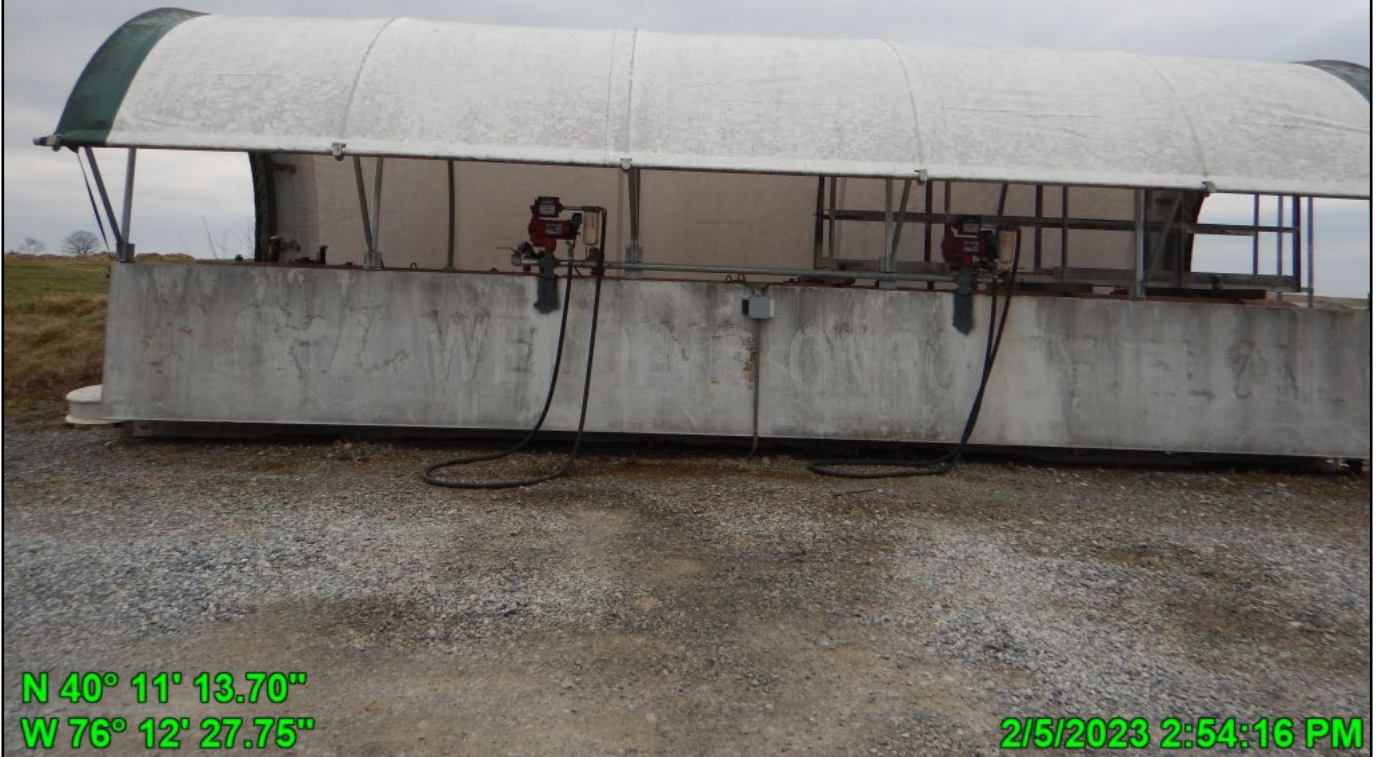
DSCN5040.JPG

Front view of the six (6) 1,000-gallon diesel tanks used for fueling onsite equipment and vehicles under a canvas structure.

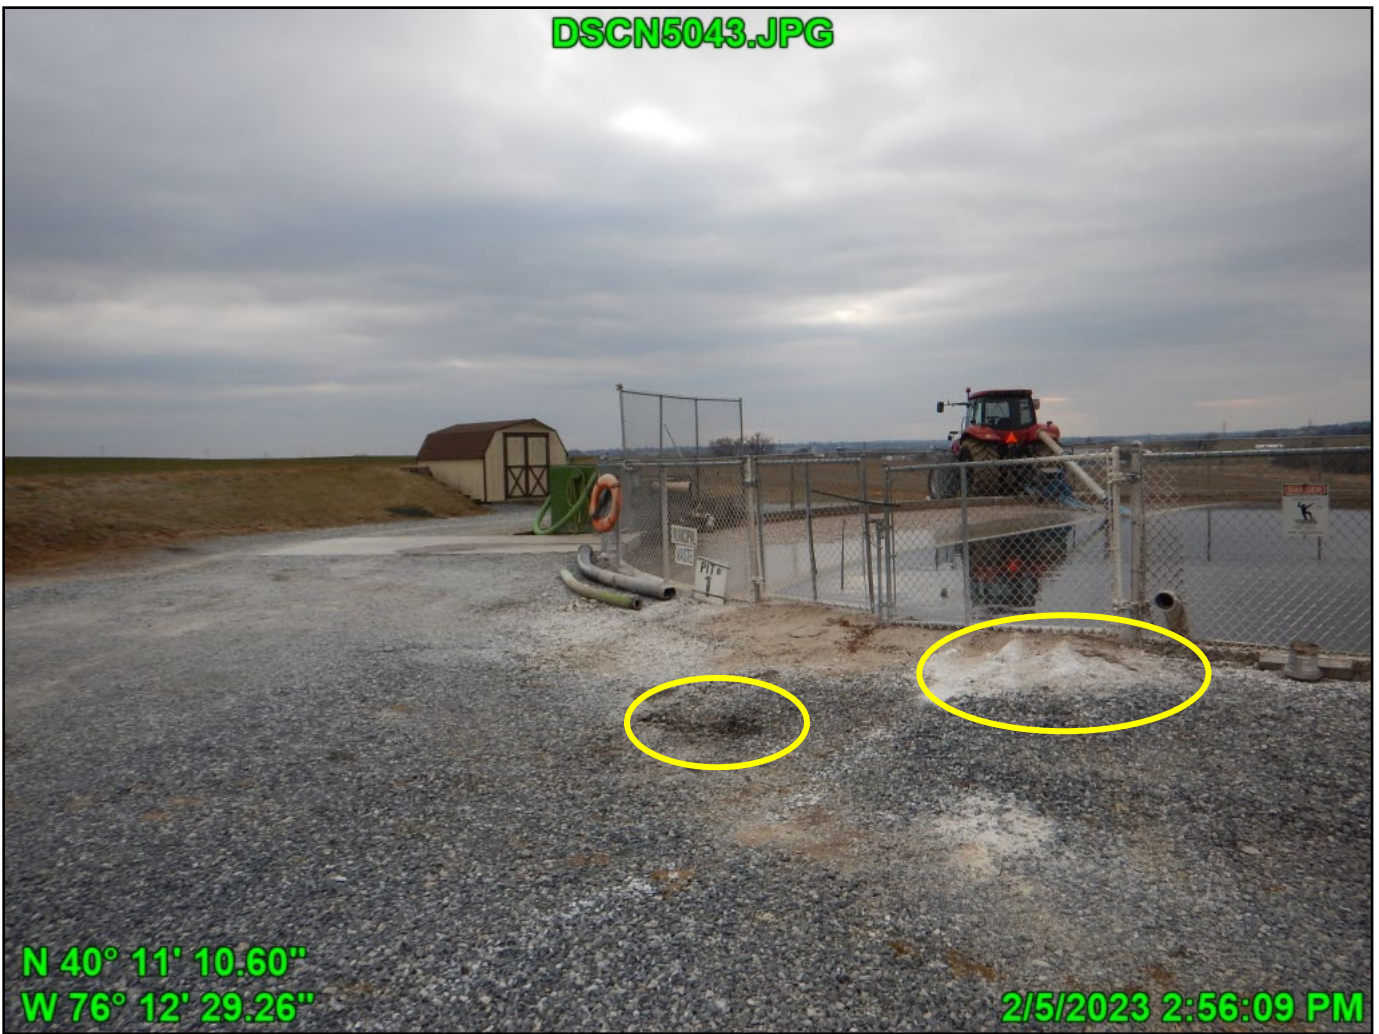
DSCN5043.JPG

| Description | Lime and unknown spillage adjacent to Tank P1. P1 stores and treats waste via lime stabilization. |

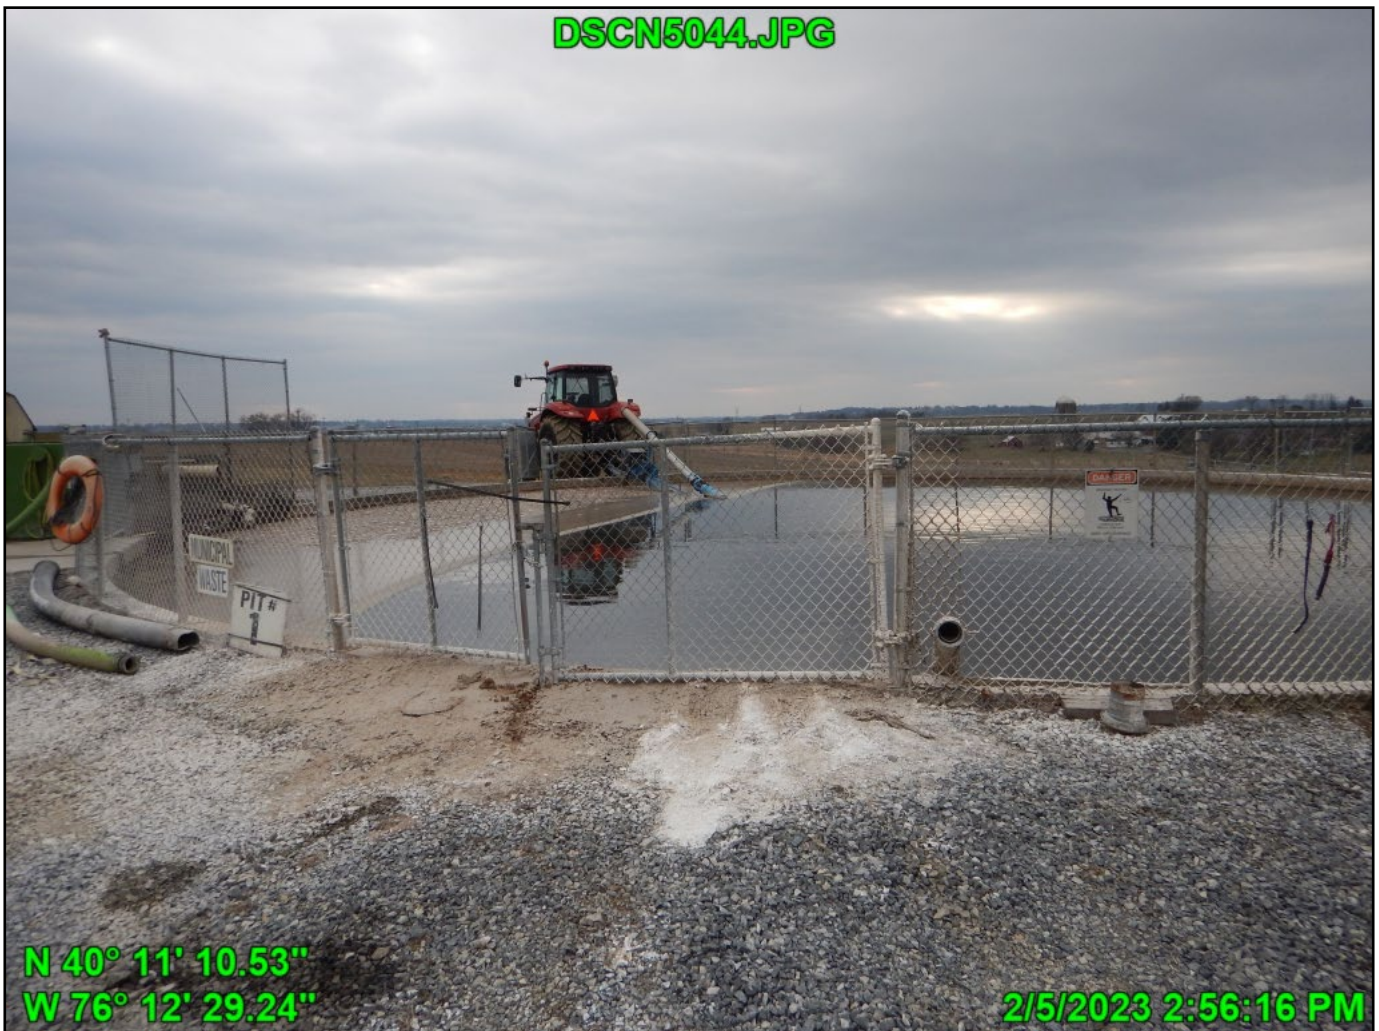
DSCN5044.JPG

| Description | Lime and unknown spillage adjacent to Tank P1. |

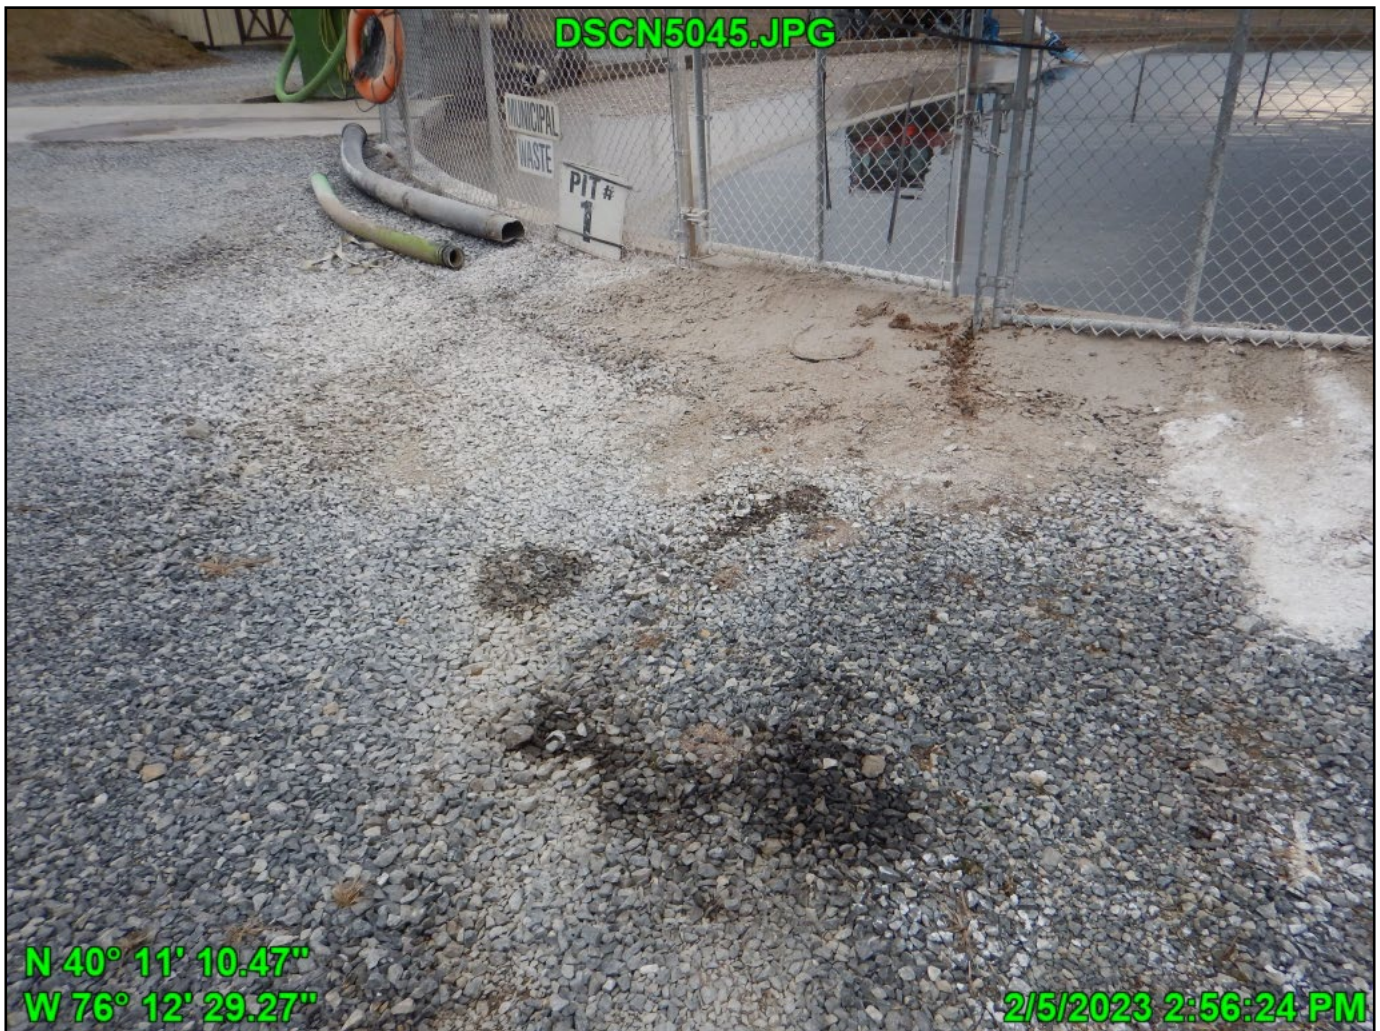
| Description | Lime and unknown spillage adjacent to Tank P1. |

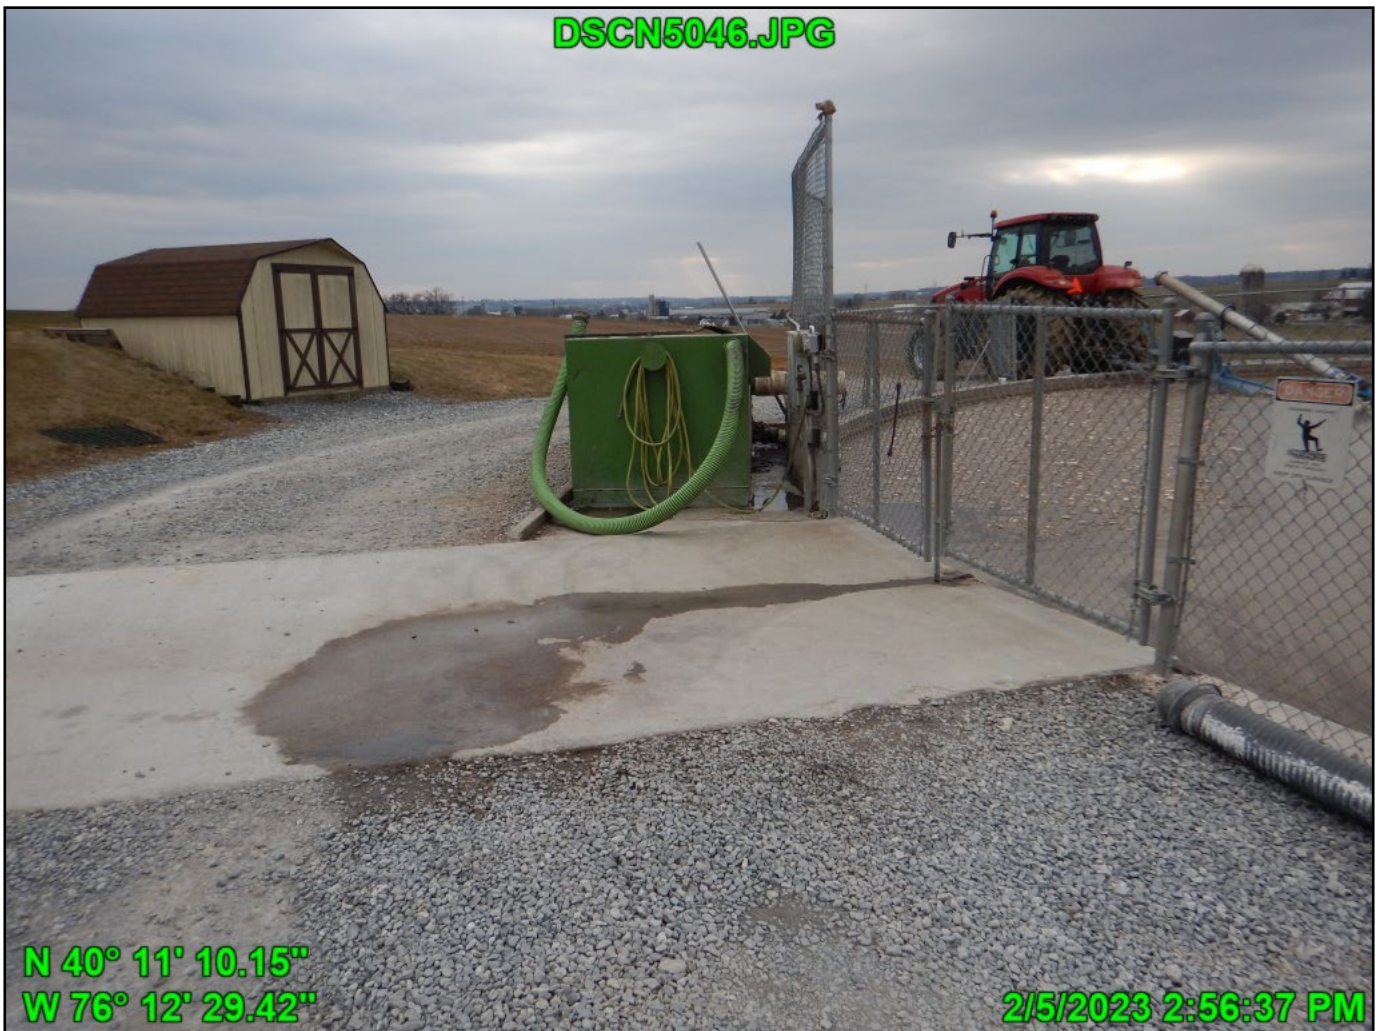
DSCN5046.JPG

| Description | Spillage on the concrete area adjacent to Tank P1. |

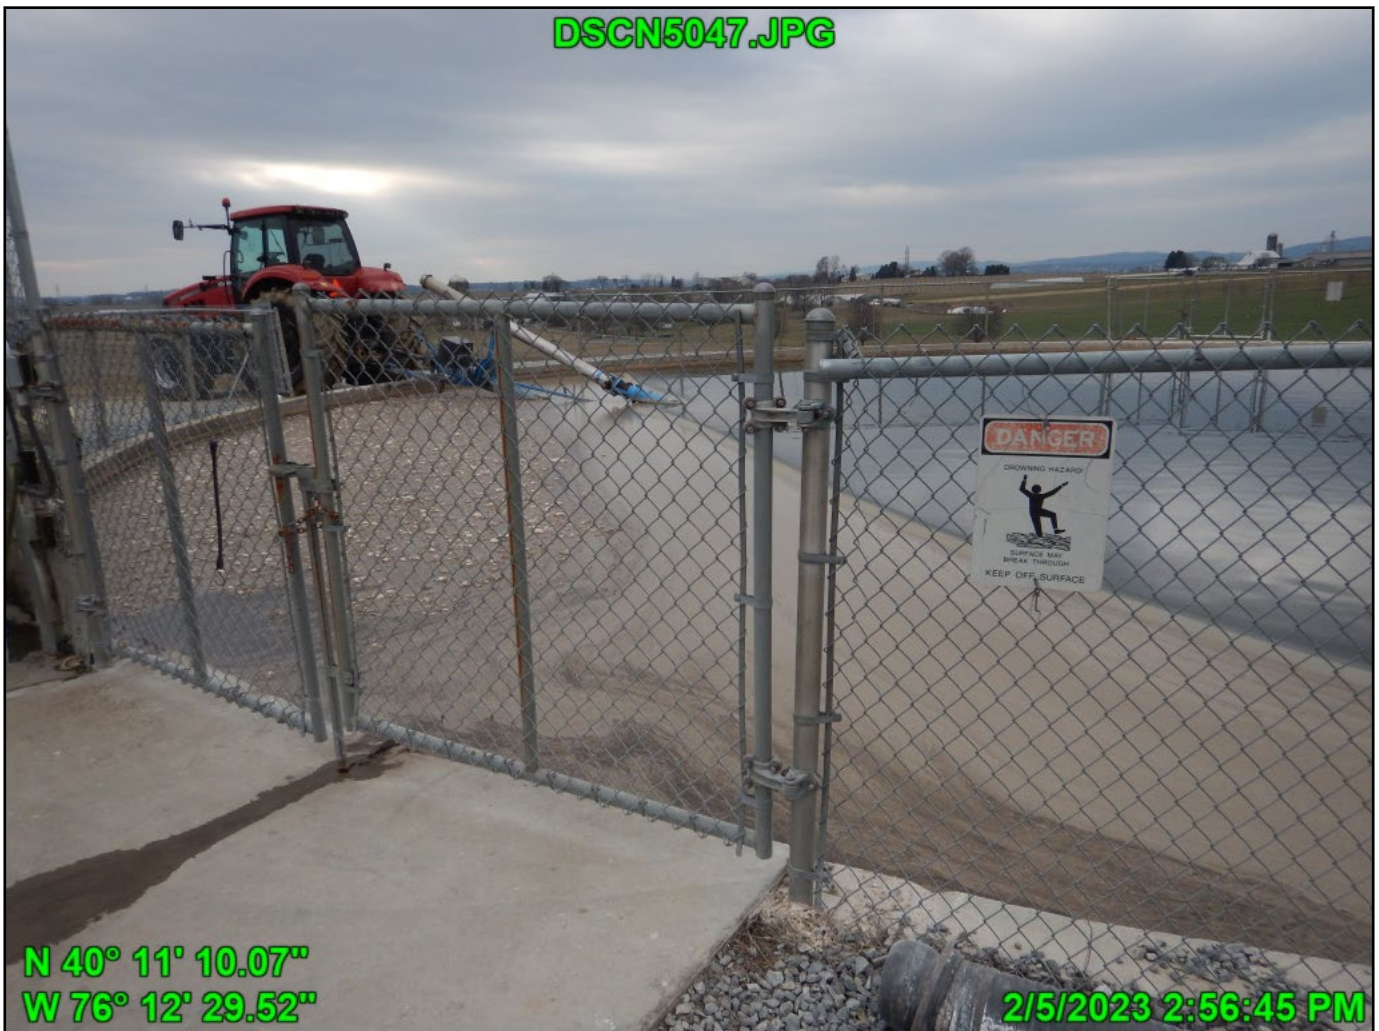
DSCN5047.JPG

| Description | Spillage on the concrete area adjacent to Tank P1. |
