## MULTI-SECTOR GENERAL PERMIT NON-FILER INSPECTION CHECKLIST

| <b>Inspection Date(s):</b> | 2/6/2023 | |
| <b>Operator Name:</b> | Nolt Services LLC | |

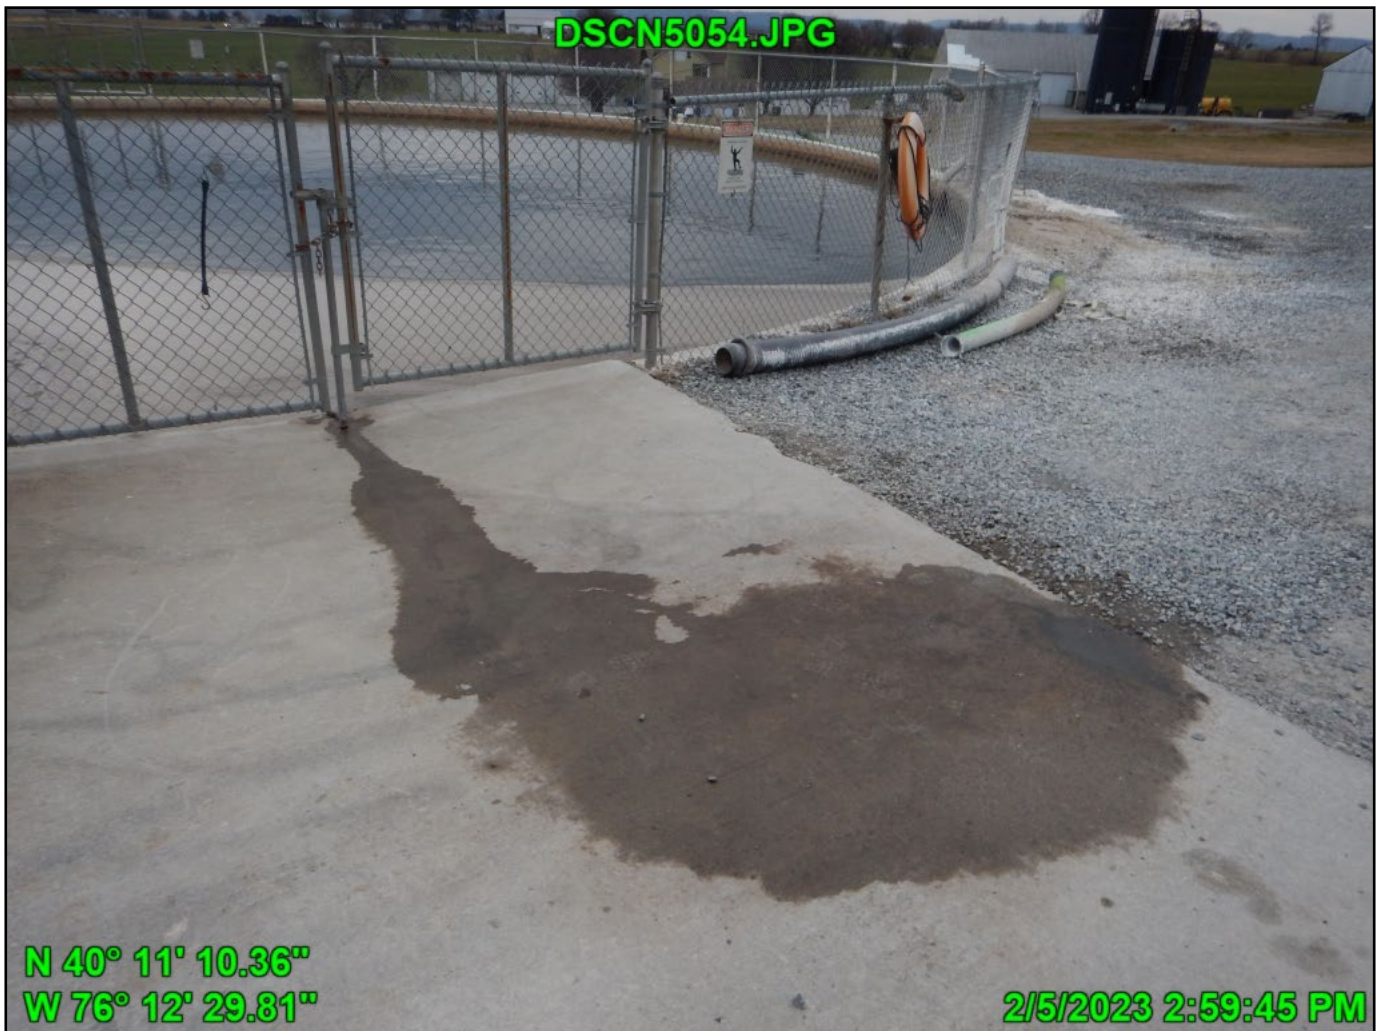
| Description | Spillage on the concrete surface adjacent to Tank P1. |

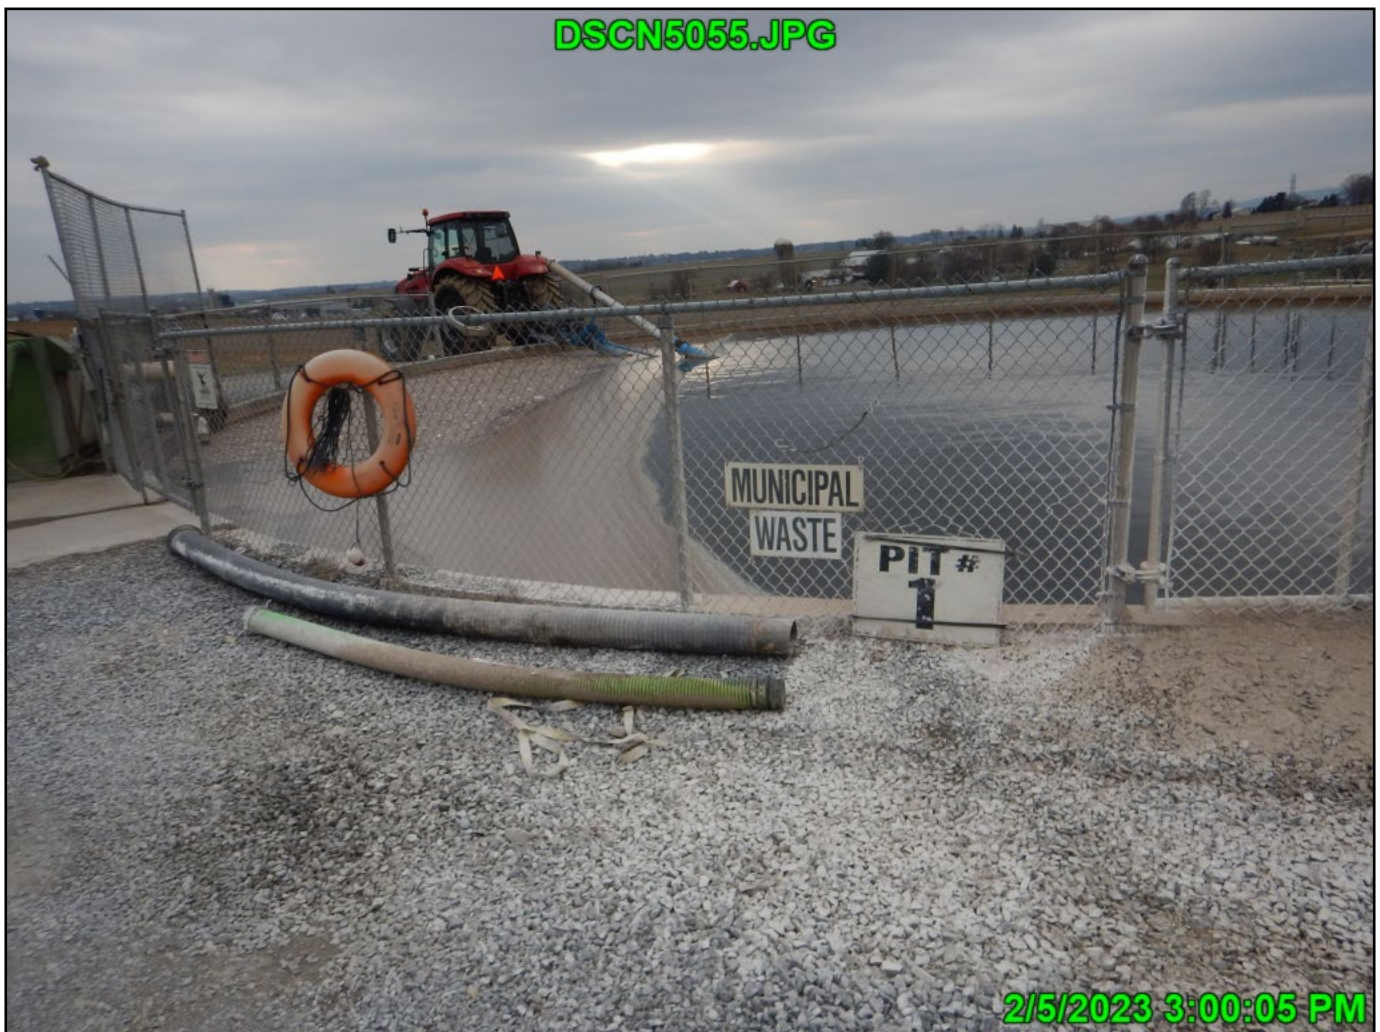
| Description | View, facing southwest, of spilled lime on the ground adjacent to Tank P1. |

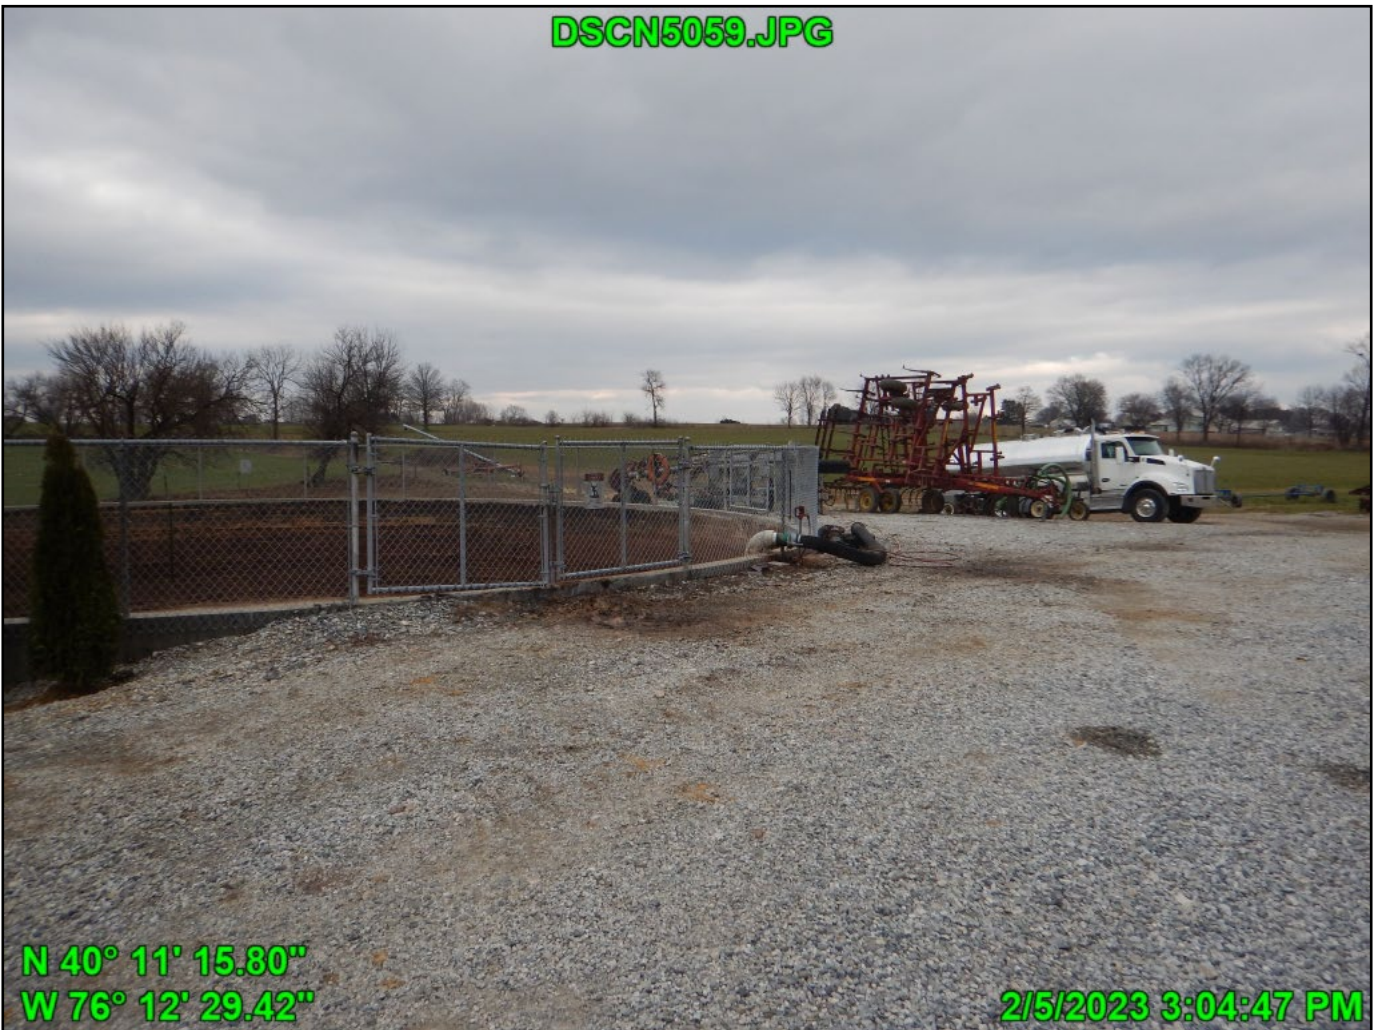
DSCN5059.JPG

| Description |
|---|
| Spillage on the ground adjacent to Tank P2. |

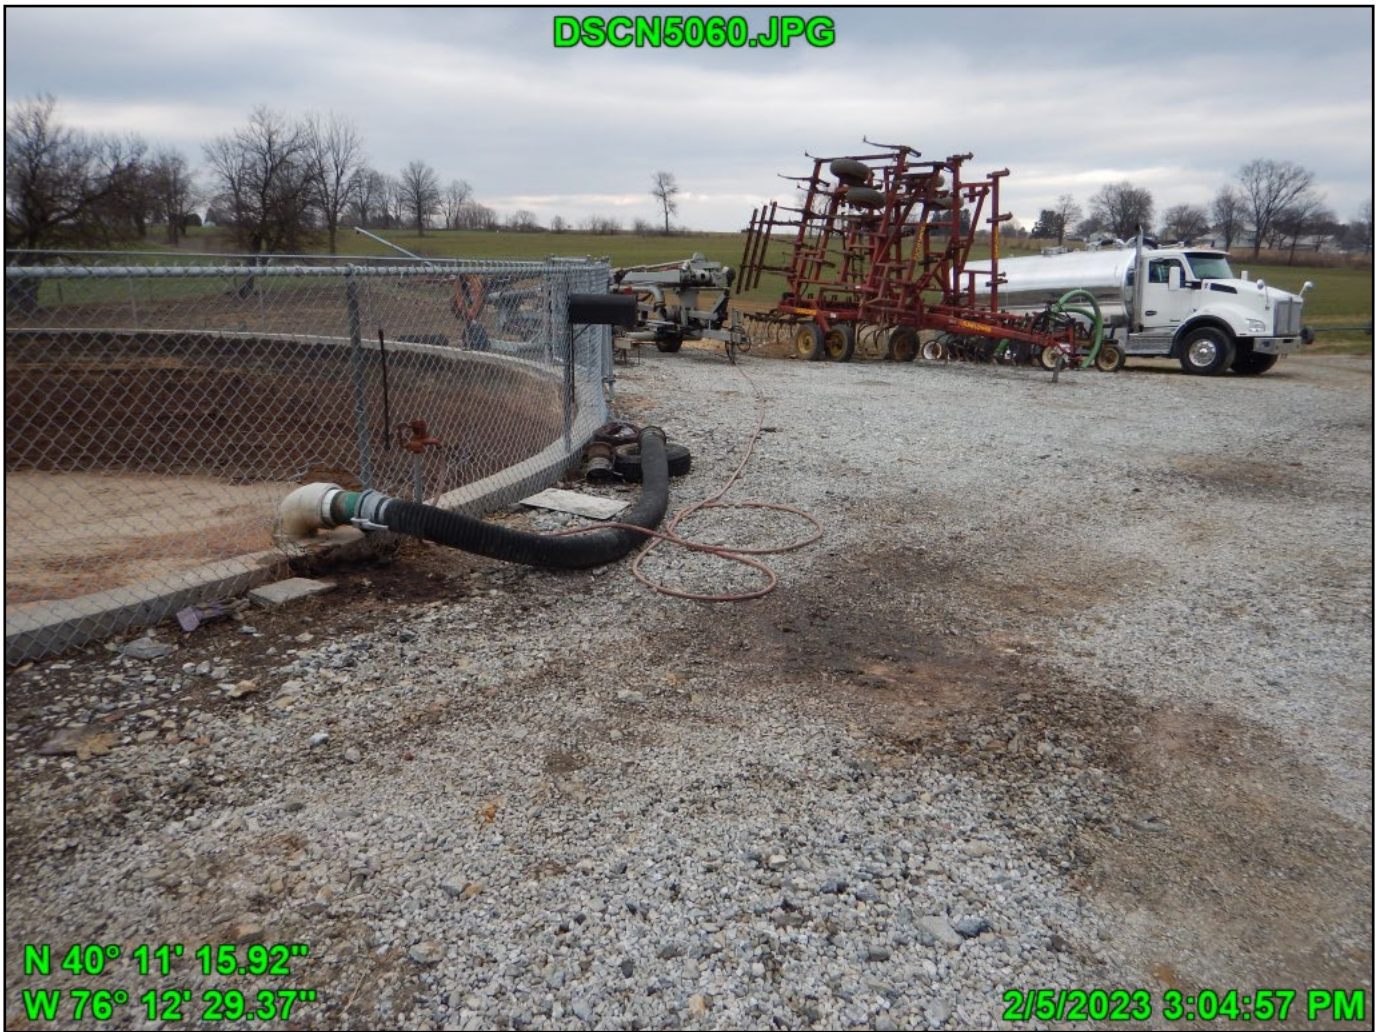
DSCN5060.JPG

| Description | Spillage on the ground adjacent to Tank P2. |

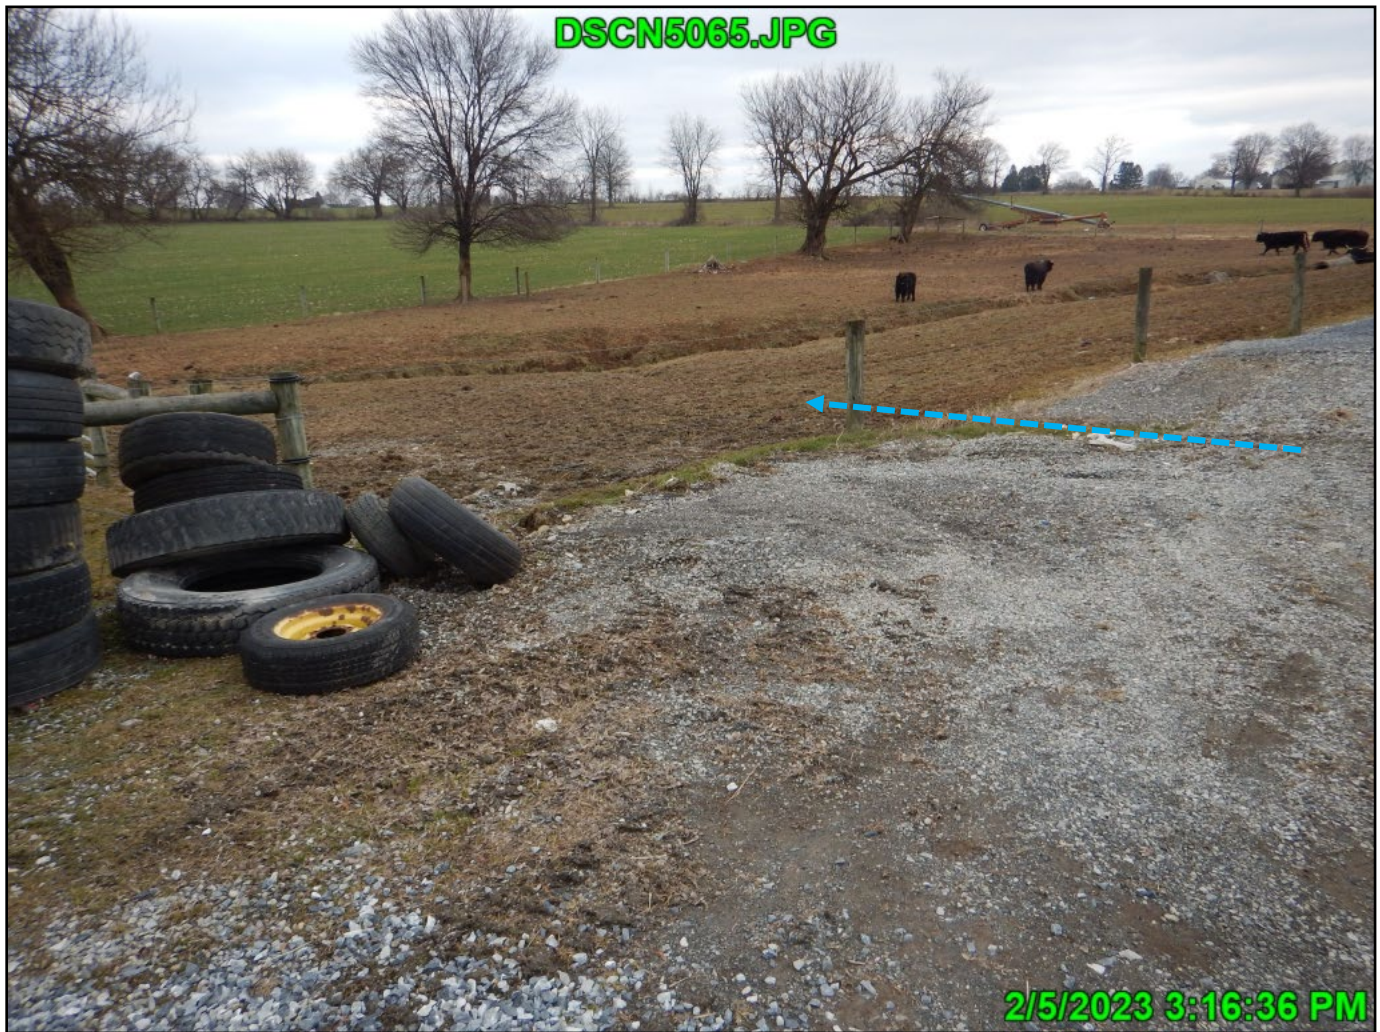
| SITE EVALUATION | |
|---|---|
| <b>Number and description of each potential Stormwater Discharge Point from the Facility</b> | Meadow Run flows southwest through the Western portion of the Facility. Due to the topography, the EPA Inspection Team observed several points of potential discharge adjacent to Tank P2 and the maintenance/storage building. Stormwater in this area appears it would flow north from these areas towards Meadow Run located approximately 25 feet north of the Facility (refer to <u>Appendix B, Photographs DSCN5065 and DSCN5066</u> ). |

| Description | Direction of sloping terrain from the area adjacent to Tank P2 towards Meadow Run. |

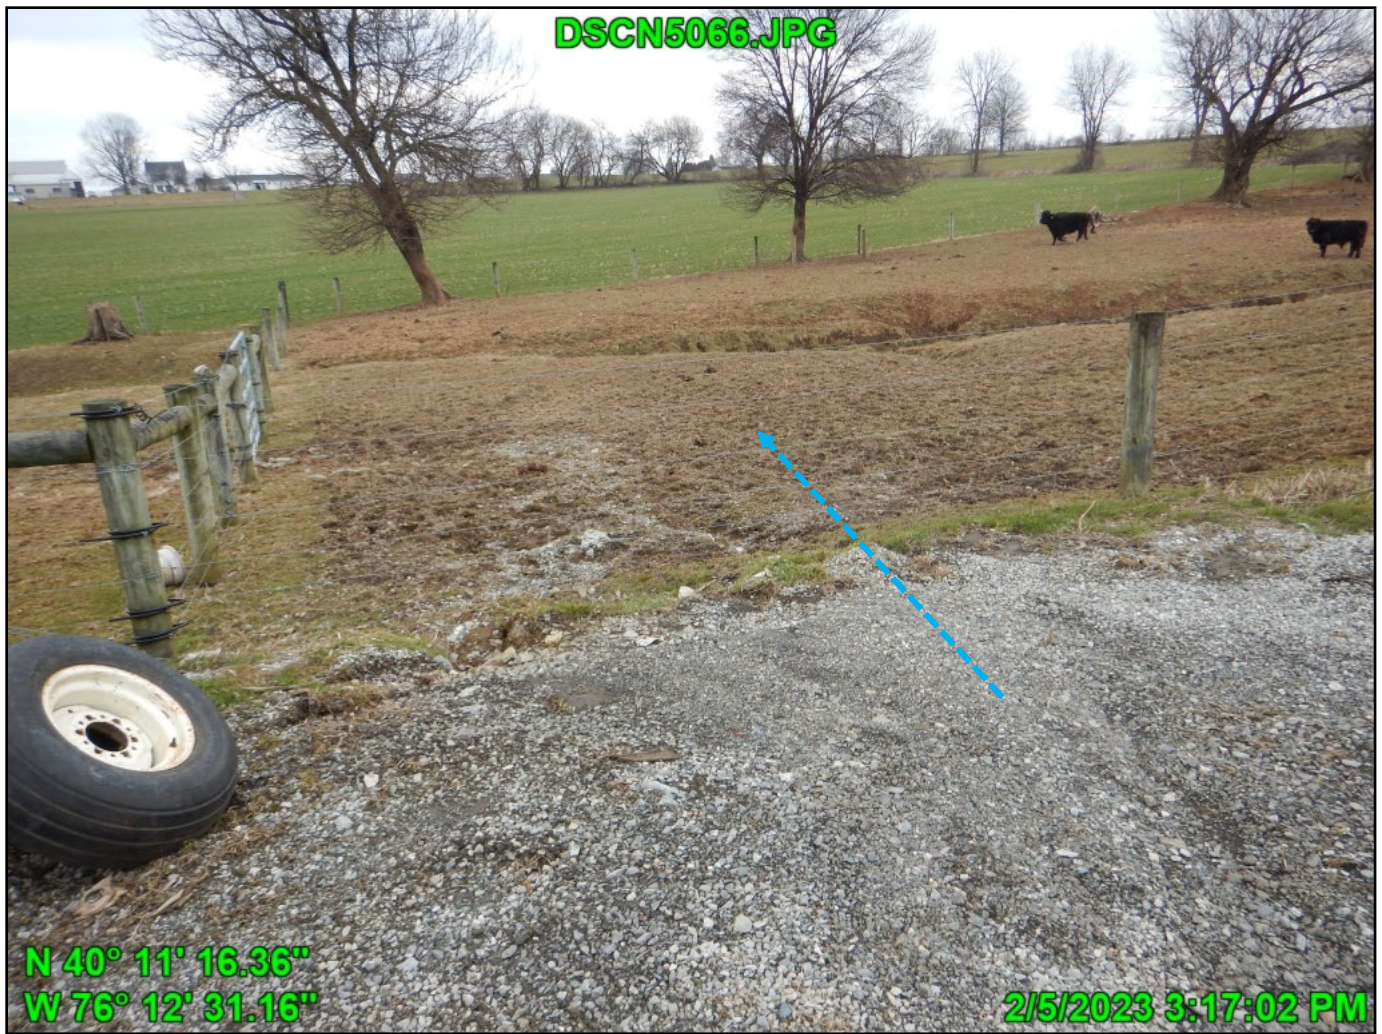
| Description | Direction of sloping terrain from the area adjacent to Tank P2 towards Meadow Run. |

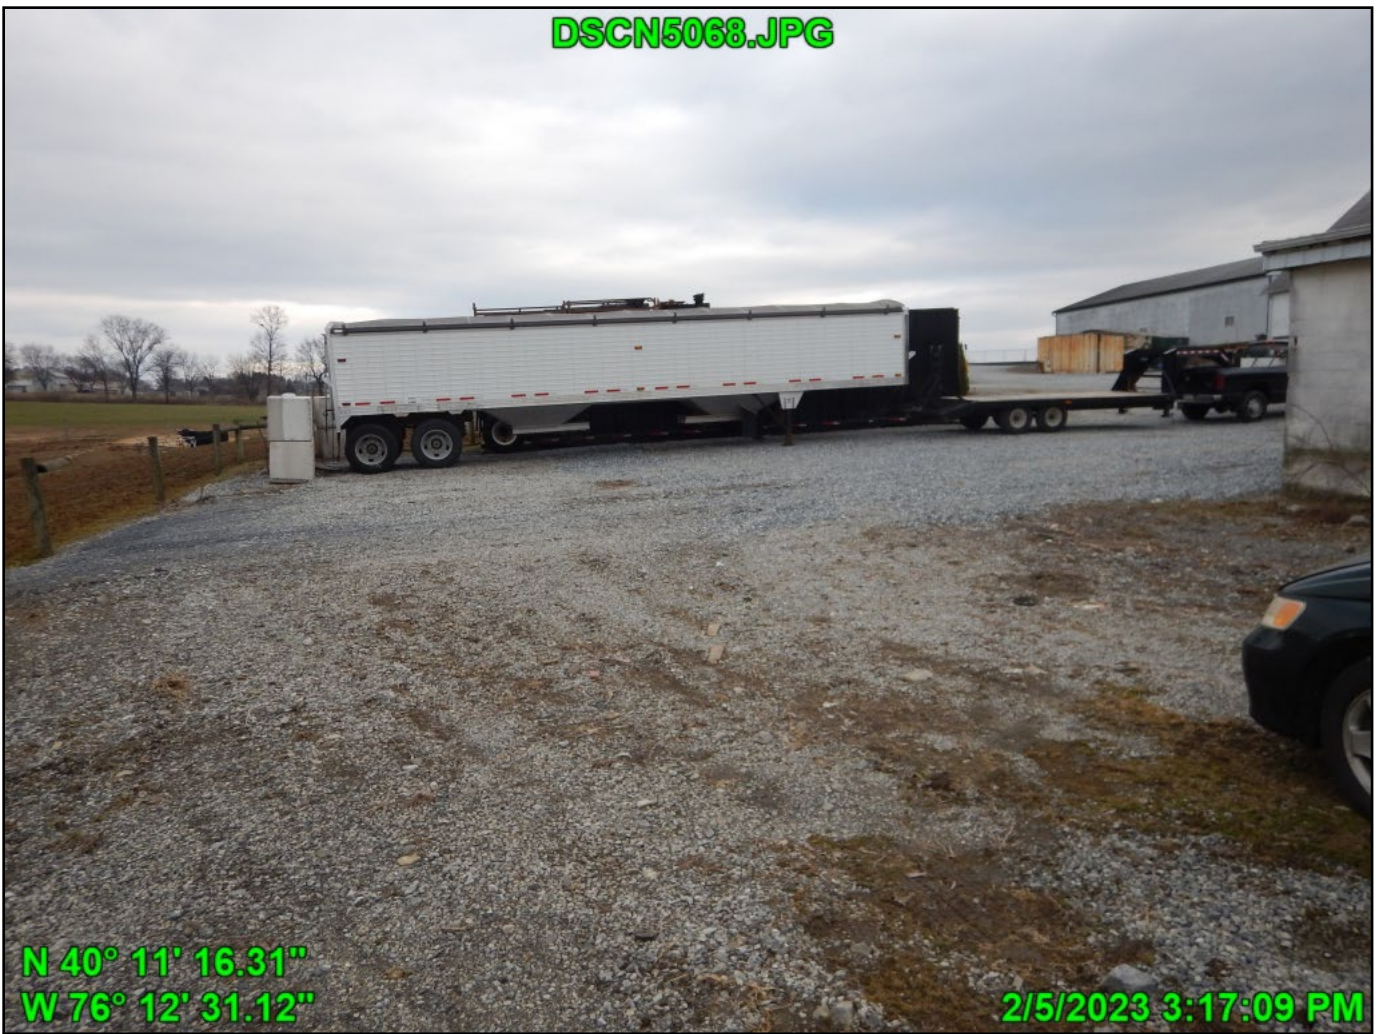
DSCN5068.JPG

| SITE EVALUATION | |
|---|---|
| <b>Industrial Machinery &amp; Equipment Storage</b> | <p>The EPA Inspection Team observed outside uncovered storage areas for vehicles and Facility equipment (refer to <u>Appendix B, Photographs DSCN5017 and DSCN5068</u>). The outside storage areas did not have any cover.</p> <p>The Facility representative stated that the Facility has its own trucks, but also receives septage/biosolids materials directly from customers/contractors via their respective vehicles.</p> |

| Description |
|---|
| View of Facility trucking equipment. |
