VCM RELEASES WHICH OCCURRED FEBRUARY 10, 1979,  
APRIL 14, 1982 AND JANUARY 8, 1983 BECAUSE  
OF THE PREMATURE FAILURE OF A  
REACTOR RUPTURE DISC

Summary:

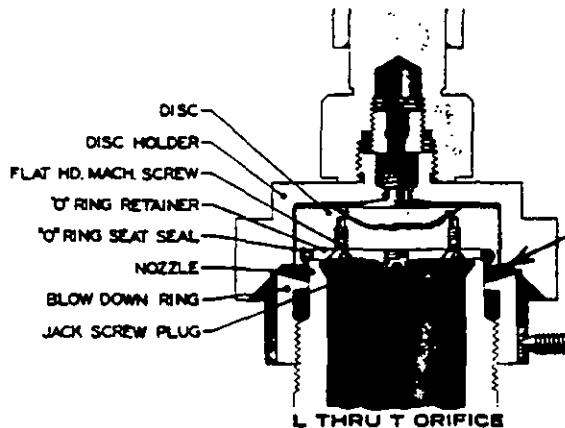
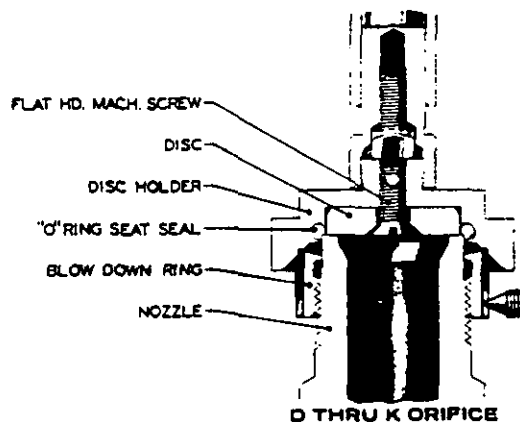
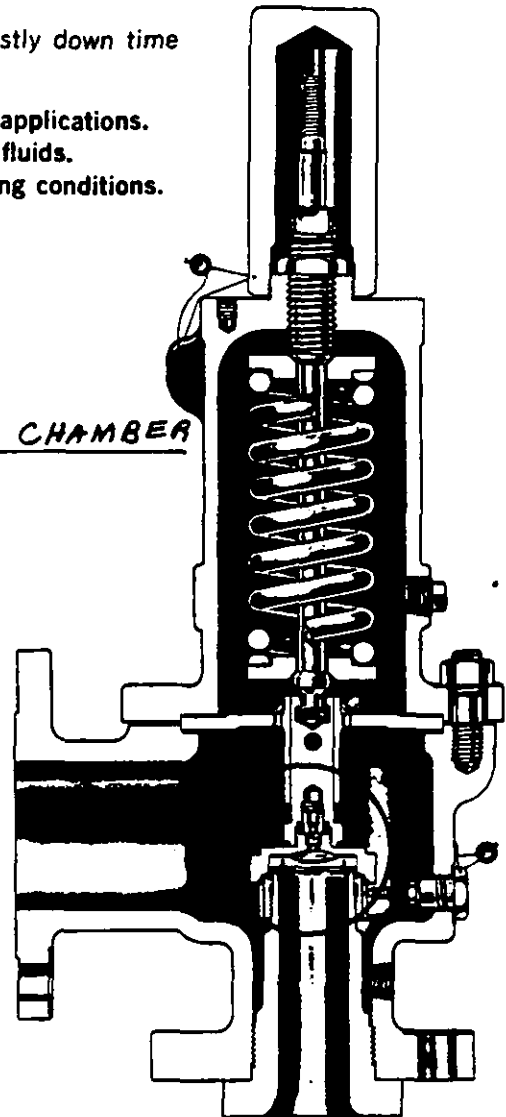
A discussion of how the blowdown ring affects safety relief valve operation will help to show why this change in blowdown ring setting will reduce the likelihood of VCM relief valve emissions. A diagram of the Farris 2600 safety relief valve which is used on most of the plant reactors is reproduced from the Farris catalog on the following page. An understanding of how the blowdown ring controls the relief valve reseating pressure at blowdown can be obtained by referring to the diagram. As the pressure increases in the protected vessel, the force against the disc begins to overcome the spring pressure. The disc then lifts slightly which allows some leakage past the valve O-ring seal into the huddling chamber. Leakage out of the huddling chamber (simmer) is controlled by the clearance between the blowdown ring and the disc holder. A setting of the blowdown ring close to the disc holder will thus reduce the clearance and the leakage rate out of the huddling chamber. When the leakage rate into the huddling chamber becomes greater than the leakage rate out then pressure will buildup in the huddling chamber. Pressure in the huddling chamber will lift the disc holder. The force on the disc holder added to the force on the disc overcomes the closing force of the spring and causes the valve to open quickly in the characteristic pop action. After the valve opens, it is kept open by the kinetic energy of the flowing gas as it changes direction in the huddling chamber. A gas flow of 25% or more of valve capacity is generally required to keep the valve open. When the relieving pressure drops below the valve set pressure, the spring force is able to overcome this kinetic energy and close the valve. However, if the blowdown ring is set close to the disc holder, pressure will again build in the huddling chamber as the disc holder approaches the blowdown ring and the force against the disc holder will prevent the valve from closing. Increasing the blowdown ring setting to a higher number of notches will increase the clearance between the blowdown ring and the disc holder and thus reduce the huddling chamber pressure and the force on the disc holder. This allows the spring to close the valve at a higher pressure. By positioning the blowdown ring further away from the disc holder, it should also be more difficult for the shock wave from a premature rupture disc failure to pop open the valve. This was confirmed by the plant tests. Thus a consideration of both the way the reactor safety relief valves are designed to operate and the results of the tests that were conducted leads to the conclusion that the new blowdown ring settings should reduce the possibility of VCM releases. Training in the changes that were to be made in the blowdown ring settings was provided to the plant engineers on July 13, 1984 which is documented in reference B-34, Appendix B.

These tests were run in May 1984 and a Farris representative participated. The tests evaluated the effect of the blowdown ring setting on the reseating pressure of the valve. The amount of relief valve opening when a rupture disc beneath the valve was burst below the valve set pressure was also investigated. From the results of these tests, it was concluded that the possibility of a VCM release would be reduced if the blowdown rings were set further away from the disc holder. This change was completed in October 1984 when all of the blowdown rings were set at 30 notches which is almost double the normal 18 notches. This change was documented in a plant memorandum dated October 29, 1984 which is attached as reference B-33, Appendix B.
