**Clean Air Act Inspection Report**

**Inspection Date:** October 8, 2024

**Facility Name:** R. M. Packer Company, Inc.

**Facility Location:** 188 Beach Road, Tisbury, MA 02568

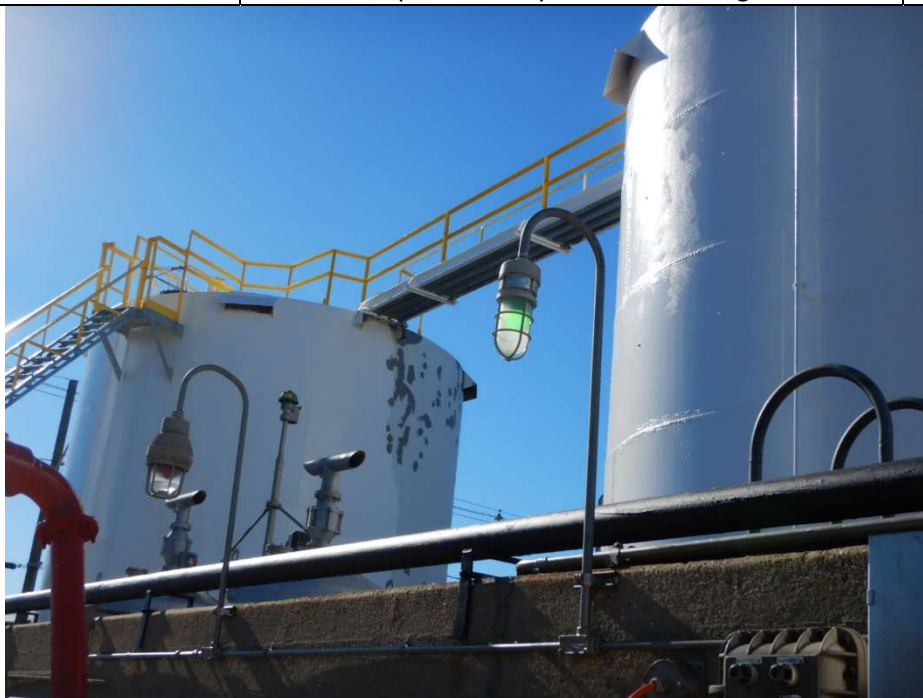
| Number | Image Identification | Description | Time (A.M.) |
|---|---|---|---|
| 7 | DSCN1748.JPG | Vapor recovery unit indicator light | 9:41 |

Inspector Rapp asked Mr. Bailey to explain how the gasoline loading system worked, including the VRU, and for a demonstration of the recently installed lockout system ("Scully system"). Mr. Bailey showed the inspectors the facility's new "Toptech EXI" fuel loading control system which requires the operator to log in with a key card and PIN. He said it was similar to the type of system used at the larger gasoline distribution terminals, such as the Motiva terminal in Providence. Mr. Bailey showed the inspectors that the VRU was operational which was indicated by a green light above the equipment. See photo DSCN1748.JPG. He said that if the VRU was not fully operational, the red light next to the green would turn on.

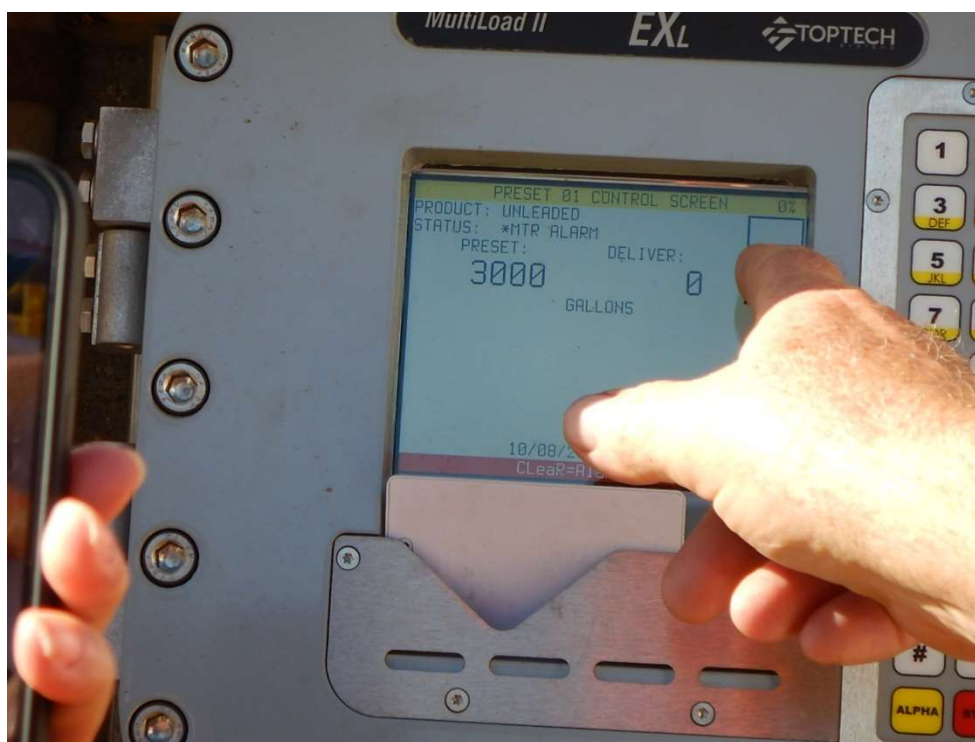
| Number | Image Identification | Description | Time (A.M.) |
|---|---|---|---|
| 8 | DSCN1749.JPG | Toptech EXL fuel loading control system screen | 9:48 |

Mr. Bailey inserted a key card and logged into the Toptech system. He set the system to load 3,000 gallons of gasoline from the storage tanks to the truck. He showed the inspectors that the screen indicated an alarm, "MTR ALARM," because the truck was not connected to the control system. Mr. Bailey showed the inspectors the vapor return line which must be connected from the rack to the truck for the fuel to flow. Because the line was not connected, the screen indicated that the vapor return line was not connected ("CHECK VR"). See photo DSCN1749.JPG.

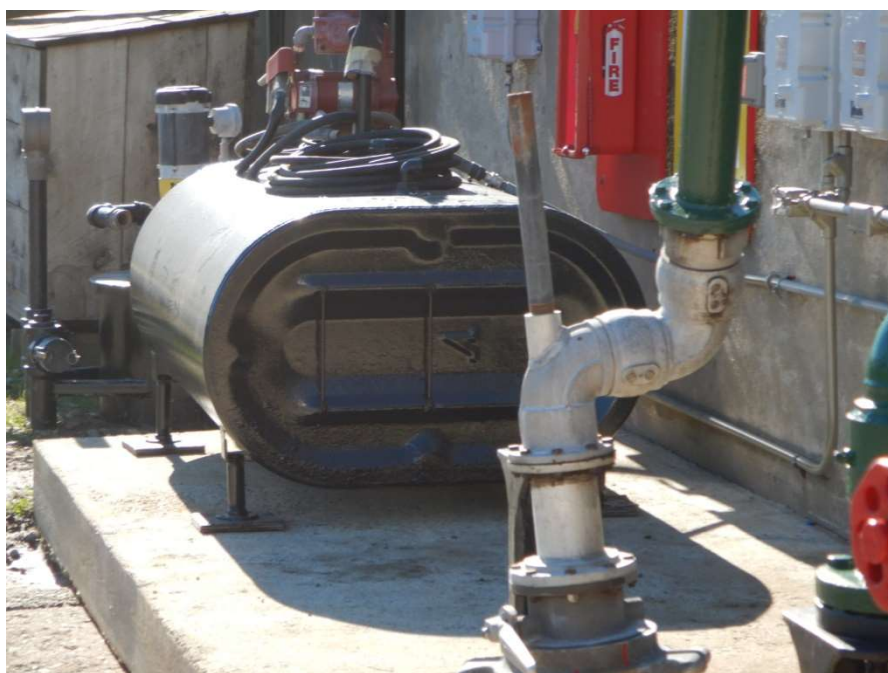
| Number | Image Identification | Description | Time (A.M.) |
|---|---|---|---|
| 10 | DSCN1751.JPG | Thermal expansion tank for diesel and fuel oils | 9:50 |

gasoline. See photos DSCN1751.JPG, DSCN1752.JPG, and DSCN1758.JPG. Mr. Bailey explained that the diesel/fuel oils expansion tank is disconnected and the valves plugged but Packer is waiting for an electrician to decommission them before they remove them. He said the new system released pressure directly back to the storage tanks. He said the gasoline thermal expansion system was still in service and would not be changed.

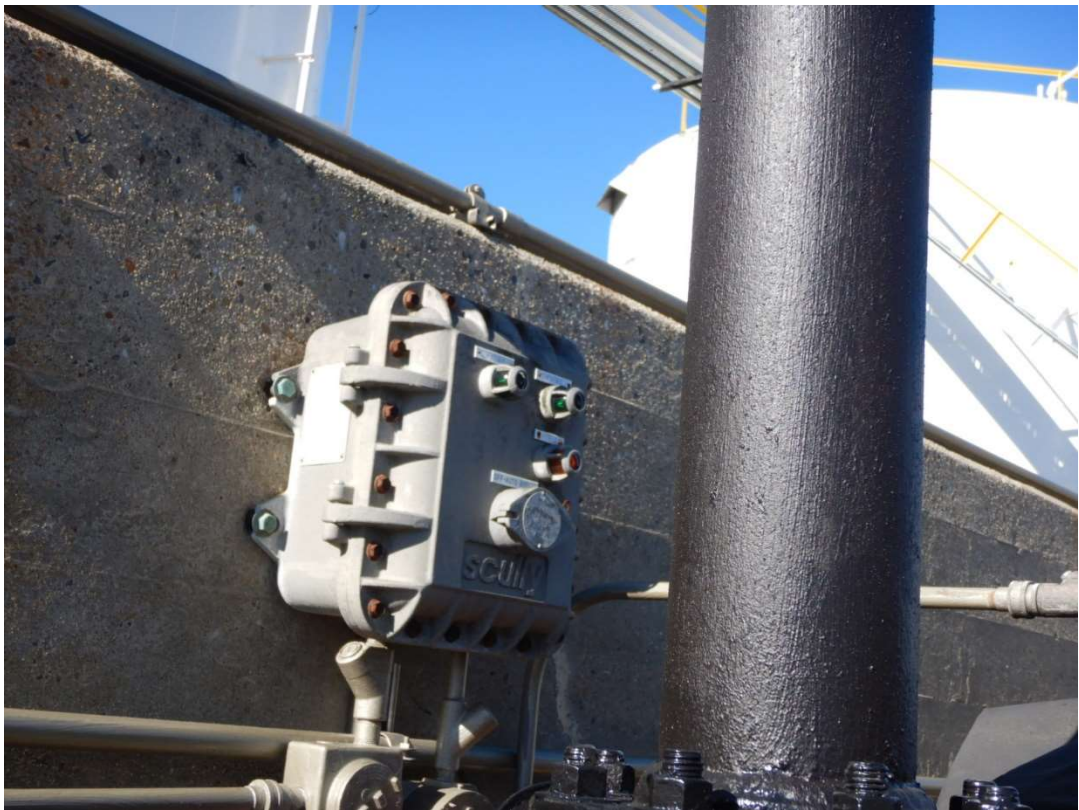
| Number | Image Identification | Description | Time (A.M.) |
|---|---|---|---|
| 13 | DSCN1754.JPG | Control panel of Scully lockout system | 9:52 |

lights in the front of the Scully system panel indicating that the required connections were in place to allow gasoline to flow into the truck. See photo DSCN1754.JPG. Mr. Bailey said that prior to the installation of the Toptech and Scully equipment, gasoline could be loaded into a truck even if the vapor return line was not connected or the VRU was not operational. He said that the Toptech system allowed them to track the flow of gasoline to the trucks more accurately than previously which allowed them to fill the trucks closer to the maximum without risk of overflow.

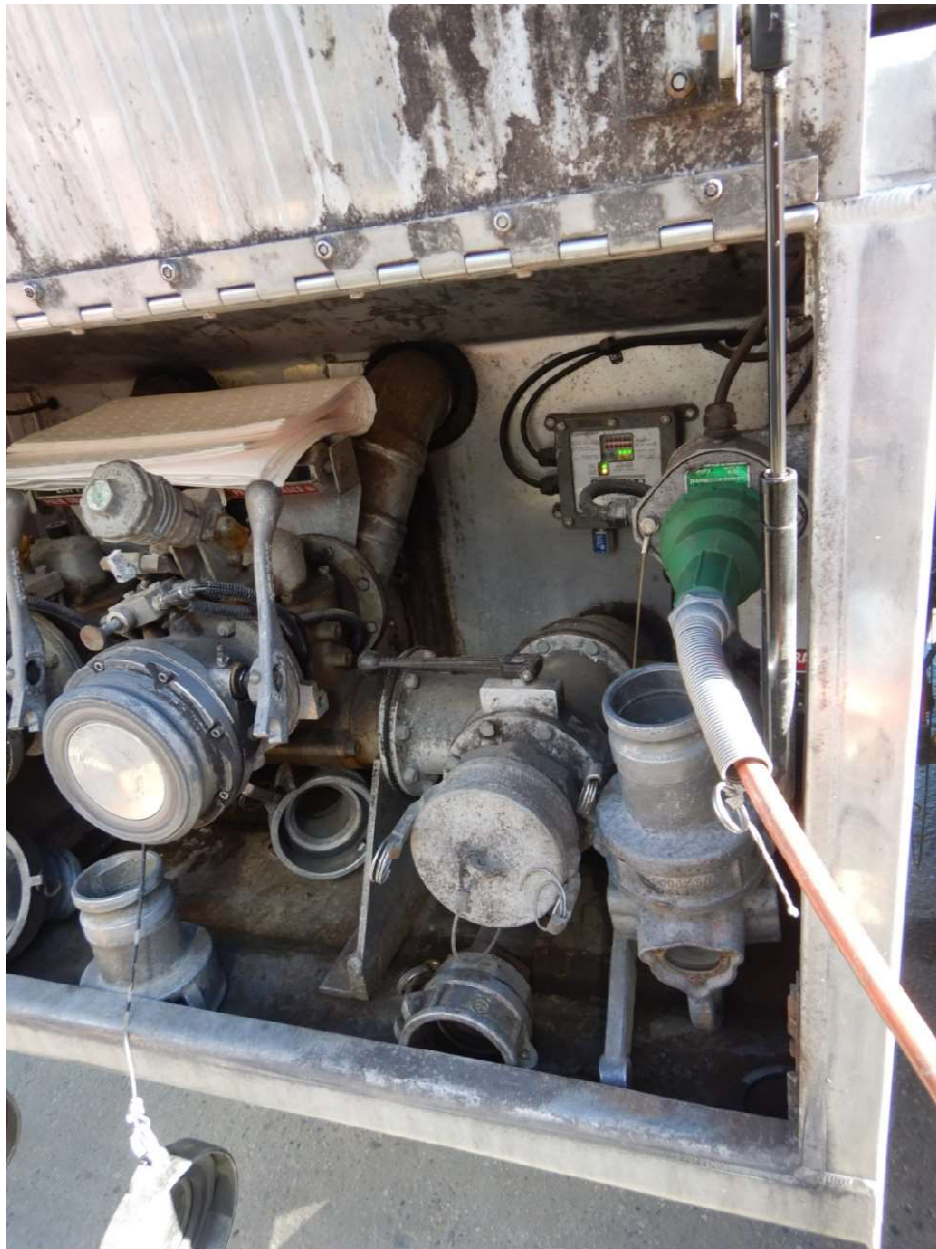
| Number | Image Identification | Description | Time (A.M.) |
|---|---|---|---|
| 14 | DSCN1755.JPG | Truck computer and electronic hookup | 9:53 |

Mr. Bailey showed the inspectors the tank truck's computer system which also must be connected to the fuel loading rack's control system for gasoline to flow from the storage tank to the truck. See photo DSCN1755.JPG. He explained that given the vapor return line and electronic probe were not connected to the control system, gasoline could not be loaded into the truck, i.e., it was locked out.

Next, Mr. Bailey connected the electronics probe from the system to the truck. See photo DSCN1755.JPG. Mr. Bailey then attached the gasoline transfer pipe to the truck. See photos DSCN1756.JPG and DSCN1757.JPG. Mr. Bailey pointed out the two green

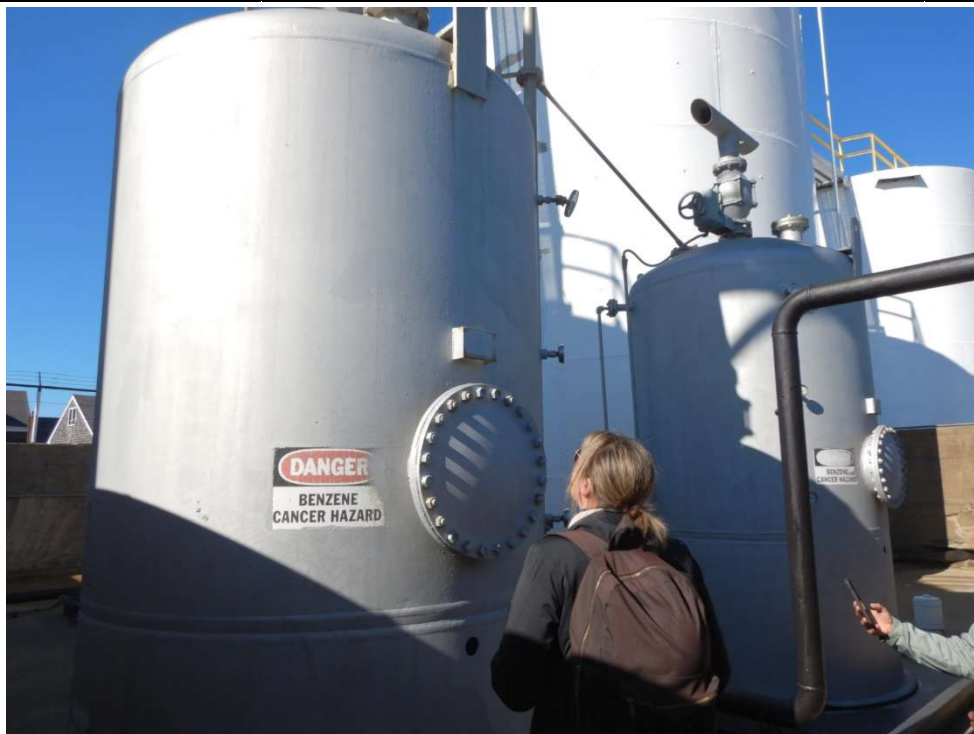
| Number | Image Identification | Description | Time (A.M.) |
|---|---|---|---|
| 19 | DSCN1760.JPG | Carbon adsorber beds (A on left, B on right) | 10:09 |

Inspector Rapp asked to see the VRU system. Mr. Bailey explained the VRU includes two carbon adsorption beds (Carbon Beds A and B) designed to adsorb and collect gasoline vapors generated during transfer from the storage tanks to the trucks. See photos DSCN1760.JPG, DSCN1761.JPG, and DSCN1762.JPG. He said vapors are sent to one of the carbon beds where the vapors are adsorbed onto activated carbon. He said while one carbon bed is adsorbing vapors, the second carbon bed is offline and is regenerated. He said the vapors trapped in the closed carbon bed are pulled by vacuum pump and sent to an absorption tower which uses liquid gasoline taken as the absorption liquid. See photos DSCN1759.JPG, DSCN1763.JPG, DSCN1764.JPG, and DSCN1765.JPG. He explained that the carbon beds switch to active or off-line based on a timer rather than by process parameters but the process can be controlled manually from the control panel. See photo DSCN1766.JPG. Mr. Bailey said that Packer often leaves the VRU system running after loading is completed in order for the beds to cycle through a few times which helps keep the carbon performing well.

Inspector Rapp asked Mr. Bailey about the “electrical problems” indicated in the October 2023 semi-annual report from Packer. Mr. Bailey said that the VRU is an old system and there were several solenoids and valves that needed repair or replacement but the system is now working well. Inspector Rapp asked Mr. DeBlase about the VRU’s program logic controller (“PLC”) issues noted in the Spring 2024 semi-annual report, specifically if the PLC had needed to be replaced in order for the lockout system to work. Mr. DeBlase said that they resolved the issues and were able to continue using the original PLC.
