WALK-THROUGH SURVEY OF  
Goodyear Tire and Rubber Co.  
Cast Film Division  
St. Marys, Ohio

February 9-10, 1976

January, 1977

Industry-Wide Studies Branch  
Division of Field Studies, Hazard Evaluations, and Field Studies  
National Institute for Occupational Safety and Health  
Cincinnati, Ohio

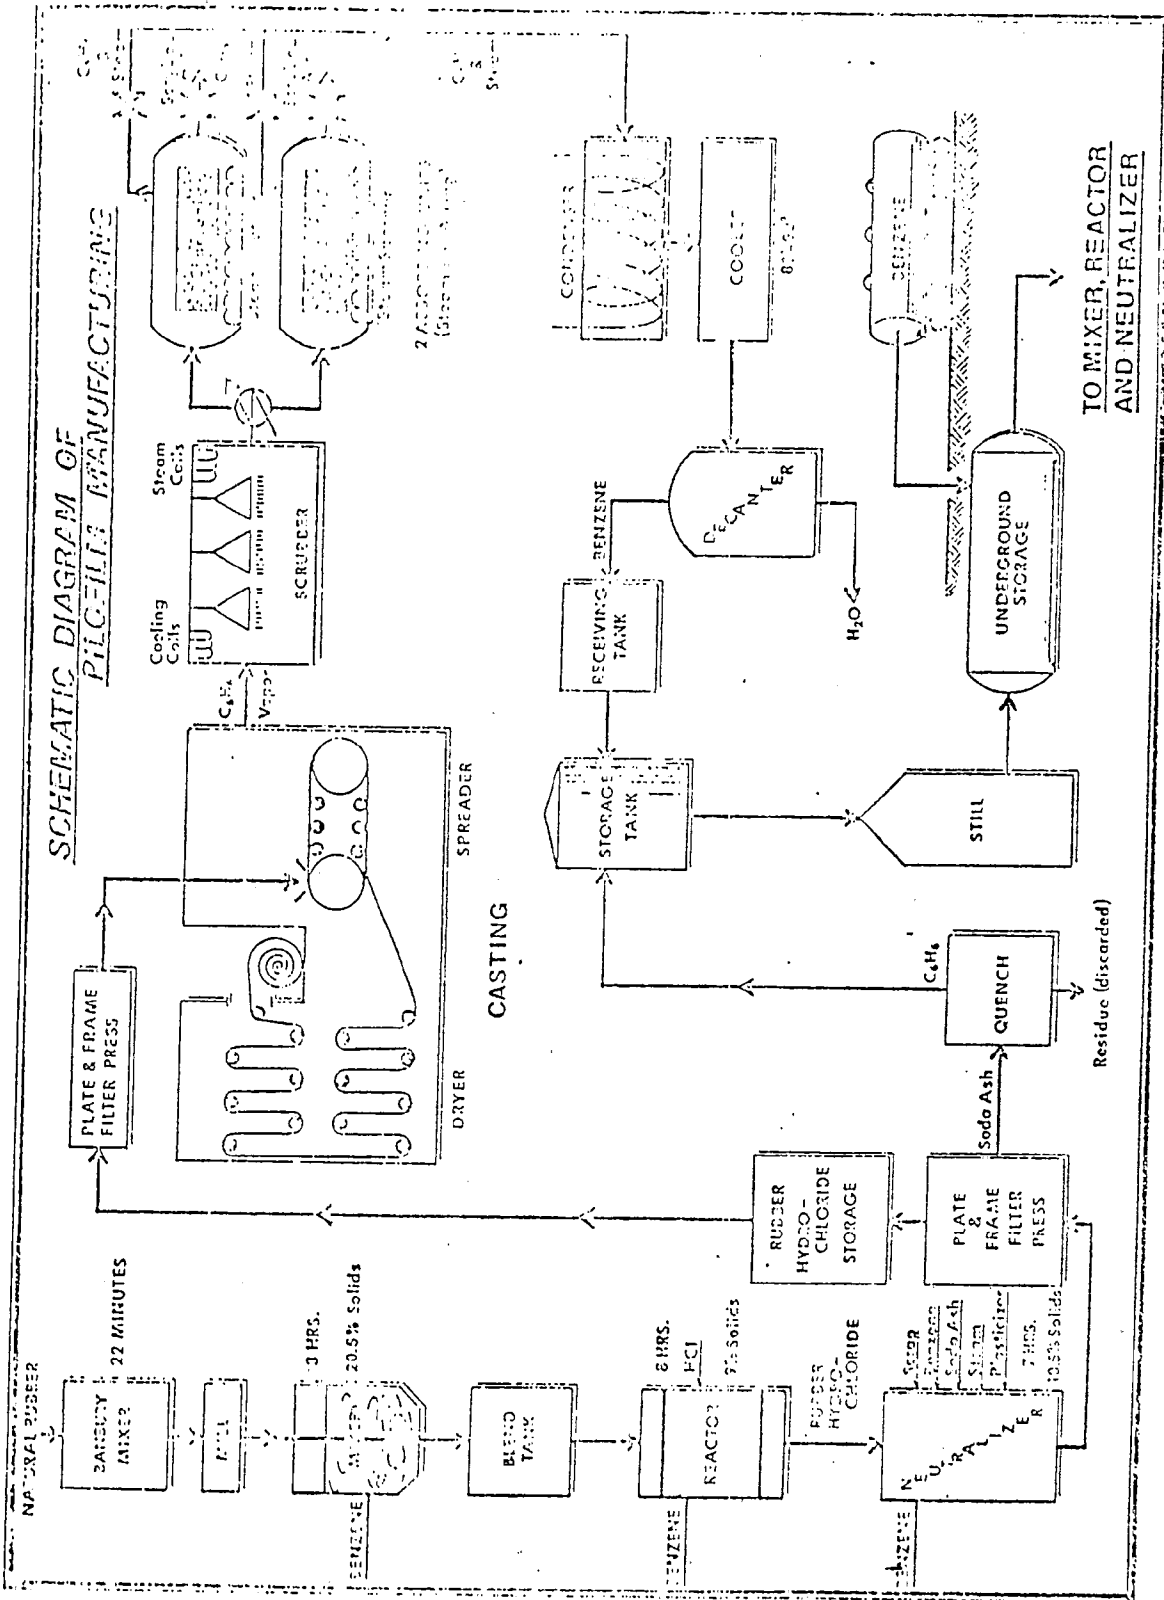
SCHEMATIC DIAGRAM OF

A schematic diagram of the process is shown in Figure 1. Natural rubber is uncrated and dumped in a Banbury mixer for approximately 22 minutes. The rubber from the Banbury passes through a mill and is conveyed to agitated mixing tanks where benzene is added. During this three hour mixing process, the rubber is dissolved in the benzene. This liquid is then piped to blending tanks where further mixing takes place. These tanks also serve as a hold tank for the reactor. As the process continues, the solution is introduced to the reactor, where hydrochloric gas (HCl) is added. Also, measured amounts of benzene are added to reduce the percent solids from 20% to 9% or less. From the reactor tanks the rubber hydrochloride is dropped into neutralizing tanks. Film scraps, soda ash, plasticizers and additional benzene are added. The mixing is a 6 to 7 hour process, and is adjusted to 10% rubber hydrochloride. Next the mixture is passed through a plate and frame filter press. The
