**Region 2 Caribbean Environmental Protection Division  
Multimedia Permits and Compliance Branch**

**CAA Inspection Report**

**Inspection Date:** 12/4/2024

**Facility Name:** Steri-Tech Inc.

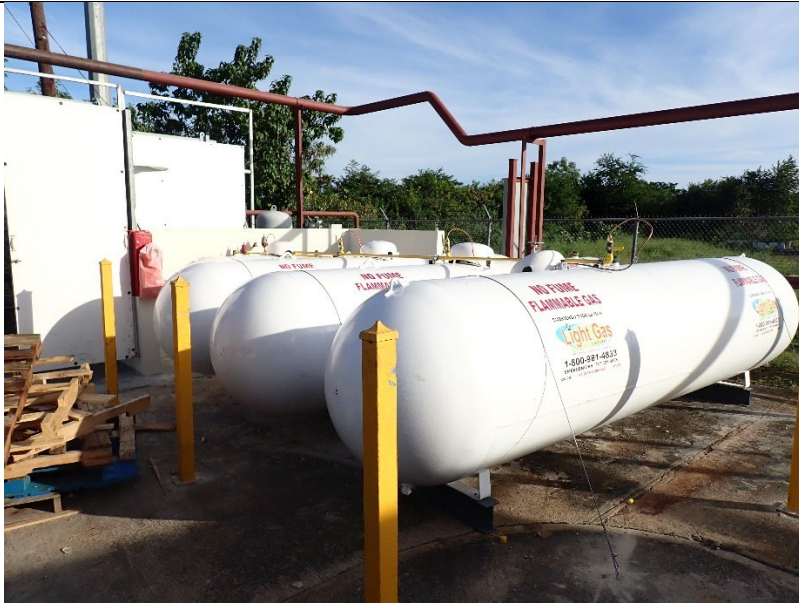
3. The facility previously has three (3) 500 gallons propane storage tanks. The project completed on December 3, 2024, consisted of the installation of three (3) new 1,000 gallons propane storage tanks and kept one (1) of the existing 500 gallons tanks. See Appendix A images PC040002 and PC040003 for further details.

| 2 | PC040002 | <p>Partial view of the facility propane storage tanks.</p> | 12-4-24 | 16:16 PM |

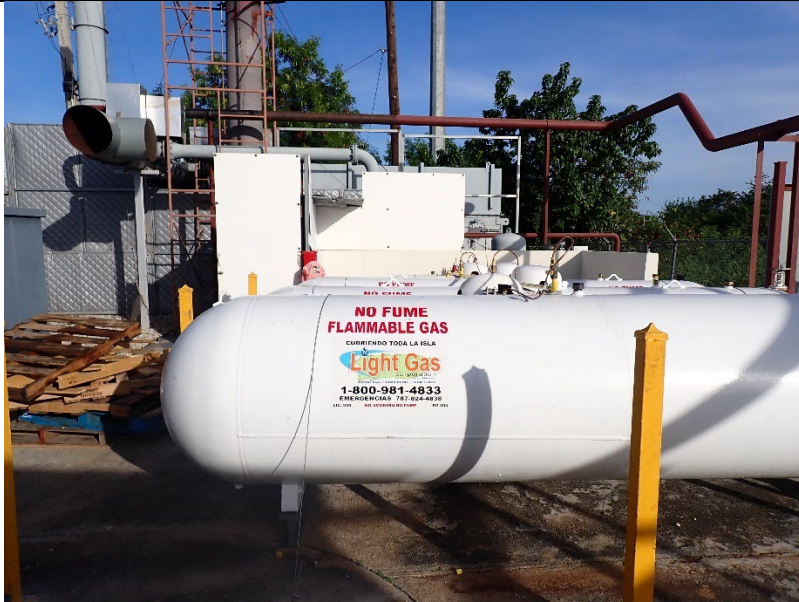
| 3 | PC040003 | <p>Partial view of the facility propane storage tanks.</p> | 12-4-24 | 16:16 PM |

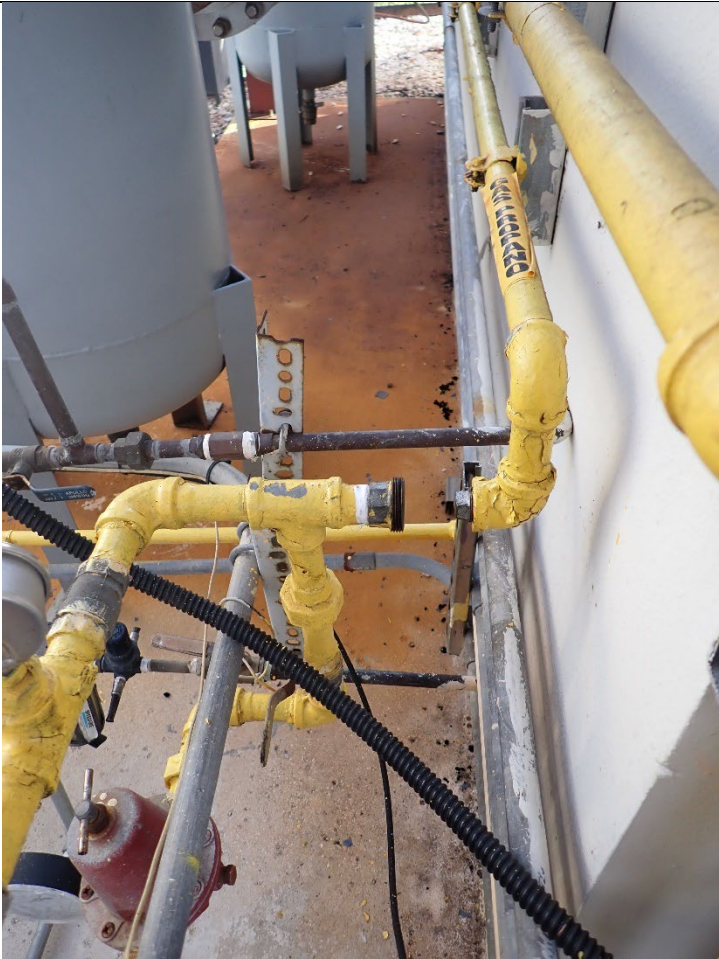
5. The TO was off at the time of the inspection and Mr. Sánchez informed that a mechanic recently disconnected the TO from its propane supply piping. Mr. Sánchez showed Inspector Rivera where the disconnection was done and that the piping was blinded. See Appendix A image PC040004 and further details.

| 4 | PC040004 | <p data-bbox="573 1024 1514 1084">Partial view of the TO propane supply piping. The piping was cut and blinded at the time of the inspection to disconnect the TO from its propane supply.</p> | 12-4-24 | 16:20 PM |

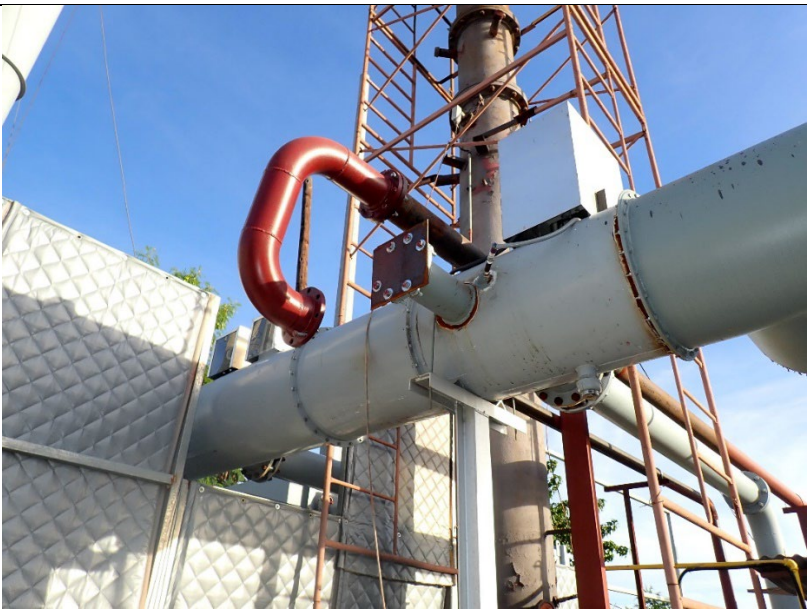
6. Inspector Rivera asked Mr. Sánchez about new piping connected to the CRO inlet. Mr. Sánchez informed that the piping is for the future connection of Chamber #6 and that the connection is currently blinded and disconnected. See Appendix A image PC040012 for further details.

| 12 | PC040012 | <p>Partial view of the CRO process gas inlet pipe. A new inlet connection, currently blinded, was installed for allowing the future connection of Chamber 6.</p> | 12-4-24 | 16:27 PM |

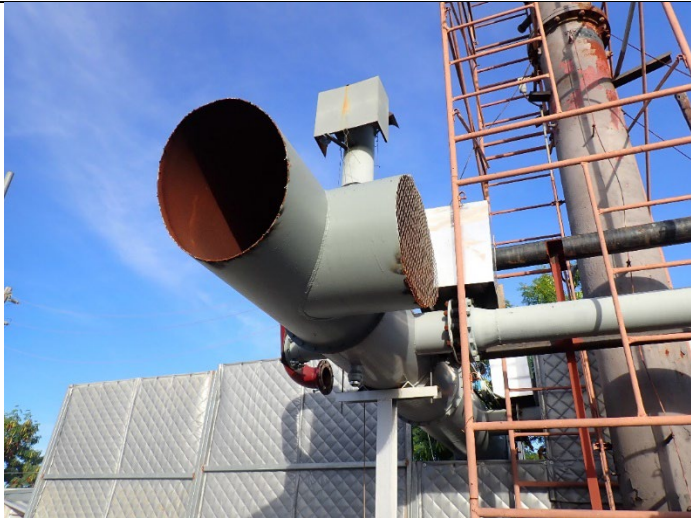
7. Mr. Sánchez informed Inspector Rivera that STI also added a new connection next to the CRO fresh air damper that was for the purpose of adding air from the sterilization building as supplement to the fresh air intake, but the project is no longer under consideration. See Appendix A image PC040013 for further details.

| 13 | PC040013 | <p>Partial view of the CRO fresh air damper.</p> | 12-4-24 | 16:30 PM |

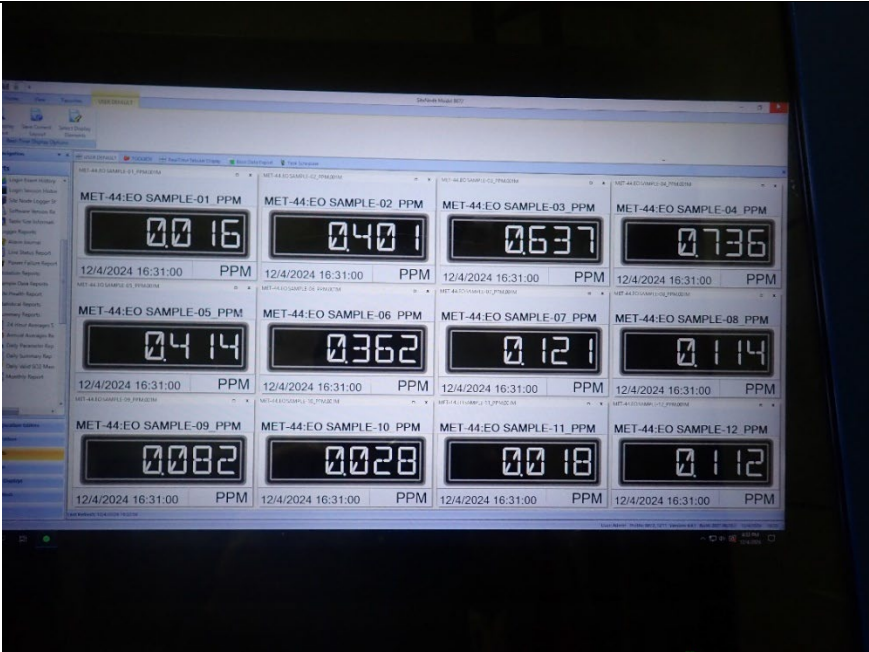
10. Inspector Rivera asked Mr. Sánchez to provide access to the EtO indoor monitoring system control room. Mr. Sánchez provided access to the EtO indoor monitoring system control room and Inspector Rivera took a photo of the system monitor screen. See Appendix A image PC040015 for further details.

| 15 | PC040015 | <p>View of the facility EtO indoor monitoring system control panel screen.</p> | 12-4-24 | 16:35 PM |
