INTEROFFICE / LAKE CHARLES

DATE: FEBRUARY 7, 1989

SUBJECT: SPILLS AND RELEASES,  
1988

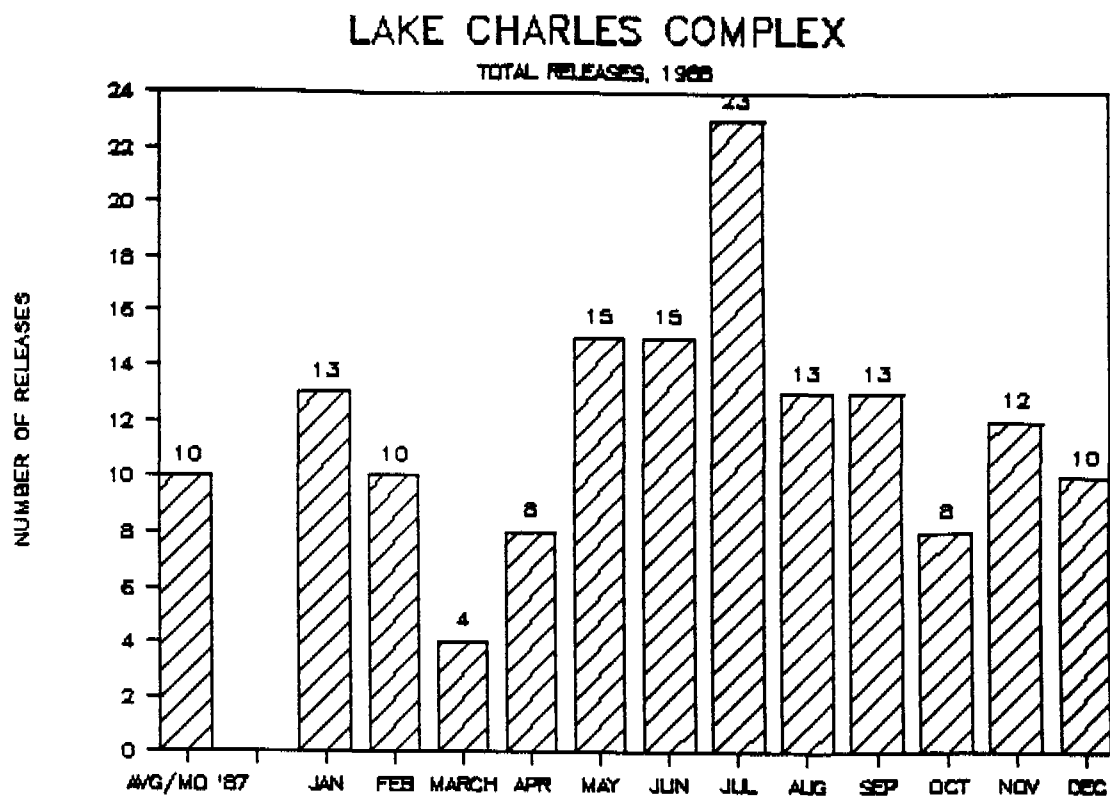
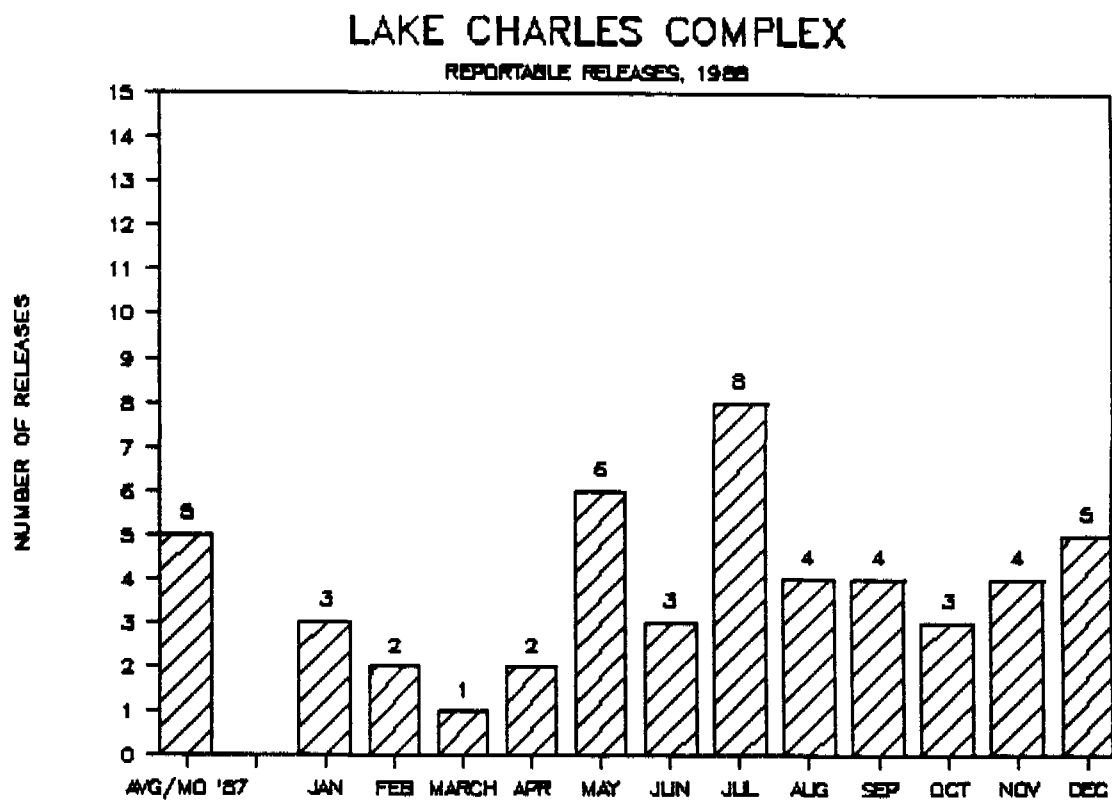
FIGURE 1

Figure 1 presents the total number and reportable number of spills/releases for the entire Complex by month in 1988 and compares the monthly values to the average monthly values of 1987. There were 144 total incidents for an average of 12/month in 1988 as compared to 124 and 10/month, respectively in 1987. This amounts to an increase of 16% in the total number of incidents from 1987 to 1988. However, on the positive side, only 45 of these incidents were reportable to a regulatory agency, or 4/month, as compared to 58 and 5/month in 1987. This represents a 22% decrease in the number of reportable incidents from 1987 to 1988.

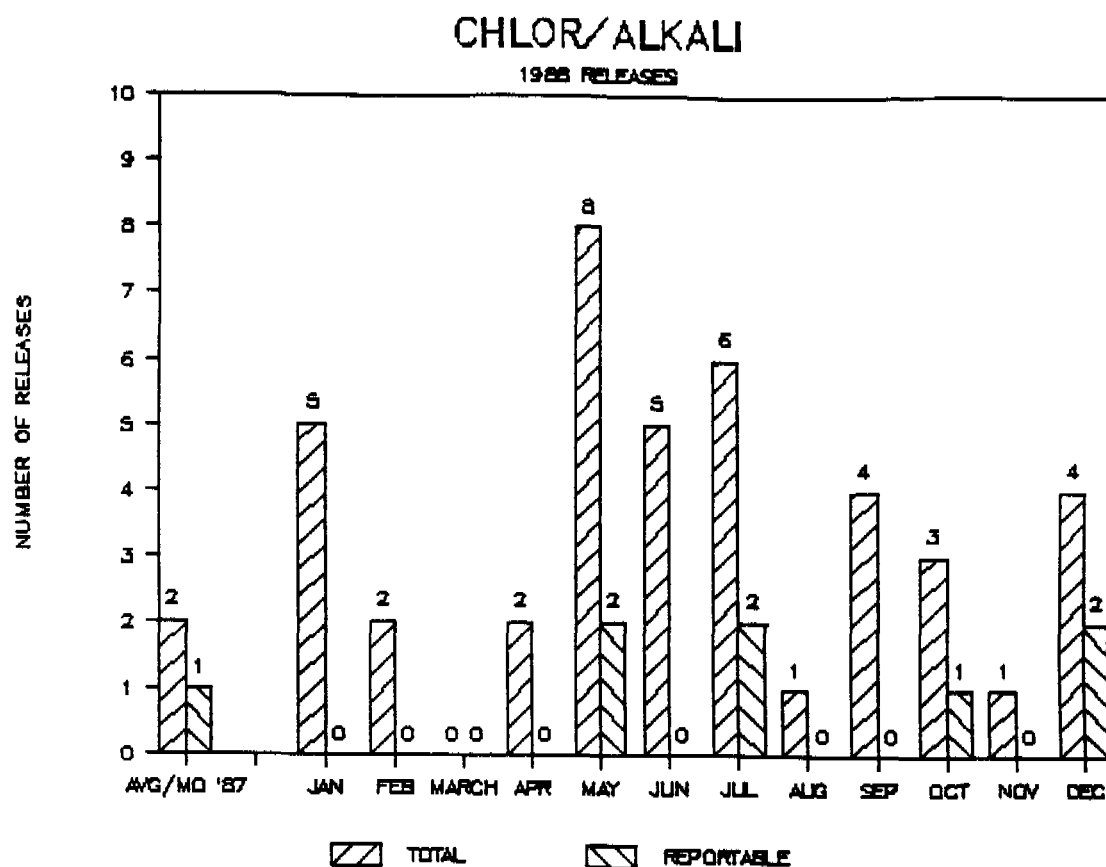
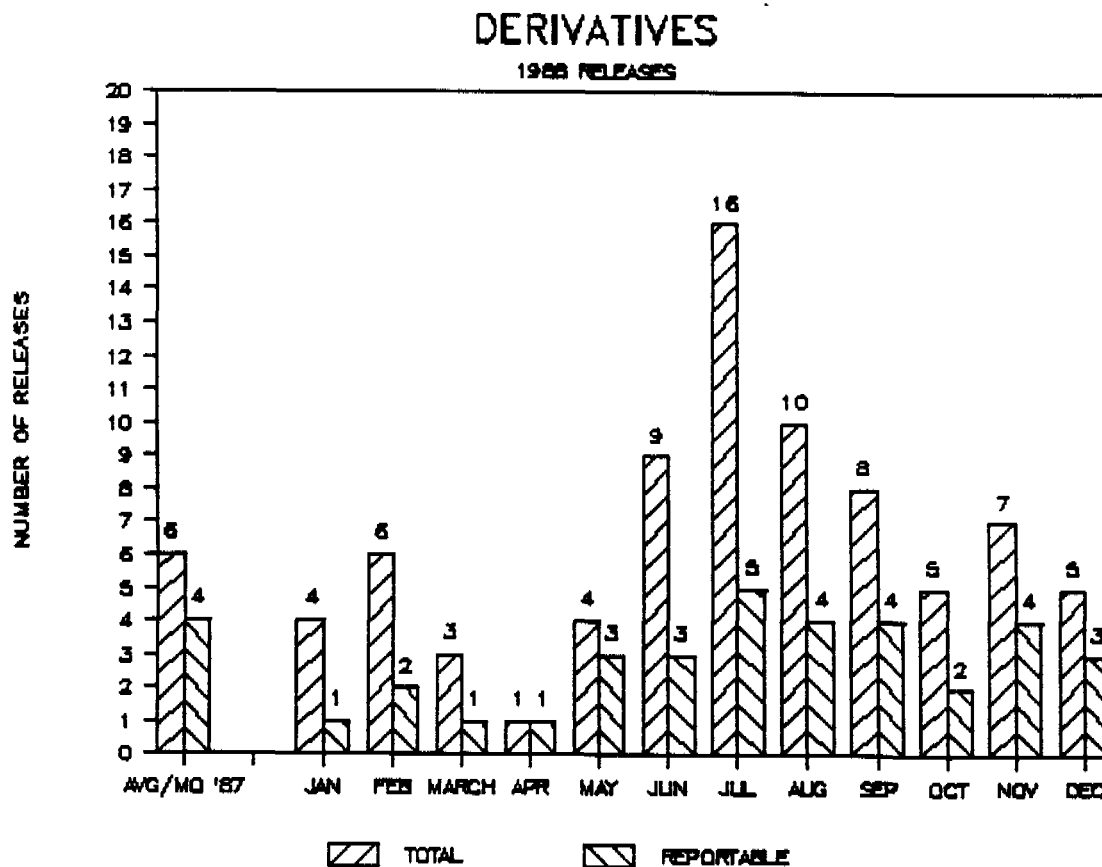
FIGURE 1

Figure 2 illustrates the releases by month from the Chlor/Alkali and Derivatives areas. No graphs are shown for the Shipping, Silicas, and Complex areas as they are responsible for very few of the total incidents.

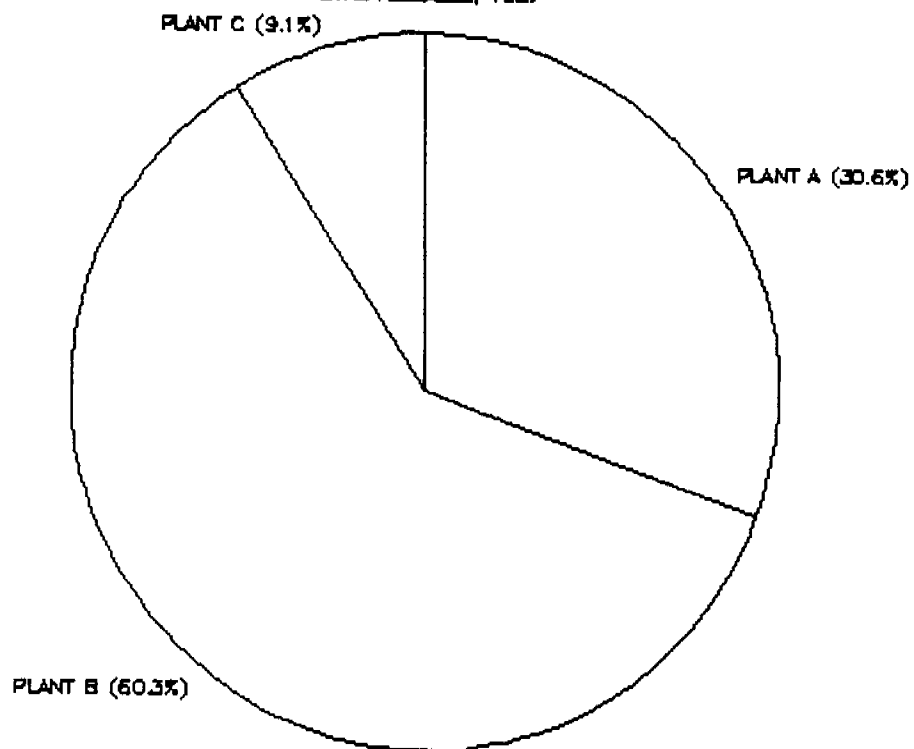
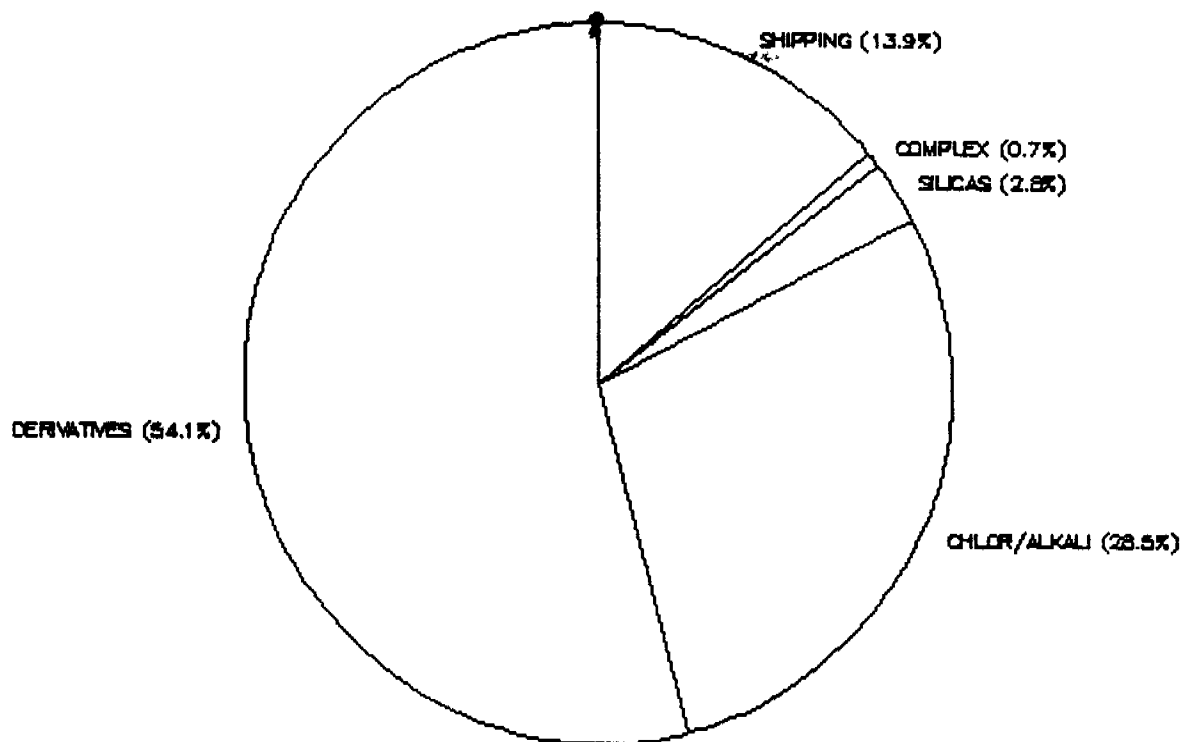
FIGURE 3

The pie charts shown in Figure 3 illustrate the percentage of total releases attributable to each section of the Complex. A better accounting of area of responsibility for an incident was made in 1988 resulting in statistics being obtained for Shipping, Silicas, and Complex in addition to Chlor/Alkali and Derivatives.

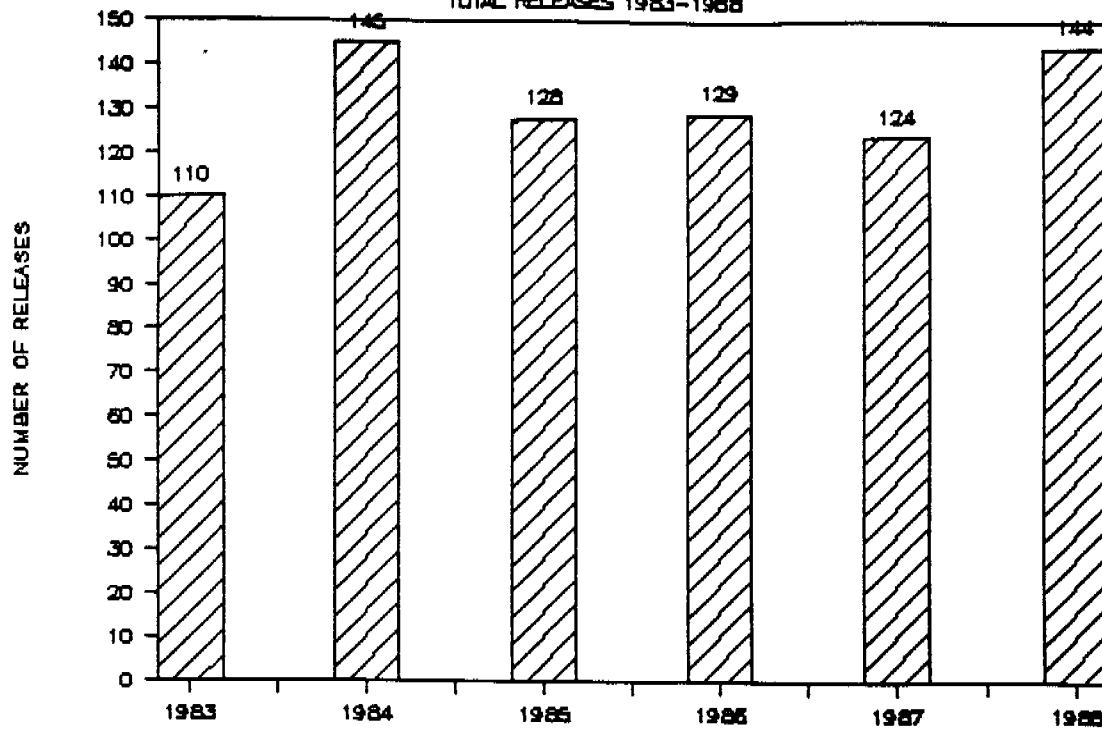
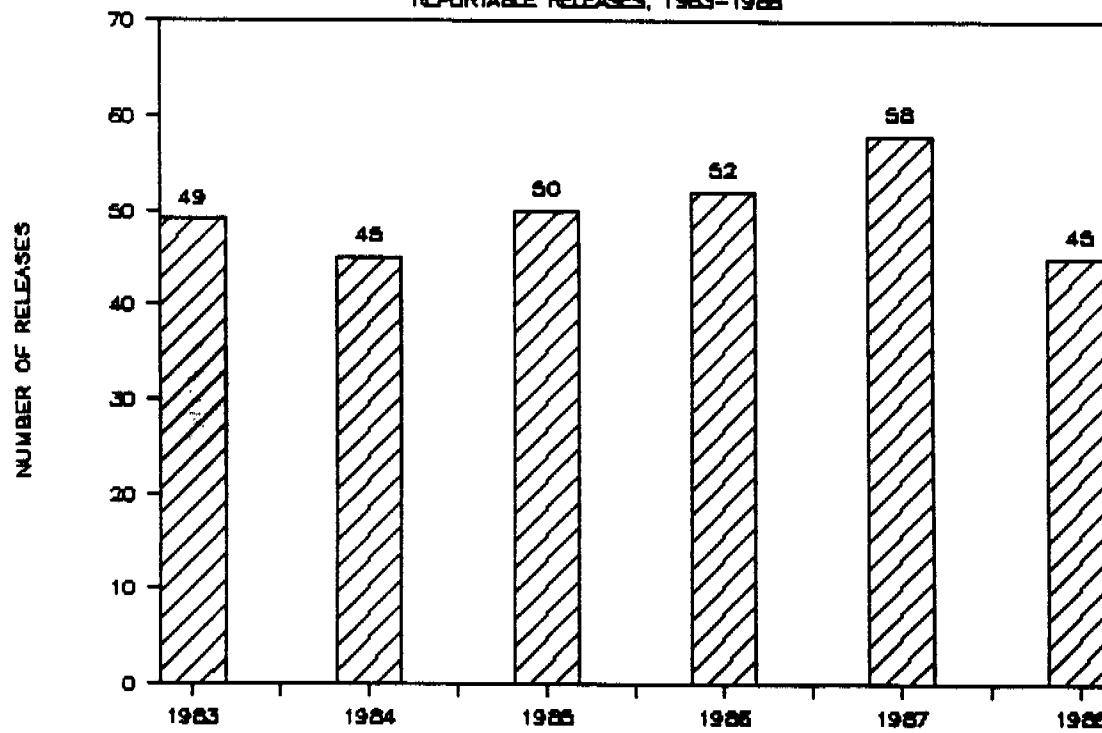
TOTAL RELEASES 1983-1988

Figure 4 shows a comparison of total and reportable incidents since 1983. This figure again illustrates the increase in total incidents but decrease in reportable incidents that occurred this year.

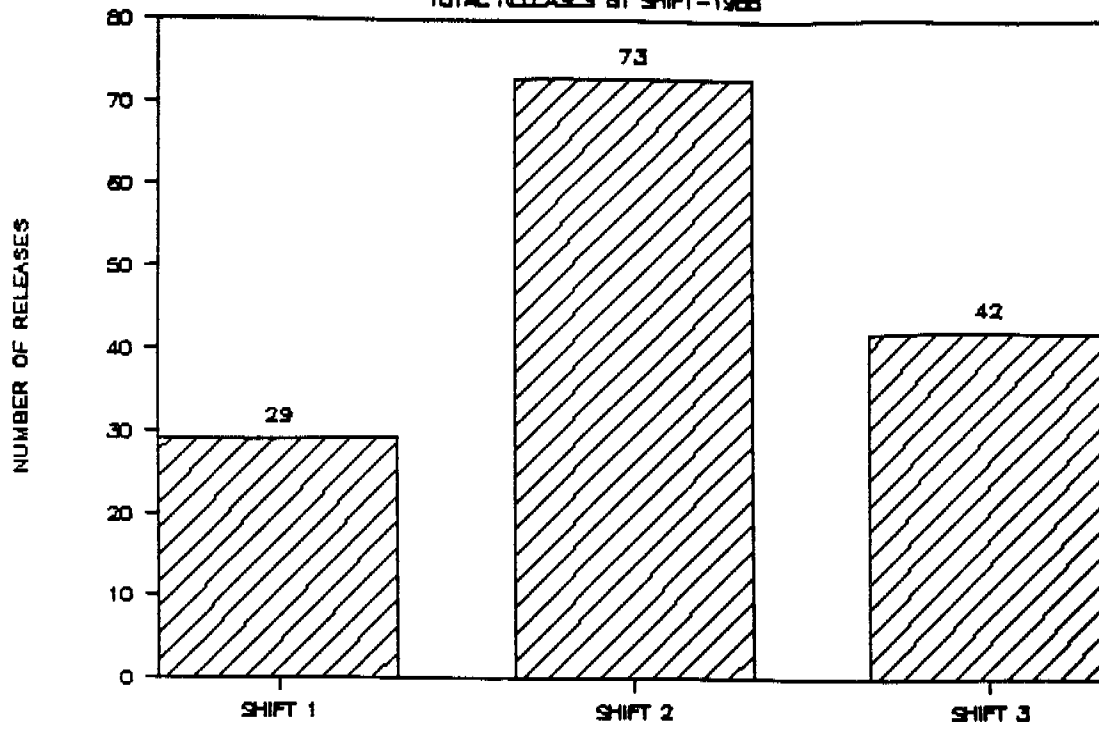
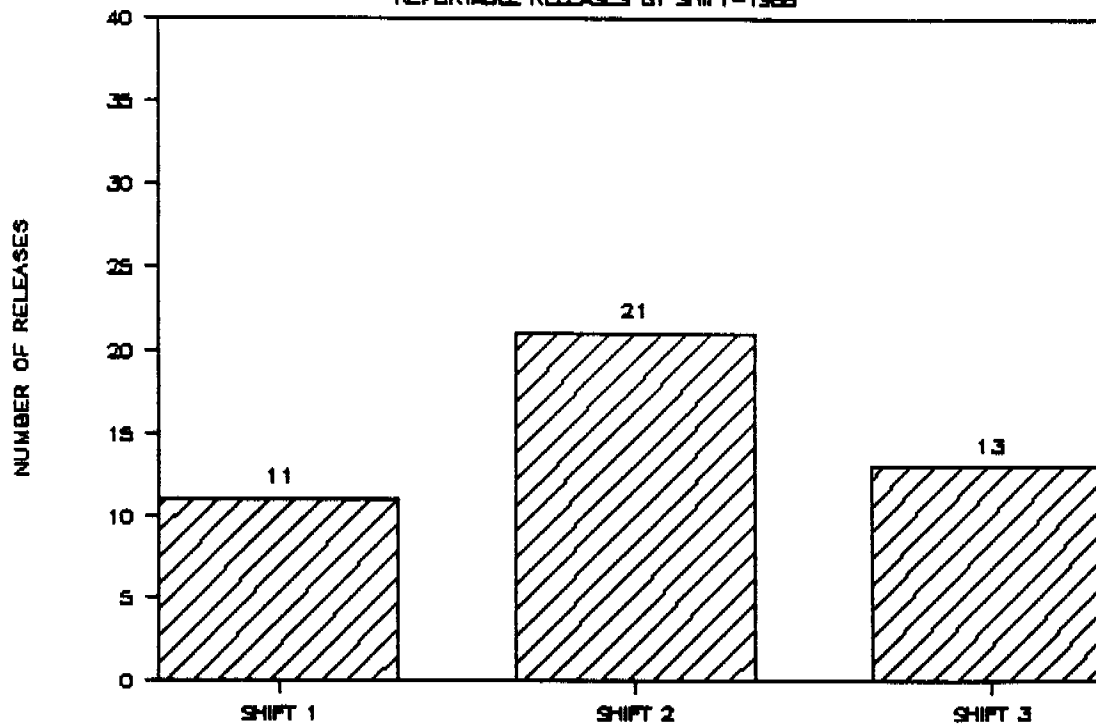
FIGURE 5

Figure 5 illustrates the 1988 incidents by Shift. Shift 1 represents Graveyards, Shift 2, Days, and Shift 3, Evenings. The distribution remains similar to that observed for 1987 with the majority of the total incidents occurring during Shift 2. A significant increase of incidents occurring during Shift 3 is noted (42 in 1988 vs. 25 in 1987).

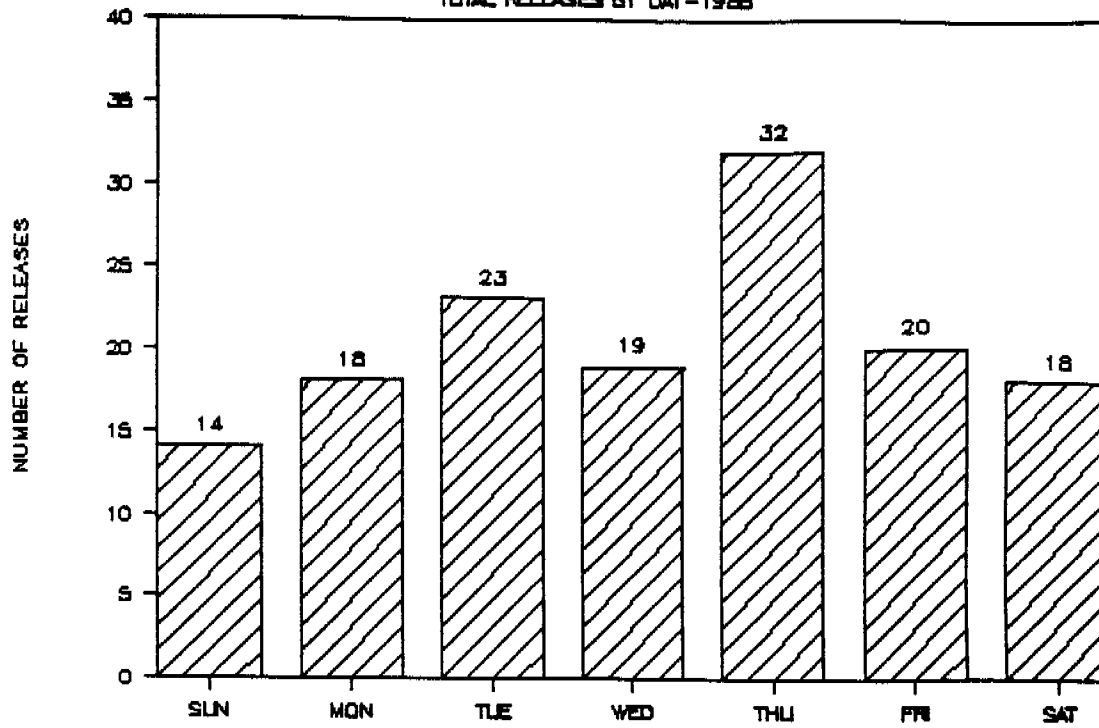
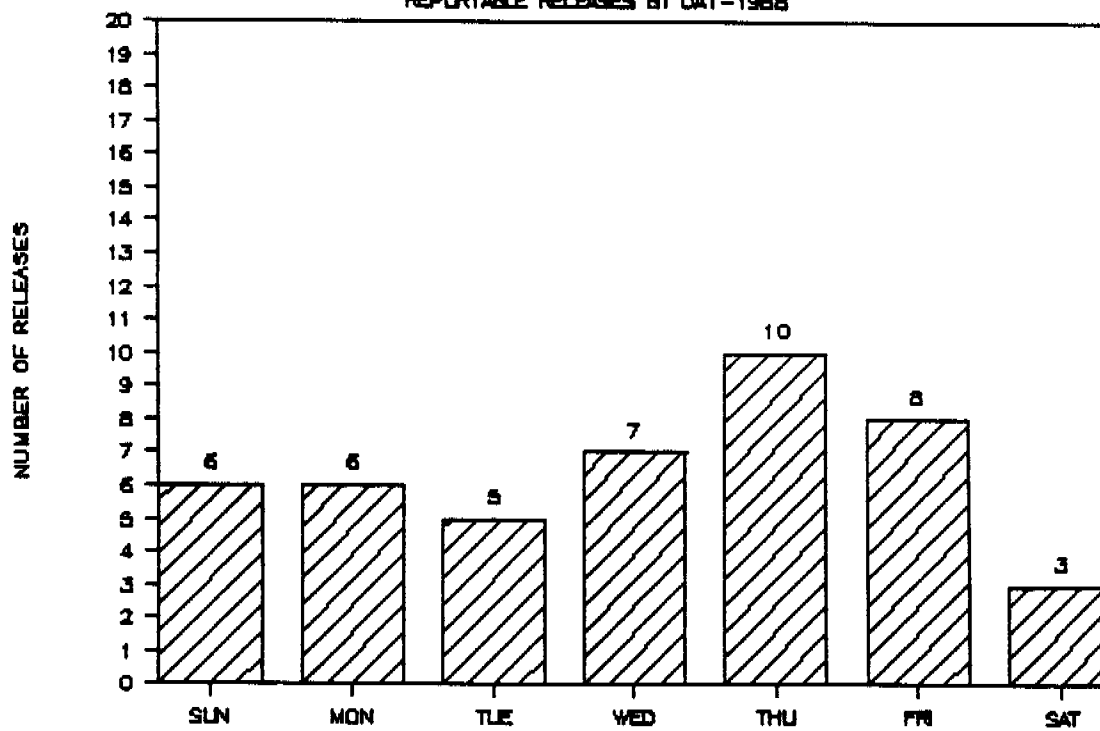
FIGURE 6

Figure 6 illustrates 1988 total and reportable incidents by day of the week. As compared to last year, a shift occurred to Thursday

(from Tuesday) as being the day for the majority of the total and reportable incidents in 1988.

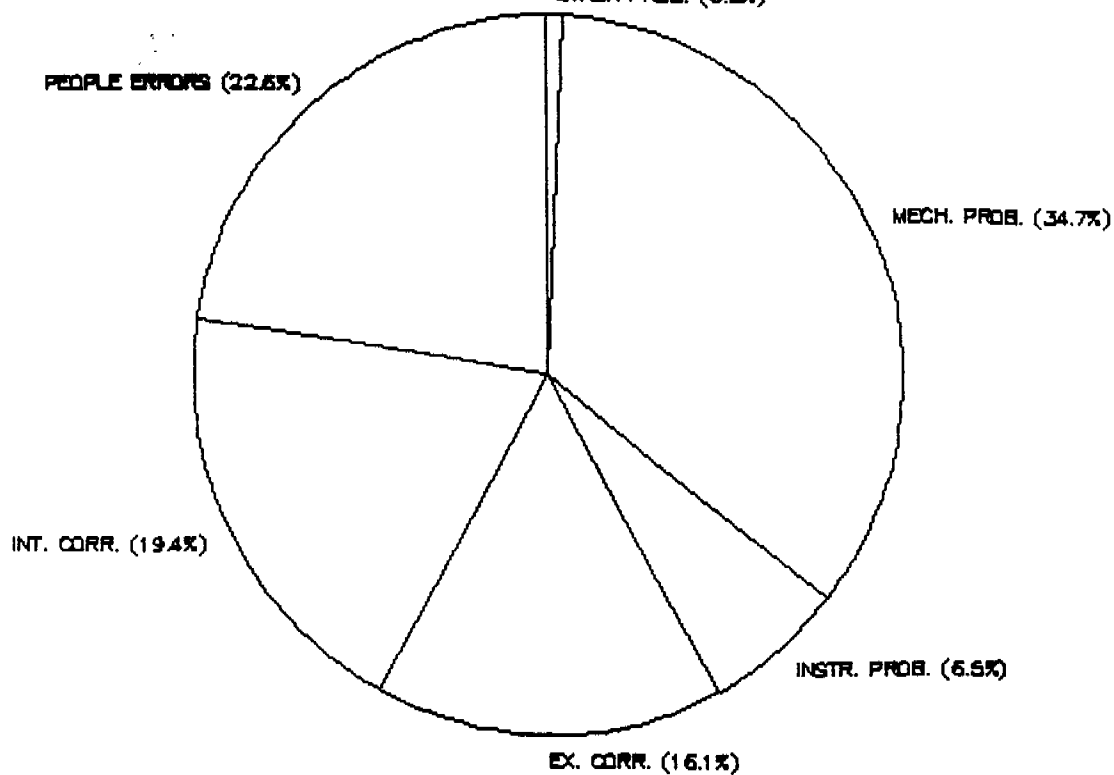
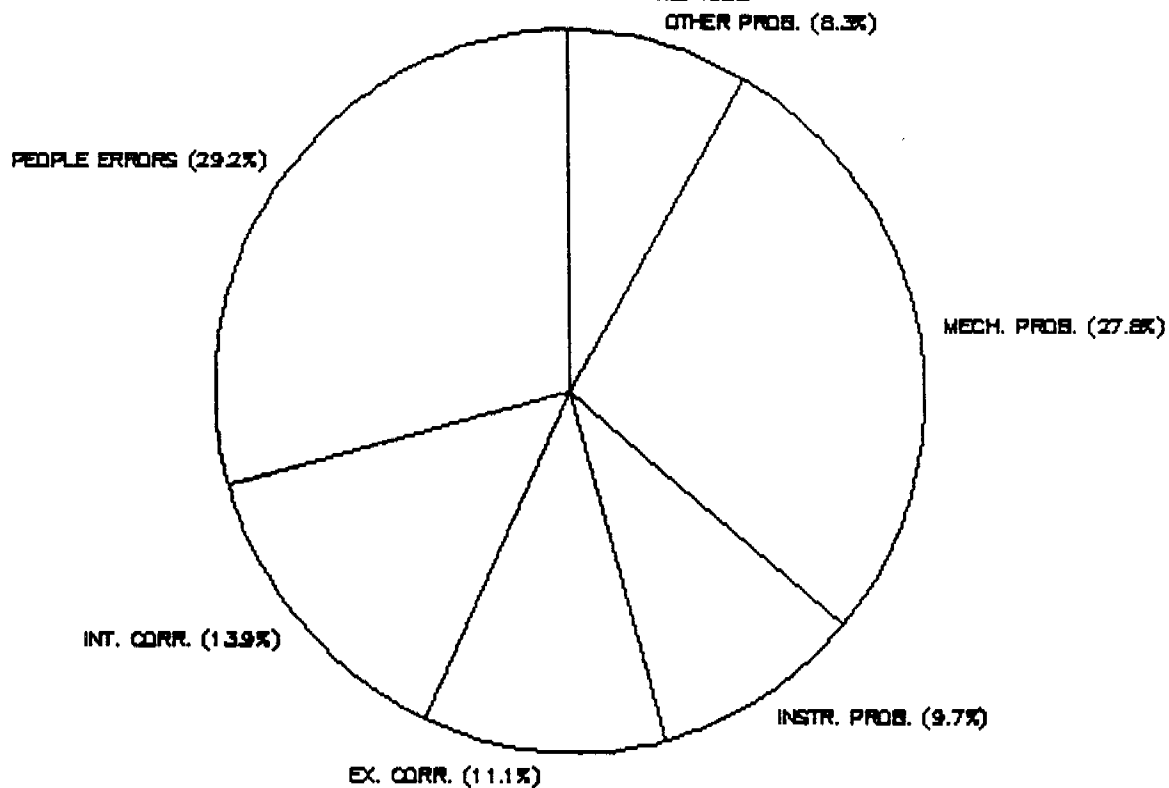
CAUSES FOR TOTAL RELEASES 1988

Figure 7 compares the breakdown of incidents by cause between 1987 and 1988. The relative magnitudes did not change appreciably. The major changes appear to be a 7% increase due to People Errors and Other Problems and a 75 decrease due to Mechanical Problems.
