**Well Inspection**  
**Osage DNR / Environmental Protection Agency**  
**1201 Elm Street, Suite 500**  
**Dallas, Texas 75270**

| | | <b>Lease Name</b> | North Burbank Unit | | |
| | | <b>Well ID</b> | 82-W6 | | |
| <b>Inspection Reason</b> | Plugging Witnessed | <b>Responsible Company at Time of Inspection</b> | CapturePoint, LLC | | |

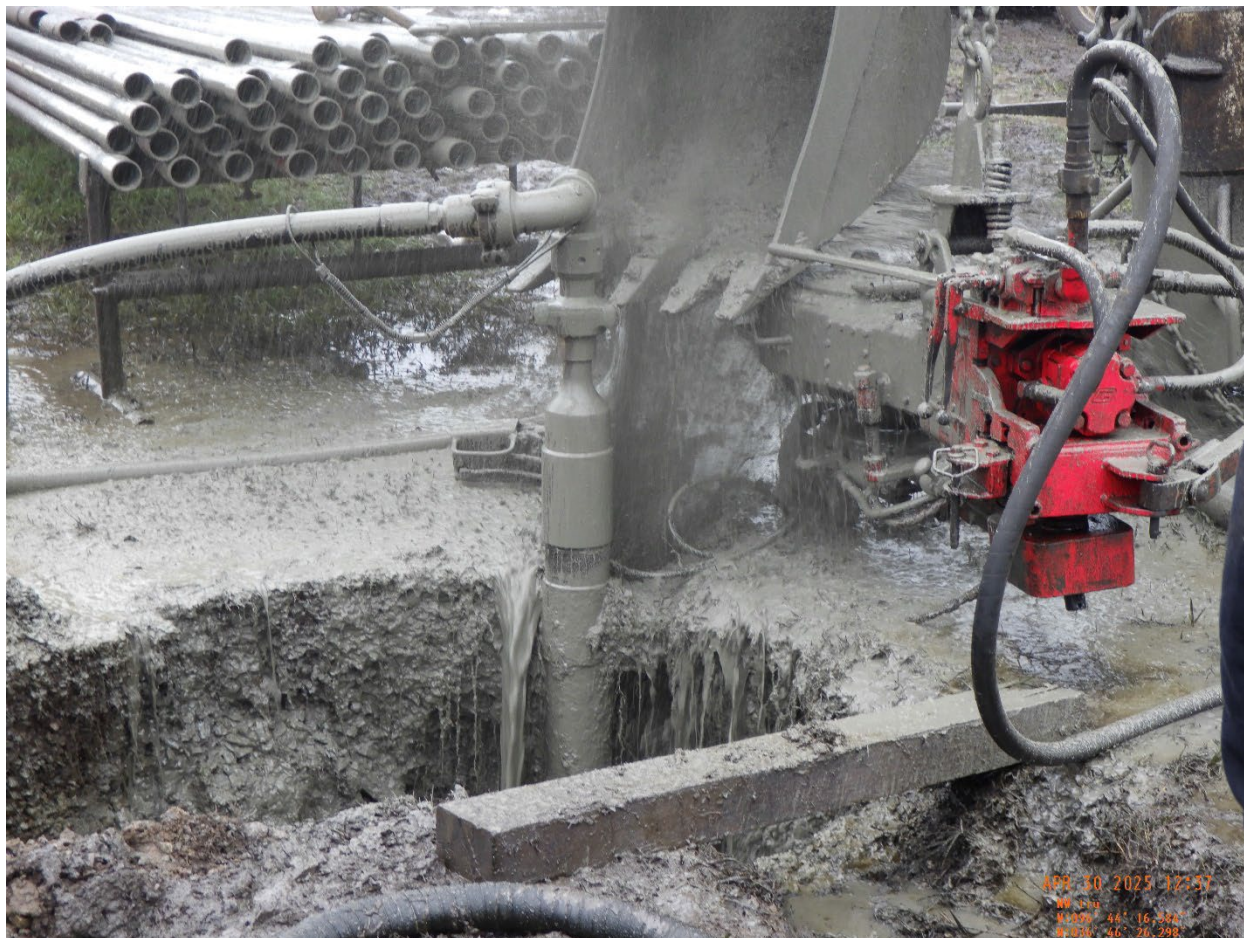
Photo No. 1

**Description:** This was well OS0508000 with cement circulating to the surface during the top cement plug placement.
