## **RCRA Inspection Report**

Hyundai Motor Manufacturing Alabama, LLC  
700 Hyundai Boulevard  
Montgomery, Alabama 36105  
Montgomery County

EPA ID No.: ALR000025486

July 26, 2021 at 1:05 p.m. and July 27, 2021 at 9:10 a.m.

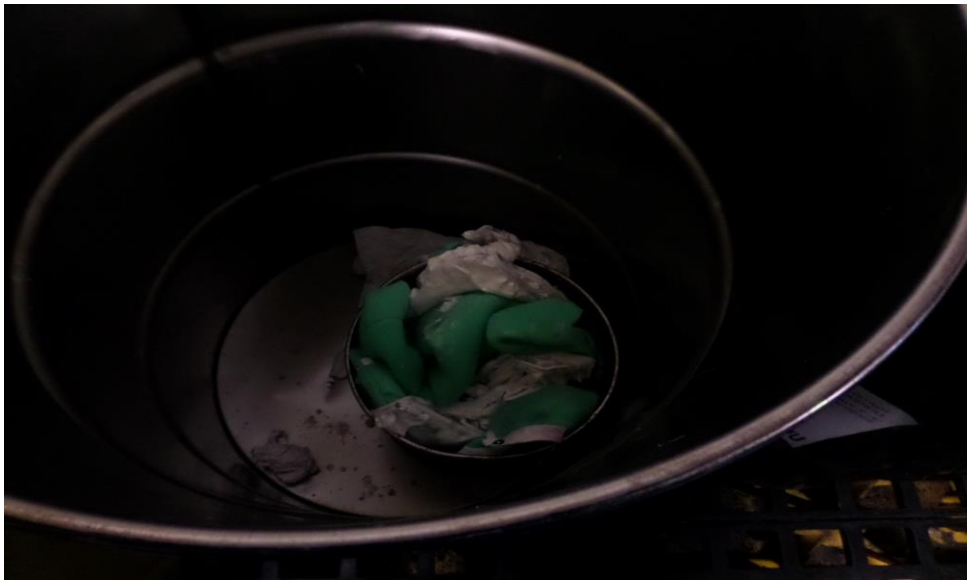
Hyundai Motor Manufacturing Al, LLC (Hyundai). Contractor Paint Area. Inspectors observed an open 5-gallon container inside an open 55-gallon container accumulating waste robotic paint socks. Inspectors observed the 5-gallon container was full, not marked/labeled with the words hazardous waste and not marked/labeled with a hazard indication. Photograph 1 taken July 26, 2021 at 2:33 p.m.

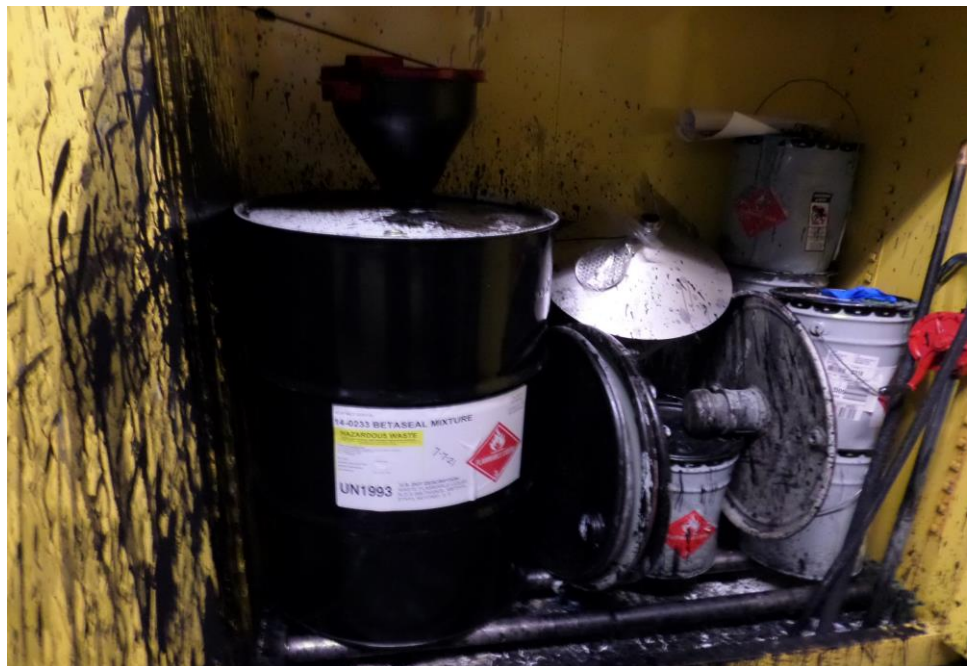
TRIDUM is Hyundai's contractor that manages hazardous waste in the contractor 90-Day Area. Mr. Gerado Pantaleon, the TRIDUM Site Manager, joined the inspectors for the inspection of this area. The inspectors observed a locked yellow flammable two-door cabinet in the contractor paint area posted with warning and security signs. Inspectors observed a 55-gallon container in the cabinet accumulating waste "betaseal mixture" (paint, methanol and methyl ethyl ketone, D001, D035, F005). Inspectors observed assorted equipment, tools, strainers, filters, several unused 5-gallon containers, container lids, and other materials stored in the cabinet. The inspectors observed spills in the cabinet's secondary containment system and on the cabinet inside walls and doors (Photograph 2). The inspectors observed a latching funnel attached to the top of the container was closed. The container was observed in good condition, labeled with the words "hazardous waste", labeled with a DOT Class 3 flammable hazard indicator, and marked with the date July 7, 2021. The inspectors observed the additional equipment, tools and other materials in the cabinet appeared not to allow for an adequate visual inspection (Photograph 2).

Hyundai. Contractor Paint Area. Inspectors observed a 55-gallon container in a yellow two door cabinet accumulating waste Betaseal Mixture. Inspectors observed equipment, tools, strainers, filters, empty containers, container covers, and other assorted materials stored in the cabinet. Inspectors did not observe aisle space and observed spills in and out of the cabinet's secondary containment system. Photograph 2 taken July 26, 2021 at 2:39 p.m.

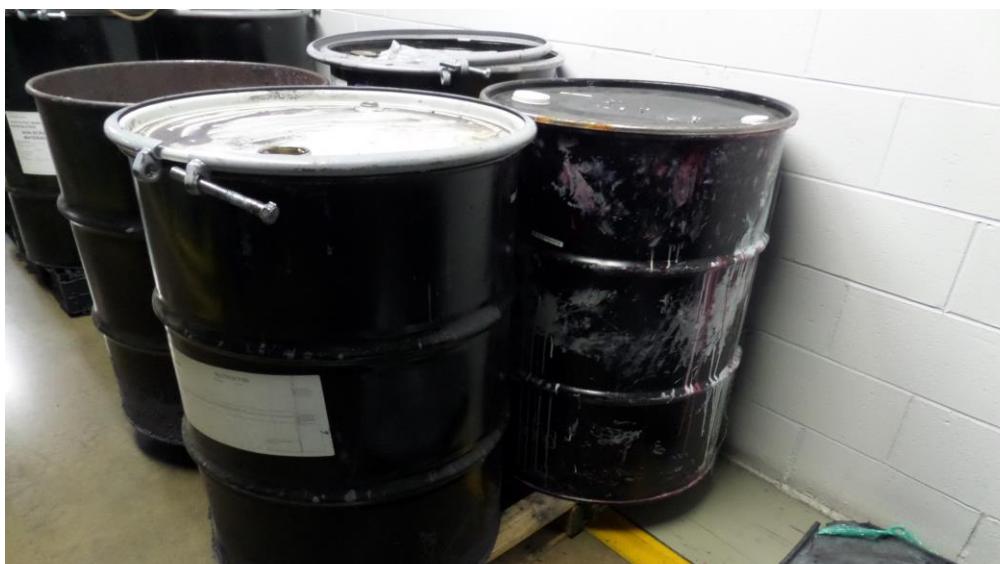
The inspectors observed seven additional 55-gallon containers on wooden pallets along the wall accumulating various amounts of solid waste. Mr. Pantaleon indicated one 55-gallon container was accumulating non-hazardous waste sealer and two 55-gallon containers appeared to be accumulating water and trash. The inspectors observed four 55-gallon containers appeared to be accumulating waste paint related liquid (Photographs 3, 4, and 5).

Documentation that an accurate waste determination was performed on the solid waste accumulating in the four 55-gallon containers was not observed in the record review.

Hyundai. Contractor Paint Area. Inspectors observed seven 55-gallon containers on pallets along the wall accumulating solid waste. Three containers appeared to have non-hazardous waste (water-based paint and waste sealer). Photograph 3 taken July 26, 2021 at 3:00 p.m.

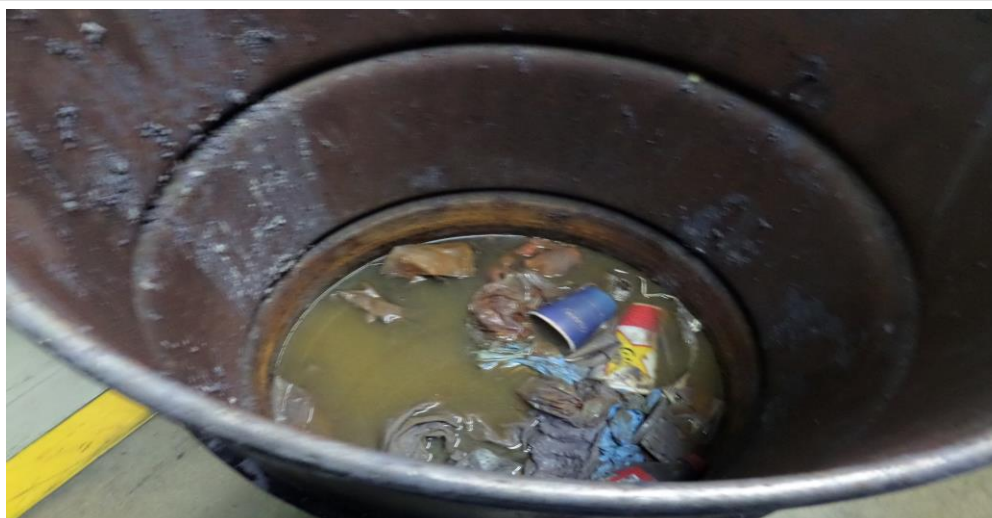
Hyundai. Contractor Paint Area. Inspectors observed seven 55-gallon containers on pallets along the wall accumulating unknown solid waste. One open container was accumulating waste liquid and trash (paper towels and cups). Inspectors observed four containers were accumulating various amounts solid waste. Photograph 4 taken July 26, 2021 at 3:03 p.m.

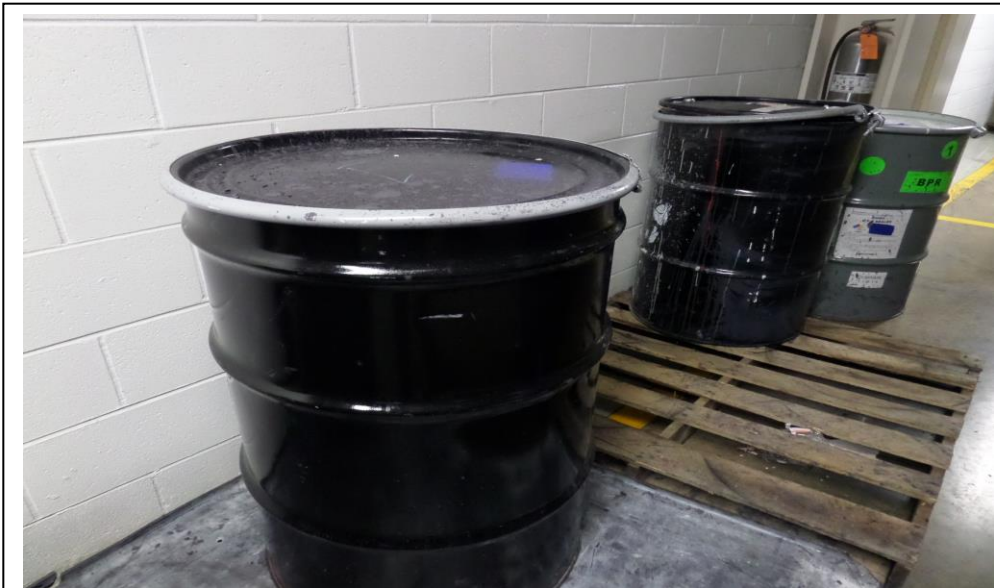
Hyundai. Contractor Paint Area. Inspectors observed seven 55-gallon containers on pallets along the wall accumulating solid waste. Three containers appeared to have non-hazardous waste (water-based paint and waste sealer). Inspectors observed four containers appeared to be accumulating solid waste. Photograph 5 taken July 26, 2021 at 3:03 p.m.

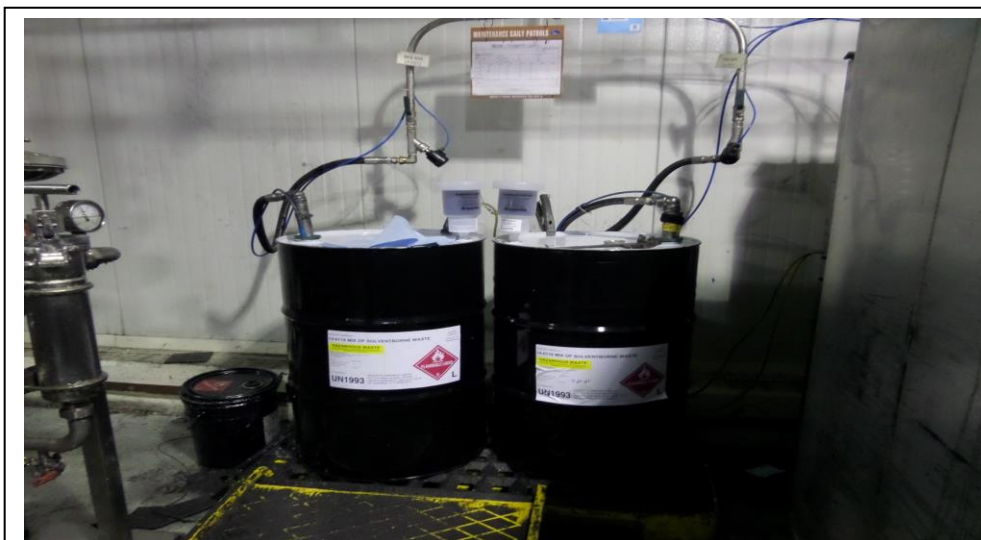
Located in the Purge Recovery 90-Day Area, the inspectors observed two 55-gallon containers on secondary containment pallets next to the wall. The inspectors observed warning and security signs posted in this area. The containers were accumulating a “mix of solvent-borne waste” (D001, F003) from cleaning the paint lines. Waste paint and solvent is pumped from the Kettle Purge Tanks through pipelines to these 55-gallon containers. The containers were in the process of receive hazardous waste, in good condition, with aisle space, labeled with the words hazardous waste, labeled with a DOT Class 3 flammable hazard indicator, and marked with the dates July 21, 2021 and July 23, 2021 (Photograph 6).

The inspectors observed both pipelines to the 55-gallon containers were identified with tags marked as WS-MR, A051 (Photograph 6).

Hyundai. Purge Recovery 90-Day Area. Inspectors observed two 55-gallon containers accumulating solvent-borne waste from the two 35-gallon “Kettle” Purge Tanks. The containers were marked with dates in July 2021. Photograph 6 taken July 26, 2021 at 3:20 p.m.

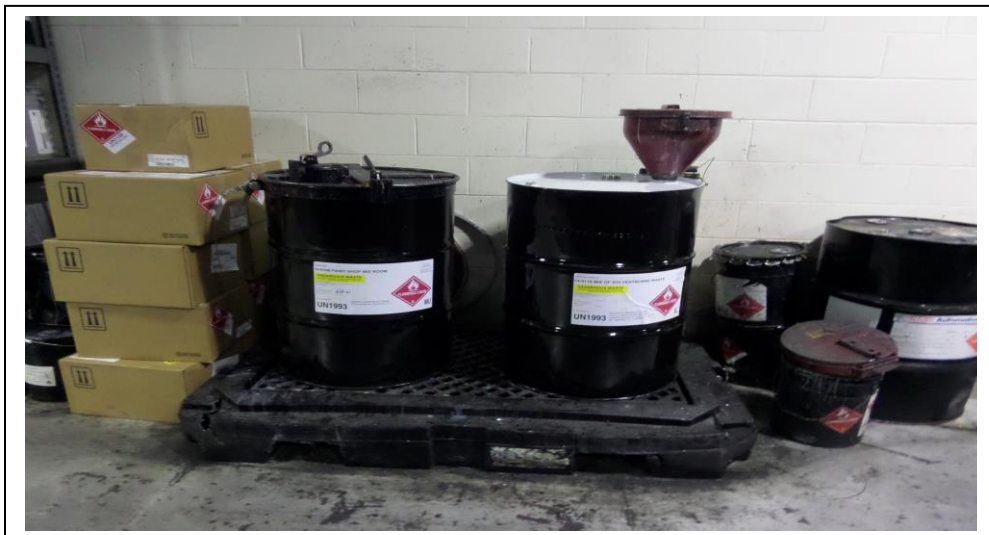
Solvent-related paint waste is accumulated in two 90-Day Areas. The inspectors observed warning and security signs posted in the locked room. The inspectors observed two 55-gallon containers on a secondary containment pallet near the entrance to the room accumulating waste paint and solvent (D001, F003). The containers were closed with a latching container funnel or a latching container lid, in good condition, with aisle space, labeled with the words “hazardous waste”, labeled with a DOT Class 3 flammable hazard indicator, and marked with the dates June 10, 2021 and July 18, 2021 (Photograph 7).

Hyundai. Paint Mix Room - Solvent Side. Inspectors observed two 55-gallon containers accumulating waste paint and solvent and solvent-borne waste from mixing paints and solvents. The containers were marked with dates in June and July 2021. Photograph 7 taken July 26, 2021 at 3:20 p.m.

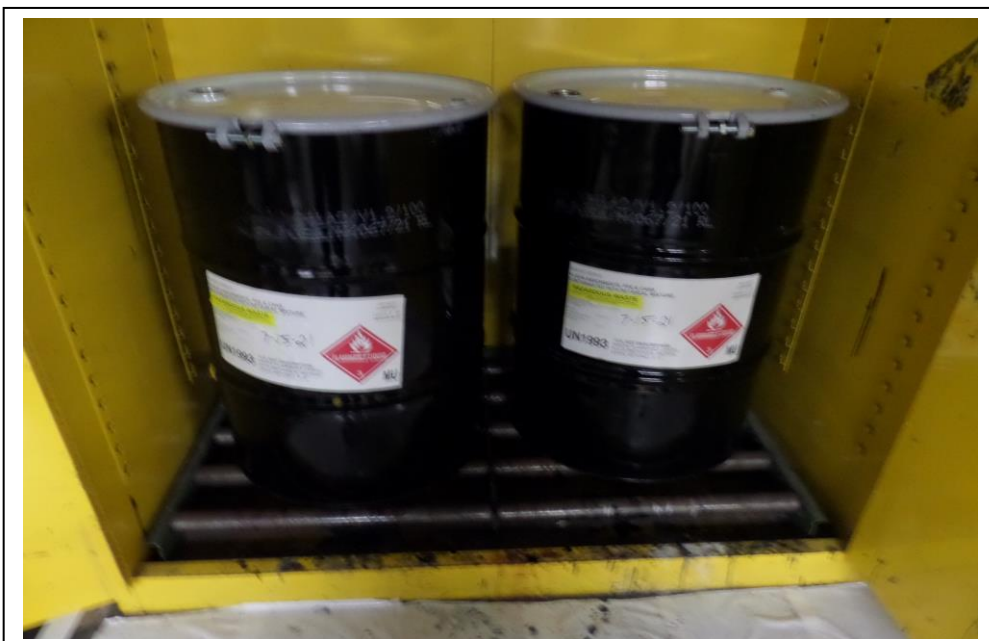
The inspectors observed a locked yellow flammable cabinet located in the spot repair area posted with warning and security signs. The inspectors observed two 55-gallon containers in the cabinet accumulating solvent contaminated absorbents, wipes, and personal protective equipment (PPE). The containers were closed, in good condition, with aisle space, labeled with the words “hazardous waste”, marked with the waste codes D001 and D035, labeled with a DOT Class 3 flammable hazard indicator, and both marked with the date July 15, 2021 (Photographs 8 and 9).

Hyundai. Spot Repair 90-Day Area. Inspectors observed two 55-gallon containers accumulating absorbents, PPE and cans contaminated with Betaseal Mixture. The containers were marked with dates in July 2021. Photograph 8 taken July 26, 2021 at 3:32 p.m.

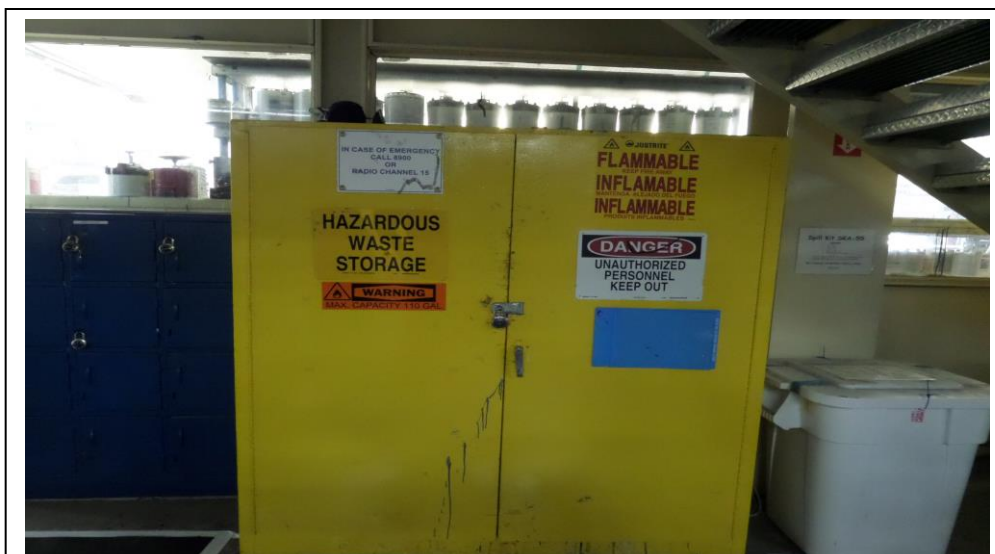
Hyundai. Spot Repair 90-Day Area. Inspectors observed a locked two-door yellow cabinet for two 55-gallon containers accumulating absorbents, PPE and cans contaminated with Betaseal Mixture identified in Photograph 8. Inspectors observed signs indicating a hazardous waste storage area. Photograph 9 taken July 26, 2021 at 3:32 p.m.

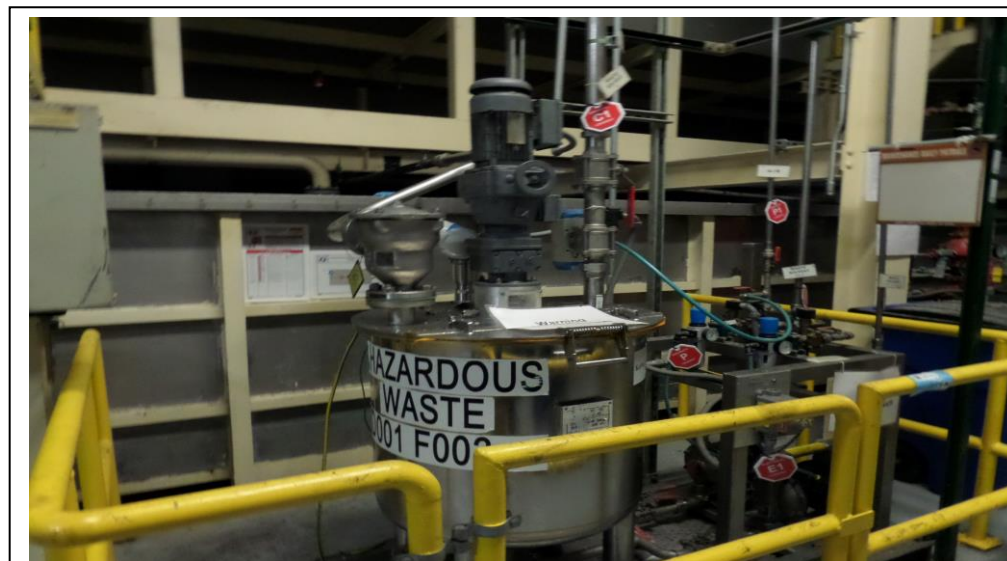
The hazardous waste is circulated in the Tanks to prevent solidification and pumping begins when the Tanks are 70 percent full and pumping stops when the Tanks are 60 percent full. The hazardous waste is pumped by pipeline to two 55-gallon containers in the Solvent-Related Paint Mix Room. The inspectors observed the Tanks were closed, in good condition, labeled with the words “hazardous waste”, and marked with the waste codes D001 and F003. The inspectors observed the Tanks were not marked or labeled with an indication of the hazards (Photographs 10 and 12).

The inspectors observed the Tanks ancillary equipment components (pipe connections, flanges, valves, pumps) appeared not to be marked in a manner that could be distinguished readily from other pieces of equipment (Photographs 10, 11, 12, 13, 14 and 15). Mr. Ron Bishop indicated that the Tanks and ancillary equipment were regulated under Subpart W - National Emission Standards for Hazardous Air Pollutants (NESHAP).

Hyundai. Kettle Purge Tank 1 Area. Inspectors observed a 35-gallon purge tank (tank 1) accumulating waste paint and solvent. The inspectors observed the tank was not marked/labeled with an indication of the hazards. Inspectors observed red octagonal shaped lockout tags and yellow diamond shaped tags designated with the letters C, P, E or RC and followed by a number (1, 2, or 3) secured by plastic cable ties to the tanks and the tank's ancillary equipment (valves, pumps, flanges, connectors, electrical and pneumatic equipment). Photograph 10 taken July 26, 2021 at 3:44 p.m.

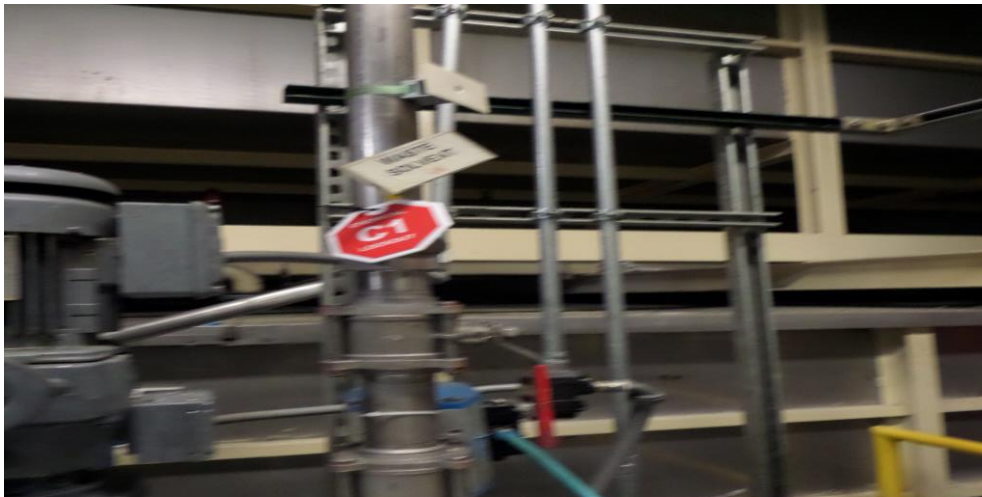
Hyundai. Kettle Purge Line 1 Area. Inspectors observed red octagonal shaped lockout tags and yellow diamond shaped tags designated with the letters C, P, E or RC and followed by a number (1, 2, or 3) secured by plastic cable ties to the tanks and the tank's ancillary equipment (valves, pumps, flanges, connectors, electrical and pneumatic equipment). Photograph 11 taken July 26, 2021 at 3:44 p.m.

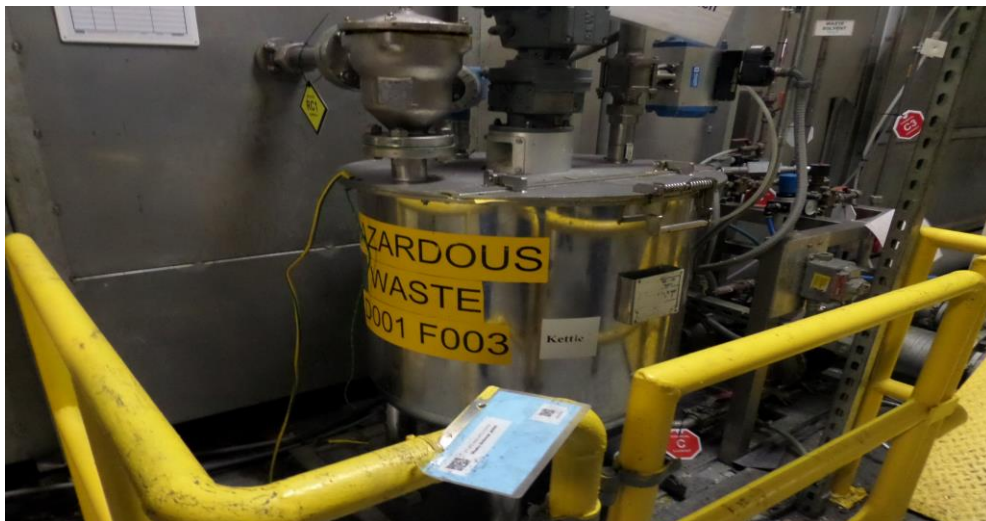
Hyundai. Kettle Purge Tank 2 Area. Inspectors observed a 35-gallon purge tank (tank 2) accumulating waste paint and solvent. The inspectors observed the tank was not marked/labeled with an indication of the hazards. Inspectors observed red octagonal shaped lockout tags and yellow diamond shaped tags designated with the letters C, P, E or RC and followed by a number (1, 2, or 3) secured by plastic cable ties to the tanks and the tank's ancillary equipment (valves, pumps, flanges, connectors, electrical and pneumatic equipment). Photograph 12 taken July 26, 2021 at 3:50 p.m.

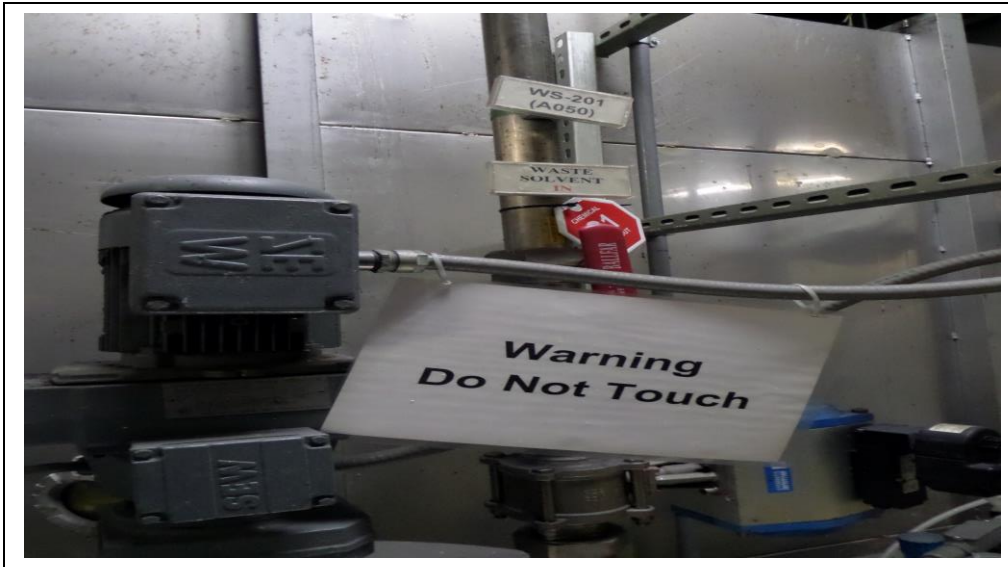
Hyundai. Kettle Purge Line 2 Area. Inspectors observed red octagonal shaped lockout tags and yellow diamond shaped tags designated with the letters C, P, E or RC and followed by a number (1, 2, or 3) secured by plastic cable ties to the tanks and the tank's ancillary equipment (valves, pumps, flanges, connectors, electrical and pneumatic equipment). Photograph 13 taken July 26, 2021 at 3:50 p.m.

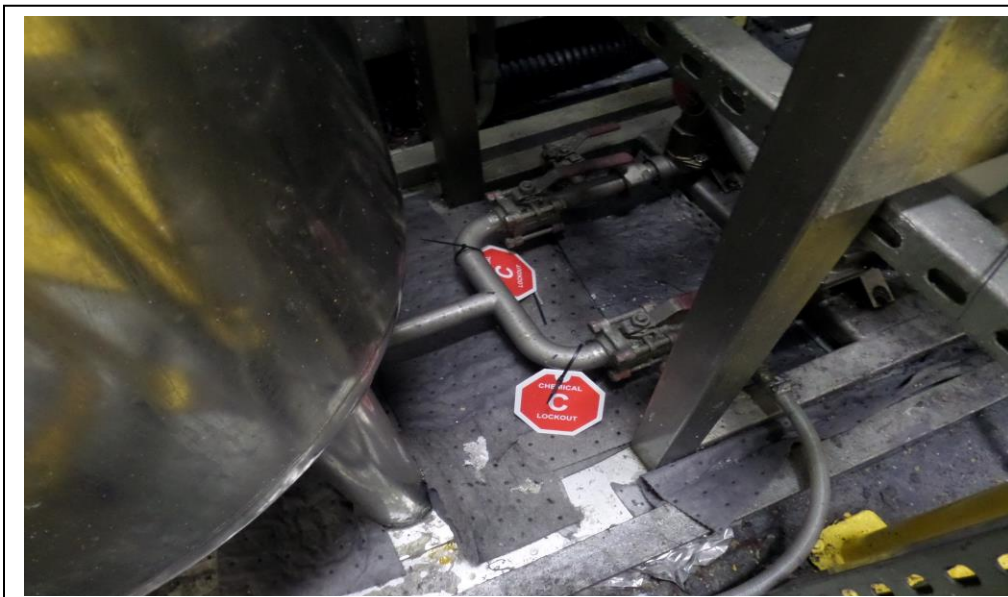
Hyundai. Kettle Purge Line 2 Area. Inspectors observed red octagonal shaped lockout tags and yellow diamond shaped tags designated with the letters C, P, E or RC and followed by a number (1, 2, or 3) secured by plastic cable ties to the tanks and the tank's ancillary equipment (valves, pumps, flanges, connectors, electrical and pneumatic equipment). Photograph 14 taken July 26, 2021 at 3:50 p.m.

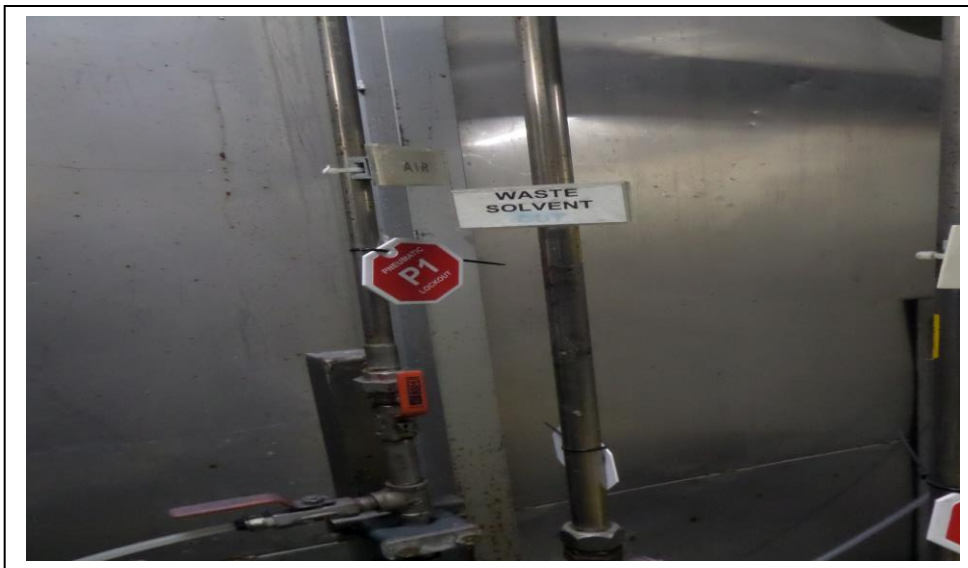
Hyundai. Kettle Purge Line # Area. Inspectors observed red octagonal shaped lockout tags and yellow diamond shaped tags designated with the letters C, P, E or RC and followed by a number (1, 2, or 3) secured by plastic cable ties to the tanks and the tank's ancillary equipment (valves, pumps, flanges, connectors, electrical and pneumatic equipment). Photograph 15 taken July 26, 2021 at 3:50 p.m.

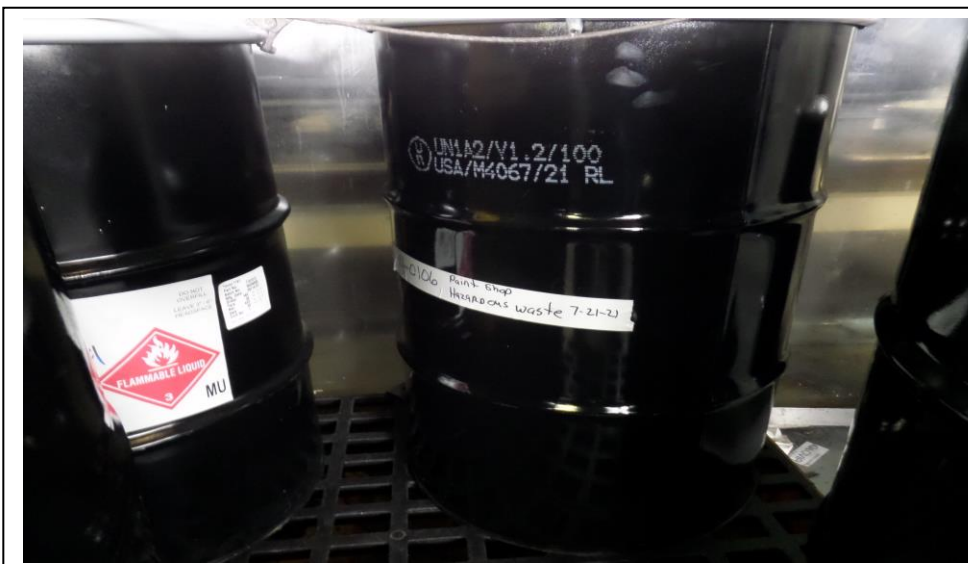
Hyundai. Top-Coat 90-Day Area. The inspectors observed four 55-gallon containers accumulating hazardous waste on a poly pallet. One container was not marked/labeled with a hazard indication and not marked with waste codes. The facility marked the container with an ignitability indication and with the waste codes D001, F003. Photograph 16 taken July 26, 2021 at 3:59 p.m.

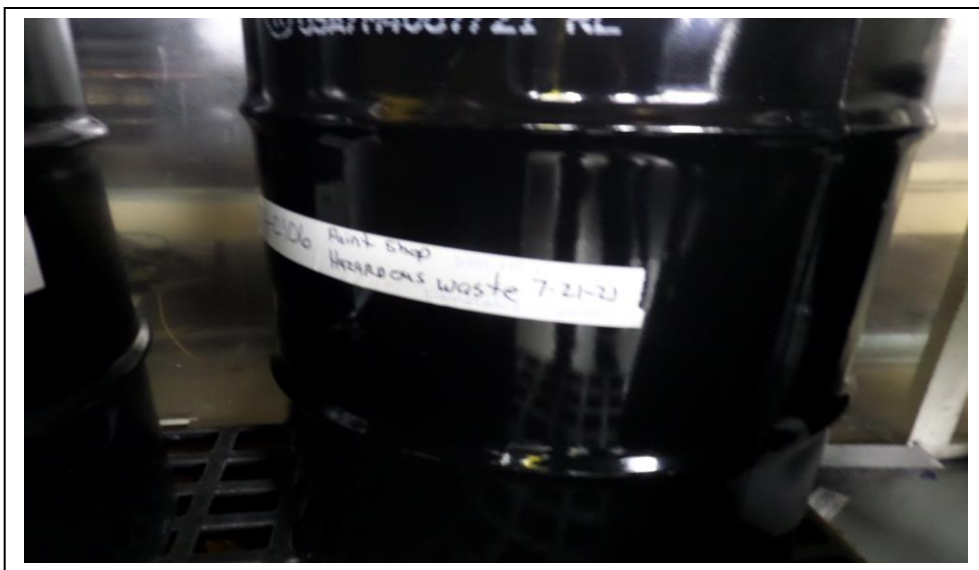
Hyundai. Top-Coat 90-Day Area. The inspectors observed four 55-gallon containers accumulating hazardous waste on a poly pallet. One container was not marked/labeled with a hazard indication and marked with waste codes. The facility marked the container with an ignitability indication and with the waste codes D001, F003. Photograph 17 taken July 26, 2021 at 3:59 p.m.

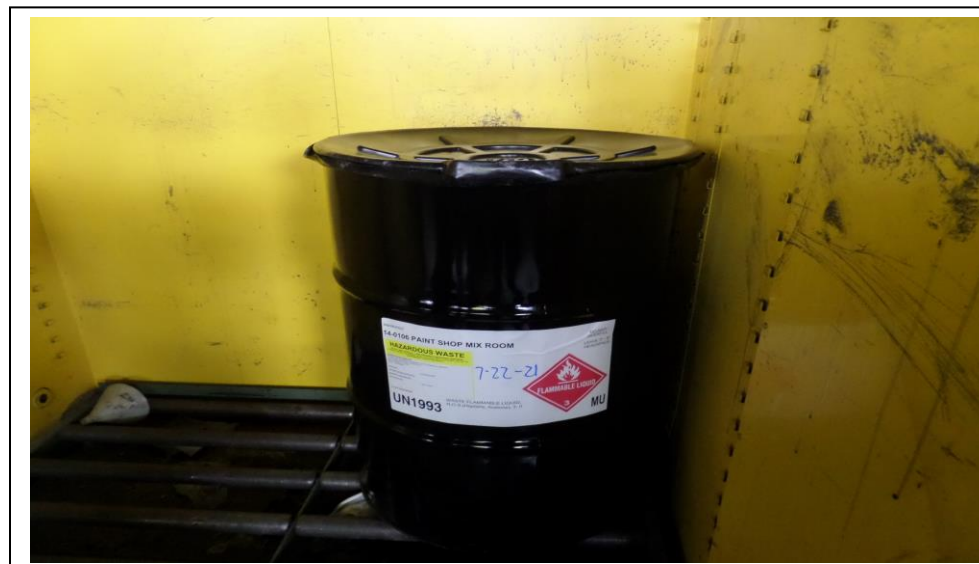
cabinet accumulating solvent-saturated absorbents, wipes, and PPE. The container was covered with a plastic “Profit Lid”, that did not securely keep the container closed. The inspectors observed the container was in good condition, with aisle space, labeled with the words “hazardous waste”, marked with the waste codes D001 and F003, labeled with a DOT Class 3 flammable hazard indicator, and marked with the date July 22, 2021 (Photograph 18).

Hyundai. Top-Coat Flammable Locker. The inspectors observed one 55-gallon containers accumulating hazardous waste in a yellow locker on a poly pallet. The inspectors observed the container was not kept closed by a plastic "Profit Lid". Photograph 18 taken July 26, 2021 at 4:06 p.m.

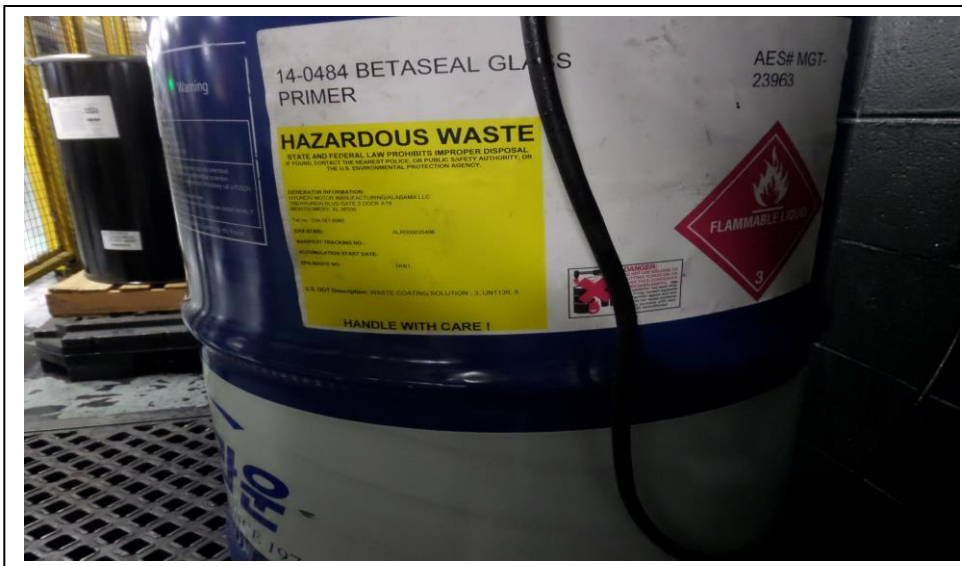
The inspectors observed one 55-gallon container accumulating waste absorbent, aerosol cans and PPE and one 55-gallon container accumulating waste “betaseal glass primer” on poly pallets inside a locked wire enclosure posted with warning and security signs. The inspectors observed the containers were closed, in good condition, with aisle space, labeled with the words “hazardous waste”, marked with waste codes (D001, D035), and labeled with a hazard indicator. The containers were marked with the dates July 18, 2021 and July 10, 2021, respectively (Photographs 19 and 20).

Hyundai. General Assembly Building - Trim Three Beta Seal 90-Day Area. The inspectors observed two 55-gallon containers accumulating hazardous waste absorbent and PPE and hazardous waste Betaseal on a poly pallet inside a locked wire cage enclosure. One container was dated July 18, 2021, the second container was marked with the date July 10, 2021, shown in Photograph 20. Photograph 19 taken July 26, 2021 at 4:23 p.m.

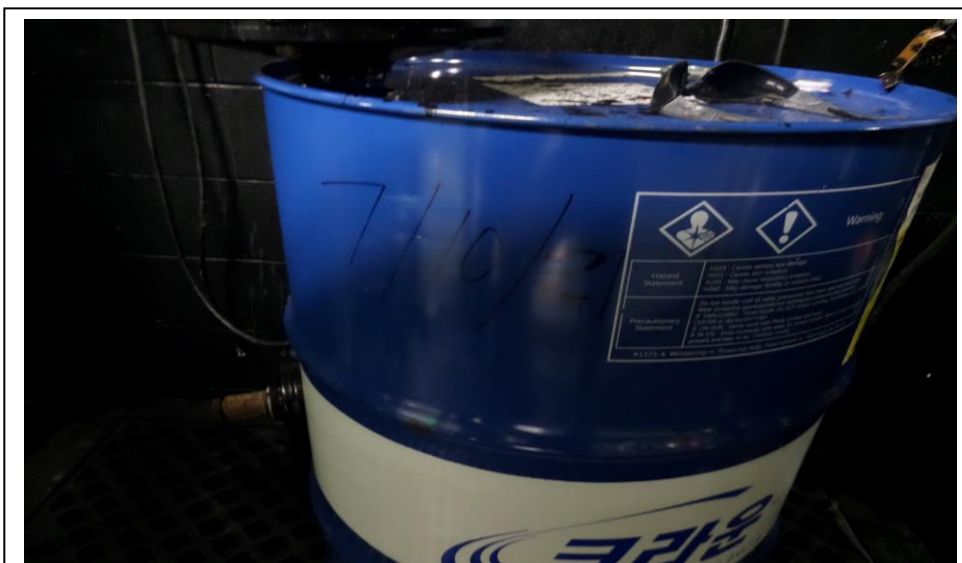
Hyundai. General Assembly Building - Trim Three Beta Seal 90-Day Area. The inspectors observed one 55-gallon containers accumulating hazardous waste Betaseal on a poly pallet inside a locked wire cage enclosure. The inspectors observed the container was marked with the date July 10, 2021. Photograph 20 taken July 26, 2021 at 4:23 p.m.

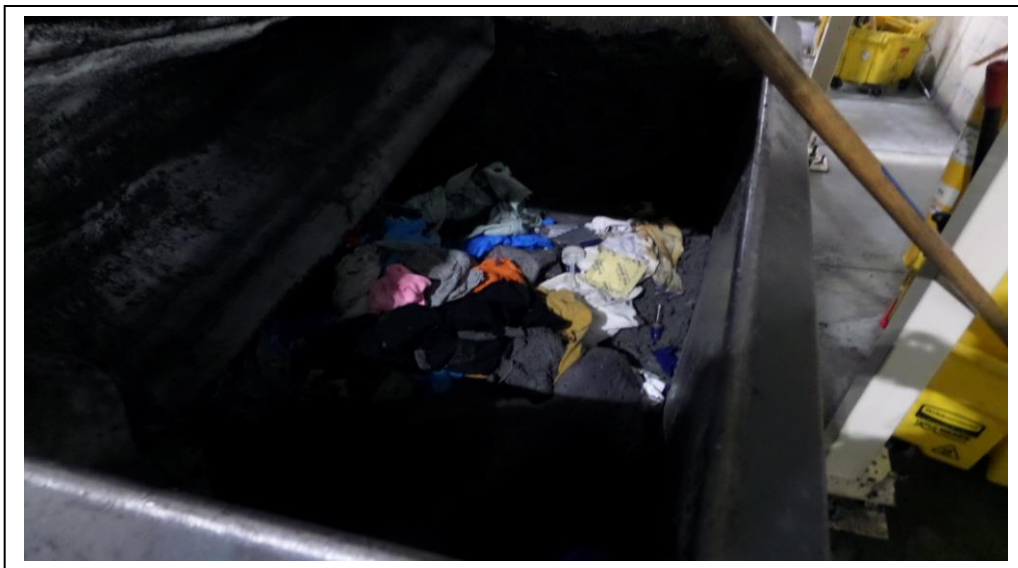
Hyundai. Engine Building 1. Inspectors observed a container accumulating metal solids, grease and oily grime from filtering coolant used in the engine machining operation. The filtered metal solids are accumulated in a 0.5 cubic yard container. Photograph 21 taken July 27, 2021 at 11:09 a.m.

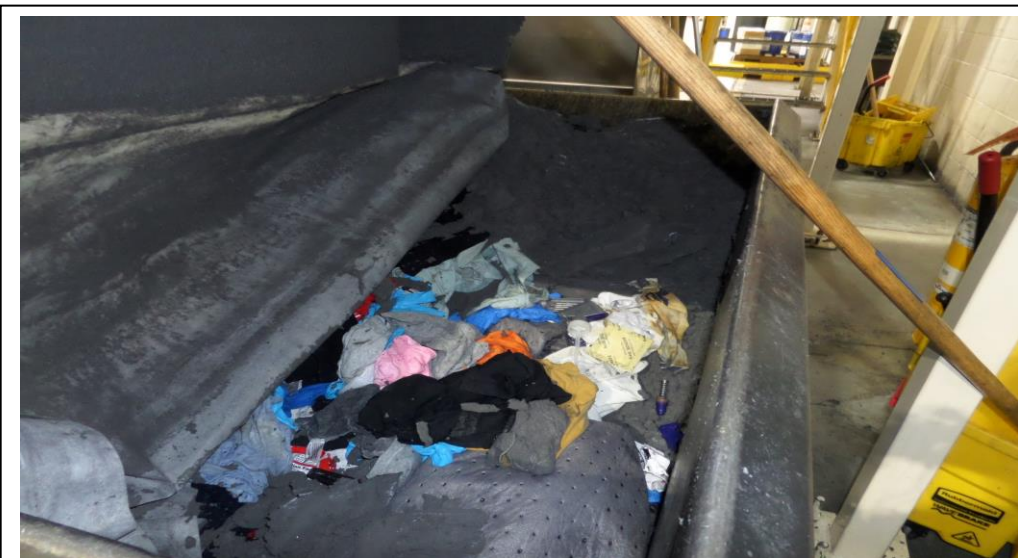
Hyundai. Engine Building 1. Inspectors observed a container accumulating metal solids, grease and oily grime from filtering coolant used in the engine machining operation. The filtered metal solids are accumulated in a 0.5 cubic yard container. Photograph 22 taken July 27, 2021 at 11:09 a.m.

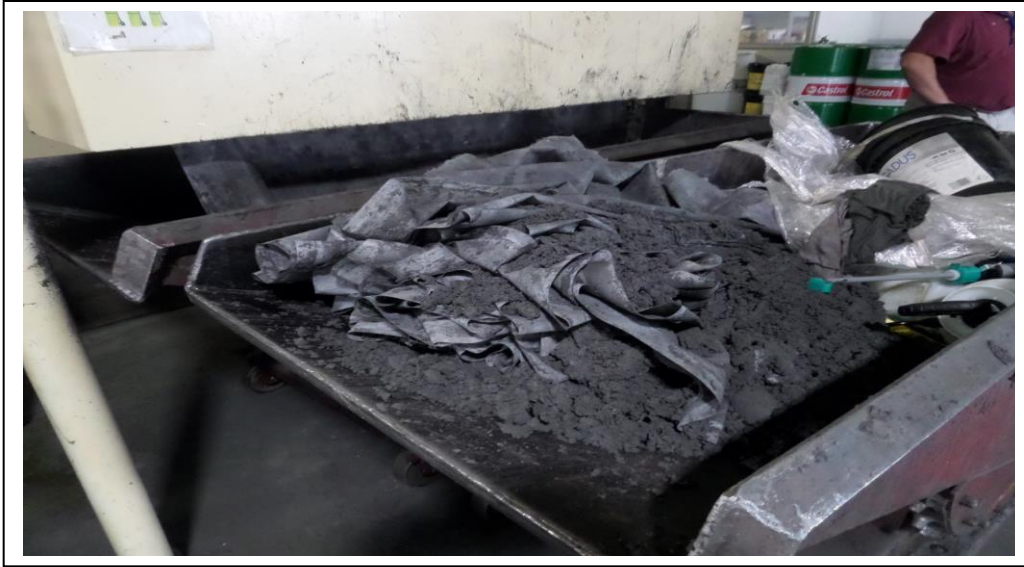
Hyundai. Engine Building 2. Inspectors observed a container accumulating metal solids, grease and oily grime from filtering coolant used in the engine machining operation. The filtered metal solids are accumulated in a 0.5 cubic yard container. Photograph 23 taken July 27, 2021 at 11:28 a.m.

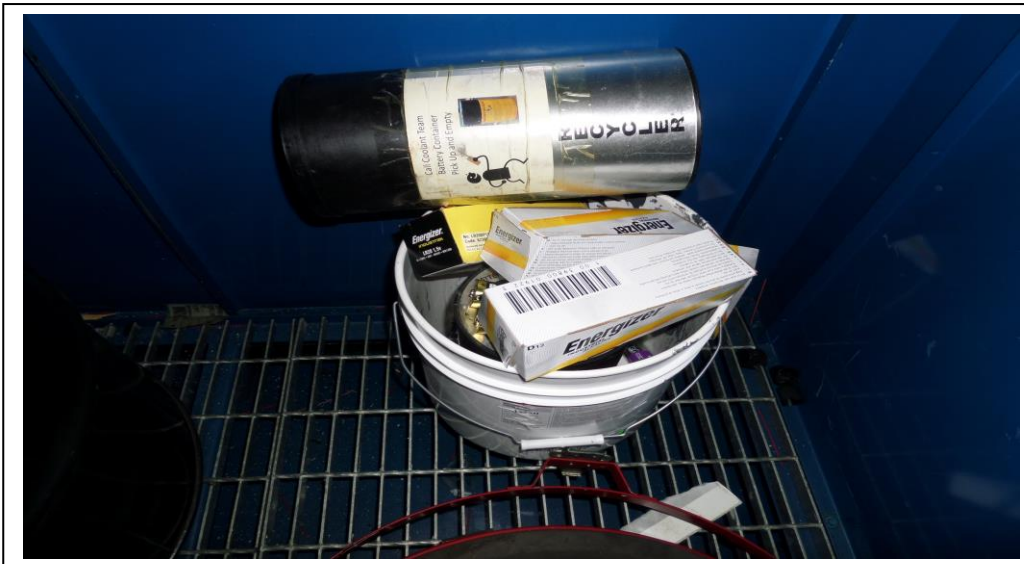
Hyundai. Engine Building 2 90-Day Area. Inspectors observed a 5-gallon container accumulating waste batteries in a metal storage locker with secondary containment. The inspectors observed the container was not marked/labeled with the words universal waste and not marked with a date. The facility corrected the deficiency by labeling the container with the words universal waste. Photograph 24 taken July 27, 2021 at 11:30 a.m.

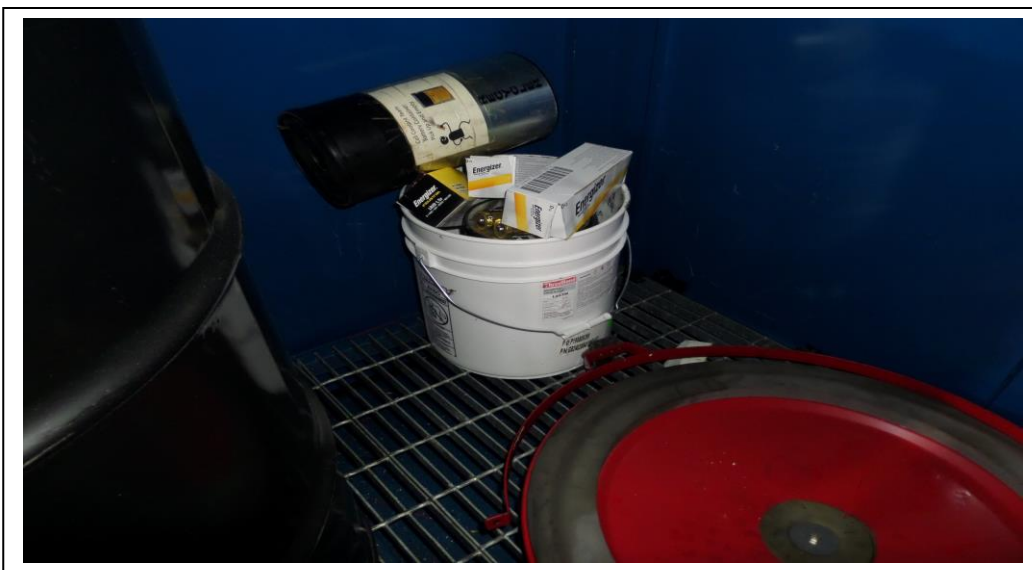
Hyundai. Engine Building 2 90-Day Area. Inspectors observed a 5-gallon container accumulating waste batteries in a metal storage locker. The inspectors observed the container was not marked/labeled with the words universal waste and not marked with a date. The facility corrected the deficiency by labeling the container with the words universal waste. Photograph 25 taken July 27, 2021 at 11:30 a.m.

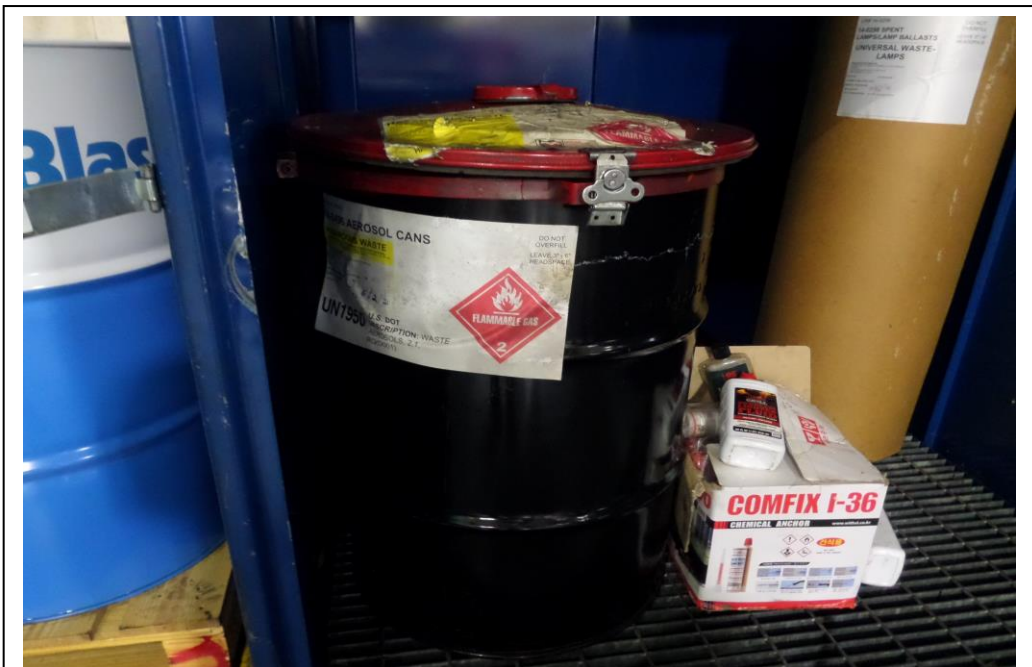
The inspectors observed one 55-gallon container accumulating waste aerosol cans, one box of waste fluorescent lamps, and one 5-gallon container of used batteries in a locked metal cabinet constructed with secondary containment and posted with warning/security signs in the 90-Day Area. The 55-gallon container of waste aerosol cans was closed, in good condition, with aisle space, labeled with the words “hazardous waste”, marked with a waste code, labeled with a hazard indicator, and marked with the date June 2, 2021 (Photograph 26).

Hyundai. Engine Building 2 90-Day Area. Inspectors observed a 55-gallon container accumulating waste aerosol cans in a metal storage locker with secondary containment. The inspectors observed the container was closed, in good condition with aisle space, labeled with the words hazardous waste, labeled with a hazard indication and marked with the date June 27, 2021. Photograph 26 taken July 27, 2021 at 11:32 a.m.
