**WORK REQUISITION**  
**TO : MAINTENANCE PLANNER**  
**PLANT** #6 Crude Unit

**EQUIP. NO. OR DESCRIPTION** Debut Reboiler E-1622

**INSTRUCTIONS:** THE DEBUT REBOILER, E-1622, WILL BE REMOVED FROM SERVICE TO REPAIR A SUSPECTED FLOATING HEAD LEAK. NEW MATERIALS HAVE BEEN ORDERED TO DO THIS WORK. NEW BELLVILLE WASHERS, B-16 STUDS AND SS CLADDED ASBESTOS GASKETS. AN EXTENSIVE CHECK OF FLANGE DIMENSIONS AND GASKET SURFACES WILL BE NECESSARY BEFORE THE NEW MATS ARE USED AND THE FOLLOWING SEQUENCE OF WORK WILL HELP INSURE THE RECOMMENDED INSTALLATION. PLEASE COMPLETE THE FOLLOWING.

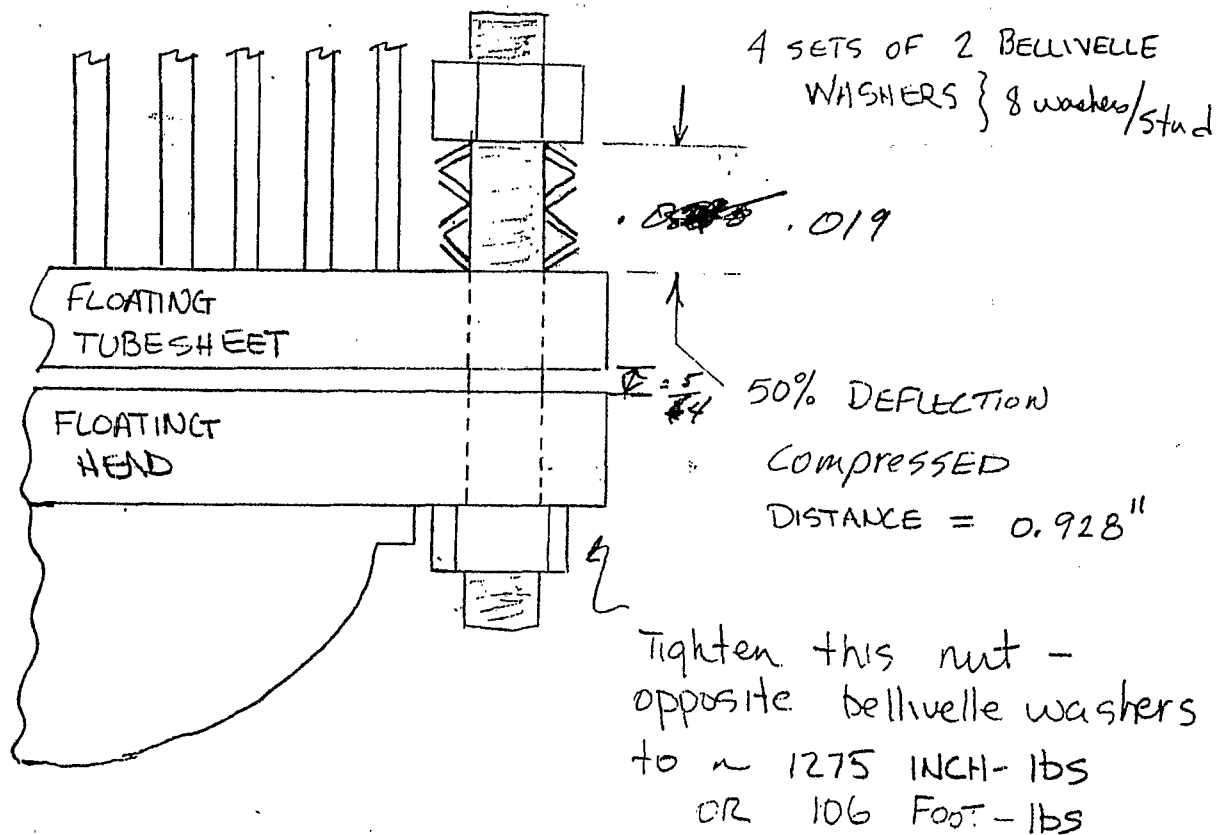
SKETCH 2

NOTE: ALL STUDS & WASHERS (BELLIVELLE) TO BE WELL LUBRICATED WITH HEAVY OIL & GRAPHITE TO REDUCE FRICTION

FLANGES GAP =  $\frac{5}{64}$ "

(7) THE NEW SS CLAD ASBESTOS GASKET, ITEM 1 ON RDBM-8135, STUDS AND BELLVILLE WASHERS WILL THEN BE INSTALLED AS SHOWN ON ATTACHED DWG. (Sketch #2) USE THE ATTACHED PROCEDURE FOR APPLICATION OF BOLT TORQUE ON FLANGED JOINTS. TORQUE EACH BOLT TO A MAXIMUM OF 106 FOOT- LBS.

THE GAP BETWEEN FLANGES (Floating Head and Tube Sheet) should now be even ALL AROUND AND THE BELLVILLE WASHERS COMPRESSED TO APPROXIMATELY 50% OF THEIR DEFLECTION. THIS DIMENSION IS SHOWN ON ATTACHED DWG AND EQUALS 0.928". USE heavy grease to hold gasket in place and heavy OIL with graphite on all studs, nuts and bellville washers to reduce friction when tightening.
