**Region 6 - Enforcement & Compliance Assurance Division**  
**INSPECTION REPORT**

| Inspection Date(s): | 03/22/2023 | |
| Company Name: | <b>Dlubak Glass Company</b> | |
| Facility Physical Location: | 1018 W. 14 <sup>th</sup> St. | |

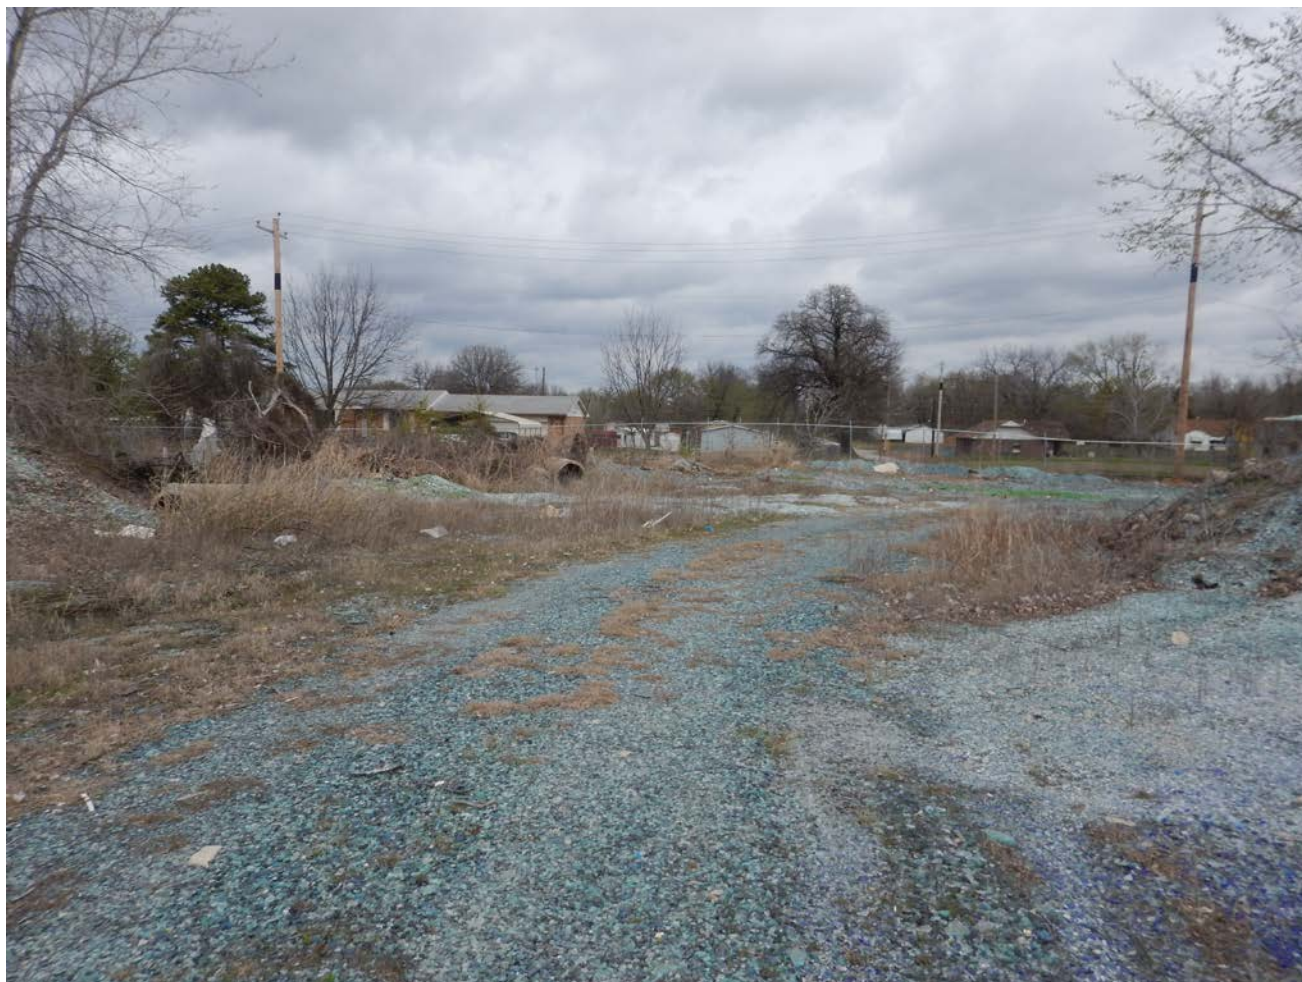
Photo No. 1

We began the tour of the facility heading west from the office along a facility road paved with crushed glass and rock. The point where the road curved south, was photographed (Appendix 1, photo 1 -3). This used to be another entrance to the facility but was closed off in 2019. Ms. Berry said there was no

| Description: | Photo taken in landscape mode facing North on path/trail showing crushed glass. Near the Northwest corner of the facility. |

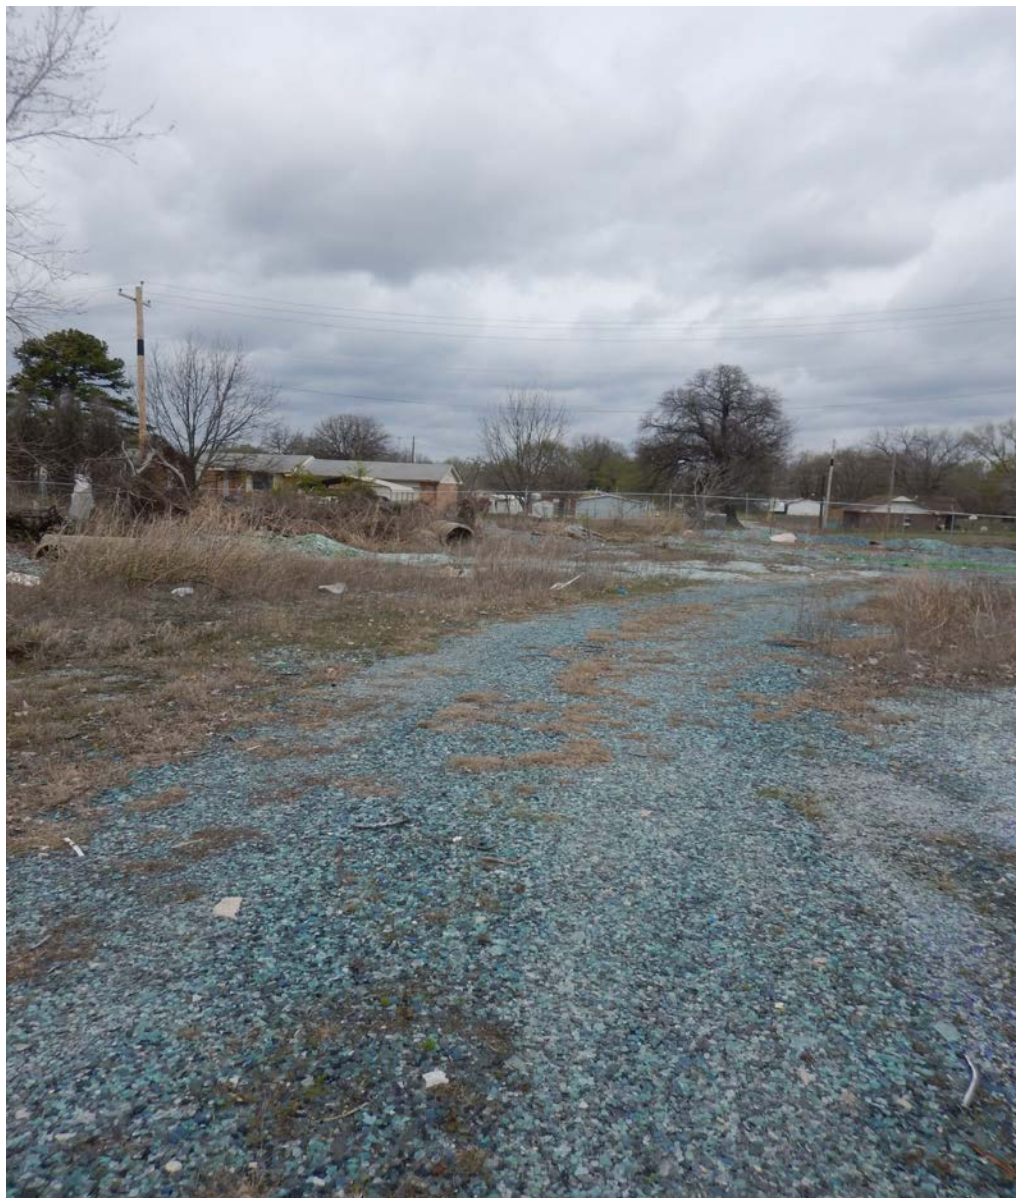
Photo No. 2

| Description:<br>Photo taken in portrait mode facing North on path/trail showing crushed glass. Near the Northwest corner of the facility. | |

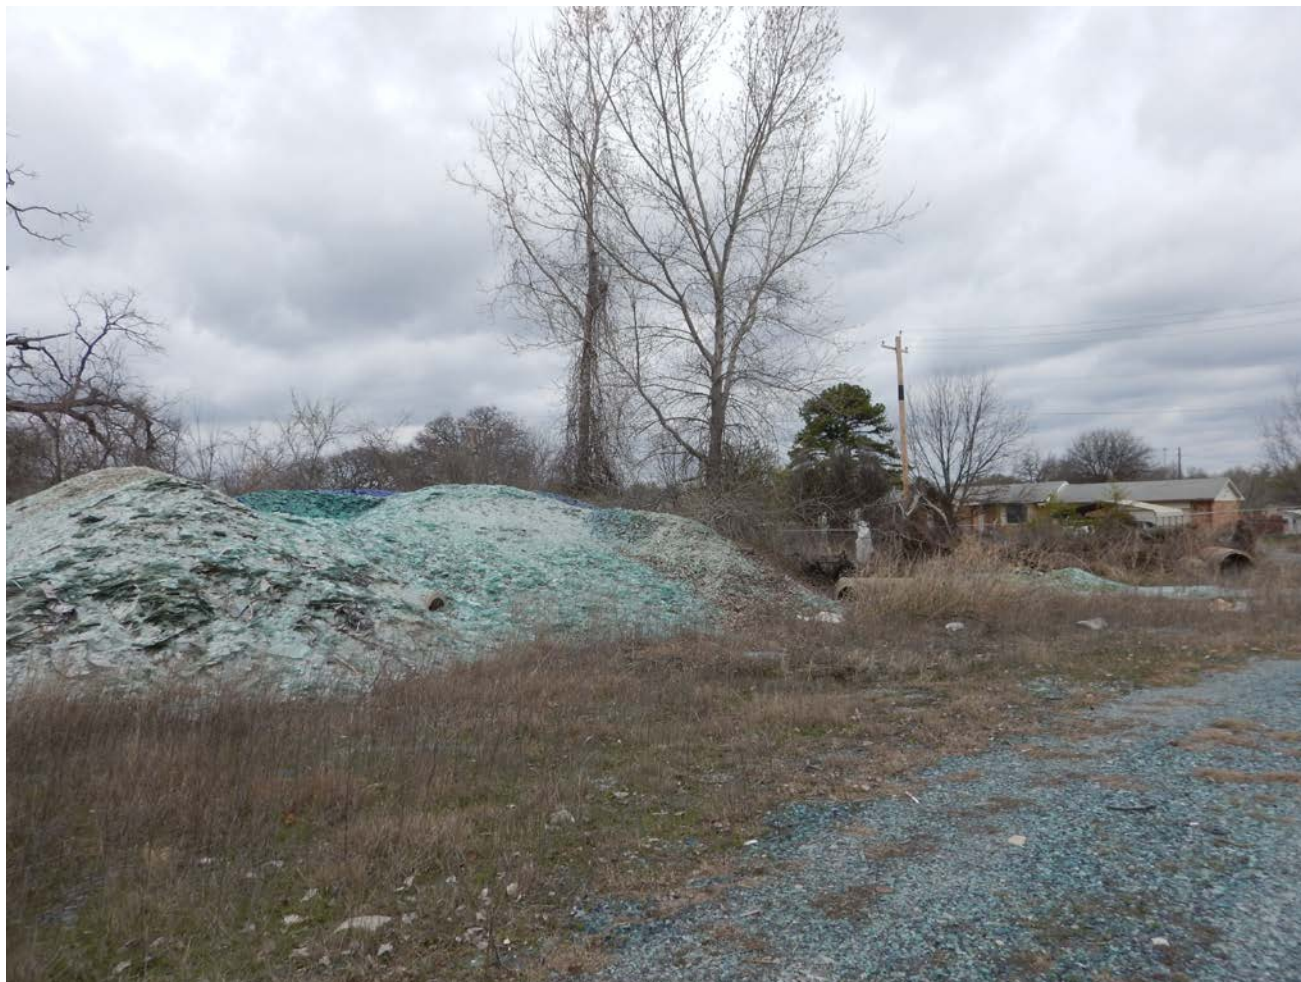
Photo No. 3

| Description:<br>Photo taken facing North of crushed pile of glass to the left of photo. This pile of glass appears to have increased in volume since ODEQ photo taken in 2020. The ODEQ photo in 2020 shows a cement culvert that has a certain length that is exposed from under the glass pile. This photo appears to show that same culvert with just the very end exposed. This indicates that more glass has piled on top of the culvert. | |

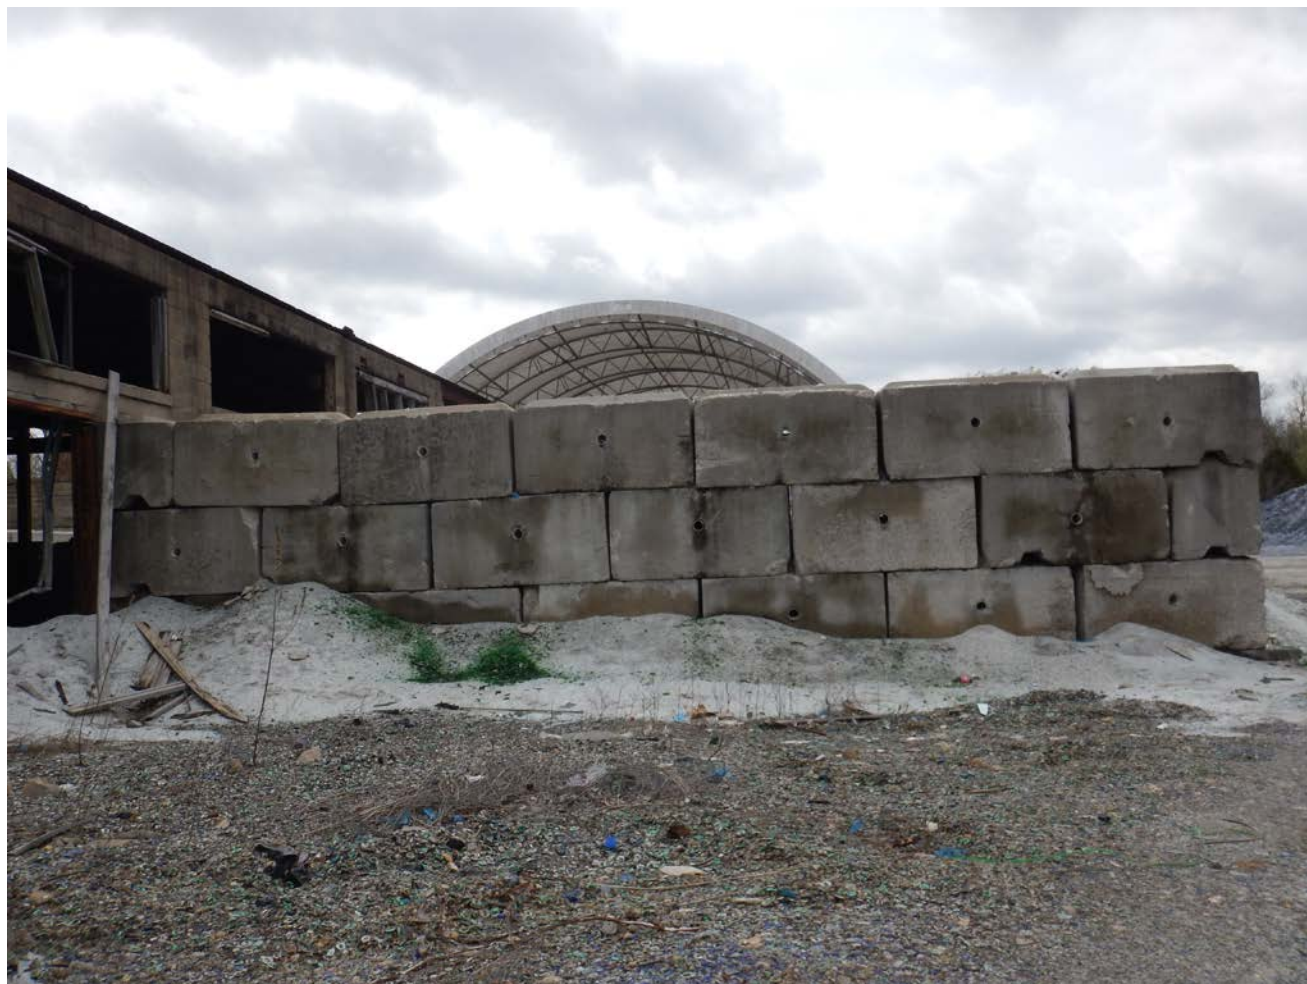
Photo No. 4

Continuing south, we arrived at a lightbulb storage area called a bunker, located immediately adjacent to a warehouse (later identified as the Bottle Shop Warehouse). We observed glass on the outside of the bunker (Appendix 1, photo 4). I asked how the glass gets outside the bunker. Ms. Berry directed our attention to the holes in the concrete blocks serving as walls and said glass can extend beyond the bunker by being carried in rainwater washing through the holes or from openings on the west side of the Bottle Shop Warehouse, during loading or unloading of the glass.

| Description:<br>Photo taken facing South showing what the facility representative described as crushed flint (clear) glass piled up against this concrete barrier near the Bottle Shop Warehouse, just North of the CRT canopy storage area. The facility representative stated that this material was discharged out the storage area and onto the ground via the drain holes in the wall during rain events. | |

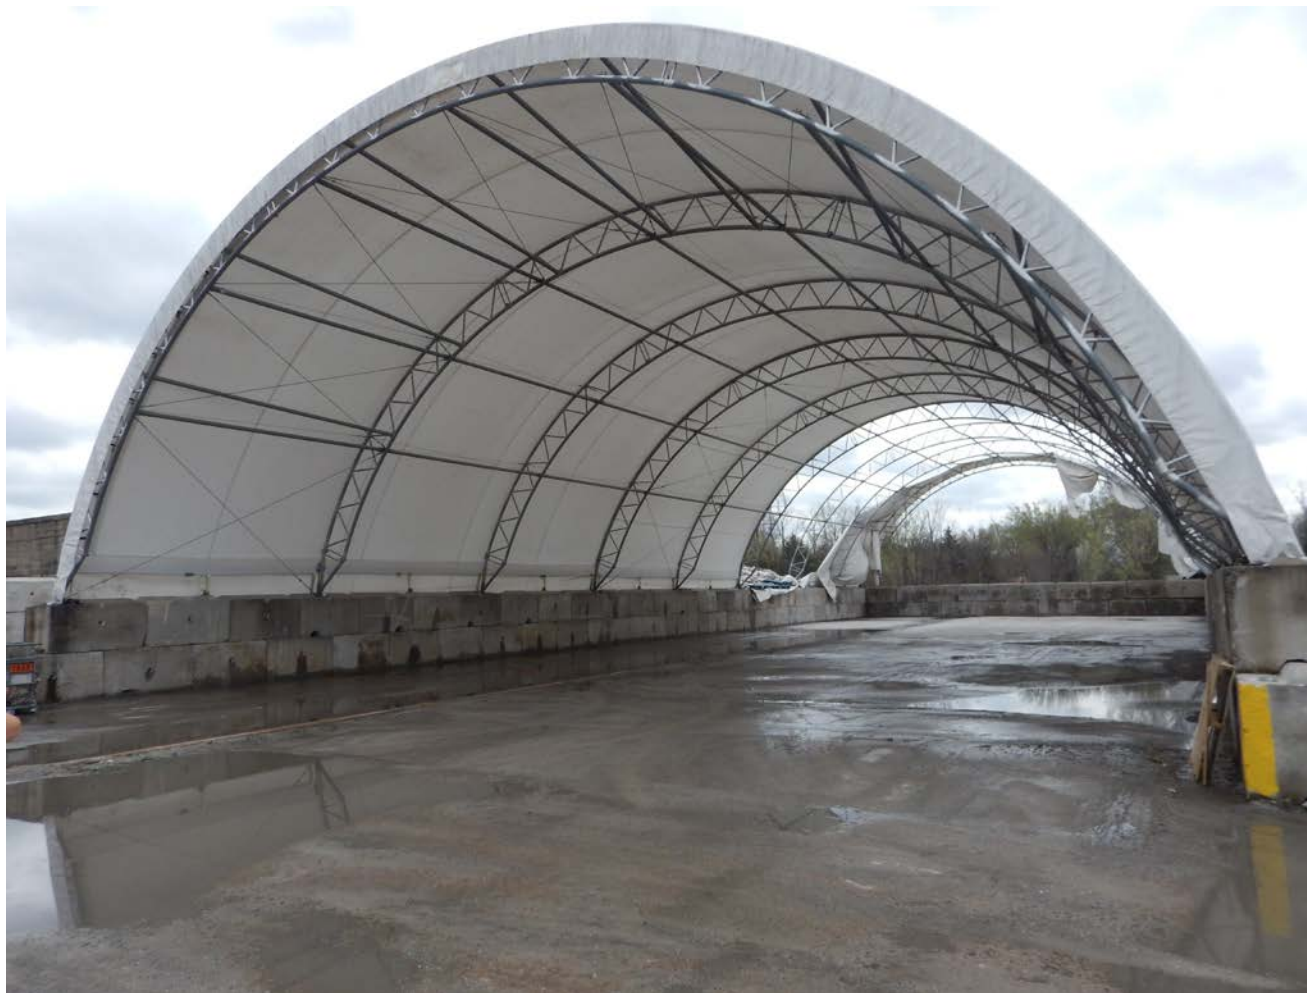
Photo No. 5

Continuing to the end of the Bottle Shop Warehouse, we arrived at the canopy structure used to contain the CRT glass. The canopy was empty (Appendix 1, photo 5). We walked along the west side and the back of the canopy and observed a pile of glass appearing to have moved out of the canopy via the same types of holes in the concrete block walls. Ms. Berry identified the greyish glass as the CRT glass. She also identified bottle glass along the back side of the canopy (Appendix 1, photos 6, 7).

| Description:<br>Photo taken facing South showing CRT storage canopy. The canopy is no longer storing CRT glass and is completely empty. | |

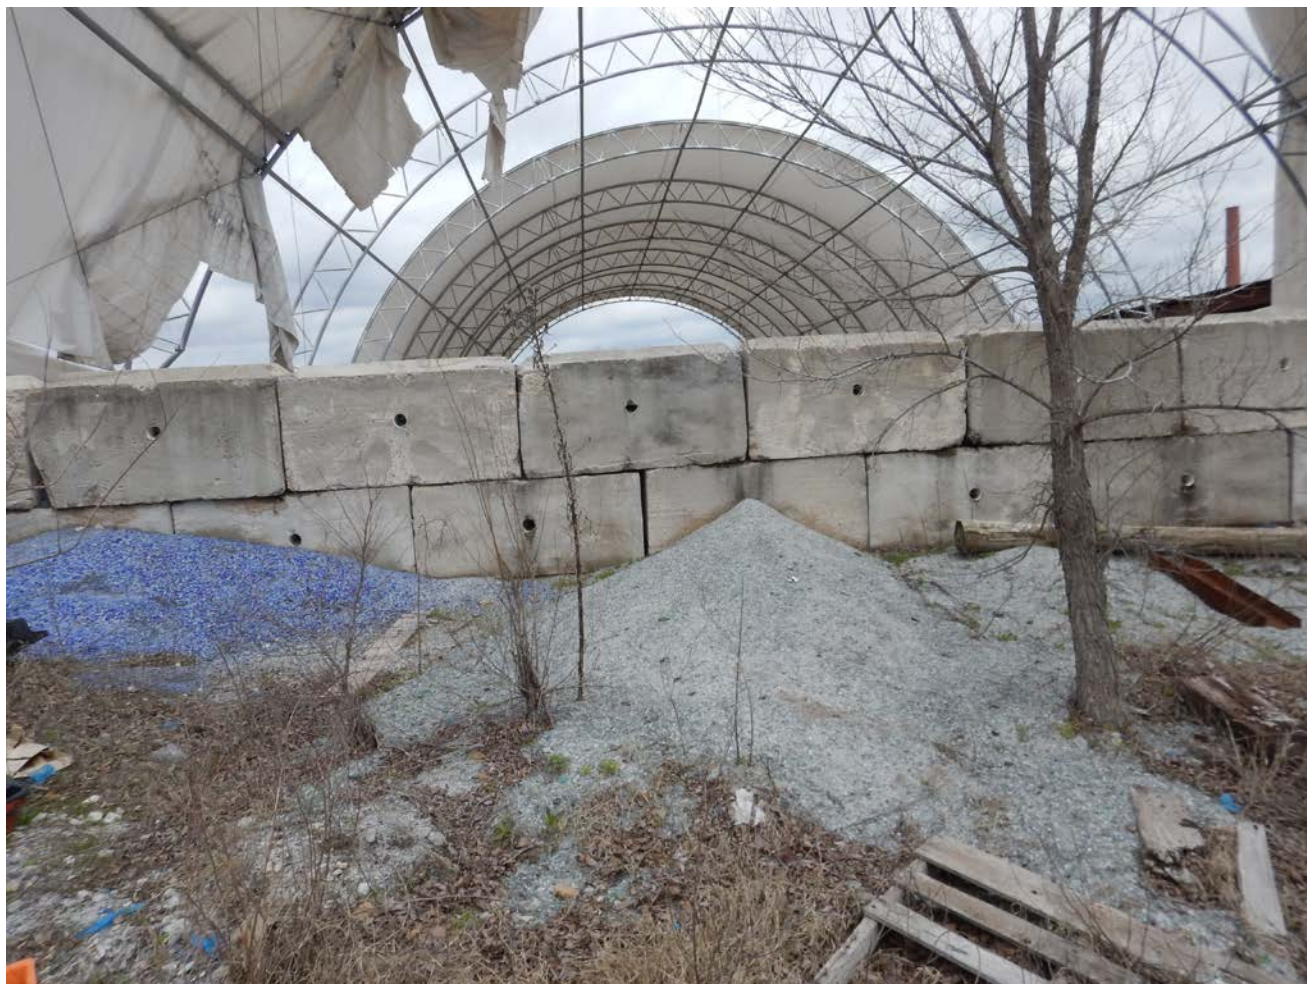
Photo No. 6

EPA's areas of concern during the inspection are the spill-over areas onto the ground on the backside of the canopy and the openings on the west side of the Bottle Shop Warehouse (Appendix 1, Photos 6, 7, 11 and 12). Per Ms. Berry, these piles may contain CRT glass within or under the piles.

| Description:<br>Photo taken facing North of crushed CRT glass (the white/gray pile near center of photo) that has discharged onto the ground outside the CRT storage canopy. The facility representative stated that this pile was discharged from the drains in the concrete wall during rain events. | |

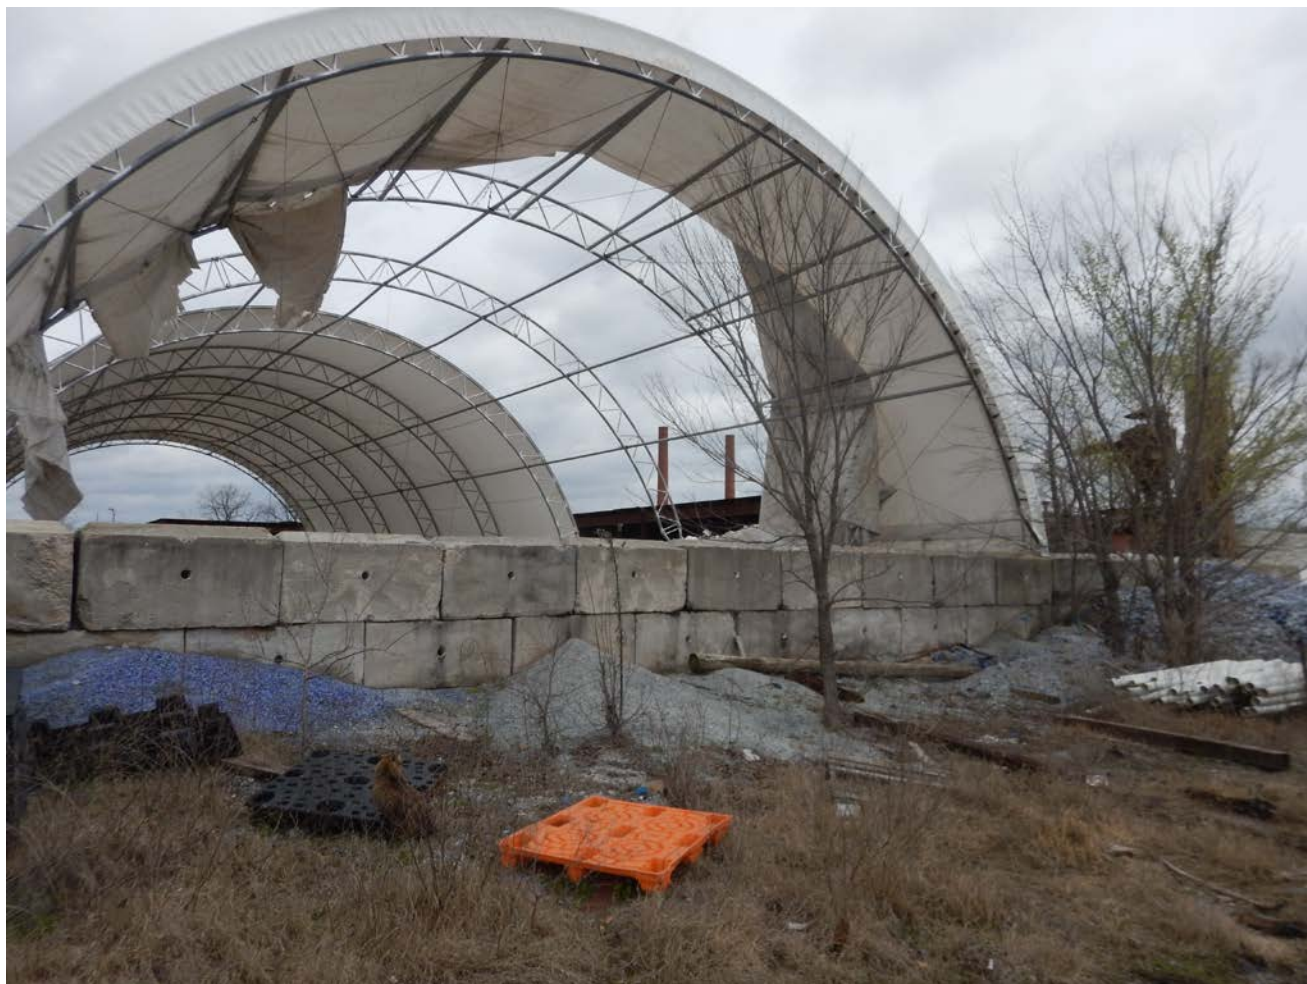
Photo No. 7

| Description:<br>Photo taken facing Northeast with a wider view of Photo 6. This photo shows the same pile of crushed CRT glass (near the center of this photo) that was taken in Photo 6. The facility representative stated that other piles of glass along this wall shown in this photo may also contain a mixture of CRT glass that has been discharged onto the ground outside the CRT storage canopy. | |

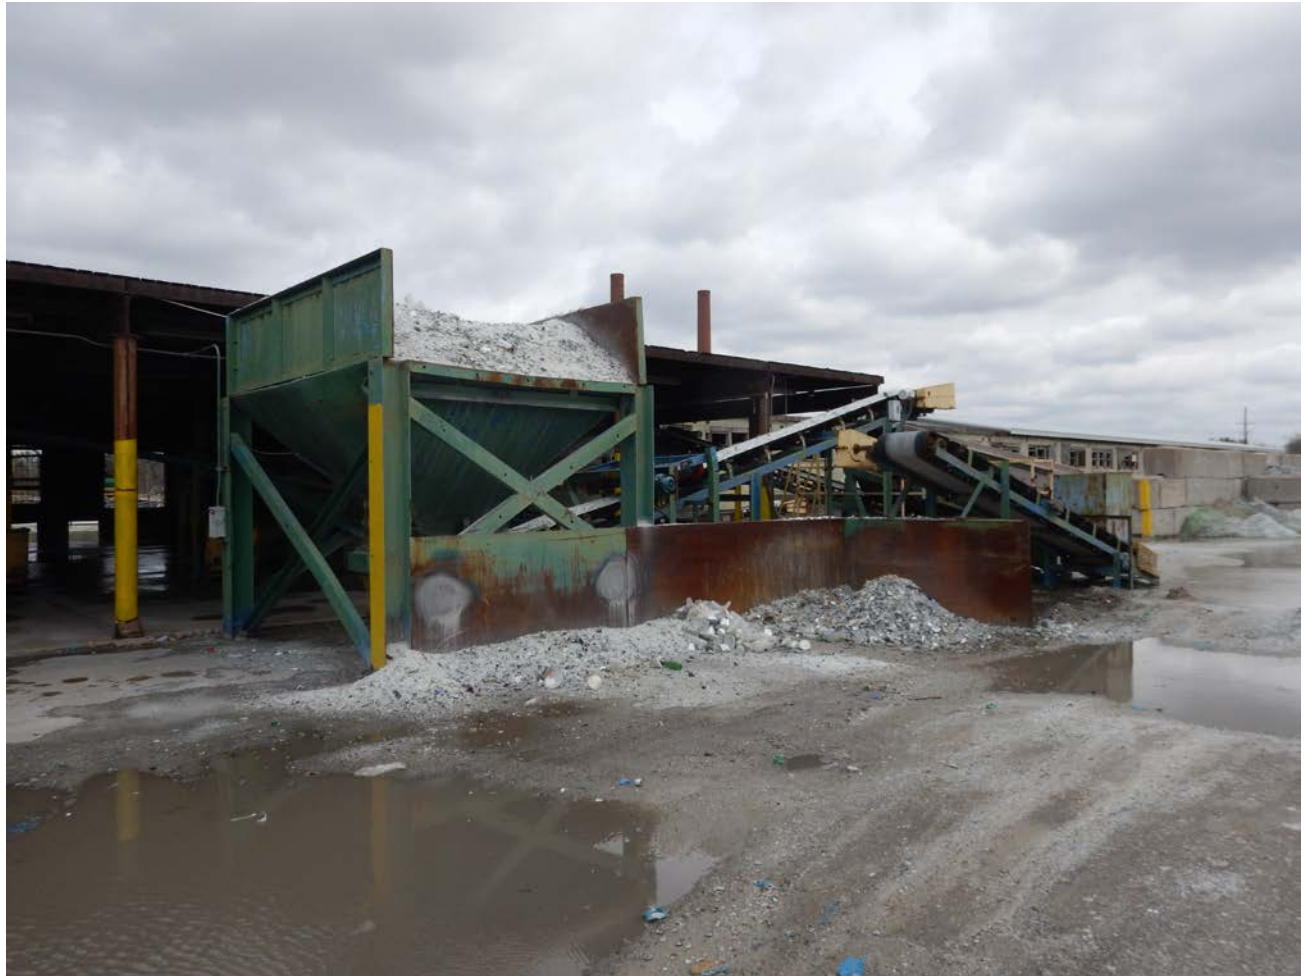
Photo No. 8

Behind the Bottle Shop Warehouse, we observed a processor – grinder (Appendix 1, photo 8) . Ms. Berry said the glass being processed is light bulb glass. She said they have not processed/ground CRT glass for at least 5 years. I asked if they processed the CRT glass that was stored at the facility since 2016 and she said the glass was received processed/ground.

| Description:<br>Photo taken facing Northeast of the glass processor that crushes glass. This unit is used to crush various types of glass received at the facility, including past CRT glass received. According to the facility representative, the processor has not been used to crush CRT glass for over 4 years. | |

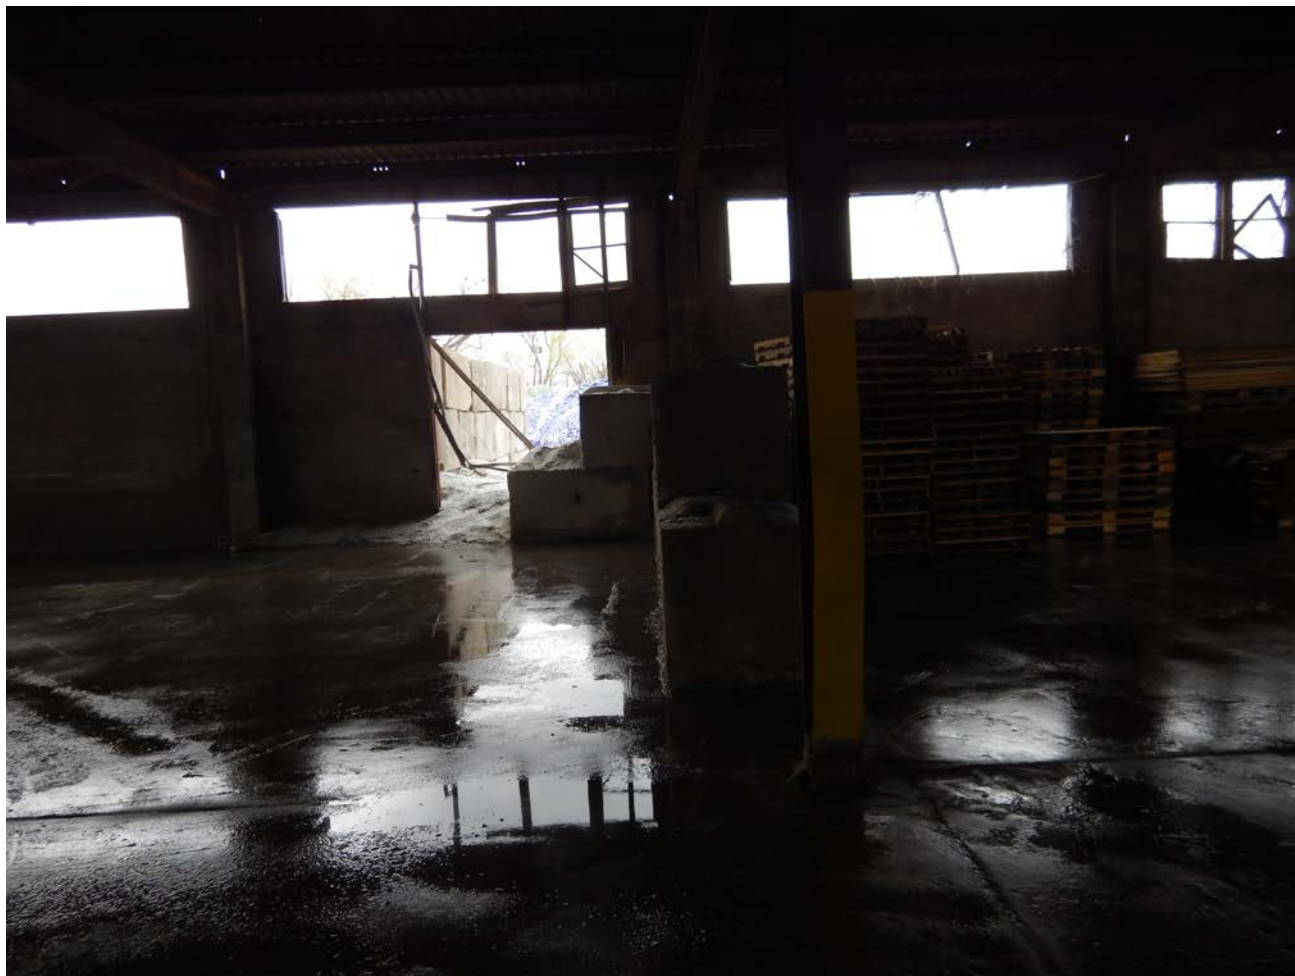
Photo No. 9

Entering the Bottle Shop Warehouse, we observed it to be empty except for a pile of light bulb glass at the north end of the warehouse (Appendix 1, photos 9, 10). This warehouse was used to store CRT glass as previously observed by ODEQ during their investigations. The CRT glass was sold and shipped to the customer. We observed the openings on the west side of the building where piles of glass from 2 openings cascaded down to the ground (Appendix 1, photos 11, 12). I asked if these piles could contain CRT glass and Ms. Berry said it was possible but would be on the bottom of the pile. She also said once glass is outside of its storage bunker, it is considered contaminated and can not be resegregated for sale based on mixing with other glass and other debris.

| Description:<br>Photo taken facing West in the Bottle Shop Warehouse. Previous ODEQ photos documented crushed CRT glass piles stored in this area. This photo shows that piles of crushed glass in this area have been removed and is now empty. There are only wooden pallets to the right of photo. | |

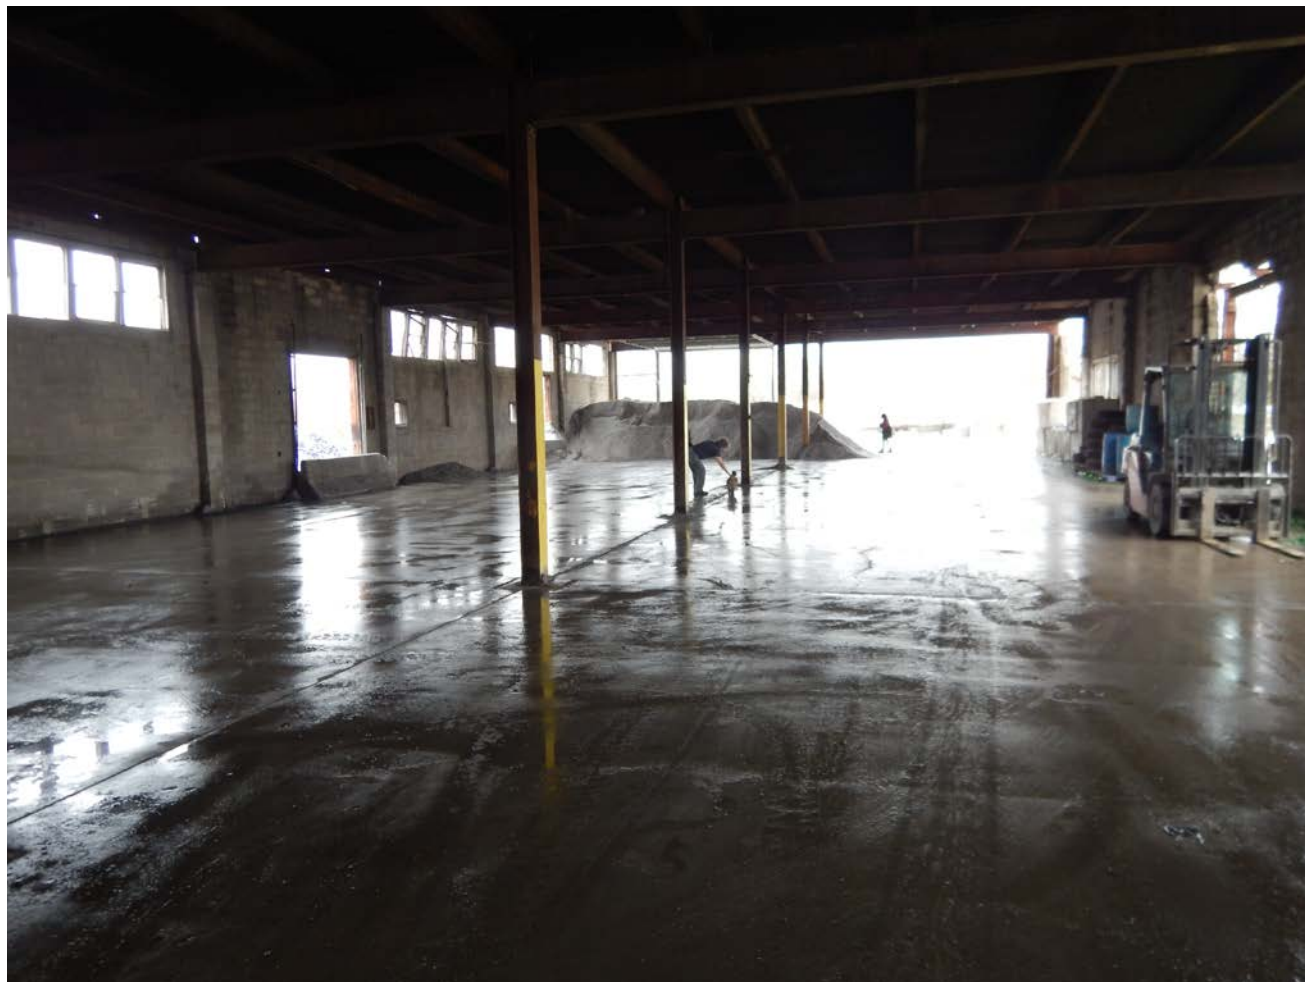
Photo No. 10

| Description:<br>Photo taken facing North in the Bottle Shop Warehouse. This photo shows this area as mostly empty of storage with exception of one pile of crushed light bulbs and tableware (food grade glass) at the far North end of the building. | |

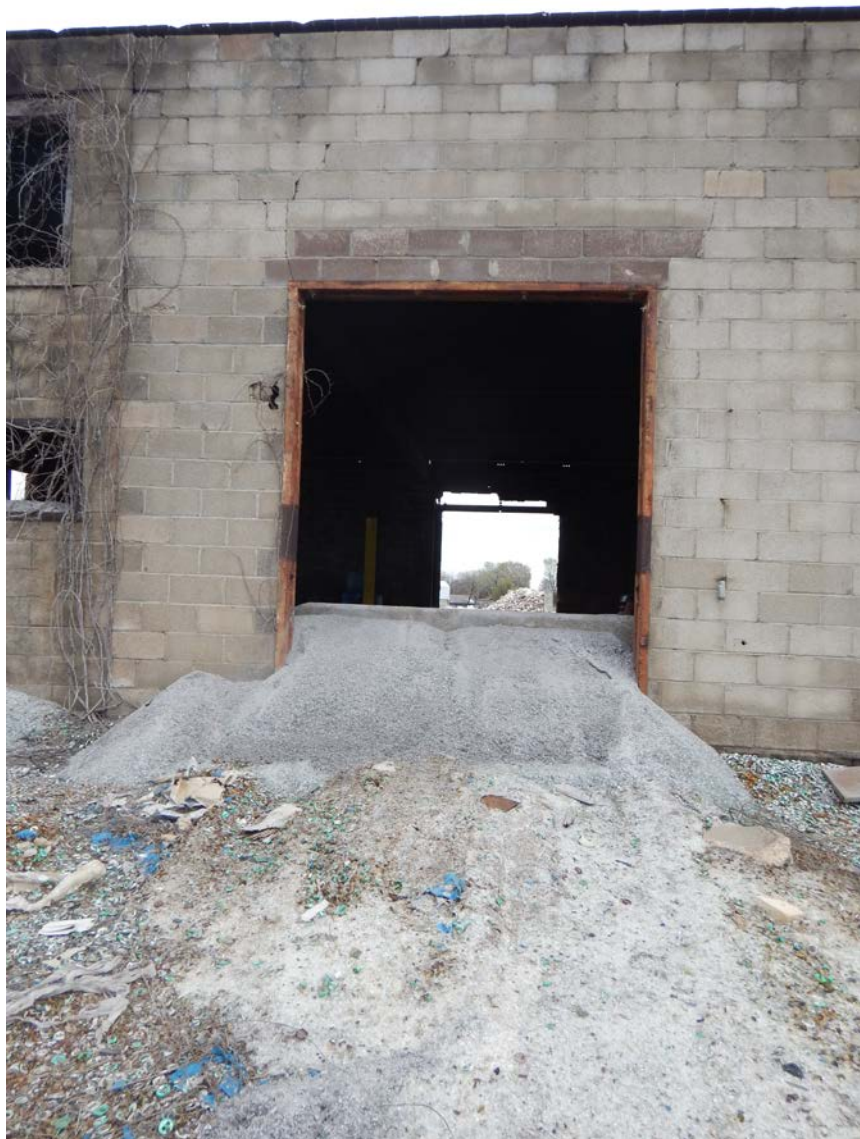
Photo No. 11

| Description:<br>Photo taken facing East showing the West side wall of the Bottle Shop Warehouse. The photo shows spillover described by the facility representative as tableware glass (food grade glass) that discharged onto the ground outside the Bottle Shop Warehouse building. The facility rep stated it is possible that there are residuals of crushed CRT glass underneath the pile shown in this photo. | |

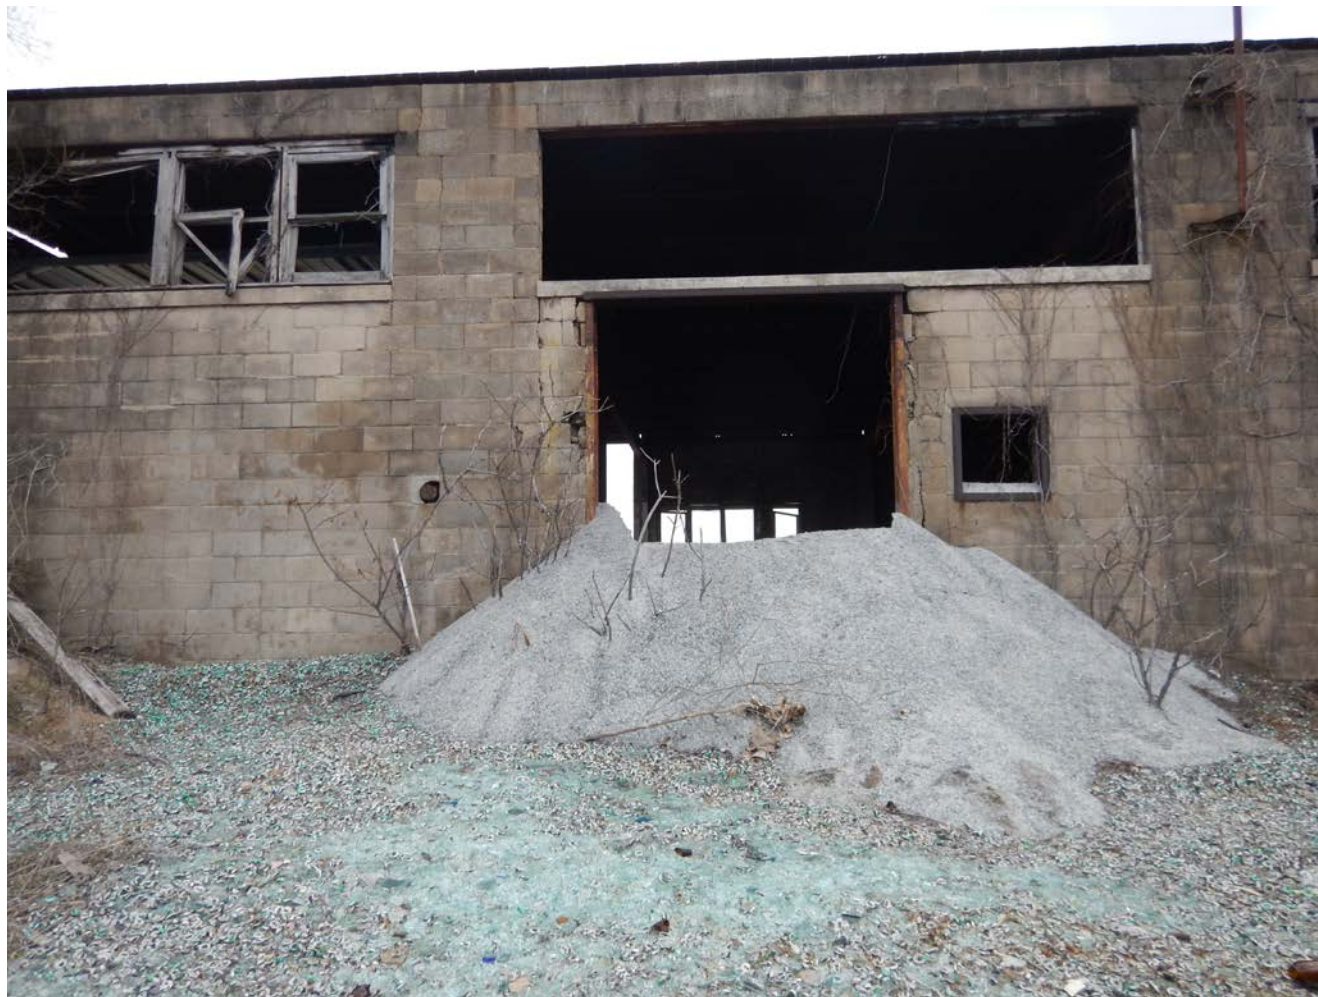
Photo No. 12

| <b>Description:</b><br>Photo taken facing East showing the West side wall of the Bottle Shop Warehouse. This photo location is about 20 feet north of photo 11. This photo shows the same scenario as photo 11. There is spillover described by the facility representative as tableware glass (food grade glass) that discharged onto the ground outside the Bottle Shop Warehouse building. The facility rep stated it is possible that there are residuals of crushed CRT glass underneath the pile shown in this photo as well. | |
