**Region 6 - Enforcement & Compliance Assurance Division**  
**INSPECTION REPORT**

| Inspection Date(s): | 05/10/2022 | |
| Regulatory Program(s) | SDWA | |
| Facility Name: | <b>USCOE Rocky Creek Park 2 Tarrant</b> | |

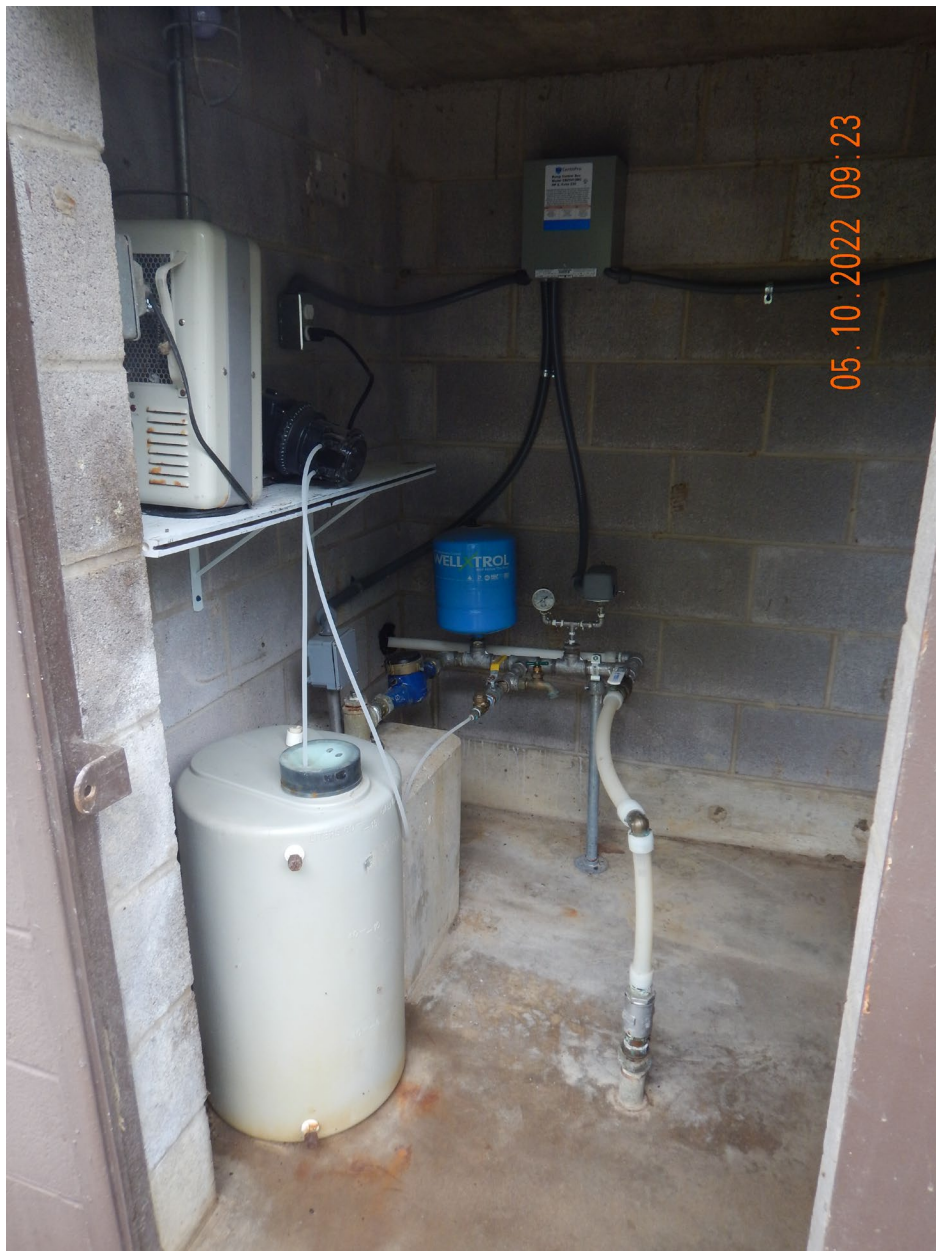
Photo No. 1

- The interior of the wellhouse was observed to be in good condition (Photo 1). We were informed that the wellhouse is cleaned on a weekly basis.
- The sodium-hypochlorite barrel was missing an original label (Photo 2, AOC 1) and had three openings through the lid (Photo 2, AOC 2).
- Evidence of wasp nests were observed on the ceiling of the wellhouse (Photo 3, AOC 3).

Description: Well house interior in good condition. Sodium hypochlorite barrel missing label.

1. The sodium-hypochlorite barrel was missing a label. We recommend replacing the missing label.
2. The sodium-hypochlorite barrel had three openings through the lid, which could serve as paths of contamination. We recommend properly sealing the barrel.
3. Evidence of wasp nests were observed on the ceiling of the wellhouse. We recommend proper insect removal and prevention to mitigate biological hazards inside the wellhouse.

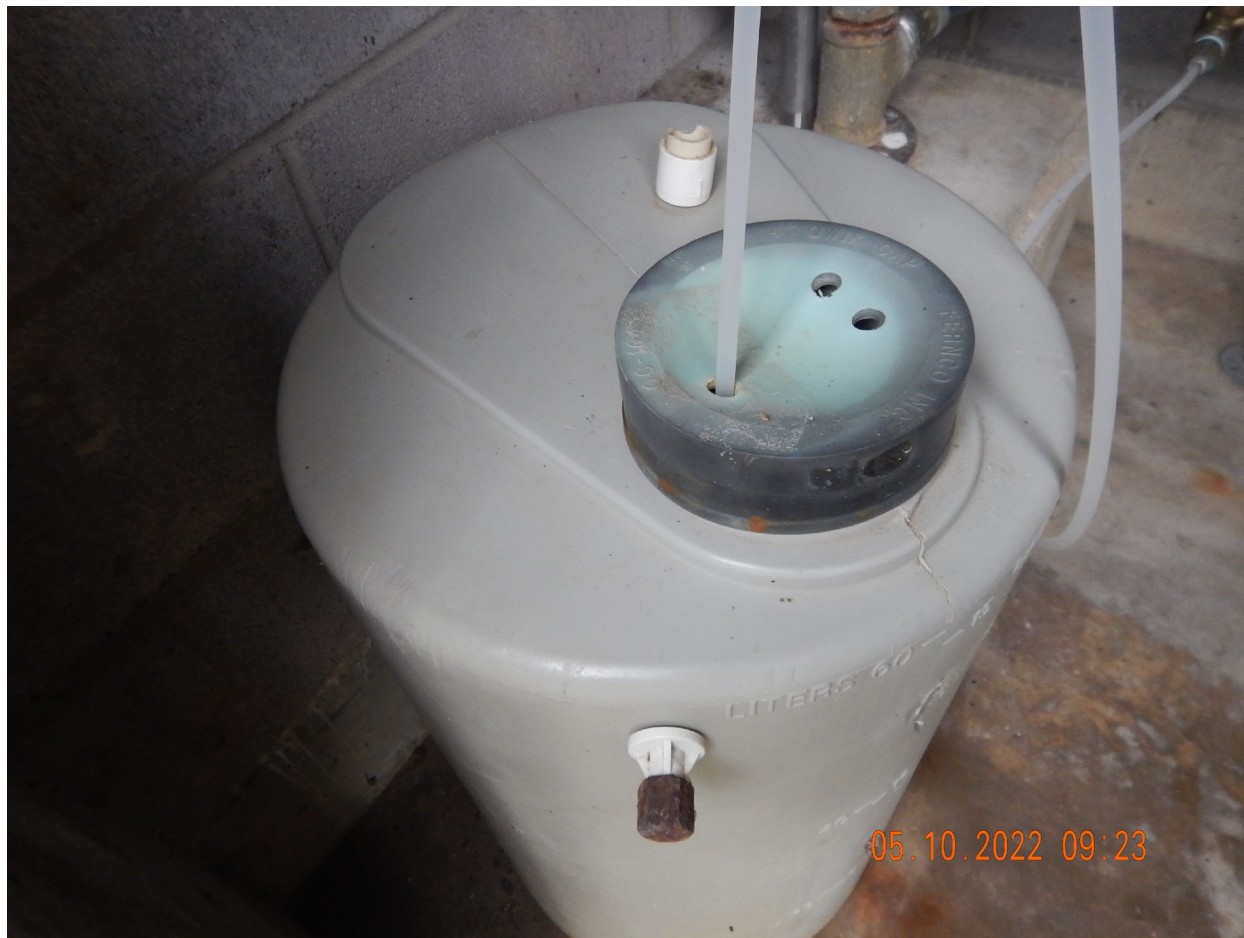
Photo No. 2

Description: Openings in the top of the sodium hypochlorite barrel.

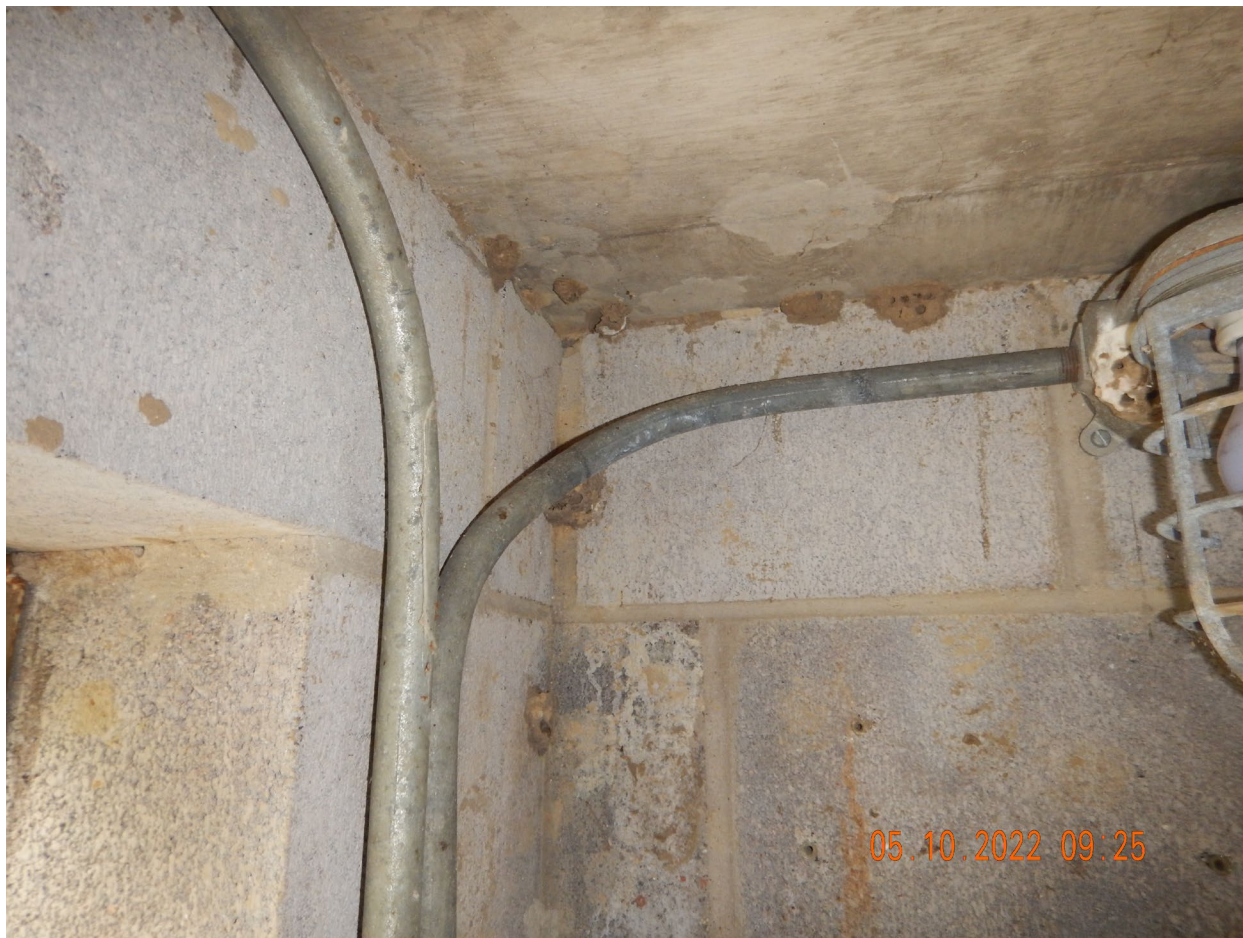
Photo No. 3

Description: Evidence of wasp nests on the wellhouse ceiling.

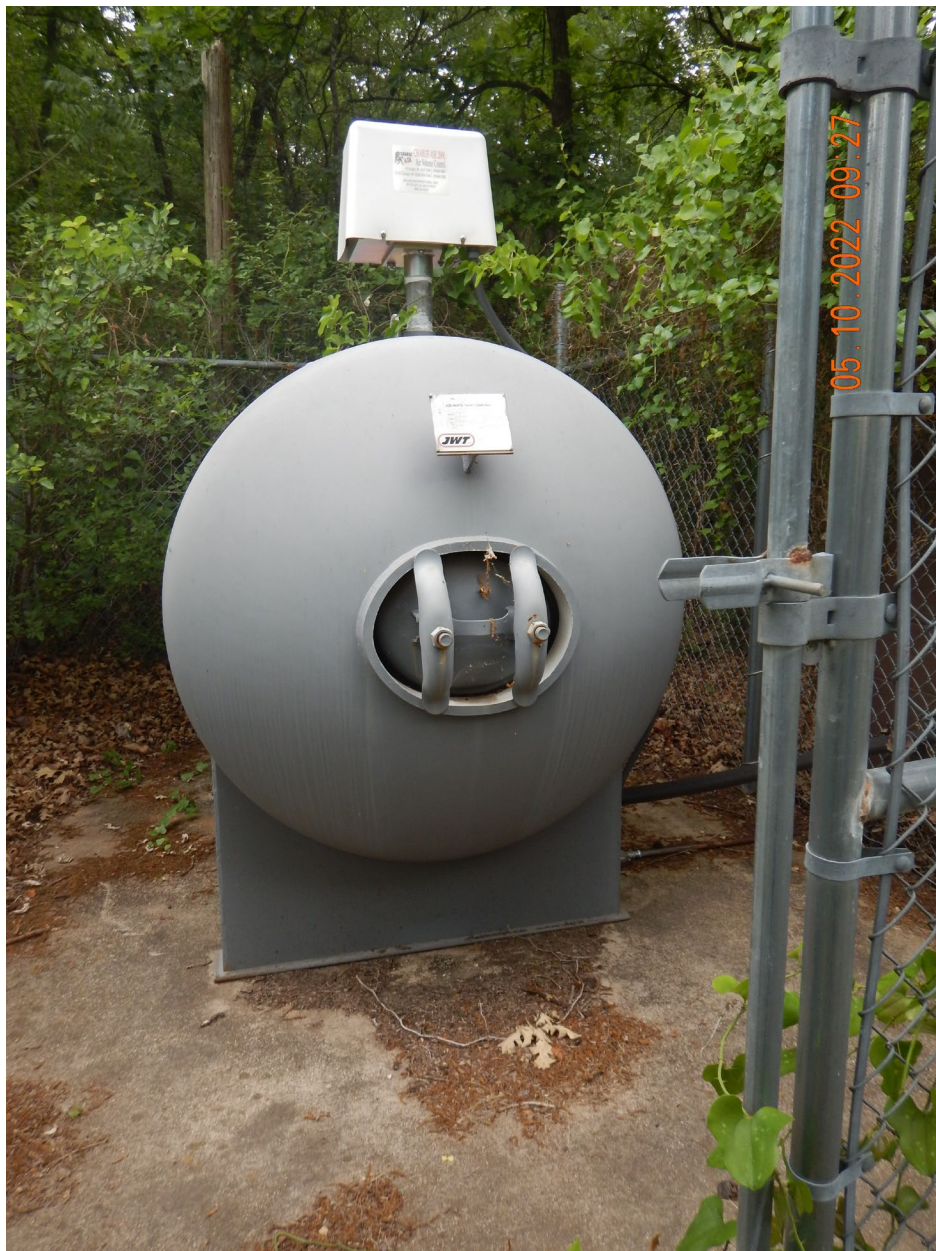
Photo No. 4

- Tank was recently installed in 2019 and was observed to be in good condition (Photo 4).

Description: Hydro-pneumatic tank in good condition inside a secured fence.
