**Region 2 Caribbean Environmental Protection Division  
Multimedia Permits and Compliance Branch**

**CAA Inspection Report**

**Inspection Date:** 4/12/2024

**Facility Name:** Oil Energy Systems Inc.

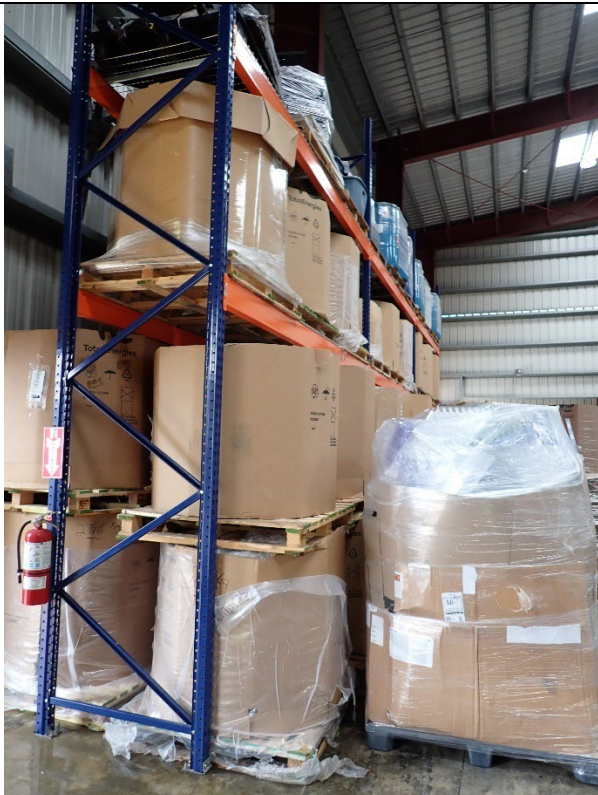
1. The Facility is storing plastic material within the Pyrolysis Unit building. Several large cardboard boxes were observed shelved in pallets racks. Some of the cardboard boxes were full of shredded plastic material. See images P4120033-P4120036 and P4120038 in Appendix A for more details.

| Appendix A: Digital Image Log for Oil Energy Systems Inc., Arecibo, PR | | | | |
|---|---|---|---|---|
| 1 | P4120033.JPG | <div></div> <div>Partial view of shredded plastic material storage area within the Pyrolysis Unit building.</div> | 4/12/2024 | 11:11 am |

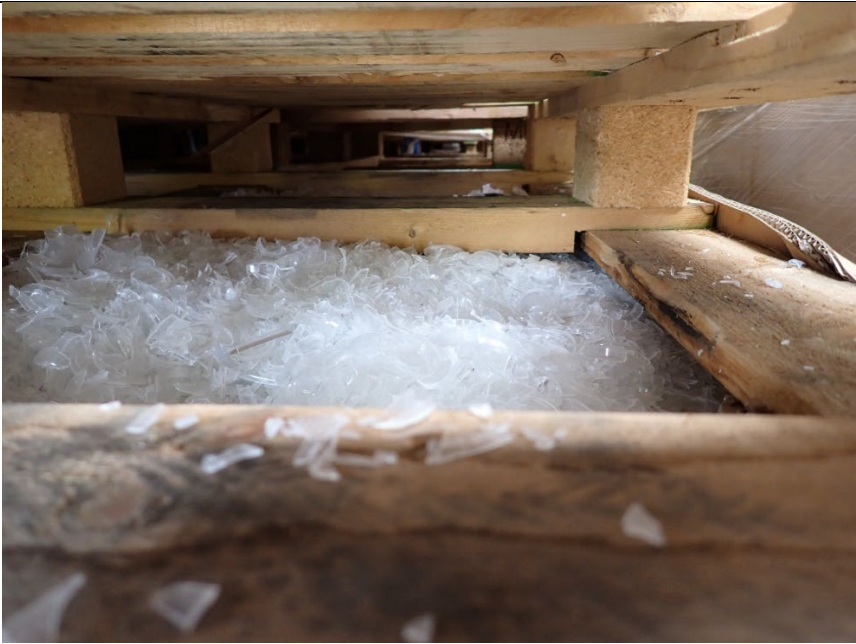
| | | Partial view of shredded plastic material stored at the Pyrolysis Unit building. | | |

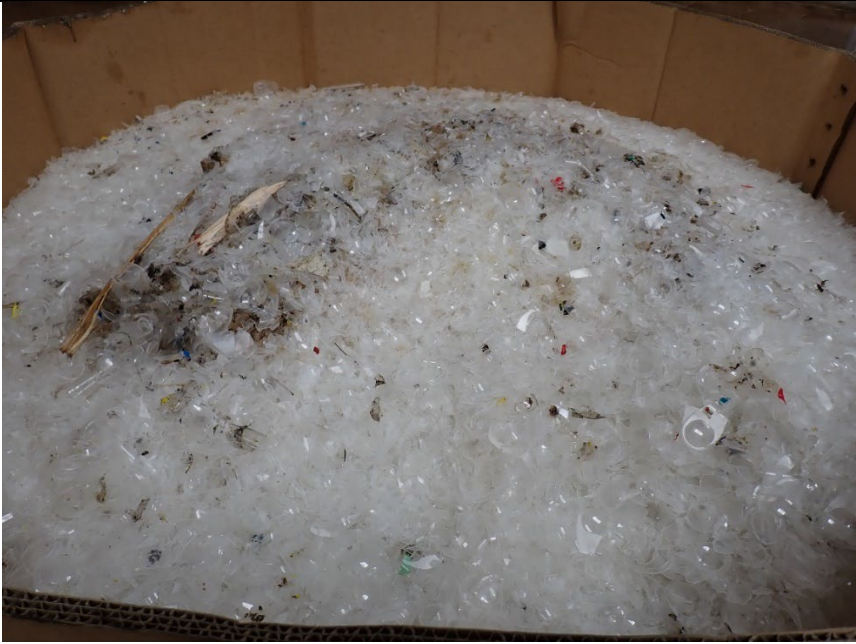
| | | Partial view of shredded plastic material stored at the Pyrolysis Unit building. | | |

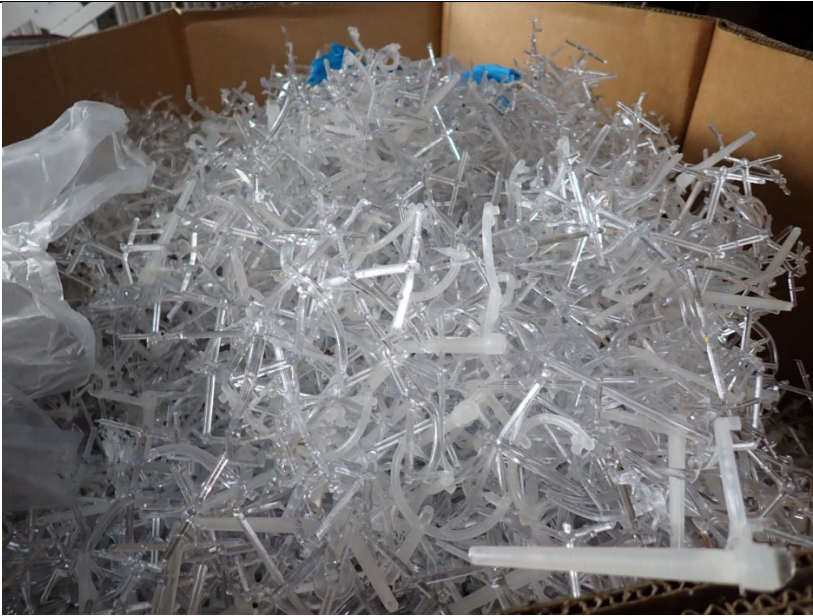
| 4 | P4120036.JPG | <p>Partial view of plastic material stored at the Pyrolysis Unit building.</p> | 4/12/2024 | 11:16 am |

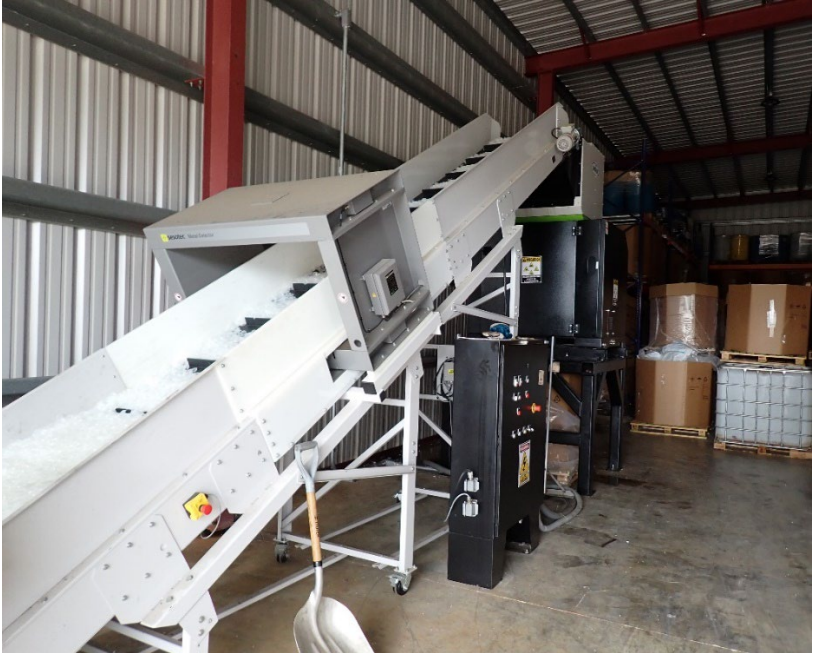
4. A shredder unit was observed in operation. See P4120037 in Appendix A for more details. Several operators were observed placing the plastic material in an open table to sort the material prior to be shredded. Eng. Ramos explained that operators inspect the material and discard any non-plastics or domestic waste.

| 5 | P4120037.JPG | <p>Partial view of the shredding unit within the Pyrolysis Unit building facing southwest.</p> | 4/12/2024 | 11:17 am |

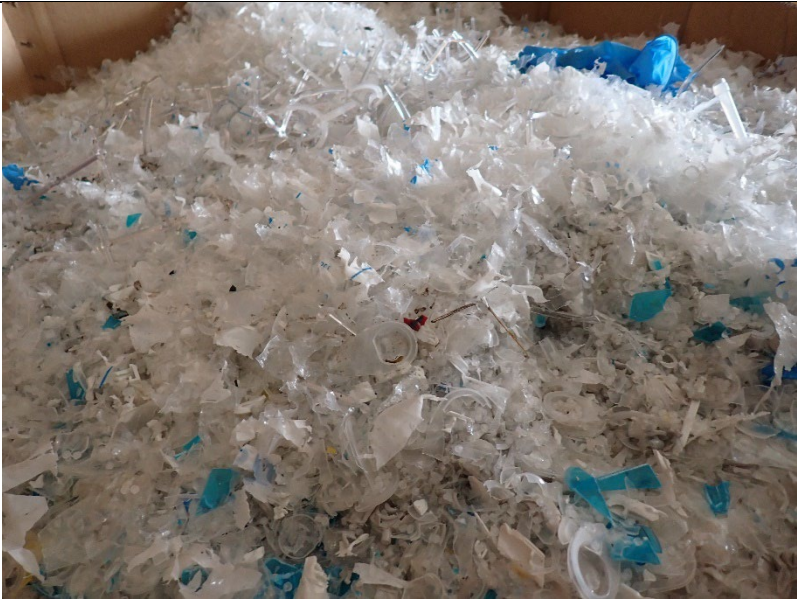
Shredded plastic material stored at the Pyrolysis Unit building.

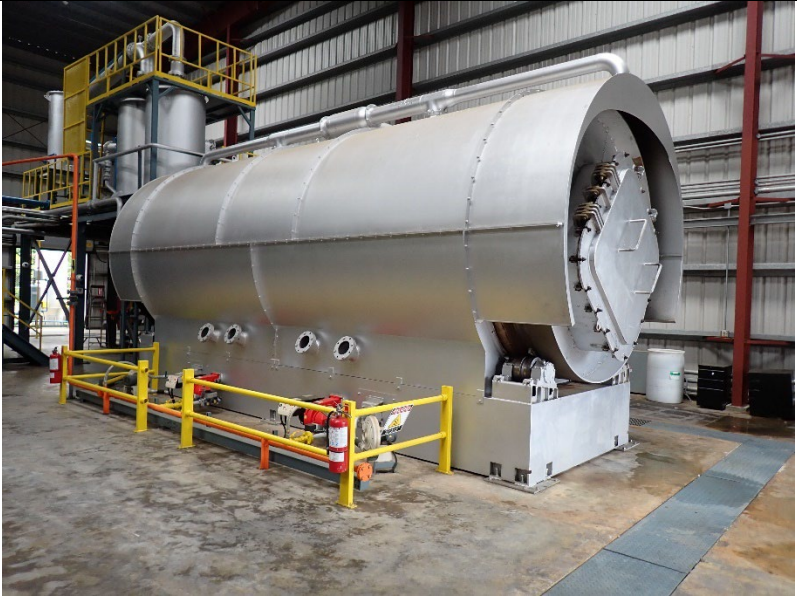
7. The Facility has one (1) pyrolysis rotary kiln reactor. See images P4120039, P4120040, and P4120059 in Appendix A for more details. The reactor has a burner box on which propane and excess syngas are used as fuel. Eng. Ramos explained that the combustion gases that are generated as part of the burner box and the enclosure of the rotary kiln are collected and conveyed through a wet scrubber. Eng. Ramos further explained that the syngas is generated as a result of the the pyrolysis process within the reactor and that prior to be used as supplemental gas in the rotary kiln burner box it is treated using a series of catalysts, heat exchangers and scrubbers. Eng. Ramos also mentioned that the excess syngas that it is not used as supplemental gas, is conveyed, and treated through a thermal oxidizer. See image P4120041 in Appendix A for more details about the syngas scrubbers.

View of the Pyrolysis Unit reactor facing northwest.

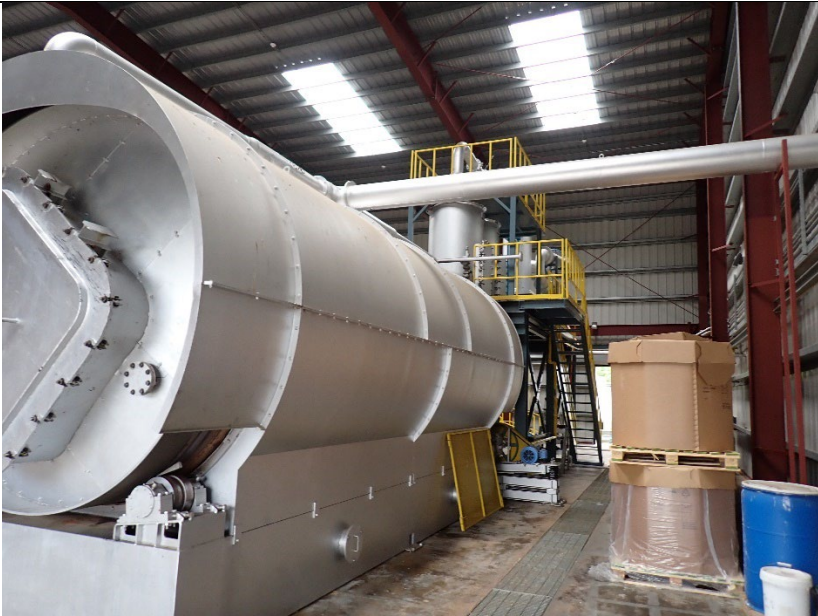
| 8 | P4120040.JPG | <p>Partial view of the Pyrolysis Unit reactor facing west.</p> | 4/12/2024 | 11:27 am |

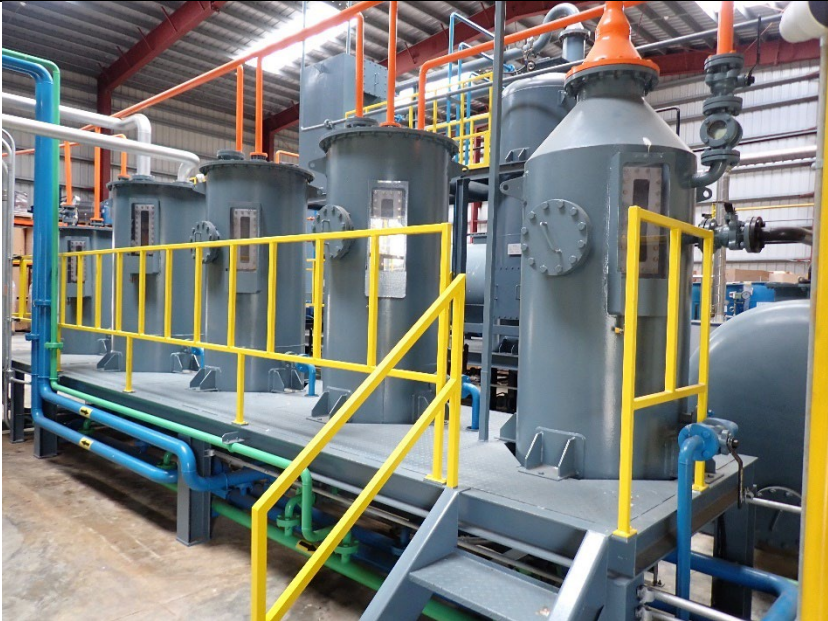
| 9 | P4120041.JPG | <p>View of the Pyrolysis Unit syn-gas scrubbers facing southeast.</p> | 4/12/2024 | 11:28 am |

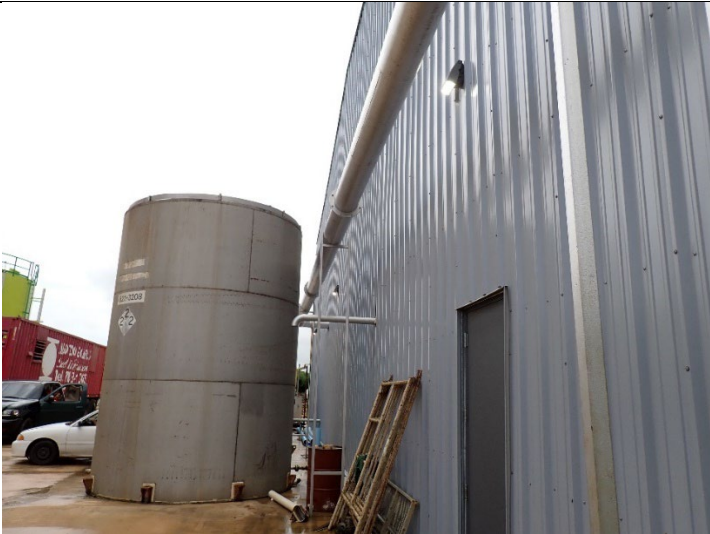
9. The inspectors were led outdoors where the Facility thermal oxidizer and wet scrubber are located. See images P4120042-P4120049 in Appendix A for more details. The inspectors informed Mr. Martínez and Eng. Ramos that both units are starting to show corrosion issues and that the wet scrubber is identified as a dust collector in the process layout that was included in the Facility air emission source construction permit application.

| 10 | P4120042.JPG | <p>Partial view of water storage tank and reactor combustion gases pipeline connected to the wet scrubber.</p> | 4/12/2024 | 11:29 am |

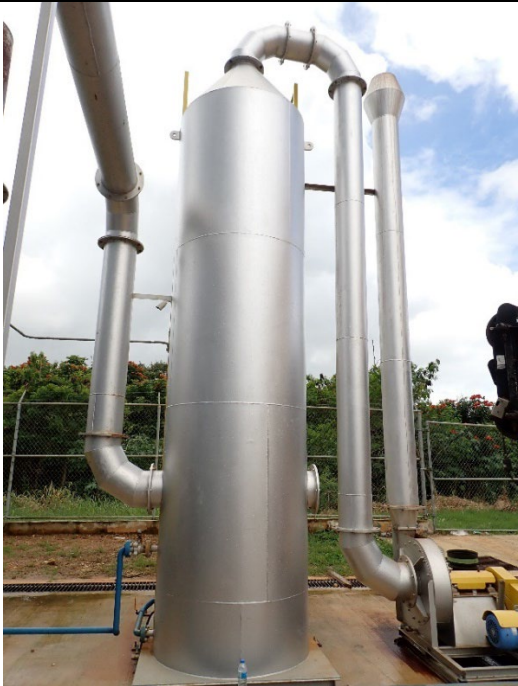
| 11 | P4120043.JPG | <p>View (facing west) of the Pyrolysis Unit wet scrubber connected to the reactor combustion gases pipeline.</p> | 4/12/2024 | 11:29 am |

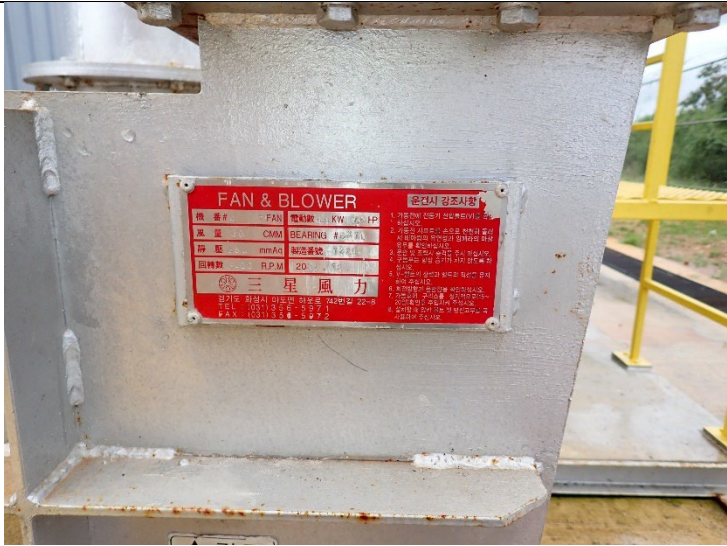
| | | View of the Pyrolysis Unit wet scrubber fan and blower specifications plate. | | |

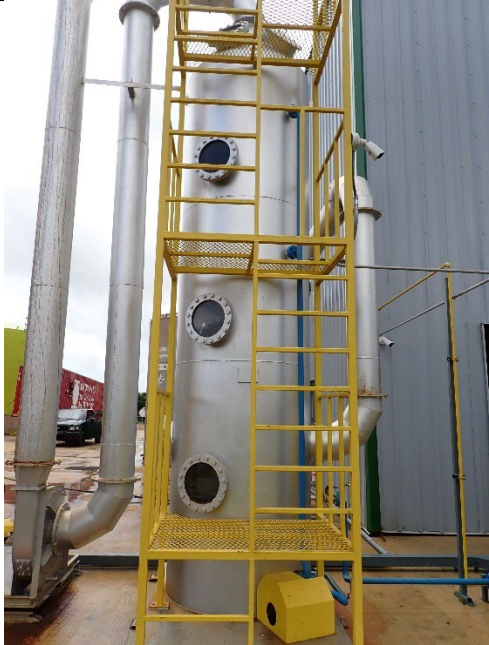
| | | View (facing east) of the Pyrolysis Unit wet scrubber connected to the reactor combustion gases pipeline. | | |

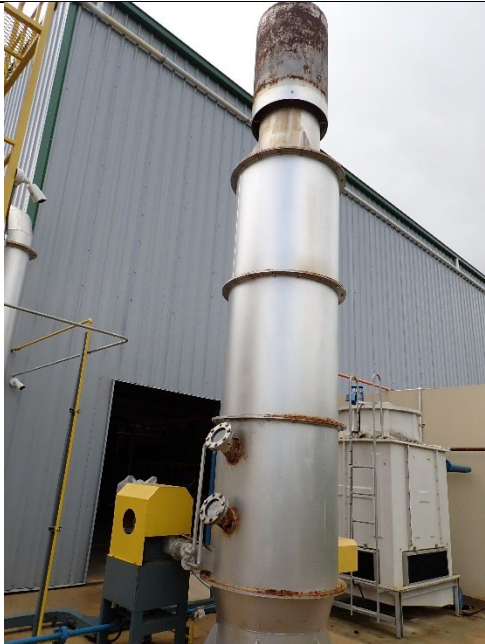
| 14 | P4120046.JPG | <p>View (facing southeast) of the Pyrolysis Unit thermal oxidizer connected to the residual syn-gas pipeline.</p> | 4/12/2024 | 11:32 am |

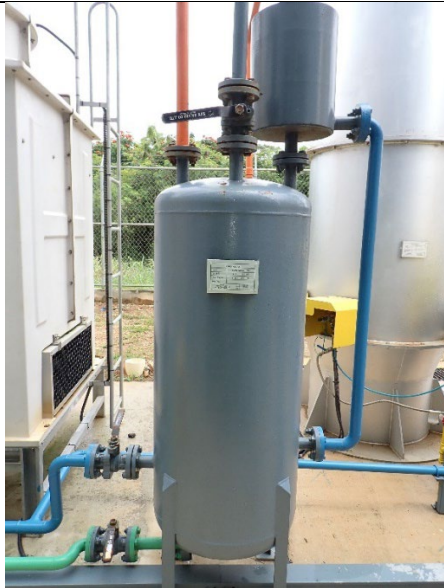
10. The thermal oxidizer is equipped with a flame arrestor. See image P4120047 in Appendix A for more details.
11. At the time of the inspection there was a contractor working on construction activities in two (2) of the Facility storage tanks. Construction activities on two (2) out the four (4) storage tanks are already completed. See images P4120050-P4120051 and P4120058 in Appendix A for more details.

| 15 | P4120047.JPG | <p>View (facing west) of the thermal oxidizer flame arrestor.</p> | 4/12/2024 | 11:33 am |

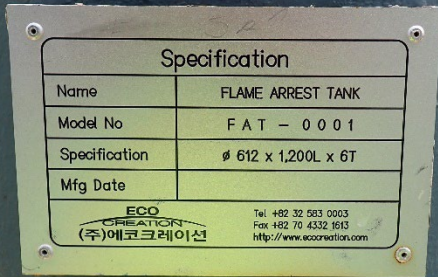
| 16 | P4120048.JPG | <p>View (facing west) of the thermal oxidizer flame arrestor specification plate.</p> | 4/12/2024 | 11:33 am |

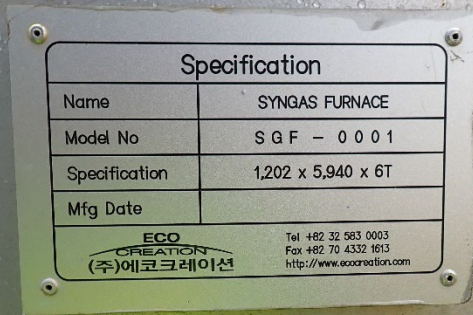
| 17 | P4120049.JPG | <p>View (facing west) of the thermal oxidizer specification plate.</p> | 4/12/2024 | 11:35 am |

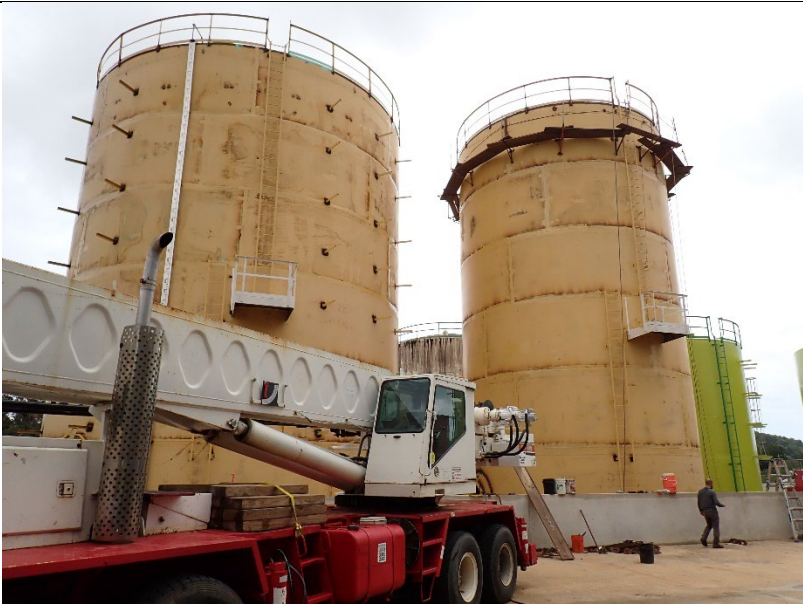
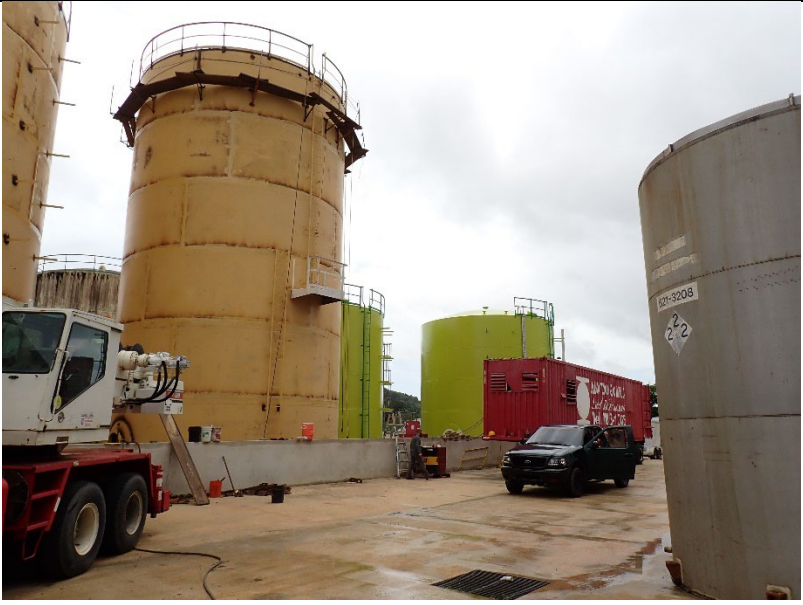
Partial view (facing northeast) of the Pyrolysis Unit product storage tanks.

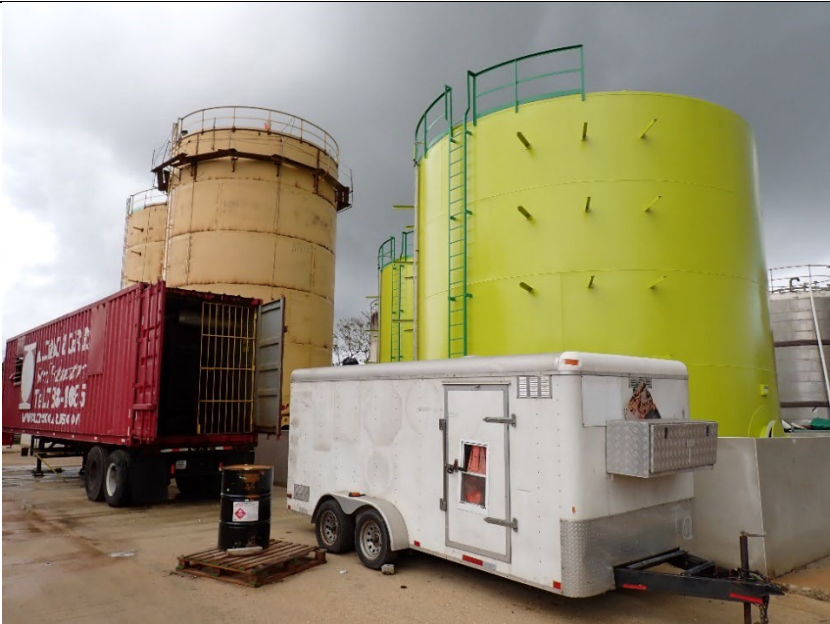
Partial view (facing northwest) of the Pyrolysis Unit storage tanks.

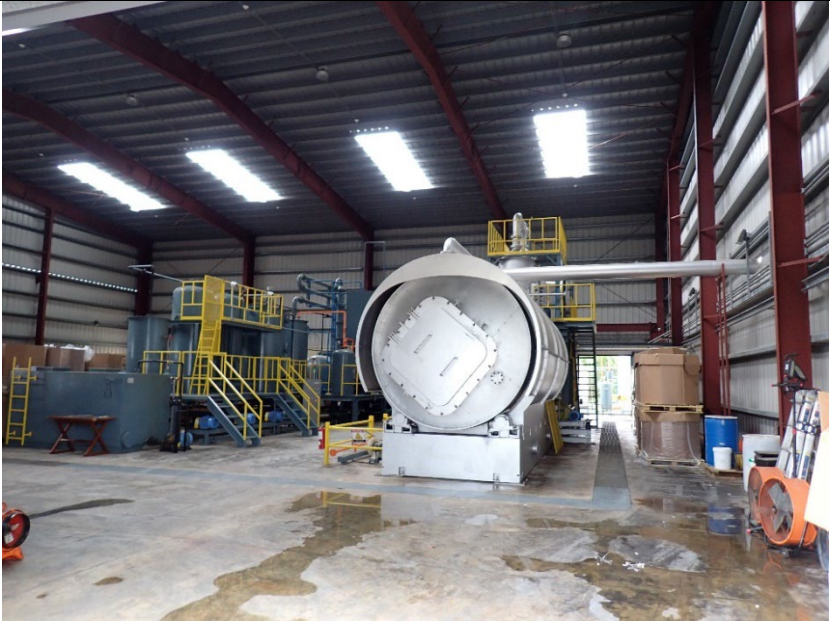
Partial view (facing west) of the Pyrolysis Unit.
