## Clean Water Act Section 404: Site Visit/Case Development

| Site Name | The Outpost Golf Course | | | | |

| Inspection Purpose | Initial site visit | | |

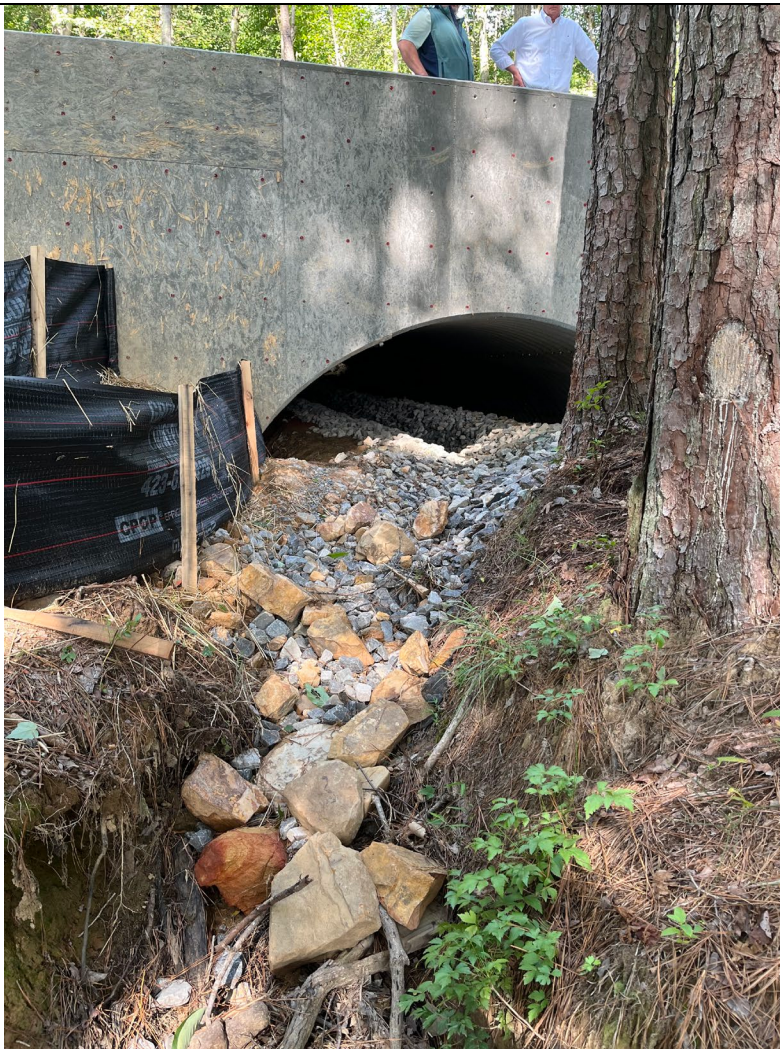
| <b>Photo ID:</b> | Photo 1 (taken by Chris Parker with an iPhone 13) |

| <b>Description:</b> | Bottomless culvert on entrance road. Culvert was installed incorrectly resulting in impacts to the tributary (facing upstream). |

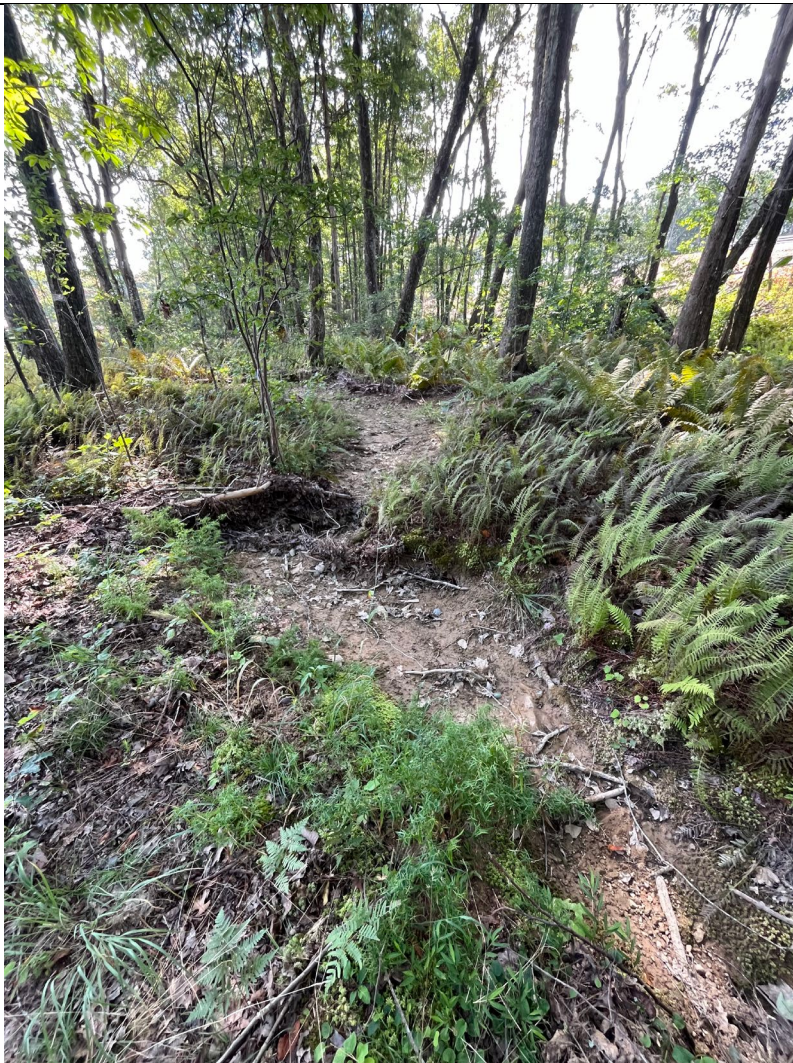
| <b>Photo ID:</b> | Photo 2 (taken by Chris Parker with an iPhone 13) |

| <b>Description:</b> | Downstream, view of tributary shown in photo 1. |

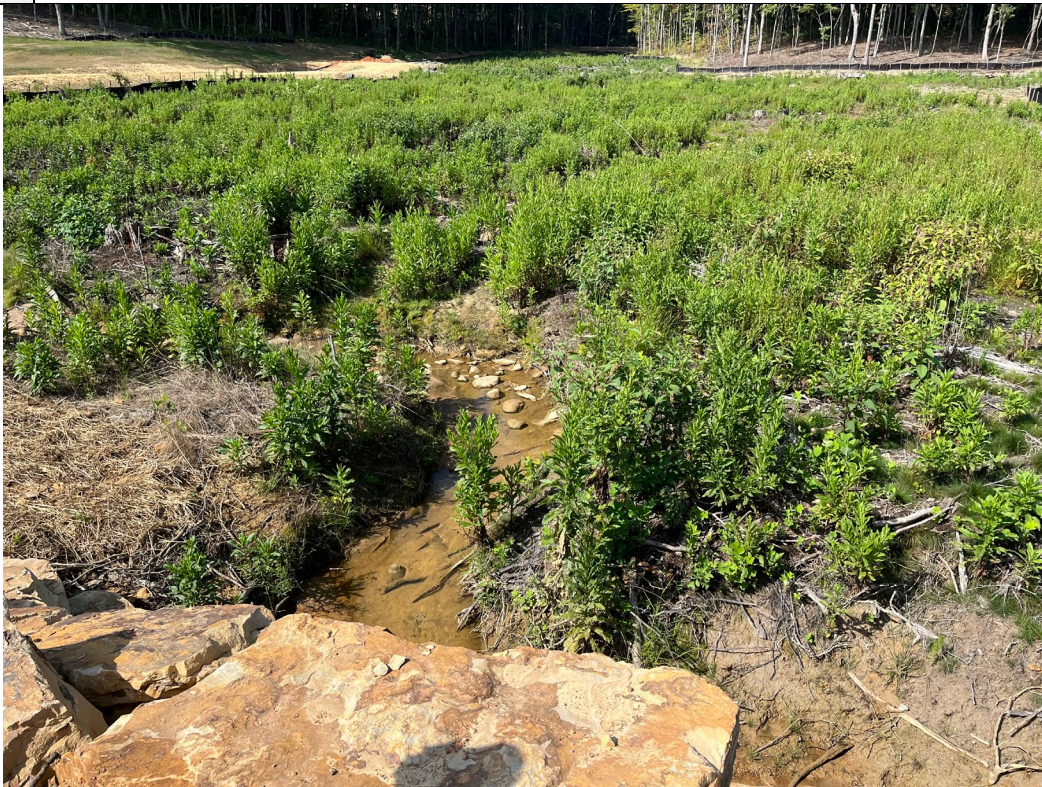
| <b>Photo ID:</b> | Photo 3 (taken by Chris Parker with an iPhone 13) |

| <b>Description:</b> | Tributary flowing from wetland on Site (facing upstream). |

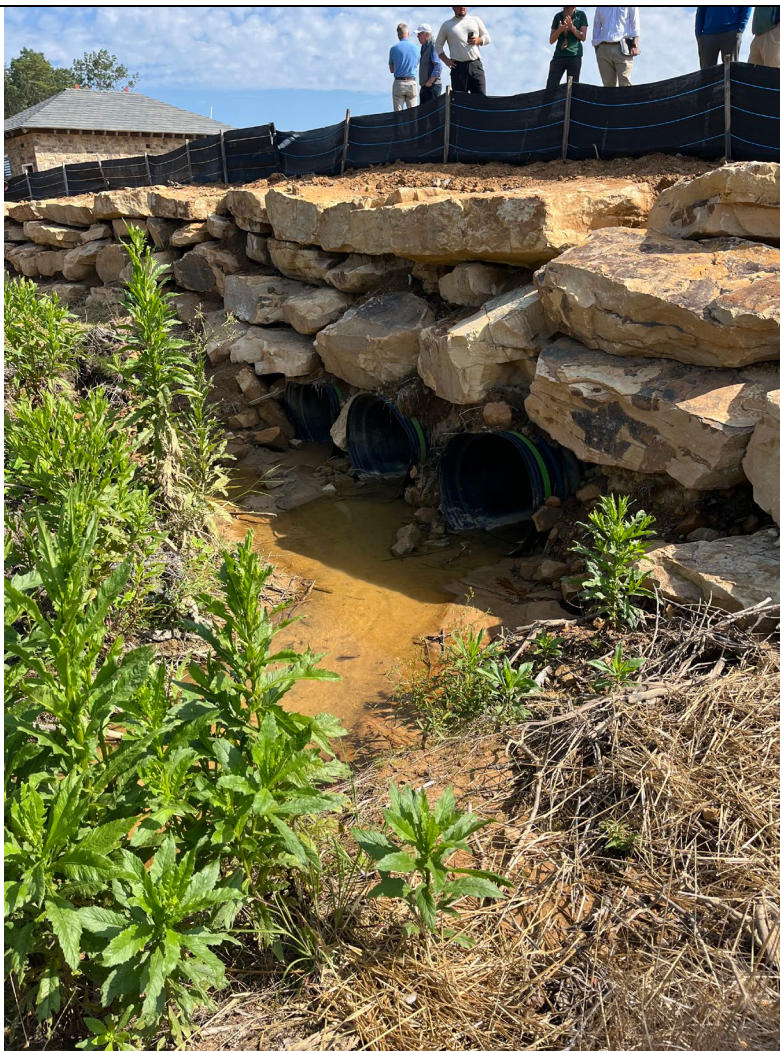
| <b>Photo ID:</b> | Photo 4 (taken by Chris Parker with an iPhone 13) |

| <b>Description:</b> | Same tributary shown in Photo 3, facing downstream. |

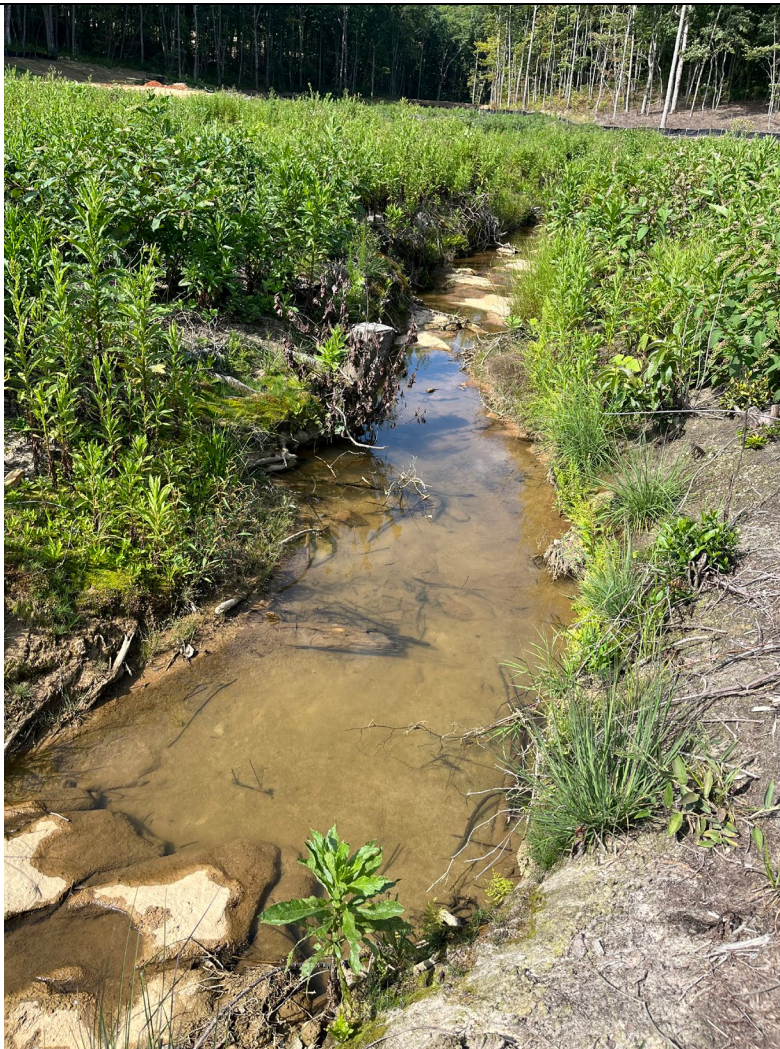
| <b>Photo ID:</b> | Photo 5 (taken by Chris Parker with an iPhone 13) |

| <b>Description:</b> | Same tributary as Photos 3 and 4, further upstream (facing upstream). |

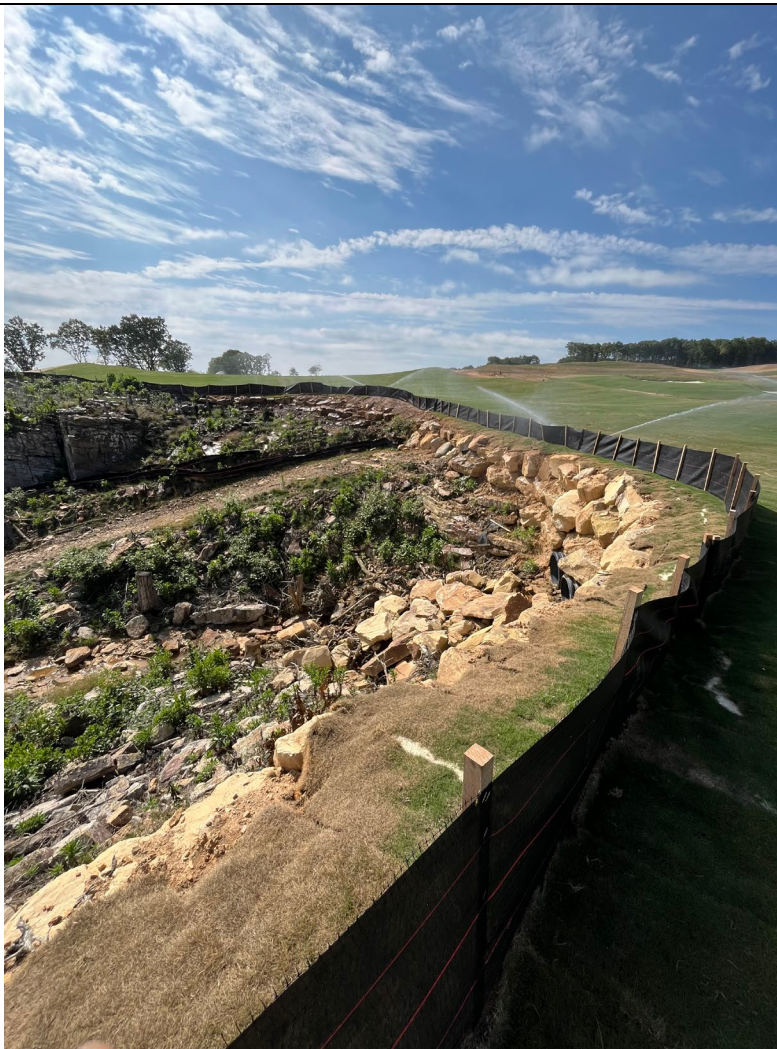
| <b>Photo ID:</b> | Photo 6 (taken by Chris Parker with an iPhone 13) |

| <b>Description:</b> | Outflow from tributary in Photos 3-5. |

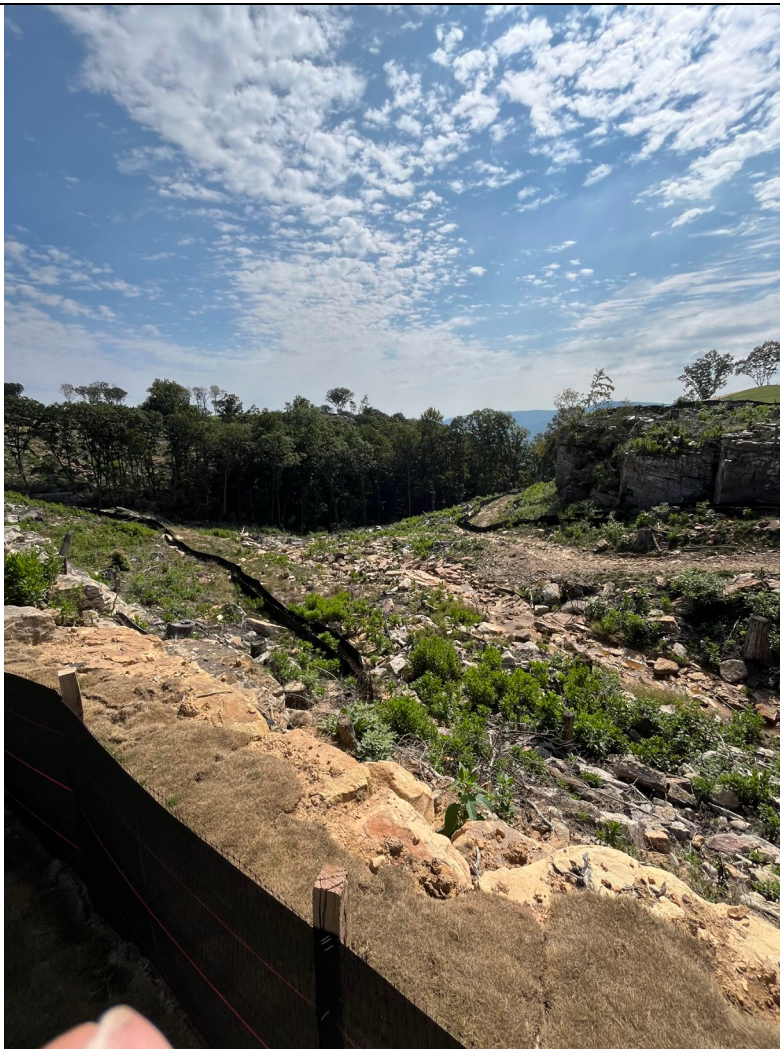
| <b>Photo ID:</b> | Photo 7 (taken by Chris Parker with an iPhone 13) |

| <b>Description:</b> | Tributary downstream of pipes in Photo 6. |

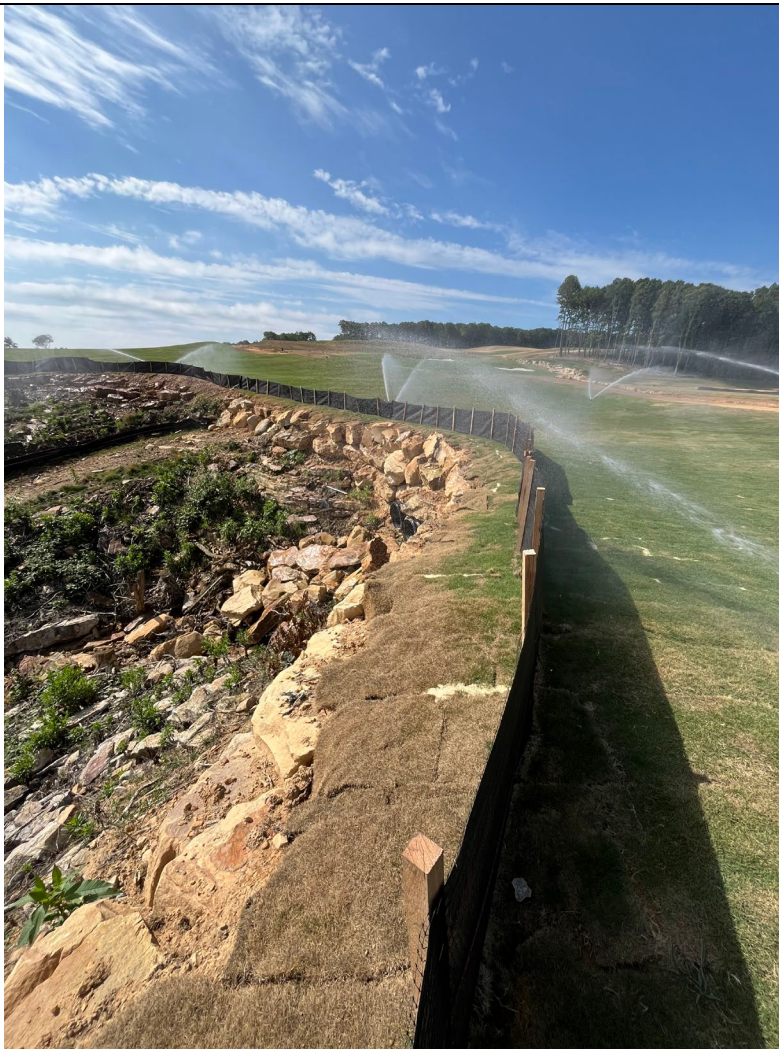
| <b>Photo ID:</b> | Photo 8 (taken by Chris Parker with an iPhone 13) |

| <b>Description:</b> | Same view as Photo 6. |

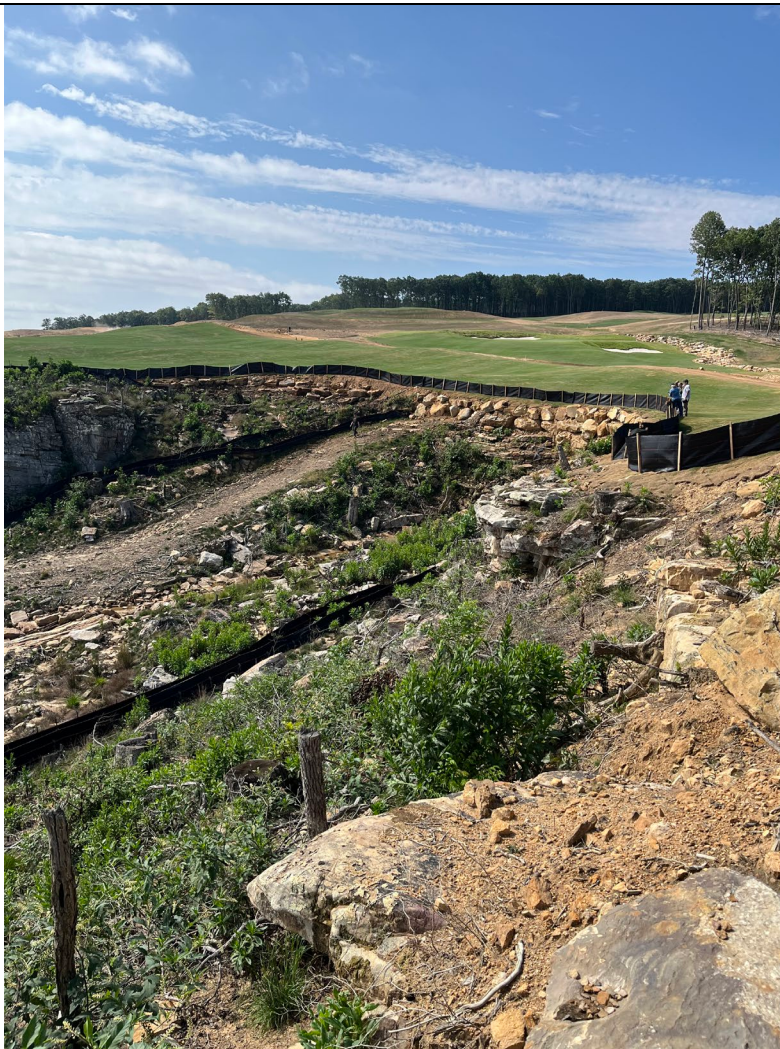
| <b>Photo ID:</b> | Photo 9 (taken by Chris Parker with an iPhone 13) |

| <b>Description:</b> | Another view of area in Photos 6 and 8. |

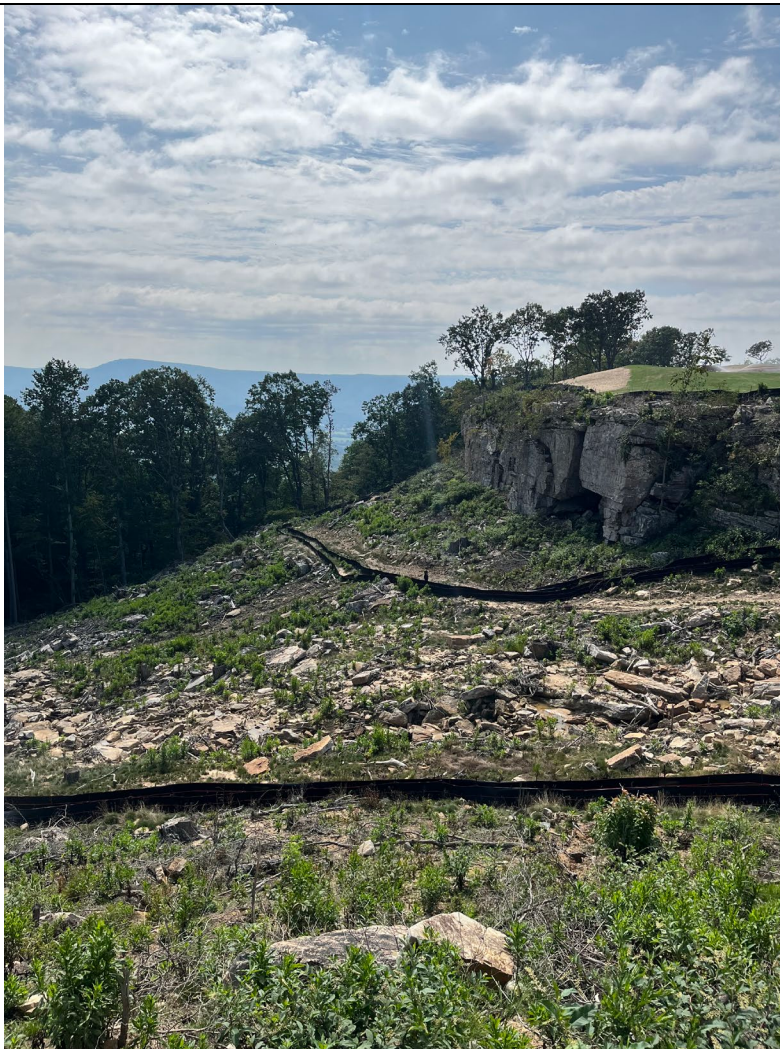
| <b>Photo ID:</b> | Photo 10 (taken by Chris Parker with an iPhone 13) |

| <b>Description:</b> | Native American rock shelter area. |

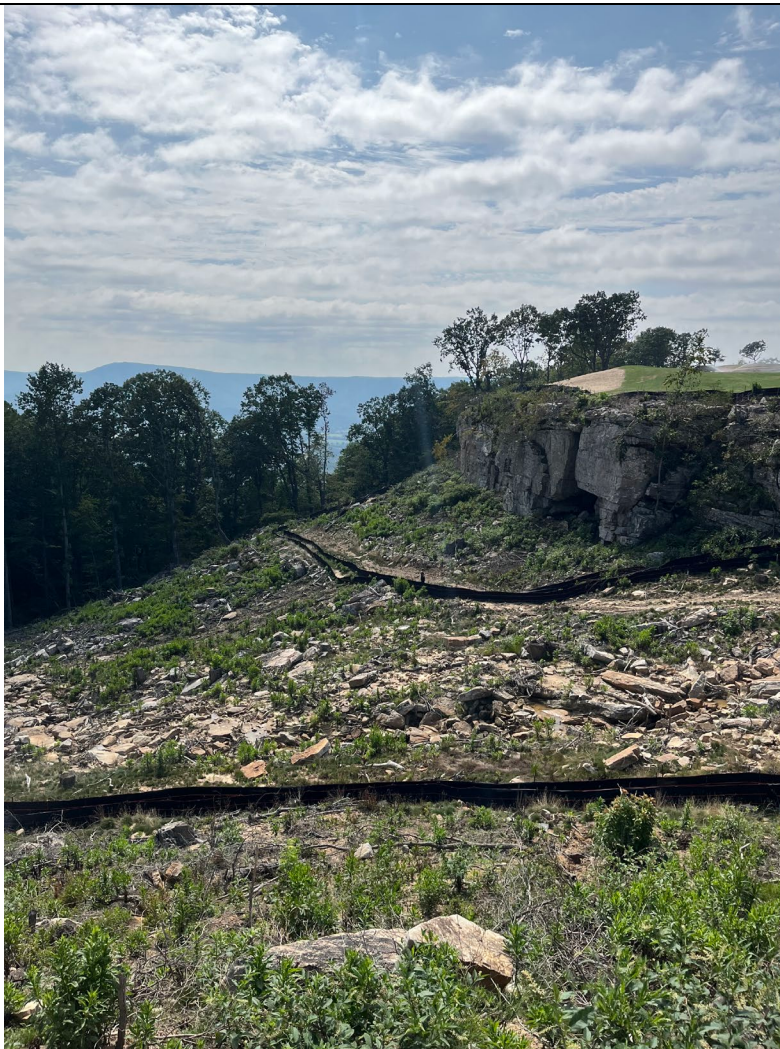
| <b>Photo ID:</b> | Photo 11 (taken by Chris Parker with an iPhone 13) |

| <b>Description:</b> | Rock shelter area, tributary is between silt fences. |

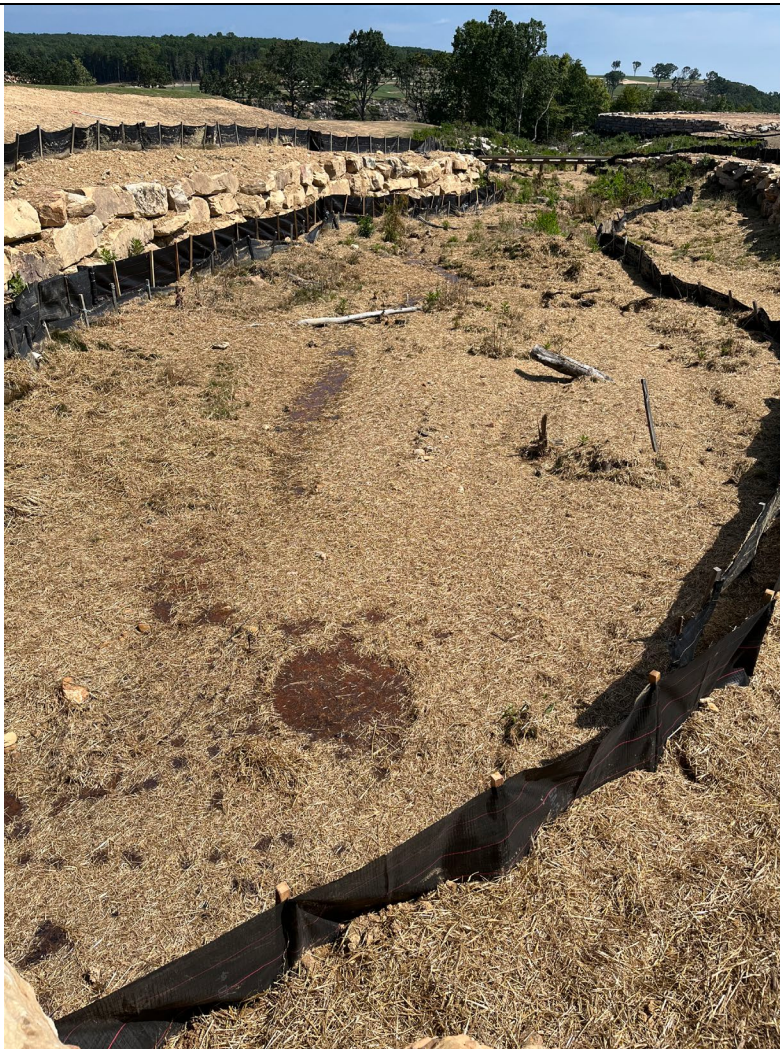
| <b>Photo ID:</b> | Photo 12 (taken by Chris Parker with an iPhone 13) |

| <b>Description:</b> | Third tributary in impact area, facing downstream. |

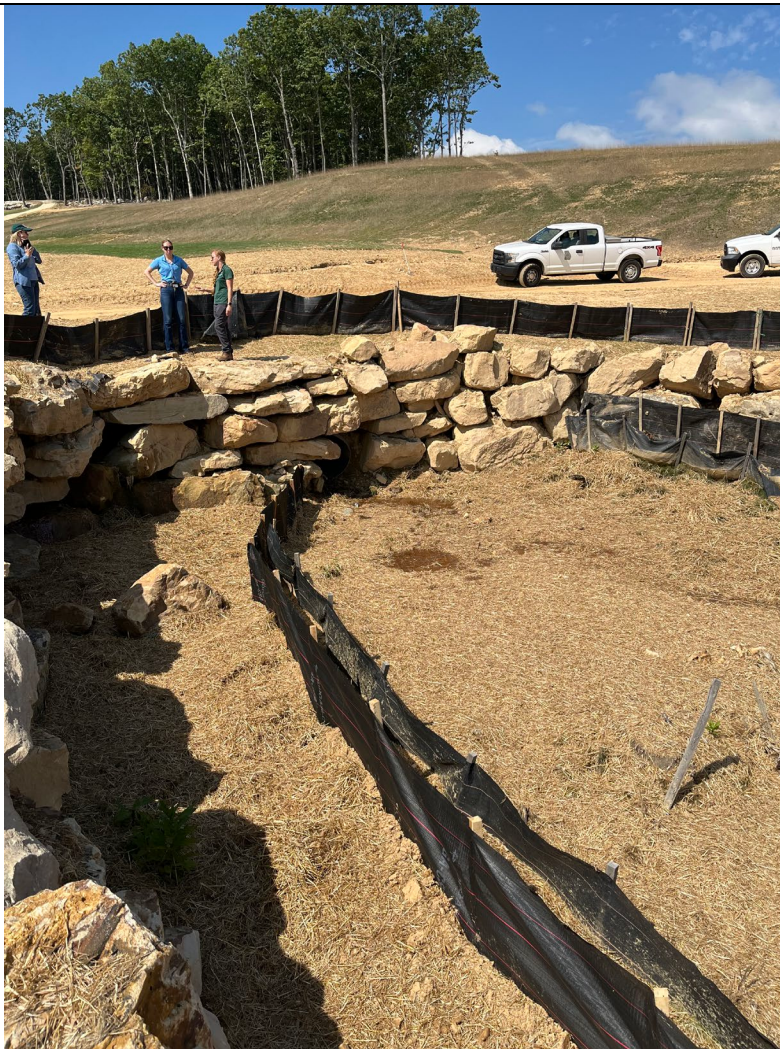
| <b>Photo ID:</b> | Photo 13 (taken by Chris Parker with an iPhone 13) |

| <b>Description:</b> | Tributary in Photo 12, facing upstream. |

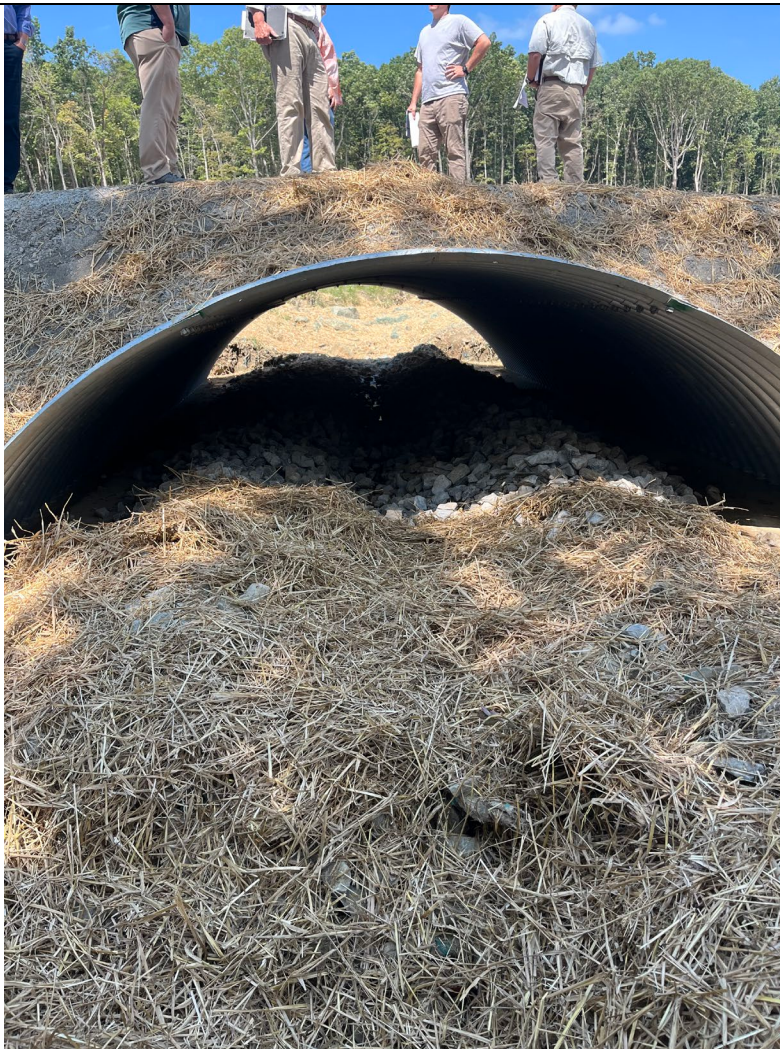
| <b>Photo ID:</b> | Photo 14 (taken by Chris Parker with an iPhone 13) |

| <b>Description:</b> | Tributary draining out of second wetland area (facing upstream). Incorrectly installed bottomless culvert. |

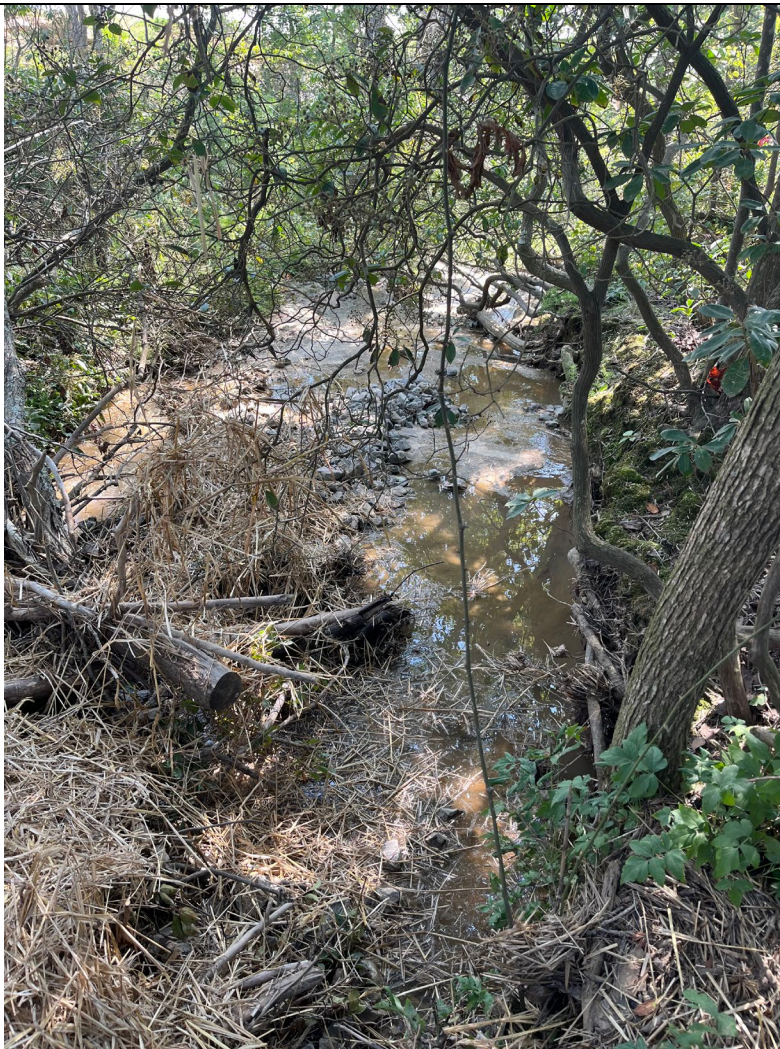
| <b>Photo ID:</b> | Photo 15 (taken by Chris Parker with an iPhone 13) |

| <b>Description:</b> | Tributary in Photo 14, facing downstream. |

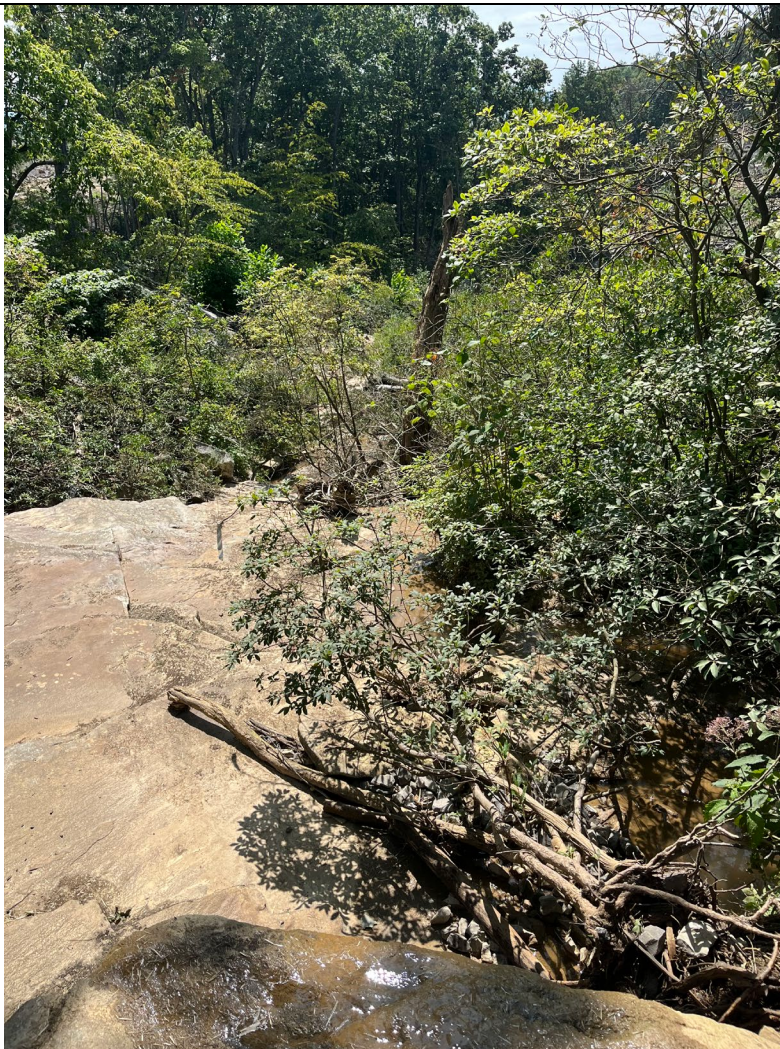
| <b>Photo ID:</b> | Photo 16 (taken by Chris Parker with an iPhone 13) |

| <b>Description:</b> | Same tributary as Photo 14, further downstream )facing downstream). |

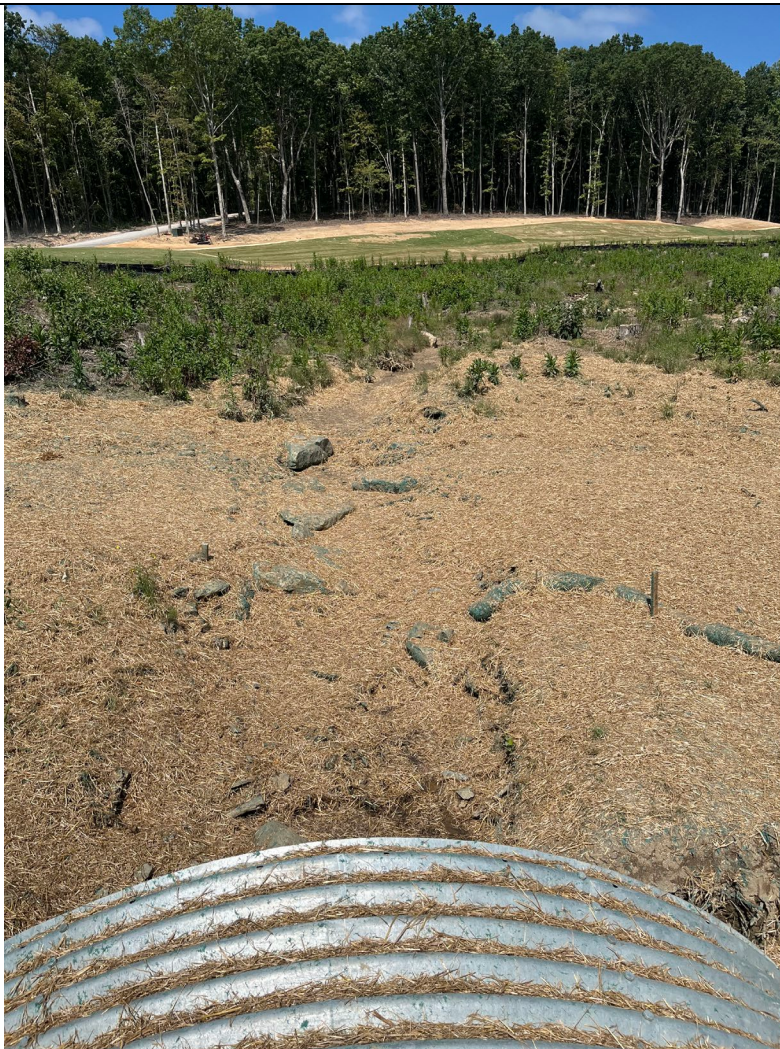
| <b>Photo ID:</b> | Photo 17 (taken by Chris Parker with an iPhone 13) |

| <b>Description:</b> | Tributary flowing from third wetland area, facing upstream. A portion of the wetland has been cleared. |

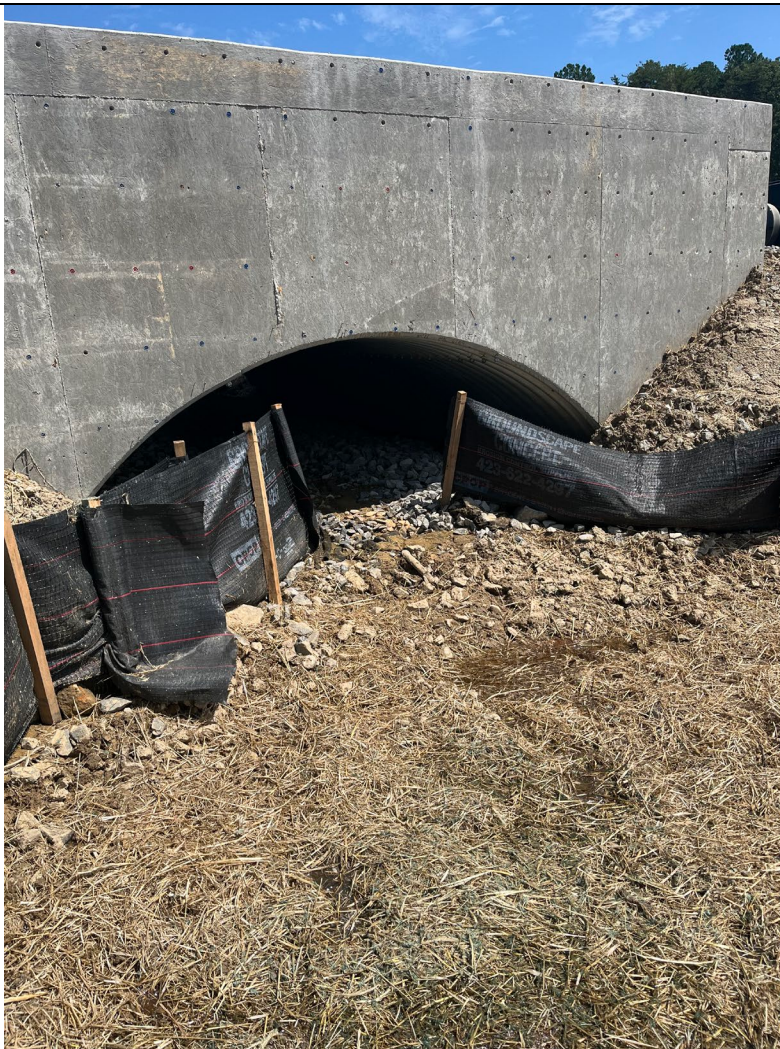
| <b>Photo ID:</b> | Photo 18 (taken by Chris Parker with an iPhone 13) |

| <b>Description:</b> | Outflow of stream shown in Photo 17, facing upstream. |

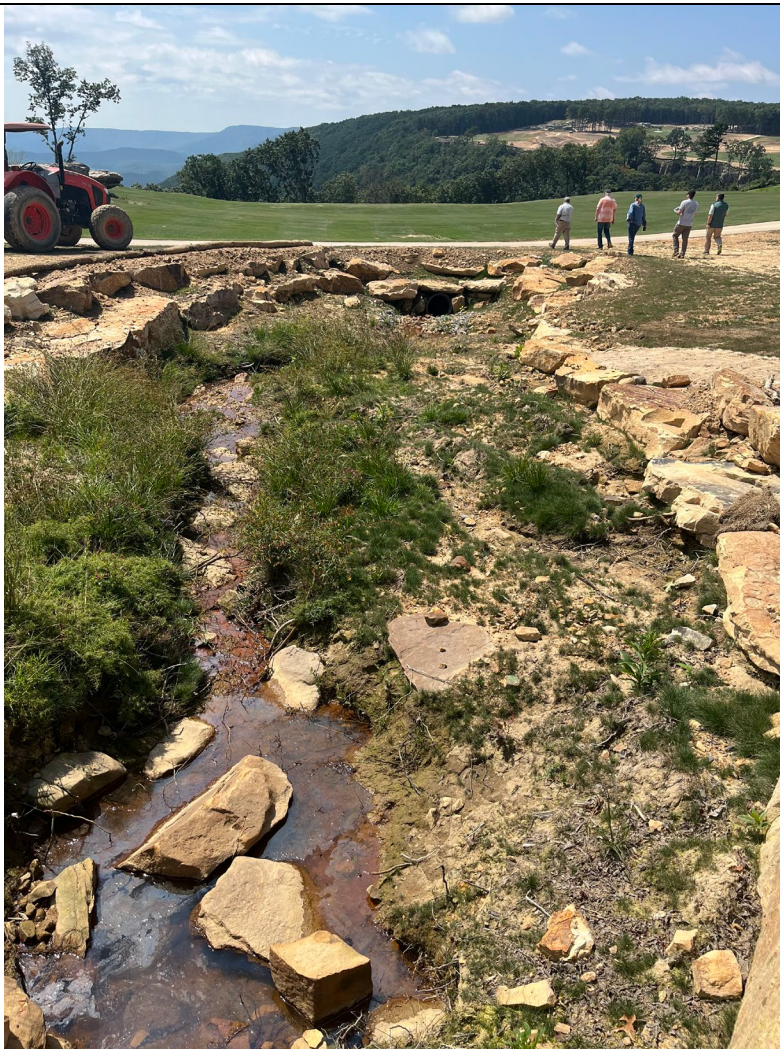
| <b>Photo ID:</b> | Photo 19 (taken by Chris Parker with an iPhone 13) |

| <b>Description:</b> | Open area of sixth tributary (facing downstream). Grassed area has been piped. |

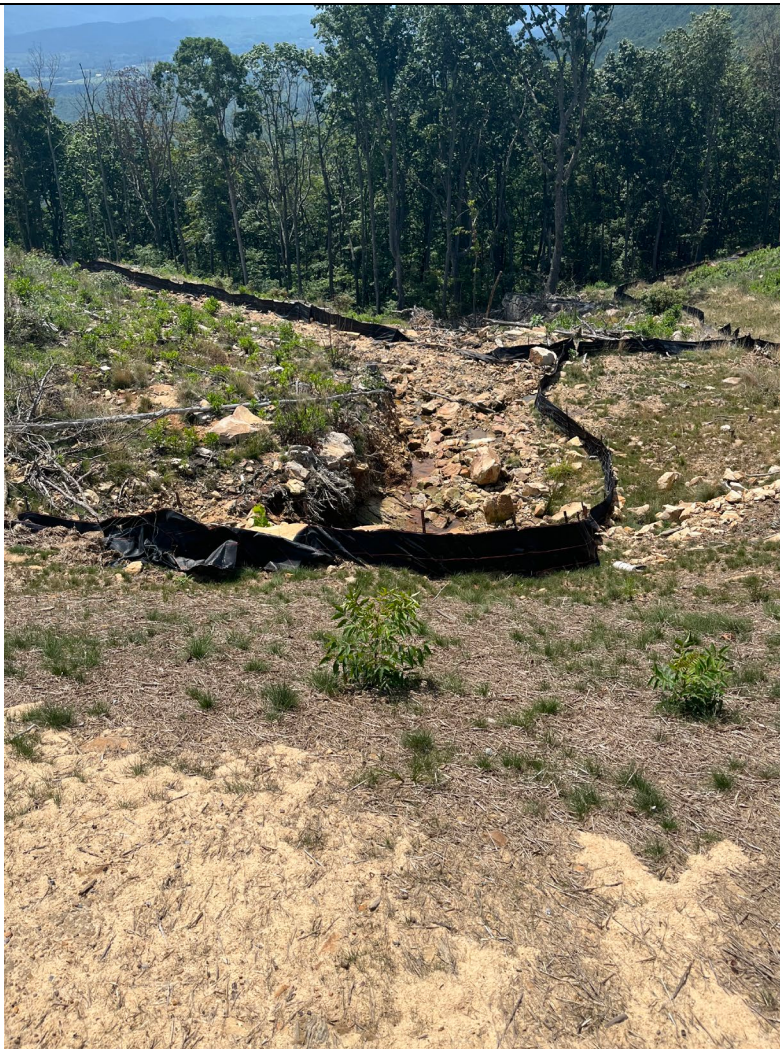
| <b>Photo ID:</b> | Photo 20 (taken by Chris Parker with an iPhone 13) |

| <b>Description:</b> | Tributary in Photo 19 downstream of the grassed area (facing downstream). |
