## Region 6 - Enforcement & Compliance Assurance Division

### INSPECTION REPORT

| Regulatory Program(s) | Safe Drinking Water Act (SDWA) – Lead and Copper Rule (LCR) | |
| System Name: | <b>Sandia Resort and Casino Public Water System</b> | |

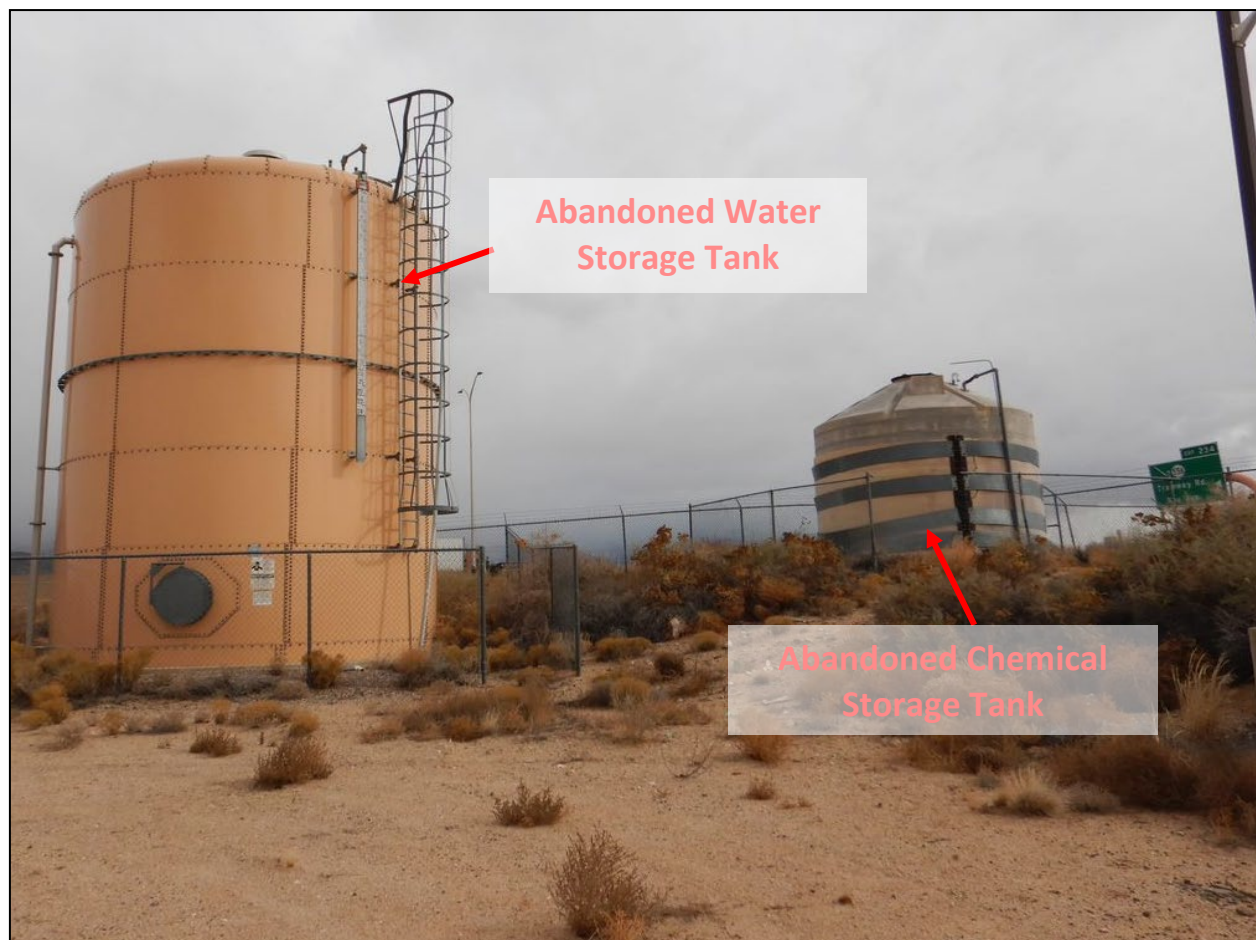
**Photograph 1. Abandoned Water Storage and Chemical Storage Tanks** View of the abandoned water storage tank and chemical storage tank which were used to support the old casino that was located on the western side Interstate 25 from the new casino, and adjacent to the site of the old police station. The EPA Inspection Team could not locate the abandoned well associated with assets, but they received a well plugging record that documented removing the asset connections to the distribution system.

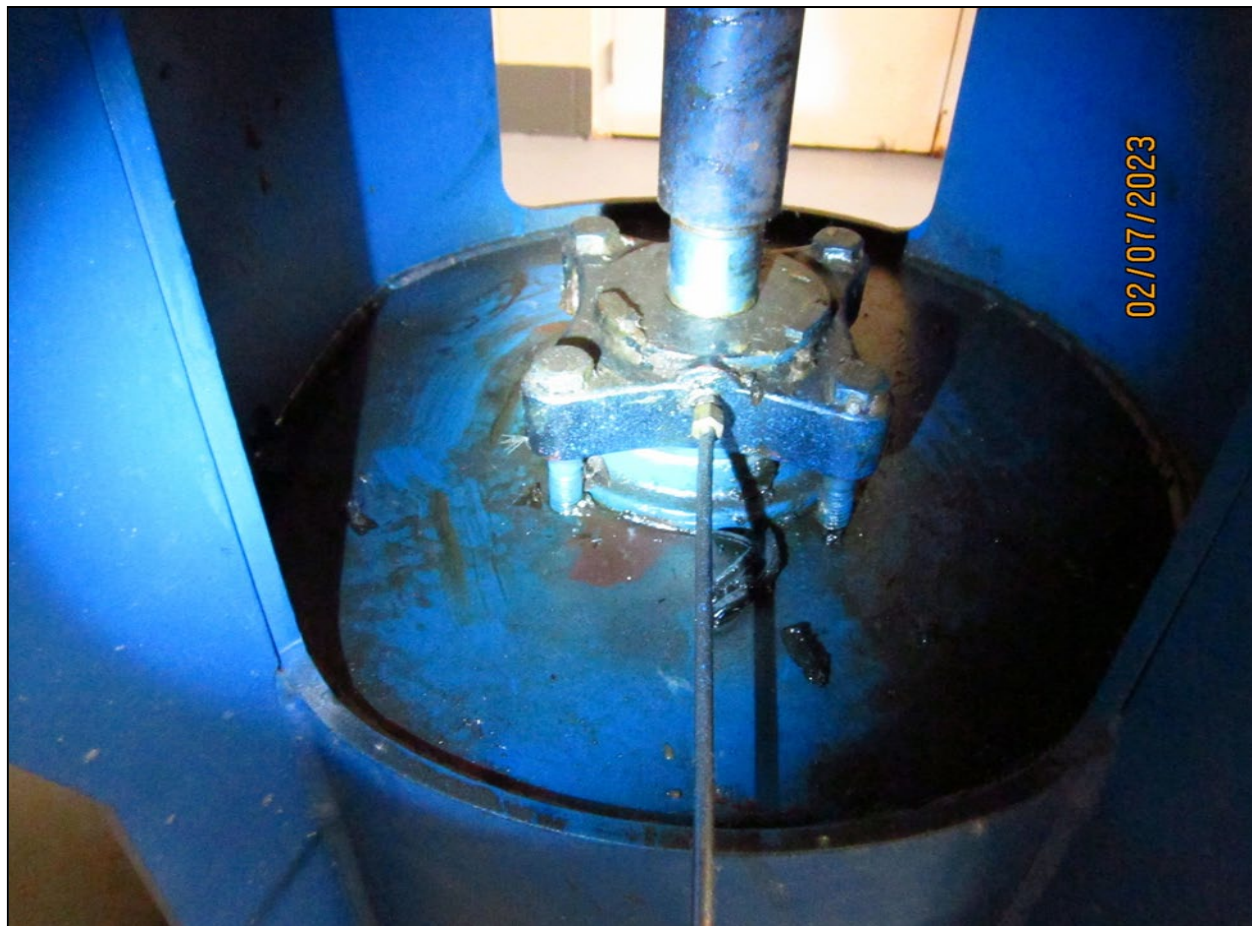
**Photograph 2. Well No. 1 (W0001) Pump** View of the food-grade lube line connection to the pump in the W0001 building. Some excess lube was observed.

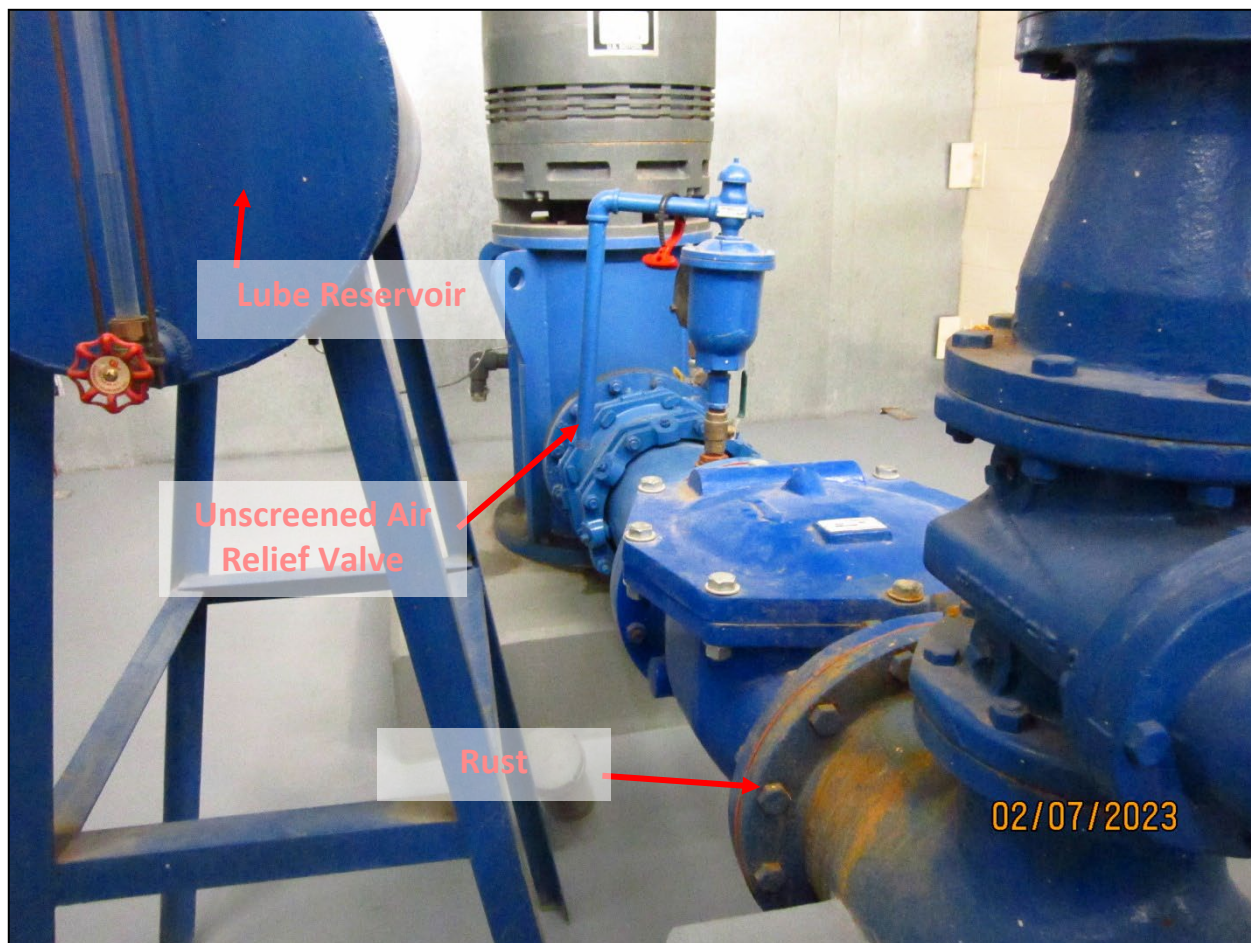
**Photograph 3. Air Relief Valve, W0001 Line** View of an unscreened air relief valve on the W0001 pump line. Also visible in this image is rust (immediately under the PRV) at the point where the W0001 line connects to the pump-to-waste line.

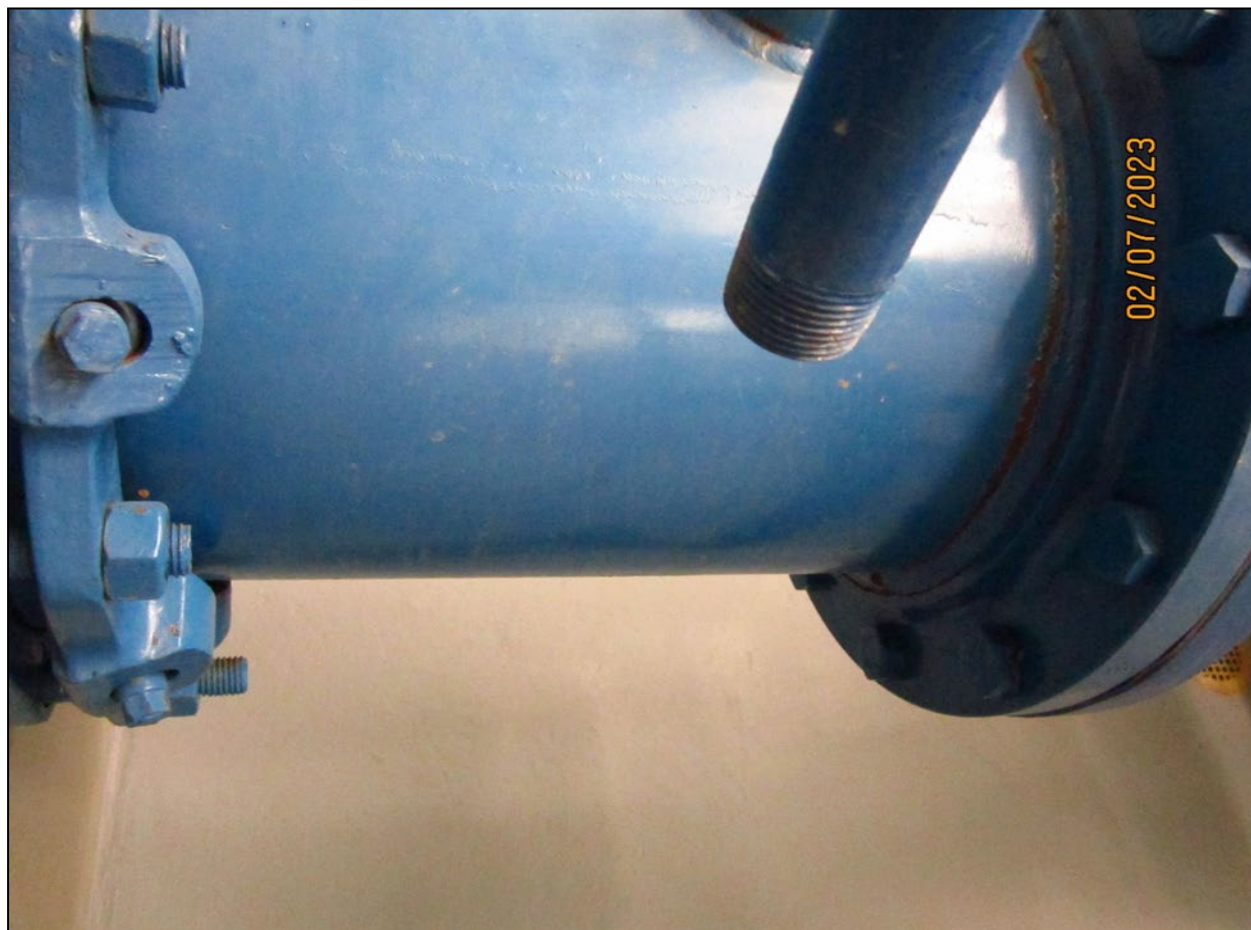
**Photograph 4. Air Relief Valve, W0001 Line** Close up view of an unscreened air relief valve discharge on the W0001 pump line.

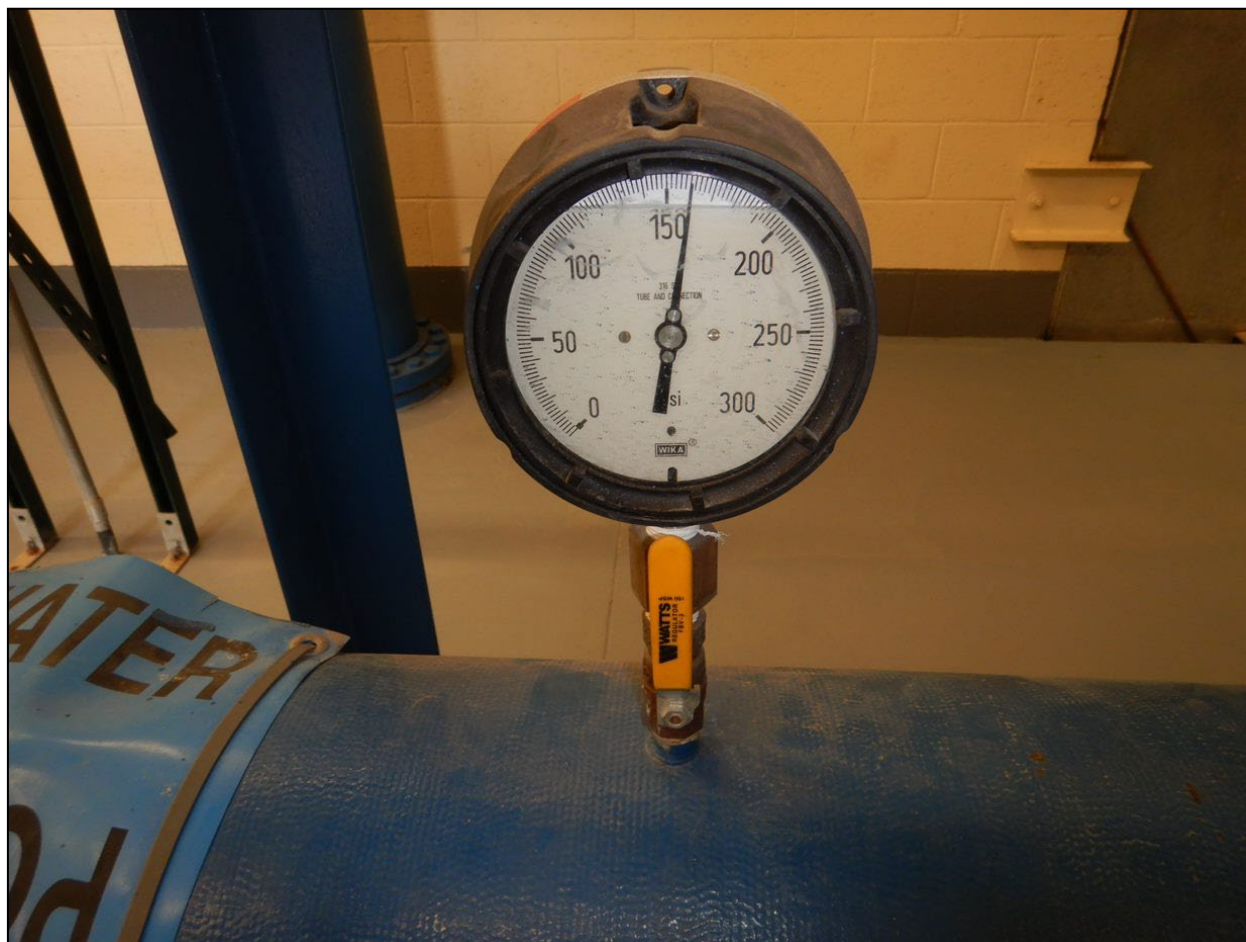
Casino Well No. 1 has an intake that is 480-1160 feet deep, and the soft start pump in the well building has a 1100 GPM capacity. The pump is lubricated using food-grade machinery mineral oil (Clarion A/W 32 Machinery Oil), and the EPA Inspection Team observed the lube line connection to the mechanical seal of the pump (refer to [Appendix 1, Photograph 2](#)). An air relief valve drain line along the pump line was not screened (refer to [Appendix 1, Photographs 3 and 4](#)). When operators became aware of this, a screen was placed on the valve drain line. The pump was not on at the time of the inspection, and the pressure gauges in the line downstream of the check valve read approximately 160 psi (refer to [Appendix 1, Photograph 5](#)).

**Photograph 5. Pressure Gauge, W0001 Line** View of a pressure gauge on the W0001 line that read approximately 160 psi on February 7, 2023, the first day of the inspection.

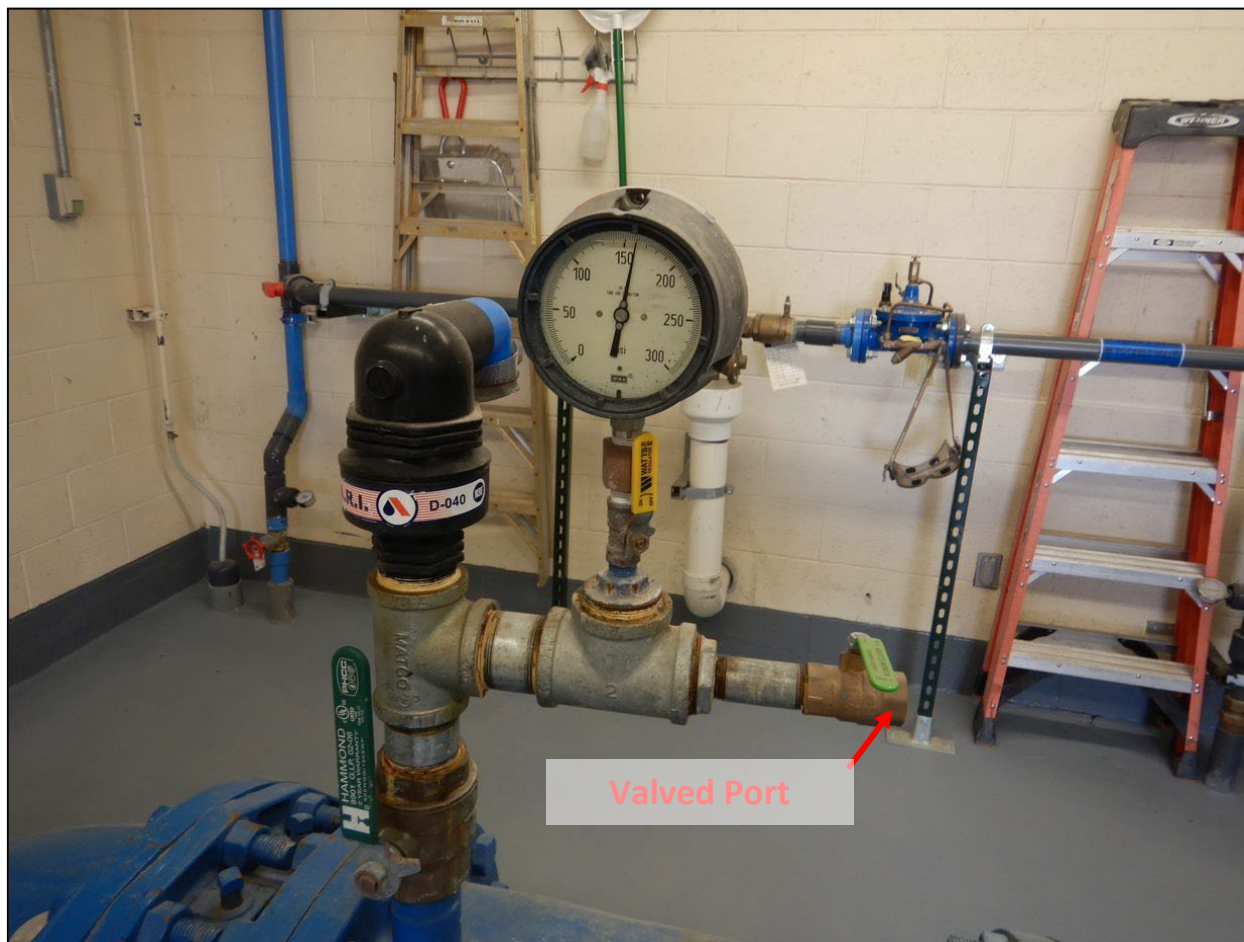
**Photograph 6. Operational Valve on Air Relief Valve/Pressure Gauge Port, W0001 Line** View of an air relief valve with an additional operational port with valve. The operational valve contained a pressure gauge and an open port that was unscreened and did not contain backflow prevention.

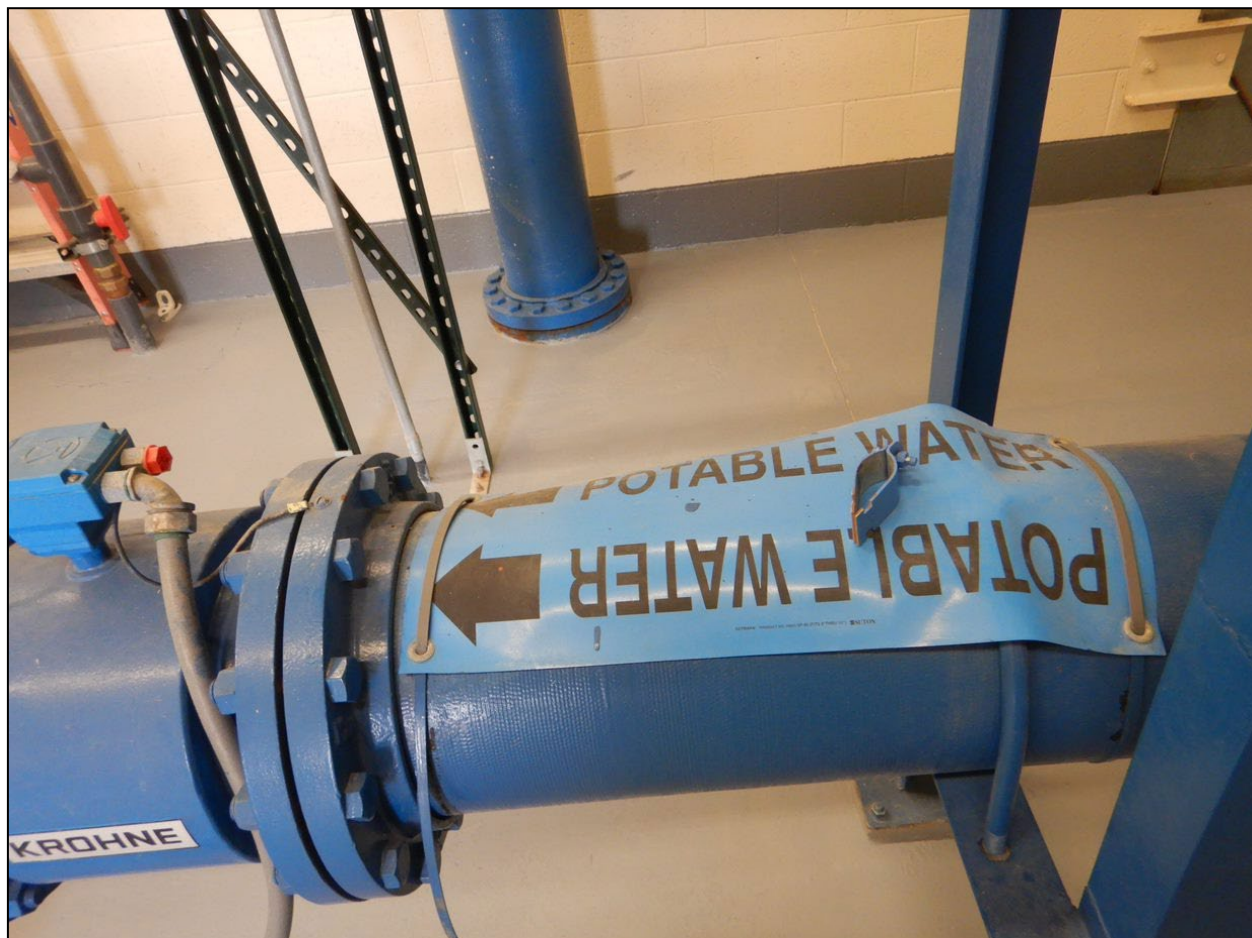
**Photograph 7. Incorrect Sign W0001 Line** View of a sign that read “potable water” on the W0001 pump line. This line actually conveys raw well water from Casino Well No. 1 to the connection with the raw water from Casino Well No. 2 and then to the water treatment system. The sign was removed after the operator was asked to confirm the raw water flow route.

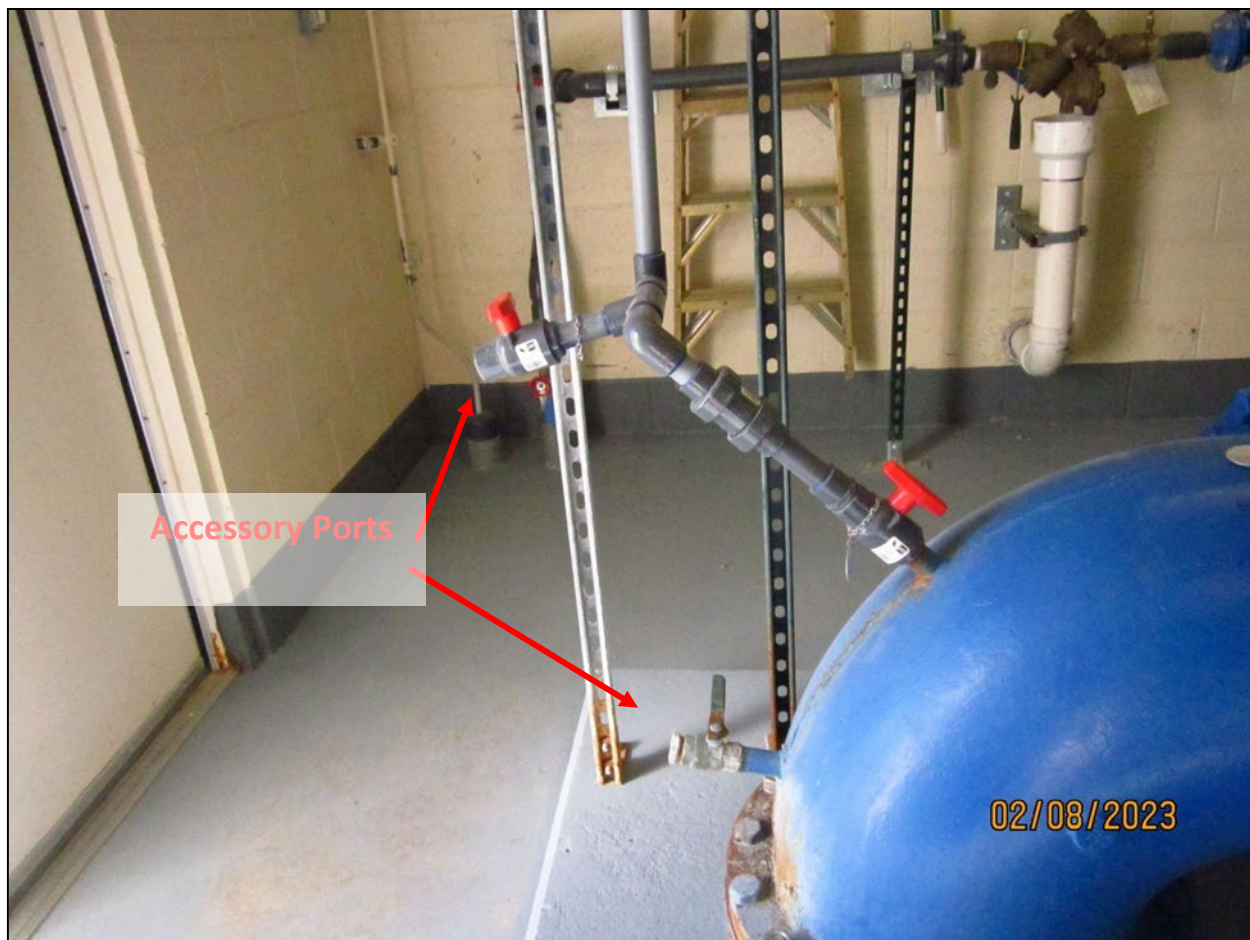
**Photograph 8. Chlorine Injection Point W0001 Line** View of the pre-chlorine injection point into the W0001 line, just after W0002 line connection and before the line goes underground to the water treatment system. There were two accessory ports at this point that did not contain screening or backflow prevention. This injection point was located before the raw water bypass. In the system's process flow diagram (refer to [Appendix 2, Exhibit 1](#)) the pre-chlorine injection point is identified to be after the raw water bypass.

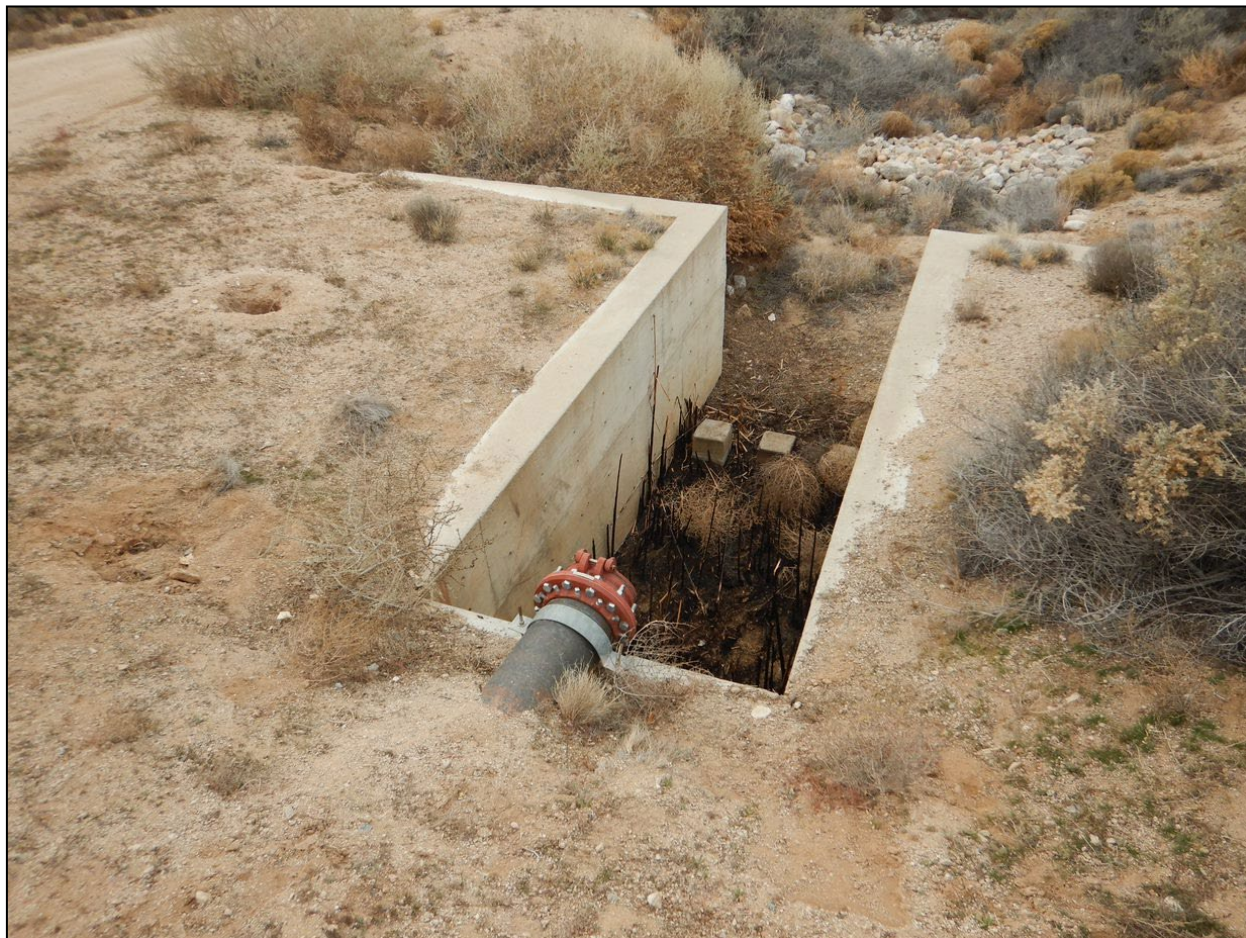
- A pump-to-waste line was discharging water from the W0001 line during the inspection (refer to [Appendix 1, Photographs 9 and 10](#)). Approximately an inch of water was present in the pipe, and it was continuously flowing into the discharge basin. When the flapper was closed, water was still dripping from the pipe (refer to [Appendix 1, Photograph 11](#)). The ground in the basin was wet, and vegetation had grown in the basin. It appeared that the cattails had been recently burned. Upon further investigation, operators learned that the PRV on the pump-to-waste line was not functioning properly. They indicated that the

**Photograph 9. W0001 Pump-to-Waste Discharge Pipe** View of the pump-to-waste discharge pipe and outfall area west of the W0001 building. There appeared to be cattails growing in the discharge basin, and the ground was wet. It appeared that the cattails had been recently burned. Water was dripping from the pipe, even with the flapper valve in the closed position.

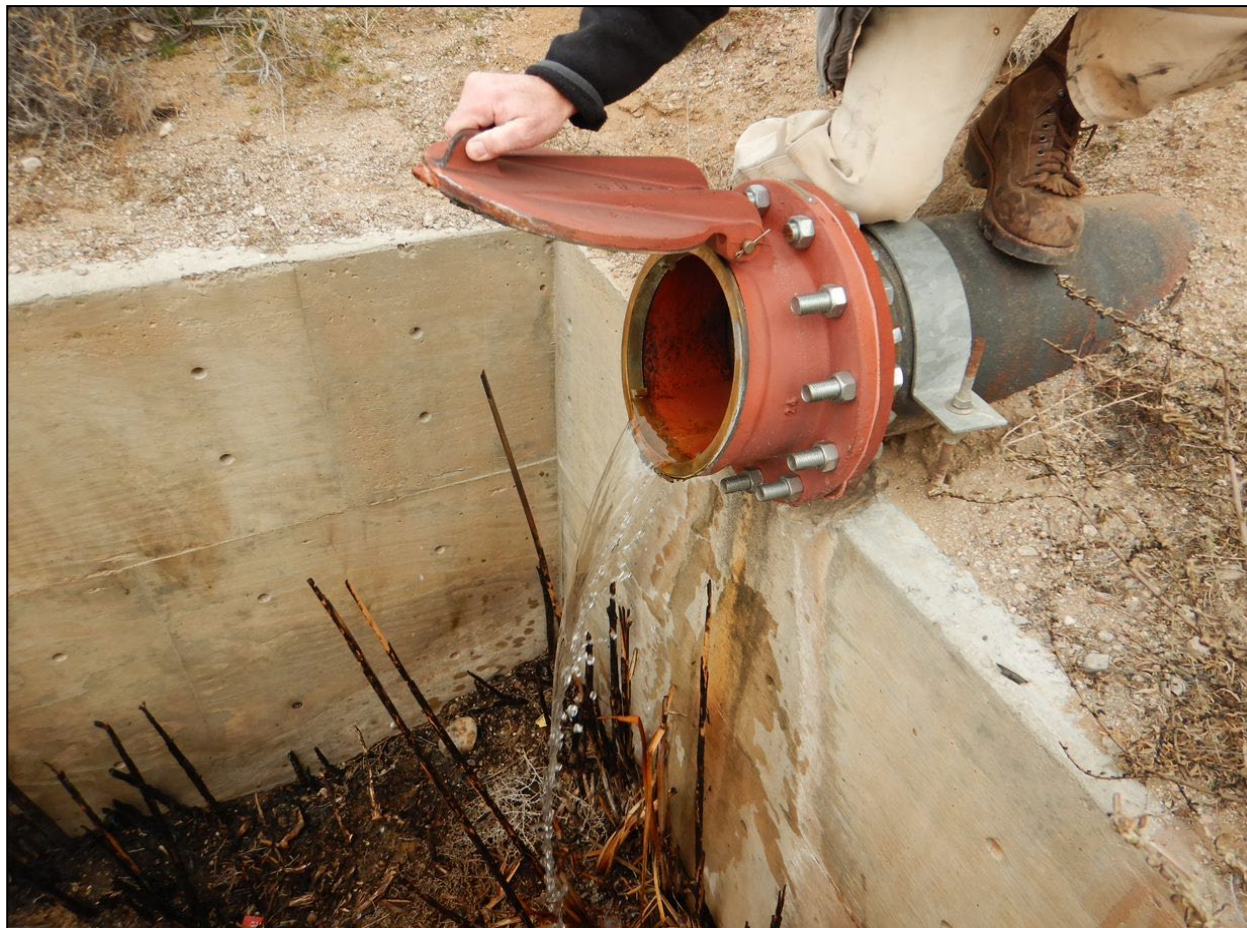
During the inspection, approximately an inch of water was present in the pump-to-waste line extending outside of the well building, and when the flapper was opened, water was continuously flowing into the concrete basin (refer to [Appendix 1, Photograph 10](#)). When the flapper was closed, water was still leaking, and a small amount of rust/peeling paint was attached in the area where the water was dripping from (refer to [Appendix 1, Photograph 11](#)). Vegetation (that appeared to be cattails) had also grown in the basin, and the ground in the basin was wet. It appeared that the vegetation had recently been burned. Operators were unaware that water was flowing through the line, and upon further inspection discovered that the PRV was not operating properly. In response to the finding, the operations team isolated the line and said that they were beginning the process of having contractors come onsite to inspect the PRV. On the second day of the inspection, the EPA Inspection Team revisited the pump-to-waste line and found that it was no longer leaking.

**Photograph 10. W0001 Pump-to-Waste Discharge Pipe** View of the open flapper on the discharge port west of the W0001 building. Water was continuously flowing out of the pipe when the flapper was open. There was approximately one inch of water in the pipe, and we observed a flow of approximately 3-4 gallons per minute.

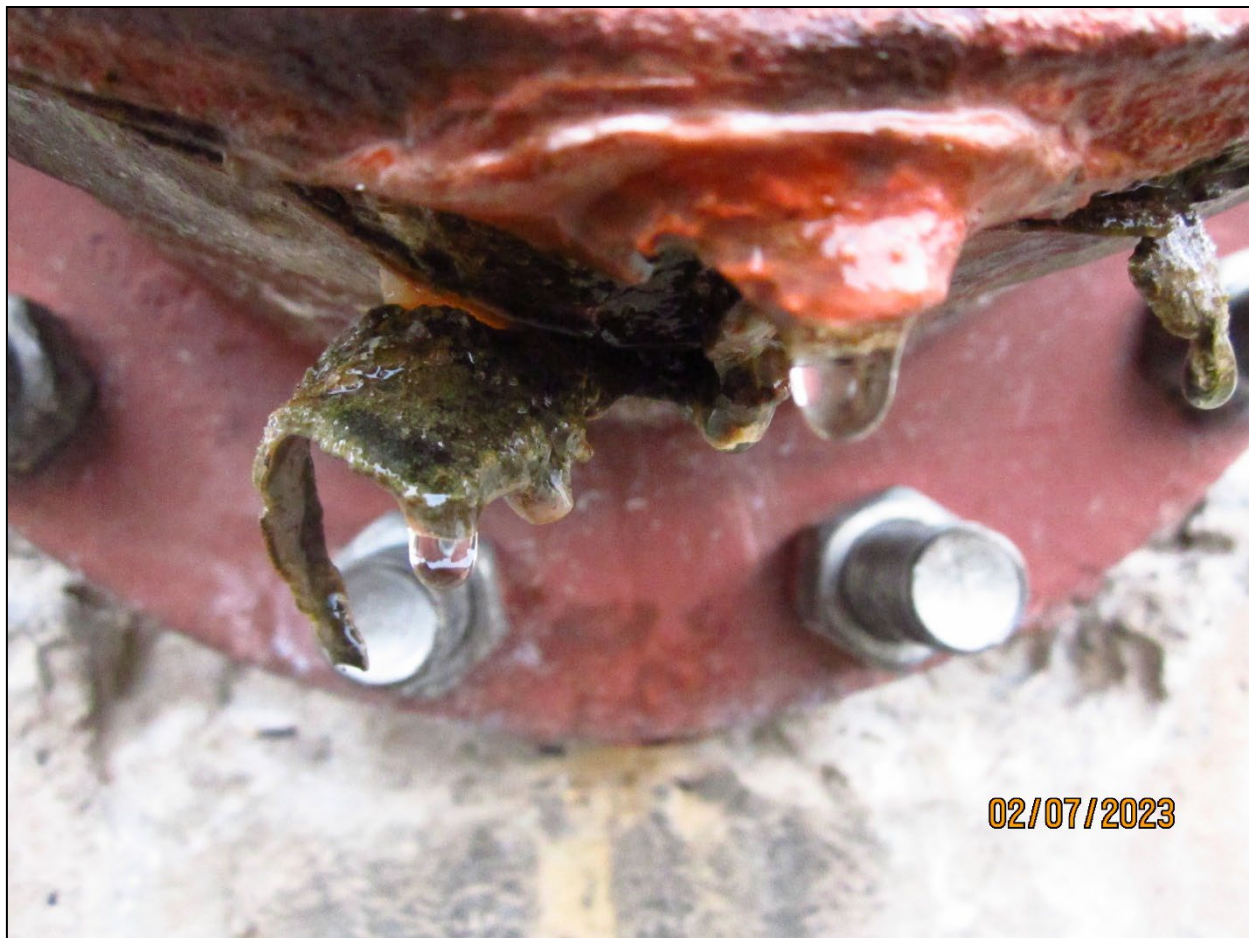
**Photograph 11. W0001 Pump-to-Waste Discharge Pipe** Close up view of the underside of the W0001 pump-to-waste discharge pipe. Water was dripping out of the pipe even when the flapper was closed. There appeared to be bio growth/debris attached to the bottom of the pipe.

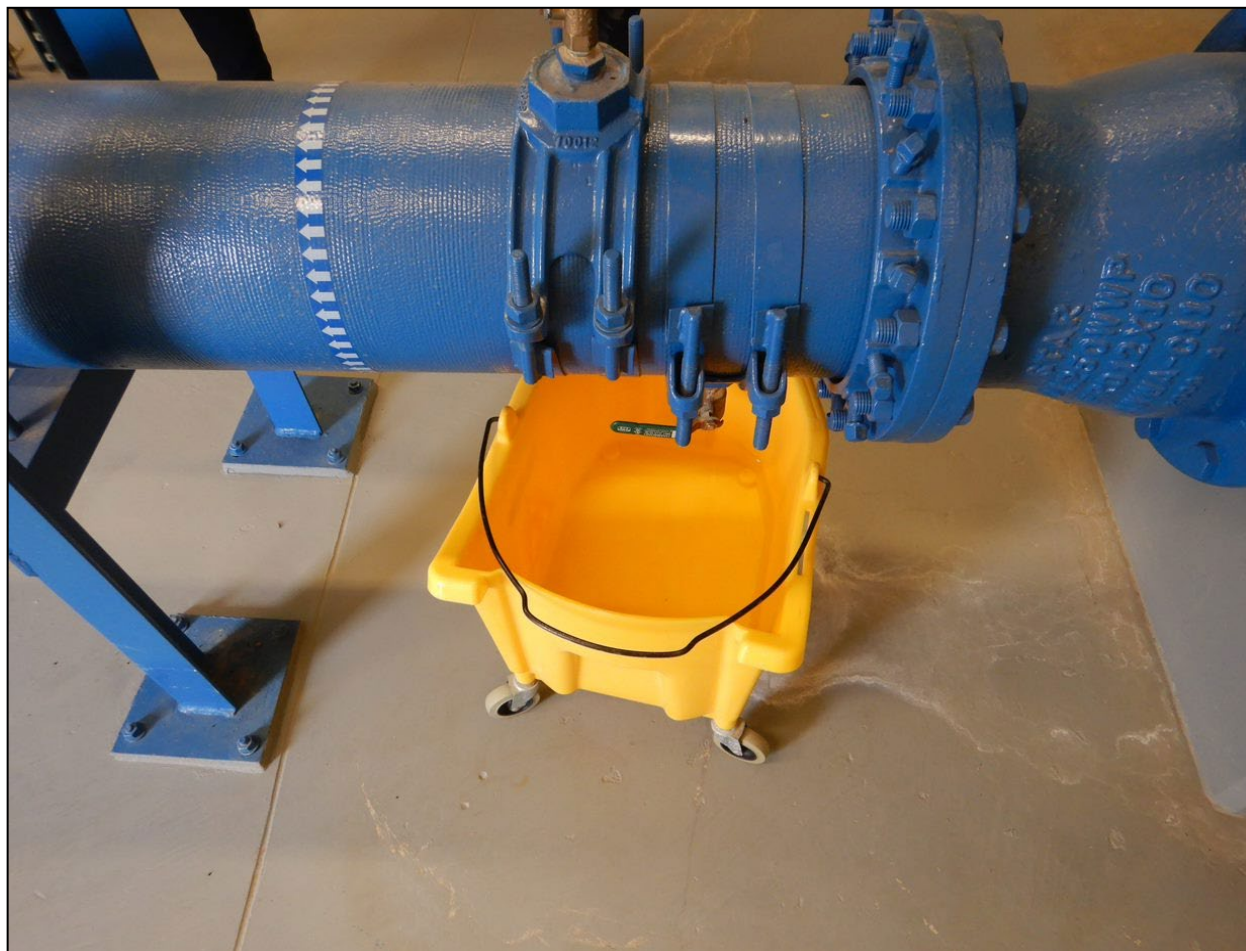
- Observation 6.** A raw water sample tap on the Casino Well No. 2 (W0002) pump line was leaking into a bucket (refer to Appendix 1, Photograph 23). Operators indicated that they had the parts on hand necessary to repair the leak, but that they were waiting until the conclusion of the inspection to make the repair.

**Photograph 23. W0002 Pump Line Sample Tap** View of the W0002 pump line and raw water sample tap that was leaking into a bucket during the inspection. Operators indicated that they had the parts on hand to make the repair.

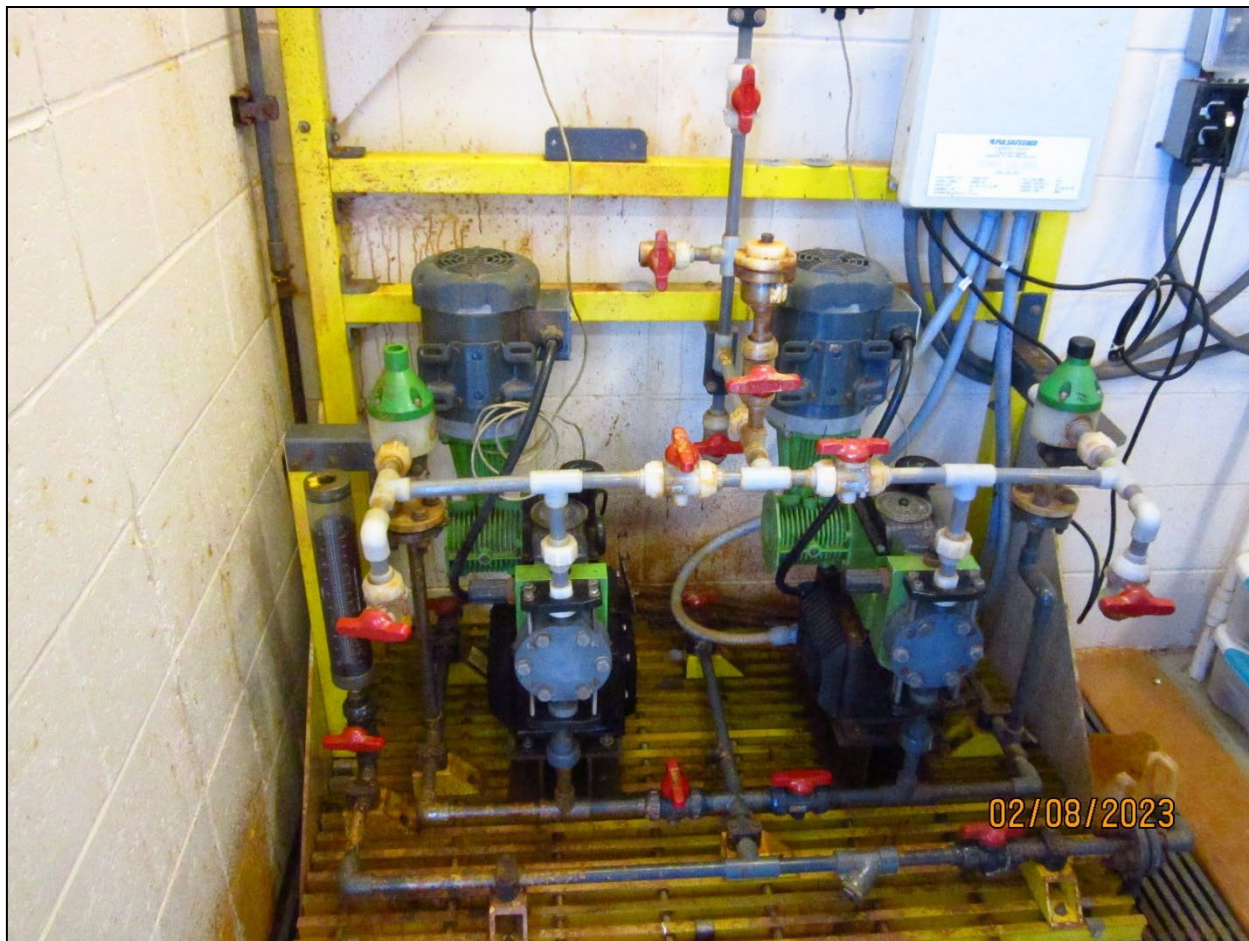
- Observation 7.** The two ferric chloride pumps and the skid they were on in the ferric chloride storage/pump room were stained brown, and there appeared to have been ferric chloride releases in the past (refer to Appendix 1, Photograph 30). The floor and walls around the pumps were also stained.

**Photograph 30. Ferric Chloride Pumps/Pump Skid** View of the two ferric chloride pumps in the ferric chloride room. The pumps were positioned on a skid over secondary containment. There was brown staining on the walls, pumps, and skid, indicating past spills or leaks.

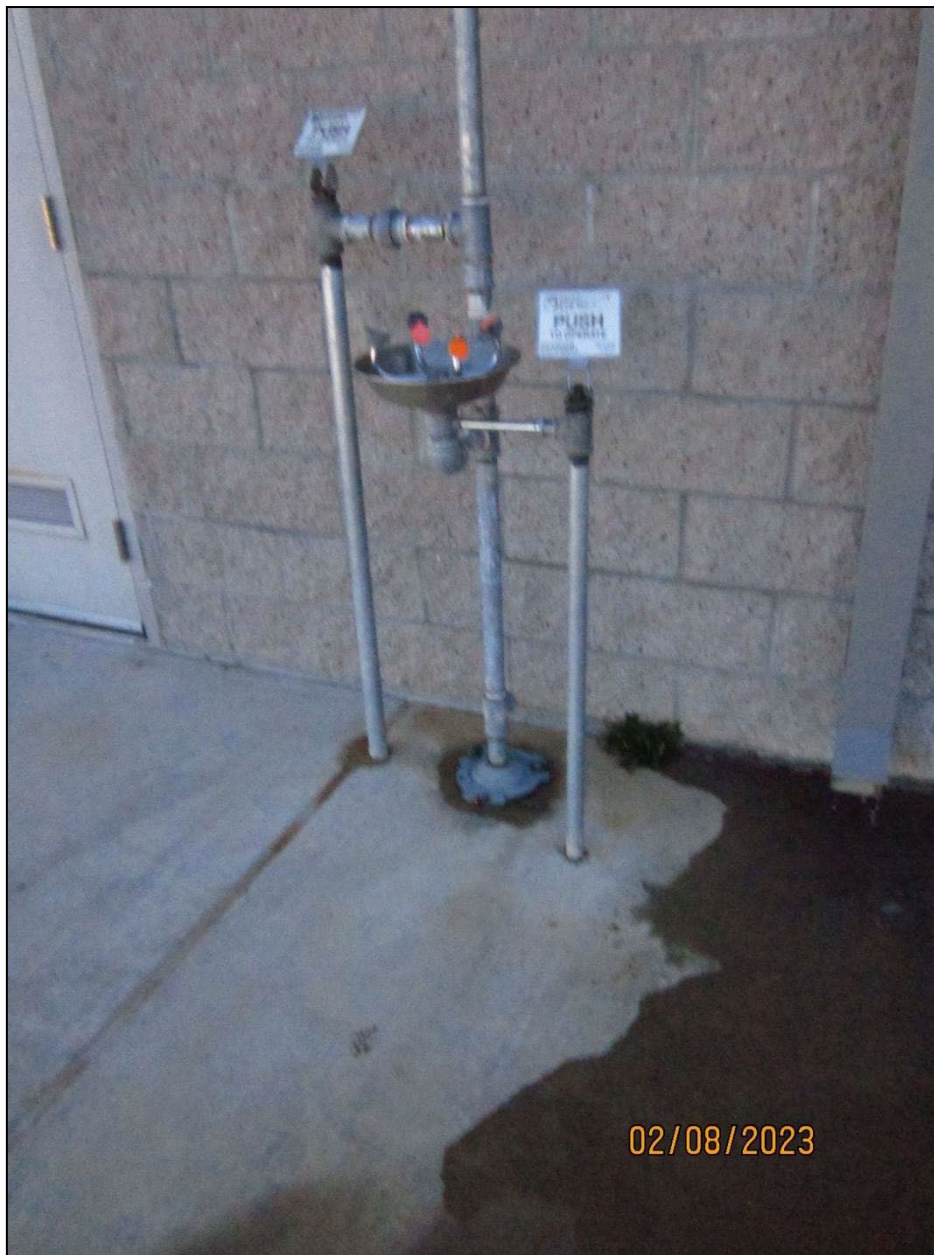
**Photograph 36. Emergency Shower/Eyewash** View of the emergency shower/eyewash station located between the two chemical rooms. The station was not winterized.

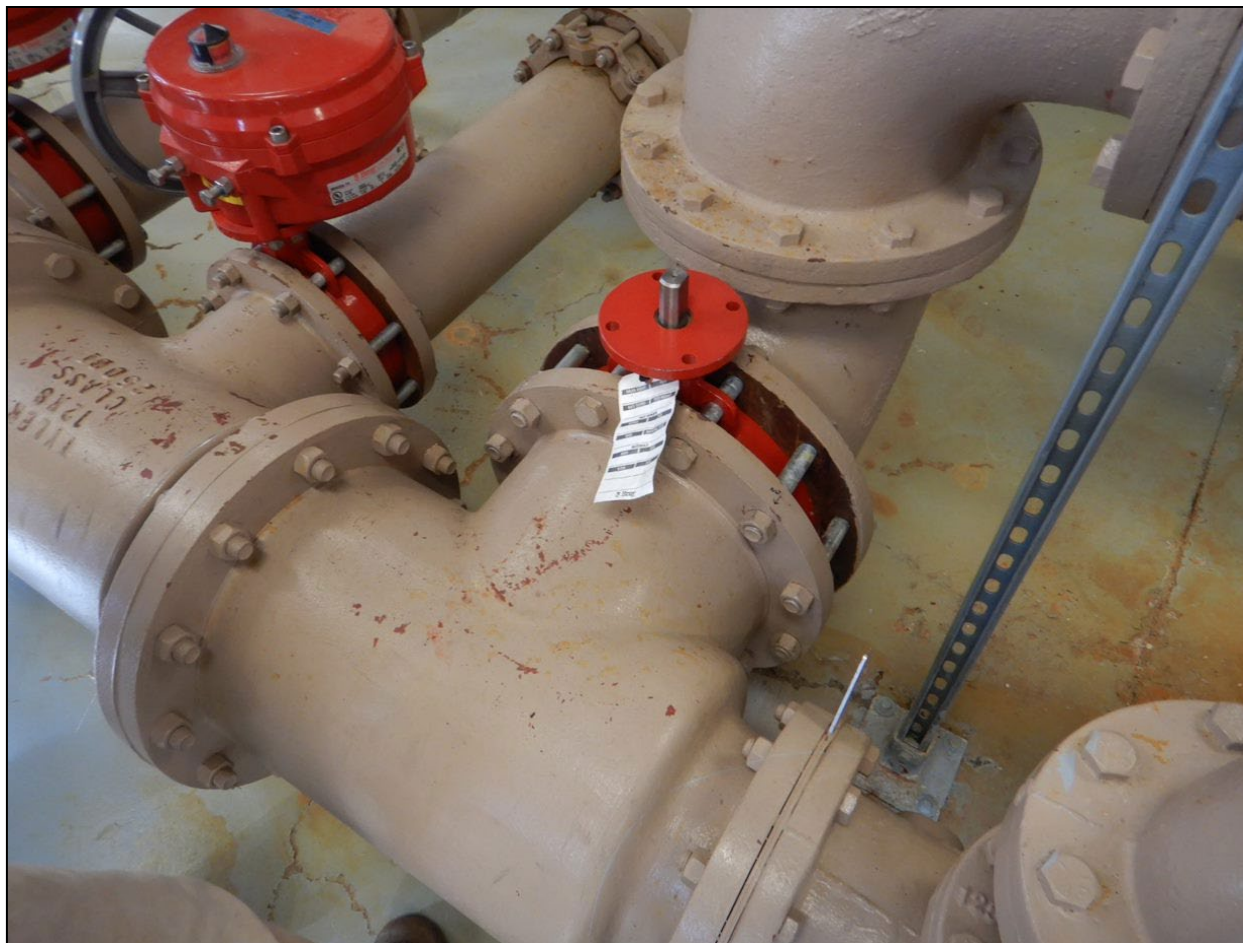
- Observation 12.** On Sunday, February 5, 2023, a valve and actuator on the filtered water discharge main line that sends water to final chemical treatment failed (refer to Appendix 1, Photographs 40 and 41). Once the valve failed, the SCADA system automatically locked out both of the well pumps, disallowing raw water from entering the treatment system. It is unclear what position the valve failed in, but according to SCADA logs and conversations with operators, W0001 was run manually on Sunday (February 5) and Monday (February 6).

**Photograph 40. Failed Effluent Valve, Treatment Room** View of the failed effluent valve in the treatment room. This valve is on the filter produced water discharge main line, immediately prior to produce water blending with bypassed water and receiving final chemical treatment.

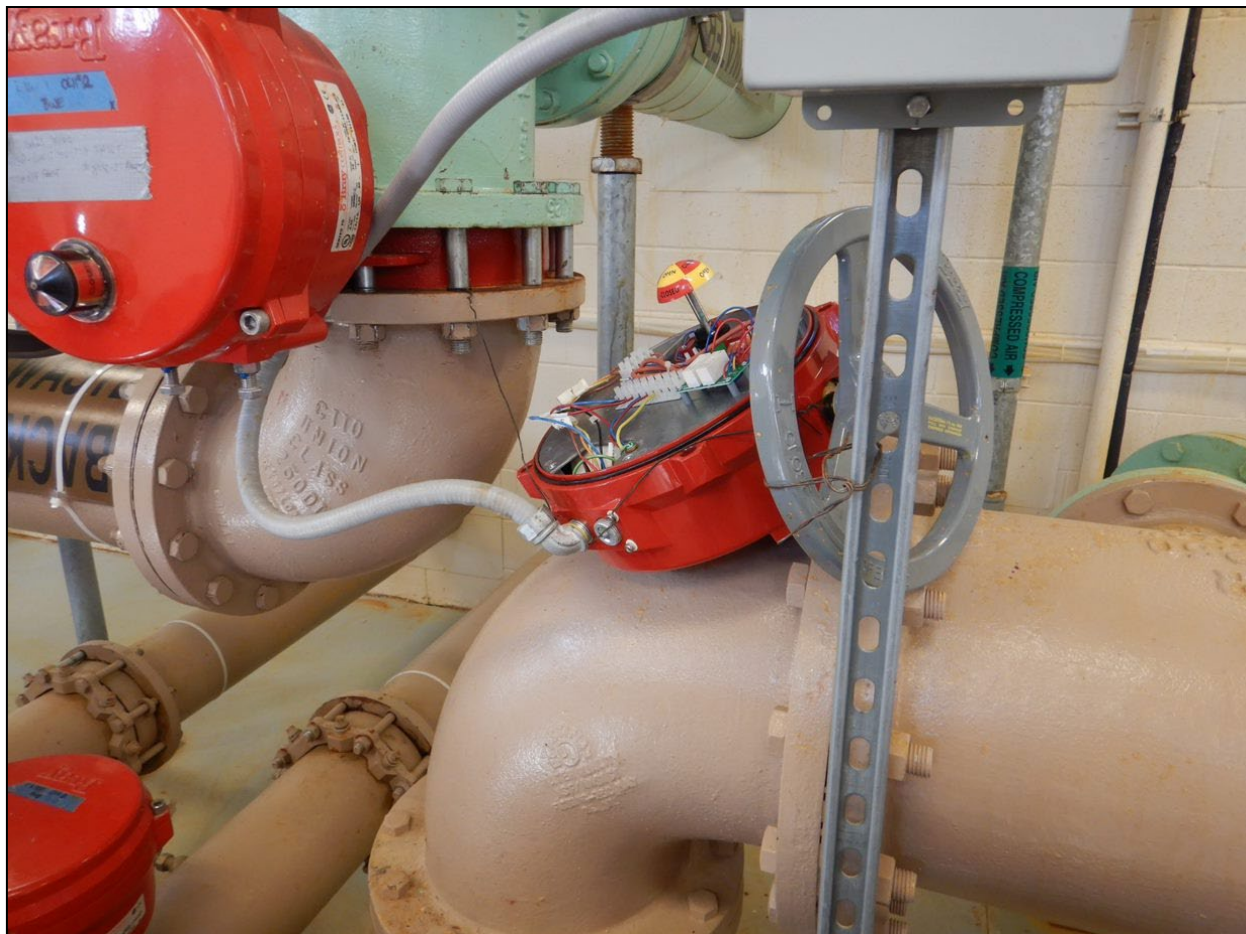
**Photograph 41. Failed Effluent Valve Actuator, Treatment Room** View of the failed actuator to the failed effluent valve in the treatment room. The actuator was supported by bailing wire above the valve waiting on repair.

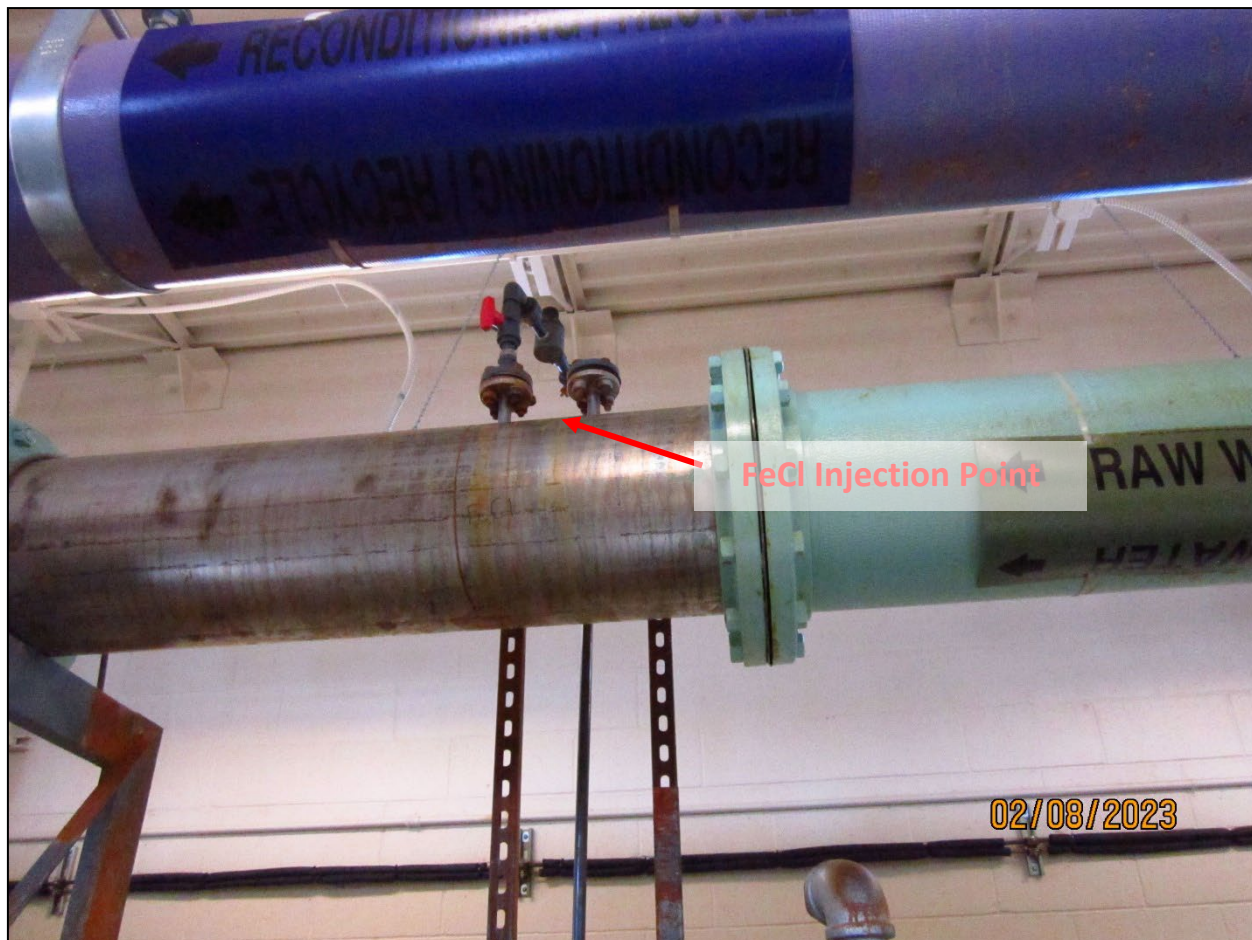
- Observation 10.** There was brown staining on the infrastructure at the ferric chloride injection point in the treatment system, including on valves, piping, nuts/bolts, and the floor (refer to Appendix 1, Photographs 44, 45, 46, 48, and 50). The staining was indicative of a ferric chloride release.

**Photograph 44. Ferric Chloride Injection, Treatment Room** View of the ferric chloride injection point in the treatment system prior to filters. There was brown staining/rust around the injection point.
