## Region 6 - Enforcement & Compliance Assurance Division

### INSPECTION REPORT

| Regulatory Program(s) | Safe Drinking Water Act (SDWA) – Lead and Copper Rule (LCR) | |
| System Name: | <b>Sandia Resort and Casino Public Water System</b> | |

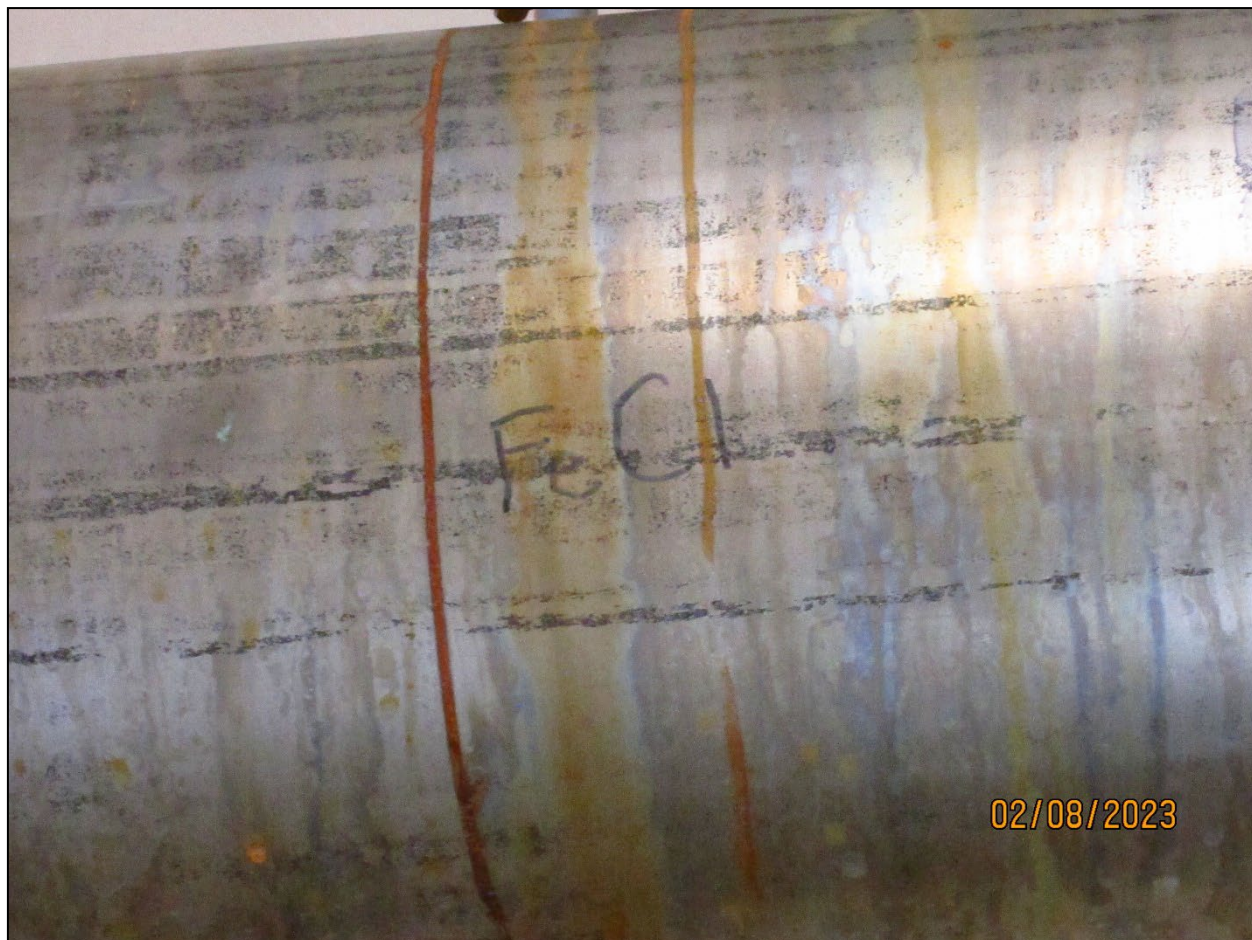
**Photograph 45. Ferric Chloride Injection, Treatment Room** Close up view of the ferric chloride injection pipe. The injection point was labeled with black marker, and there was brown staining/corrosion around the injection point that appears to drip downward.

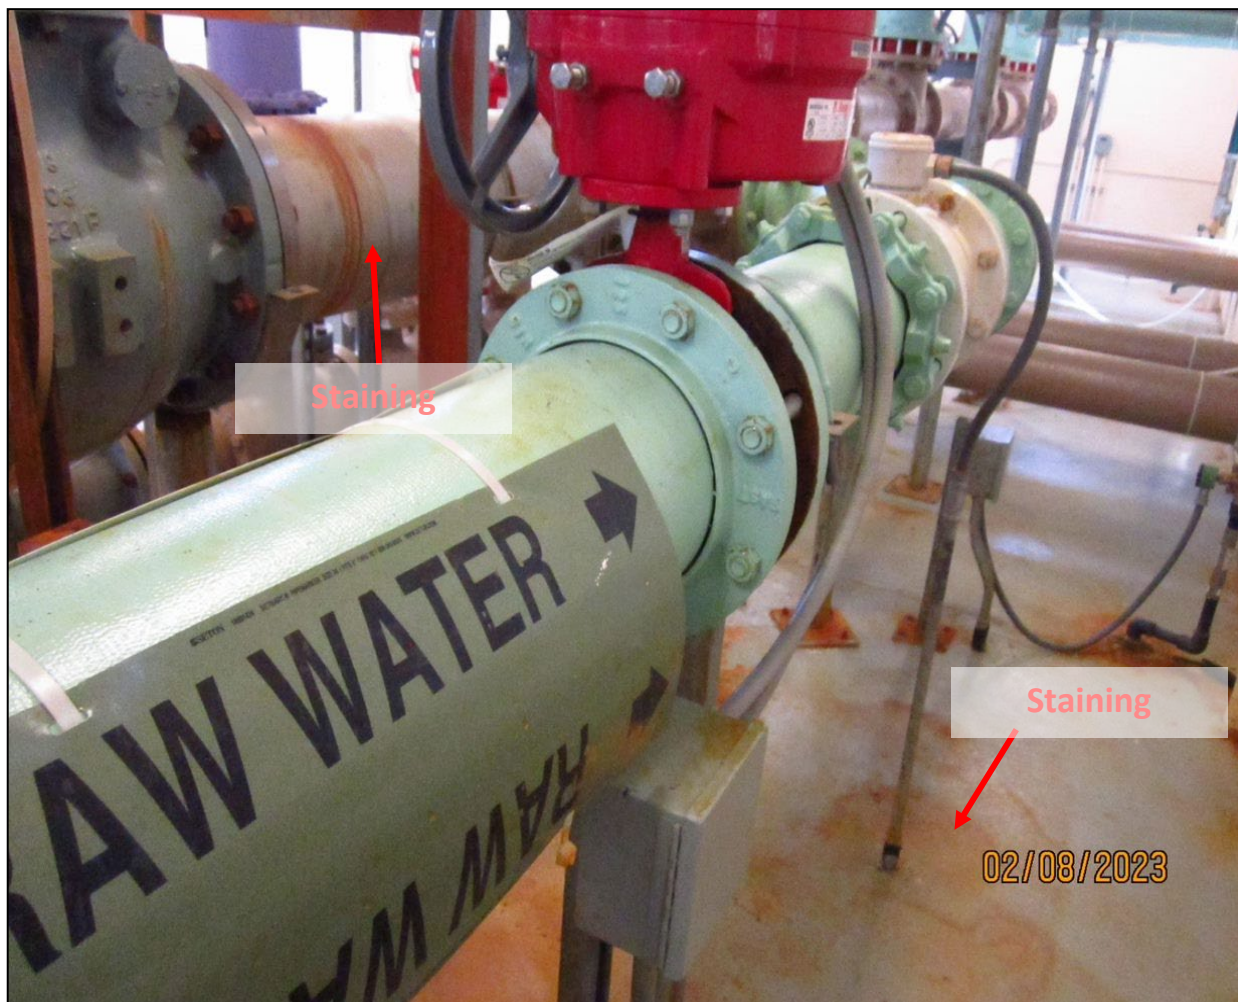
**Photograph 46. Raw Water Pipe, Treatment Room** View of the raw water bypass pipe in the treatment room. This pipe runs beneath the ferric chloride injection point, and there was evidence of brown staining and corrosion on the floor, piping, and nuts and bolts, possibly indicative of a ferric chloride spill.

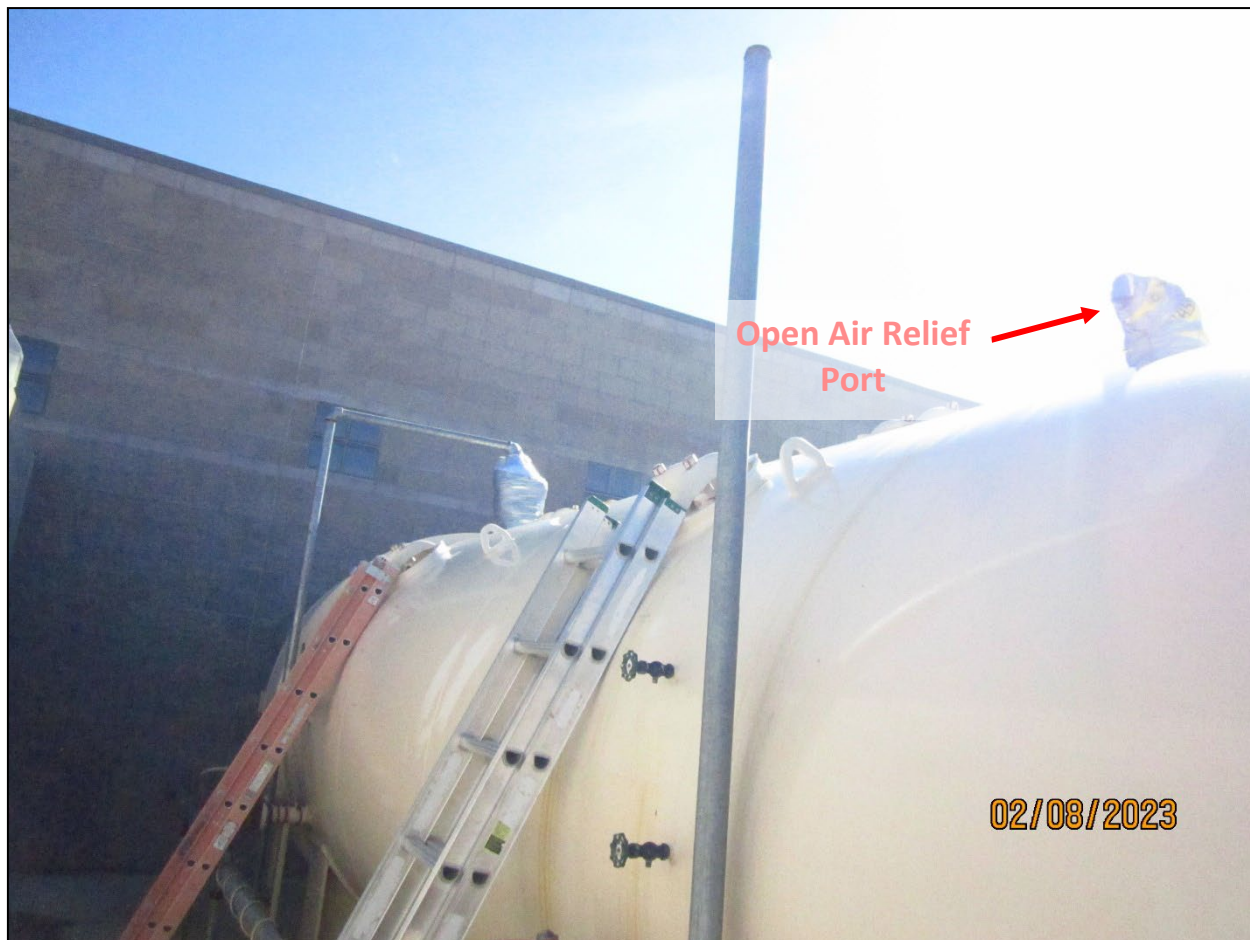
- Observation 11.** One of the air relief ports on top of Filter No. 2 was recently replaced and did not contain mesh screening over its opening (refer to Appendix 1, Photograph 47).

**Photograph 47. Filter Unit No. 2** View of mixed media (anthracite, sand, and gravel) Filter No 2. The air relief port at the right of the image was recently replaced and did not contain a screen over its opening or an extension line so that releases would not drain on tank.

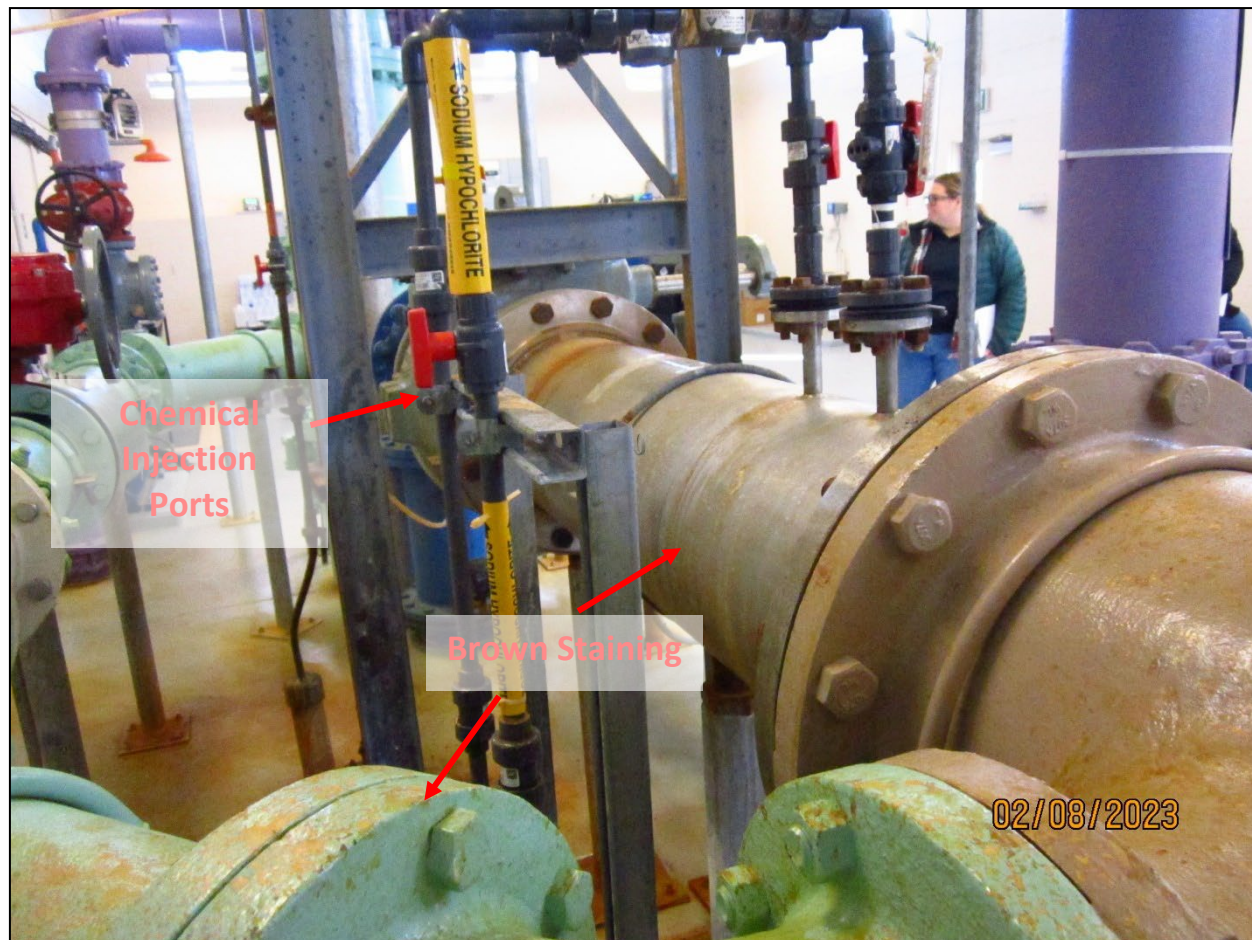
**Photograph 48. Chemical Injection Point, Treatment Room** View of the chemical injection point on the chemical mixing line. The system's process flow diagram indicates that the caustic soda injection is upstream of the sodium hypochlorite when in reality the opposite was observed. The caustic soda line was not labeled. Also visible in this image is brown staining on the pipes/infrastructure around the chemical injection point.

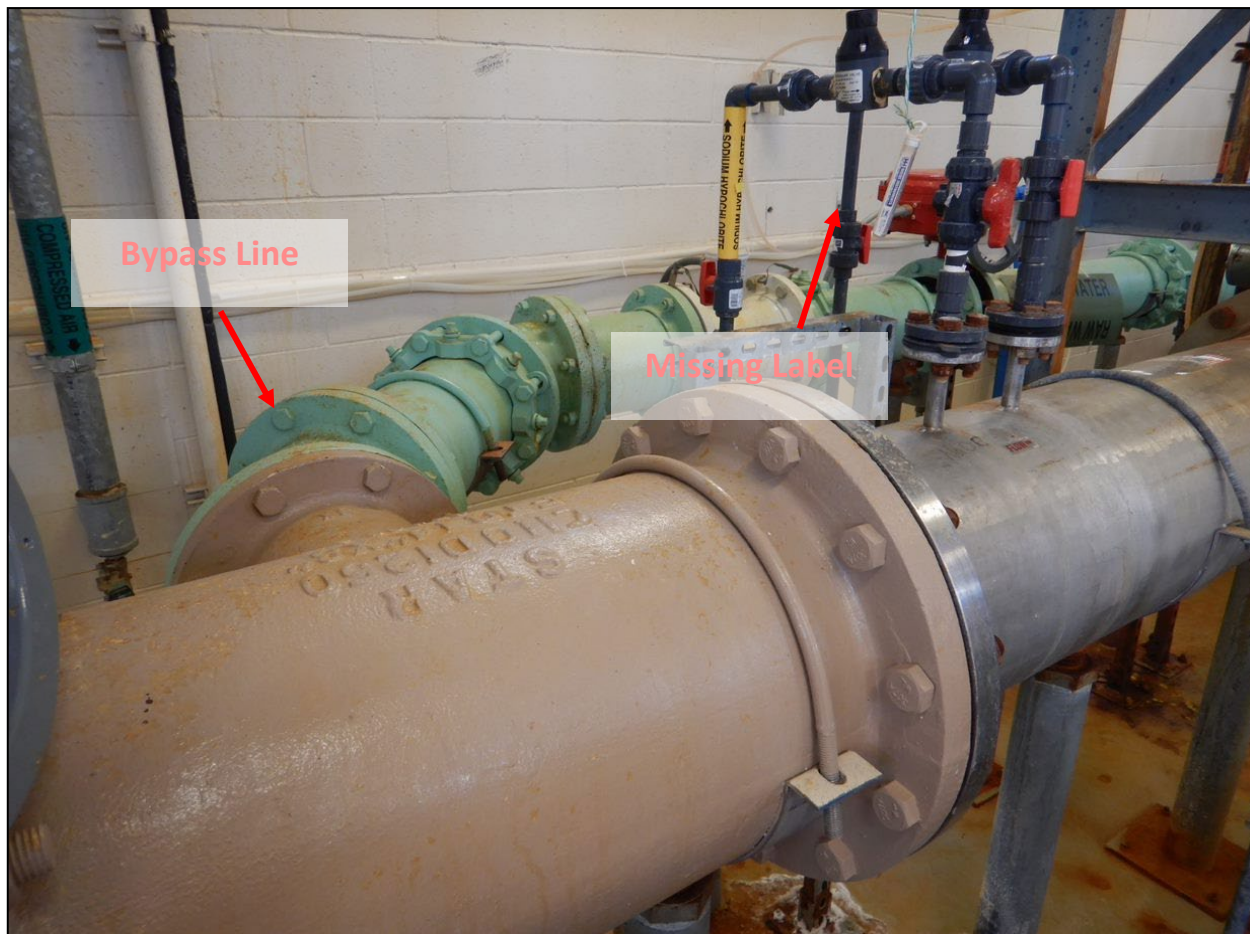
**Photograph 49. Bypass Line, Treatment Room** View of where the raw water bypass line meets the produced filter water immediately upstream of the chemical injection point. Also visible in this image is the missing chemical label on the caustic soda line. The image also shows that the position and order of the chemical injection lines. The treatment diagram has the chemical injection points reverse of what was observed in the field.

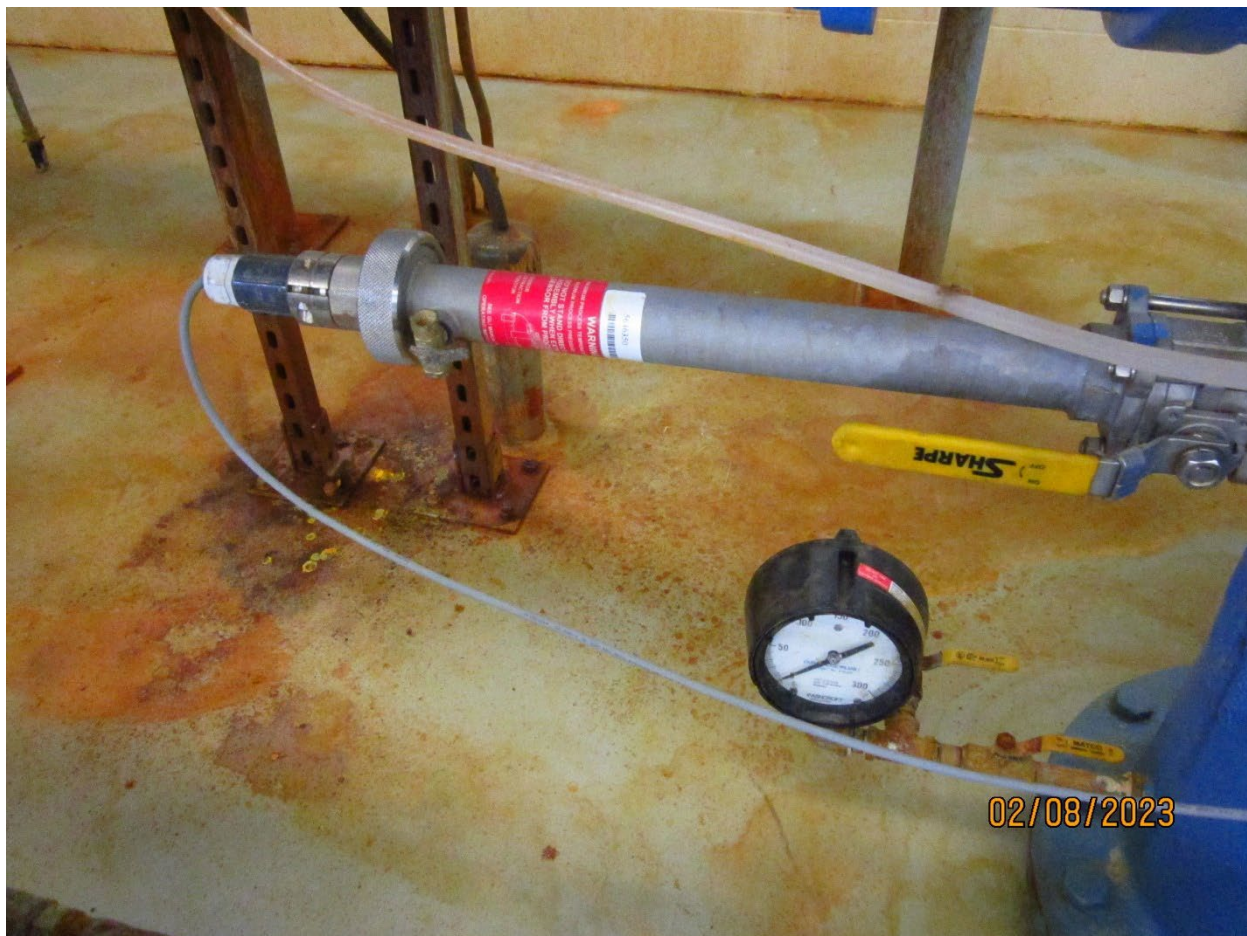
**Photograph 50. pH Probe, Treatment Room** View of the “finished water” pH probe located at the end of the treatment system, after chemical injection. There was also a pressure gauge present at this location which was reading 0 psi. Brown staining can also be seen on the floor and infrastructure in this image.

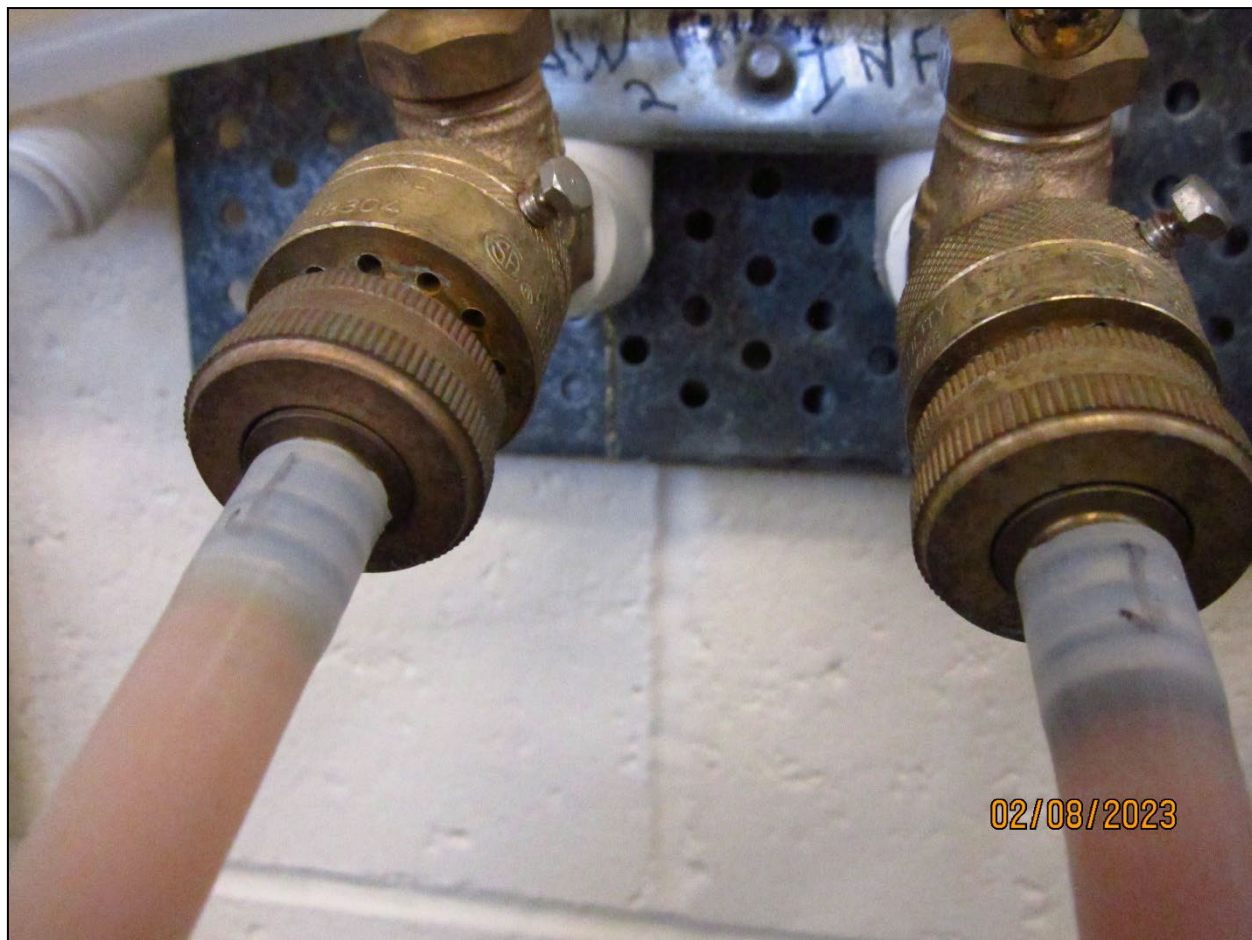
**Photograph 53. Filter Nos. 1 and 2 Influent Sample Ports** Close up view of the Filter Nos. 1 and 2 influent sample ports. The ports were stained brown from ferric chloride. The sample ports contained backflow prevention.

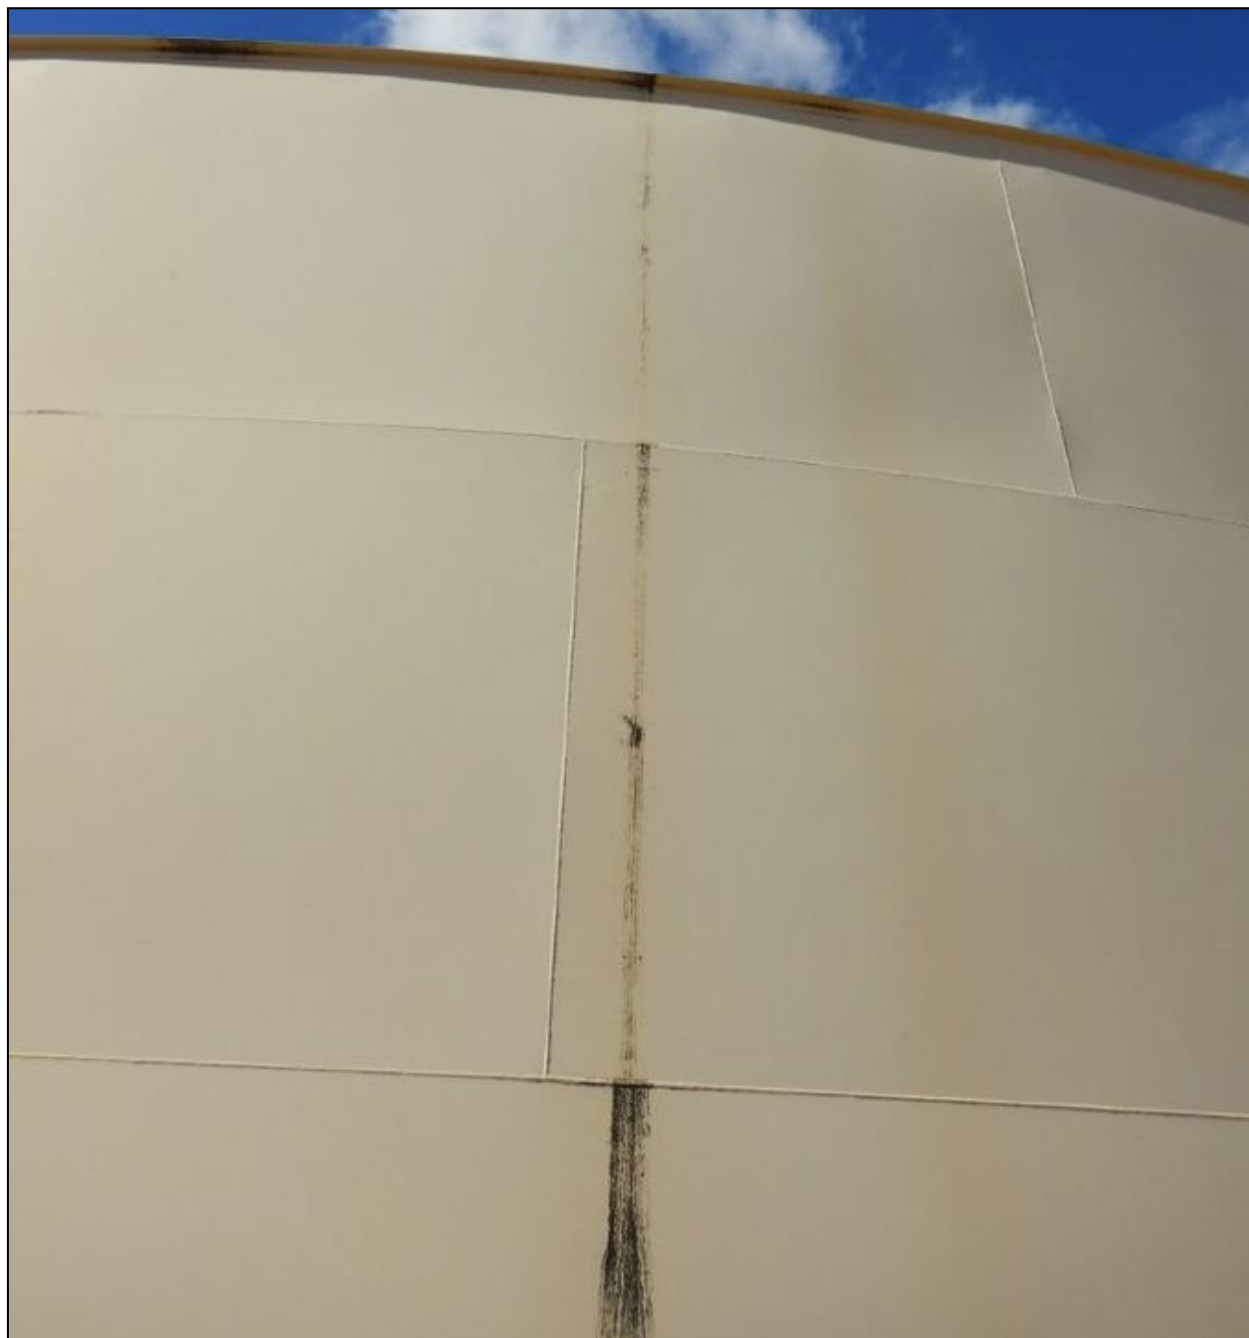
The tank is located in a small depression and is therefore hidden from view. The tank appeared to be in good condition; however, there was some staining/algal growth on the tank sides where it appeared that water would frequently run off (refer to [Appendix 1, Photograph 56](#)). Since the ground surrounding the tank slopes inward, a drainage system is in place to collect flow and send it to an outfall located approximately 500 feet west of the tank. An overflow line extends from the top of the tank and discharges into a manhole below grade (refer to [Appendix 1, Photograph 57](#)). The drainage system surrounding the tank also drains into this manhole. There was no screen over the overflow pipe in the manhole, nor was there an air gap (refer to [Appendix 1, Photograph 58](#)). A second, larger diameter pipe was also present in the manhole, and the drainage/overflow flows through this pipe to get to the outfall (refer to [Appendix 1, Photograph 59](#)). A computerized alarm system communication cabinet was present next to the tank, and operators said that in the event of a power loss, the system would send an alarm to their SCADA system alerting them of the issue. The EPA Inspection Team observed the outfall (refer to [Appendix 1, Photograph 60](#)). The point where the outfall daylighted was covered by a mesh screen that contained some mud/dirt on the bottom. There also appeared to be four different water level marks on the screen (refer to [Appendix 1, Photograph 61](#)).

**Photograph 56. Sandia Casino Tank (ST001)** View of the side of the ST001 tank. The tank had spots where it appeared that water on top of the tank ran off causing algal growth.

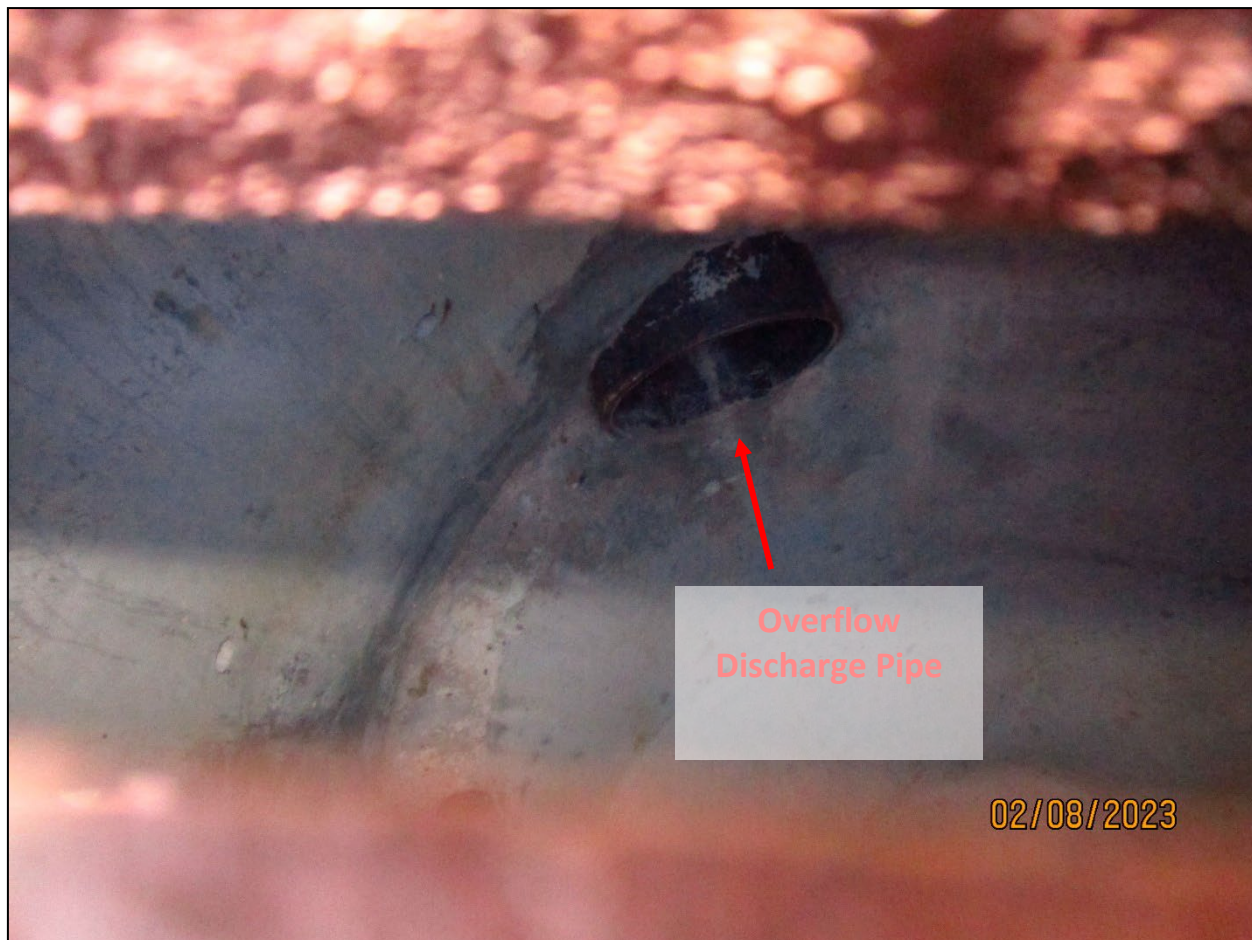
**Photograph 58. Underground ST001 Overflow Pipe Discharge** View of the ST001 overflow pipe discharge point below grade into the drainage basin. The opening of the overflow pipe was unscreened.

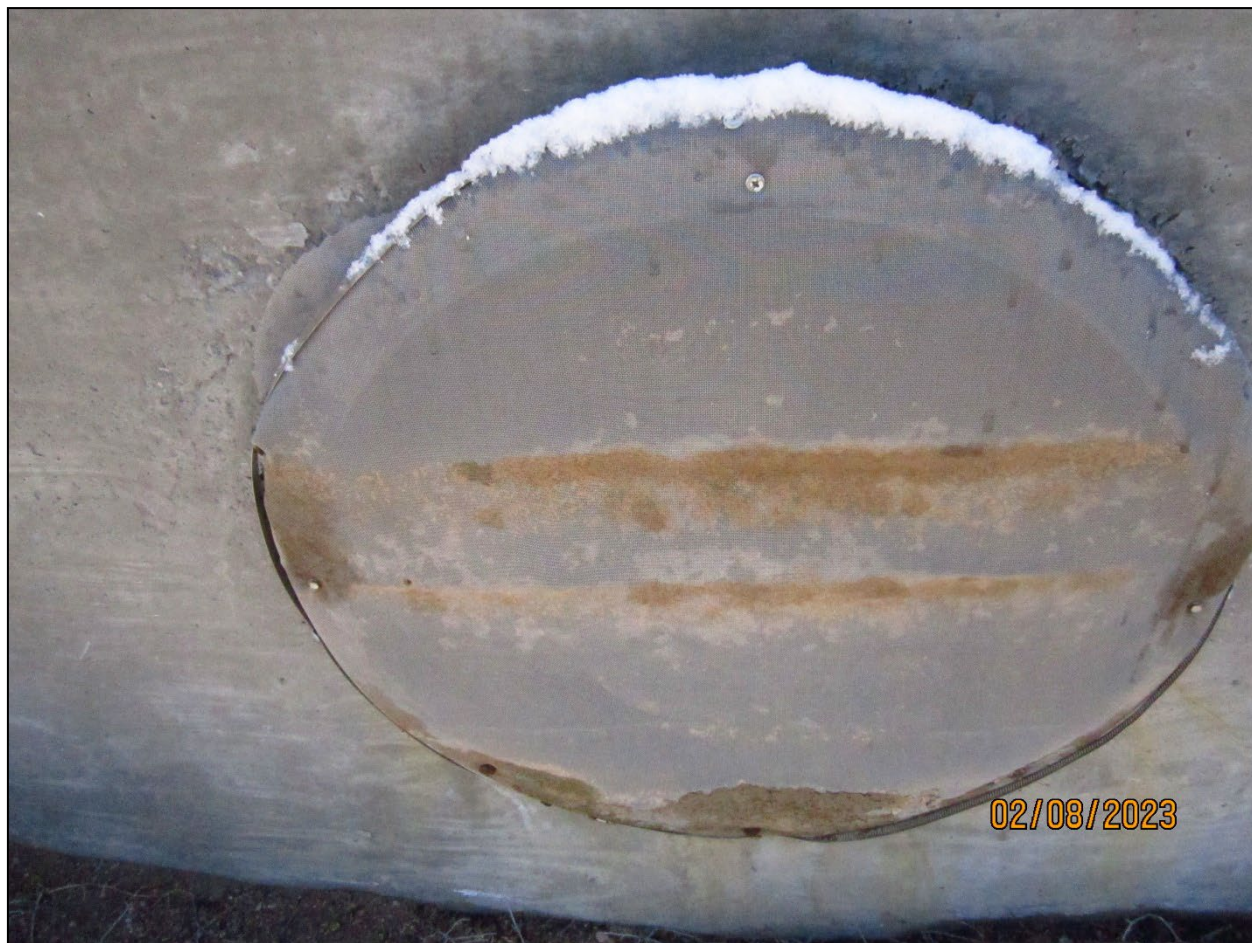
**Photograph 61. ST001 Tank Overflow Outfall** Close up view of the overflow outfall pipe screen. There was mud/dirt at the bottom of the screen, and there appeared to be four different water mark levels on the screen.
