# NPDES Compliance Inspection Report

## Propak Corporation - Boise Caldwell, Idaho

NPDES Permit Tracking Number  
# IDR050264

Inspection Date: May 23, 2023

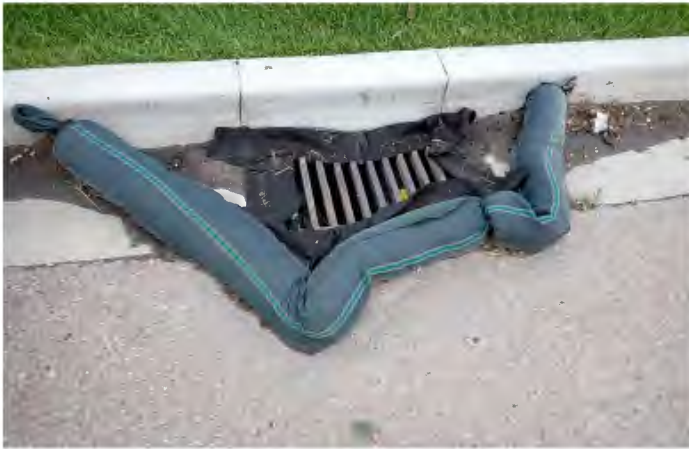
Photo #:01 (P5230001)

We began the facility walkthrough with Mr. Murkle starting at the Facility's main parking lot. Stormwater from the parking lot enters into two storm drains identified as outfall 004 and outfall 005 (**Photo 1 & Photo 3**). The parking lot generally slopes to these drains/outfalls. We walked toward outfall 005 and observed a worn sock and witch's hat in the drain cover as stormwater control measures, but they could benefit from replacement (**Photo 1**). We continued North along the parking lot to outfall 004. We walked past a food truck on the way to outfall 004 that periodically comes to the Facility during lunch hours that can be a potential source of oil and grease that stormwater can come into contact with (**Photo 2**). At outfall 004 we observed worn witch's hat in the drain cover and barrier material as stormwater control measures, but they could benefit from replacement (**Photo 3**). When I asked Mr. Murkle where stormwater went after entering these outfalls, he did not know for sure but reasonably assumed stormwater discharged to "A Drain" as described in the old SWPPP he had on site. Outfalls 004 and 005 are identified as substantially identical discharges (SIDs) and are both SIDs to outfall 006. According to the Facility's updated SWPPP, sampling for outfalls 004 and 005 is conducted at outfall 006 since all three of those outfalls are SIDs. According to the 2021 MSGP, SIDs can be identified if discharge points have the potential for stormwater exposure to the same pollutants. Based on the Facility's site map in its updated SWPPP, it is possible for stormwater in Areas 5 and 6 (outfalls 005 and 006) to come into contact from potential outdoor storage pollutants, whereas stormwater in Area 4 (outfall 004) may not come into contact with outdoor storage based on drainage direction (depicted by arrows on the SWPPP site map). Therefore, sampling at outfall 006 may not be representative of discharges at outfall 004.

Description: Facing west, photo of storm drain (outfall 005) with witch's hat inside drain cover and with sock in main facility parking area.

Outfalls at the Facility had worn socks and witch’s hats and required replacement to properly function as intended.

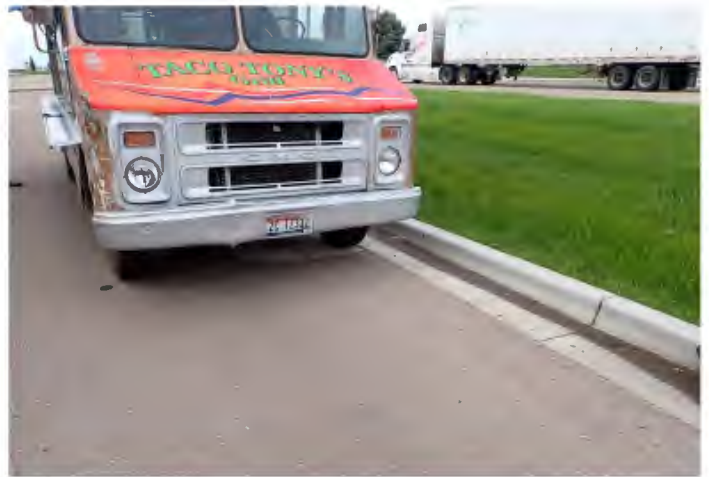
Photo #:02 (P5230004)

During the inspection, we observed a food truck in the Facility’s main parking area. Although no leaks were observed on the food truck, if it had any vehicle-related leaks during future Facility visits, pollutants could contact with stormwater and subsequently discharge at outfall 004 or 005.

Description: Facing southwest, photo of a food truck in main facility parking area.

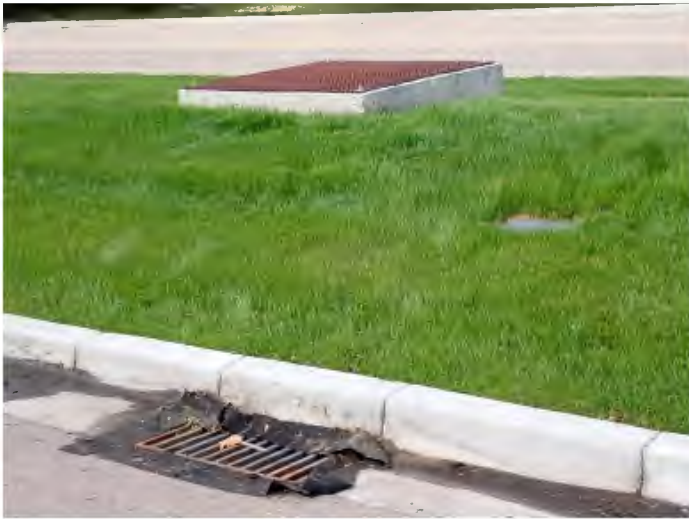
Photo #:03 (P5230013)

Description: Facing west, photo of outfall 004 in facility's main parking area and additional city stormwater drain near the street not connected to the facility's stormwater drainage.

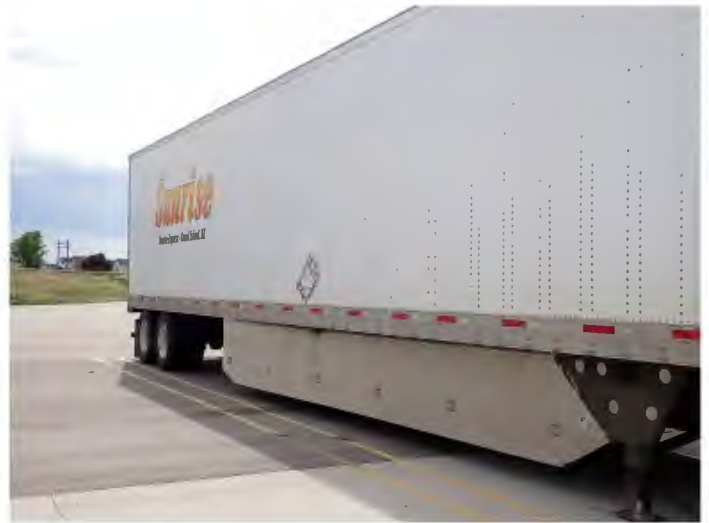
Photo #:04 (P5230020)

We continued walking North to observe the northern part of the Facility where we observed the trailer lot. Trailer on site appeared well maintained and free of leaks (**Photo 4**). We observed the northern perimeter of the Facility that was a vegetative swale serving as outfall 003 (**Photo 5**) that receives stormwater from parking lot and trailer lot sheet flow. This outfall was identified by the Facility for possible removal as an outfall as upon closer examination, it did not appear there was anywhere else for stormwater to discharge to other than infiltrate into the ground. Sampling for outfall 003 is conducted by hand as a grab type sample from any standing water in the swale using a cup that is then placed in a cooler to be sent to a lab for analysis.

Description: Facing north, photo of a trailer in the facility's northern trailer drop lot.

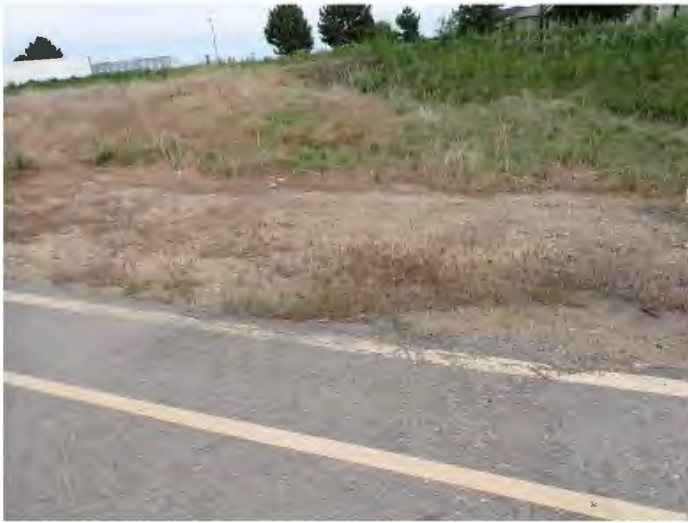
Photo #:05 (P5230027)

Description: Facing northwest, photo of the vegetative swale that absorbs sheet flow from the trailer drop lot. Area identified as outfall 003, but water in area determined to simply infiltrate.

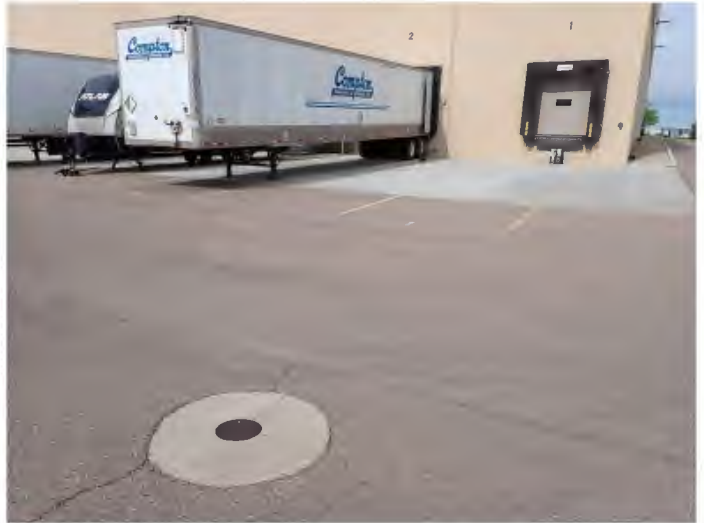
Photo #:06 (P5230031)

We then walked to the northeastern corner of the Facility to observe some of the shipping and receiving (loading and unloading) docks. We observed a smaller circular shaped covered drain in this part of the Facility (**Photo 6**). I asked Mr. Murkle what the drain is for and where stormwater went, and he was not entirely certain but reasonably assumed stormwater entering that drain discharges into "A Drain". We proceeded South and came

Description: Facing west, photo of shipping and receiving dock area with smaller drain that directly drains into "A Drain" but not identified as a facility outfall.

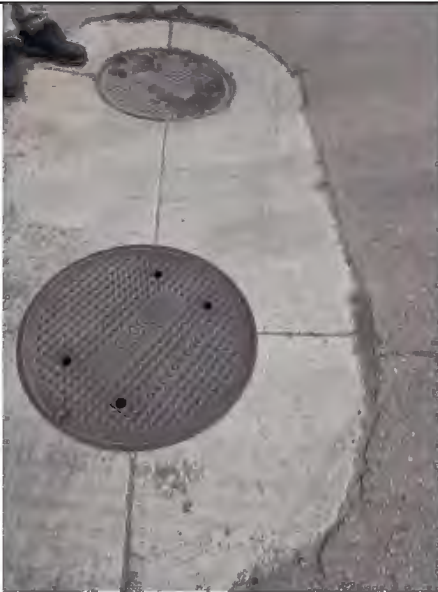
Photo #:07 (P5230035)

across 2 additional and unknown manhole stormwater drains that were not identified as outfalls at the Facility (**Photo 7**). These unknown drains contained standing water, but Mr. Murkle was not sure where the water in these drains discharge to, but reasonably assumed it discharged to “A Drain”. From these unknown drains, we then walked East approximately 35 feet to observe outfall 002. At outfall 002, we opened the drain cover and observed a worn witch’s hat as a stormwater control that could benefit from replacement, and this outfall showed signs of receiving insufficient drainage (**Photo 8**). We continued walking South on the eastern part of the Facility to outfall 001 (**Photo 9**). Approximately 35 feet West of outfall 001 was another pair of the same unknown manhole type stormwater drains as observed by outfall 002. When I asked Mr. Murkle where stormwater went after entering outfalls 001 and 002, he did not know for sure but reasonably assumed stormwater discharged to “A Drain” as described in the old SWPPP he had on site. Outfalls 001 and 002 are identified as SIDs. According to the Facility’s updated SWPPP, sampling for outfalls 001 and 002 is conducted at outfall 001 since both of those outfalls are SIDs. However, Mr. Murkle explained that outfall 001 also does not receive sufficient drainage and instead samples for outfall 001 from one of the mystery manhole stormwater drains 35 feet away (see **Photo 7**; mystery drains the same at outfalls 001 and 002). The Facility may benefit from identifying outfalls 001 and 002 as the mystery manhole storm drains to ensure sampling at those mystery storm drains would be representative of where measurable stormwater discharges assuming discharge into the mystery storm drains subsequently discharge to the same waters.

Description: Facing north, photo of additional stormwater drains on eastern side of the facility not identified as facility outfalls, however sampling for outfall 002 is taken at these drains due to sufficient drainage in them compared to drainage in outfall 002.

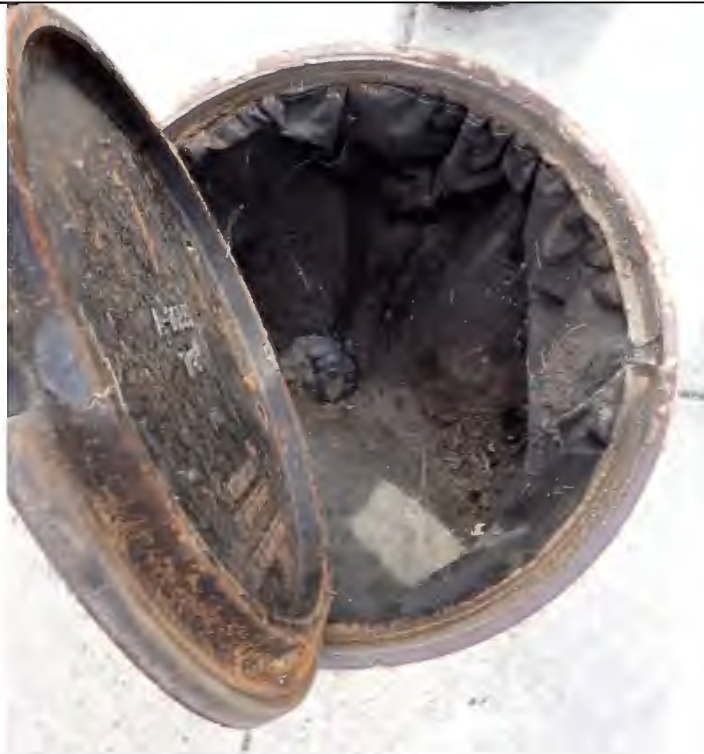
Photo #:08 (P5230039)

Description: Facing east, photo of inside storm drain cover for outfall 002 showing signs of receiving insufficient drainage.

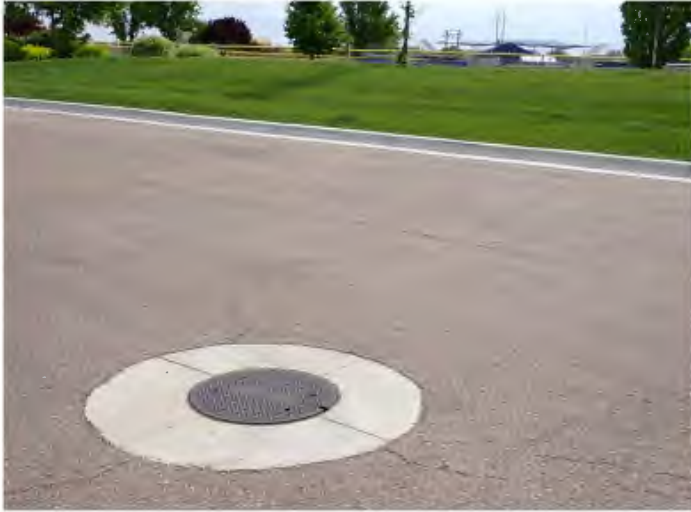
Photo #:09 (P5230045)

Description: Facing northeast, photo of outfall 001 on the eastern side of the facility.

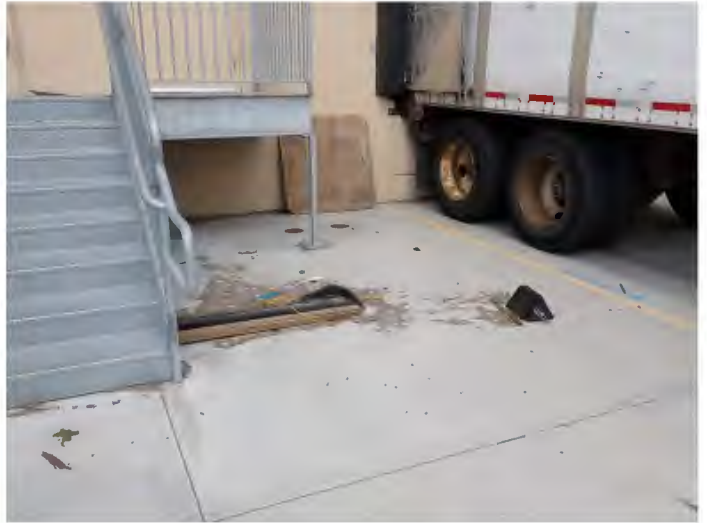
Photo #:10 (P5230047)

Midway down the eastern perimeter of the Facility’s main building, we also observed a loading/unloading area next to some stairs with debris on the ground that may lead to possible tracking (**Photo 10**), though no obvious visible signs of track out was observed throughout the Facility. As part of the Facility’s best management and housekeeping practices described by Mr. Murkle, Propak staff sweep the Facility grounds weekly.

Description: Facing west, photo of another of facility shipping and receiving area with light debris on the ground.

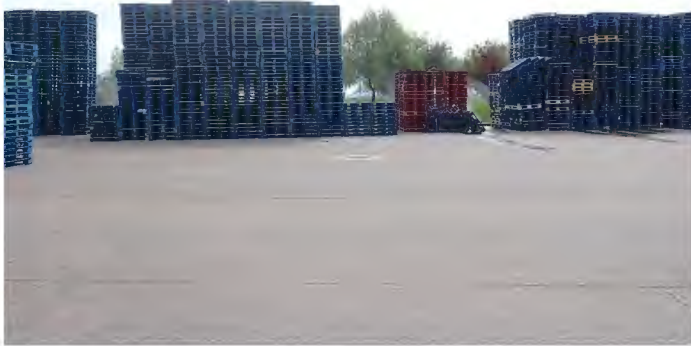
Photo #:11 (P5230053)

Along the southeastern perimeter of the Facility, we observed uncovered outdoor storage of pallets that need to be repaired or otherwise processed (**Photo 11**). Mr. Murkle indicated pallets are not washed down nor chemically treated or coated and did not have concerns about the pallets’ exposure to the elements as the pallets are not stored outside very long before they come indoors for processing. We continued to walk to the southeastern corner of the Facility where we observed a fenced off/barricaded entrance and exit point (**Photo 12**). Mr. Murkle indicated this entrance and exit point was blocked off to discourage regular vehicle traffic from driving through the Facility grounds as a safety measure to protect employees from potentially getting hit by vehicles. Mr. Murkle has never observed stormwater leaving the Facility at this entrance and exit point. Based on the Facility’s updated SWPPP and drainage arrows, Areas 1 and 6 could potentially drain out this entrance and exit point, but there are no stormwater control measures to ensure stormwater would not leave the Facility via the southeastern entrance/exit.

Description: Facing east, photo of outdoor pallet storage area on the southeastern part of the facility.

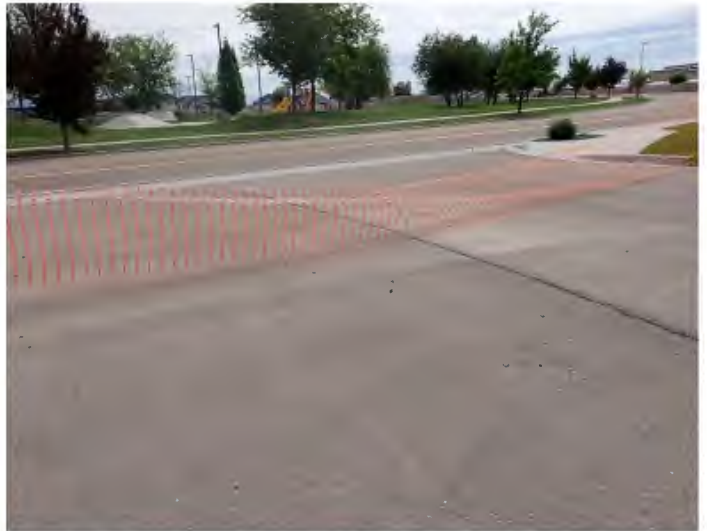
Photo #:12 (P5230058)

The fenced off/barricaded entrance and exit point on the southeastern corner of the Facility could potentially receive drainage from Areas 1 and 6 based on the Facility’s SWPPP site map, but the area did not have any stormwater controls to keep stormwater in the Facility. Although Mr. Murkle has never observed stormwater leaving the Facility at this entrance and exit point, it might be possible during a major storm event and as much discharge prevention as possible is in the spirit of the permit.

Description: Facing east, photo of the facility's southeastern entrance/exit blocked off to discourage regular vehicle traffic driving through facility grounds as a facility safety measure. This entrance/exit may benefit from stormwater control measures to prevent stormwater from entering the street.

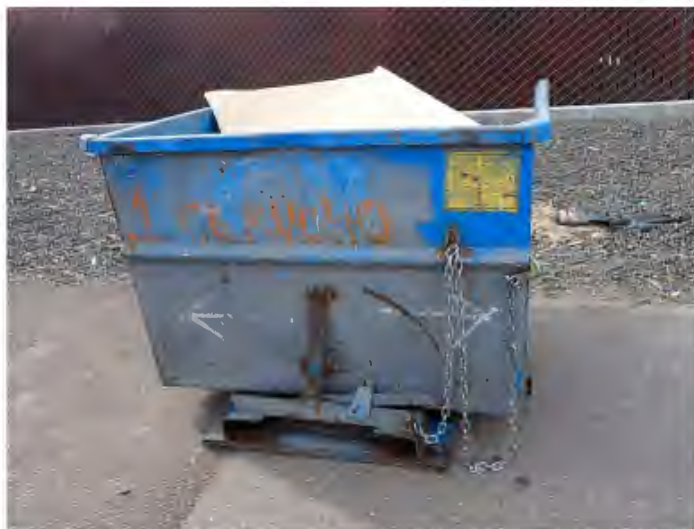
Photo #:13 (P5230062)

Just west of the southeastern perimeter’s blocked entrance and exit point, we observed an uncovered trash hopper (**Photo 13**). Trash is held in the hopper temporarily and then dumped into the bigger dumpster located at the southeastern corner of the Facility’s main building (**Photo 15**). A portion of the Facility’s gravel spit that runs along the southern perimeter also was observed behind the trash hopper (**Photo 13**). The gravel spit had light scattered debris. We then observed the large, uncovered dumpster and temporary

Description: Facing south, photo of trash hopper without a lid on the southern part of the facility and part of the gravel spit that runs along the facility's southern perimeter with light debris.

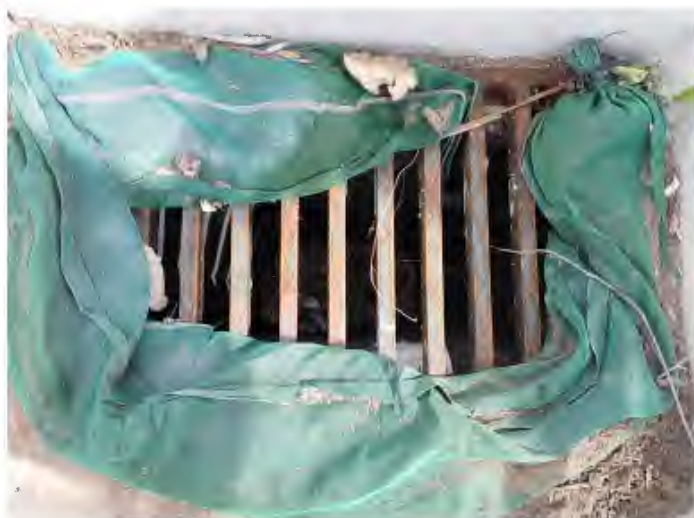
Photo #:14 (P5230066)

Description: Facing north, photo of outfall 006 with worn sock in need of replacement.

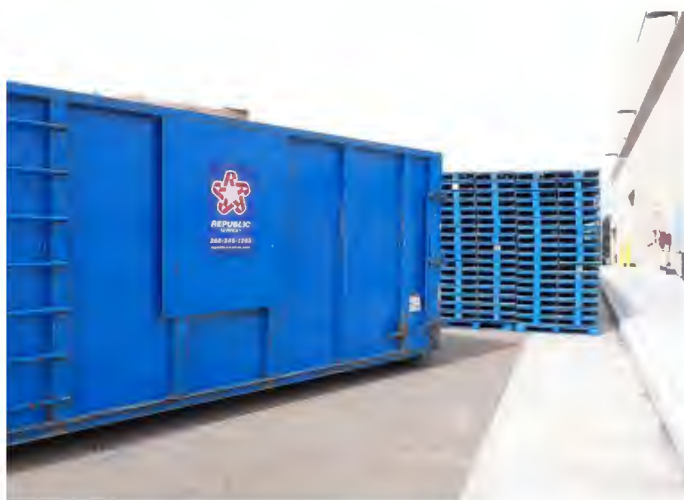
Photo #:15 (P5230069)

uncovered outdoor storage/staging of pallets and found the immediate surrounding area to be free and clear of debris (**Photo 15**). The Facility's large dumpster is emptied and taken offsite for proper disposal twice a week by Allied Waste Service. We observed outfall 006 with worn sock and witch's hat and could benefit from replacement as there was debris inside and outside this storm drain, and the worn sock and witch's hat may not properly function to filter debris and particulates (**Photo 14**). When I asked Mr. Murkle where stormwater went after entering this outfall, he did not know for sure but reasonably assumed stormwater discharged to "A Drain" as described in the old SWPPP he had on site. Outfall 006 was identified as an SID to outfalls 004 and 005. Outfall 006 is where sampling occurs to represent all three outfalls as SIDs, however as already mentioned, sampling at outfall 006 may not be representative as an SID to outfall 004.

During the inspection we observed some light debris in different areas of the Facility grounds despite the Facility’s weekly sweeping. The large garbage dumpster did not have a lid and is uncovered at the Facility. Exposed debris in the dumpster has the potential to intercept with stormwater.

Description: Facing west, photo of the facility's main uncovered dumpster along with some outdoor wood pallet storage and staging area.

Additionally, Section 2.1.2.2.c states that dumpsters that do not have lids and could leak, “ensure that discharges have a control (e.g., secondary containment)”.

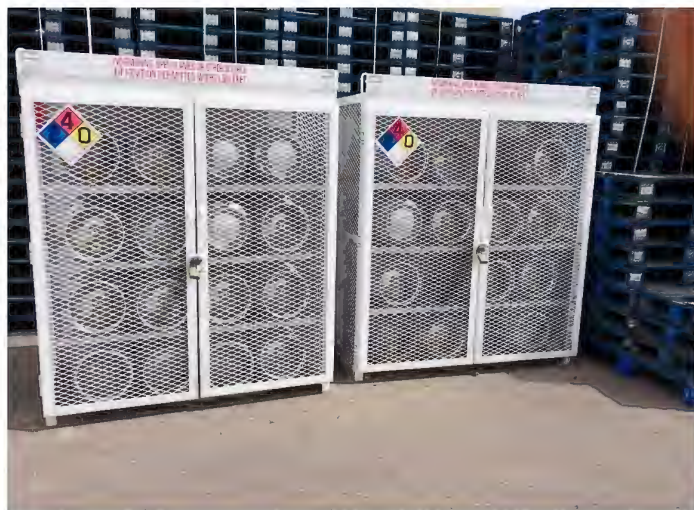
Photo #:16 (P5230073)

We continued walking down the southern part of the main building and observed outdoor storage of propane tanks (**Photo 16**). The propane tanks are stored outside for safety due to their flammability. The tanks are checked monthly by Mr. Murkle's supervisor and weekly during Ferrel Gas fill-ups. We then walked by a southern loading and unloading area with minor signs of possible vehicle tracking (**Photo 17**).

Description: Facing north, photo of outdoor storage of propane tanks. Tanks are stored outside for safety reasons but are inspected weekly during Ferrell Gas fill-ups.

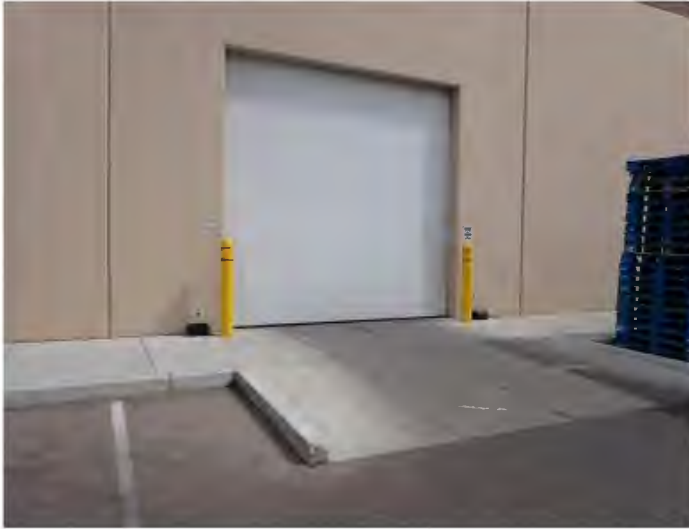
Photo #:17 (P5230076)

Description: Facing north, photo of a loading and unloading dock at the southern end of the facility's main building.

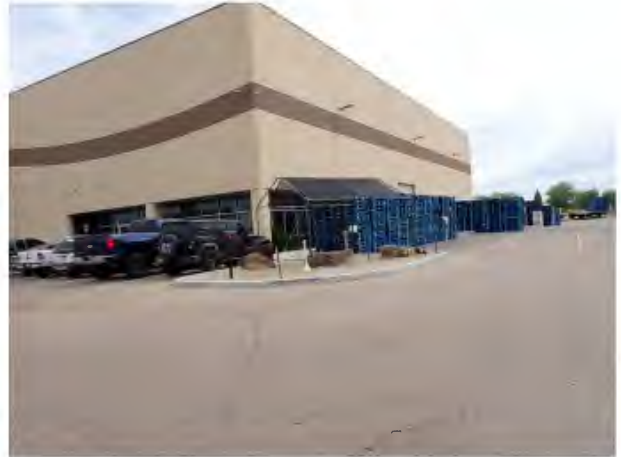
Photo #:18 (P5230082)

Description: Facing east, photo looking at southwestern corner of the facility's main building showing impervious area that may drain to additional stormwater drain next to the facility's main southwestern entrance/exit not labeled as an outfall.

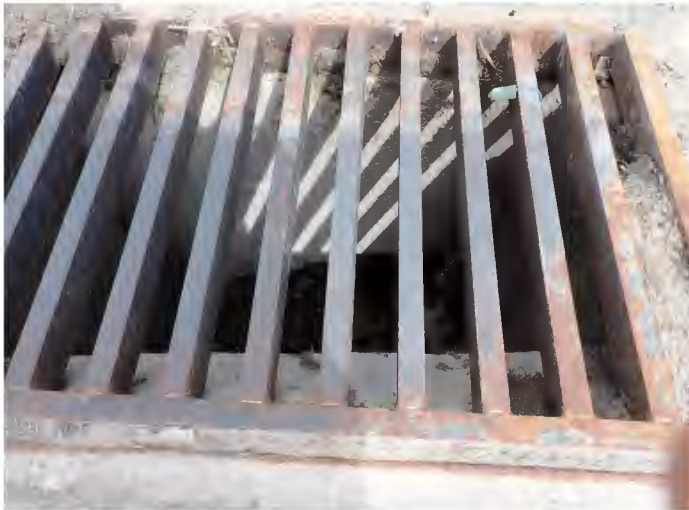
Photo #:19 (P5230083)

Description: Facing north, close up photo of the additional stormwater drain next to the facility's main southwestern entrance/exit not labeled as an outfall. Where stormwater went once it entered this drain was unknown to the facility at the time of inspection.

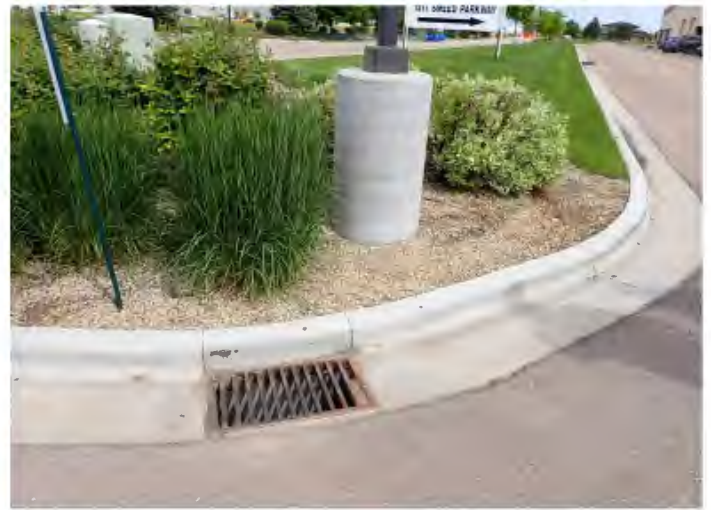
Photo #:20 (P5230085)

We proceeded to the southwestern entrance and exit point of the Facility where we observed another unknown storm drain containing debris (**Photo 20**). There was no visible water inside the drain, suggesting that it may not receive sufficient drainage (**Photo 19**) from the western and southern parts of the Facility (**Photo 18**). Mr. Murkle did not know where stormwater went if it entered this drain, and it is not considered as an outfall for the Facility. The southwestern entrance and exit point could potentially receive drainage from the southern part of the Facility based on drainage arrows on the SWPPP site map, but this entrance and exit point did not have any stormwater controls to prevent stormwater from exiting the Facility onto Smeed Parkway (**Photo 21**). Mr. Murkle conveyed that he's never observed stormwater leave the Facility at any entrance and exit point, and that the Facility receives little rain/precipitation.

Description: Facing north, photo of the additional stormwater drain with background next to the facility's main southwestern entrance/exit not labeled as an outfall.

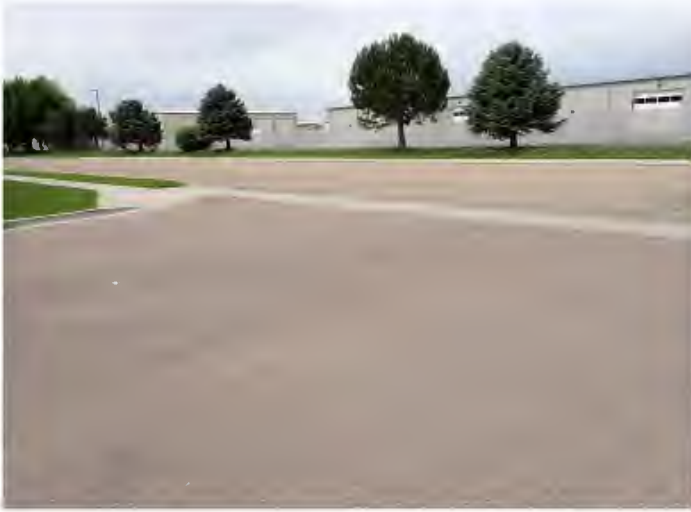
Photo #:21 (P5230087)

Description: Facing southwest, photo facility's main southwestern entrance/exit where stormwater could possibly exit the facility onto the street. This area could benefit from stormwater controls.

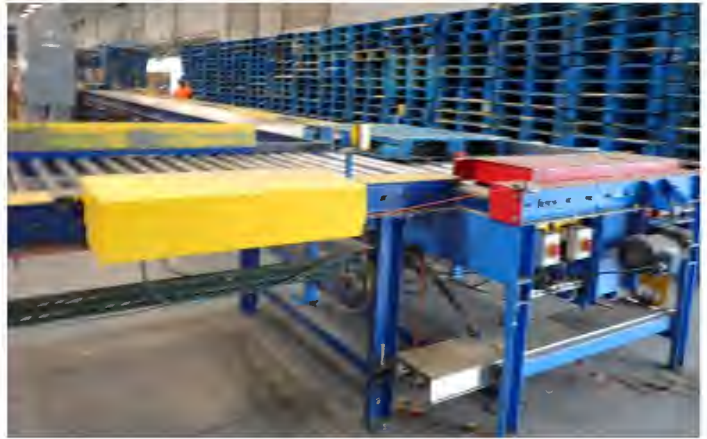
Photo #:22 (P5230113)

We then went inside the main building where the repair plant is located. We observed how pallets are sorted, examined, stacked, repaired by hand, sawed as necessary, and finally painted in assembly line fashion (**Photo 22 and Photo 24**). Concentrated paint was contained in large totes with secondary containment and was water filtered and recycled within the tote (**Photo 24**). The Facility maintained a proper spill kit near the start of the assembly line (**Photo 23**). The Facility had empty gas tanks/containers inside the main plant that were going to be filled and then stored in a flammable locker (**Photo 25**). We then proceeded back to the main building's conference room where we completed a records review and held the closing conference.

Description: Photo of the assembly line in the facility's main building to load, sort, and stack pallets that then feed to builders to conduct repair work on pallets before they are returned to the assembly line.

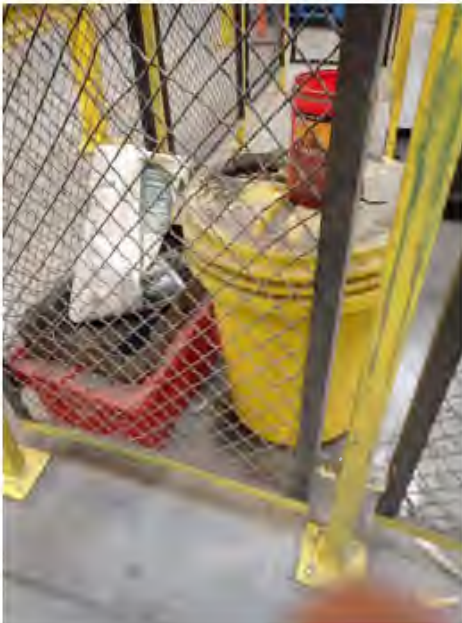
Photo #:23 (P5230114)

Description: Photo of the facility's spill kit in main building.

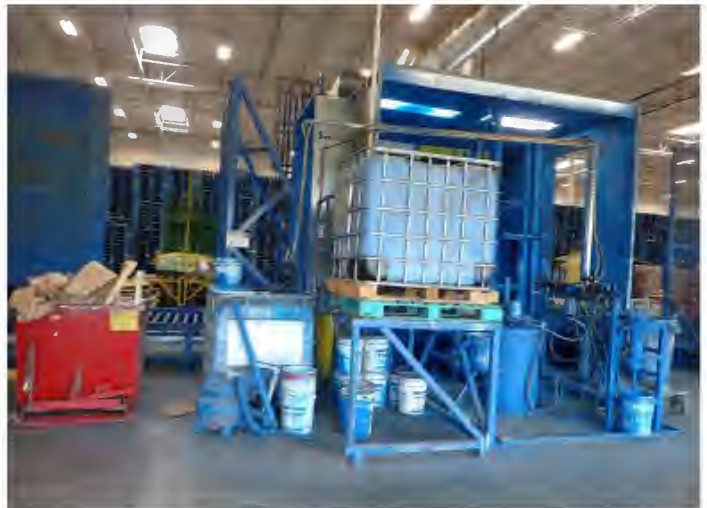
Photo #:24 (P5230117)

Description: Photo of red-colored dumpster next to the painting part of the pallet repair process. Paint tote uses secondary containment.

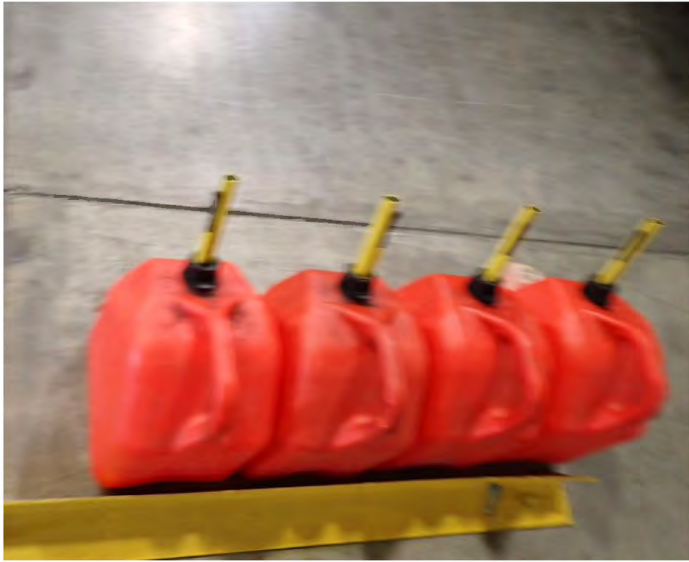
Photo #:25 (P5230123)

Description: Photo of gas tanks inside the facility's main building that are normally stored in a flammable locker but were out to be filled.
