**Region 6 - Enforcement & Compliance Assurance Division**  
**INSPECTION REPORT**

| Inspection Date(s): | 03/23/2026 | |
| Company Name: | McCann Resources, Inc | |
| Facility Name: | Bowring Lease | |

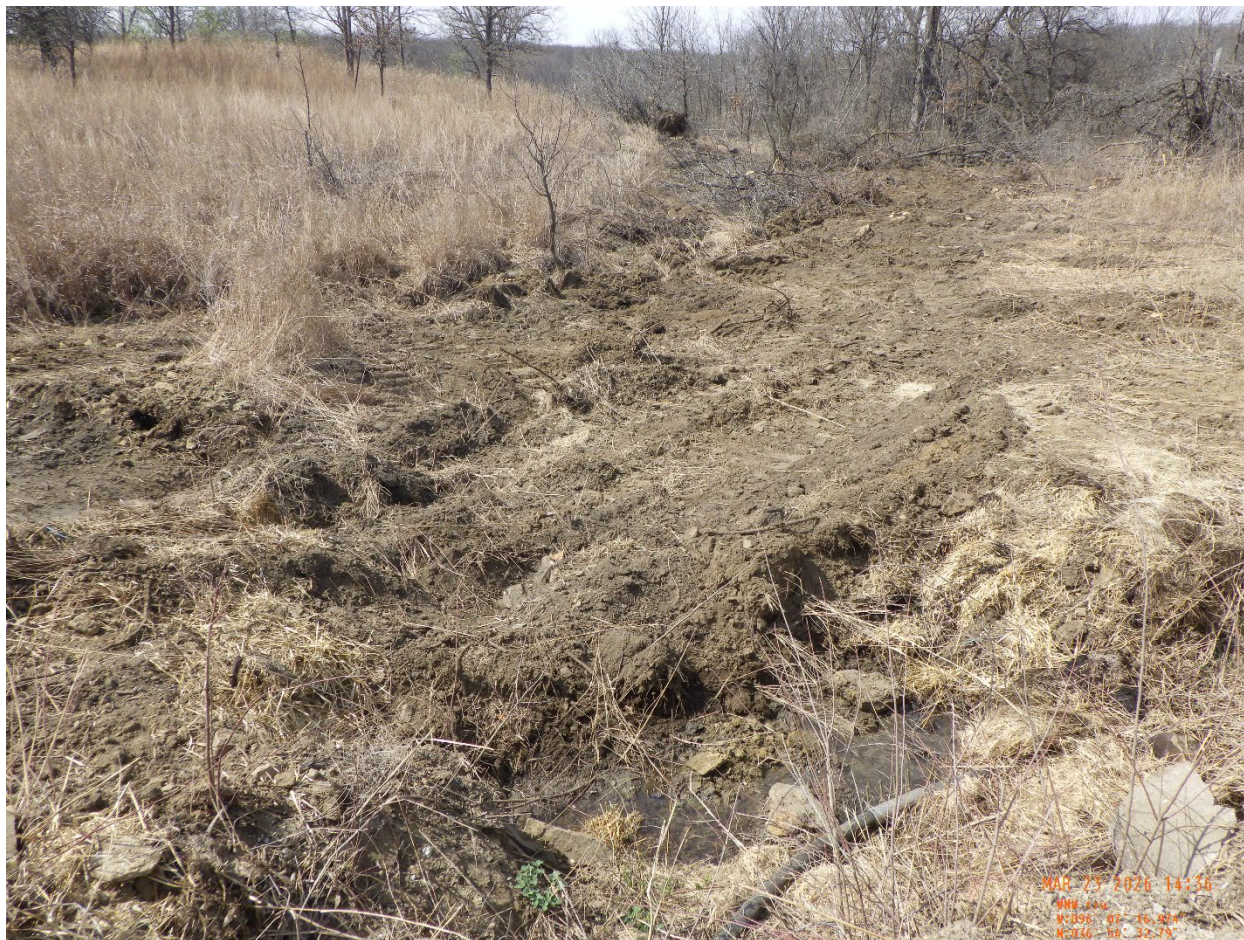
Photo No. 1

I observed the release point and the point of entry (POE) into the unnamed tributary of Hulah Lake. The straw, straw bales and most of the oil-stained soil observed during the initial spill inspection were covered by recent bulldozer activity which collapsed the banks and filled in the main channel of the tributary. Oil-stained soil was still present, indicating the contamination had been covered up rather than removed from the impacted tributary. See photo No. 1 of the attached photo log. For additional location and photo metadata, see Appendix 1, photo log, which is attached to this report.

**Description:** This was the release point of the spill. The straw and oil previously observed at this location were mostly covered with dirt where the operator caved the channel banks in with a bulldozer. The soil visible in the channel of the tributary was still stained with oil.

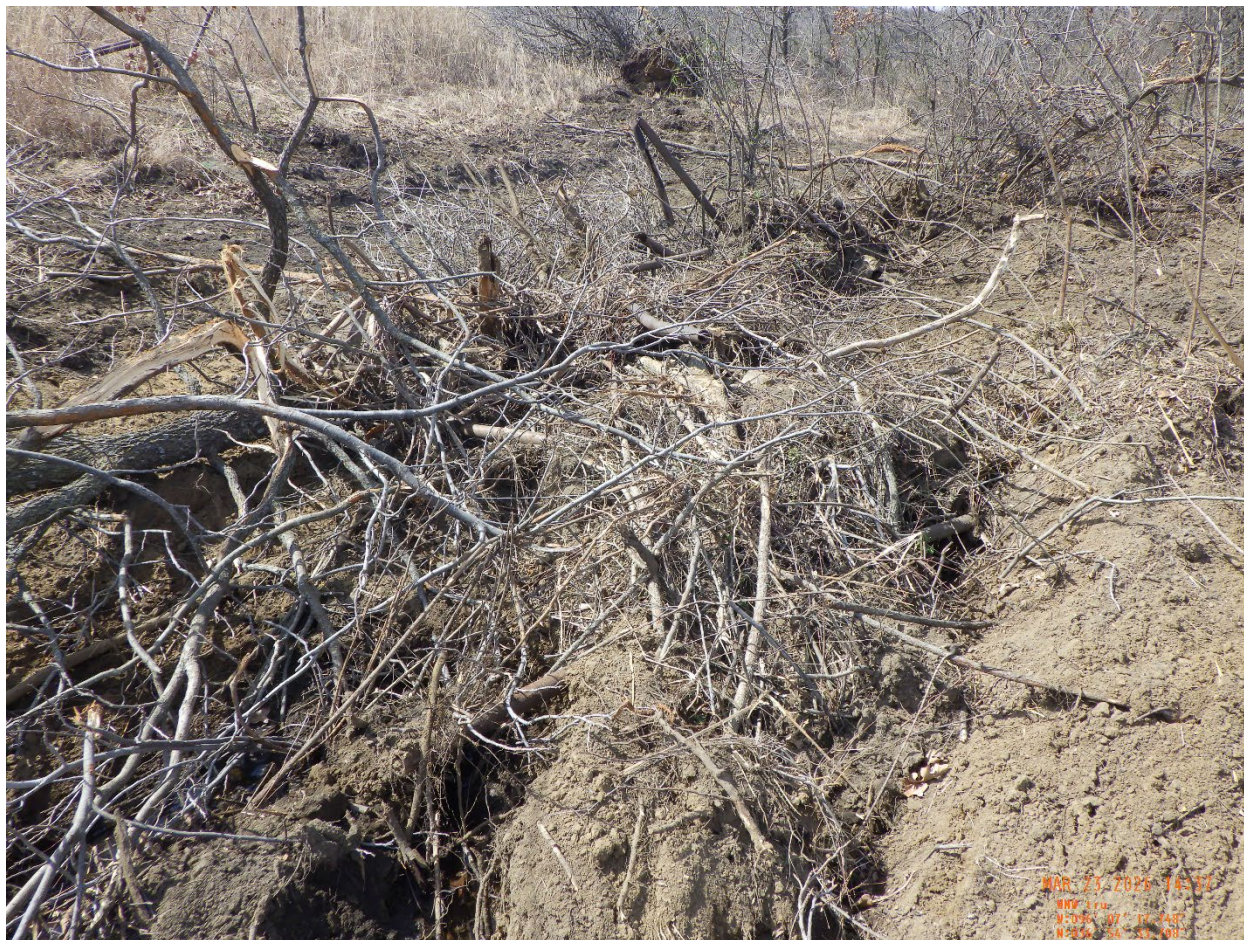
Photo No. 2

Downstream from the POE, I observed collapsed banks, steel pipe, trees and clean soil, which were used to cover up the oil in the tributary. At the same location, I observed oil-stained soil in the channel where the fill material did not completely cover the main channel, evidence the oil in the tributary was covered up rather than removed, see photo No. 2.

**Description:** This was oil-soaked soil still present in the channel of the unnamed tributary of Hulah Lake. The channel was filled with soil, steel pipe and trees by the operator.

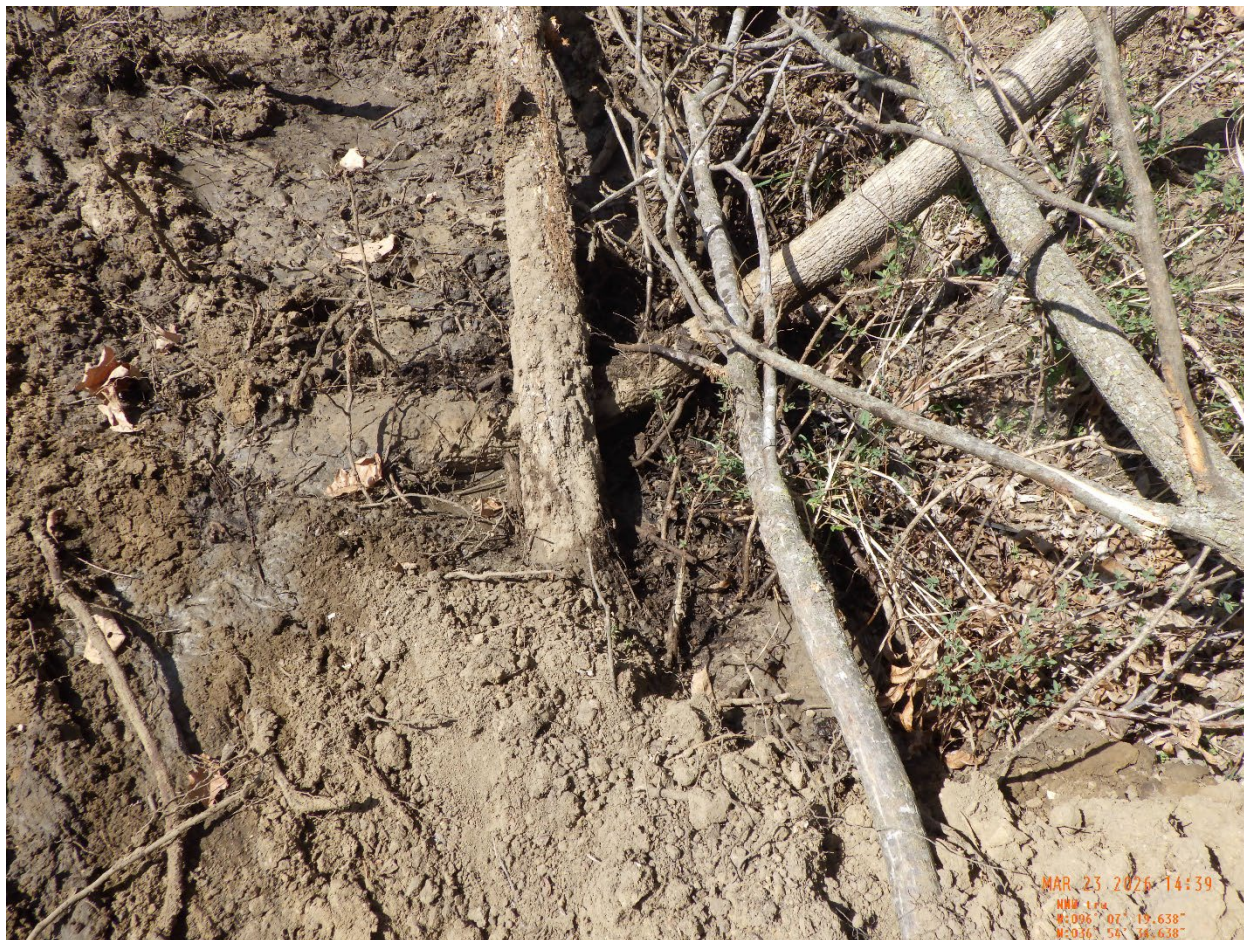
Photo No. 3

Continuing downstream, I observed additional fill material of trees and soil as well as oil-stained vegetation and soil where the fill material was not completely covering the bed of the tributary. See photo No 3.

**Description:** This was oil-stained soil in the channel of the impacted tributary of Hulah Lake. The channel was mostly filled with soil and trees at this location.

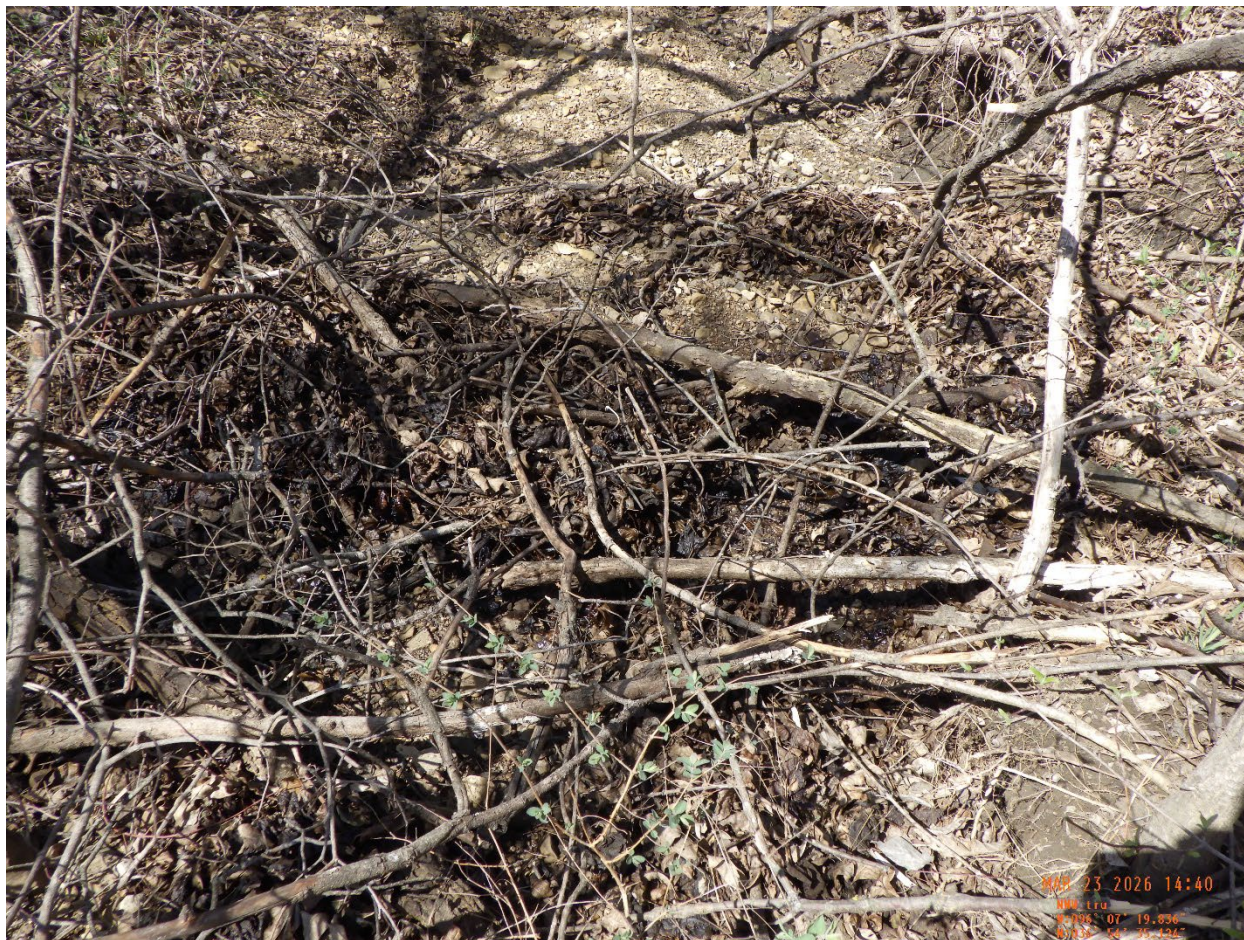
Photo No. 4

Beyond the point where the tributary was filled in, I observed oil-stained soil, leaf, and stick debris in the main channel of the tributary which had not been removed. See photos No. 4.

**Description:** This was oil-stained leaf and tree litter in the main channel of the impacted tributary, downstream from the area where the channel was filled in by a bulldozer.

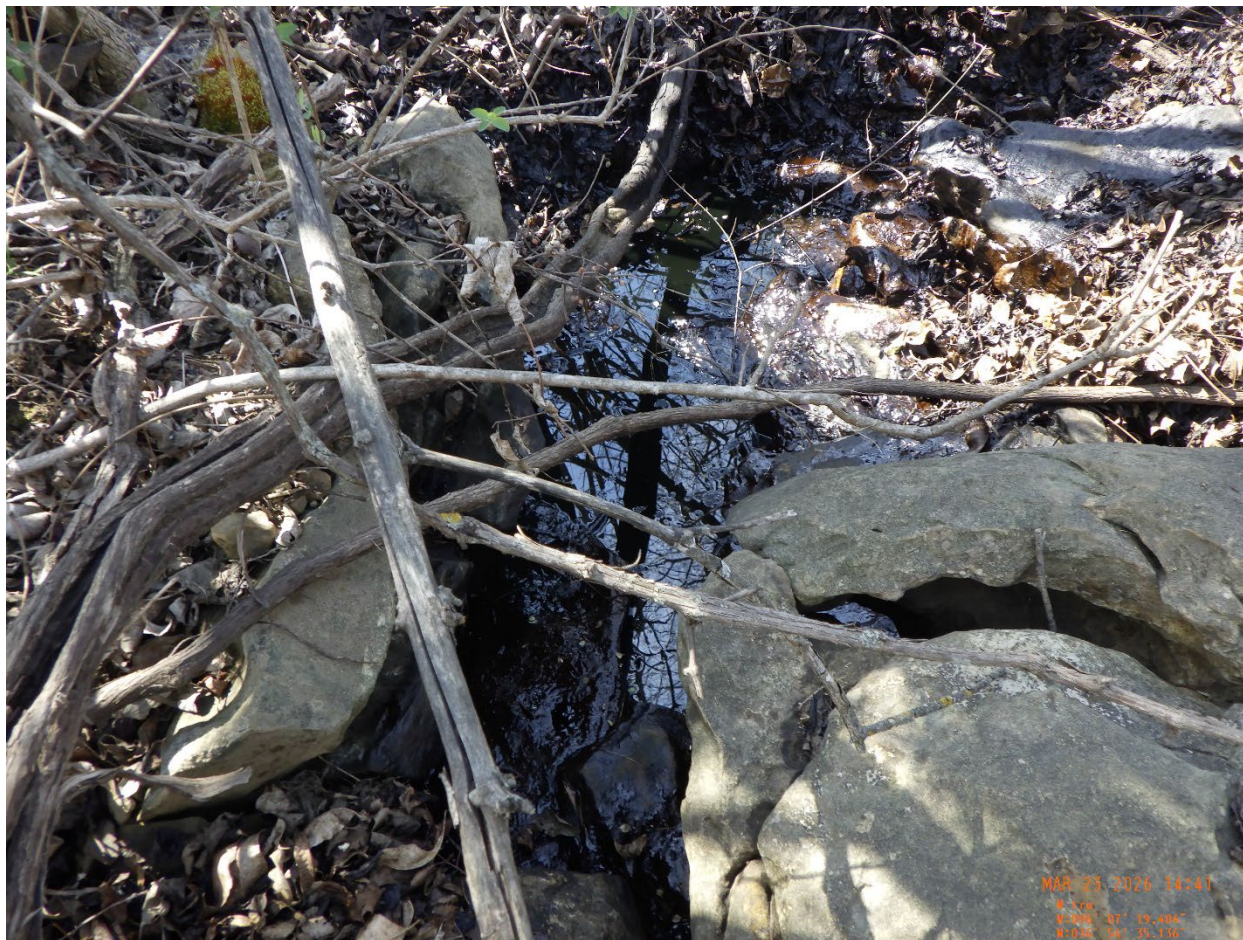
Photo No. 5

Continuing downstream, I observed oil floating in the impacted tributary. See photo No. 5.

**Description:** This was oil in the tributary, downstream from the section which was filled in.

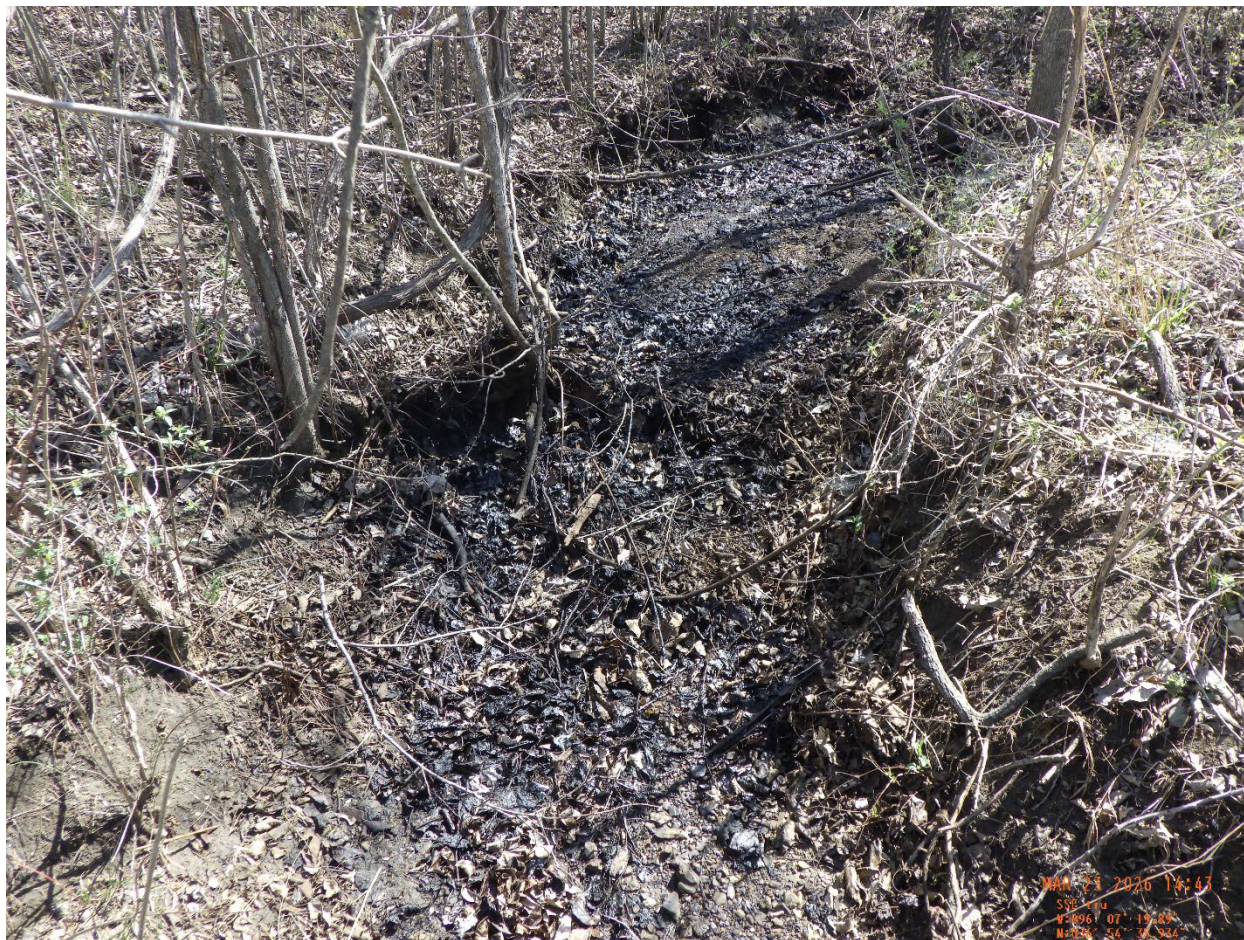
Photo No. 6

I observed additional oil-stained soil, leaf and stick debris in the channel of the impacted tributary, which had not been removed in the clean-up process. See photo No. 6.

**Description:** This was oil-stained soil, leaves and channel banks along the impacted tributary, downstream from the area where the channel was filled in.
