**Air Branch Inspection Report  
Unannounced Full Compliance Evaluation  
Central Disposal Systems Incorporated**

21265 430<sup>th</sup>  
Lake Mills, Iowa 50450  
FRS# 110022726237

**Inspection Date(s):**  
May 25, 2023

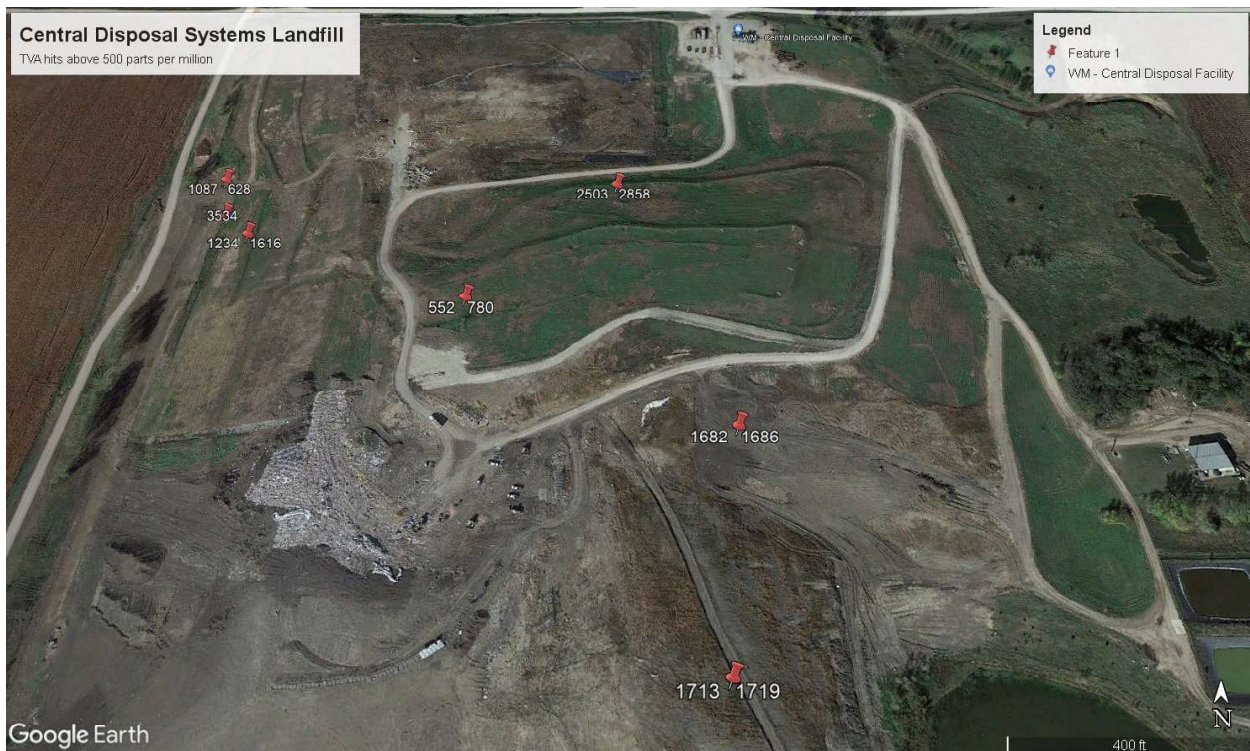
Figure 1. Areas surveyed with the Toxic Vapor Analyzer with respective methane values over 500 parts per million (ppm)

The inspection team conducted field measurements via Method 21 as required by 40 CFR 62 Subpart OOO. **Table 4** summarizes field measurements that were above the 500-ppm threshold for methane logged by the TVA only. Additional information can be found in the facility site folder. All environmental measurement activities were performed in accordance with the EPA Region 7 quality system. The team followed manufacturer and EPA processes for instrument calibration. Instrument calibration was documented on the calibration sheet located in the site file folder. The Irwin device 92004350 methane exceedances and other information logged by the Irwin device values can be found in **Appendix E**. The TVA methane values can be found in **Appendix A**. A total of 24 exceedances were found.

In a July 13, 2023, email the facility sent to me, the facility stated that it took corrective action for the exceedances EPA found during its inspection on May 25, 2023 and completed the re-monitoring required for the locations per 40 CFR 62.16720(c)(1).

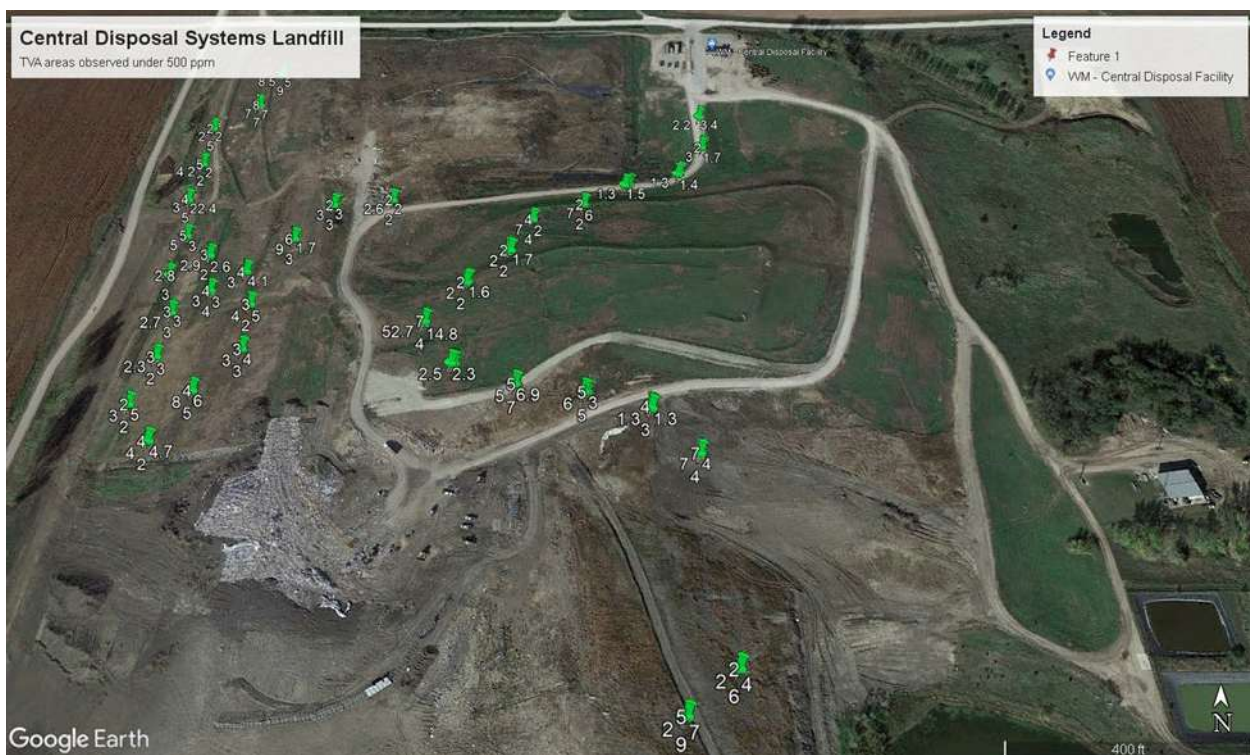
Figure 2. Areas surveyed with the TVA with respective values under 500 ppm.
