**Region 6 Compliance Assurance and Enforcement Division  
INSPECTION REPORT**

| Inspection Date(s): | June 28, 2018 | | |
| Media: | Drinking Water | | |
| Company Name: | Weston Water Supply Corporation (WSC) | | |

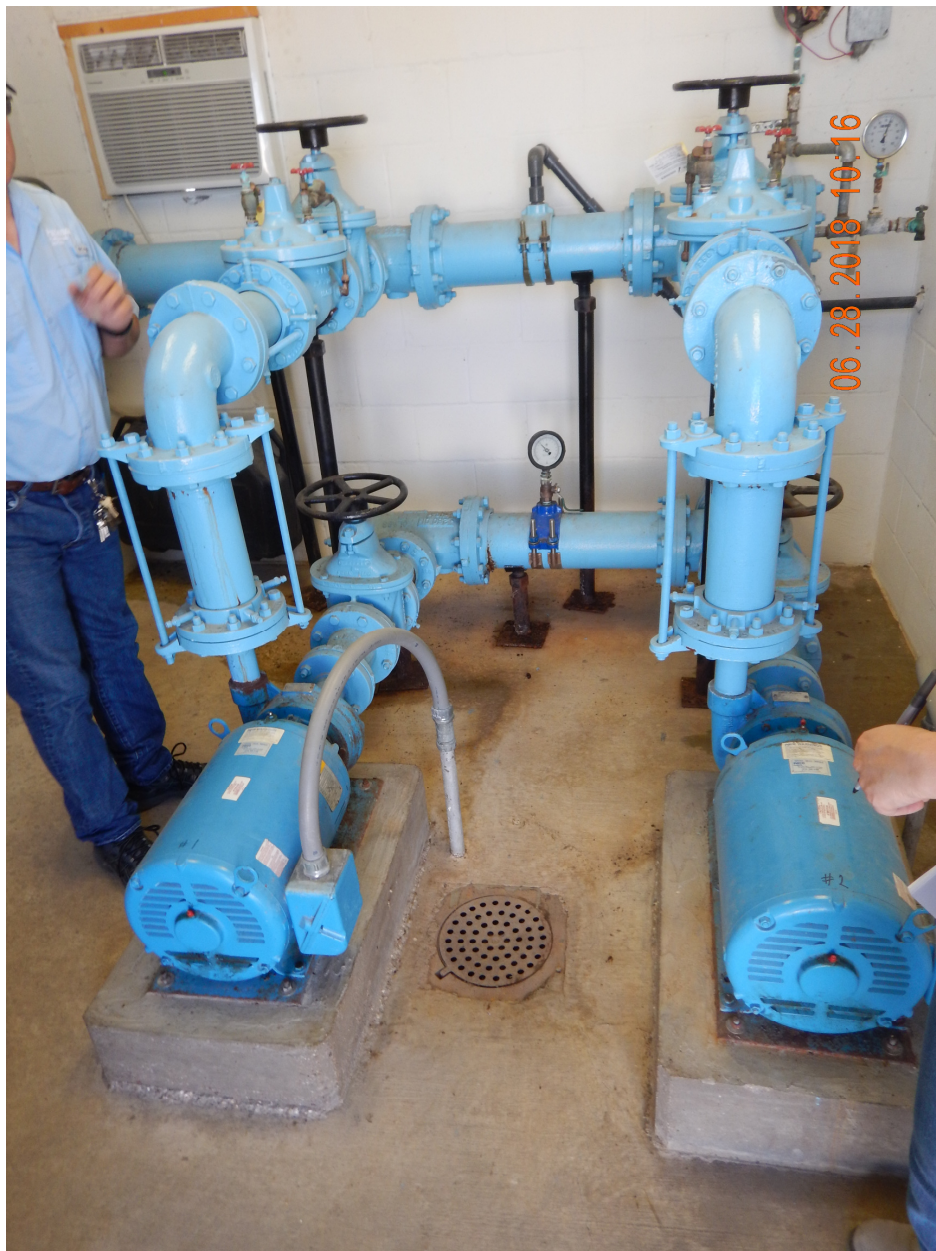
Photo No. 4

Description: Well House for booster pumps (two) with piping and appurtenances from GST to 30K gallon Elevated Storage Tank (located at another site).

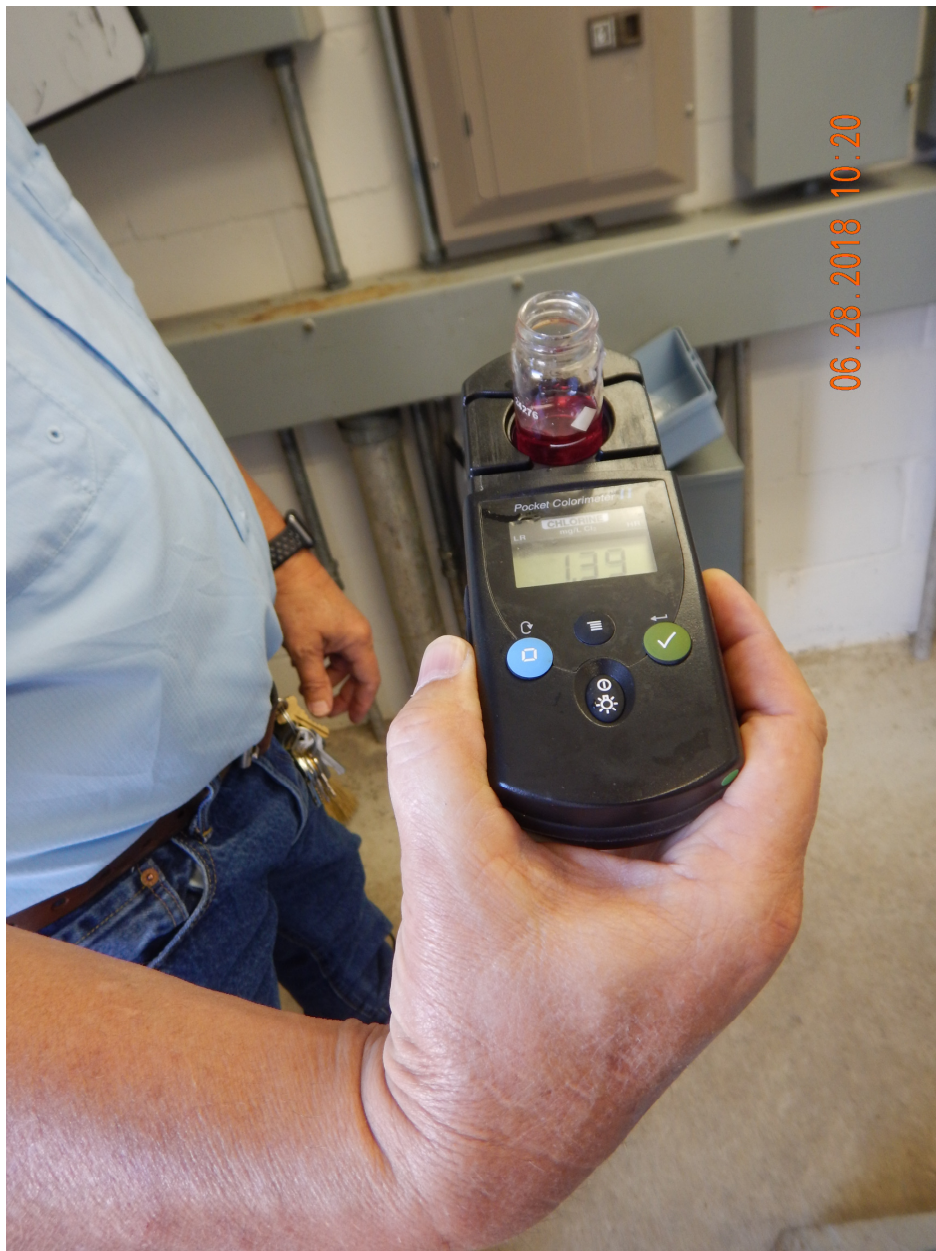
Photo No. 5

Description: Chlorine dose from well to GST at 1.39 Mg/l (ppm). Injection point prior to GST.

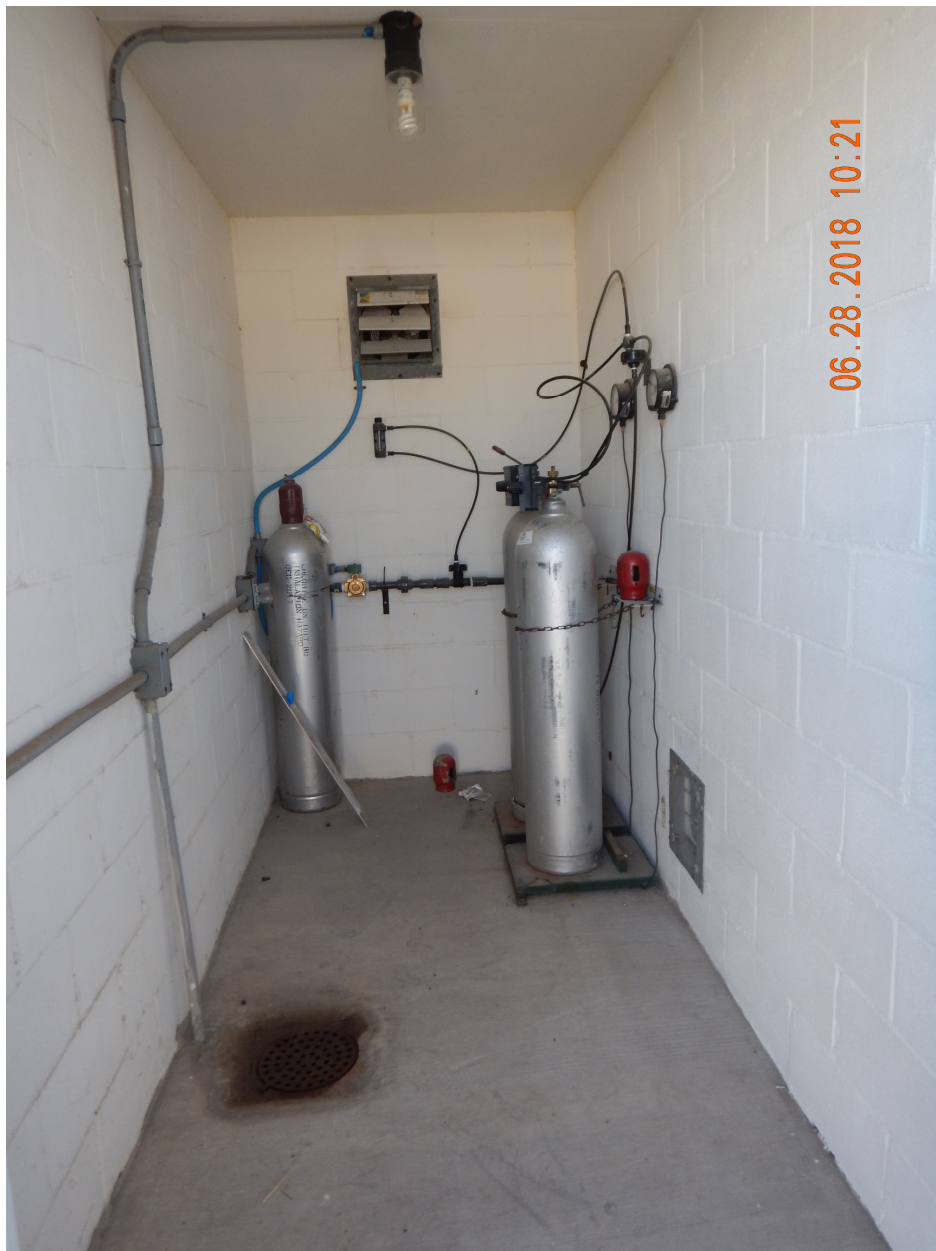
Photo No. 6

- 7) Confirm need to remove abandoned propane tank located at EST site.
- 8) One of the 150 lb. gas chlorine cylinders was observed to be unsecured at the well site.

Description: Disinfection Room. Three 150 lb. gas chlorine cylinders. Need to secure one unsecured cylinder as shown in photo to left. Recommend calibrating Cl cylinder scales per manufacturers recommendations and creating resulting SOP.

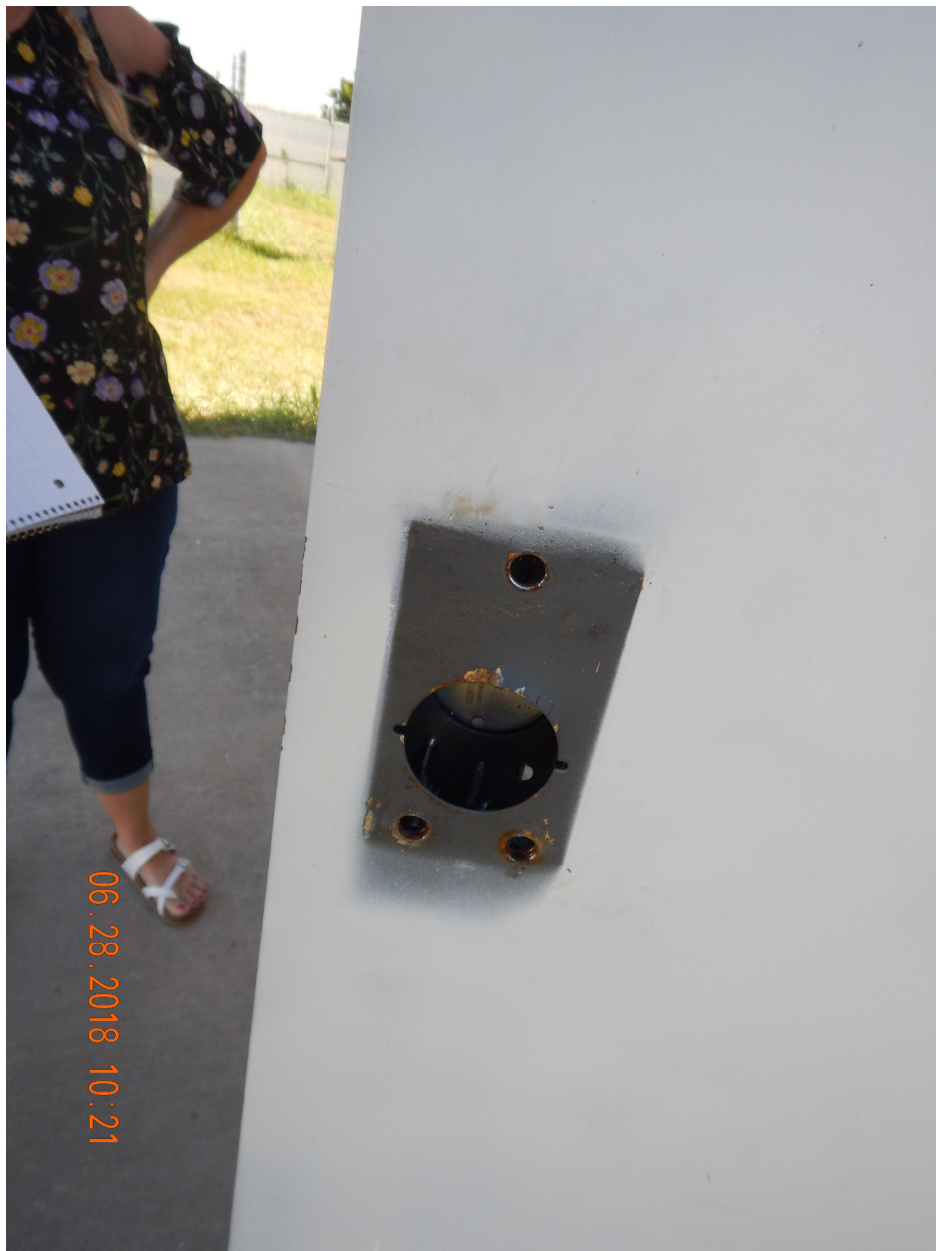
Photo No. 7

Description: Chlorine room door. Need to replace broken door with a new door with crash bar as required by Texas state law (TAC & TWC).

- Confirm need to replace broken Chlorine room door with a new door with crash bar as required by TCEQ.
- Recommend replacing the Well No. 2 sanitary seal gasket per manufacturer's recommendations, and create an SOP for this activity.
- Recommend calibrating gas chlorine cylinder scales per manufacturers recommendations and creating resulting SOP.
- Inspect well level pressure gauge and verify it needs to be replaced at well head.
- Remove tree overgrowth at EST Site fence.

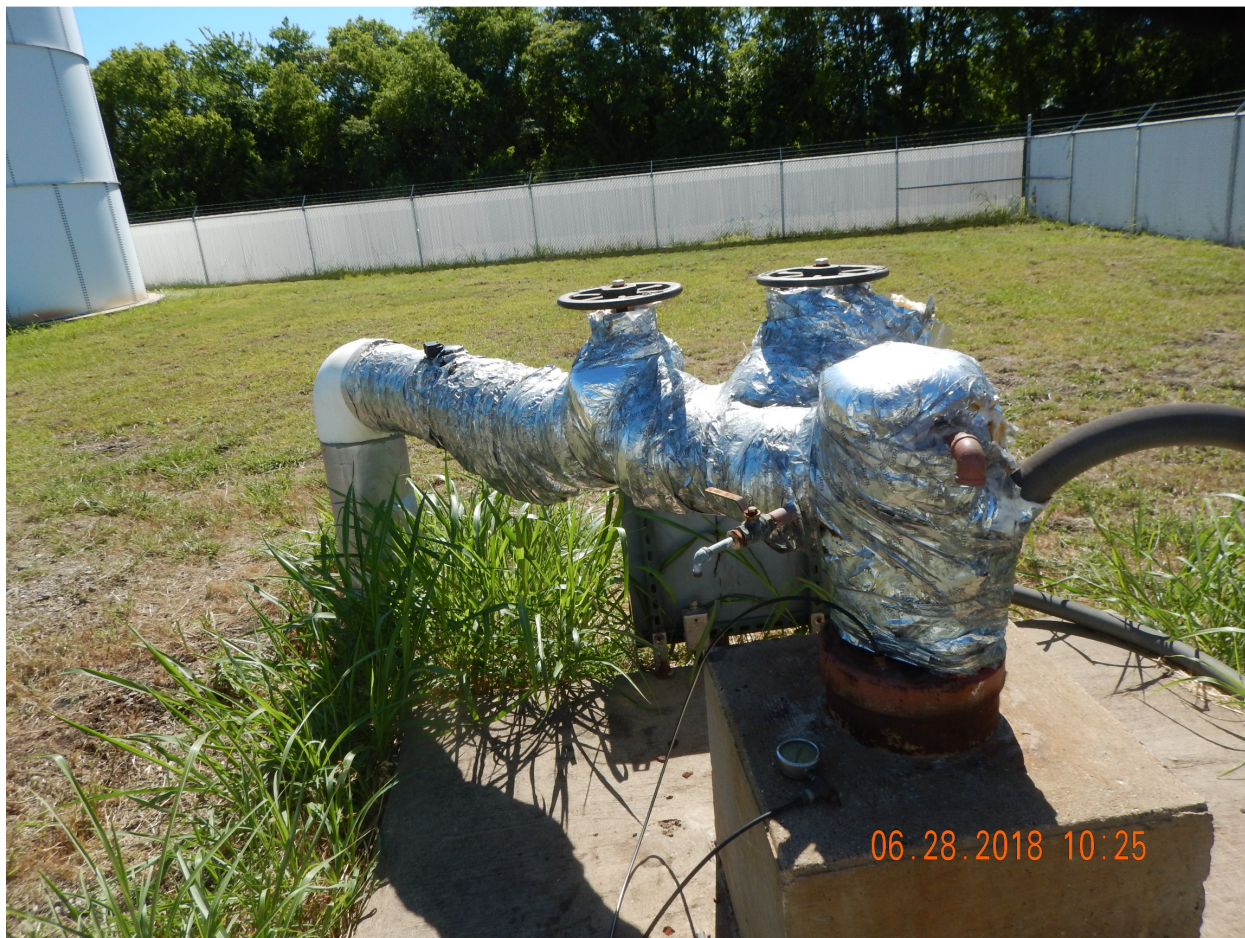
Photo No. 8

- Well head with sanitary seal, reference Photo #8.
- Sanitary seal; recommend replacing sanitary seal gasket per manufacturer’s recommendations.
- Submersible pump at 350 GPM that pumps the source water to the 60K gallon GST.
- Gas Cl injection point prior to the GST.
- Control valve.
- Foot valve.
- Blow off valve.
- Well sounder with airline and pressure gauge to measure well depth or water surface elevation.
- Pressure gauge glass observed to be cracked and broken and needs to be replaced.
- Flow meter.
- Raw water sample tap.
- Air vent with screen.
- Electrical supply in sealed conduit.
- Sufficient concrete pad(s).
- Well is insulated but otherwise exposed to the weather.

Description: Well head and system (raw water sample tap, control valve and blow off valve, flow meter, electrical to submersible pump etc.) to GST.

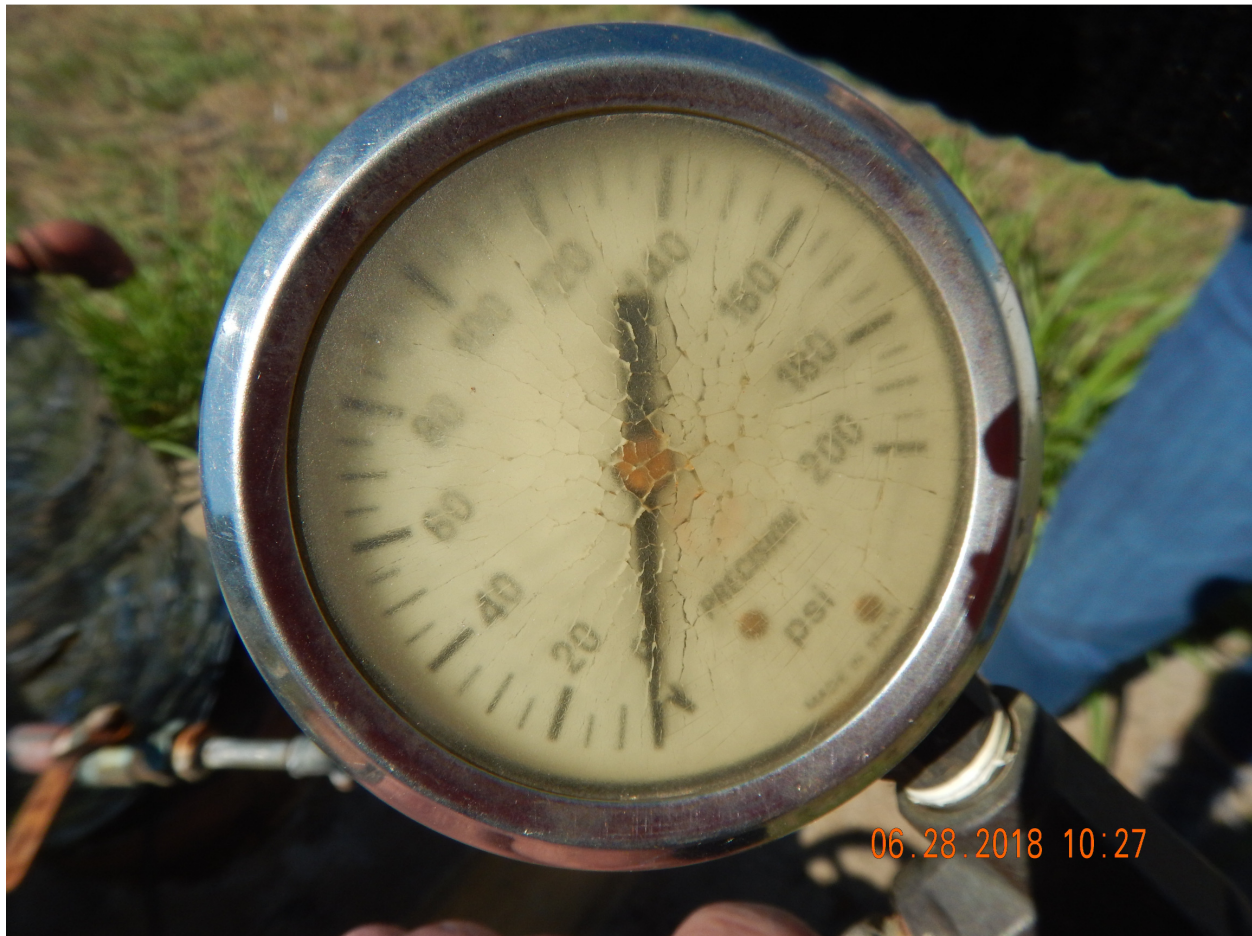
Photo No. 9

- 10) Pressure gauge glass observed to be cracked and broken and needs to be replaced at Well No. 1 site at GST, ref. Photo 9.

Description: Airline Pressure Gauge to measure the water level or draw down level in the well. Confirm Pressure gauge needs replaced.

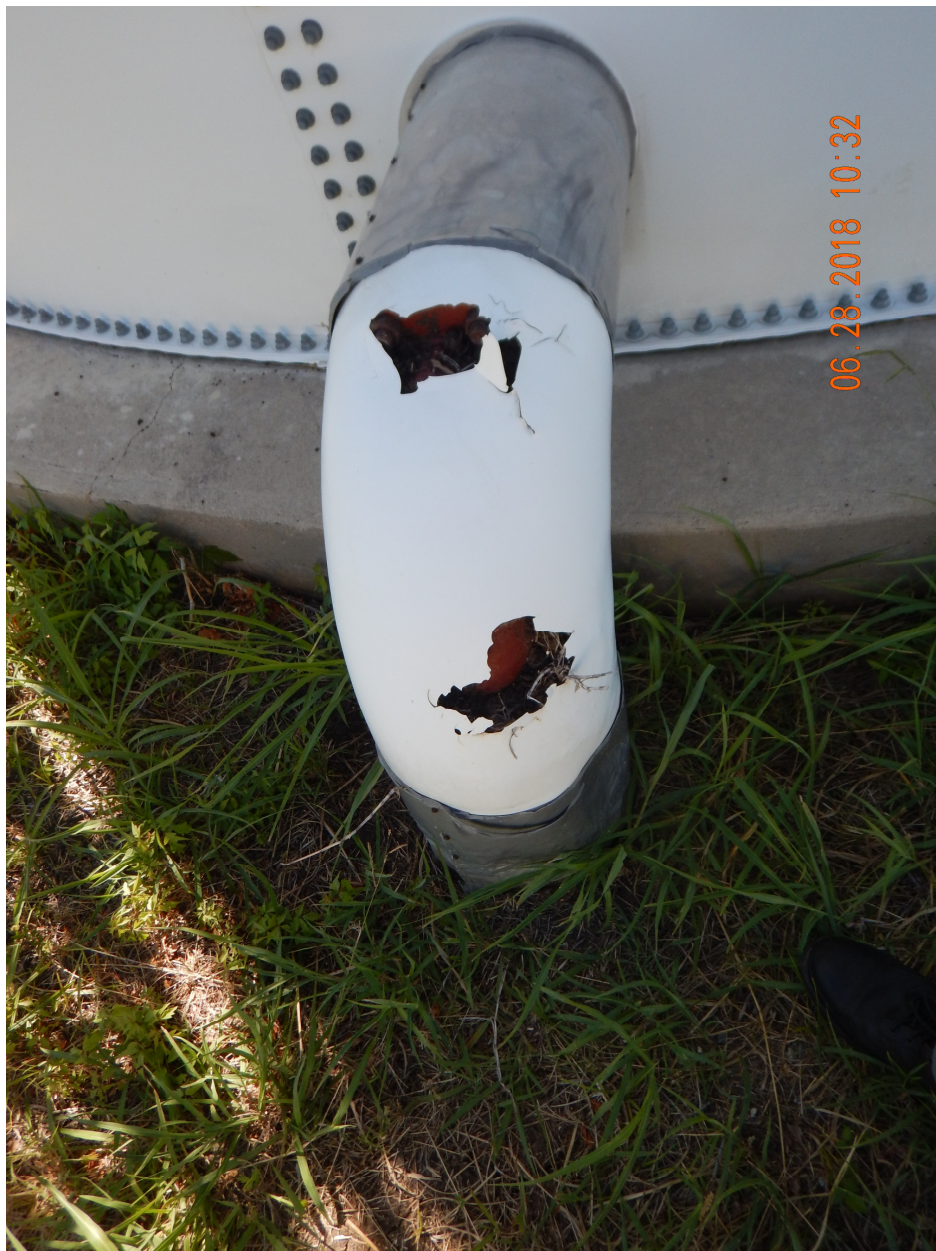
Photo No. 11

Description: Pipe from GST to booster pumps. Recommend replacing with new insulation.

- Suggest using design plans and specifications by licensed engineer to address above concerns Nos. 1 to 7.
- Pipe from GST to booster pumps - suggest replacing with new insulation, reference Photo 11.
- EST overflow flap valve. Confirm need for a concrete pad.
- Develop and implement an asset management plan with work order system to operate at the lowest possible cost.

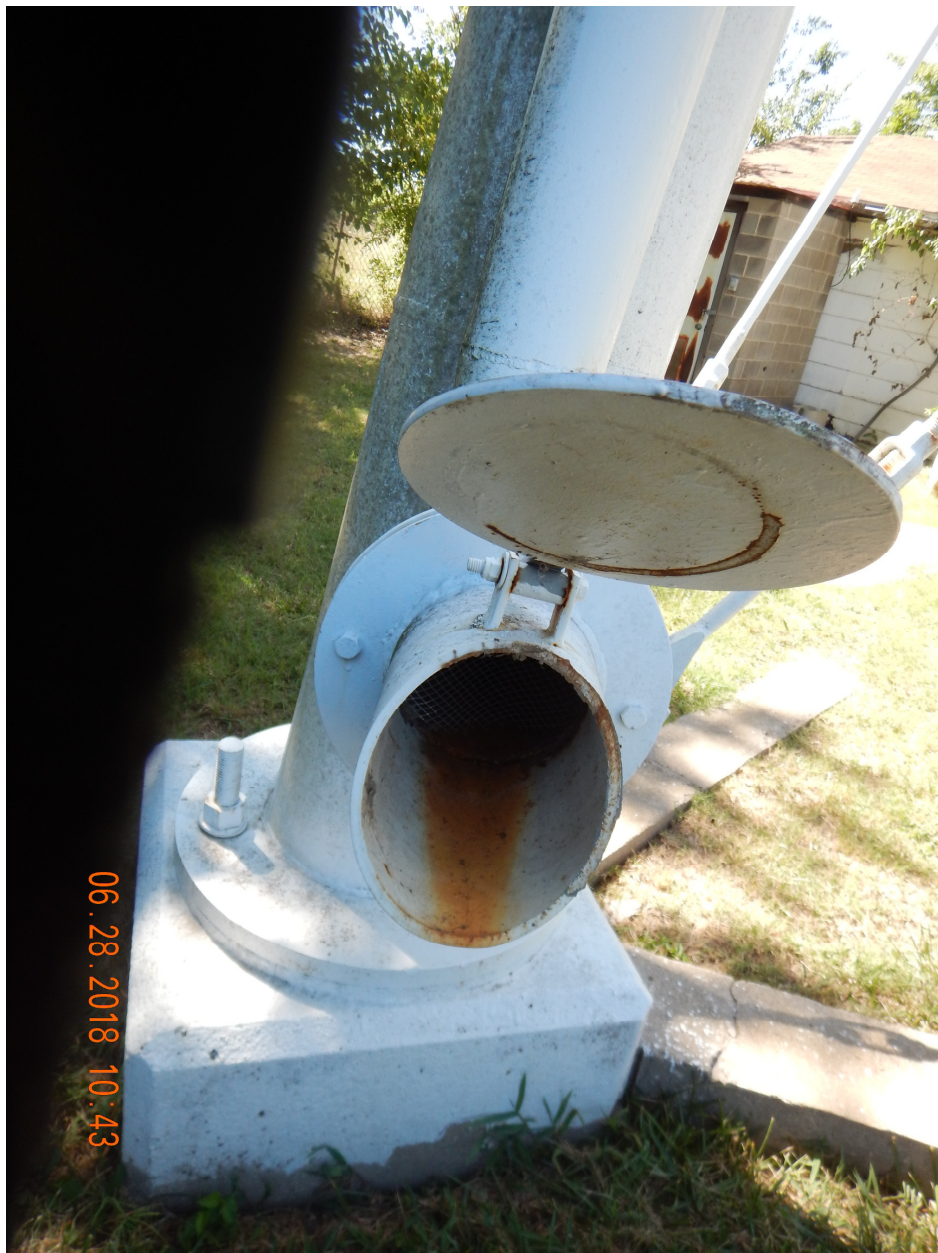
Photo No. 14

Description: EST overflow flap valve. Confirm needs concrete pad.

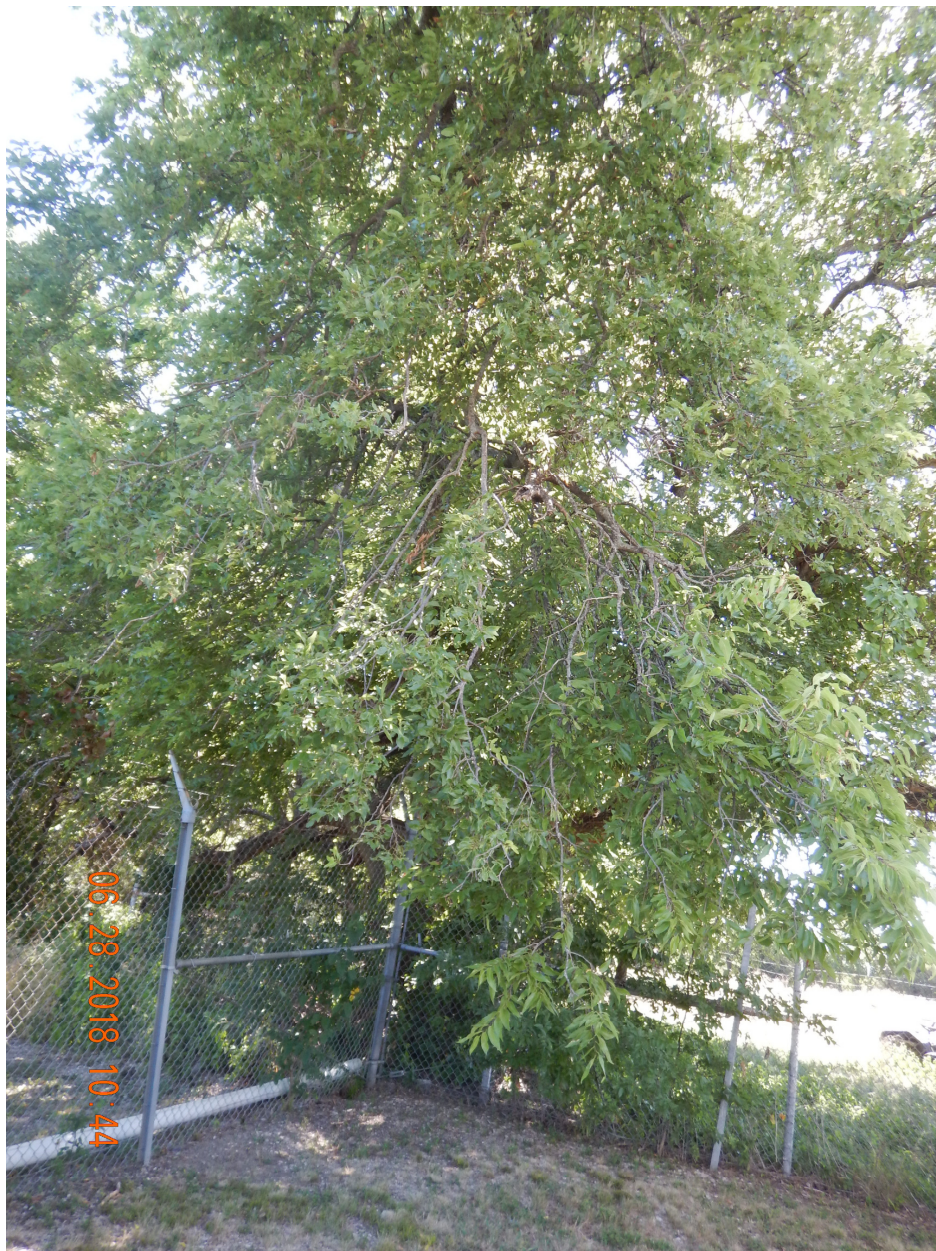
Photo No. 15

Description: Tree overgrowth example at EST Site,

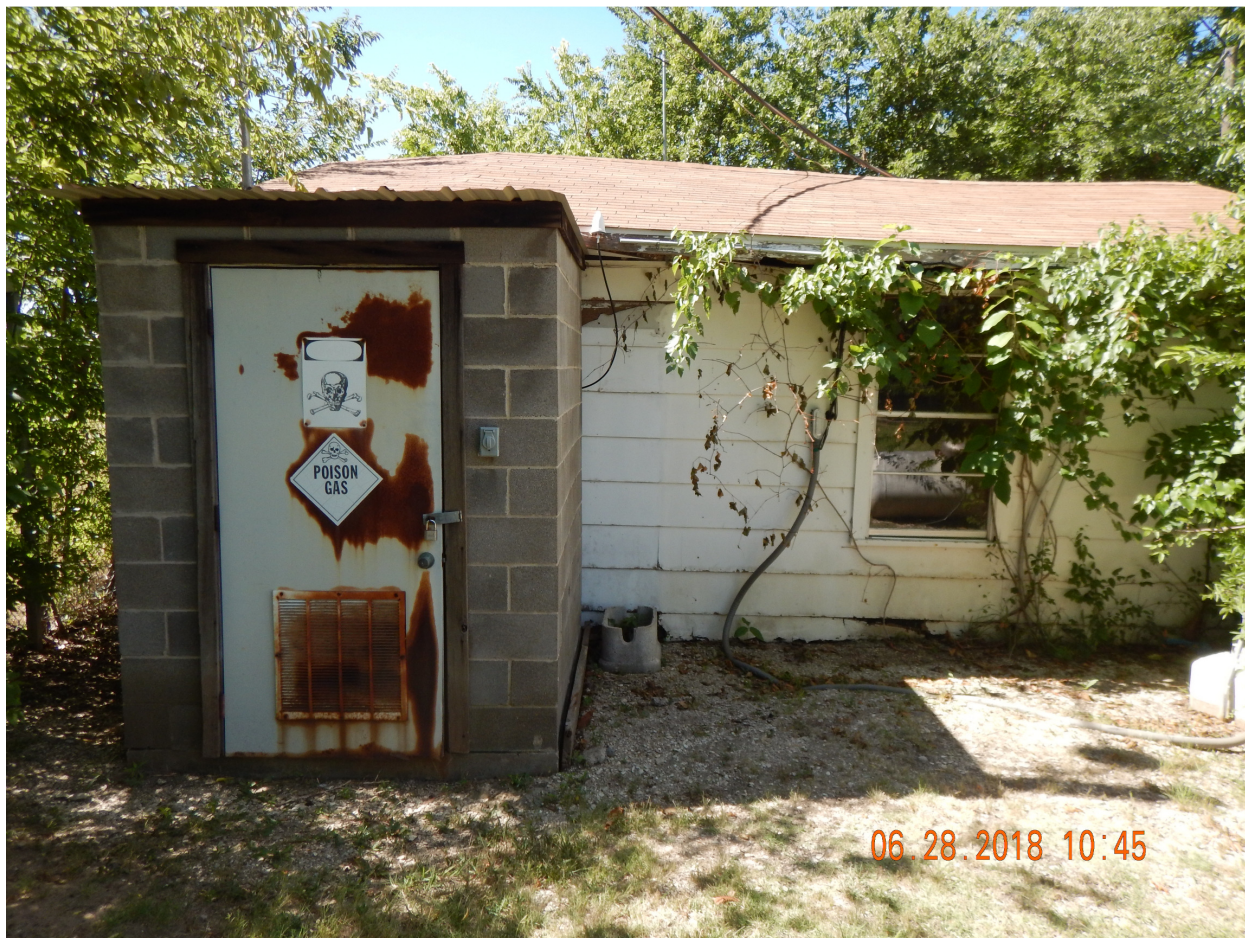
Photo No. 16

Description: Abandoned Well house. Need to demolish and remove well house and chlorine room. Need to abandon existing well per Texas law (16 TAC Chapter 76.1004 well plugging specifications) and submit a State of Texas Plugging Report. Reference web-address: <https://www.tceq.texas.gov/agency/other-jurisdiction/abandoned-wells.html>. Confirm well piping, including to GST, is cut plugged and abandoned to prevent any cross connections. Need to remove SCADA equipment currently in existing building and move to new SCADA building. Recommend using design plans and specifications by licensed engineer.

- 1) Weston WSC needs to demolish and remove abandoned Well No. 1 well-house and chlorine room at the EST site.
- 2) Confirm Weston WSC needs to abandon existing Well No. 1 per Texas law (16 TAC Chapter 76.1004 well plugging specifications) and submit a State of Texas Plugging Report. Reference web-address: <https://www.tceq.texas.gov/agency/other-jurisdiction/abandoned-wells.html>.

- 5) Need to remove SCADA equipment currently in existing abandoned building and move to new SCADA building (ref. Photos # 16 & 20).
- 6) Abandoned valves under particle board: confirm need to cut, plug, and abandon valves as needed to prevent any cross connections. Need to properly fill hole with compacted soil and grade to existing ground surface elevation, ref. Photo No. 17.

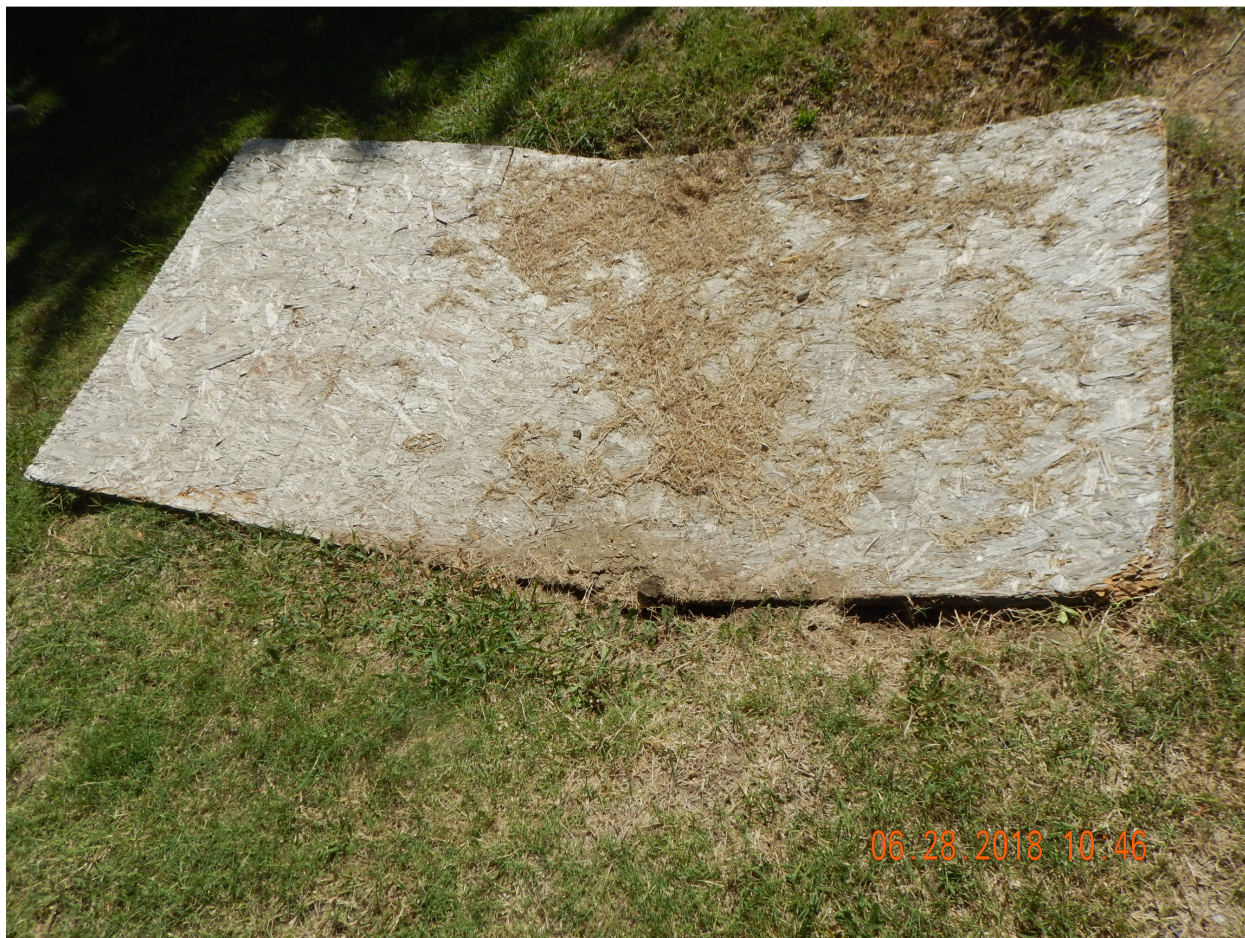
Photo No. 17

Description: Abandoned valves under particle board. Need to cut plug and abandon valves as needed to prevent any cross connections. Need to properly fill hole with compacted soil and grade to existing ground surface elevation. Recommend using design plans and specifications by licensed engineer.

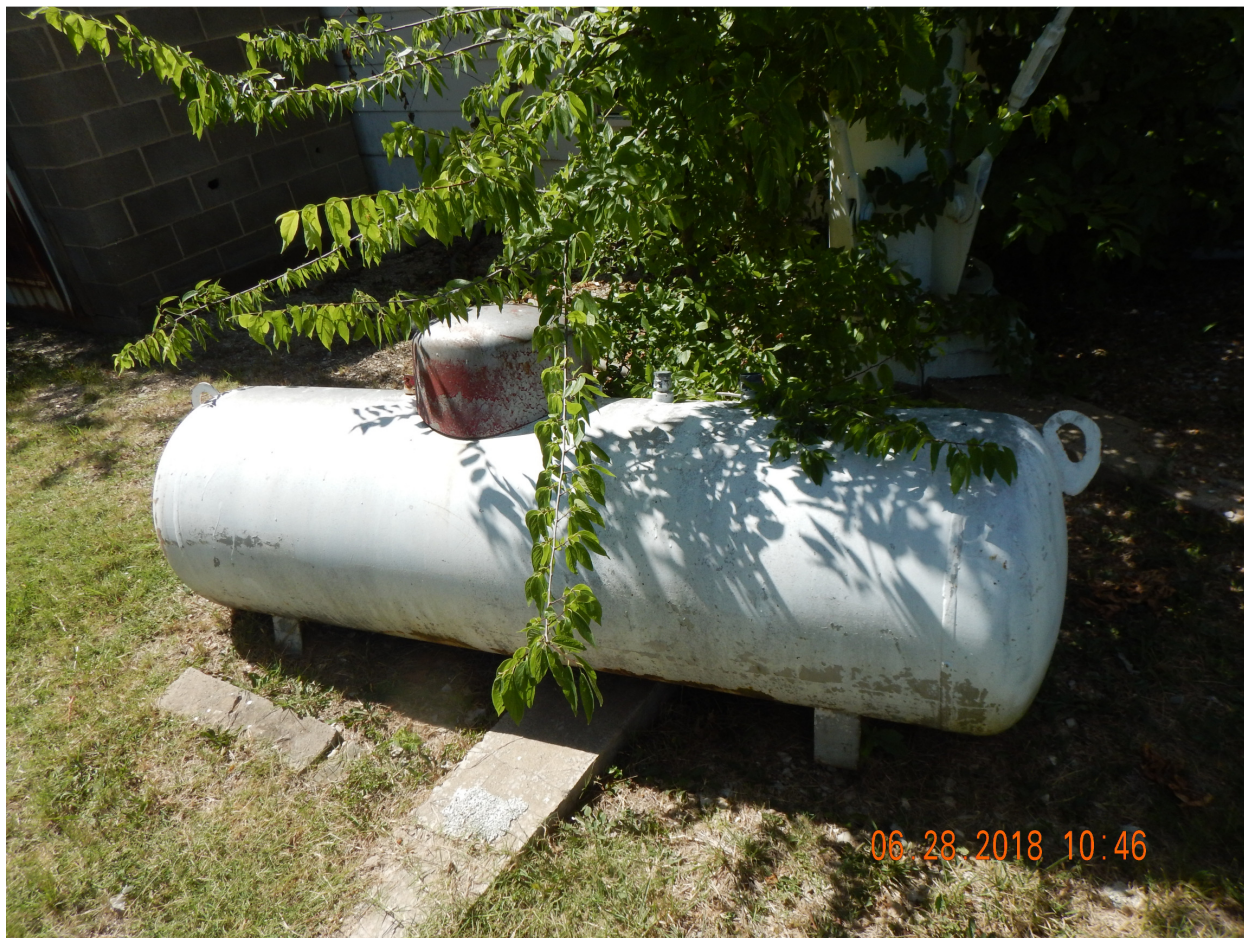
Photo No. 18

Description: Need to remove abandoned propane tank.

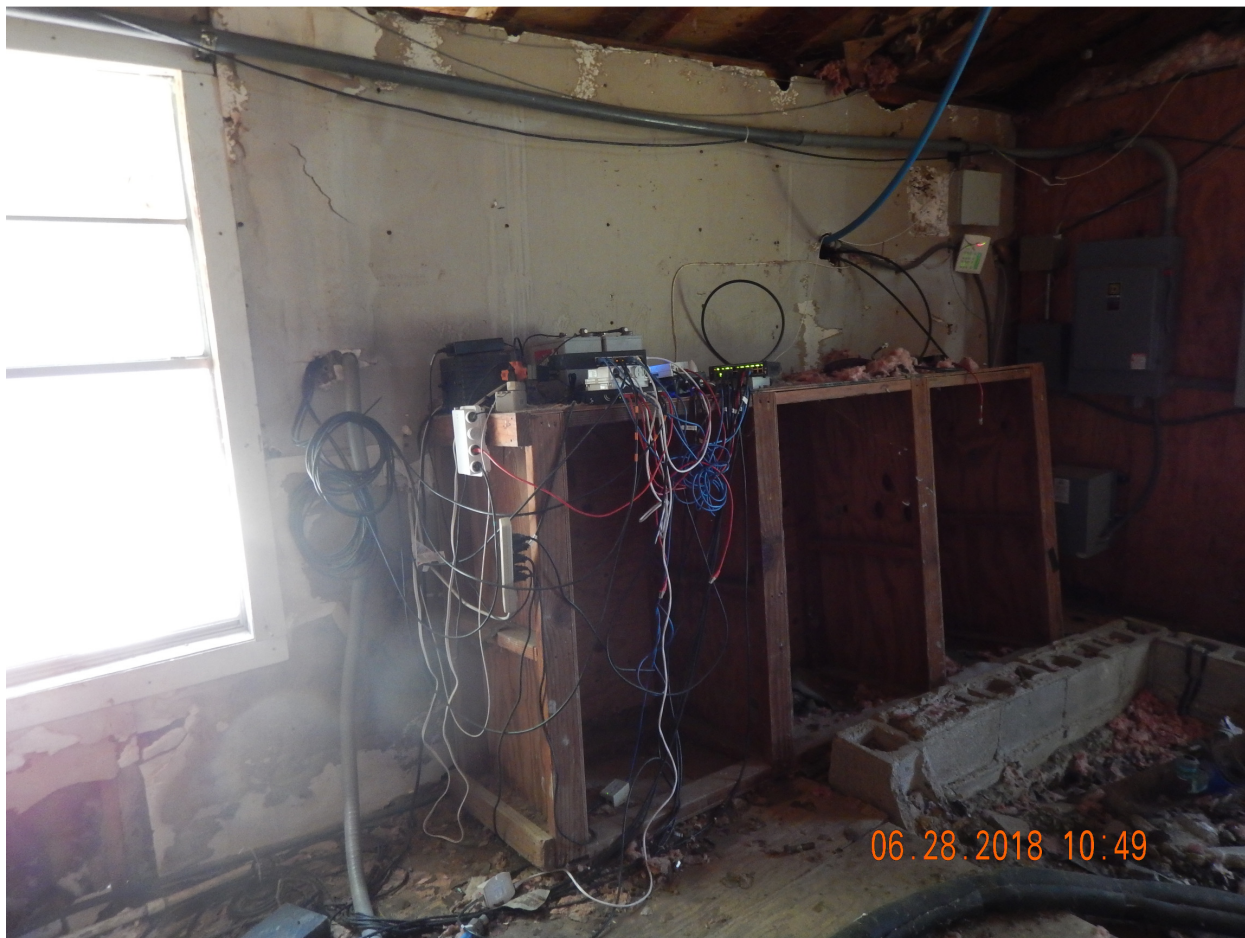
Photo No. 20

Description: Abandoned well house inside view with existing SCADA as shown. Need to remove SCADA equipment currently in existing building (to be demolished) and move to new SCADA building. Recommend using design plans and specifications by licensed engineer.

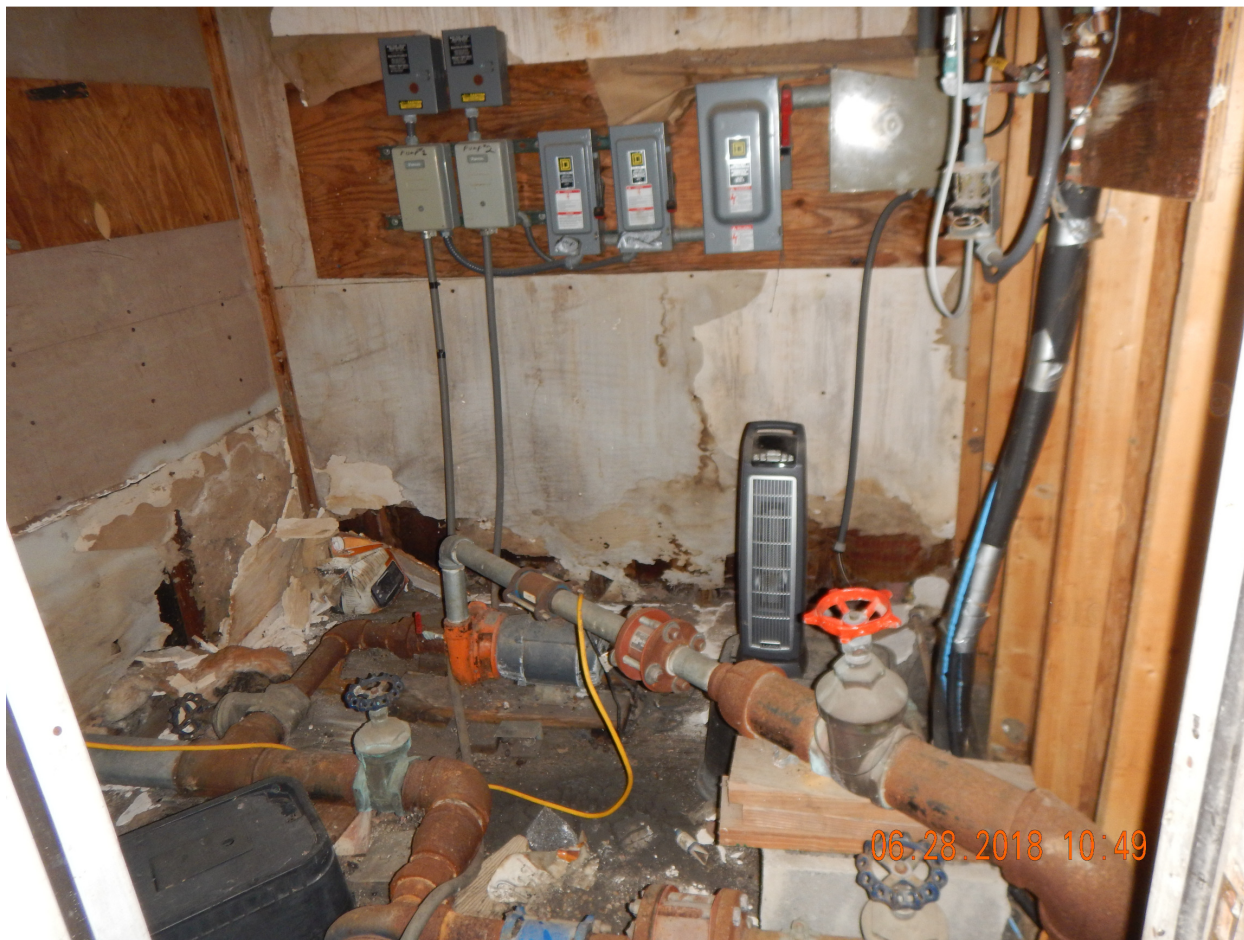
Photo No. 21

Description: Existing and abandoned well system needs to be removed. Need to abandon existing well per Texas law (16 TAC Chapter 76.1004 well plugging specifications) and submit a State of Texas Plugging Report. Reference web-address: <https://www.tceq.texas.gov/agency/other-jurisdiction/abandoned-wells.html> Confirm well piping, including to GST, is cut plugged and abandoned to prevent any cross connections.

- 3) Confirm abandoned Well No. 1 piping, including to GST, is cut plugged and abandoned to prevent any cross connections.
- 4) Confirm need to remove abandoned steel GST located at EST site and plug from DS as appropriate to prevent any cross contamination or cross connection.

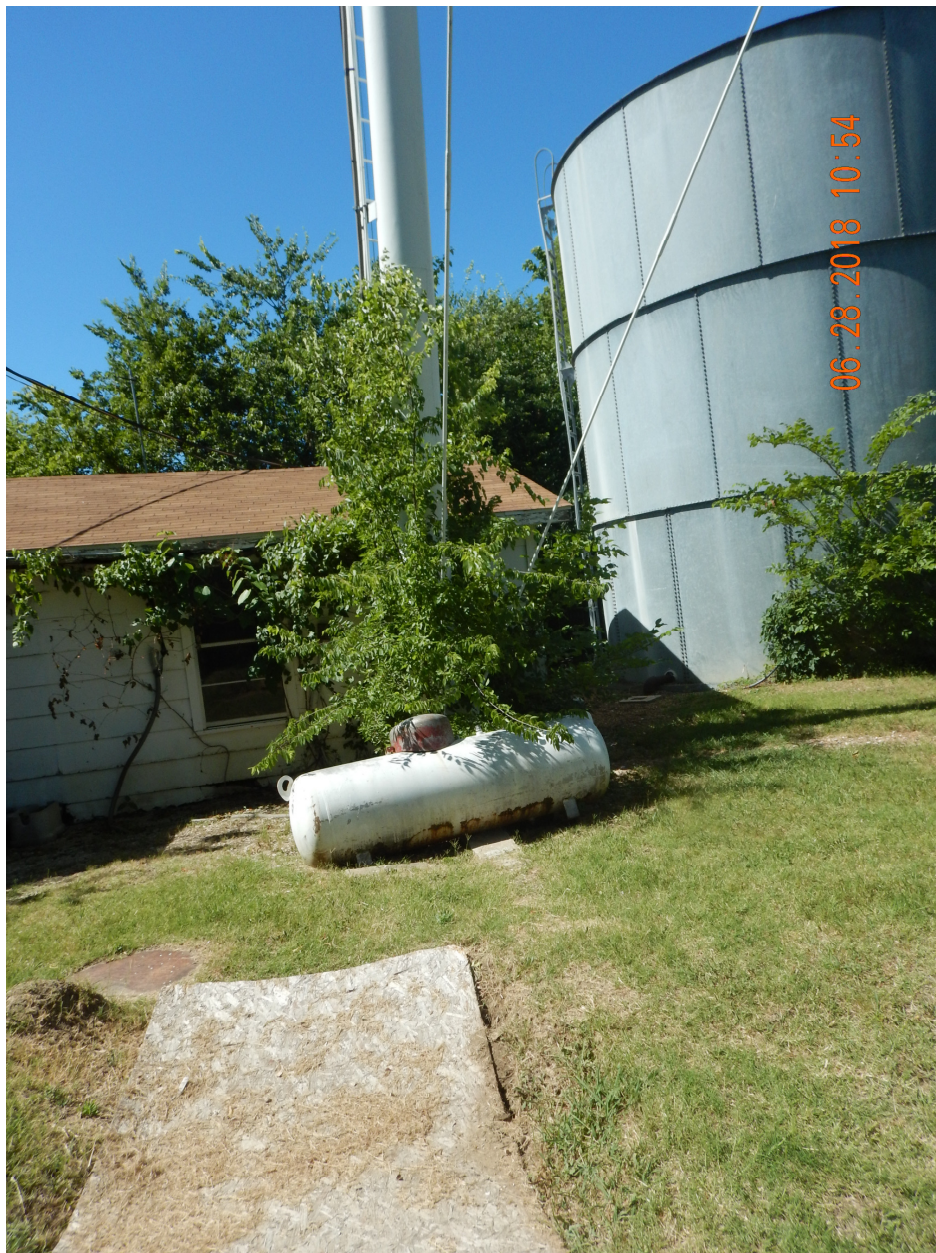
Photo No. 22

Description: Abandoned GST to be removed shown to right of photo.
