# Manufacturing Chemists' Association, Inc.

August 1965 Issue

SUBJECT: Case Histories of Accidents (including Fires and Explosions)

### SUBJECT: Case Histories of Accidents (including Fires and Explosions)

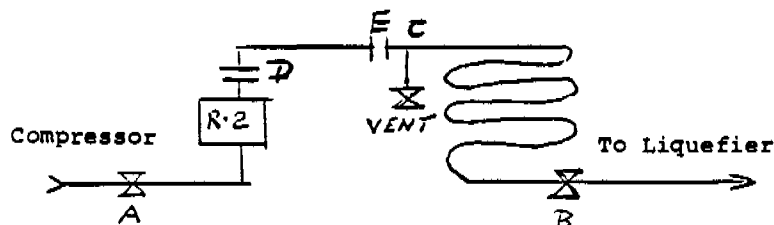
Description: A rugged converter had been shut down, block valved from the system, and depressurized in order that the catalyst could be replaced. As the operator loosened one bolt on flanged spool "E", a small flow of gas was heard. He then tightened valve "B" further and the gas flow stopped. Two operators then removed all bolts and disconnected flanged spool "E". They then began disconnecting flanged spool "D". When all but one bolt had been removed, one operator walked away. At that time gas suddenly surged and ignited, severely burning the other operator on arms and legs.

Cause: Failure of valve seat due to thread on seat being tapered.

1. Entire plant to be shut down and system depressurized before start of maintenance work.
2. Installation of double block valves, with bleeder valve between.
