**Region 6 - Enforcement & Compliance Assurance Division**  
**INSPECTION REPORT**

| Inspection Date(s): | 12/11/2024 | |
| Company Name: | <b>Merit Energy Company, LLC</b> | |
| Facility Name: | <b>Dewey Dean No. 2-8</b> | |

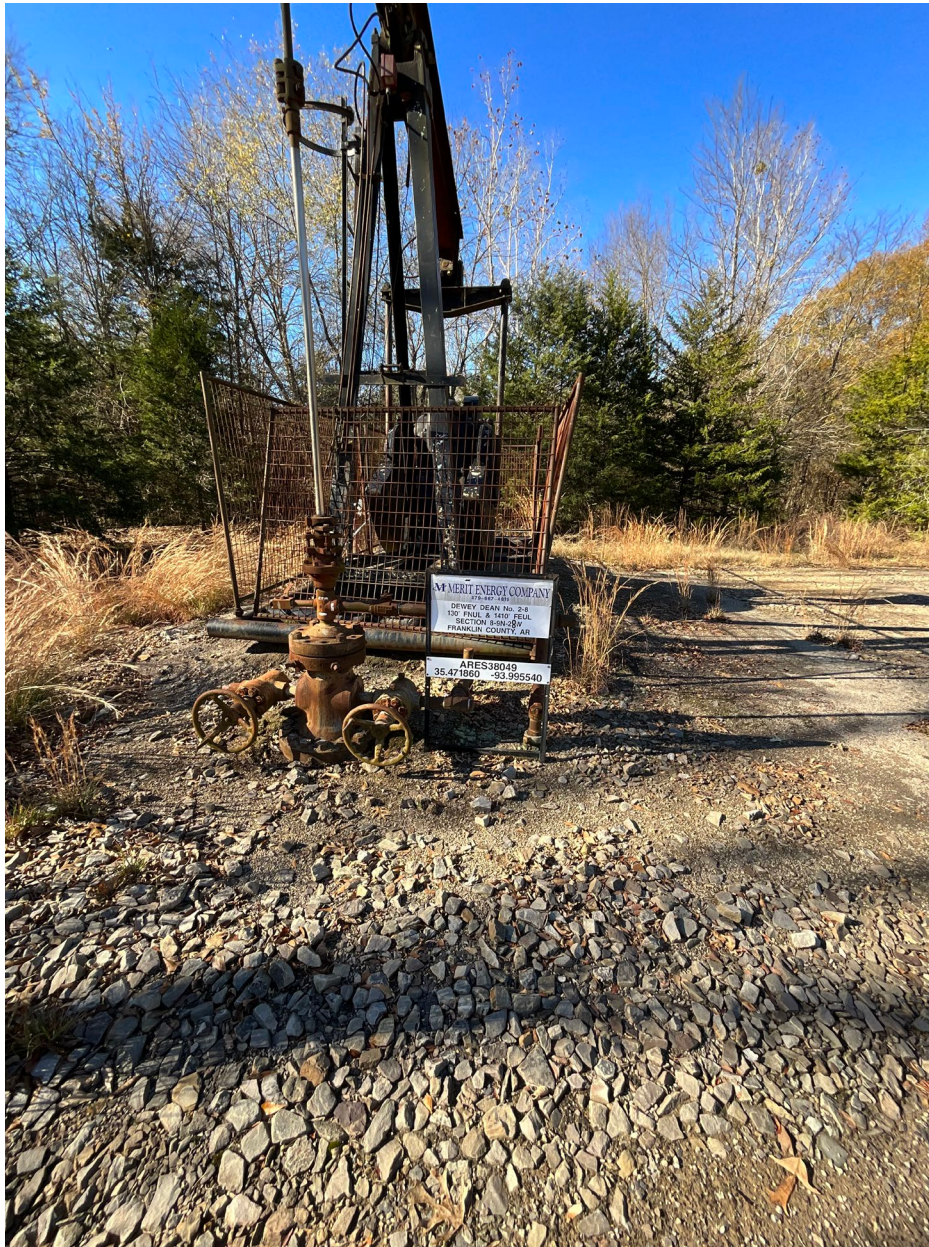
Photo No. 1

**Description:** Looking west, this photo shows the sign at the facility.

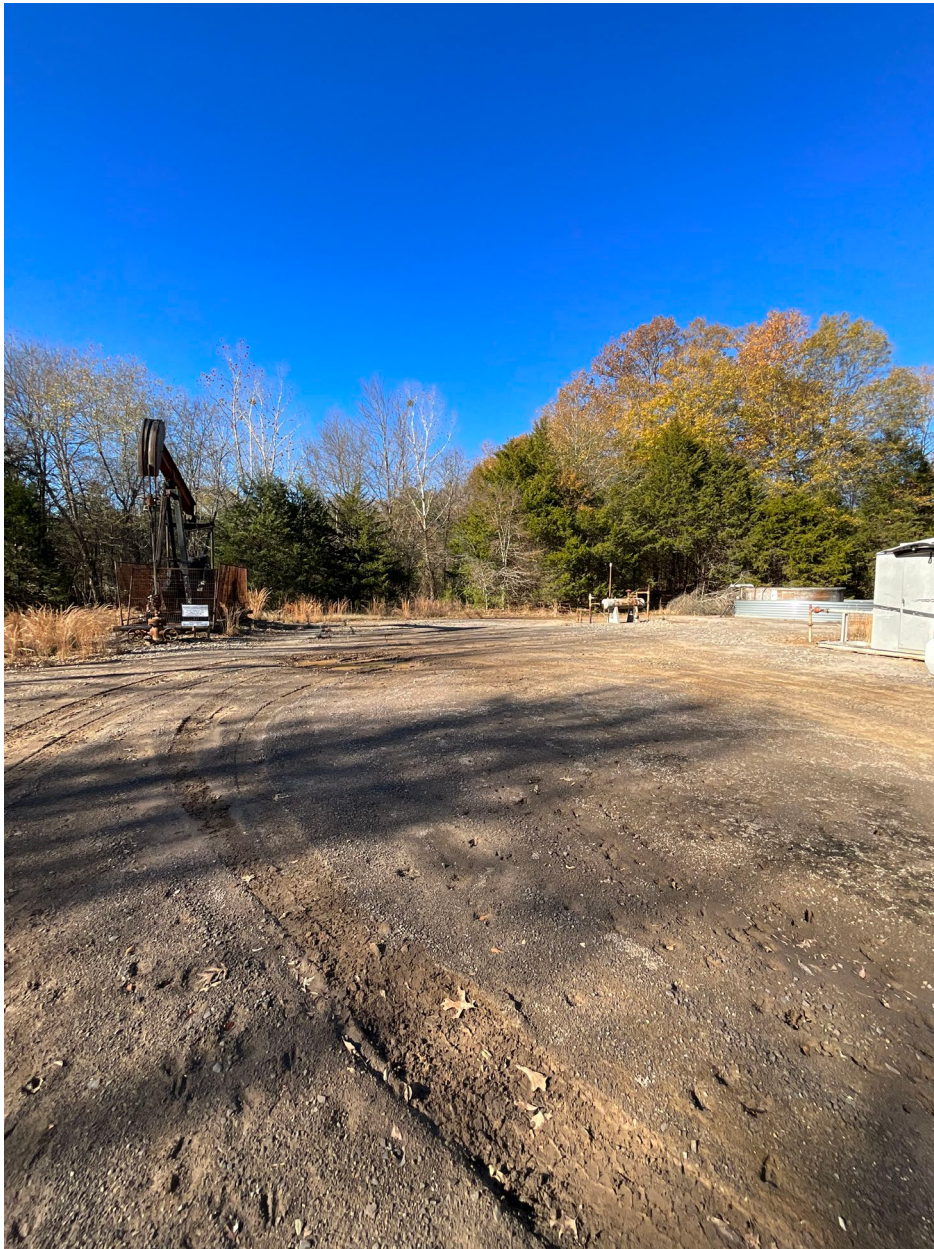
Photo No. 2

**Description:** Looking northwest, this photo shows an overview of the facility.
