REPORT OF COMPLIANCE EVALUATION INSPECTION  
(INDUSTRIAL STORMWATER)

**Alter Trading Corporation/Alter Metal Recycling-Columbus**

Authorization Number: **ISW-202201042**

**July 30 and August 2, 2024**

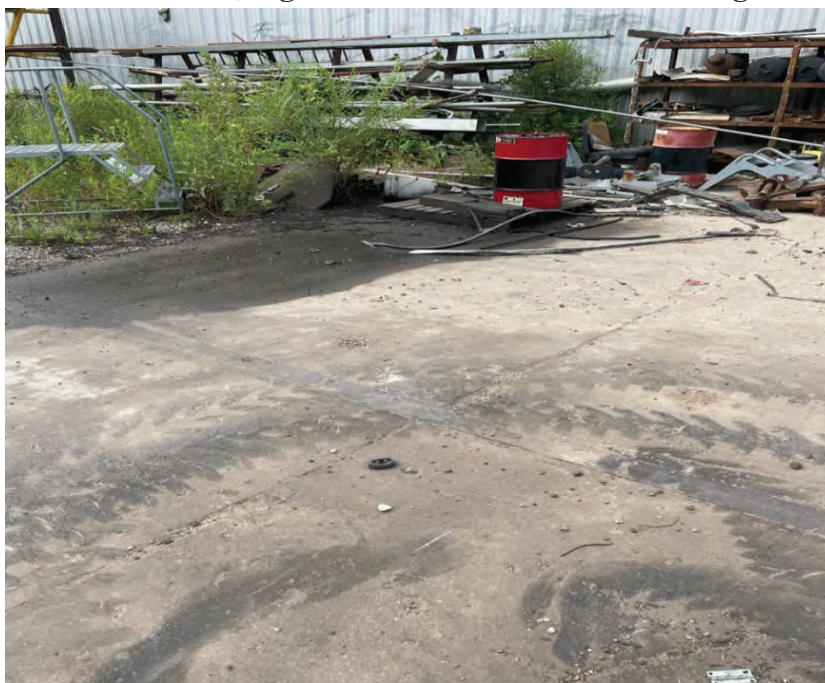
1. The Nebraska National Pollutant Discharge Elimination System (NPDES) General Permit (ISW-GP) number ISW-202201042 was issued on October 6, 2022 (Attachment 2), and will expire on March 31, 2027 (expiration date of all ISW-GPs for stormwater discharges associated with industrial Activity to waters of the state of Nebraska).
2. I issued Notice of Preliminary Finding number 1 (NOPF #1) because at the time of the inspection we observed a significant amount of fluids (used oil/hydraulic fluids) on the concrete pad on the east side of the maintenance shop. The spill appeared to be caused by leaking drums and by site personnel conducting vehicle/equipment maintenance outside the maintenance shop without taking any spill control measures. Photo shows the amount of fluid on the ground.

**Photo 39, Significant amount of fluids on the ground**

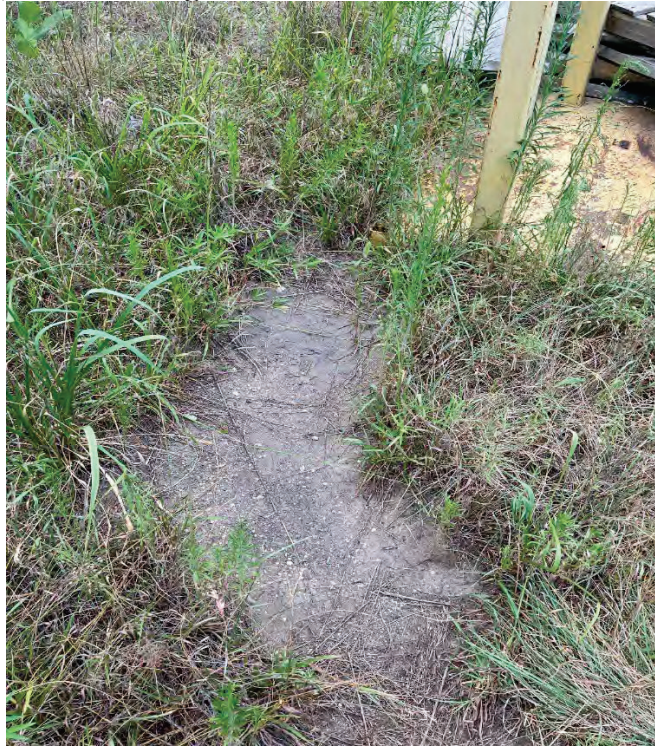
We also observed a trace of significant ground discoloration within a few feet from the spill leaving the site from beneath the east fence as shown in photo 42. Mr. Rosenbaum mentioned that he was not aware of such activities taking place.

**Photo 42, Evidence of ground discoloration caused leaving the site.**

The SWPPP identifies one outfall as Outfall 01. However, during the inspection we observed at least two additional discharge points. The discharge point upstream from Outfall 01 at the south fence line, and the discharge point on the east side of the maintenance shop along the east fence line where we observed trace of oil leaving the site. The SWPPP must identify all discharge points.

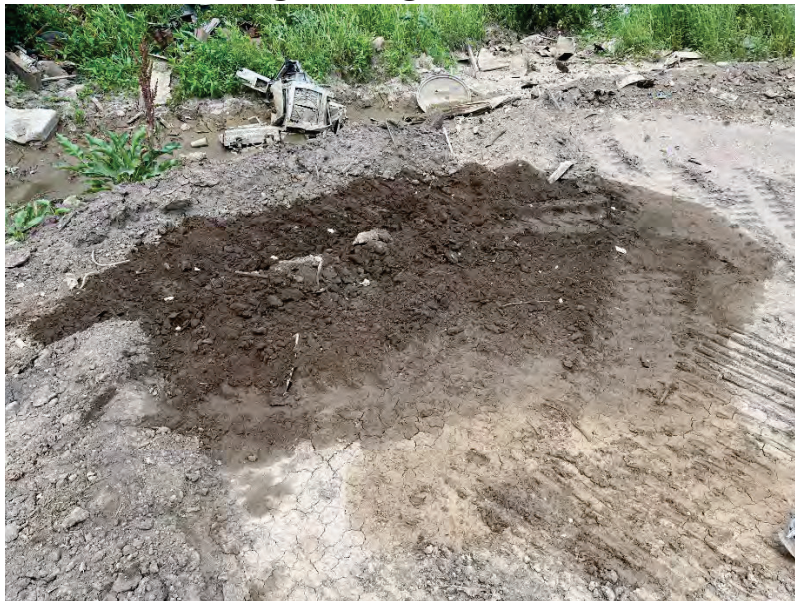
3. I issued NOPF#2, because there were at least two locations where we observed significant ground discoloration (photos 15 and 32).

**Photo 32 significant ground discoloration**
