**CLEAN WATER ACT INSPECTION REPORT  
U.S. ENVIRONMENTAL PROTECTION AGENCY  
REGION 5**

**Purpose:** Pretreatment Industrial User (IU) Inspection

**Facility:** Dynomax, Inc.  
230 W. Palatine Road  
Wheeling, Illinois 60090

**Date of Inspection:** February 13, 2024

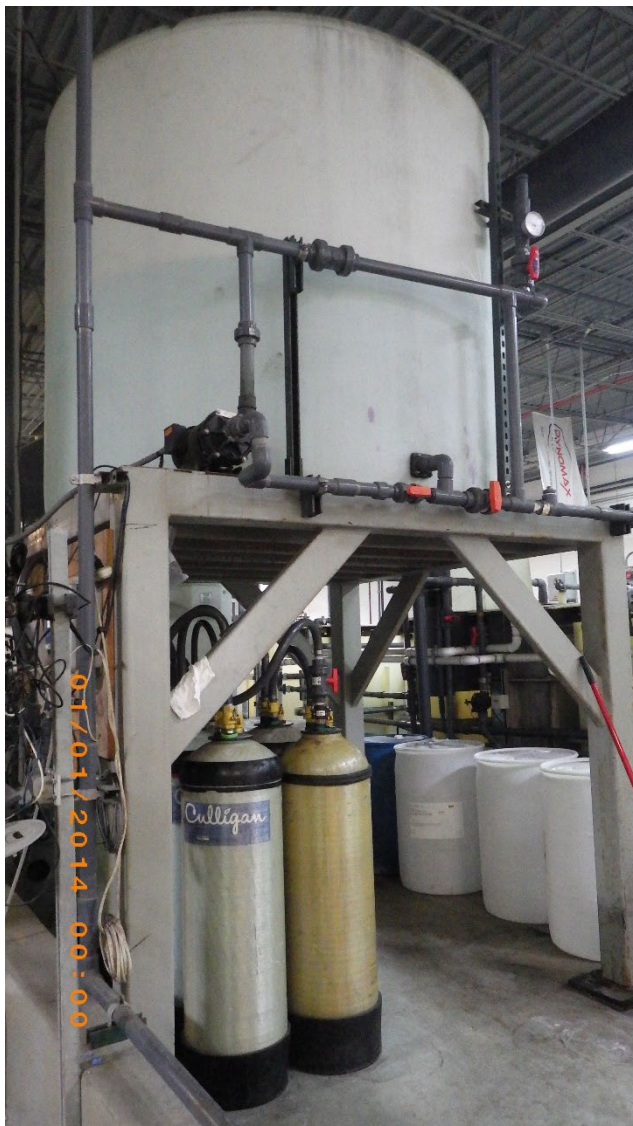
1: RIMG0147

- **Resins for DI Water**
  - DI tanks hold approximately 2,000 gallons of water. (Photo 1).
- **Metal Finishing Area**
  - Spent acid tanks are pumped into the Chrome EQ tank at a rate of 1-2 gallons per minute.
  - Treated cyanide holding tank is a sampling location for internal use.
  - There are three (3) scrubbers, Chrome scrubber, Cyanide Scrubber, and EN scrubber. These discharge to the respective treatment lines.
- **Chrome Treatment**
  - 2 pH probes in Tank 1 and only the holding tank gets agitated.
  - 716 reducer and sulfuric acid pumps.
  - All sump pumps that lead to the Chrome Treatment start at the Chrome Equalization tank (Photo 3).
- **Acid Alkaline Treatment**
  - Once Neutralization 1 overflows, discharges to Neutralization 2, which overflows to Neutralization 3 and final pH.

Description: DI water holding tank and resins

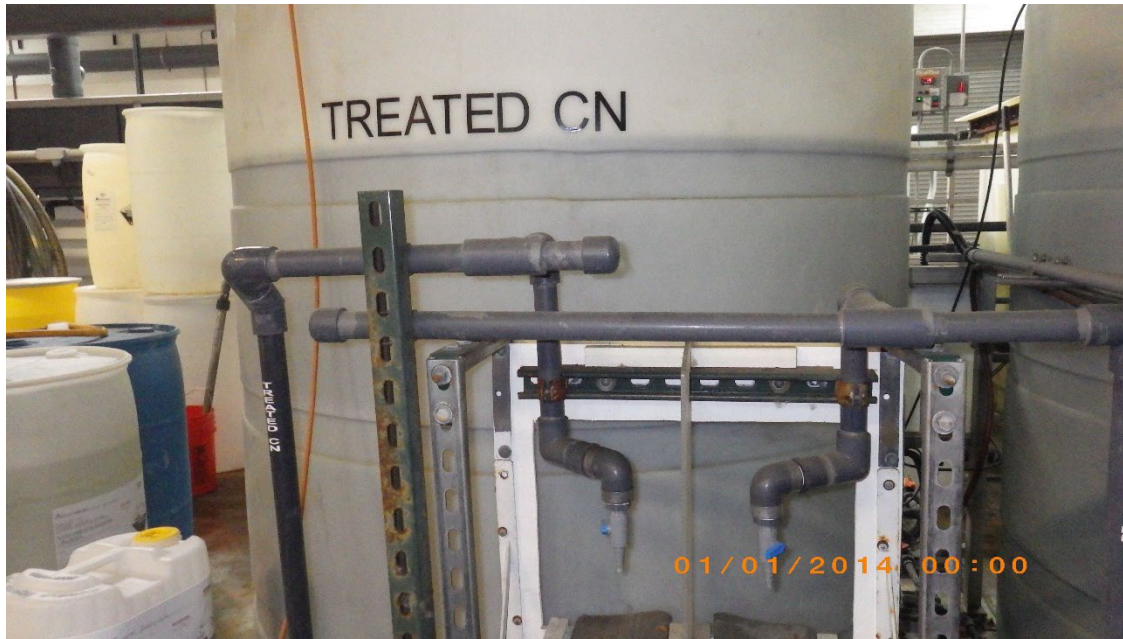
2: RIMG0148

Description: Treated cyanide waste in left tank, non-cyanide plating waste on right side

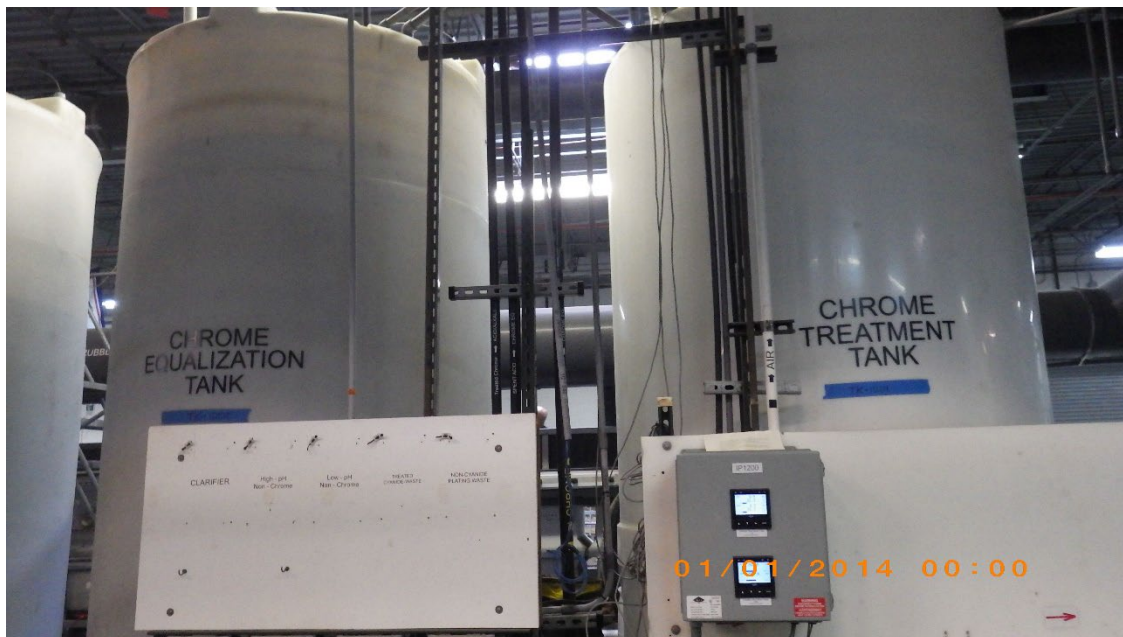
3: RIMG0149

Description: Chrome equalization tank on left (first tank of Chrome Treatment) and Chrome Treatment Tank, which is pumped to Acid Alkaline Treatment

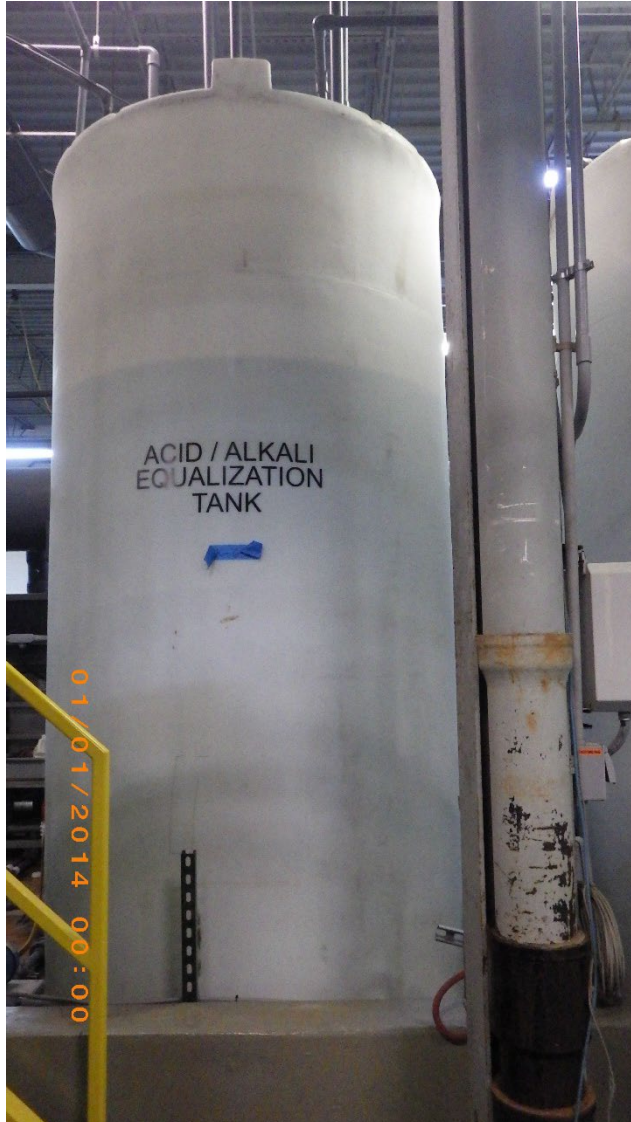
4: RIMG0150

Description: Acid Alkaline Treatment tank, all sump pits and Chrome Treatment discharge to this tank

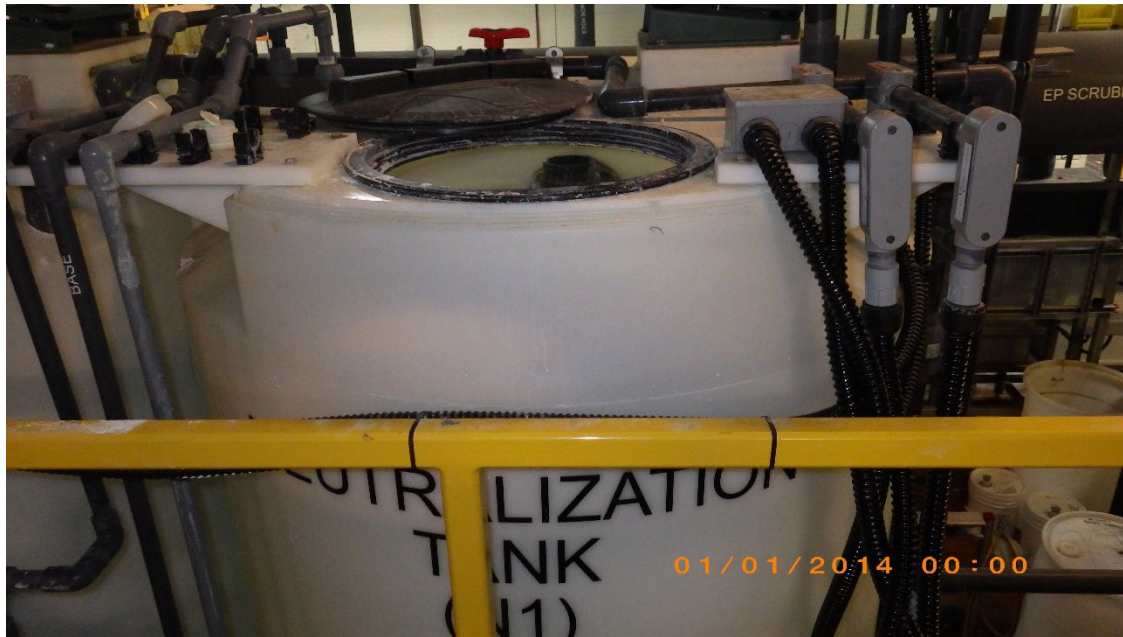
5: RIMG0151

Description: Neutralization 1 overview

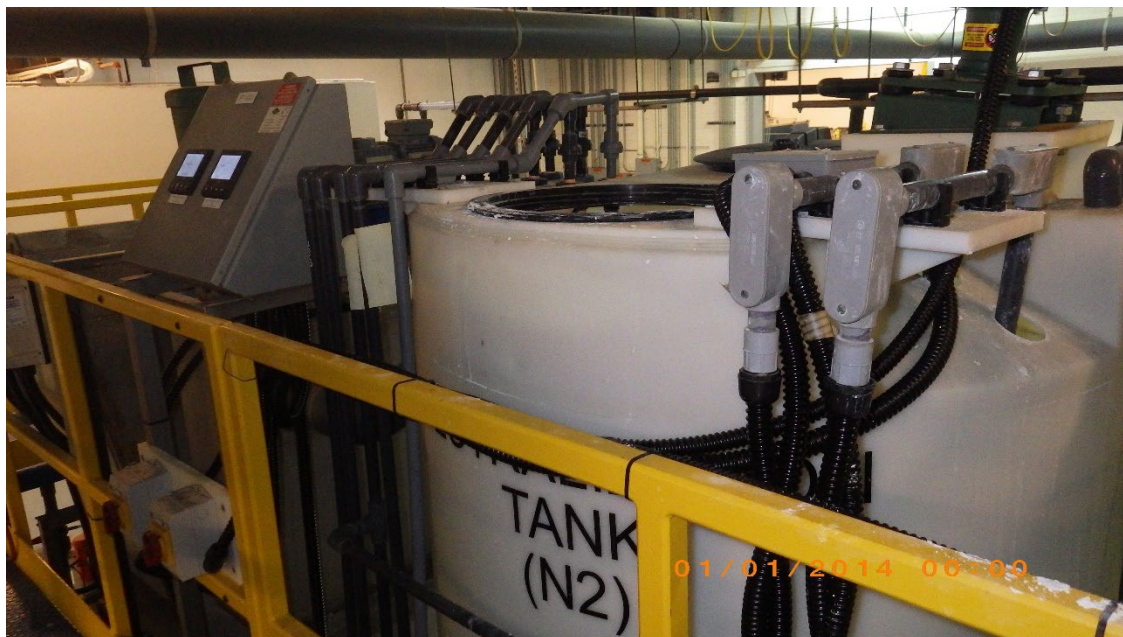
6: RIMG0152

Description: Neutralization 2 in foreground with lamella in background.

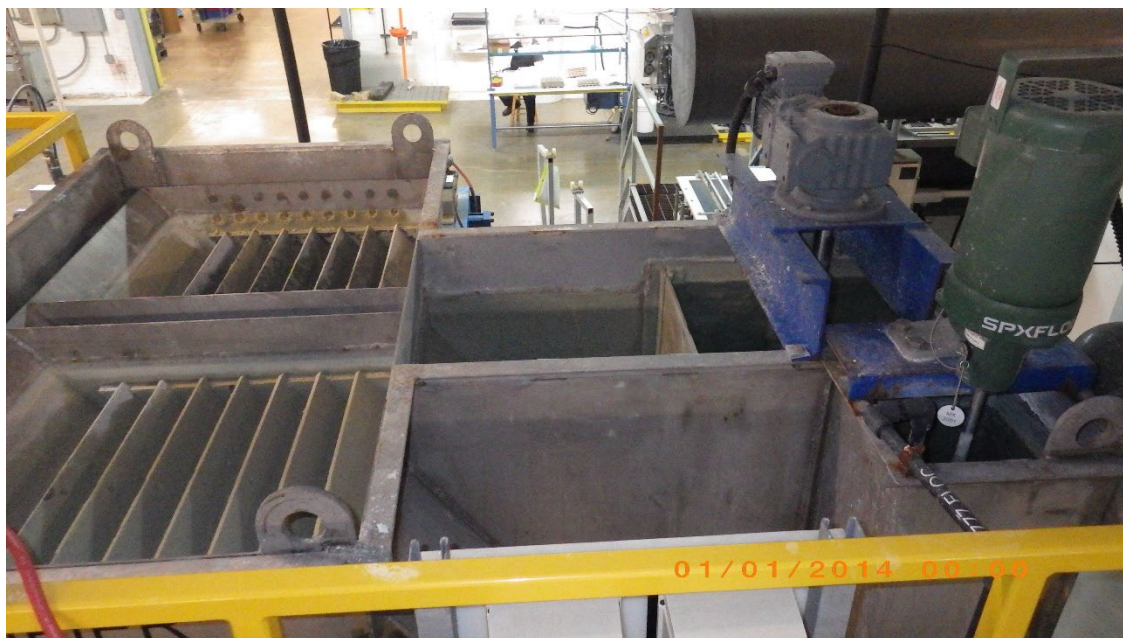
7: RIMG0153

Description: Overview of floc process, left of Neutralization 2

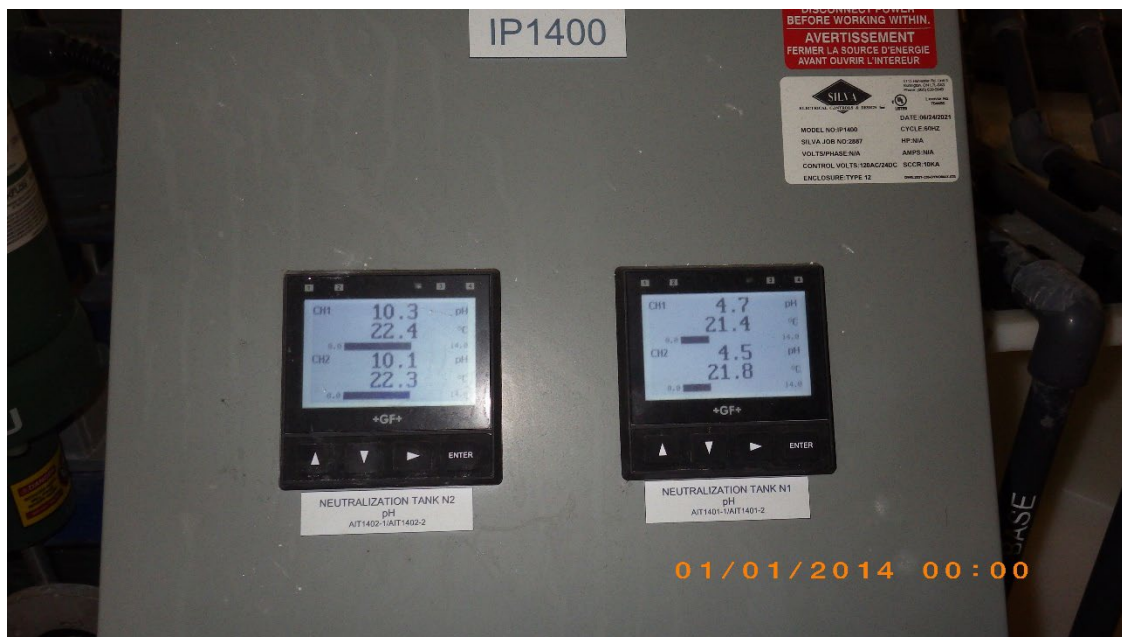
8: RIMG0154

Description: pH readings from Neutralization 1 and Neutralization 2

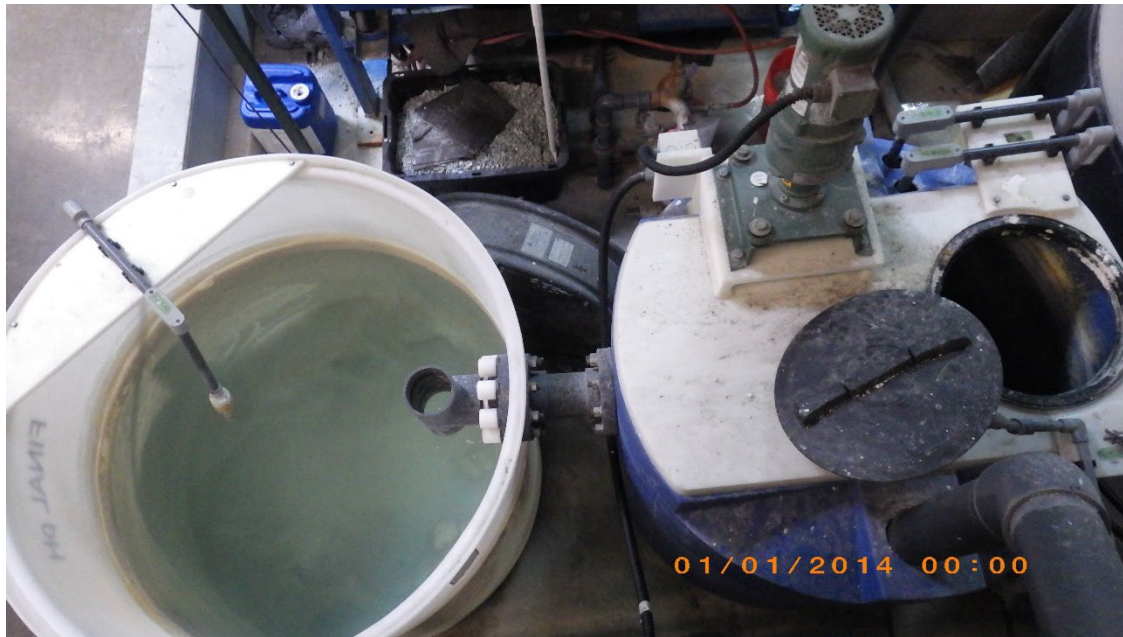
9: RIMG0155

Description: Above final pH overview on left, Neutralization 3 on right

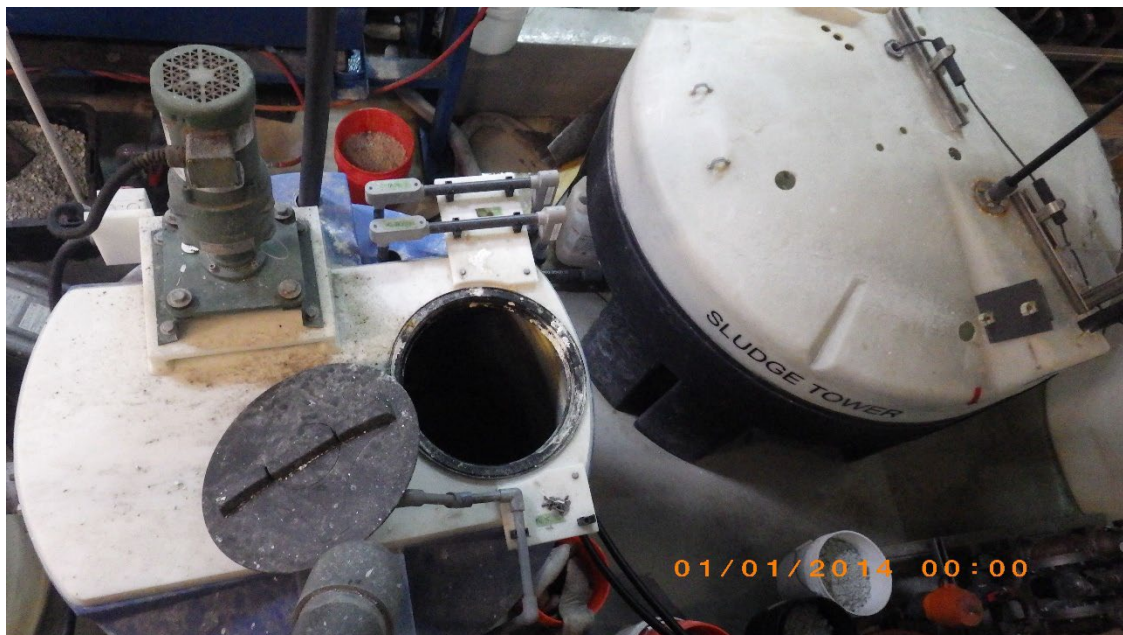
10: RIMG0156

Description: Above sludge tower on right, and Neutraliazation 3 on left

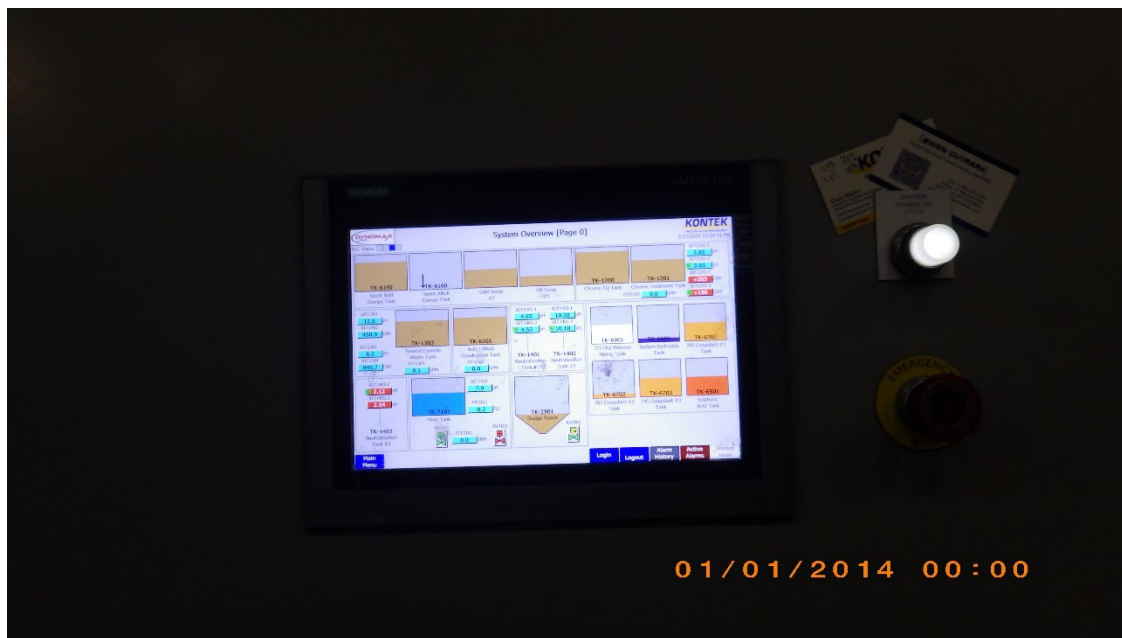
11: RIMG0157

- Dynomax recently received an iPad that has access to the HMI system, allowing the system to be portable. This also allows staff to stop systems if needed from a different location. The system requires a specific login to change settings. (Photo 11).

Description: HMI system screen overview

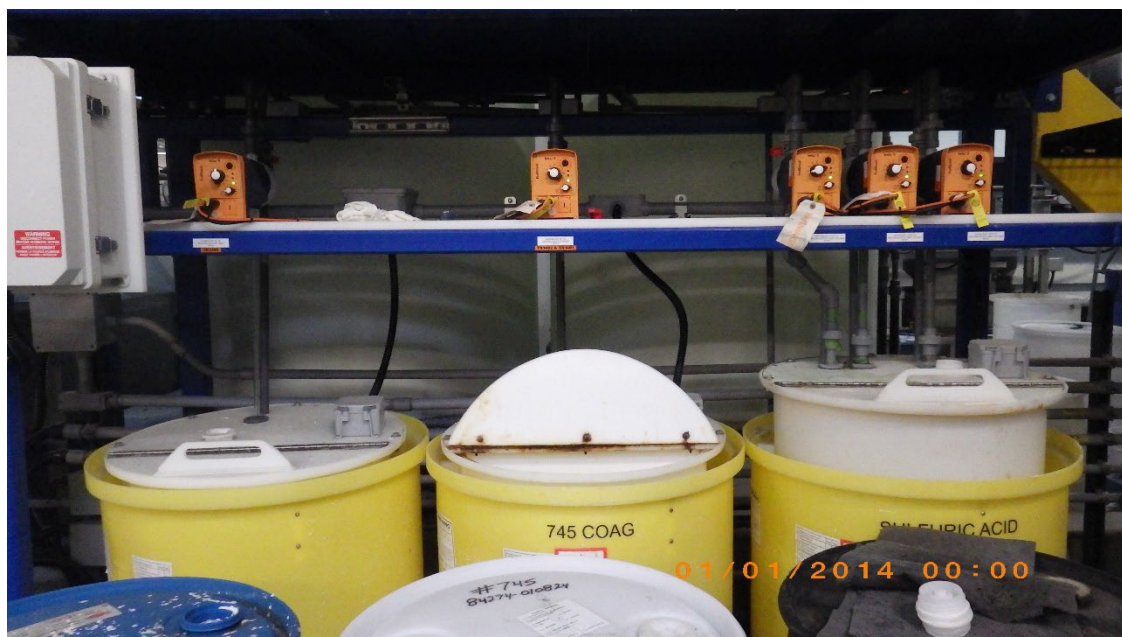
12: RIMG0158

- At the time of the Inspection, Dynomax staff were refilling chemicals used in the treatment processes. Dynomax staff told EPA the chemicals are not typically stored near the process, but staff were in the middle of refilling the process when EPA arrived for the Inspection. (Photo 12).

Description: Chemical refill to Acid Alkaline Treatment, all totes and containers labeled

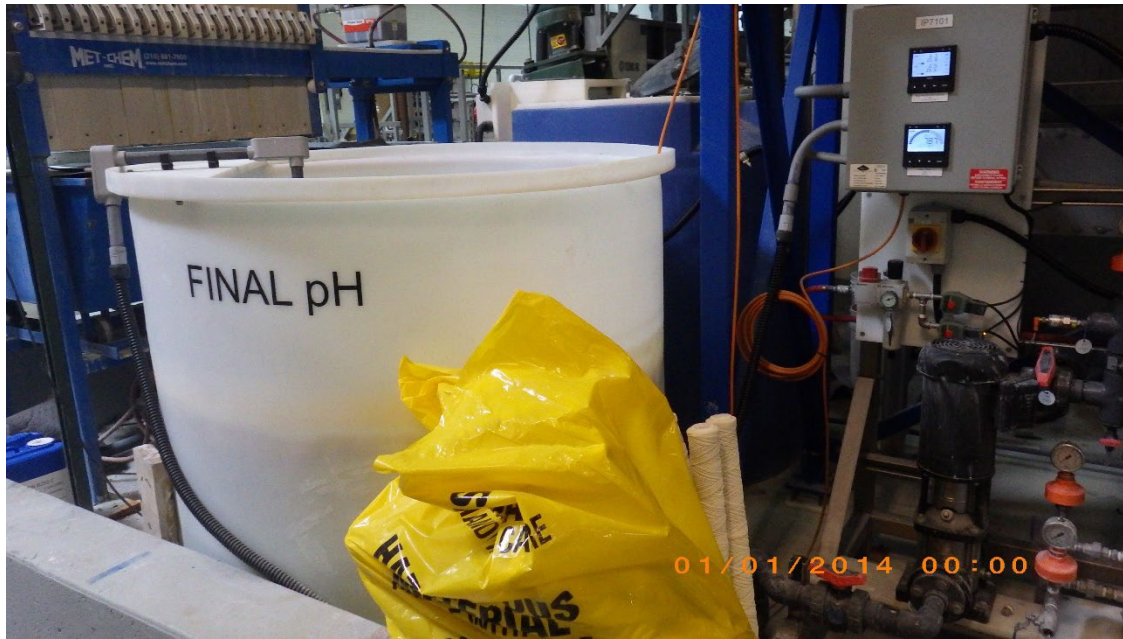
13: RIMG0159

Description: Final pH and flow level with cement berm surrounding area

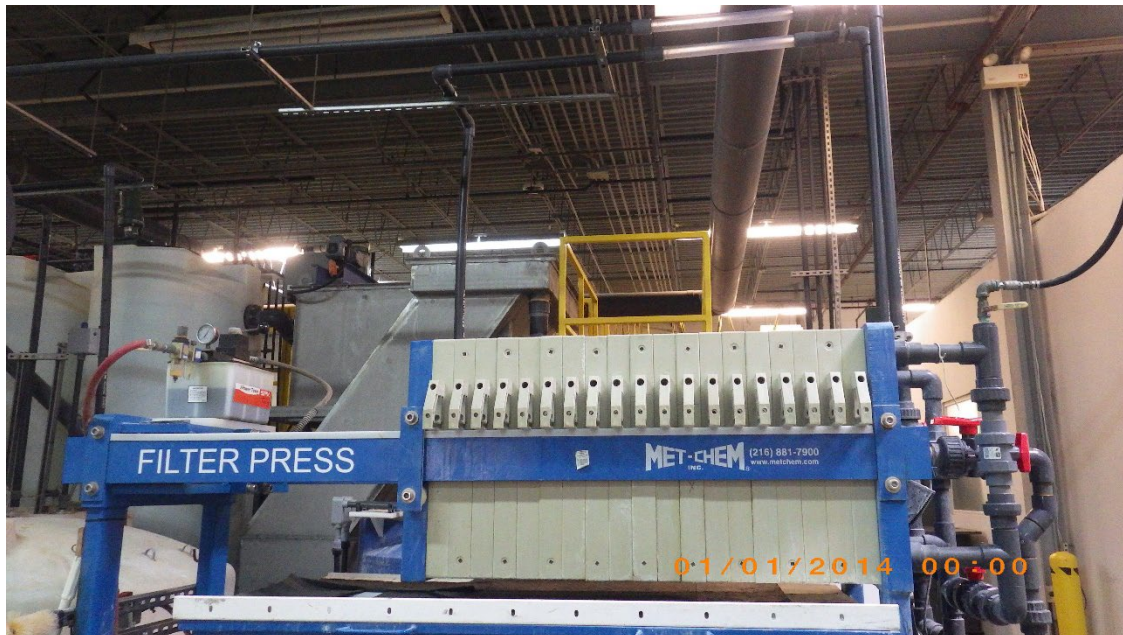
14: RIMG0160

Description: Filter press with clear piping for staff to view water flow

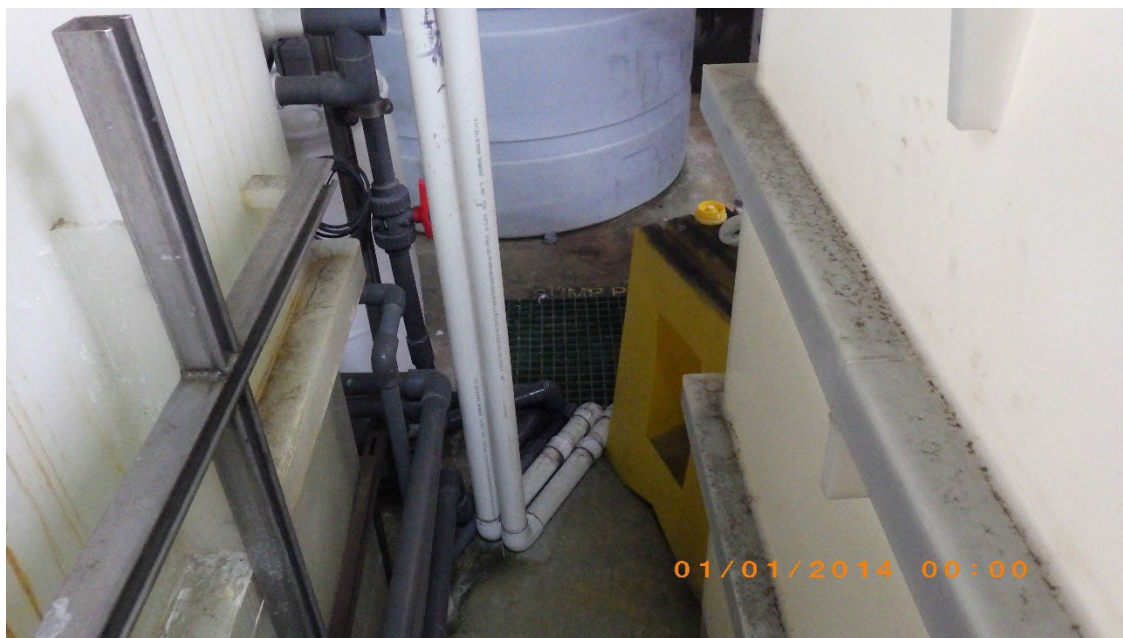
15: RIMG0161

- There is clear piping on the top of the Filter Press area for staff to have the ability to check for water flow in case of clogs from solids.
- All sumps are underground pipes within the process line which are piped into the backside of process tanks. Sumps are on the ground which are pumped to applicable treatment process. (Photo 15).

Description: Pipes going to Acid Alkaline Sump Pit 2 (as seen on Process Flow Diagram)

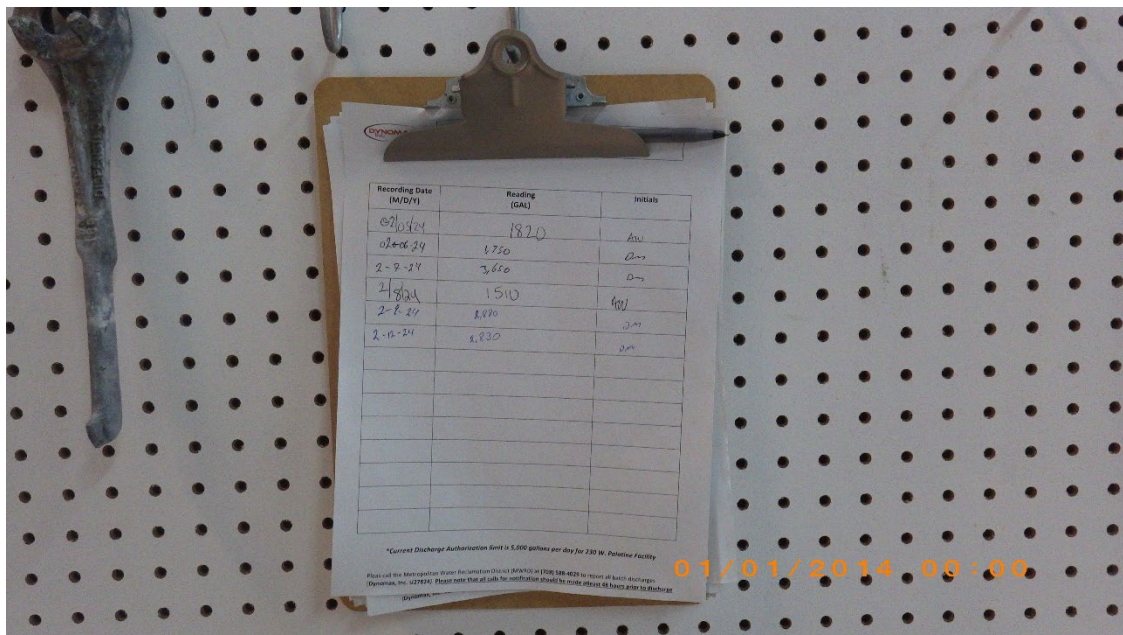
16: RIMG0162

- All DI water is controlled by the DI valve. Whenever the DI valve is turned on, there is a constant flow of DI water to the treatment lines.
- Monitoring/recording is kept on a clipboard at the end of AA Treatment. (Photo 16).

Description: Record keeping clipboard

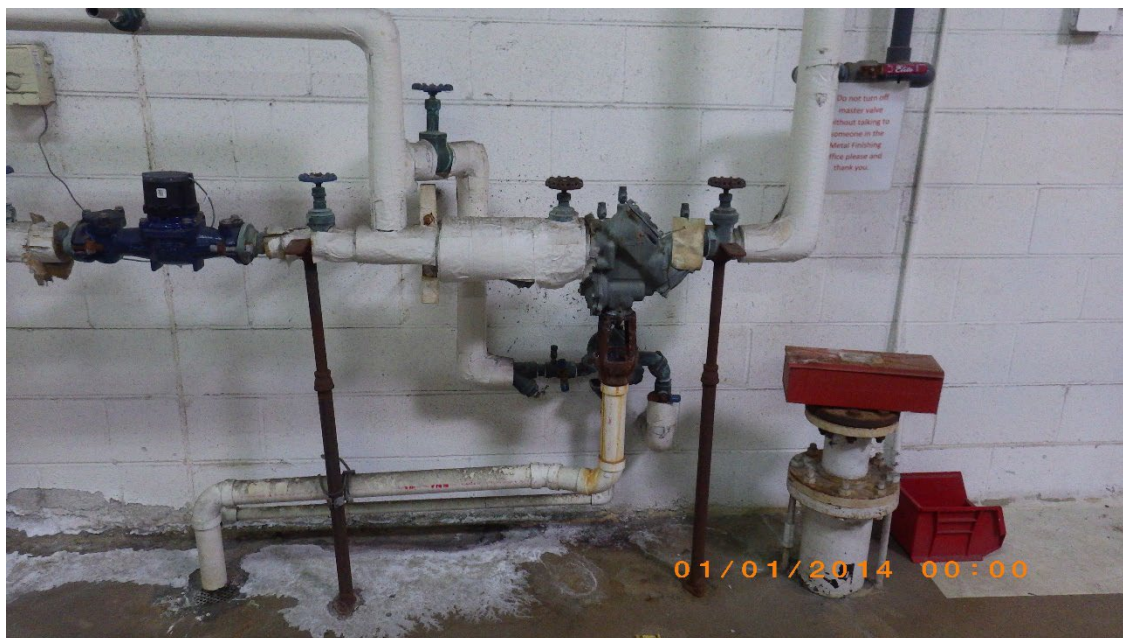
17: RIMG0163

Description: Water intake on left, floor drain under white pipe

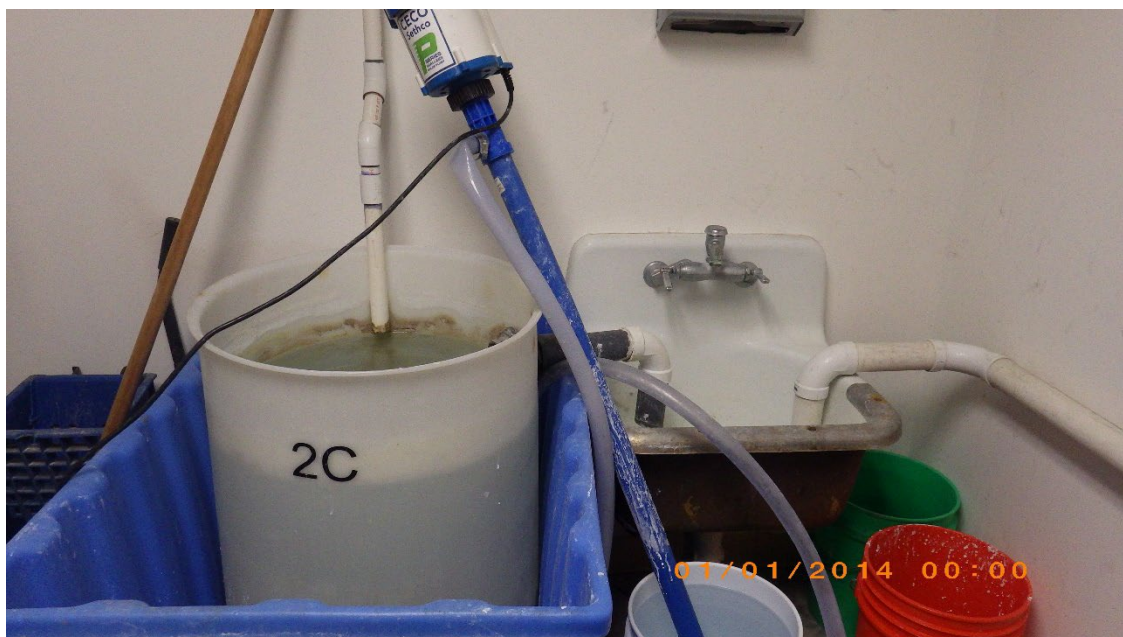
18: RIMG0164

Description: 2C Tank, after final pH. Sample collection location from grat pipe leading to sink

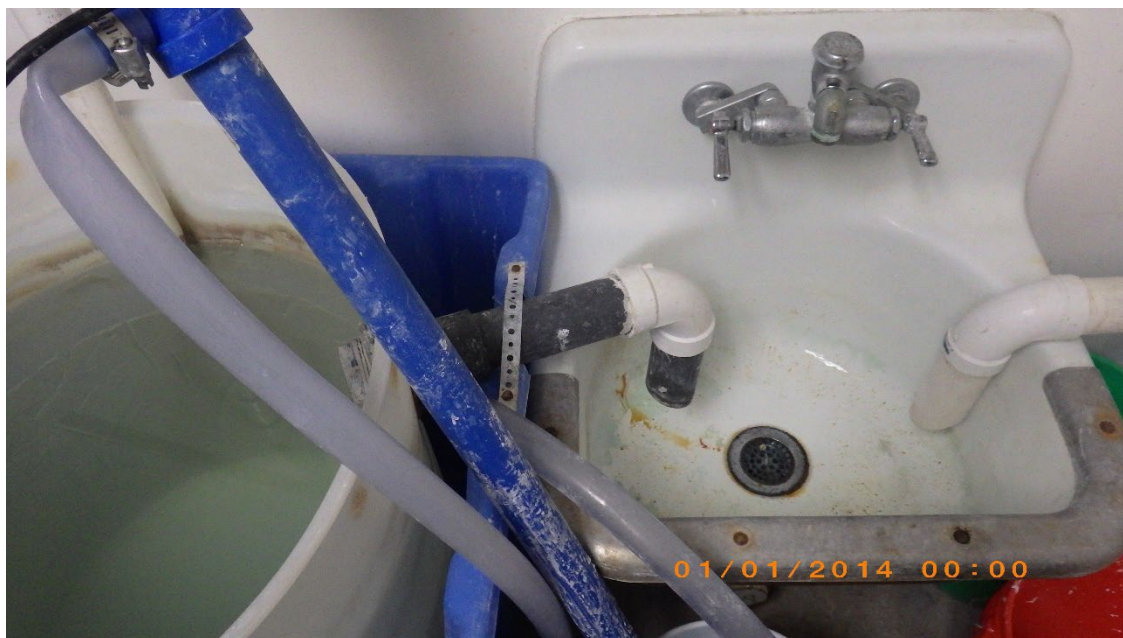
19: RIMG0165

- All process lines in the Alkaline Acid Treatment and Chrome Treatment area are surrounded by a cement berm.
- Water Intake Area
- Sampling Location
  - Dynomax showed EPA a sink, which leads to the 1A Manhole (as seen on Process Flow Diagram). 1A is where the process water connects to the domestic discharge. (Photo 19).

Description: Overview of 2C flow to sink, leading to discharge. Gray pipe used for sample collection.

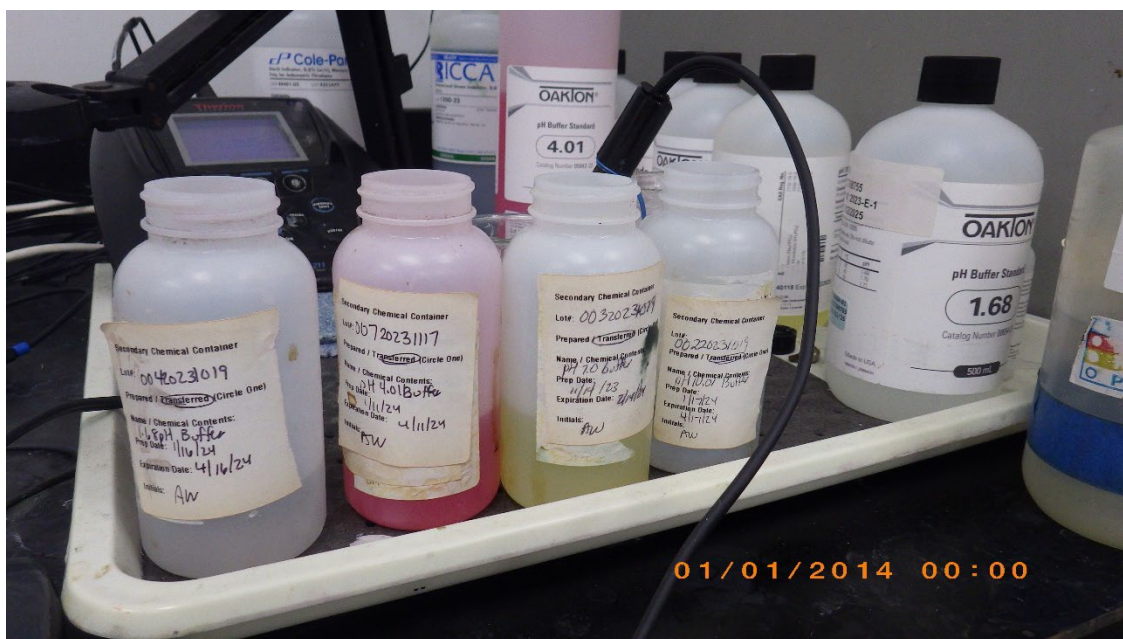
20: RIMG0166

- At the time of the Inspection, EPA observed the pH buffers in the onsite laboratory. The pH buffers being used were not expired; however, the 7 pH buffer had an expiration date of the following day, February 14, 2024. (Photo 20).
- During the site walk through, there was a floor drain near the water intake meters that was uncapped. At the time of the Inspection, Dynomax staff were not aware of where the floor drain discharged.
- EPA requested these documents to be provided by Dynomax, Inc. following the Inspection:
  - Effective Metropolitan Water Reclamation District of Greater Chicago discharge permit;
  - The last monthly, quarterly, and weekly set of samples (January 2023, Quarter Four of 2024, and most recent weekly internal sample collected by Dynomax); and
  - Flow monitoring documentation.

Description: pH buffers in onsite laboratory, 1.68, 4, 7, 10.

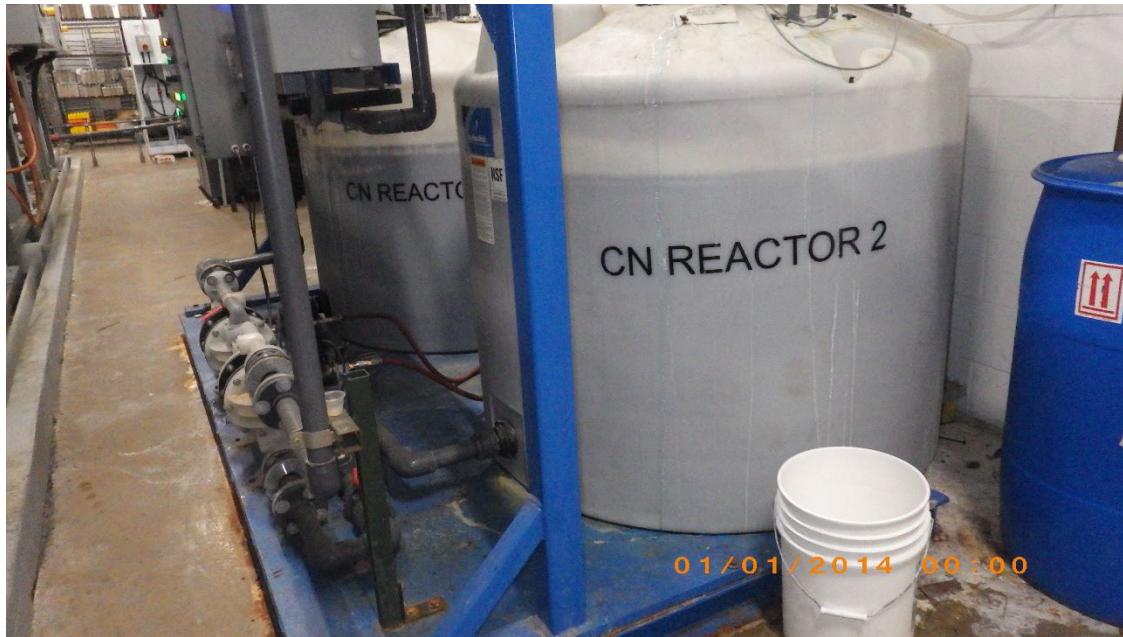
21: RIMG0167

Description: Cyanide Treatment Stage 3 in foreground, Stage 1 in background

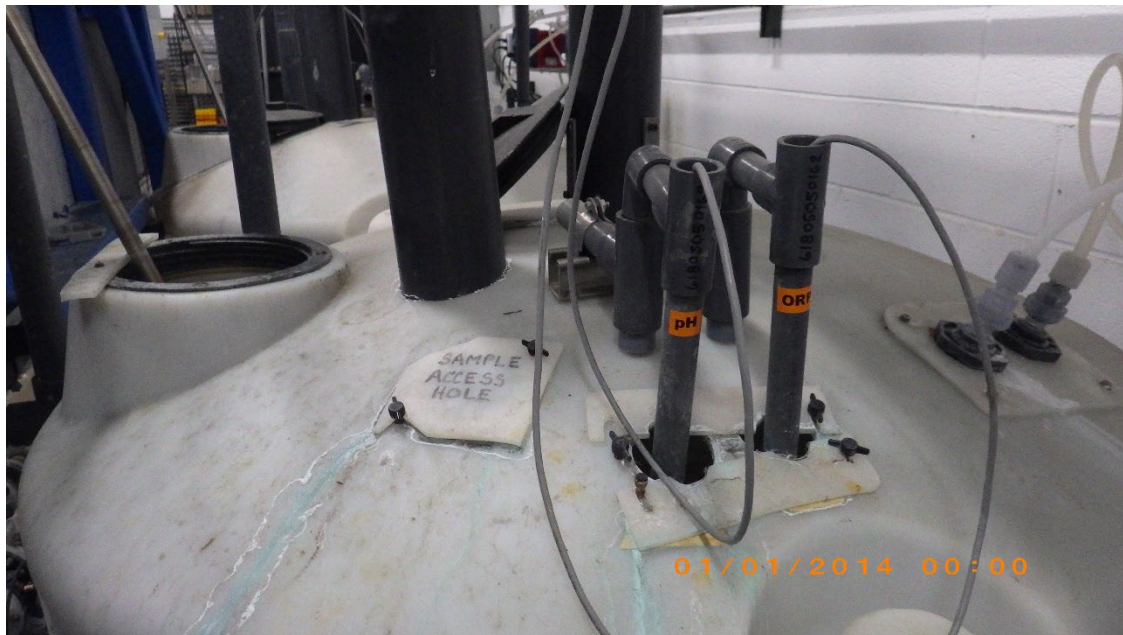
22: RIMG0168

Description: pH and ORP probes on Cyanide Treatment tank (Stage 2); sample access hole on left

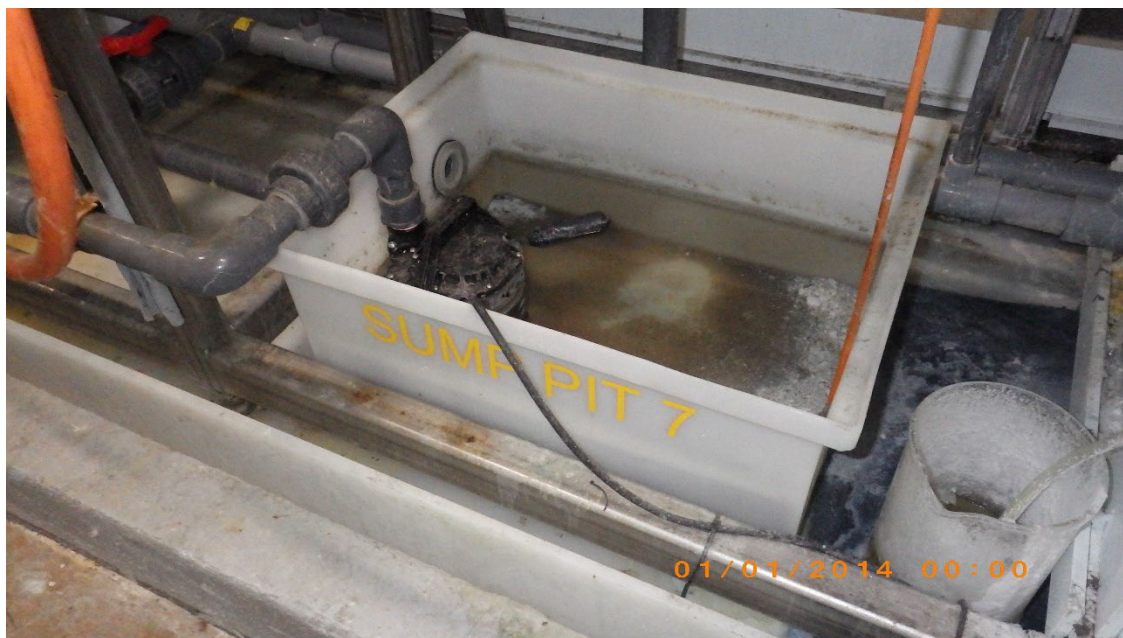
23: RIMG0169

- Cyanide Treatment is located behind the gold plating line.
  - Dynomax staff told EPA that anything discharging to Cyanide Treatment goes through Sump Pit 7 (as seen on Process Flow Diagram). (Photo 23).

Description: Sump Pit 7, prior to discharging to Cyanide Treatment. Sump is in containment area under Gold Plating Line.

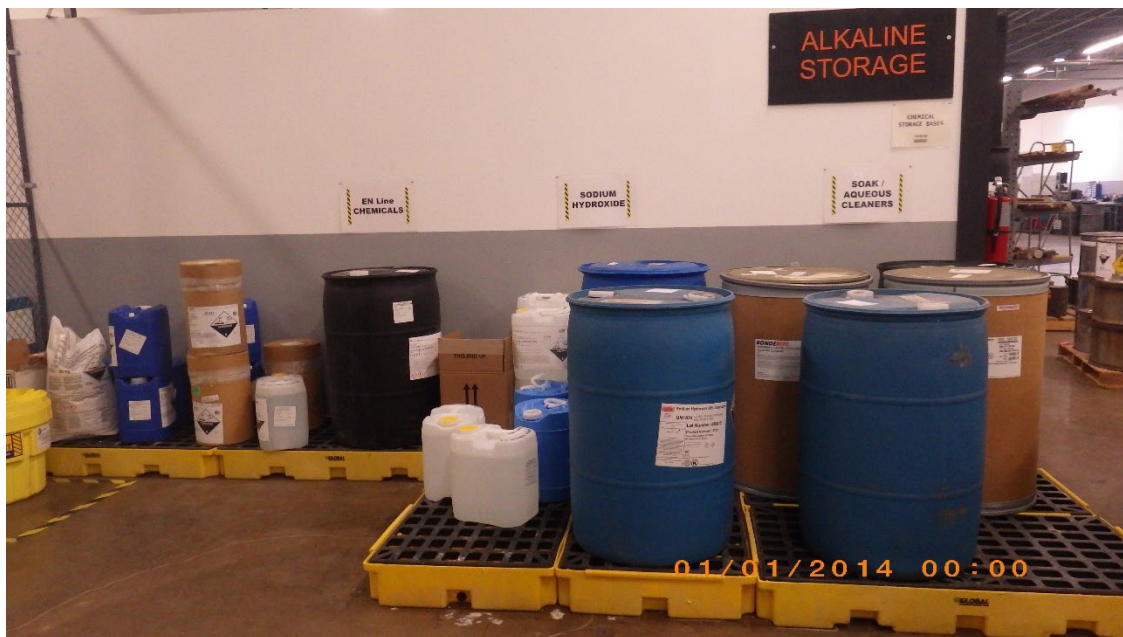
24: RIMG0170

- Chemical Storage Area (Photo 24).

Description: Storage area with labels
