## REGION 10 Enforcement Division

### INSPECTION REPORT

| <b>Company Name:</b> | State of Alaska Department of Transportation and Public Facilities (Alaska DOT & PF) | | |
| <b>Facility or Site Name:</b> | ALASKA DOT & PF SOLDOTNA | | |

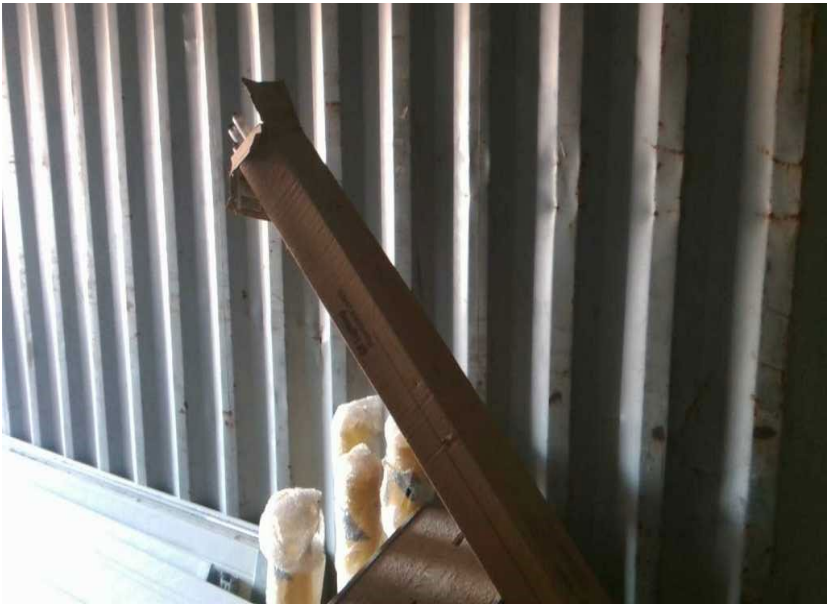
| While inspecting the contents of the Facilities Connex, I saw a box containing eight-foot fluorescent lamps. Upon closer inspection I saw that the fluorescent lamps had darkened, burnt ends, indicative of waste lamps. | |

Larry Tews, Building Maintenance Lead, told me they were waste fluorescent lamps. He also explained that just like SEF, M&O manages waste lamps as universal waste. At the time of the inspection, the container of waste lamps was not closed and not labeled as universal waste lamps, waste lamps, or used lamps. Mr. Tews said he thinks the lamps have been in the Connex box since August 2020. The container was not marked with the date the lamps first became a waste or an accumulation start date (ASD) and Mr. Tews did not provide any information about any other methods used by the facility to track the initial date(s) when the lamps became waste. There were 14 lamps in the container.

| View of a box containing 14 waste fluorescent lamps. At the time of the inspection, the container of waste lamps was not closed, not labeled as either UW Lamps, waste lamps, or used lamps. The container was not marked with the date the lamps first became a waste or an ASD. | |

The facility representative closed the waste fluorescent lamp container, labeled it with the words "Used Lamps", marked the date 8/2020 on the container, and moved it to the Electrician's Connex during the inspection.

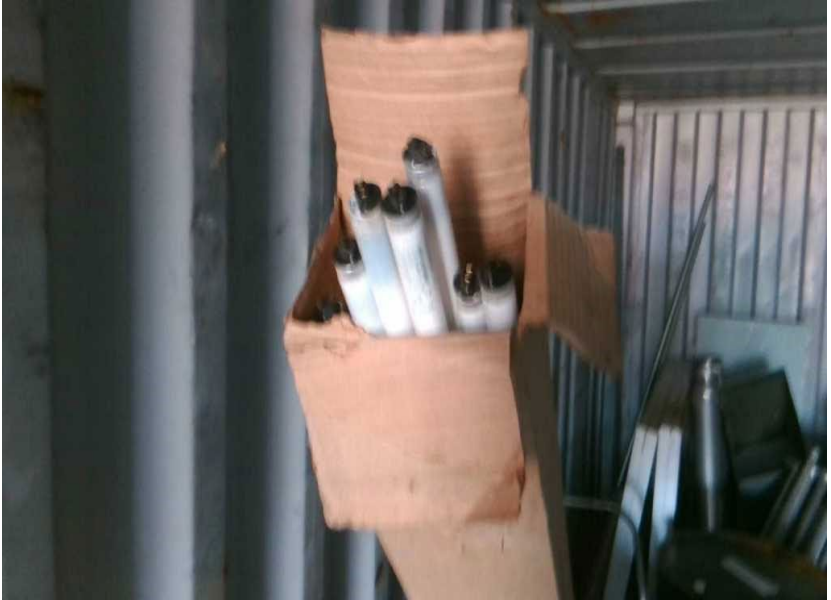
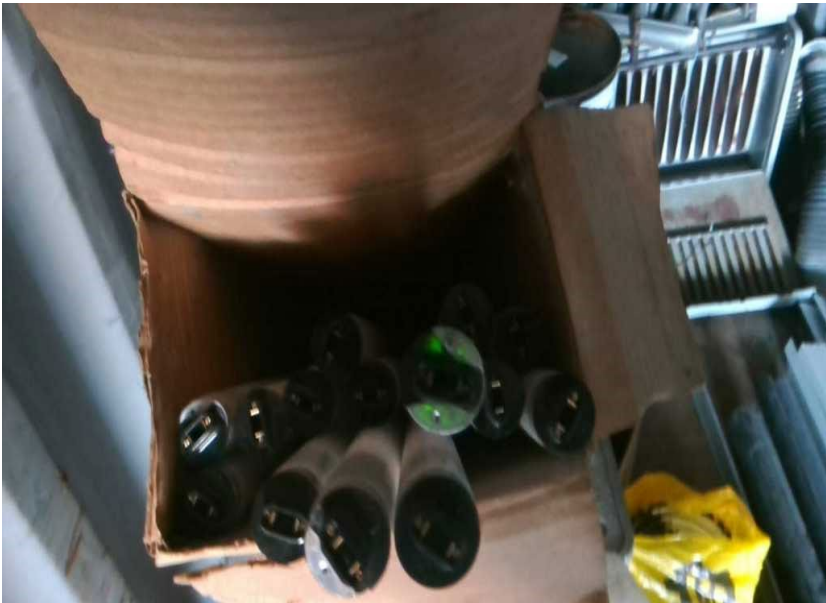
| Another view of the box containing 14 waste fluorescent lamps. At the time of the inspection, the container of waste lamps was not closed, not labeled as either UW Lamps, waste lamps, or used lamps. The container was not marked with the date the lamps first became a waste or an ASD. This view shows the darkened, burnt ends on the lamps. | |

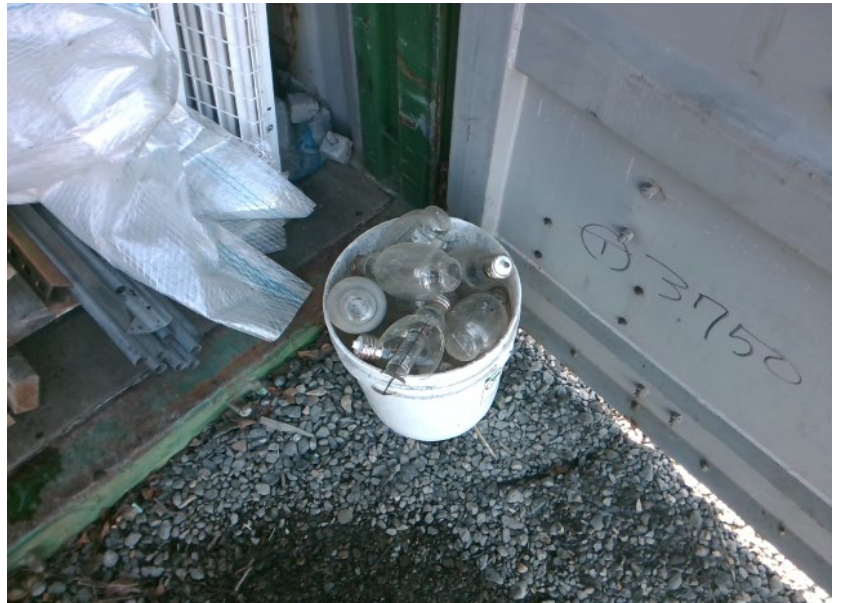
*[Title]*Observation\_Image-  
20210427113606366311848.jpg

Close-up view of five-gallon container that held approximately 15 waste high-pressure sodium bulbs. The container was not closed and not labeled and there was no ASD. This view shows that one of the bulbs is broken.

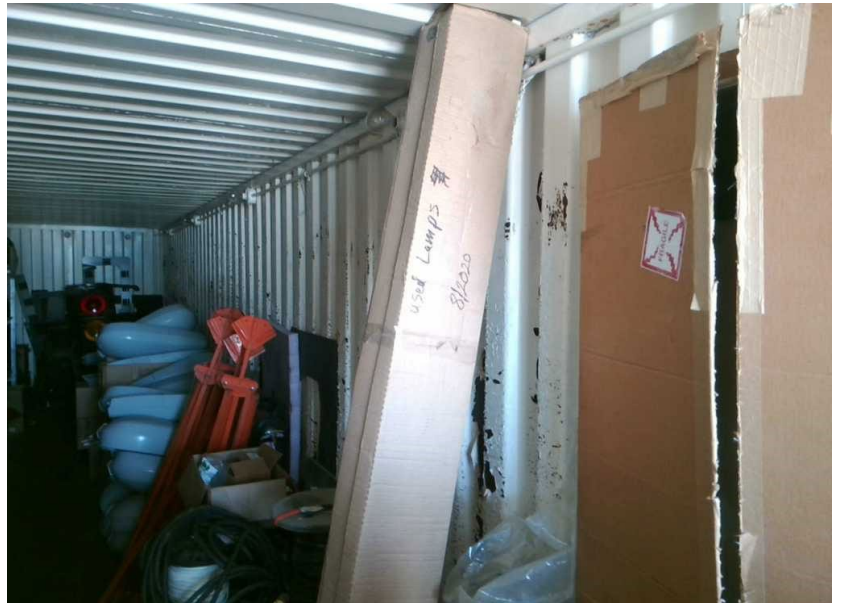
Observation\_Image-  
202104271250475047688547.jpg

View of the waste high-pressure sodium bulbs that were observed in the Cold Shed/Facilities Connex after the waste bulbs were re-packaged in a closed container, labeled "Used Lamps" and dated 8/15/2020 during the inspection.

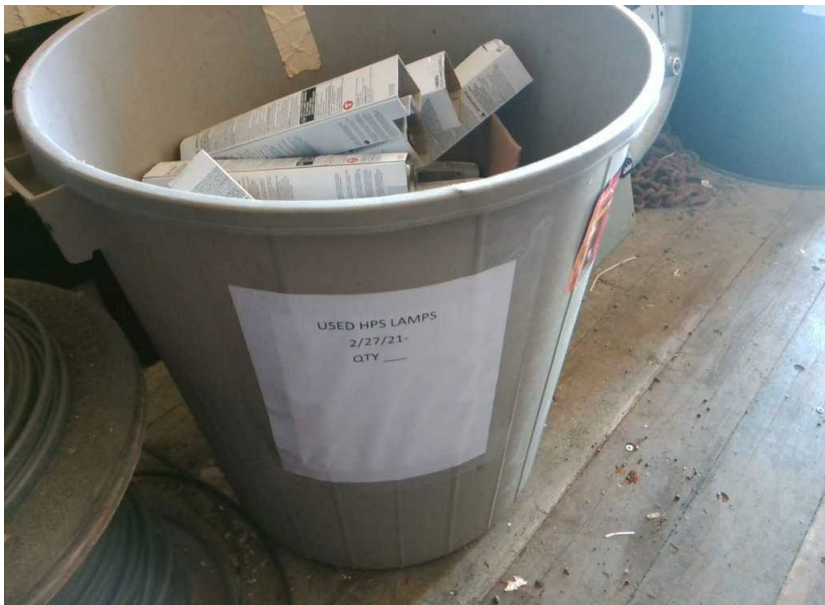
| Observation_Image-202104271233263326688003.jpg | |

| <p>While inspecting the Electrician's Connex, I saw a trash receptacle that was being used to accumulate waste high-pressure sodium bulbs. The trash receptacle was labeled and dated but was not closed. There were approximately 40 bulbs in the trash receptacle. During the inspection, Mr. Gabriel repackaged the lamps in a box that he closed and labeled with the words "Used Lamps" and the date 2/27/2021.</p> | |

| View of a trash receptacle that was being used to accumulate waste high-pressure sodium bulbs. The container seen in the photo is not closed but is labeled and dated. | |

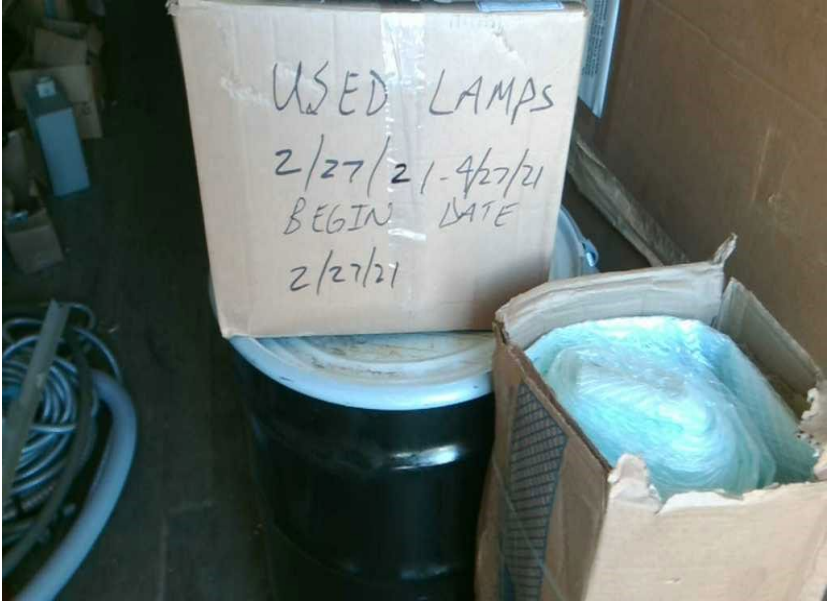
| <div>[Title]</div> <div>Observation_Image-20210427124404444379007.jpg</div> <div>04/27/2021 12:44 PM (AKT)</div> <div>Jon Jones</div> <div>Electricians Connex</div> <div>No CBI</div> <div>No PII</div> <div>View of the closed, labeled, and dated container that the waste bulbs in the trash receptacle were re-packaged in during the inspection.</div> | |

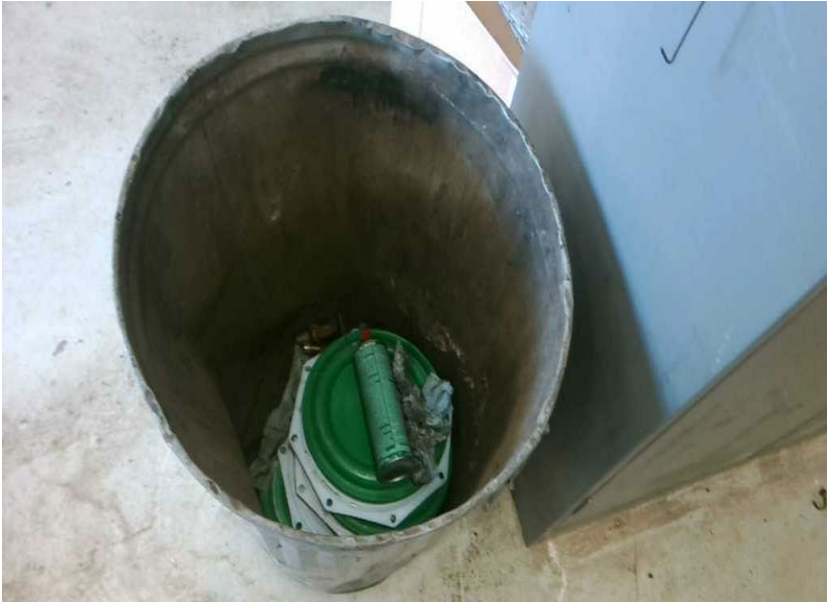
| <div>[Title]</div> <div>Observation_Image-202104270949124912318289.jpg</div> <div>04/27/2021 09:49 AM (AKT)</div> <div>Jon Jones</div> <div>Main Building/Soldotna Shop</div> <div>No CBI</div> <div>No PII</div> <div>View of a waste aerosol can that was in the bottom of a trash receptacle. The aerosol can had been punctured using a punch, according to Mr. Siemion.</div> | |

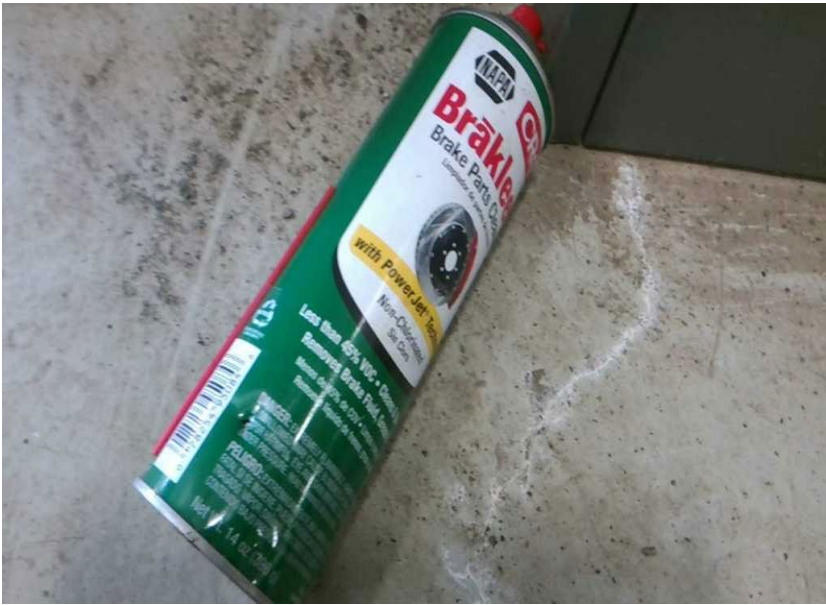
| Observation_Image-202104270949564956460303.jpg | |

| A view of the same waste aerosol can that was in the bottom of the trash receptacle. The aerosol can had been punctured using a punch, according to Mr. Siemion. | |

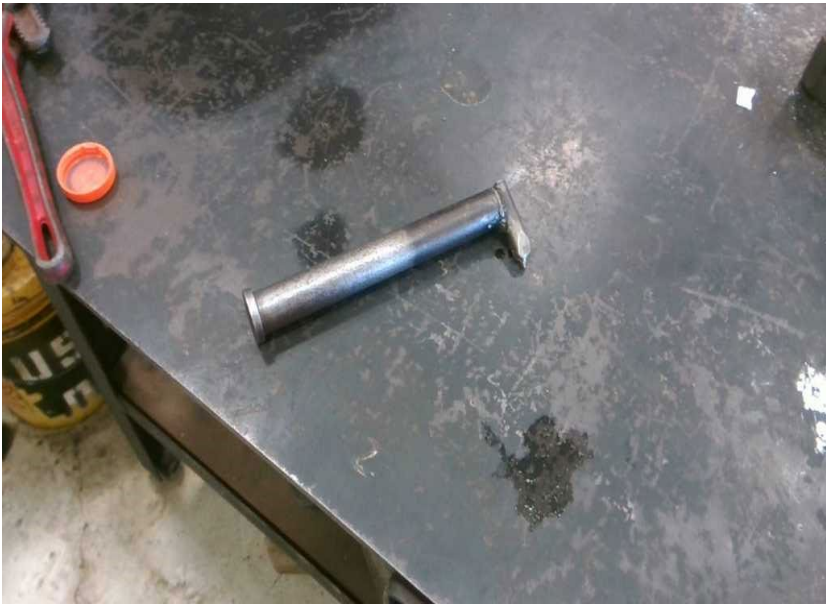
| <p>[Title]</p> <p>Observation_Image-202104270954525452395678.jpg</p> <p>04/27/2021 09:54 AM (AKT)</p> <p>Jon Jones</p> <p>Main Building/Soldotna Shop</p> <p>No CBI</p> <p>No PII</p> <p>View of the punch that Mr. Siemion said is sometimes used to puncture waste aerosol cans.</p> | |

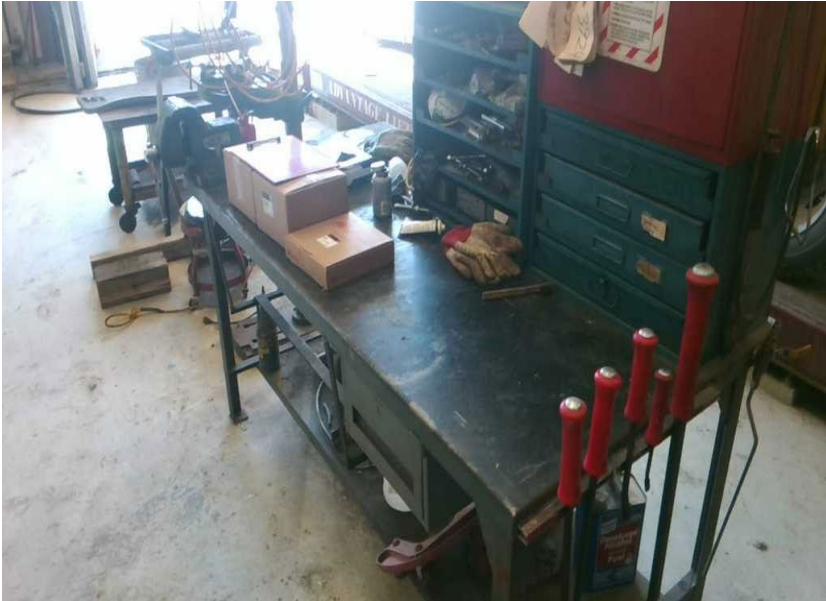
| <p>[Title]</p> <p>Observation_Image-202104270955405540426715.jpg</p> <p>04/27/2021 09:55 AM (AKT)</p> <p>Jon Jones</p> <p>Main Building/Soldotna Shop</p> <p>No CBI</p> <p>No PII</p> <p>Another view of the corner of the work bench that Mr. Siemion said is sometimes used to puncture waste aerosol cans.</p> | |

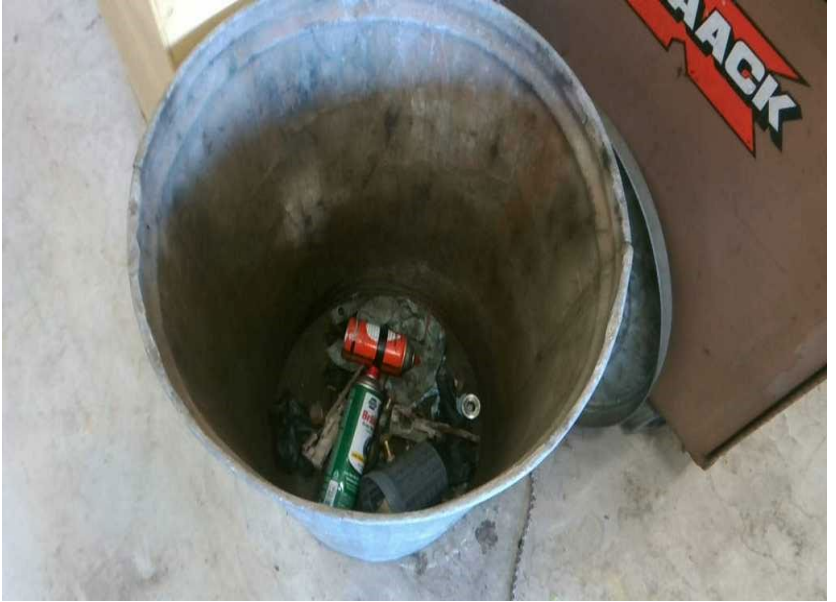
| <p>[Title]</p> <p>Observation_Image-2021042710050959369358.jpg</p> <p>04/27/2021 10:05 AM (AKT)</p> <p>Jon Jones</p> <p>Main Building/Soldotna Shop</p> <p>No CBI</p> <p>No PII</p> <p>View of two more waste aerosol cans in another trash receptacle that had been punctured.</p> | |

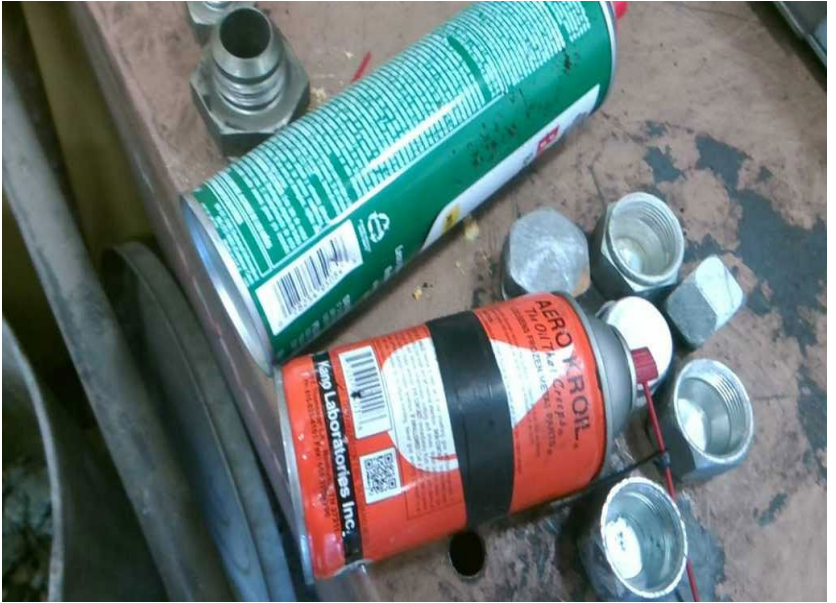
| <p>[Title]</p> <p>Observation_Image-2021042710060666634566.jpg</p> <p>04/27/2021 10:06 AM (AKT)</p> <p>Jon Jones</p> <p>Main Building/Soldotna Shop</p> <p>No CBI</p> <p>No PII</p> <p>Close-up view of the two waste aerosol cans that had been punctured.</p> | |

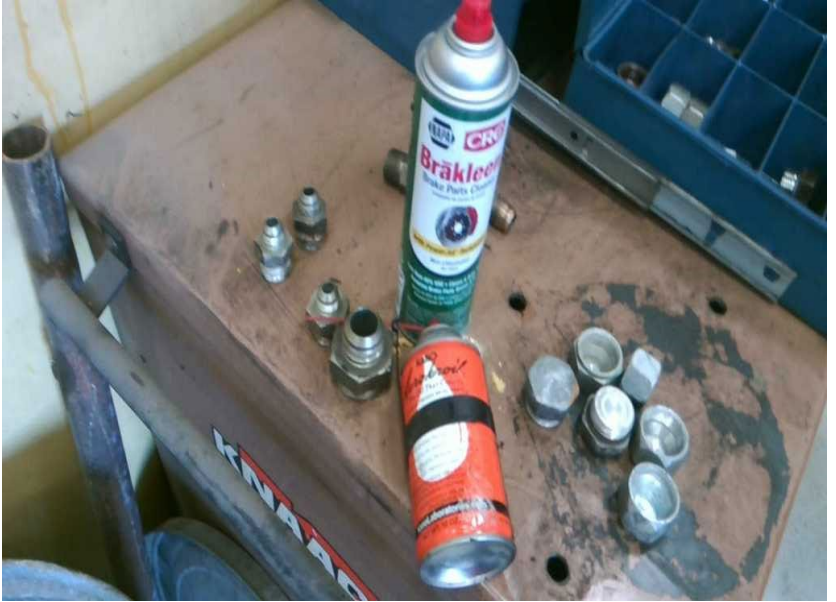
| <p>[Title]</p> <p>Observation_Image-20210427100654654475887.jpg</p> <p>04/27/2021 10:06 AM (AKT)</p> <p>Jon Jones</p> <p>Main Building/Soldotna Shop</p> <p>No CBI</p> <p>No PII</p> <p>Another view of the two waste aerosol cans that had been punctured.</p> | |

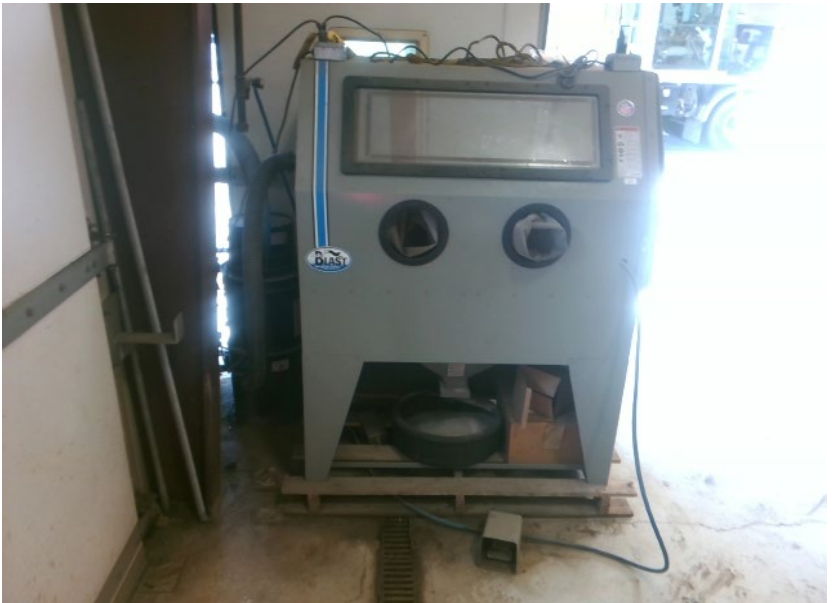
| <p>While inspecting the Soldotna Shop, I saw a small sand blast cabinet. I asked about the sand blast media, such as how much was generated and how it was being managed. Soldotna Shop personnel stated that they didn't remember when the last time was that it was disposed but said that it was re-used repeatedly to remove rust from metal prior to welding. I was told that it was not being used to remove paint from painted surfaces.</p> | |

| <p>[Title]</p> <p>Observation_Image-202104271011271127214494.jpg</p> <p>04/27/2021 10:11 AM (AKT)</p> <p>Jon Jones</p> <p>Main Building/Soldotna Shop</p> <p>No CBI</p> <p>No PII</p> <p>View of sand blast media being accumulated in a pan beneath the blasting cabinet.</p> | |

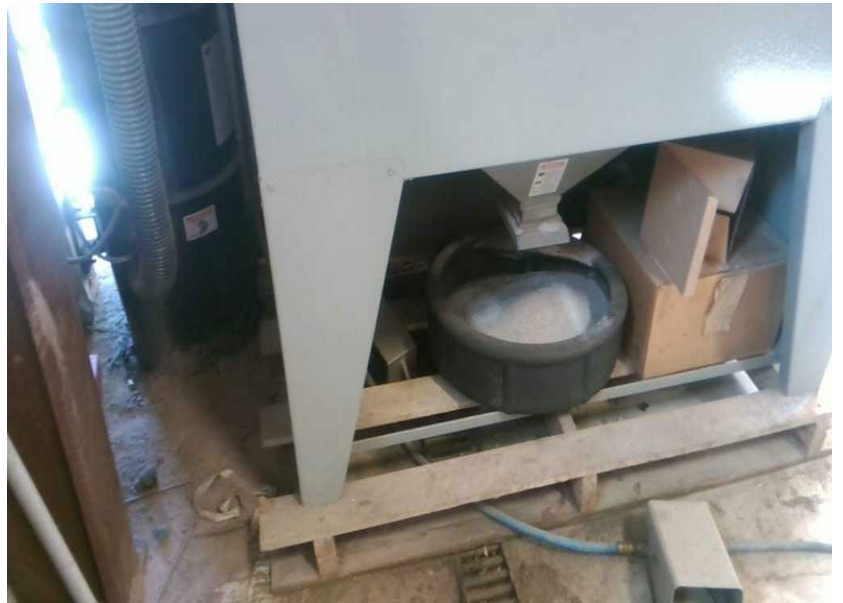
Close-up view of sand blast media being accumulated in a pan beneath the blasting cabinet.

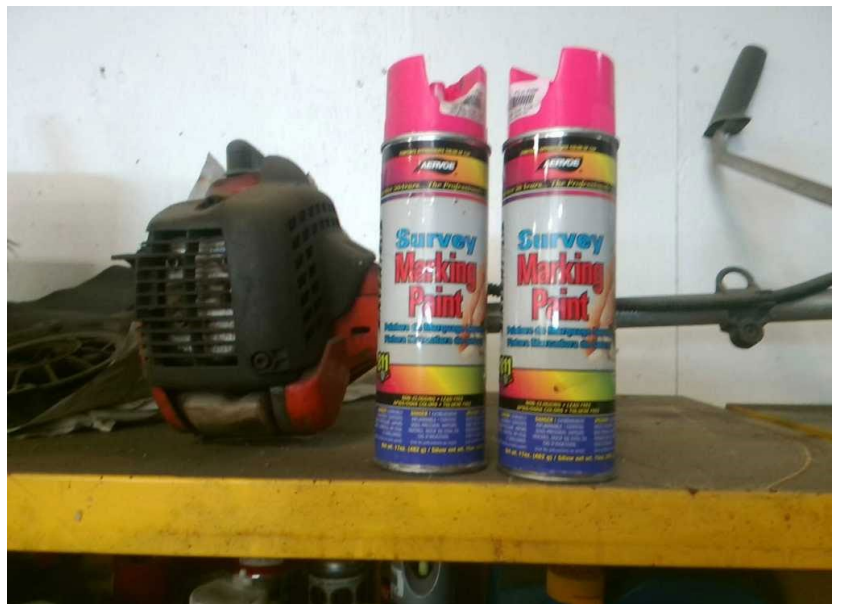
Observation\_Image-  
20210427103507357675692.jpg

| I observed two aerosol cans of survey marking paint that felt empty and appeared to be waste-like. Mr. Smith looked at the aerosol cans and verified that they were waste aerosol cans. The waste aerosol cans were stored in a flammables locker when I first observed them. | <b>Citation:</b> | <b>Section:</b> |

I observed two aerosol cans of survey marking paint that felt empty and appeared to be waste-like. Mr. Smith looked at the aerosol cans and verified that they were waste aerosol cans.

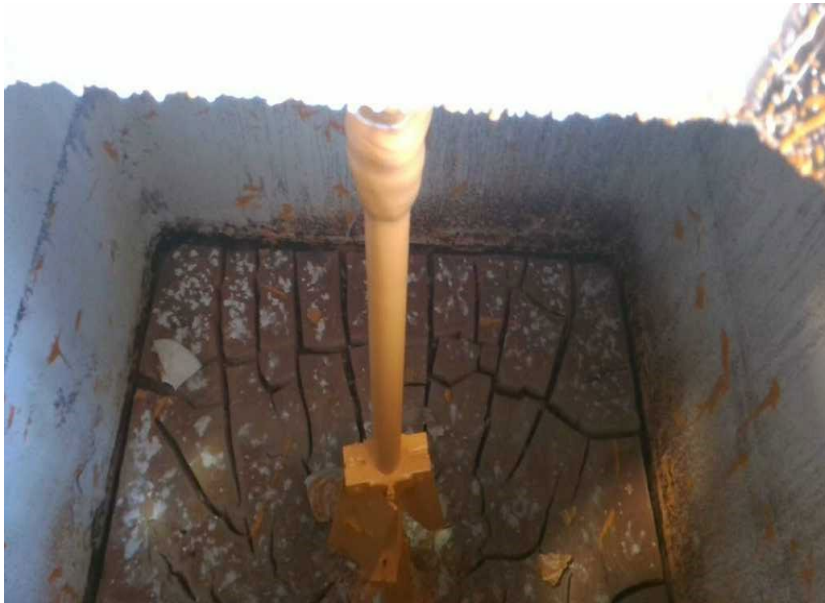
| Observation_Image-202104271156565656367626.jpg | |

While inspecting the Sand Shed, I saw a 250-gallon stainless steel tote with what looked like dried white traffic paint in the bottom. According to Jeffrey Mahan, M&O Equipment Operator, the tote is used to stage the paint mixer. According to Mr. Mahan, the paint mixer is placed inside of the totes of traffic paint to mix the paint. The mixer is then removed and placed inside an empty tote. Mr. Mahan explained that the dried paint that I observed in the bottom of the tote had dripped off the mixer and accumulated in the bottom of the tote between 2016 and 2018. At the time of the inspection, there was approx. 3 to 3.5 inches of the dried white and yellow traffic paint in the bottom of the tote. Safety Data Sheets for Alaska Low VOC White Solvent Paint and Alaska Low VOC LF Yellow Solvent Paint were provided by the facility. According to the information contained in the SDS's, the Alaska Low VOC White Solvent Paint is hazardous for ignitability (D001) with a flashpoint of -4°F. The Alaska Low VOC LF Yellow Solvent Paint is hazardous for ignitability (D001) with a flashpoint of -4°F and toxicity for benzene (D018). The Alaska Low VOC LF Yellow Solvent Paint contains benzene at less than 0.1% by weight or roughly less than 1,000 parts per million (ppm). The maximum regulatory concentration for benzene is 0.5 ppm.

| View of the dried paint that had dripped off the paint mixer. | |

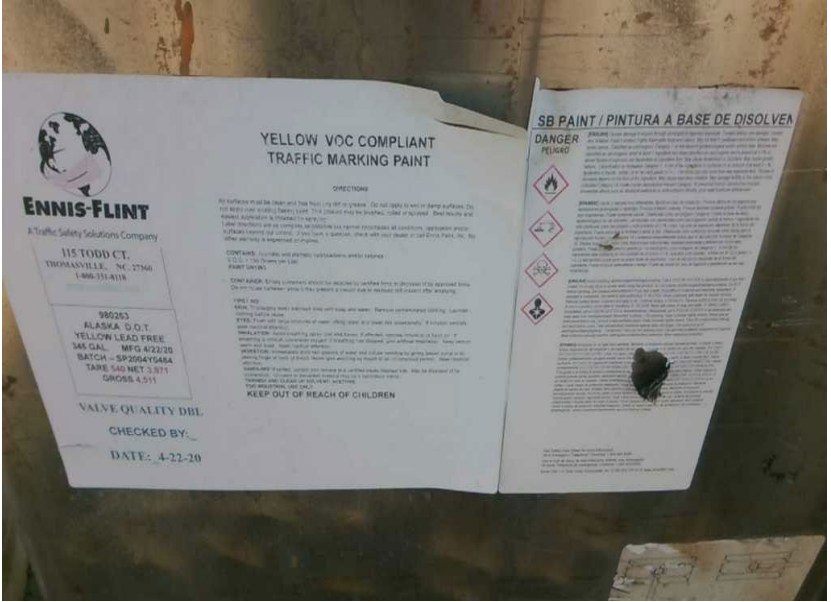
As I left the Sand Shed, I saw additional stainless-steel totes containing both white and yellow traffic paint. According to Mr. Mahan, the traffic painting equipment is cleaned out with toluene. The waste paint and toluene mixture is placed back into a stainless-steel tote and sent back to the manufacturer where it is recycled back into the paint manufacturing process.

| Close-up view of the labeling on the tote containing Yellow VOC Compliant Traffic Marking Paint. | |
