## Region 6 - Enforcement & Compliance Assurance Division

### INSPECTION REPORT

| Company Name: | <b>Betsy Production Company, Inc.</b> | |
| Facility Name: | <b>Southern No. 5 Tank Battery</b> | |

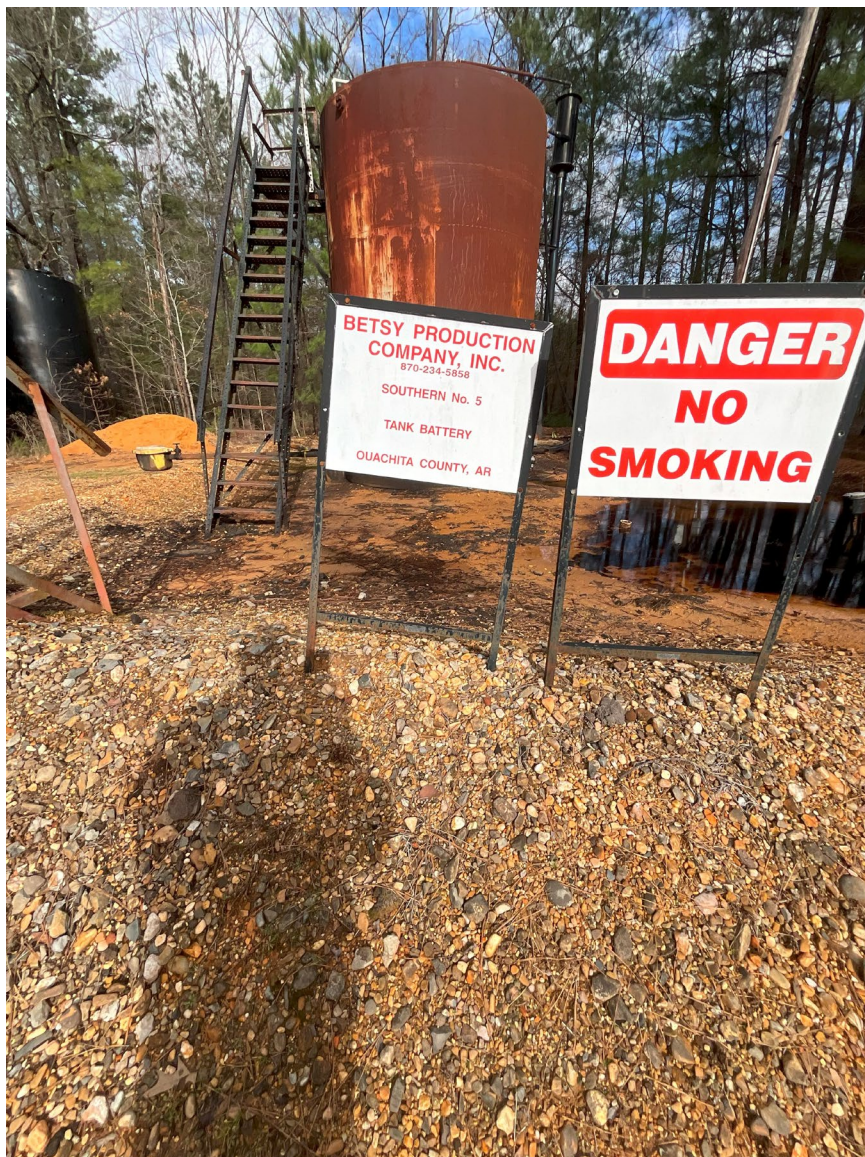
Photo No. 1

**Description:** This photo was taken looking northwest and shows the facility sign.

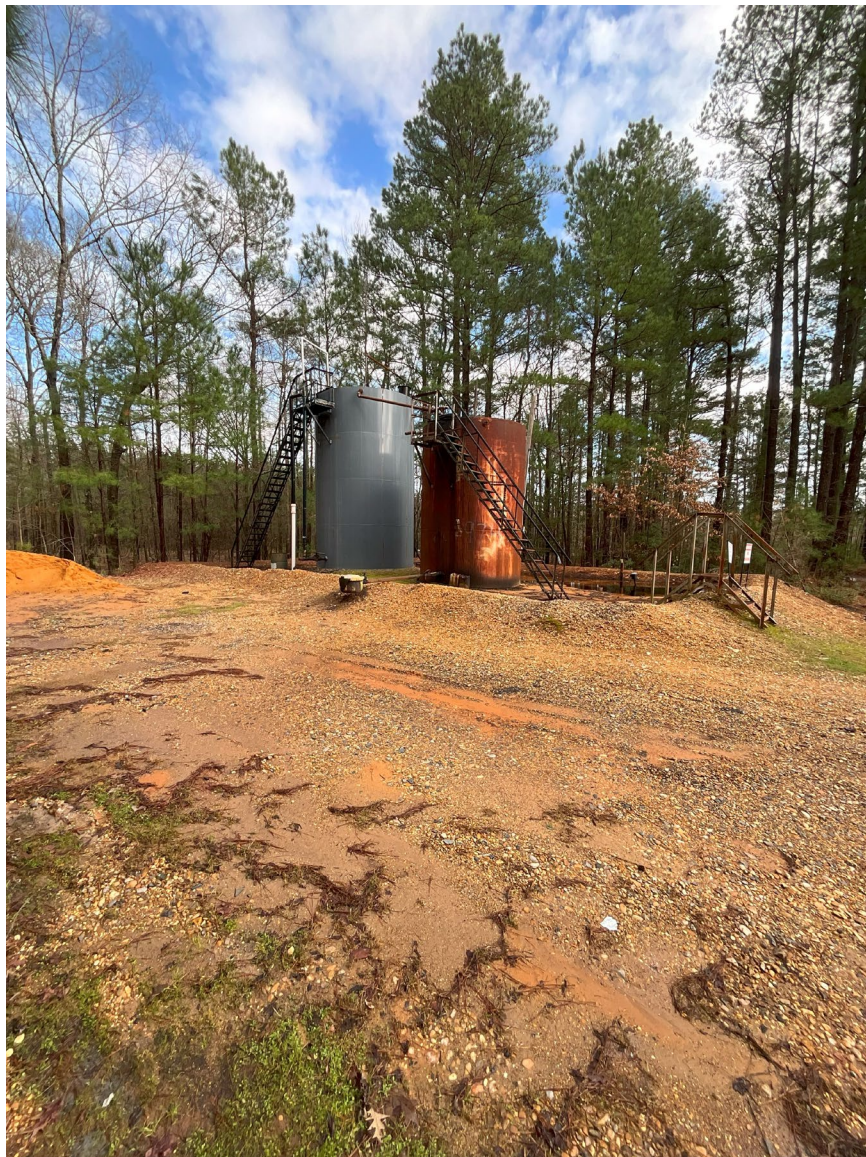
Photo No. 2

**Description:** This photo was taken looking west and shows an overview of the facility.

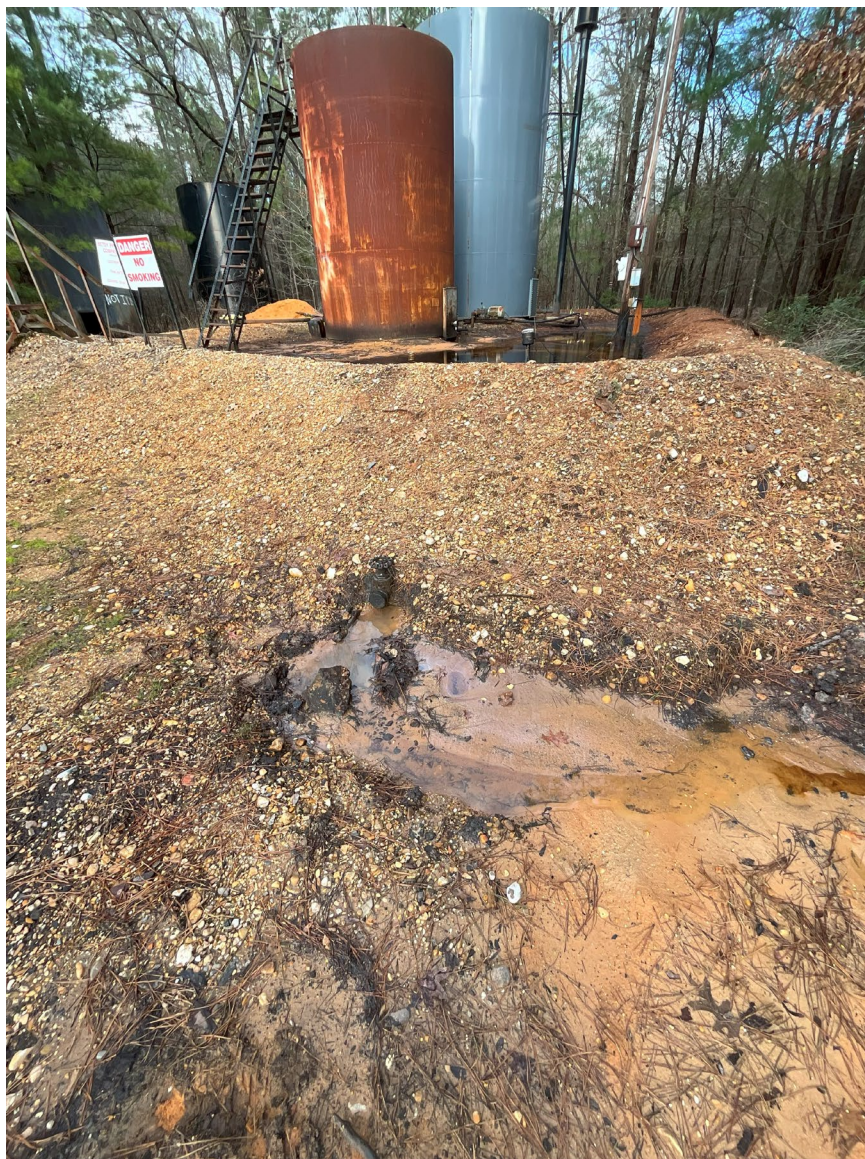
Photo No. 3

I observed a leak in the secondary containment drainage pipe, see photo No. 3.

No closing conference was held due to no Betsy Production Company, Inc. staff being present during the inspection. An area of concern at the time of the inspection is the leak from the secondary containment drainage pipe.

**Description:** This photo was taken looking west showing the secondary containment drainpipe that was leaking.

Inspector will conduct follow-up phone calls with the company representatives over the coming weeks and months to ensure areas of concern are properly addressed.
