**Region 6 Compliance Assurance and Enforcement Division  
INSPECTION REPORT**

| Inspection Date(s): | May 17, 2018 | | |
| Company Name: | <b>LBOC, LLC</b> | | |
| Facility Name: | <b><i>Staples-Olney-Lion</i></b> | | |

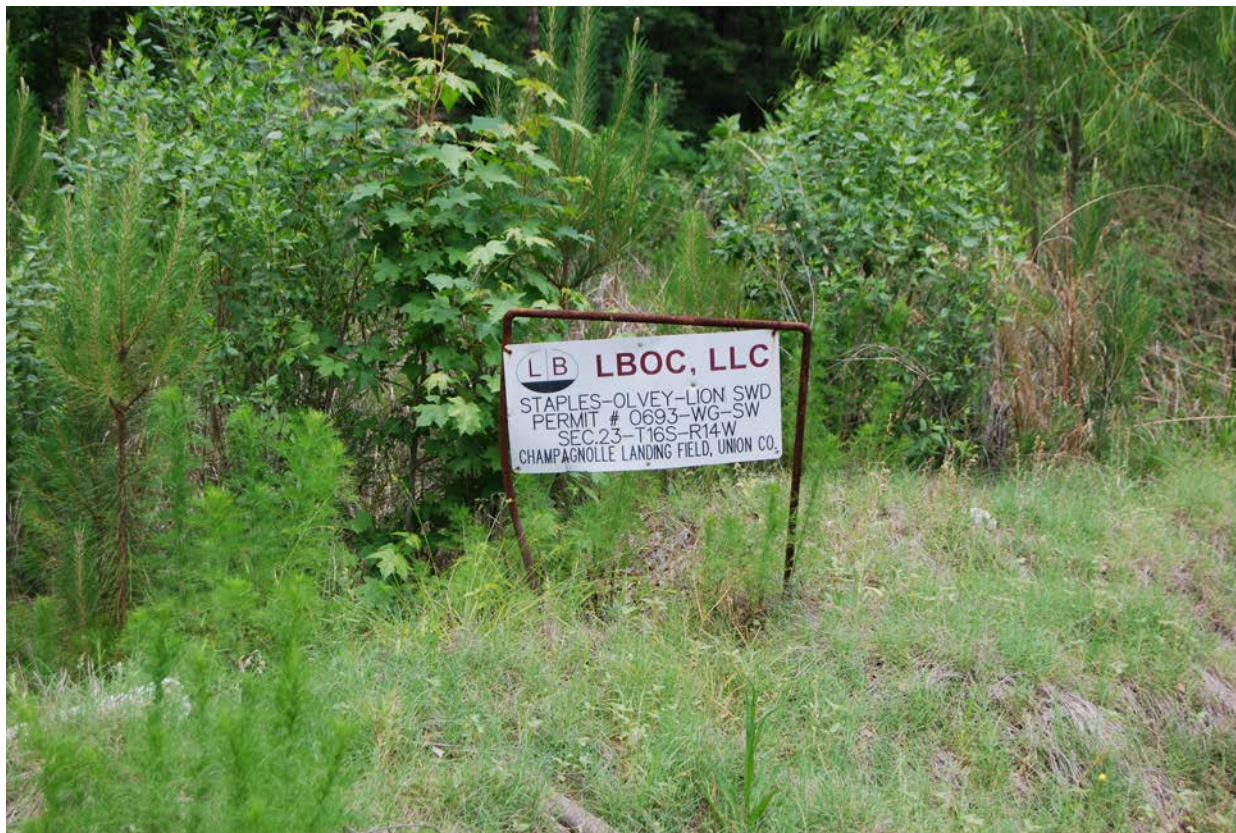
Photo No. 1

Description: This image shows the sign at the facility where a discharge originated from a pit located next to and south of the salt water disposal well indicated on the sign.

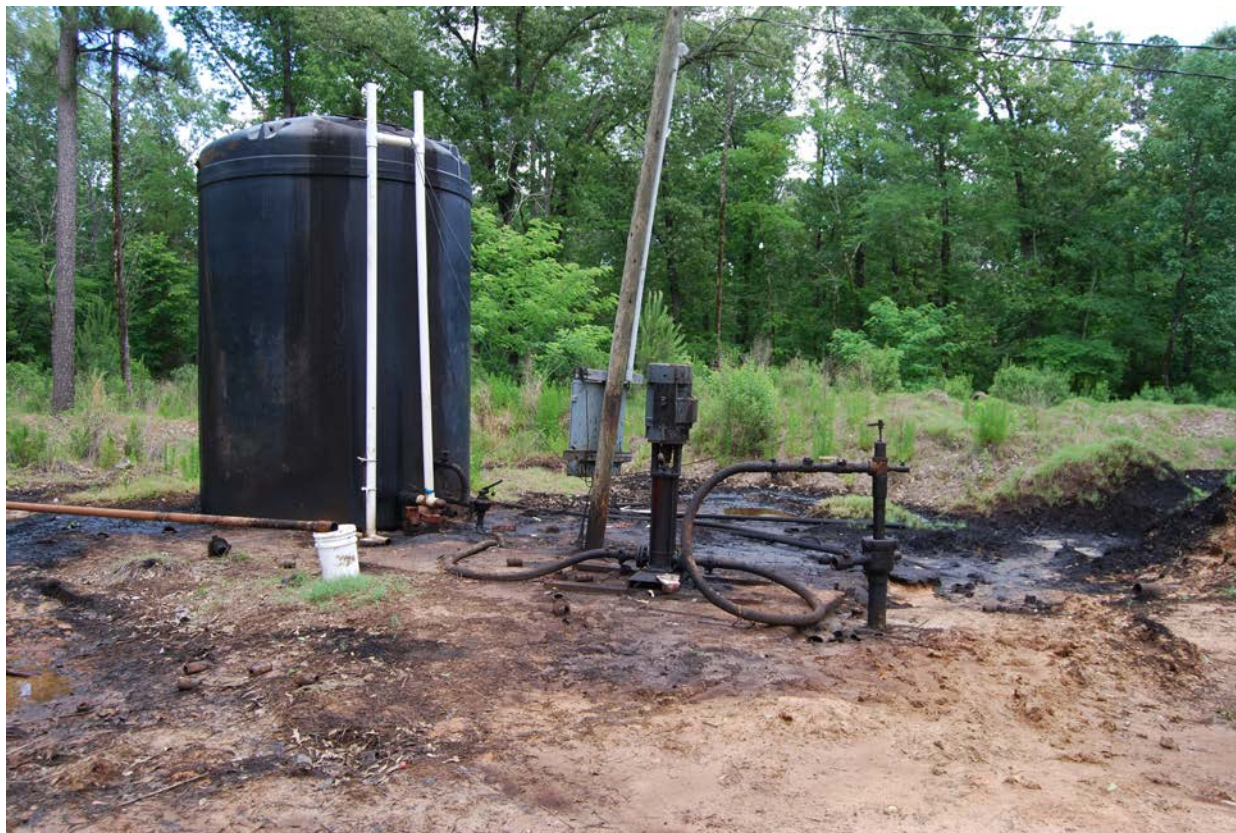
Photo No. 2

Description: The injection well was observed during the inspection. Oil and brine fluids and a flow path were visible from a tank (shown) to a large pit a few yards south of the tank.

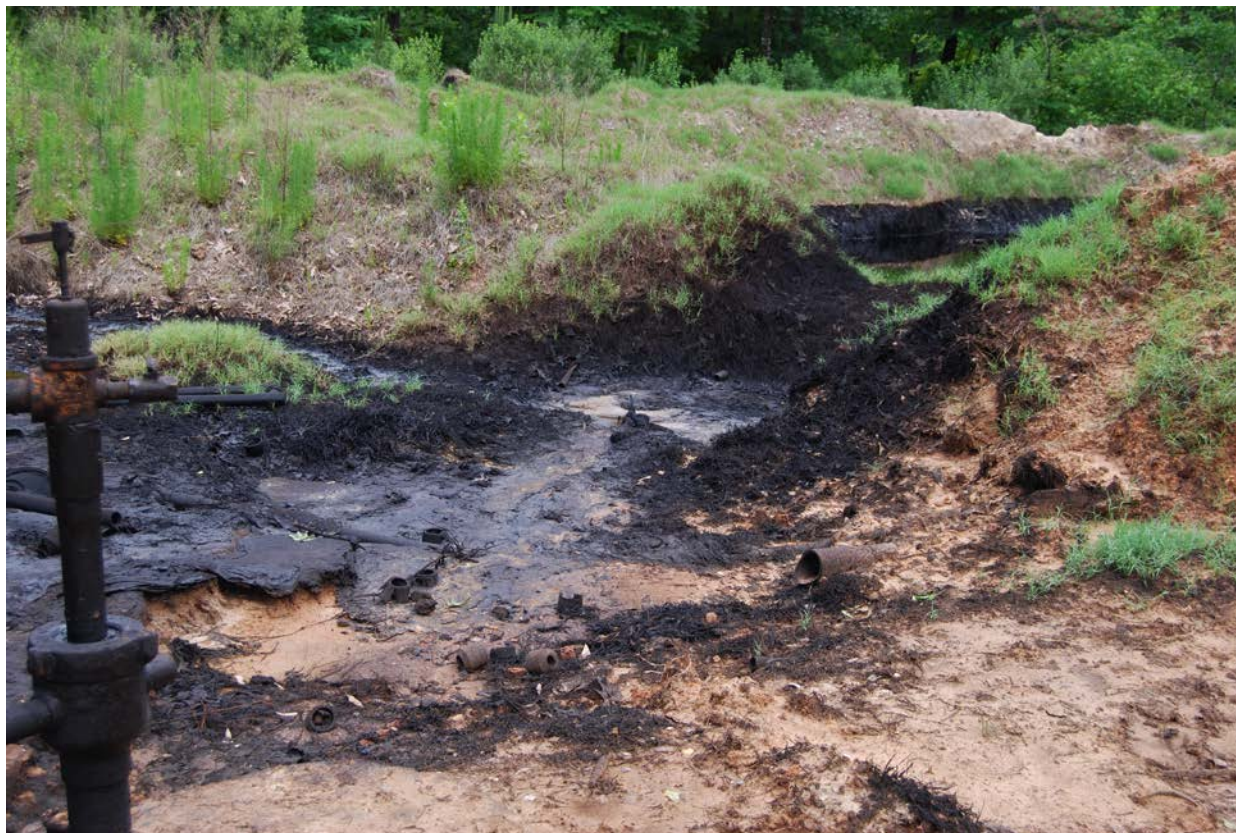
Photo No. 3

Description: I observed that fluids from the tank and well entered the pit here.

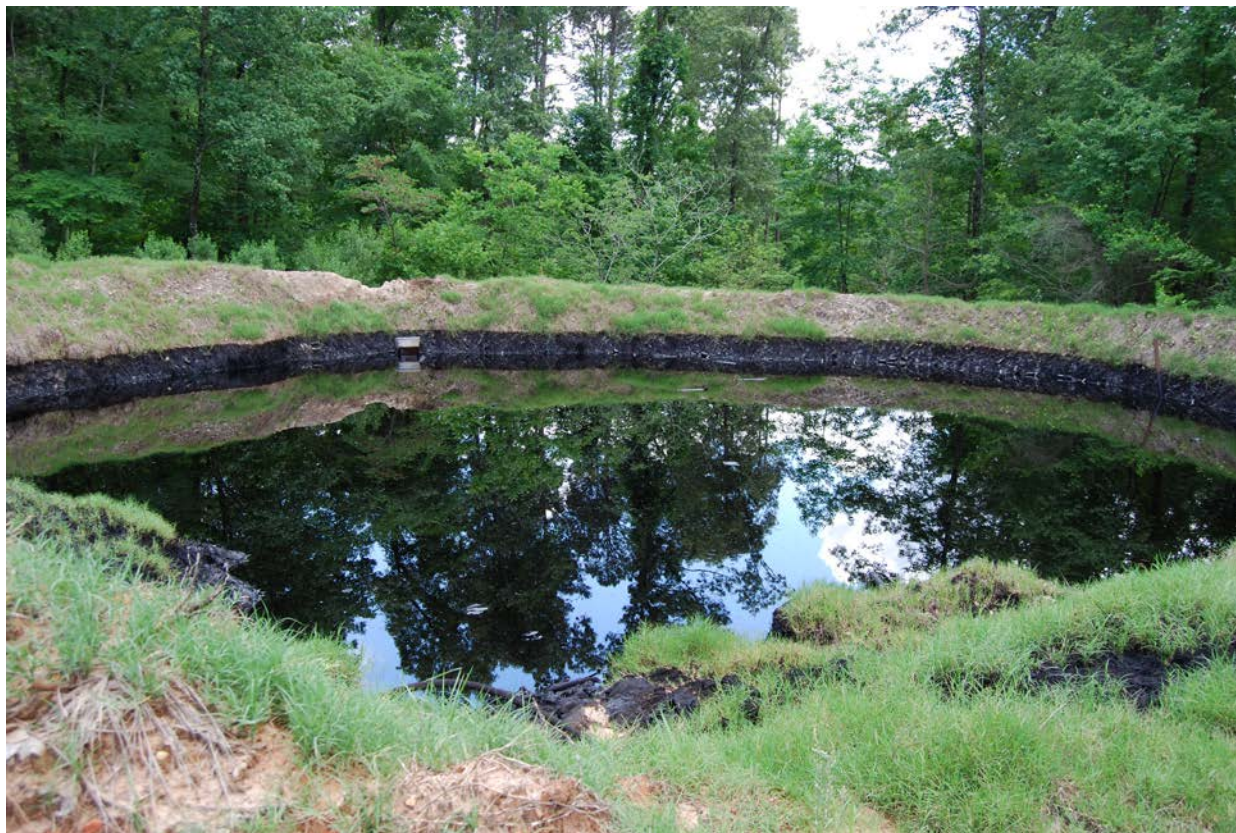
Photo No. 4

Description: The large pit shown here was covered with oil. The pit received overflowing fluids from a single fiberglass tank and the disposal well shown in Photo 2.

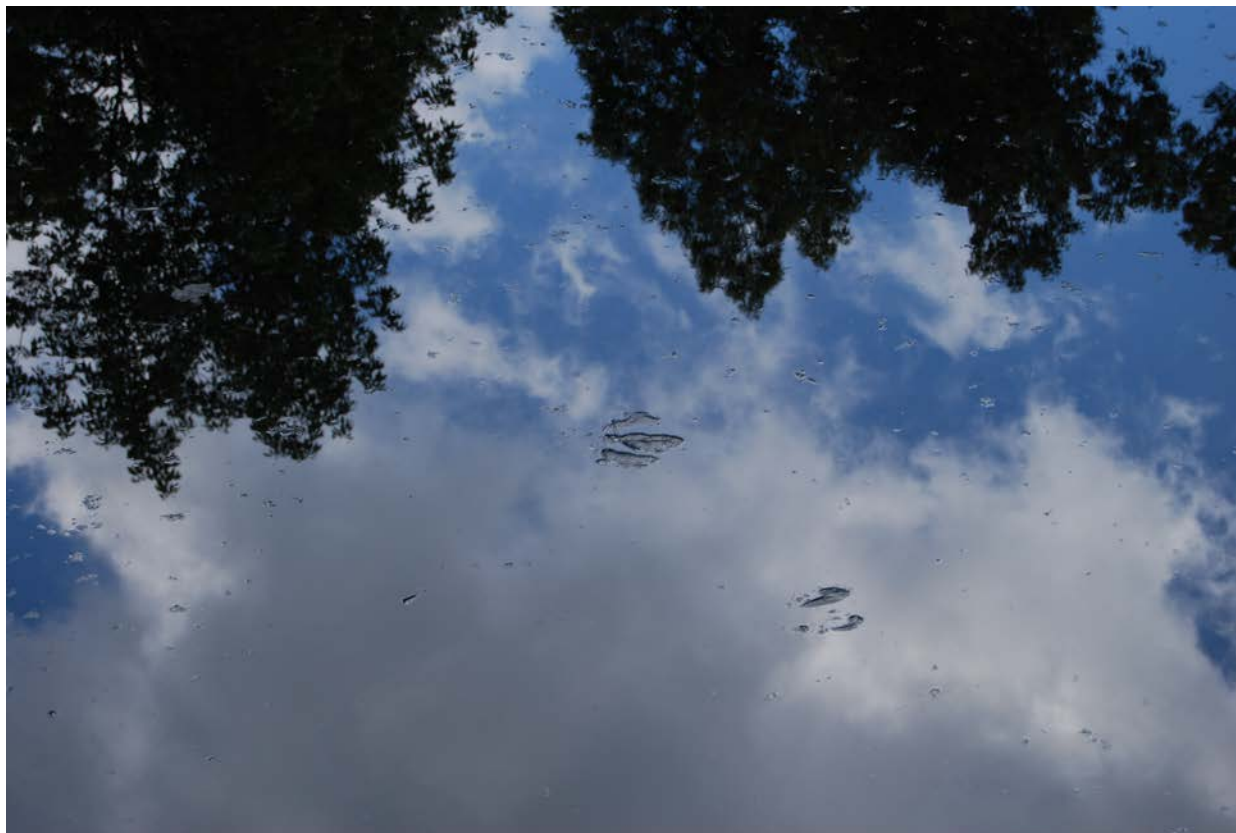
Photo No. 5

Description: The oil covered pit has trapped several birds in the oily fluids. These birds were dead during the inspection. I observed two dead birds here in the pit fluids.

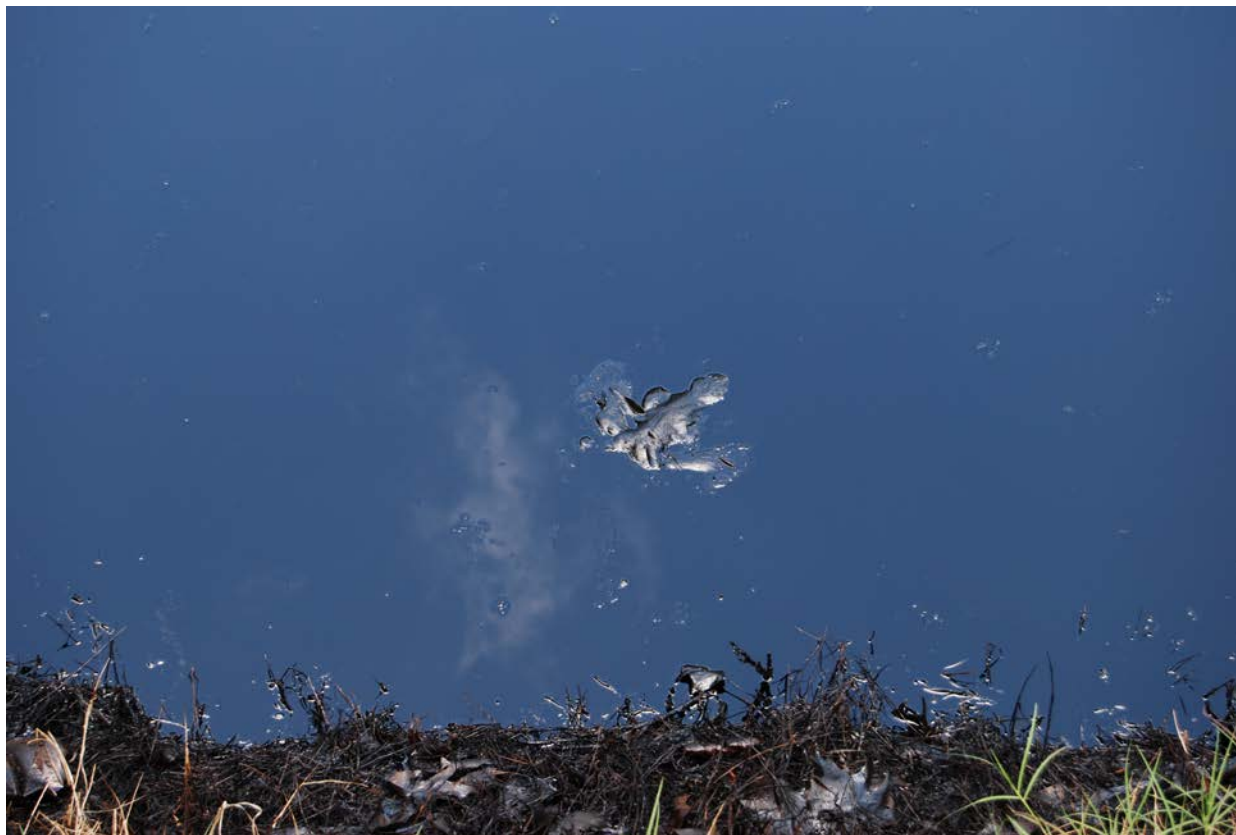
Photo No. 6

Description: I observed another bird that was trapped in the pit fluids, including oil, that was dead during the inspection.

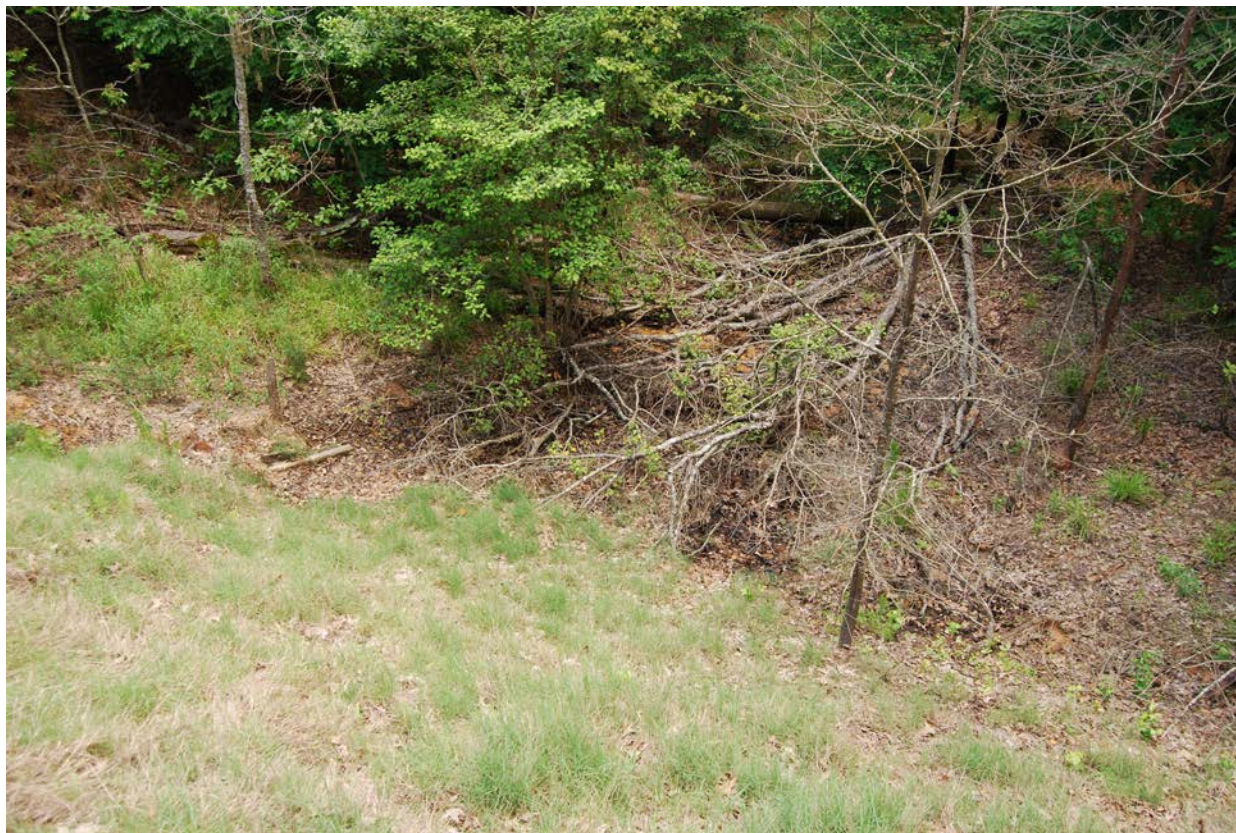
Photo No. 7

Description: This image shows a view from the top of the pit siding towards the south. I observed that the entire south side of the pit was built into a steep hill. I observed that the pit was seeping out of the base of the pit wall towards the south, and could see oil staining along the flow path south of the pit.

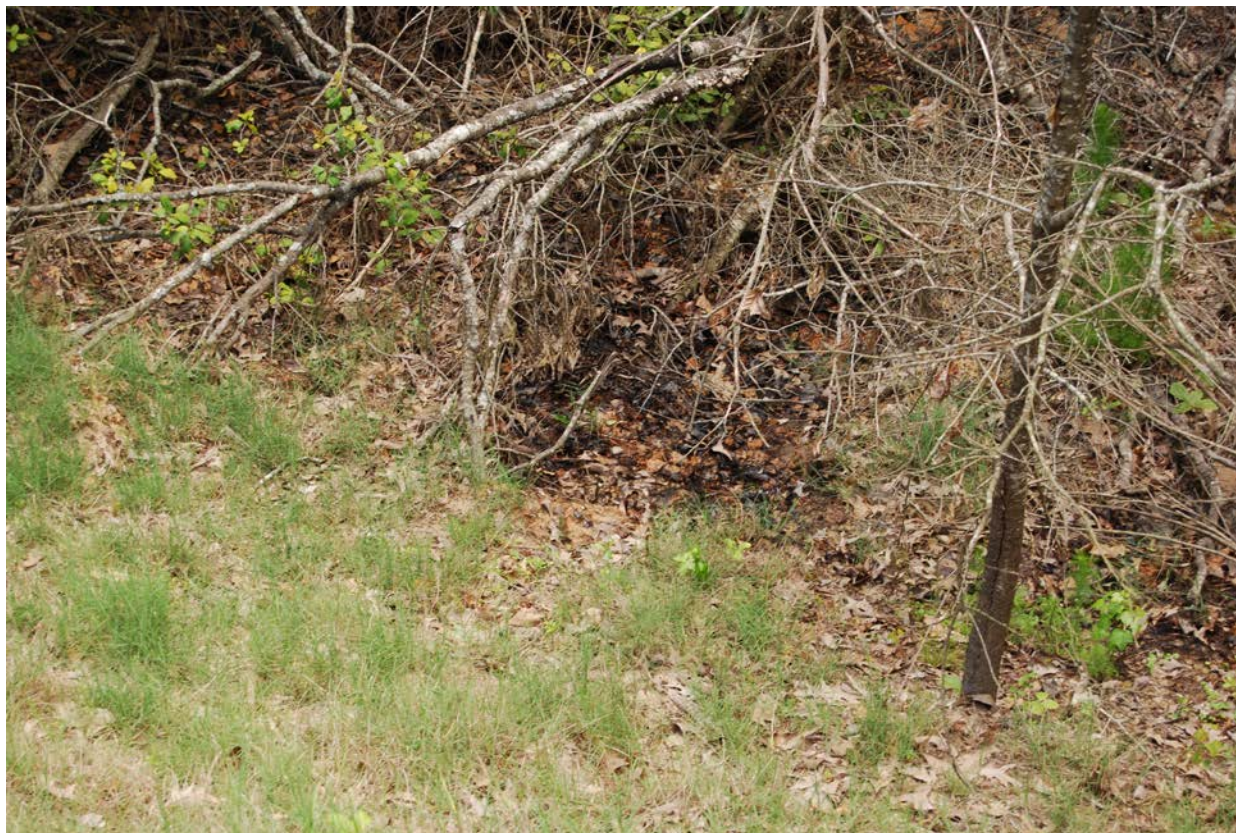
Photo No. 8

Description: This image shows the seeping south side of the pit as seen in Photo 7.

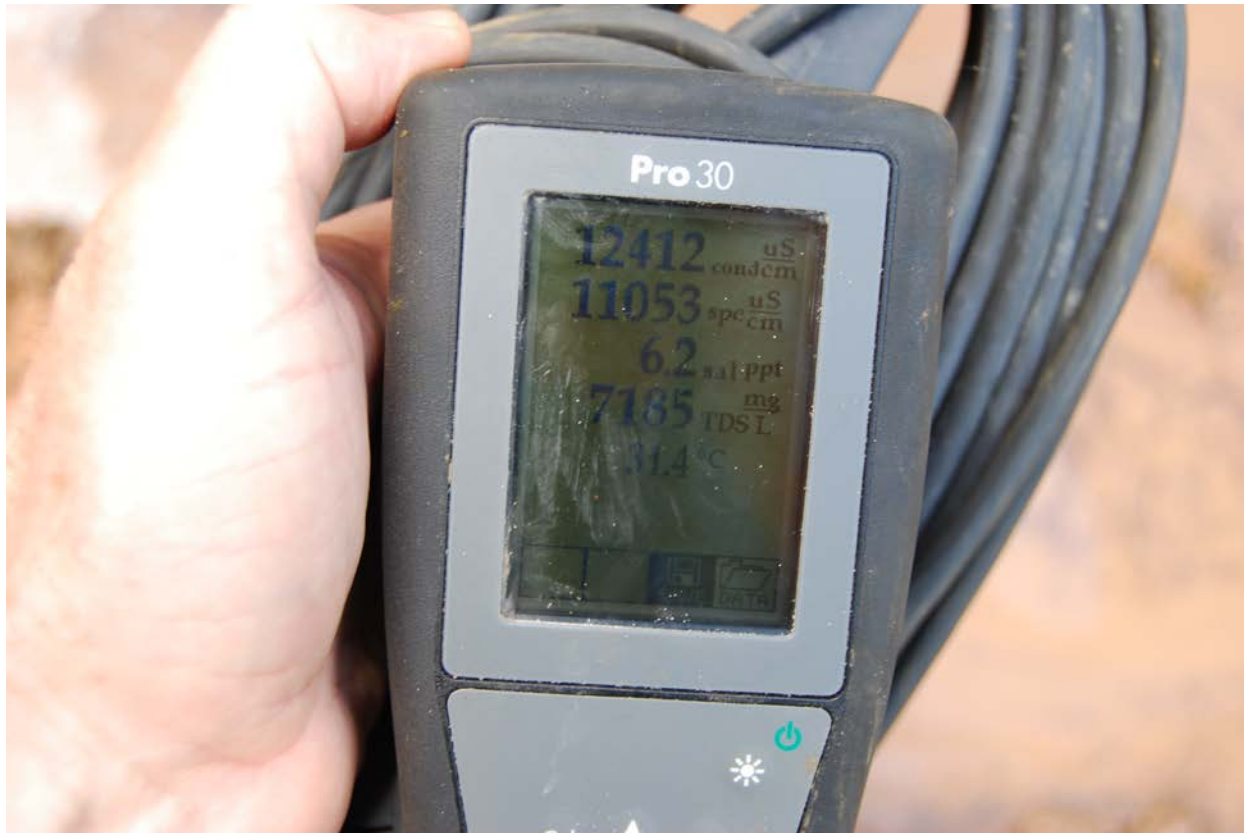
Photo No. 9

Description: With a calibrated YSI Pro 30 Conductivity meter, I took a Total Dissolved Solids (TDS) measurement at the base of the pit and the reading was 7,185 milligrams per Liter (mg/L). I observed that the seeping was active and flowing south at a trickle towards an unnamed tributary of the Ouachita River.

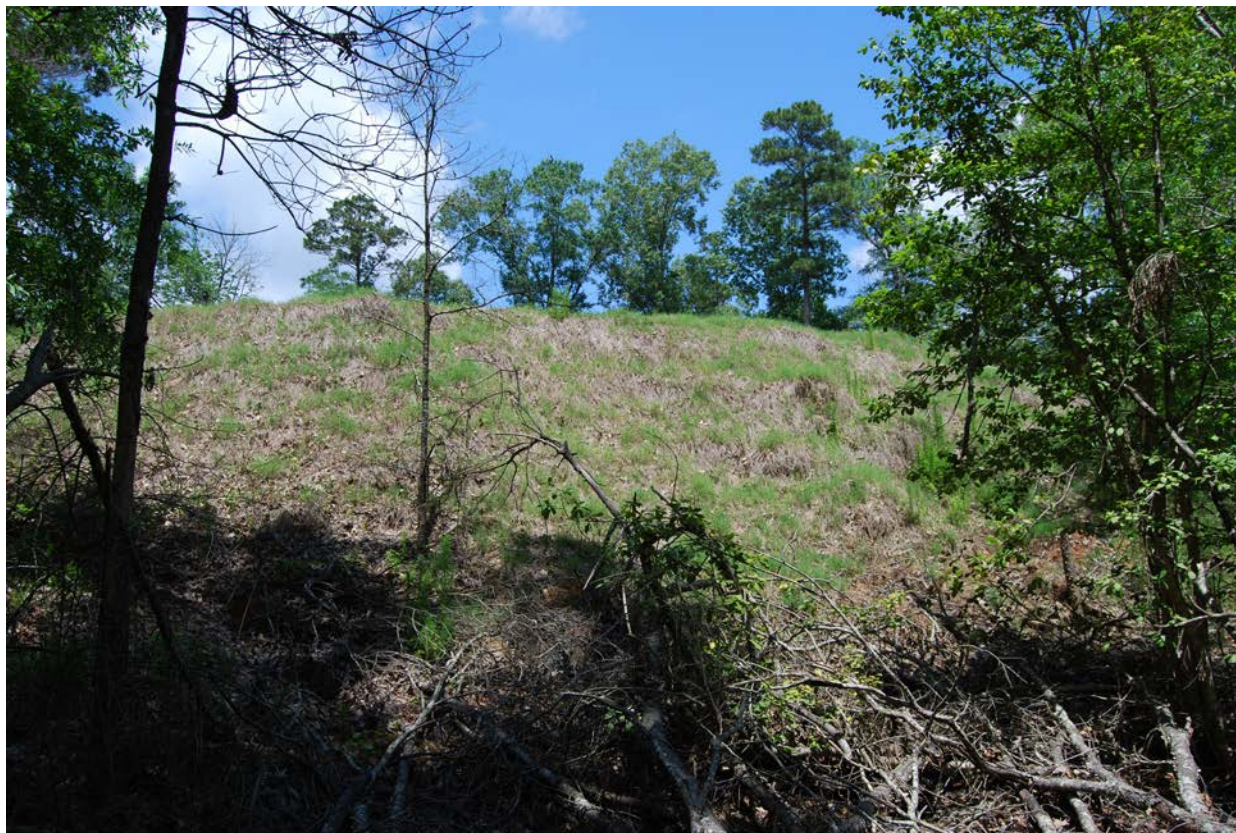
Photo No. 10

Description: This image shows a view from the point of discharge, where the seep was occurring from the base of the pit. The entire hill shown was excavated to construct the pit shown in Photo 4.

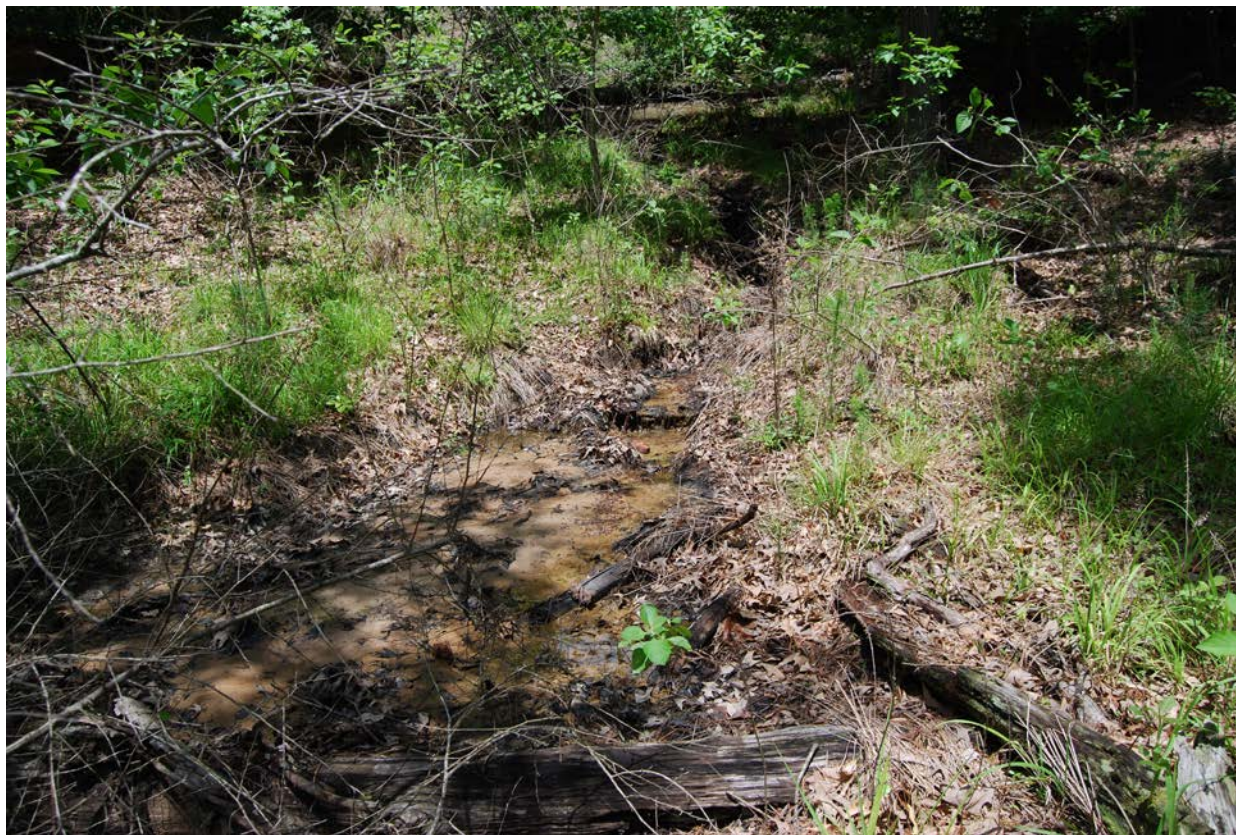
Photo No. 11

Description: In this photo, I observed that brine and some oil seeped from the pit and flowed south along this path toward the unnamed tributary.

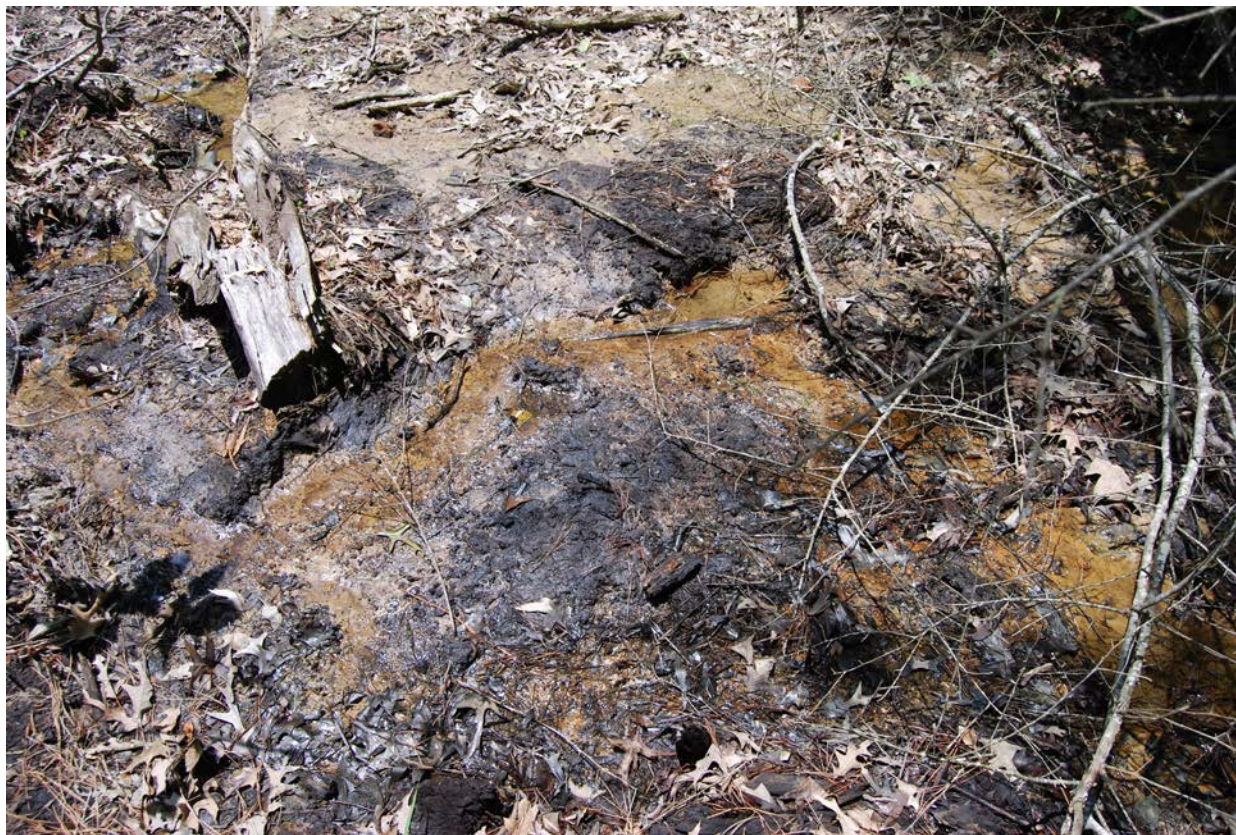
Photo No. 12

Description: This photo shows a close-up view of the seepage mixture of brine and oil along the flow path to the tributary.

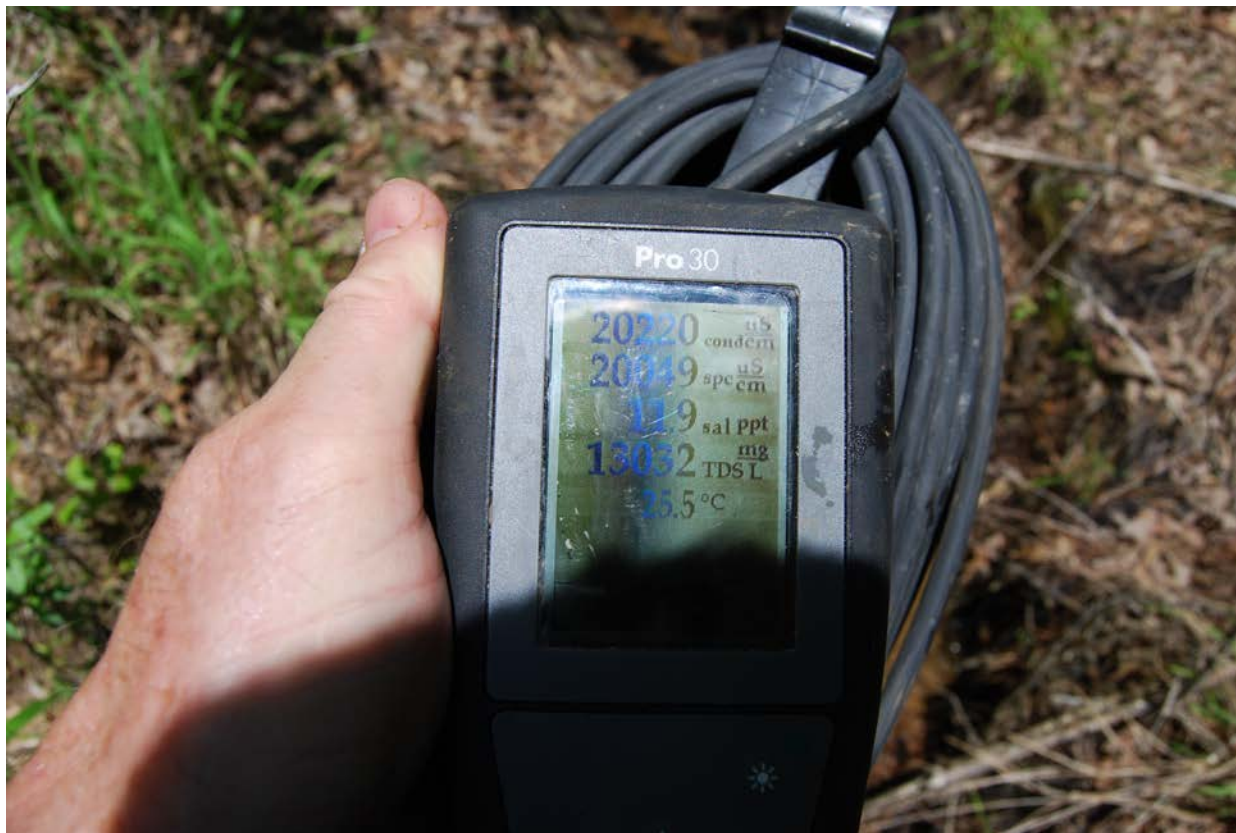
Photo No. 13

Description: I measured the TDS of the seepage mixture along the flow path was 13,032 mg/L.

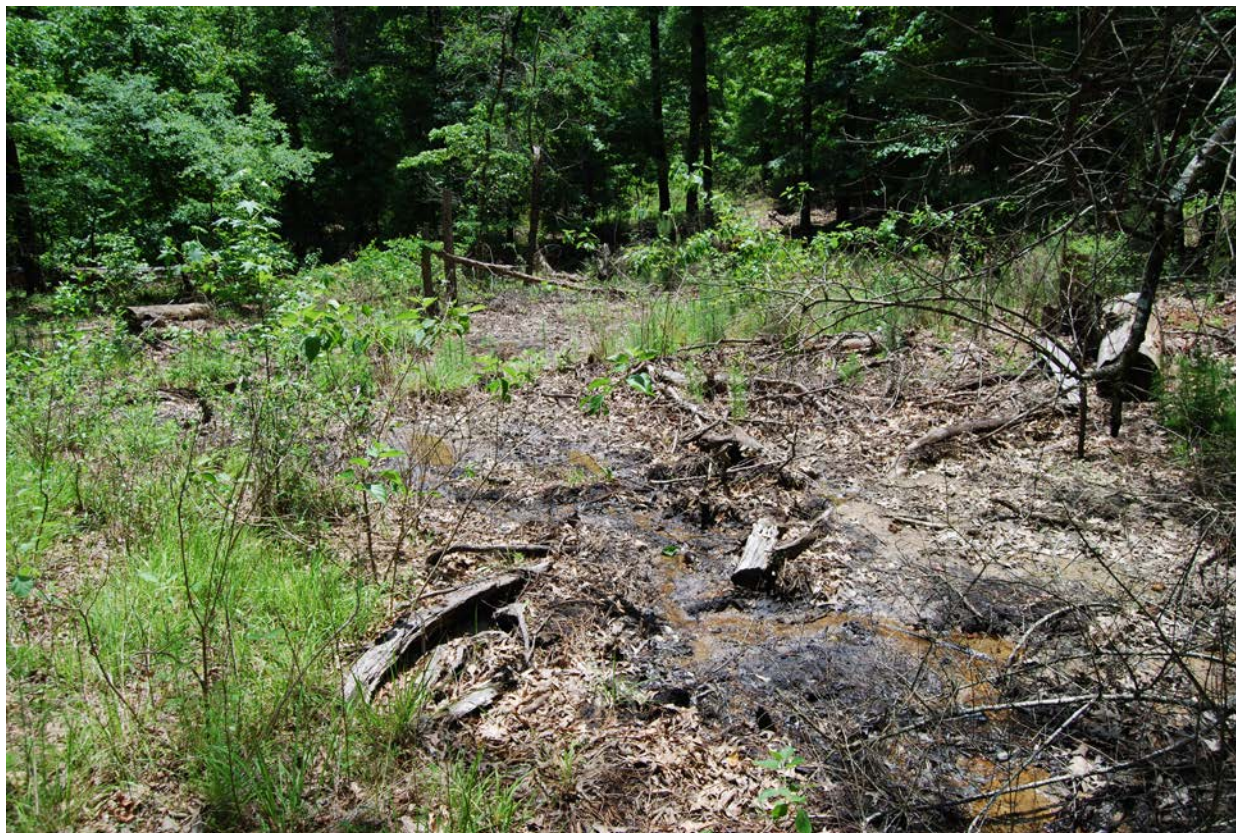
Photo No. 14

Description: I observed farther south of the point shown in Photo 13, that there was dead vegetation present along the flow path.

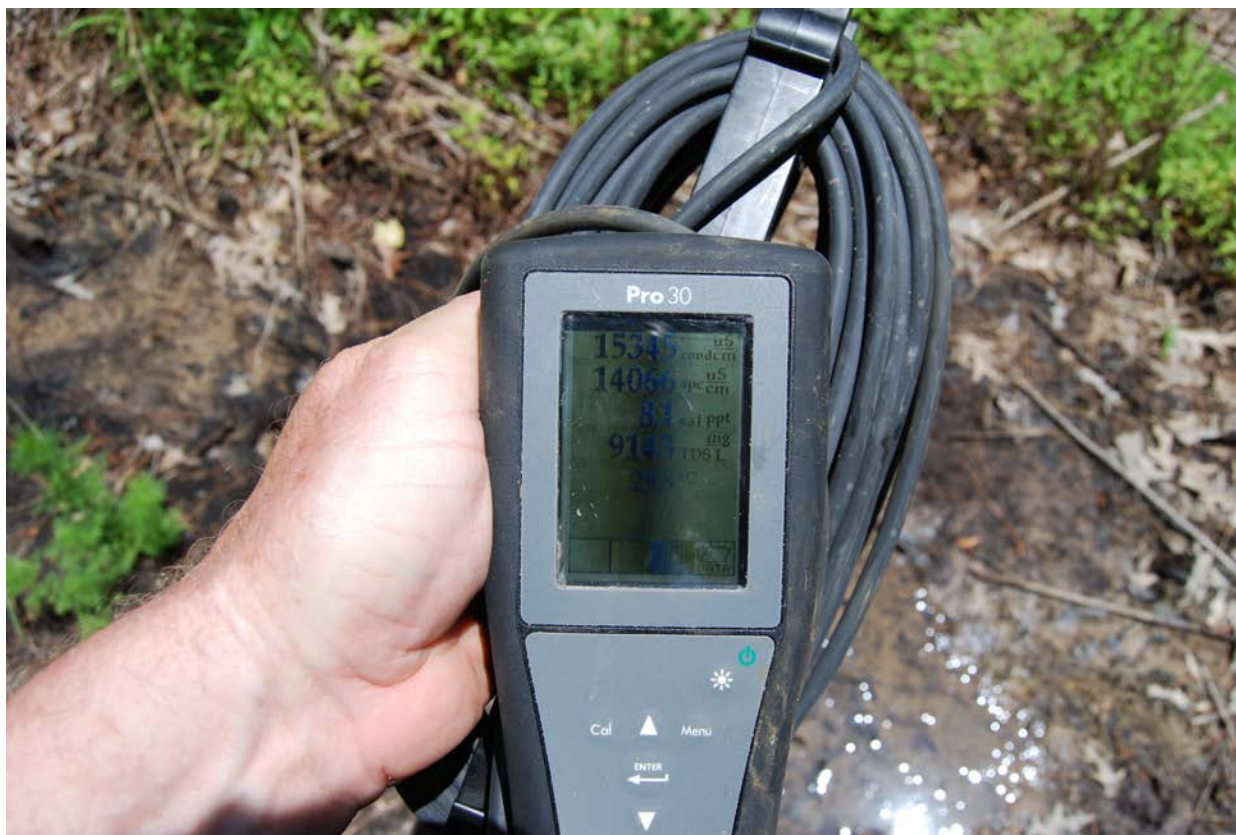
Photo No. 15

Description: I took a TDS reading at the point shown in Photo 14 and it was 9,143 mg/L.

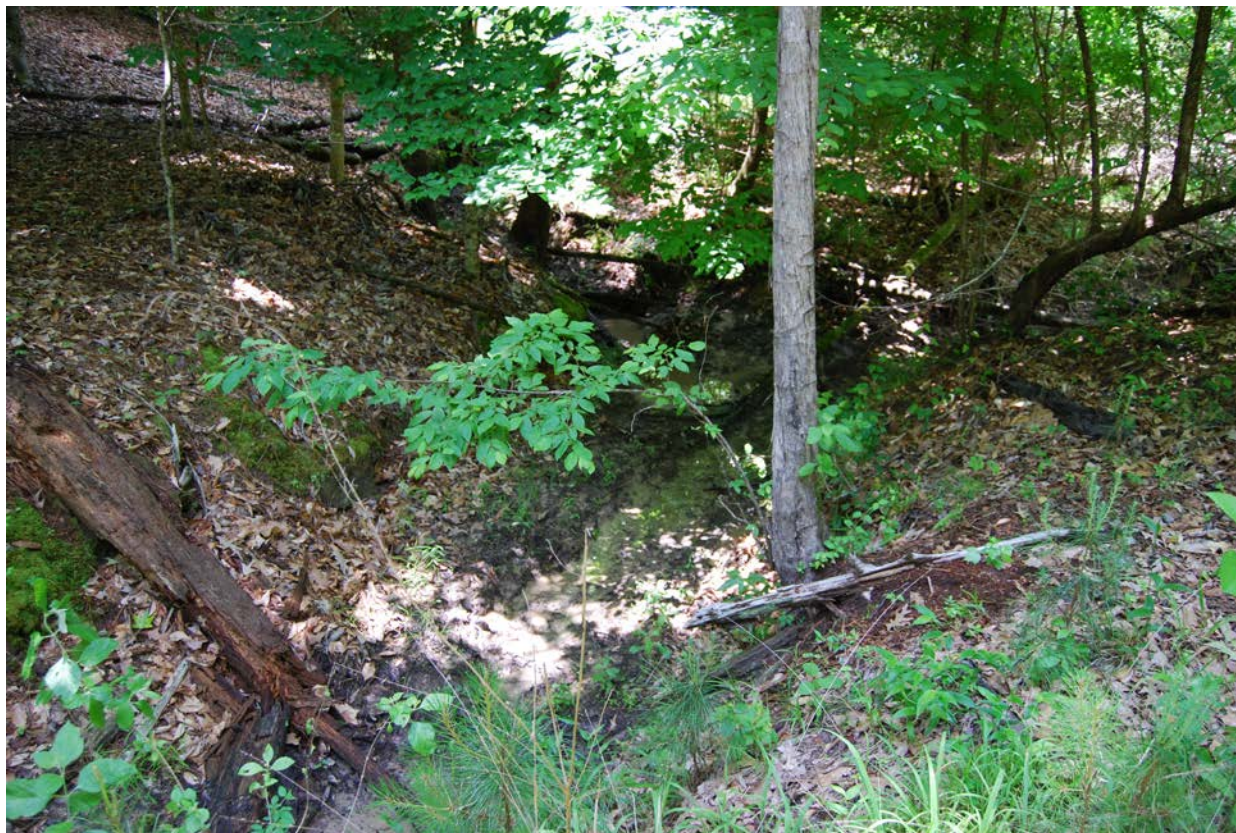
Photo No. 16

Description: This image shows the point of entry to the tributary of the Ouachita River where brine and oil fluids had entered the tributary. The flow of the tributary was east.

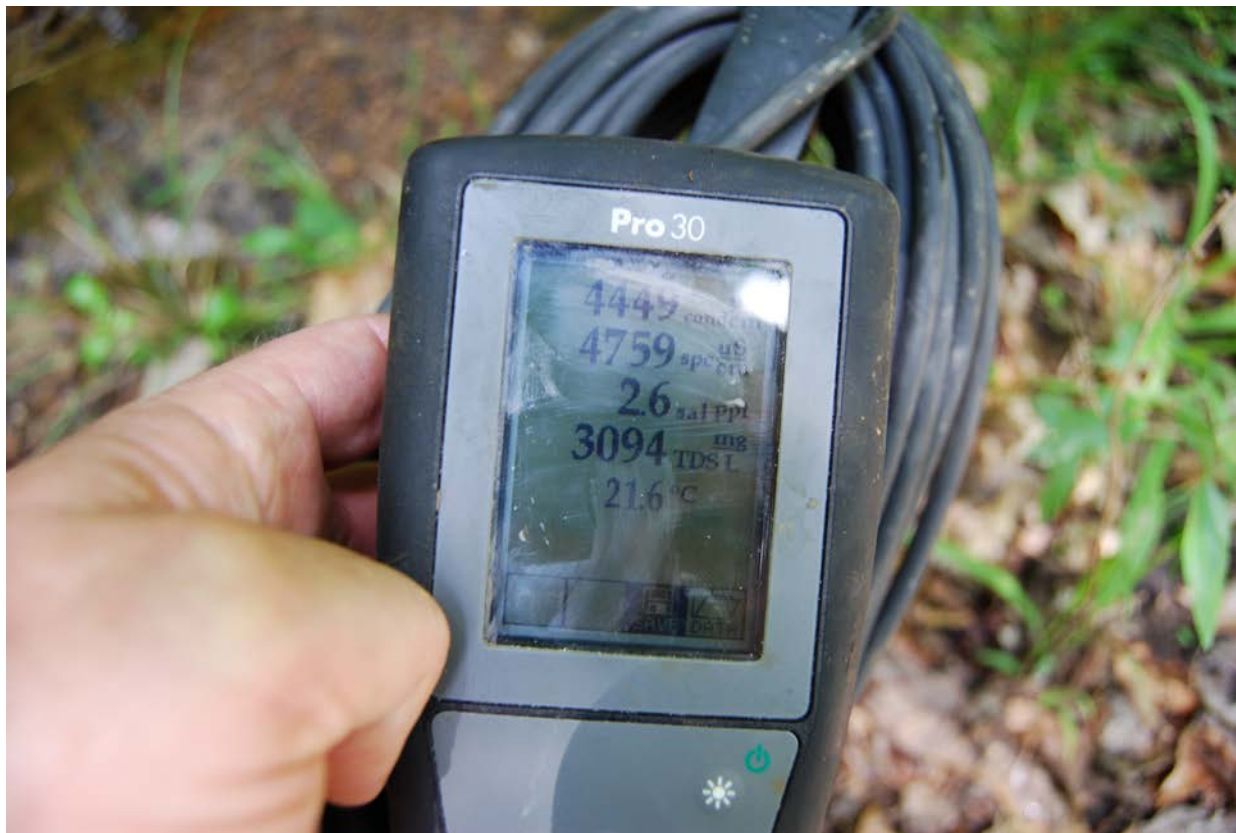
Photo No. 17

Description: A TDS reading at the point of entry was 3,094 mg/L.

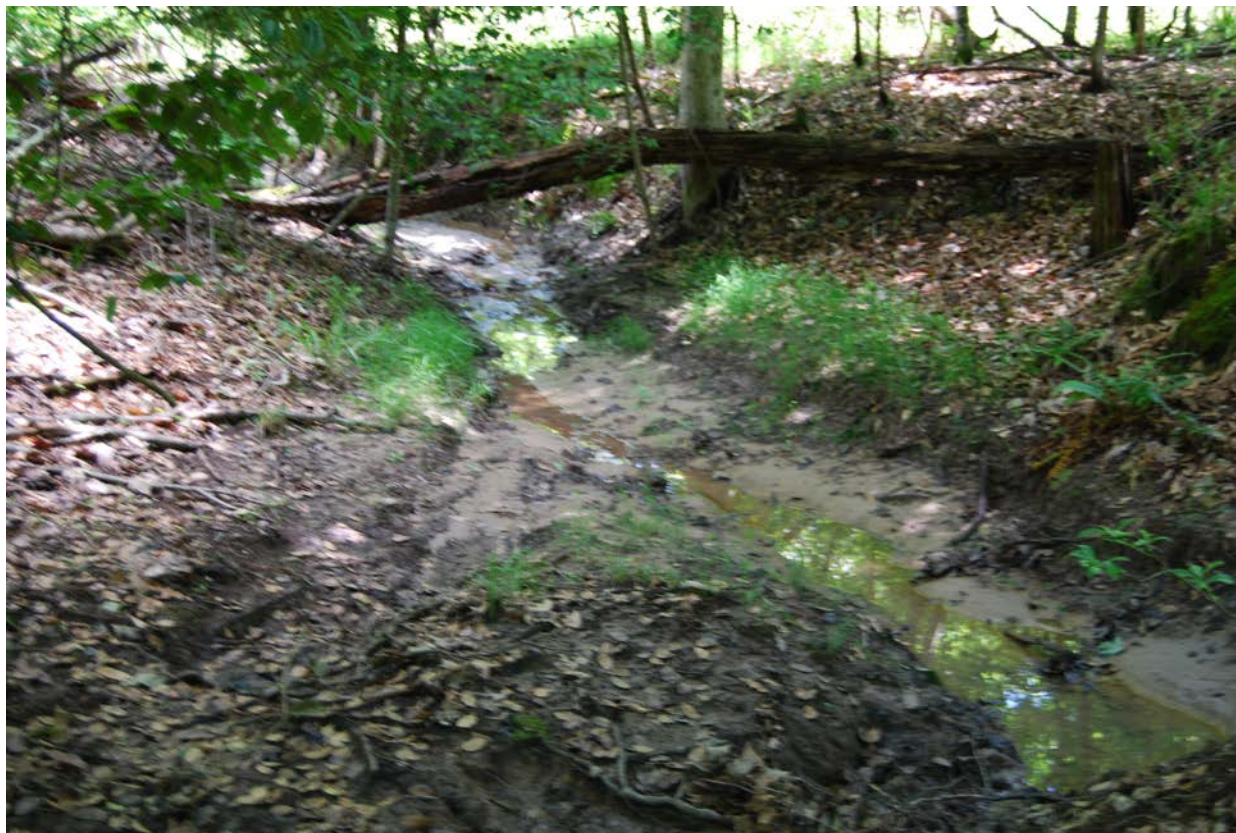
Photo No. 18

Description: This was the view of the tributary downstream from the point of entry. Flow was southeast towards another tributary of the Ouachita River which flowed to the Ouachita River. This location was approximately 1,200 feet south of the Ouachita River in a remote location and further access downstream was not feasible during the inspection.

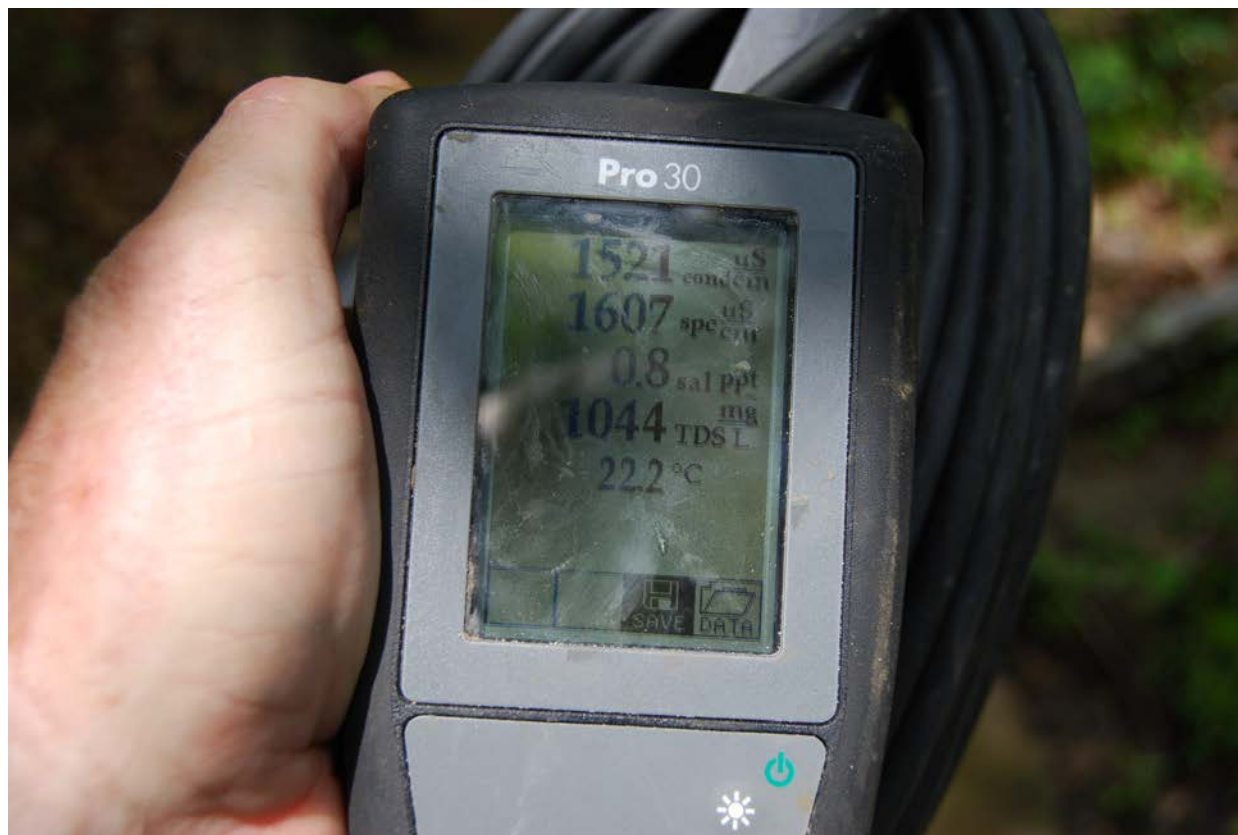
Photo No. 19

Description: I took a TDS reading of the tributary at the location in Photo 18 and it was 1,044 mg/L.

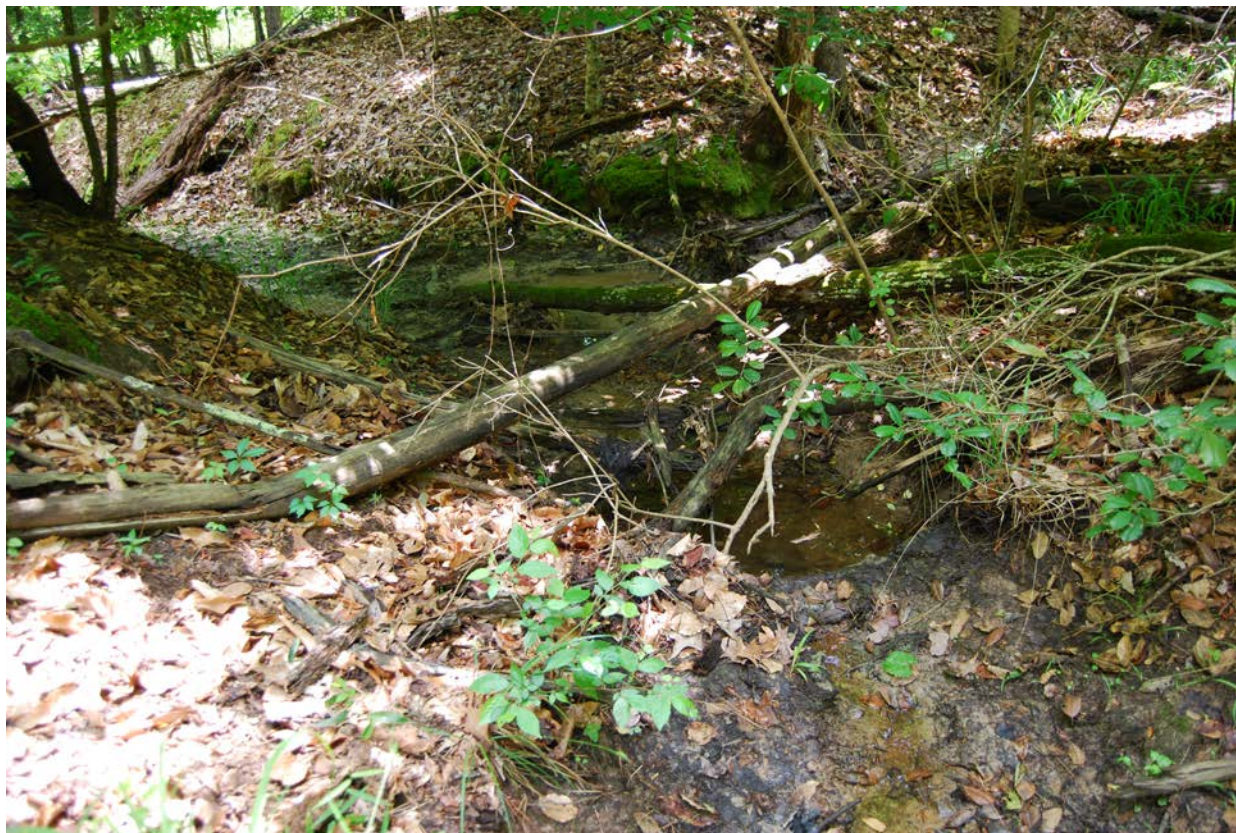
Photo No. 20

Description: This image shows a view of the creek upstream from the point of entry of the brine to the tributary. I observed flow in the tributary at this location.

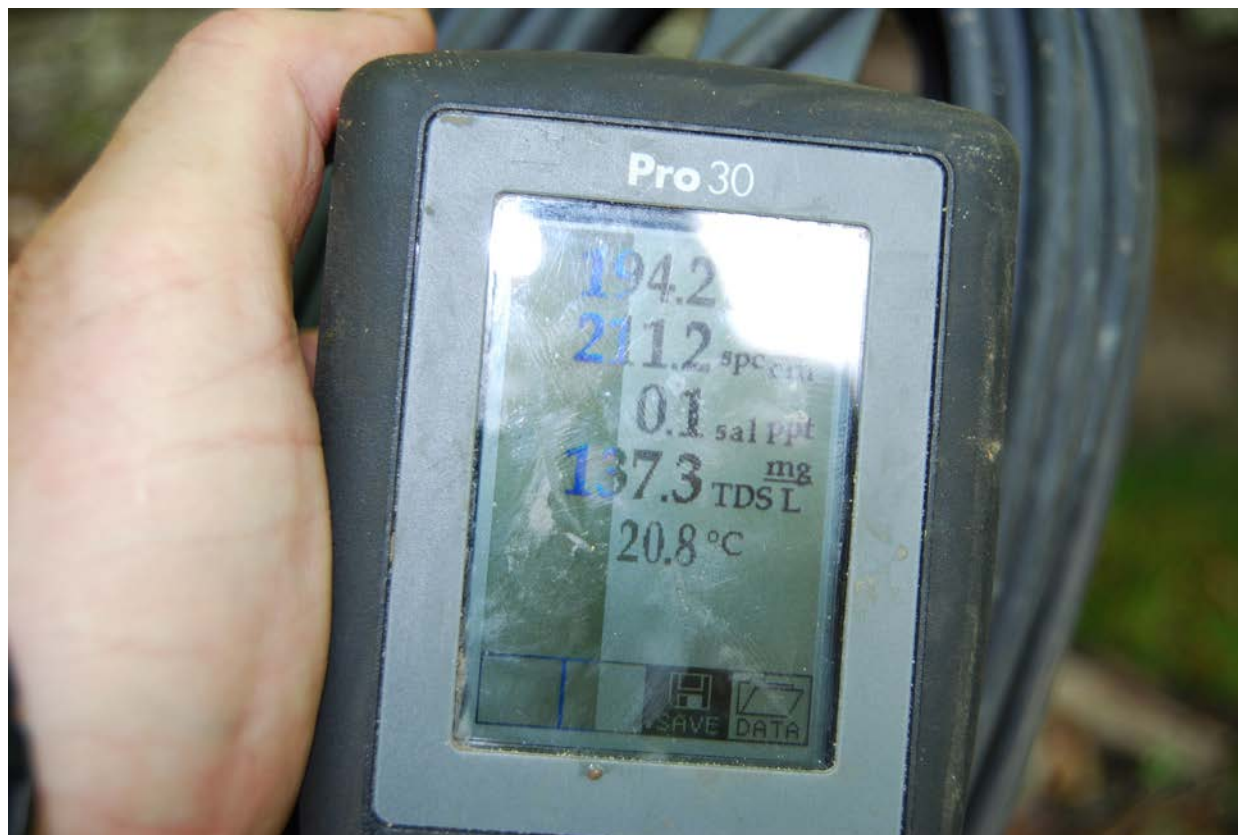
Photo No. 21

Description: The TDS reading taken here, upstream, was 137 mg/L.
