Clean Water Act (CWA) Inspection Report

| Inspection Entry Date/Time | 07/31/2024 8:55AM (PST) | Announced: Yes | | |
|---|---|---|---|---|
| Type of Inspection | CEI - Compliance Evaluation Inspection | | | |
| Facility Name | City of Orofino – Water Treatment Plant | | | |
| EPA Permit Tracking # | ID0001058 | | | |

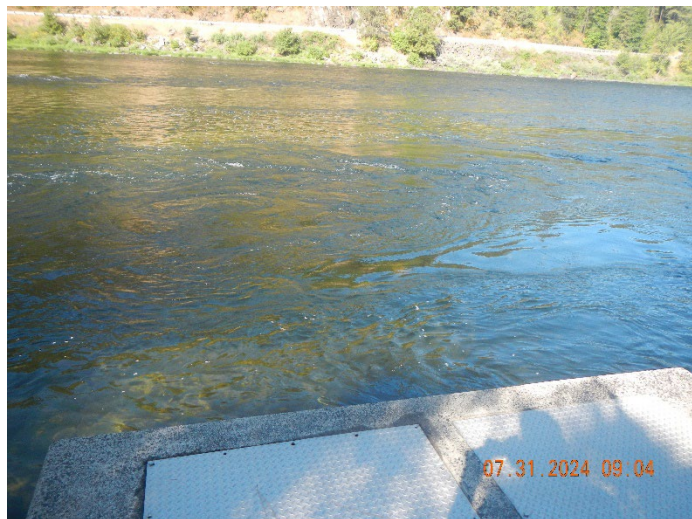
Photo #:01 (DSCN3840)

Description: Facing west, photo of the raw water intake structure.

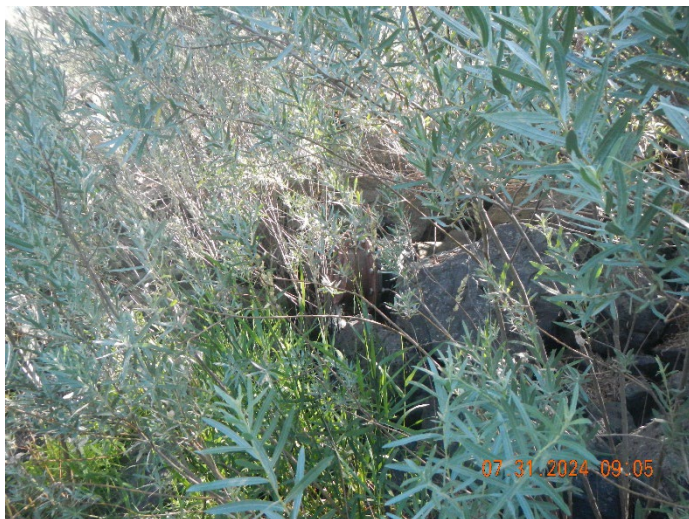
Photo #:02 (DSCN3841)

Description: Facing northeast, photo of Outfall 001 discharging to the bank of the Clearwater River. View/access limited due to vegetation and slope.

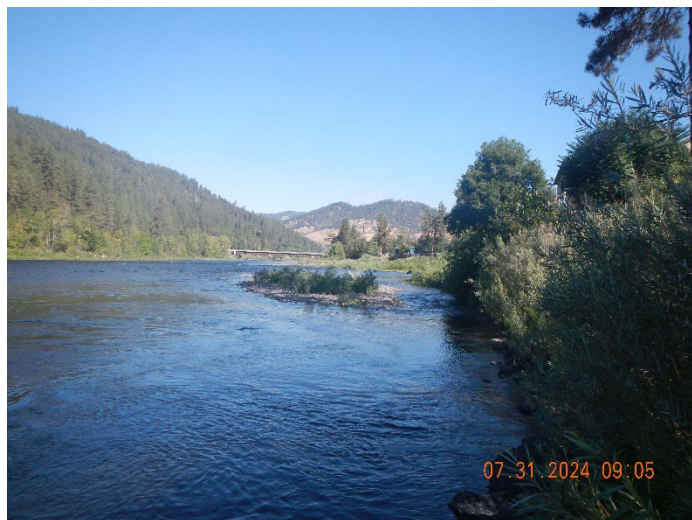
Photo #:03 (DSCN3842)

Description: Facing north, photo of Clearwater River below Outfall 001.

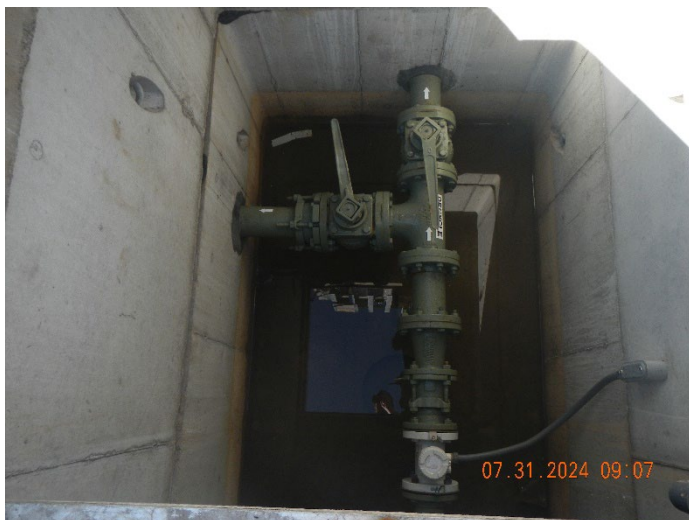
Photo #:04 (DSCN3843)

the NPDES permitted discharge line was slightly open (**Photo 4**). The discharge valve was located off the return/recycle piping to the raw water wet well from the sedimentation basin. Mr. Martin discussed that he was previously unaware of the discharge/valve opening and would have to follow-up with the other operators on the cause. Mr. Martin discussed that it's possible the valve handle was inadvertently moved when the vault was manually cleaned by another operator earlier in the year. Mr. Martin closed the discharge valve fully and the discharge stopped.

| AOC Reference #: AOC-001 | Unmonitored/Unplanned Discharge |
|---|---|
| <p>Regulation and/or Permit Requirement:</p> <p>Section I.B. of the permit states that “the permittee must limit and monitor discharges from outfall 001 as specified in Table 1.” Table 1 includes Monitoring parameters for Total Suspended Solids (TSS), pH, Flow, Hardness, Aluminum, Metals (antimony, arsenic, beryllium, cadmium, total chromium, copper, lead, nickel, selenium, silver, thallium, and zinc), Temperature and Turbidity.</p> <p>Section E. of the permit states that “the permittee must at all times operate and maintain all facilities and systems of treatment and control (and related appurtenances) which are installed or used by the permittee to achieve compliance with the conditions of this permit.”</p> <p>As discussed earlier in this report, at the time of inspection, Mr. Martin discovered that the bypass valve located off the return/recycle piping to the raw water wet well from the sedimentation basin was slightly open (<b>Photo 4</b>). The open valve resulted in Outfall 001 to have a small amount of flow discharging to the bank of the Clearwater River (<b>Photo 2</b>). The discharge was observed to be clear, with no visible indicators of impaired water quality (i.e., foam, sheen, suspended or submerged matter). Upon discovering, Mr. Martin closed the discharge valve fully and the discharge stopped.</p> <p>The concern is the unplanned/unmonitored discharge that was occurring from Outfall 001 for an unknown amount of time prior to the inspection. Mr. Martin discussed that he was previously unaware of the discharge/valve opening and would have to follow-up with the other operators on the cause. Mr. Martin discussed that it’s possible the valve handle was inadvertently moved when the vault was manually cleaned by another operator earlier in the year.</p> | |

Description: Photo within vault associated with return/recycle valve/piping. Bypass valve (left) to Outfall 001 slightly open.

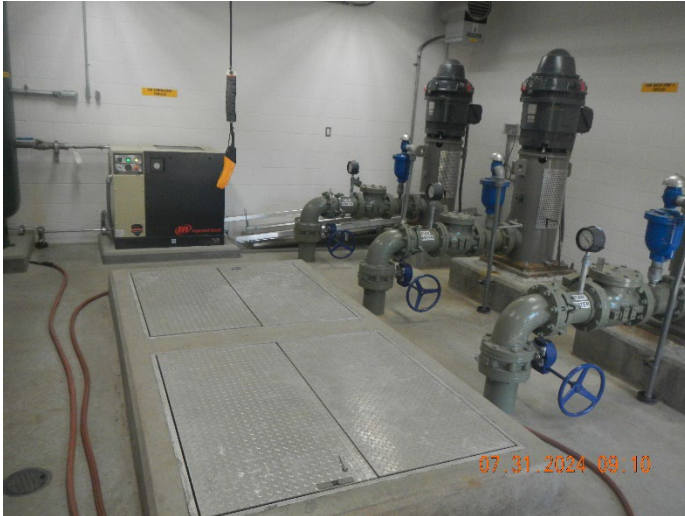
Photo #:05 (DSCN3844)  
Description: Photo of raw water pumps within the raw water pump station.

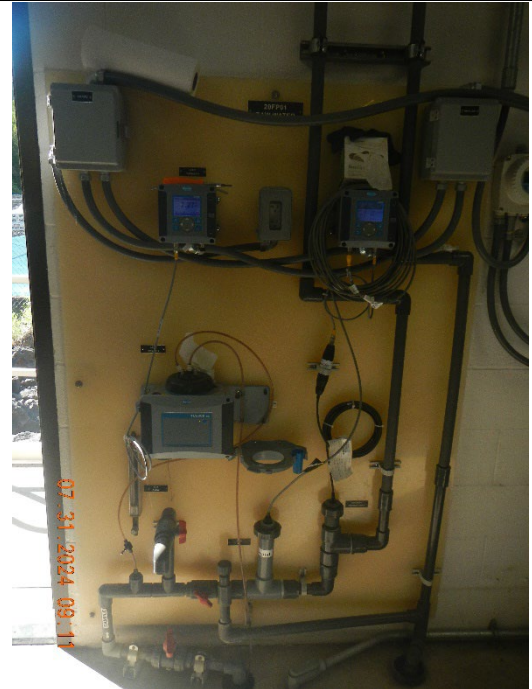
Photo #:06 (DSCN3845)  
Description: Photo of raw water monitoring equipment.

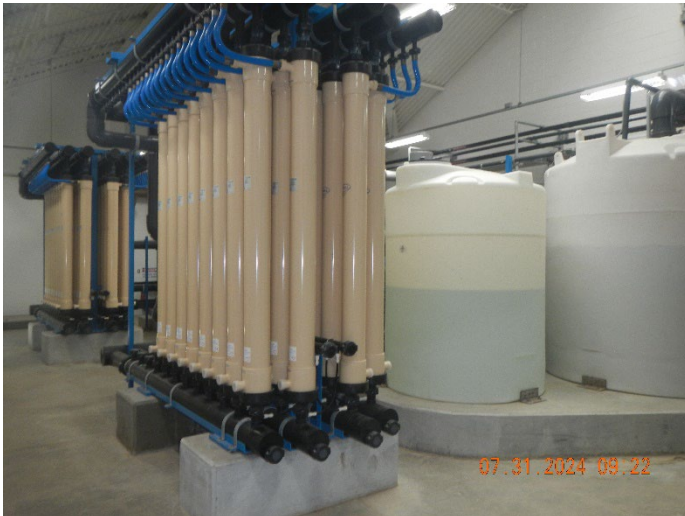
Photo #:07 (DSCN3846)  
Description: Photo of membrane filtration units.

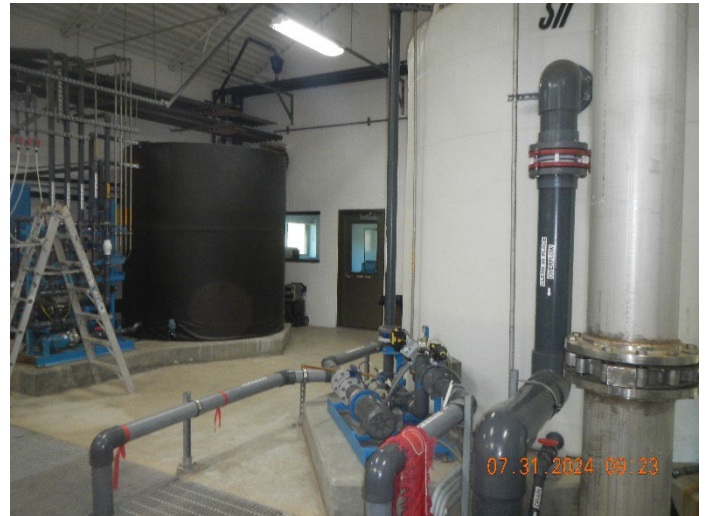
Photo #:08 (DSCN3847)  
Description: Photo of neutralization tank.

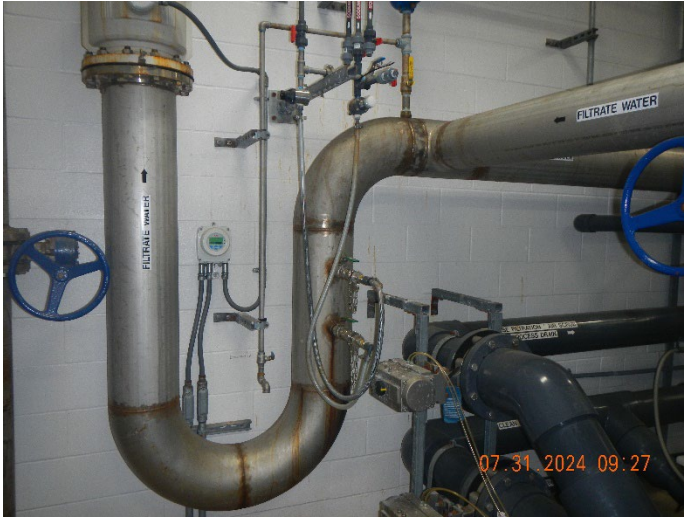
Photo #:09 (DSCN3848)  
Description: Photo of filtrate water piping.

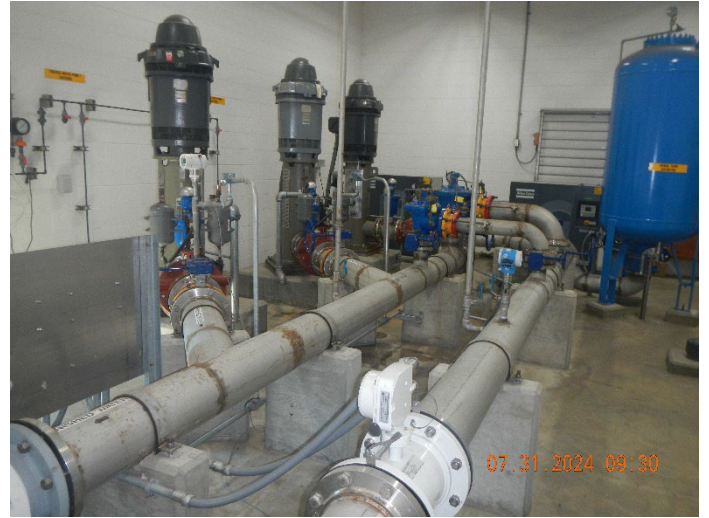
Photo #:10 (DSCN3849)  
Description: Photo of distribution pumps.

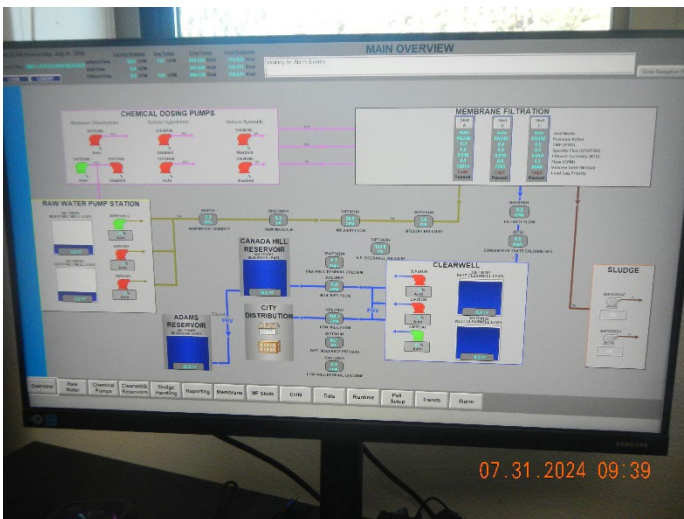
Photo #:11 (DSCN3850)  
Description: Photo of SCADA system display (overview).

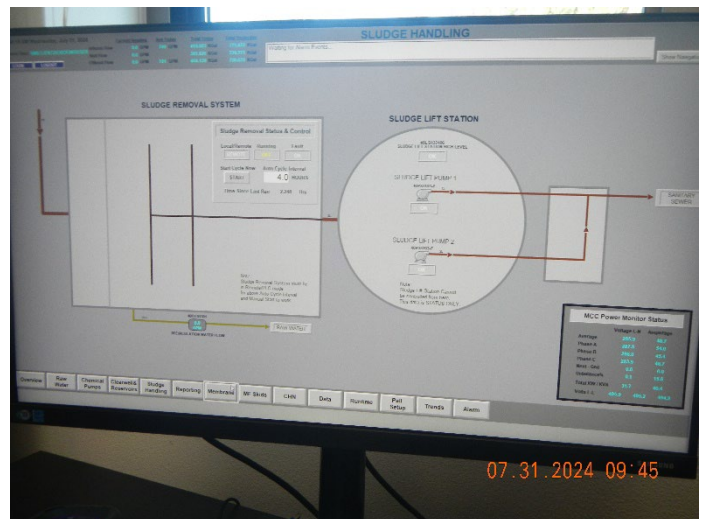
Photo #:12 (DSCN3851)  
Description: Photo of SCADA system display (sludge handling).

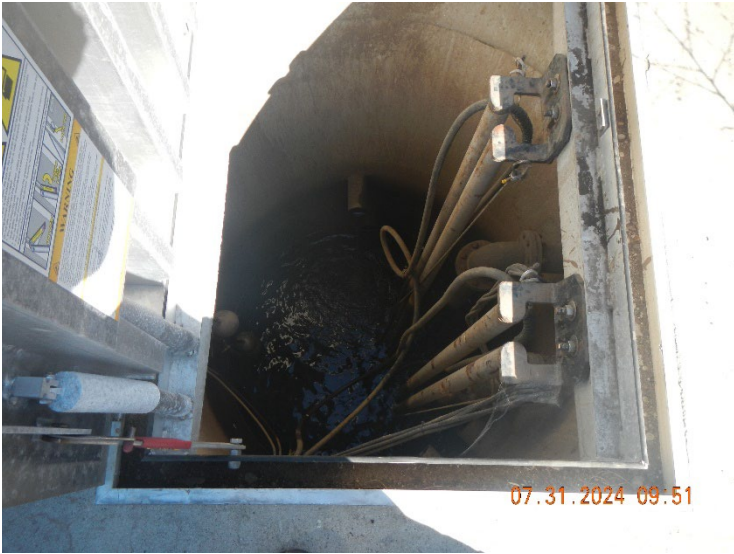
Photo #:13 (DSCN3852)

Description: Photo of sludge handling lift station.

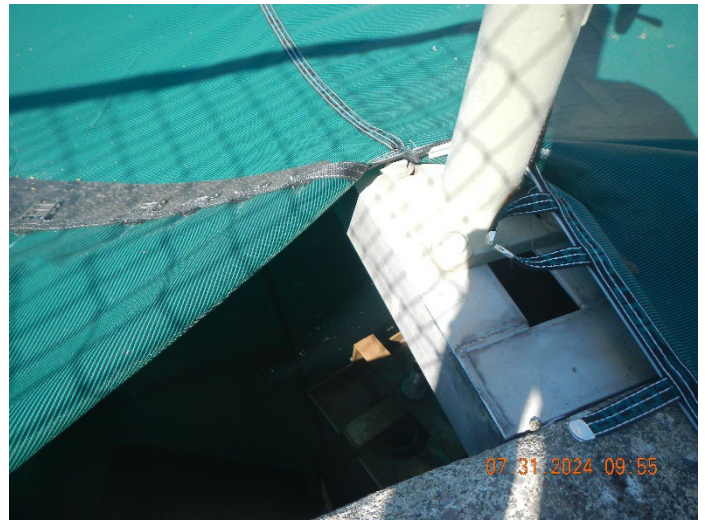
Photo #:14 (DSCN3853)

Description: Photo of the decant control box within the sedimentation basin.

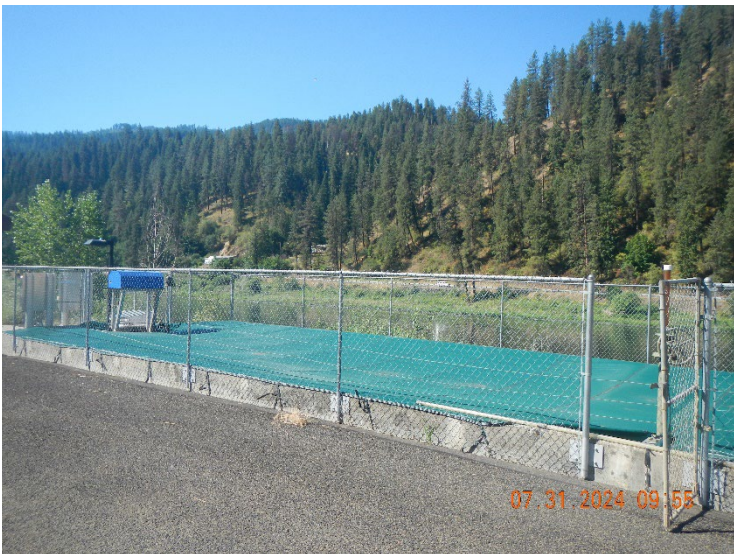
Photo #:15 (DSCN3854)

Description: Photo of the sedimentation basin.
