| REPORT NO.<br>NN8687 | NAME OF VESSEL<br>SS "ESSO BOSTON" | PORT OF ISSUE<br>Newport News, Va. |

DRYDOCKING AND REPAIRS  
SPECIAL SURVEY NO. 2 OF HULL  
ANNUAL SURVEY & LOAD LINE INSPECTION  
RENEWAL OF L.L. CERT. BY ABS-NEW YORK  
SPECIAL SURVEY OF MACHINERY  
TAILSHAFT SURVEY  
ANNUAL BOILER SURVEY

**American Bureau of Shipping**  
45 BROAD STREET, NEW YORK, N. Y. 10004

Newport News, Va., Sept. 1, 1970

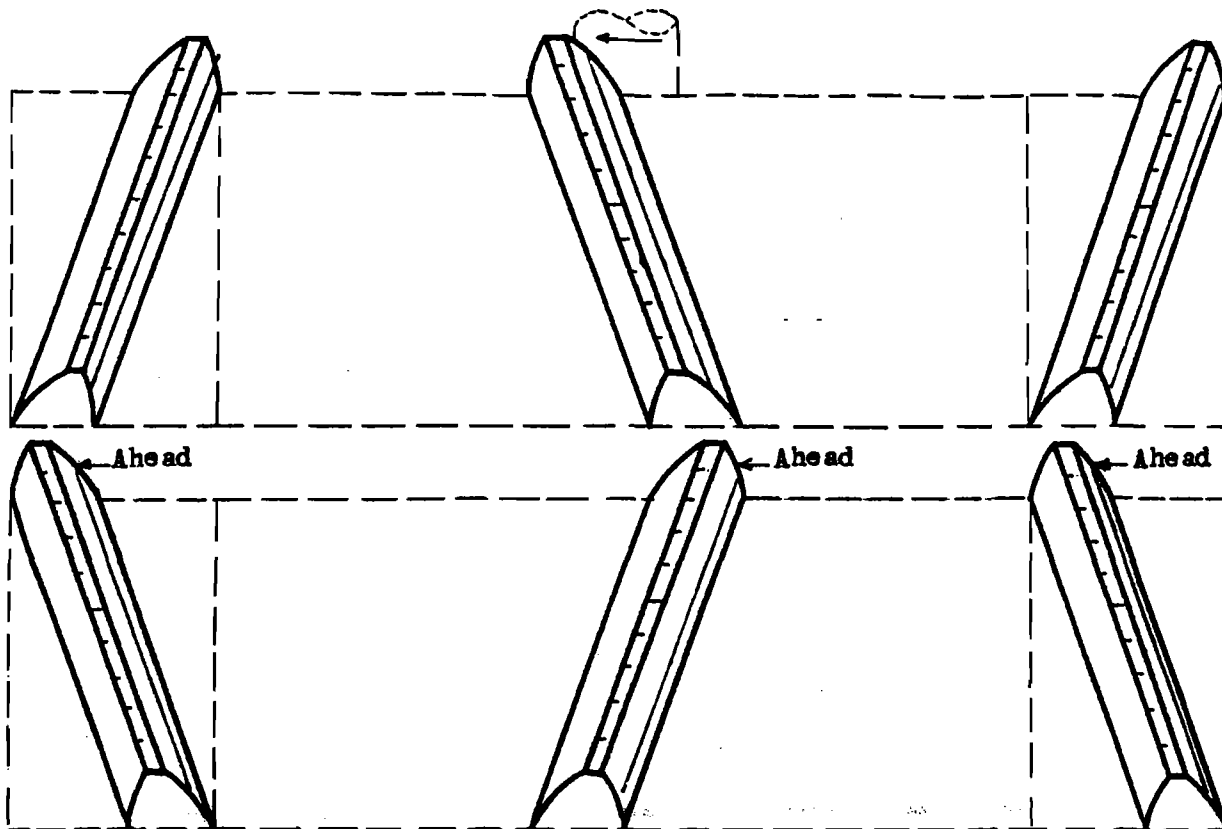
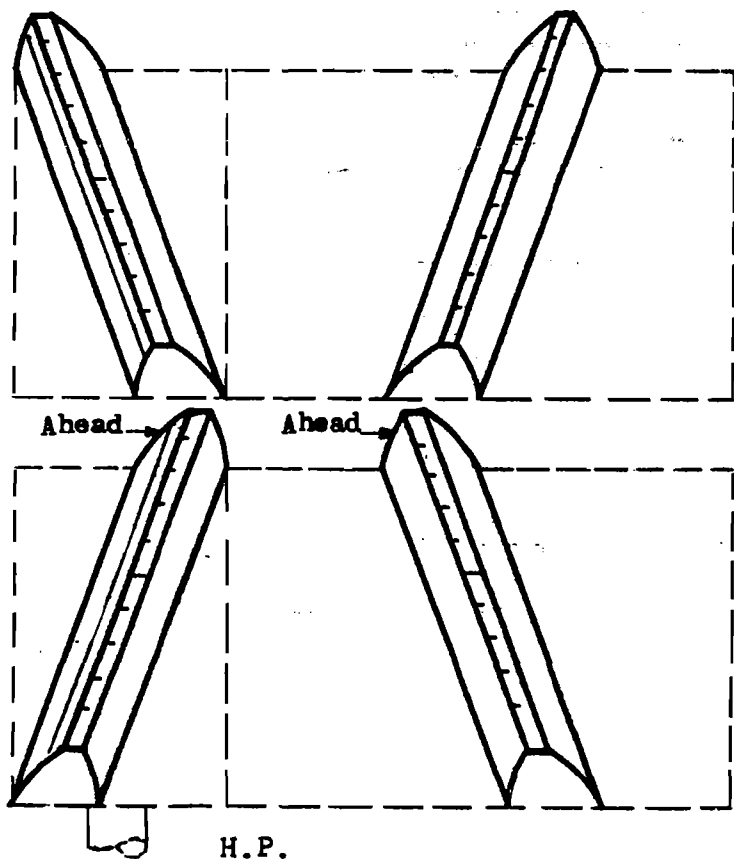
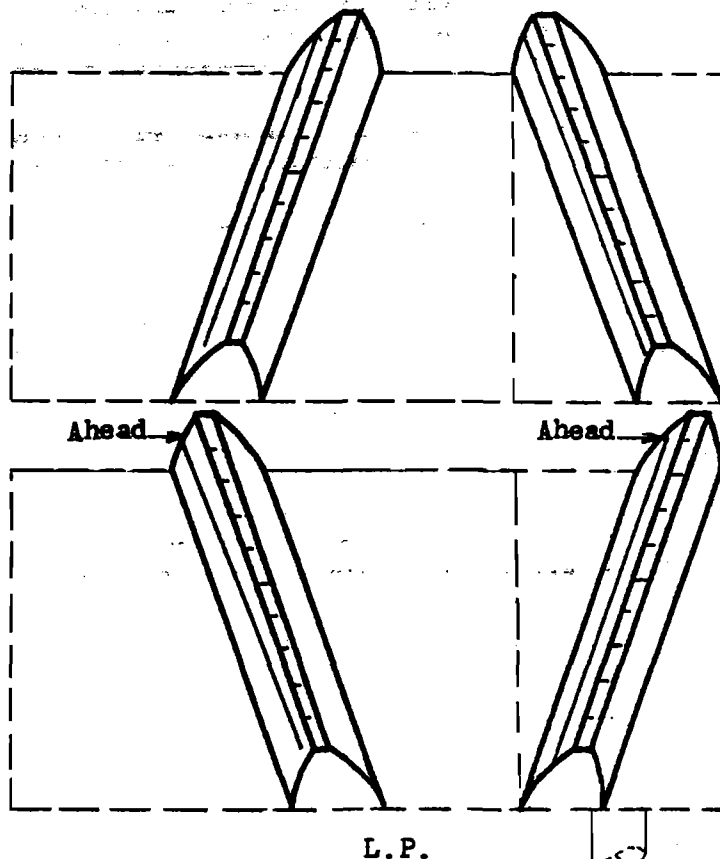
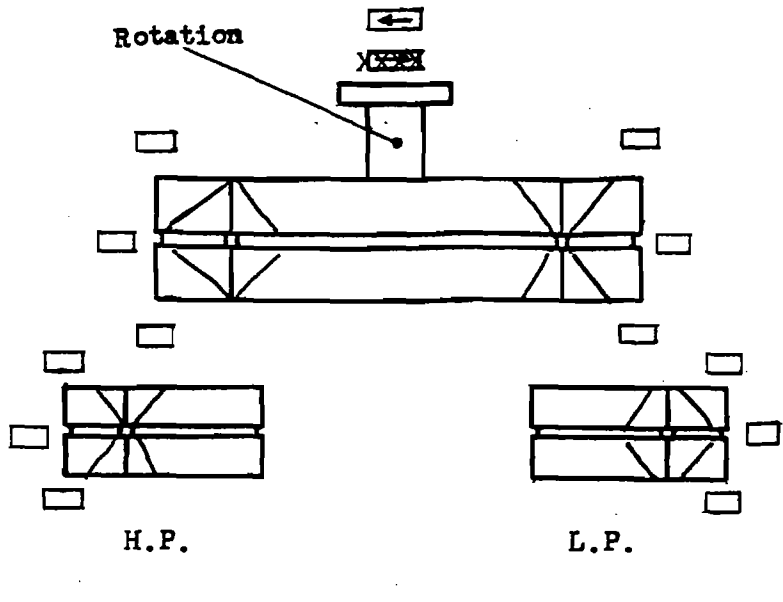
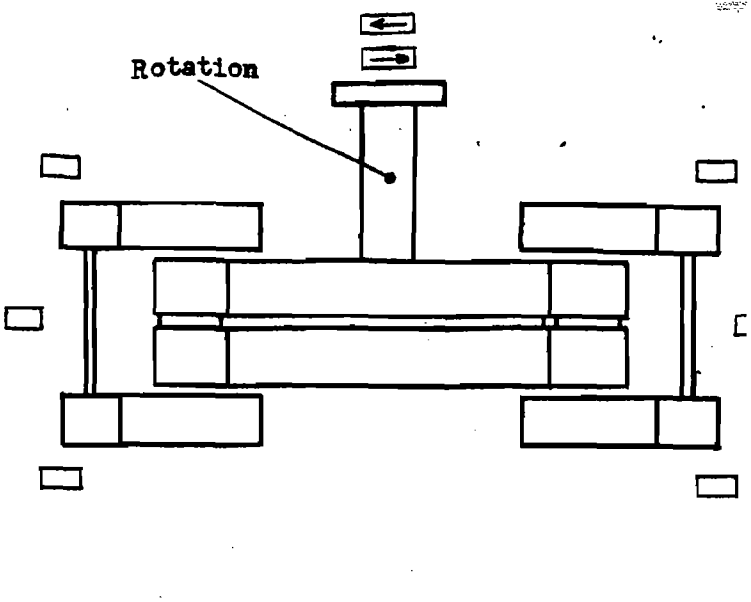
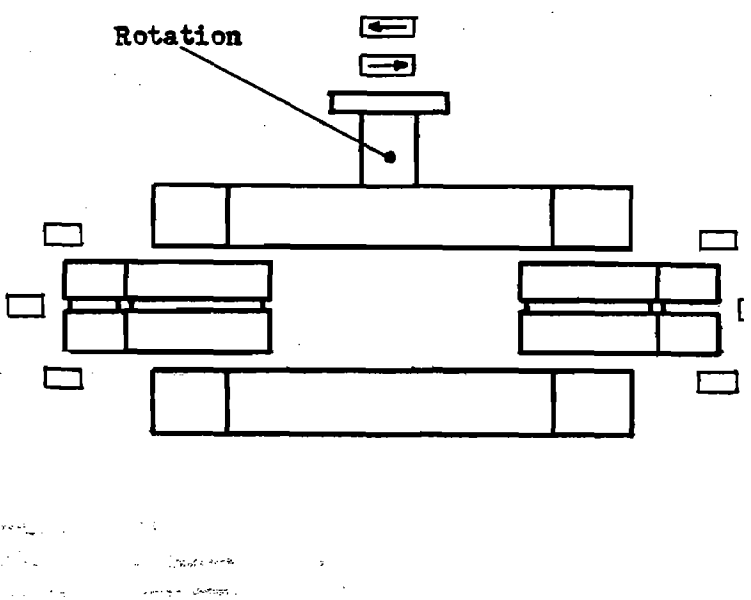
Tooth Contact Form

Straight line in teeth  
indicates satisfactory contact.

Remarks Reduction gears examined thru inspection covers of gear casing.
