**Region 6 - Enforcement & Compliance Assurance Division**  
**INSPECTION REPORT**

| Inspection Date(s): | 03/06-09/2023 | |
| Media Program: | RCRA Compliance Evaluation Inspection | |
| Facility Name: | <b>TotalEnergies Carville Polystyrene Plant</b> | |

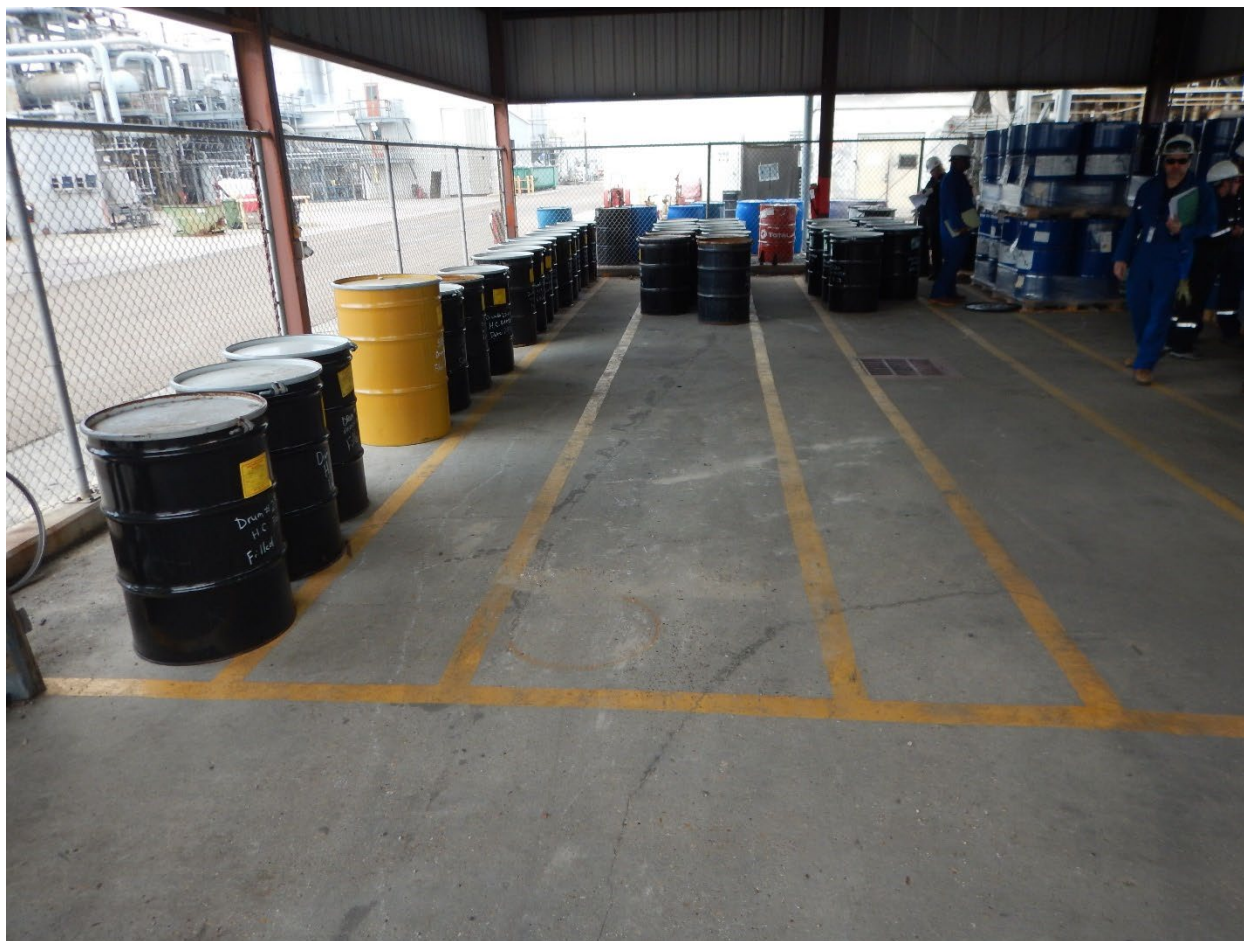
| Photo #: | DSCN0933.JPG |

| Description: External view of the designated hazardous waste container central accumulation area | |

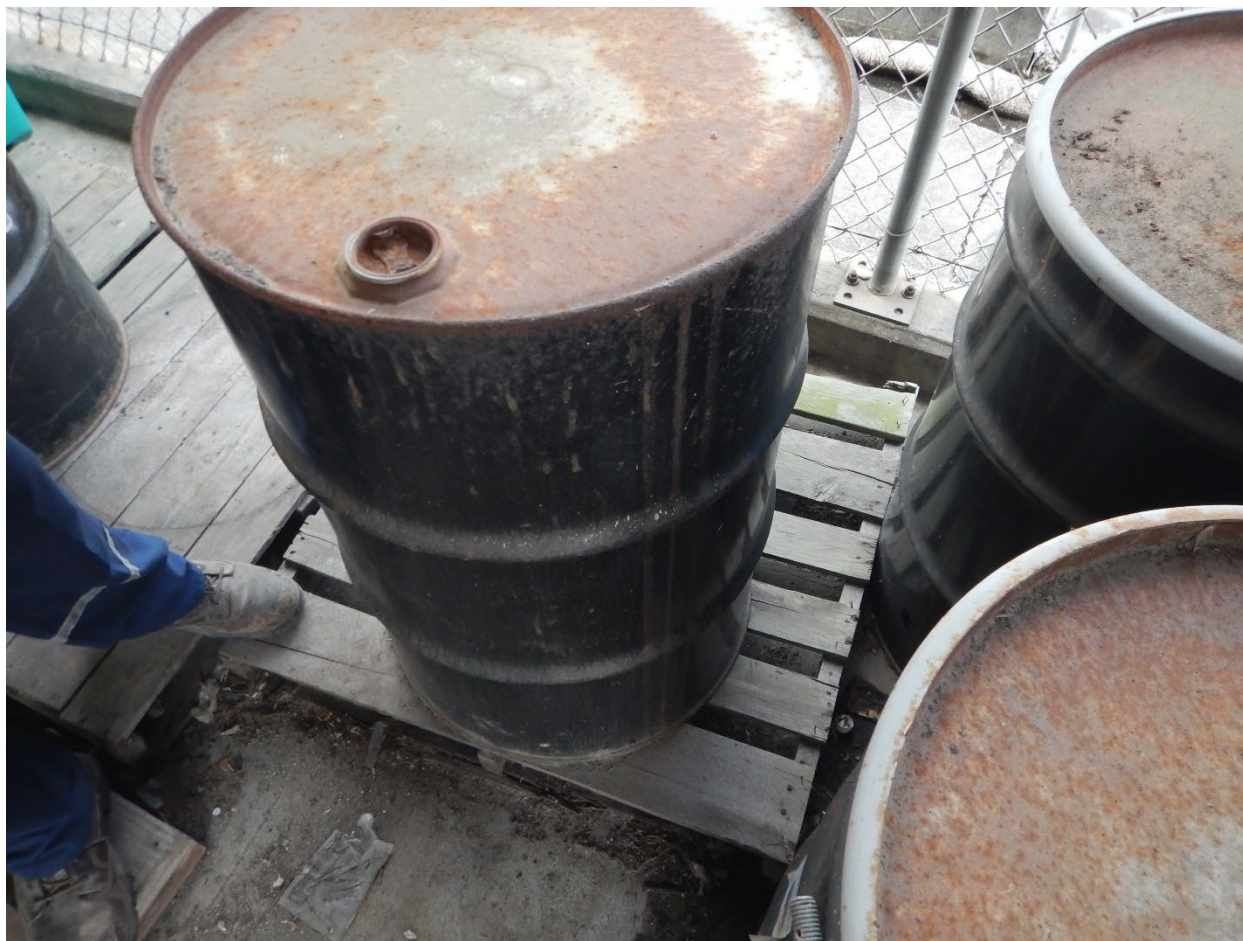
| Photo #: | DSCN0944.JPG |

| Description: Unlabeled drums located in the hazardous waste container central accumulation area | |

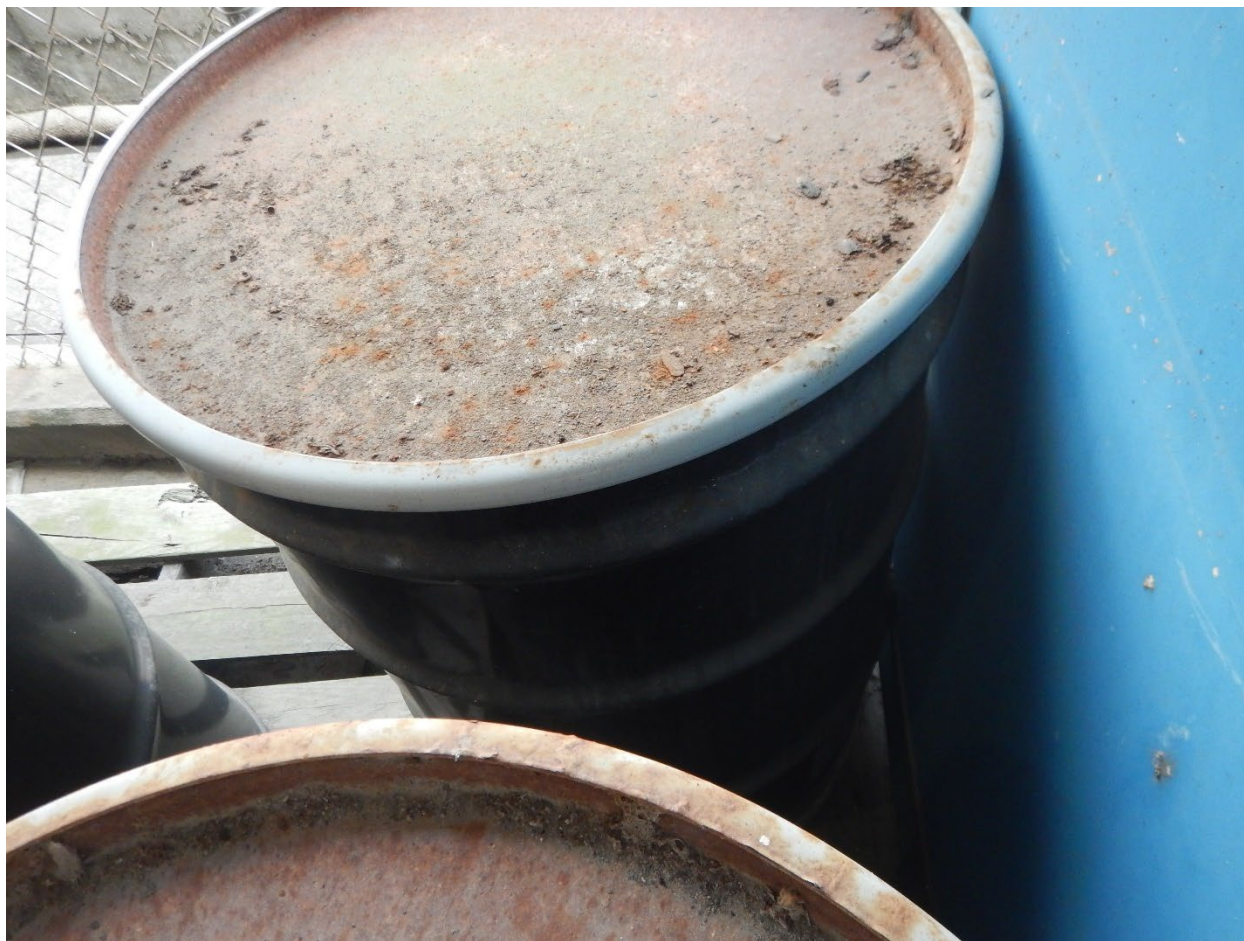
| Photo #: | DSCN0945.JPG |

| Description: Unlabeled drums located in the hazardous waste container central accumulation area | |

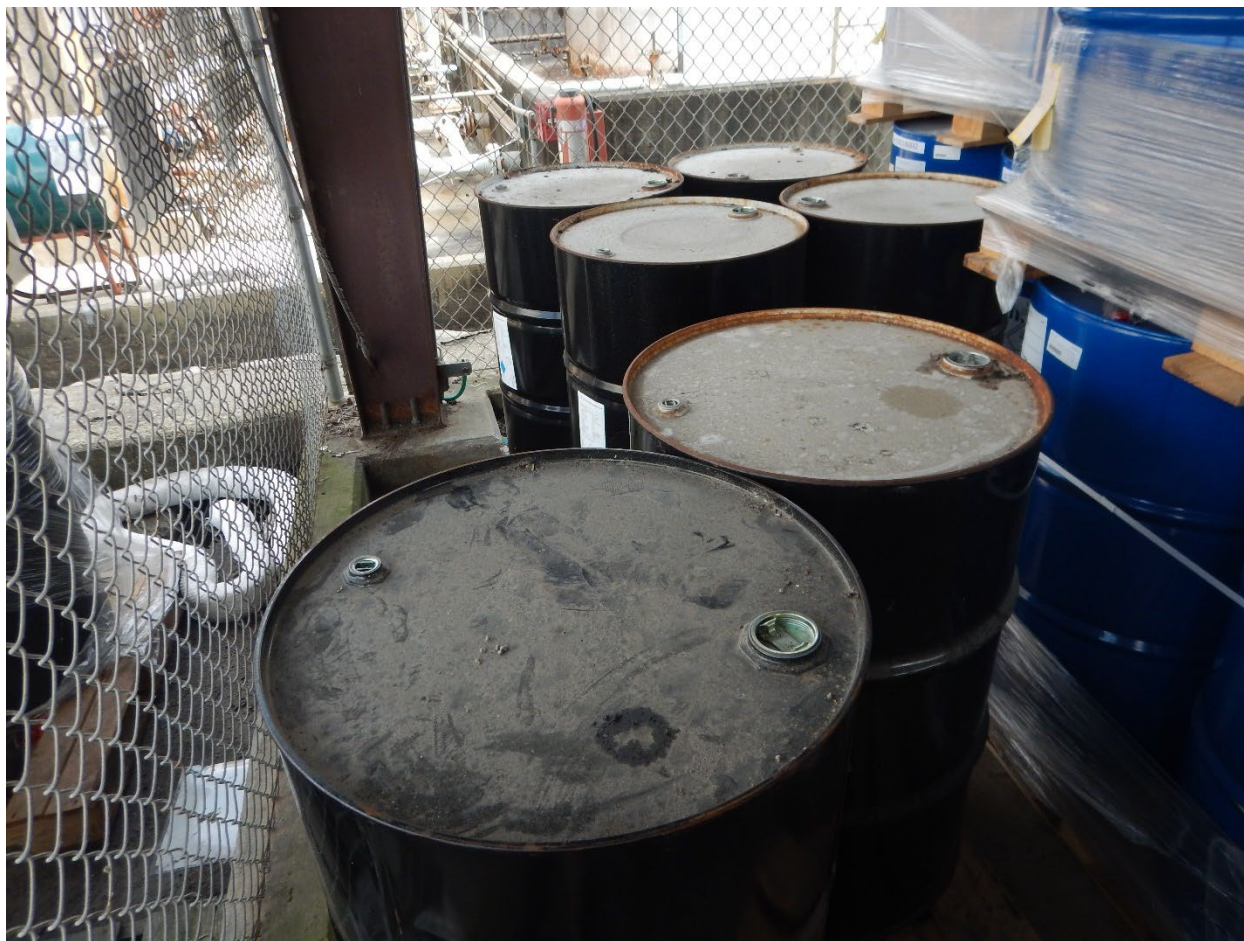
| Photo #: | DSCN0946.JPG |

| Description: Unlabeled drums located in the hazardous waste container central accumulation area | |

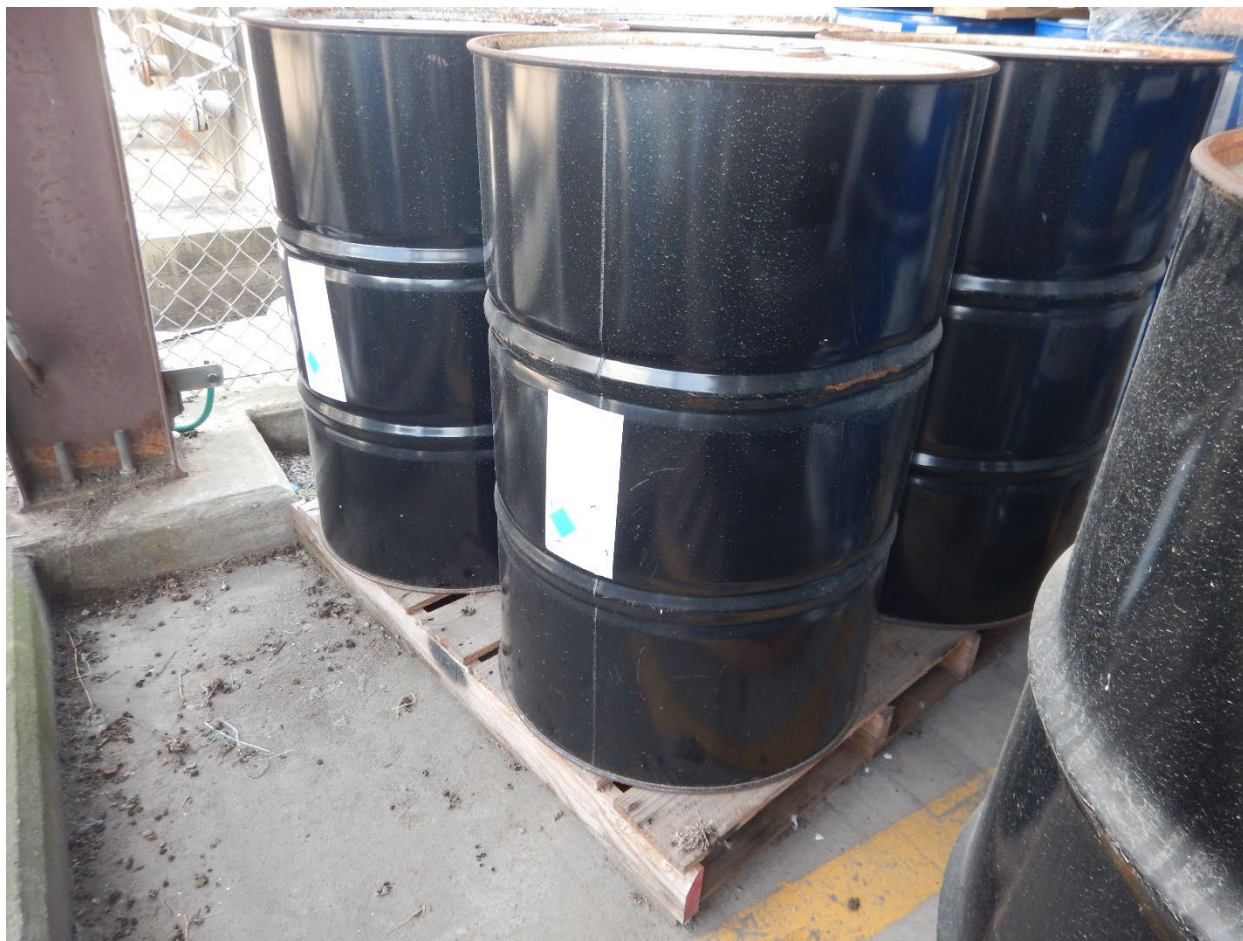
| Photo #: | DSCN0947.JPG |

| Description: Unlabeled drums located in the hazardous waste container central accumulation area | |

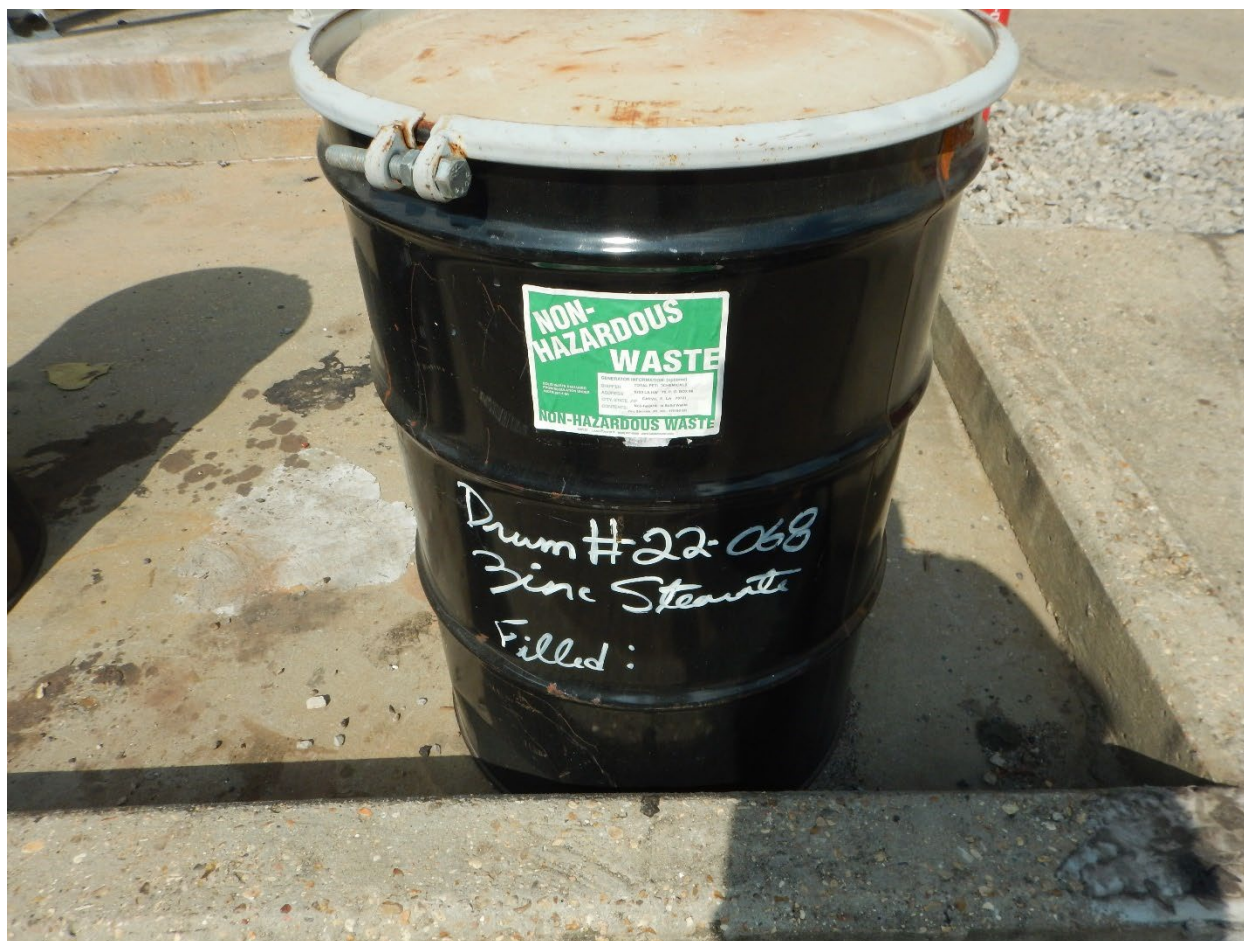
| Photo #: | DSCN0953.JPG |

| Description: Claimed satellite accumulation area for Lines 4 and 5 with 6 x 55 gallon containers. 5 labeled as hazardous | |

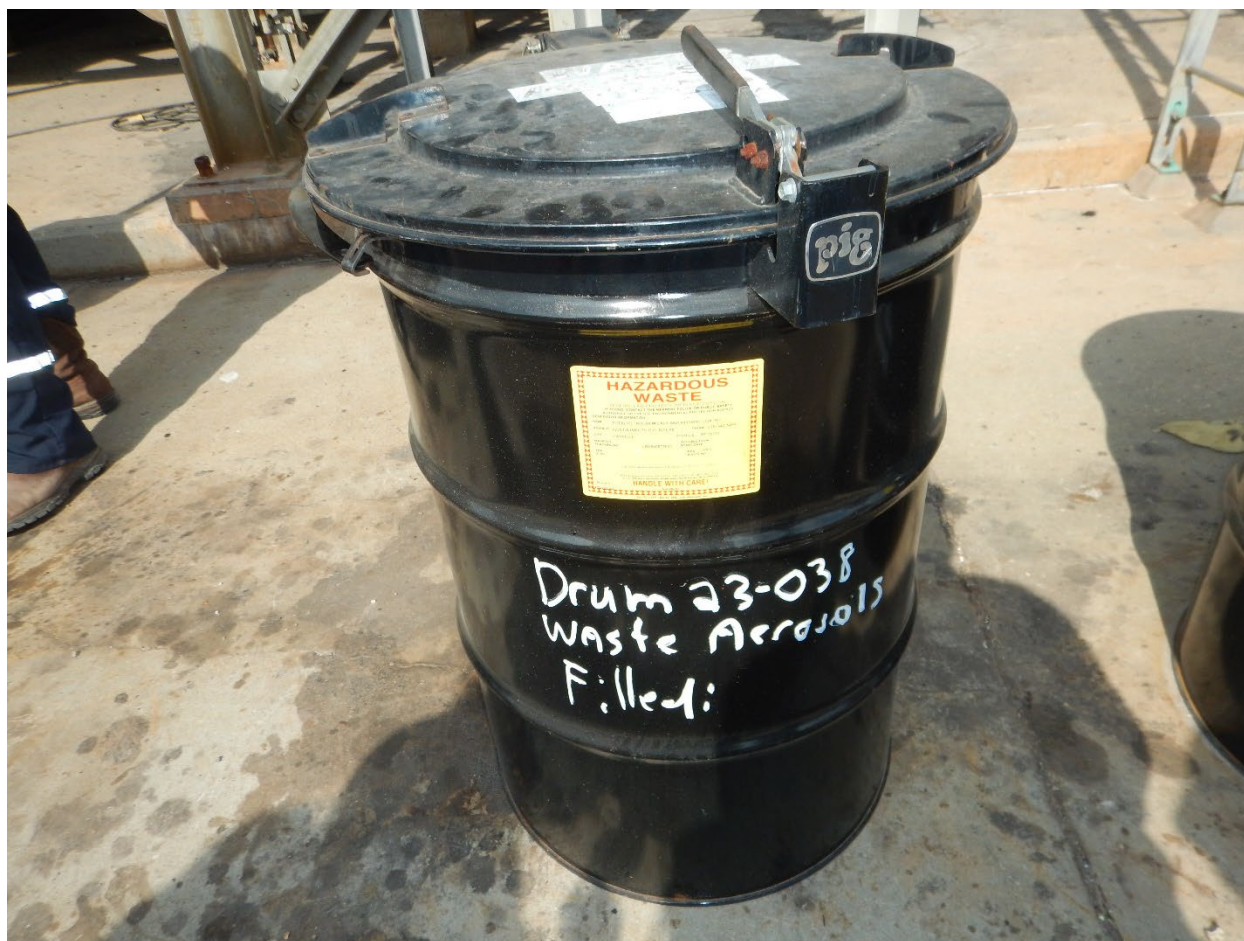
| Photo #: | DSCN0955.JPG |

| Description: Hazardous waste labeled container located in claimed satellite accumulation area for Lines 4 and 5. Hydrocarbon Tank Sludge | |

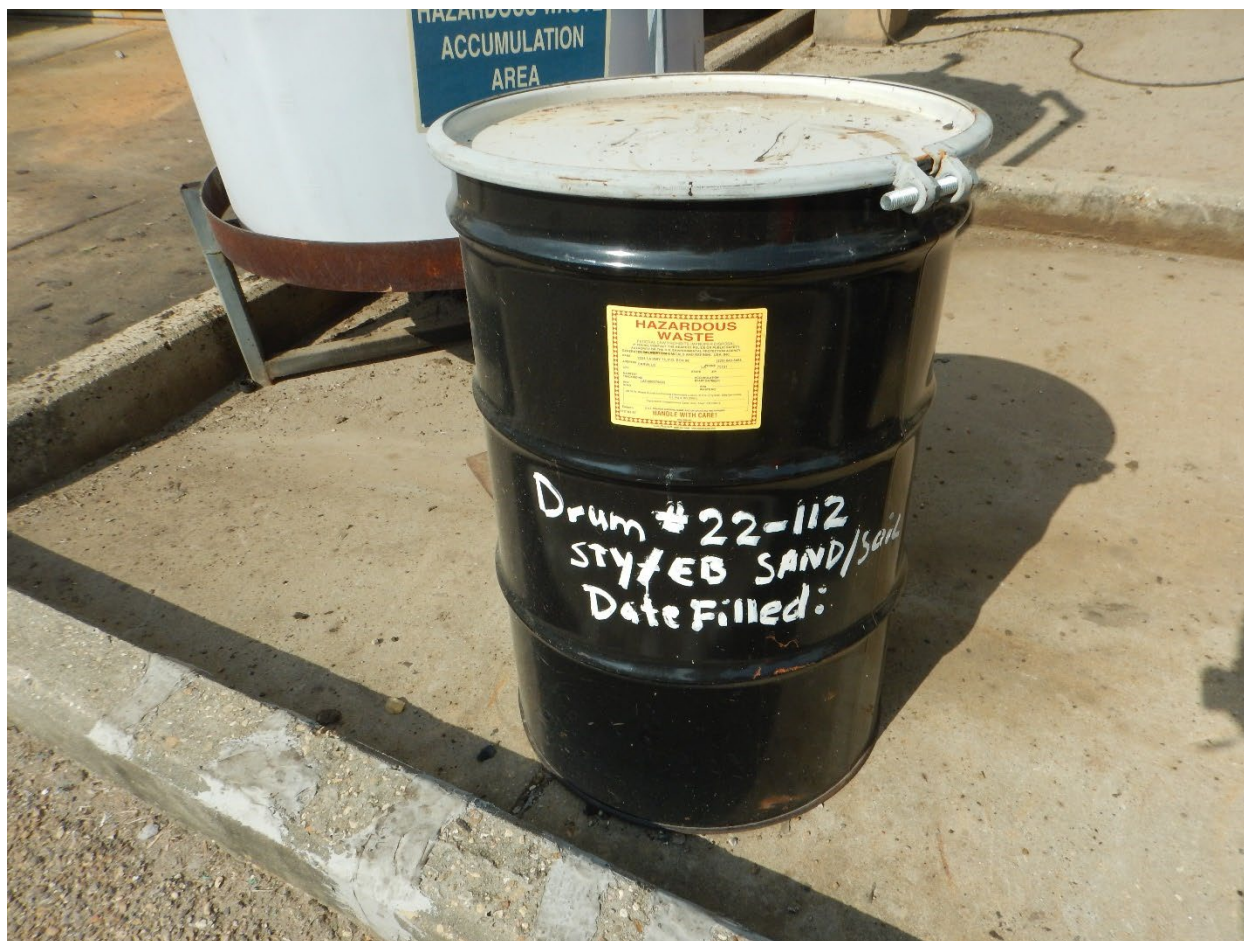
| Photo #: | DSCN0958.JPG |

| Description: Hazardous waste labeled container located in claimed satellite accumulation area for Lines 4 and 5. Hydrocarbon Contaminated Filters | |

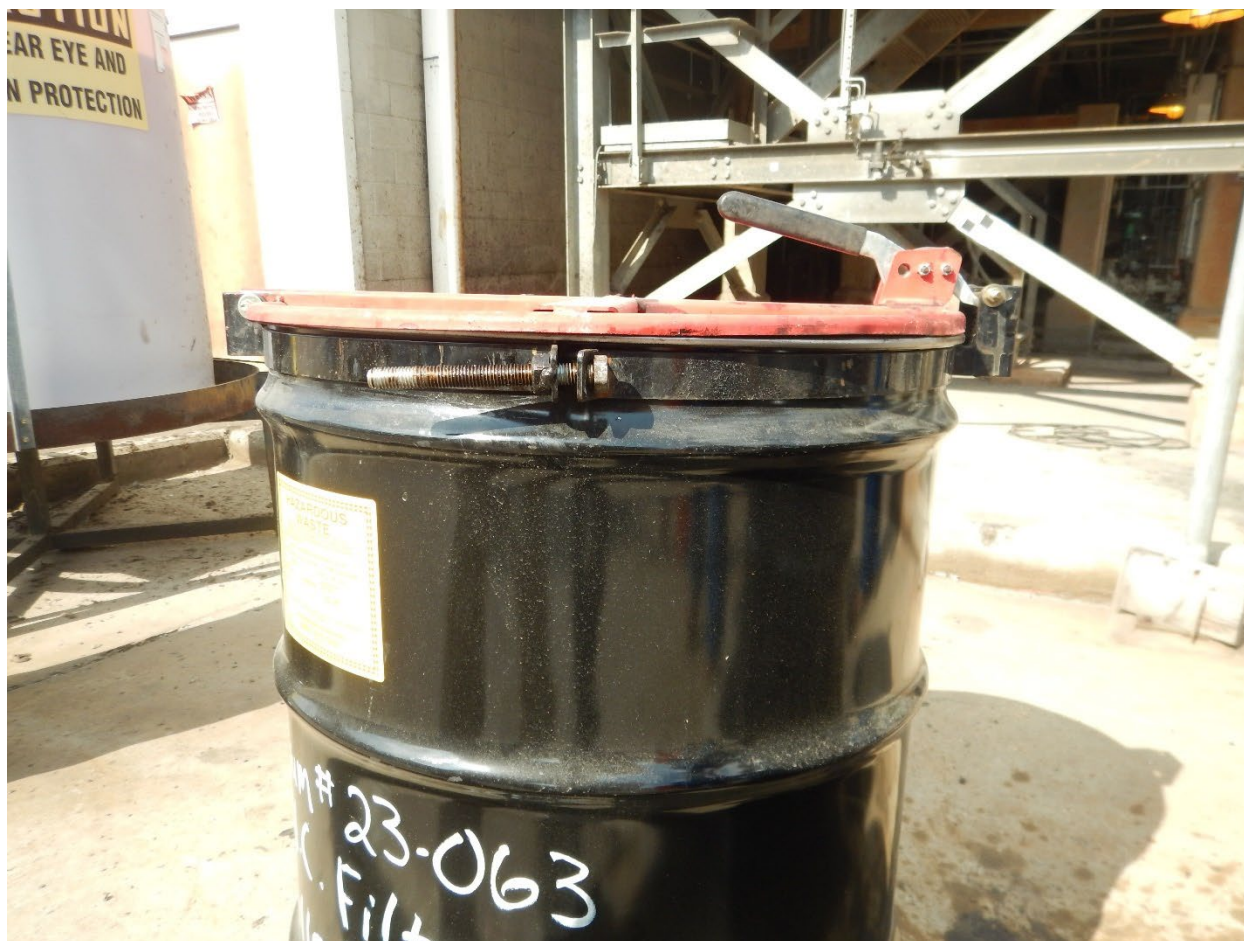
| Photo #: | DSCN0959.JPG |

| Description: Hazardous waste labeled container located in claimed satellite accumulation area for Lines 4 and 5. Styrene and Ethyl Benzene contaminated sand and soil | |

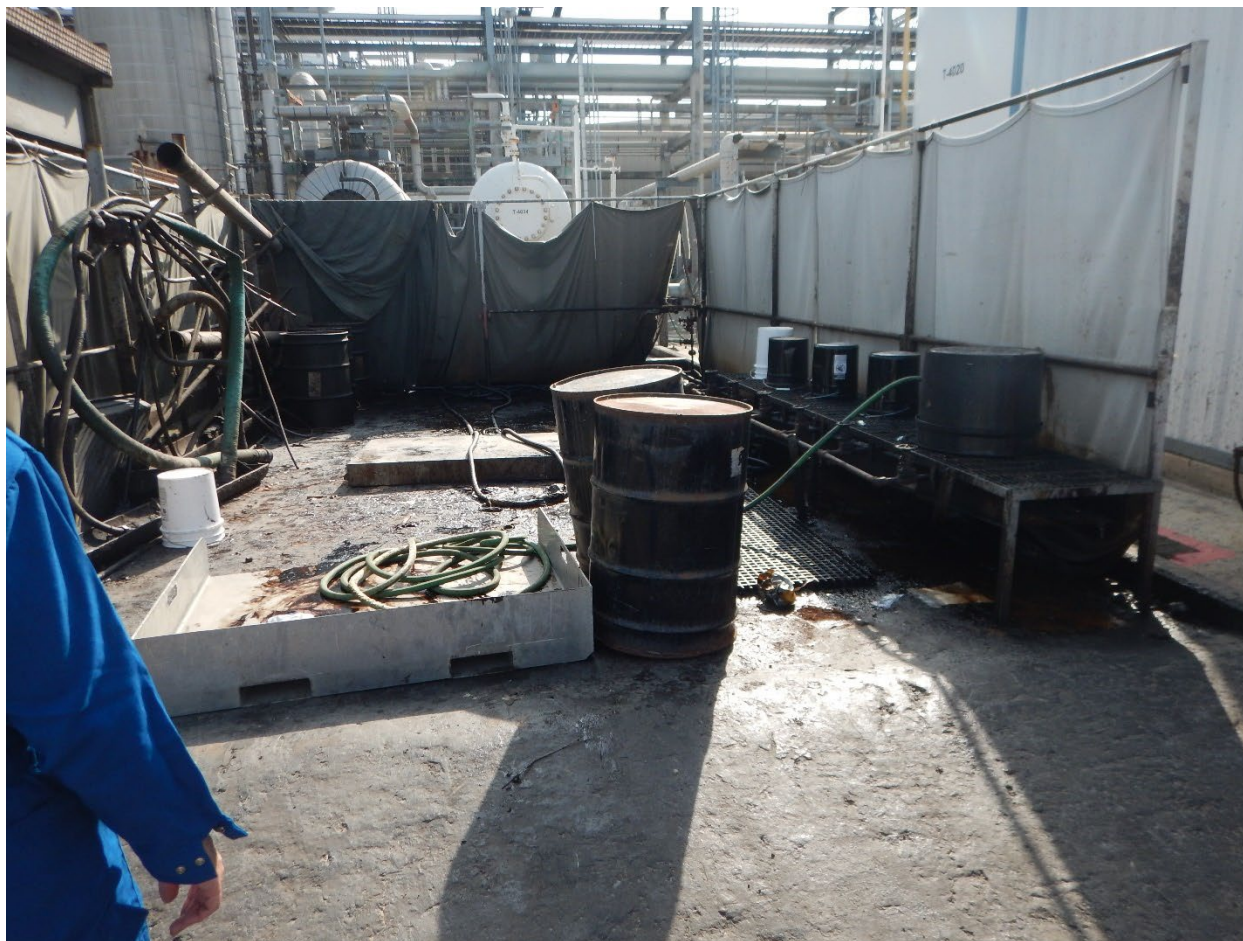
| Photo #: | DSCN0961.JPG |

| Description: Point of generation for hazardous waste hydrocarbon contaminated filters in Line 4 | |

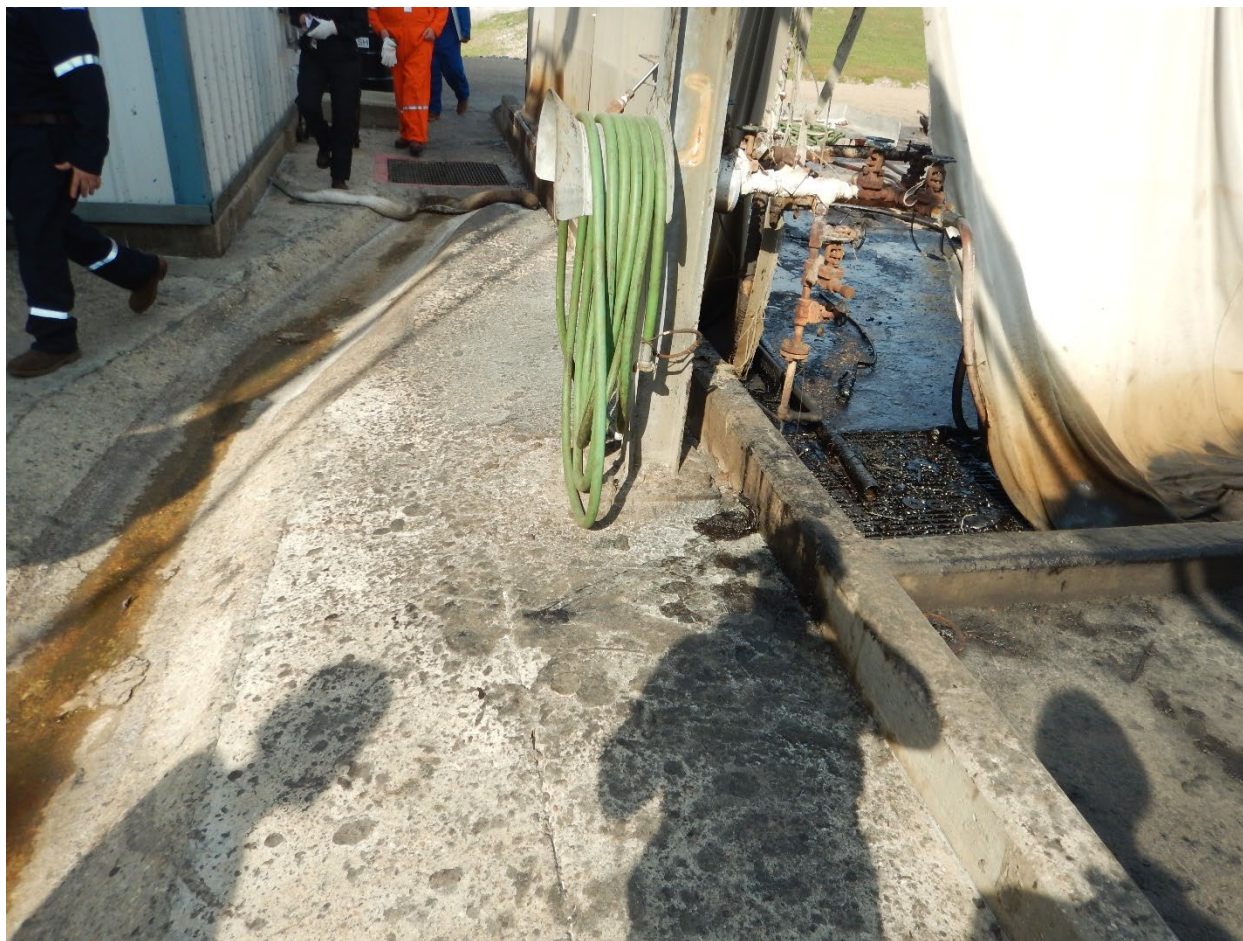
| Photo #: | DSCN0963.JPG |

| Description: Steam out area located north of Line 4. Note: waste material staining present on wall of nearby building. | |

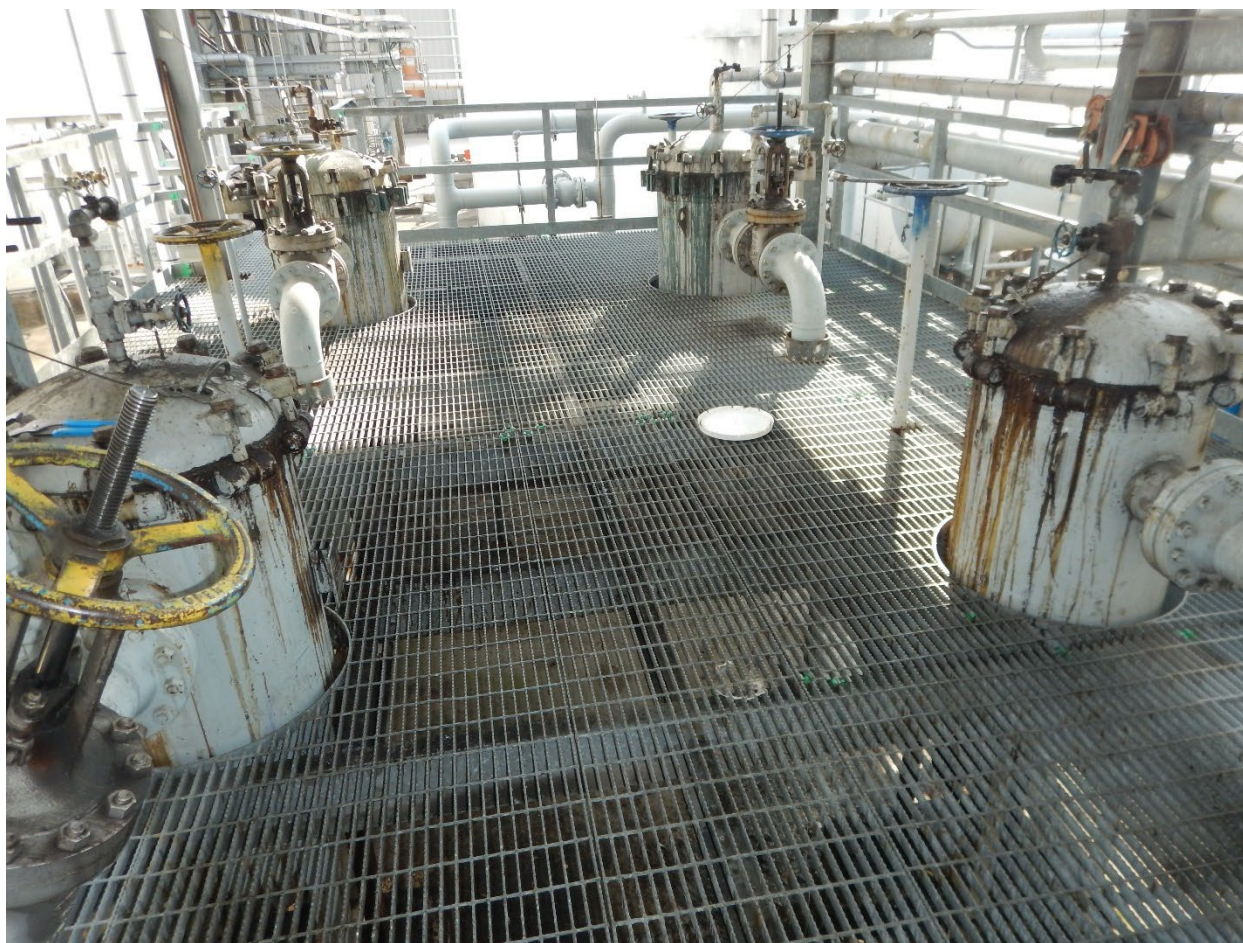
| Photo #: | DSCN0967.JPG |

| Description: Point of generation for hazardous waste hydrocarbon contaminated filters in Line 5 | |

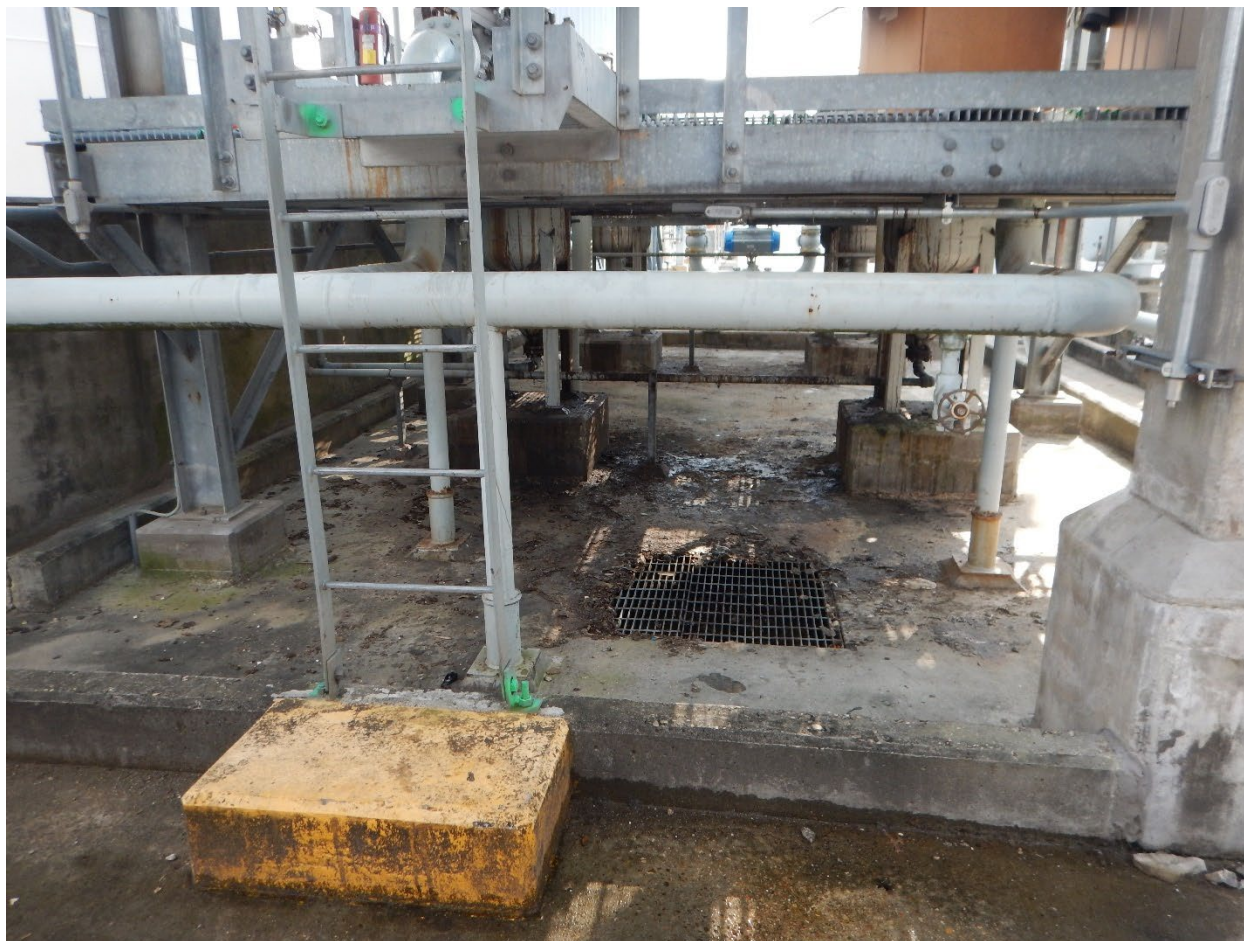
| Photo #: | DSCN0968.JPG |

On March 7, 2023, we observed a hazardous waste spill from the hydrocarbon contaminated filters (Appendix 1, Photo No. 36-37). Mr. Crow explains this is from the removal of filters from the filter canisters. We also observed spills of sludge removed from the wastewater sump present from the skimmer in this unit [Photo No. 51]. Since these two spills were not promptly cleaned up, we determined the materials to be abandoned as defined in 40 CFR 261.2(a)(2)(i)(A).

| Description: Point of generation for hazardous waste hydrocarbon contaminated filters in Line 5.<br>Note: staining and drips present on filter canisters. | |

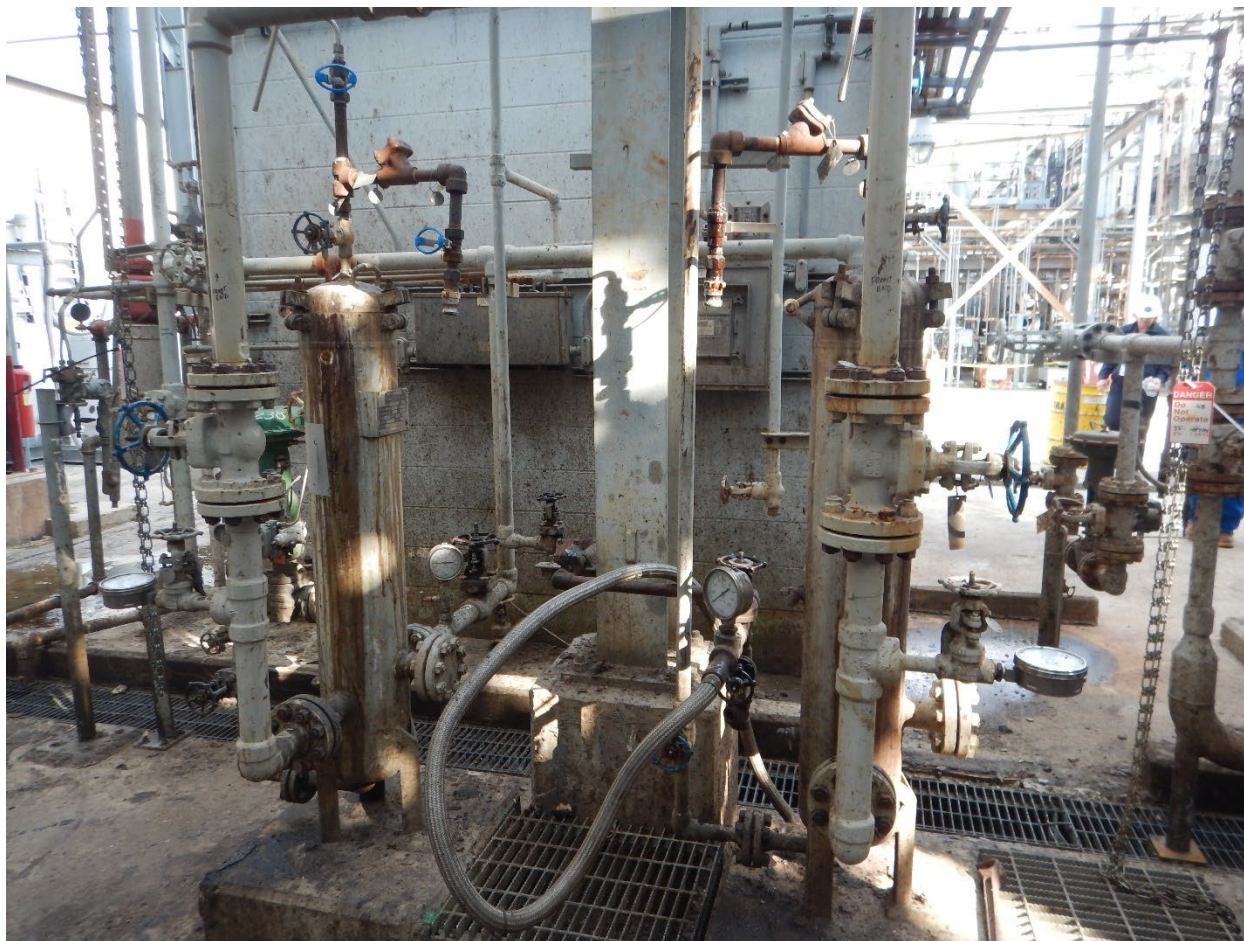
| Photo #: | DSCN0972.JPG |

| Description: Point of generation for hazardous waste hydrocarbon contaminated filters in Line 3. | |

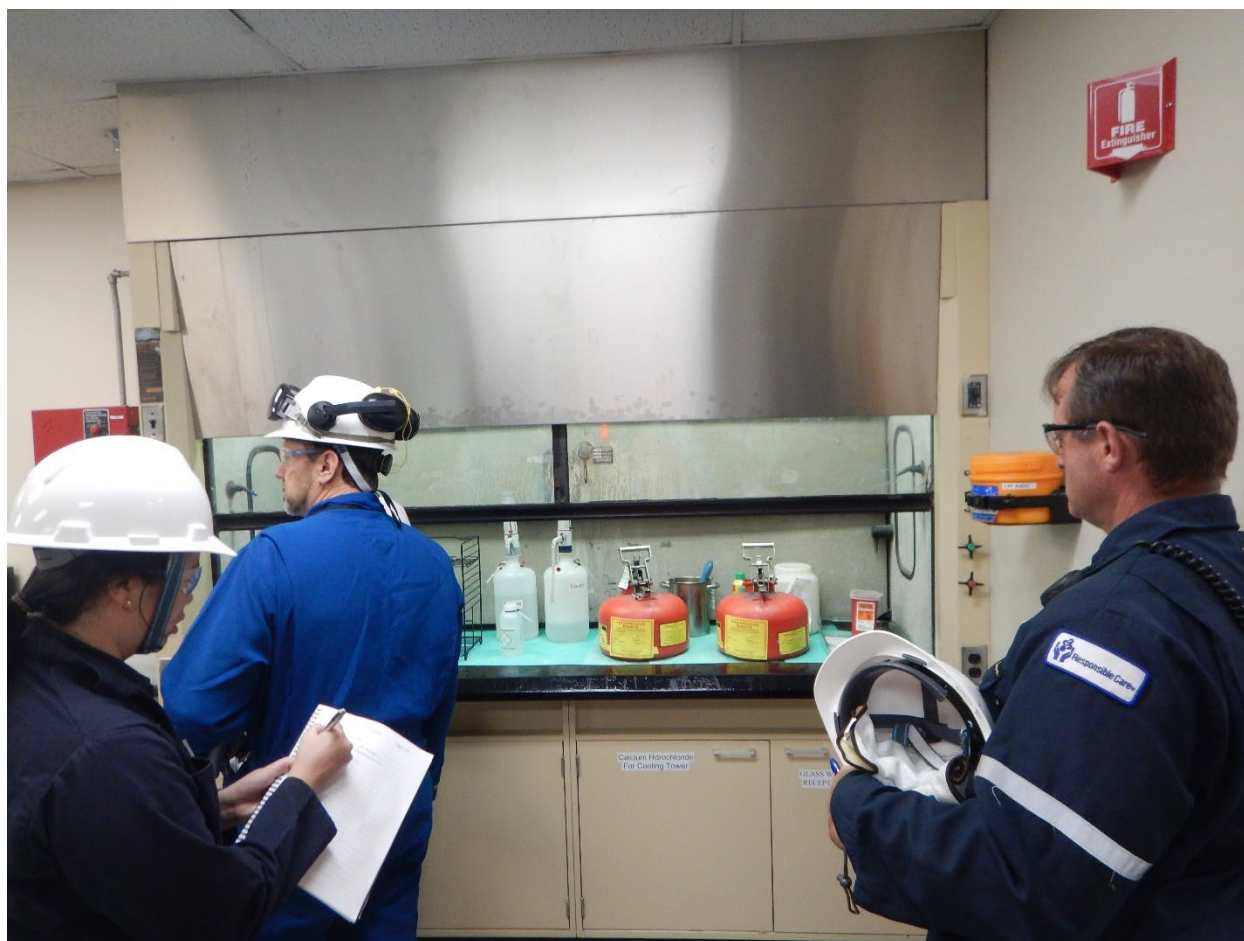
| Photo #: | DSCN0974.JPG |

| Description: Hazardous waste labeled containers located in laboratory fume hood | |

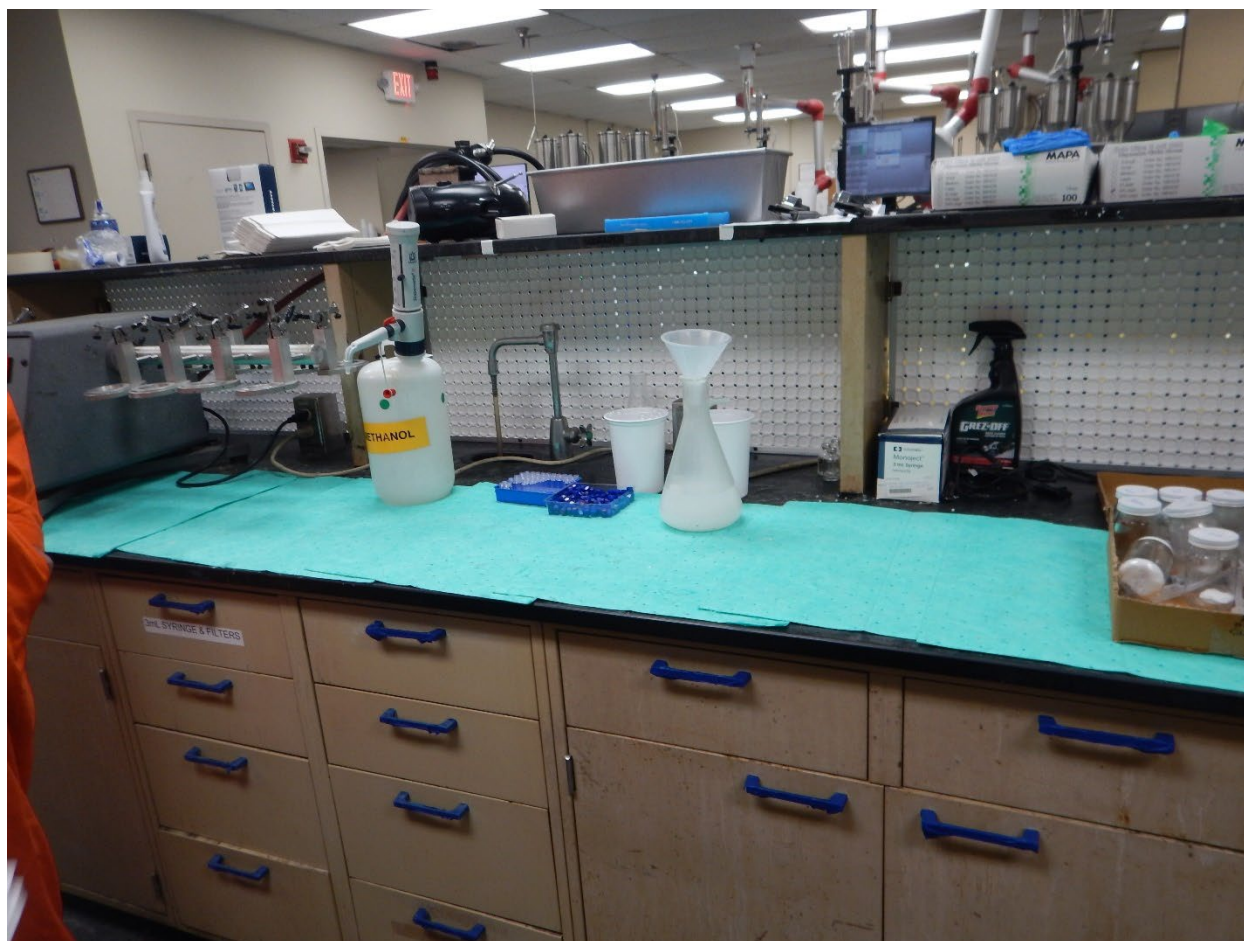
| Photo #: | DSCN0975.JPG |

| Description: Hazardous waste labeled containers located in laboratory fume hood | |

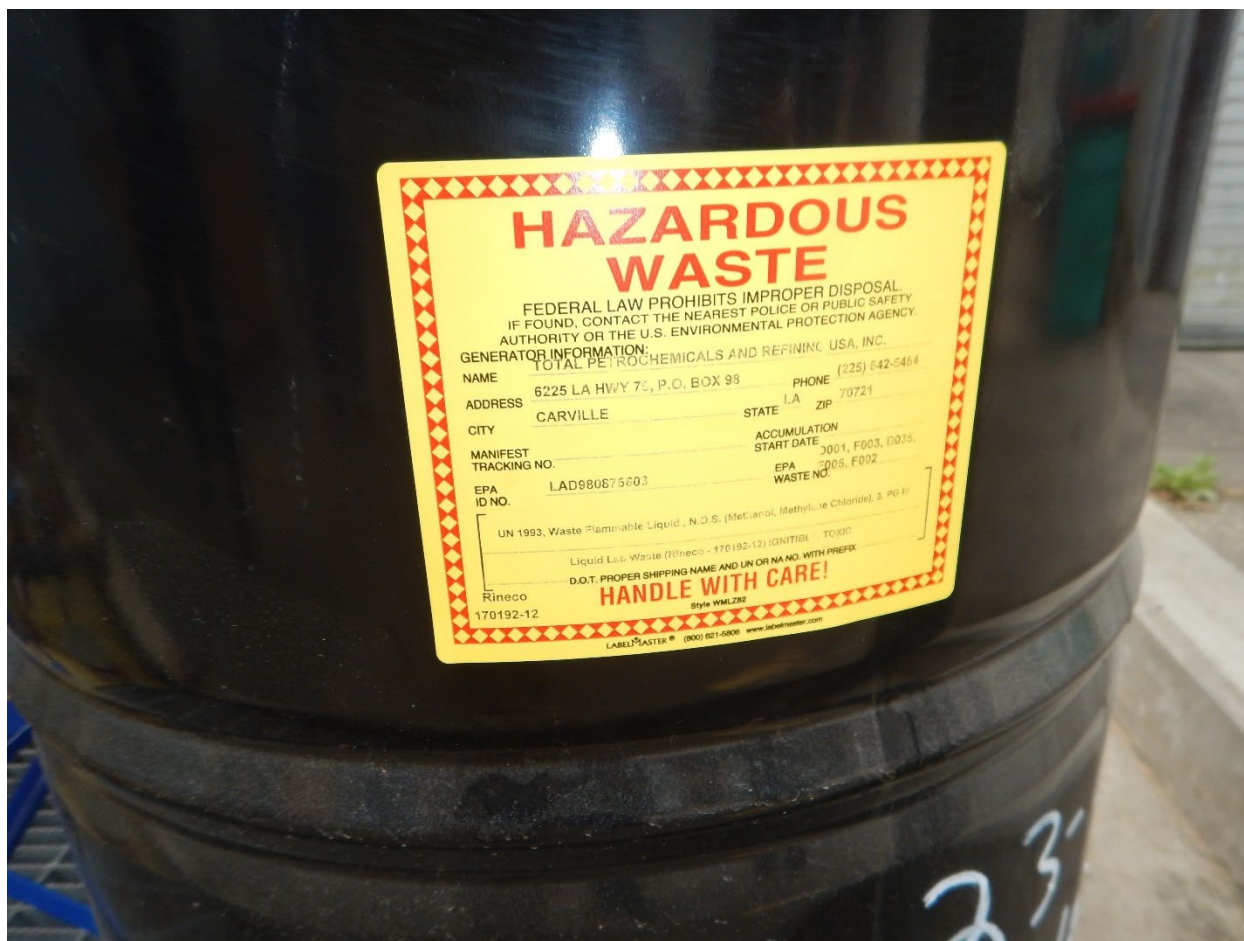
| Photo #: | DSCN0978.JPG |

| Description: Hazardous waste labeled container located behind the laboratory in satellite accumulation area. Liquid lab waste | |

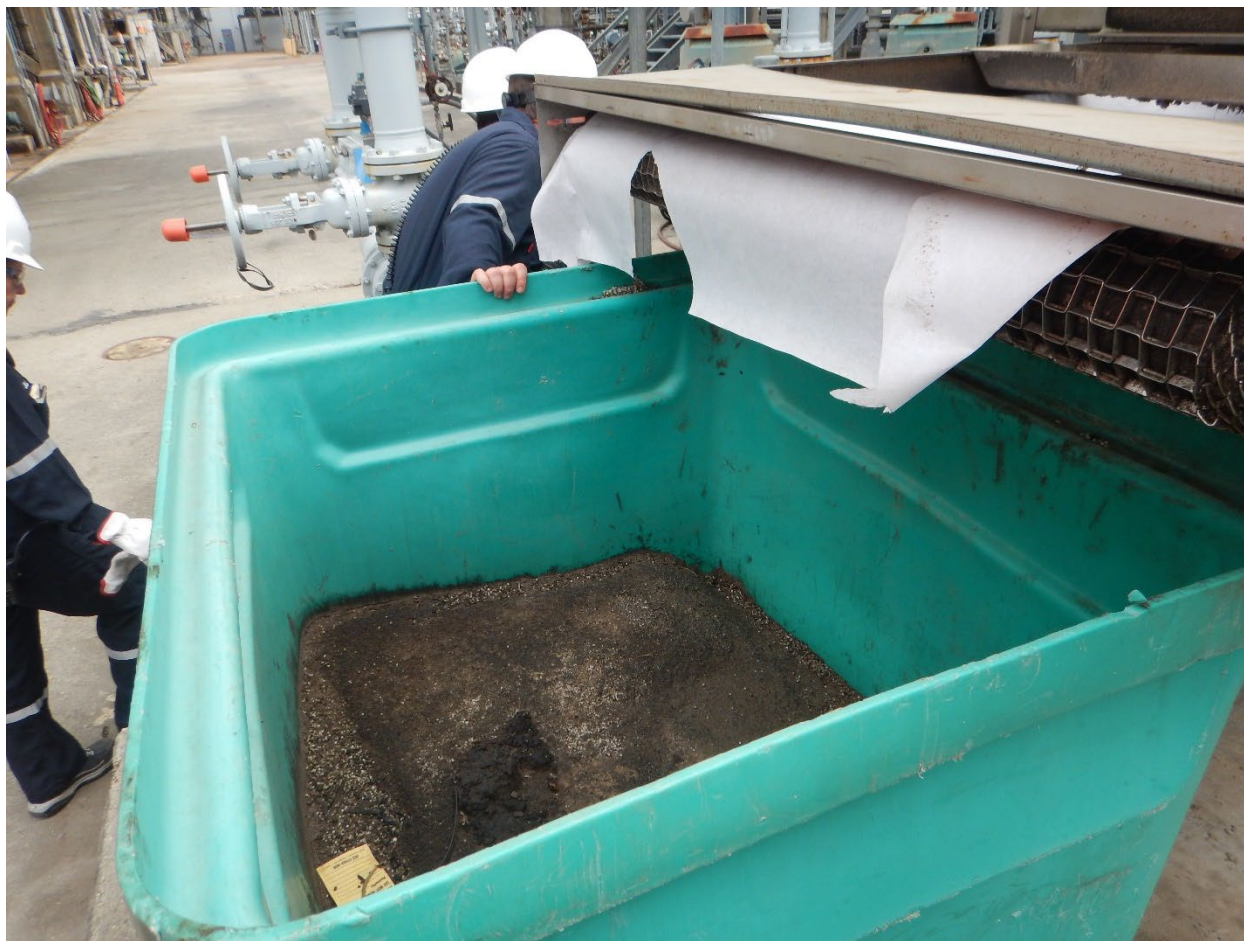
| Photo #: | DSCN0979.JPG |

| Description: Hazardous waste label on container located behind the laboratory in satellite accumulation area | |

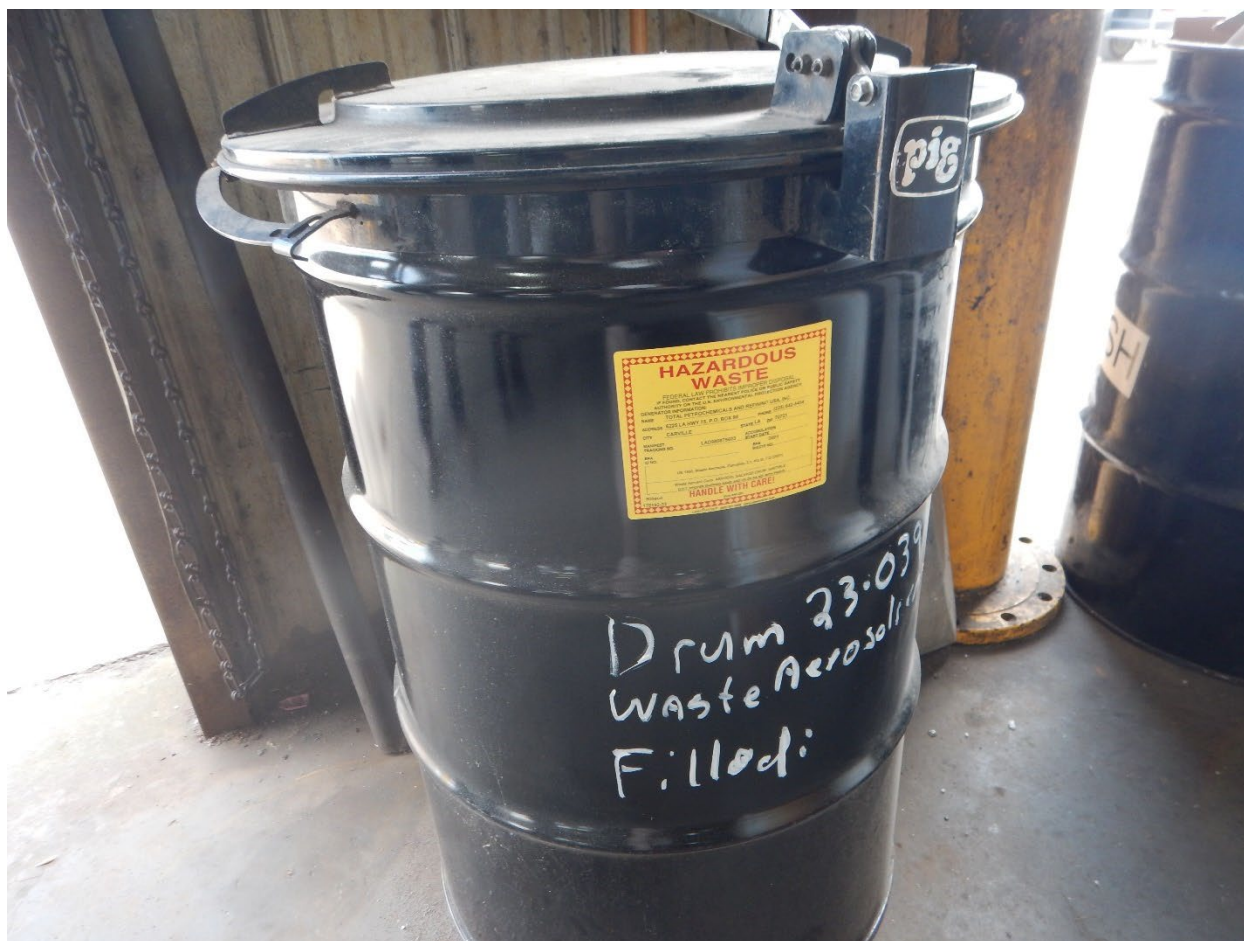
| Photo #: | DSCN0988.JPG |

| Description: Satellite accumulation area for maintenance shop with 1 x 55 gallon container labeled as hazardous waste. Waste aerosols | |
