COMPLIANCE EVALUATION INSPECTION REPORT  
U.S. ENVIRONMENTAL PROTECTION AGENCY, REGION 5

**Purpose:** NPDES Compliance Evaluation Inspection

**Facility:** OSI Environmental  
912 Tesch Court  
Waukesha, Wisconsin 53186

**Date of Inspection:** November 30, 2022

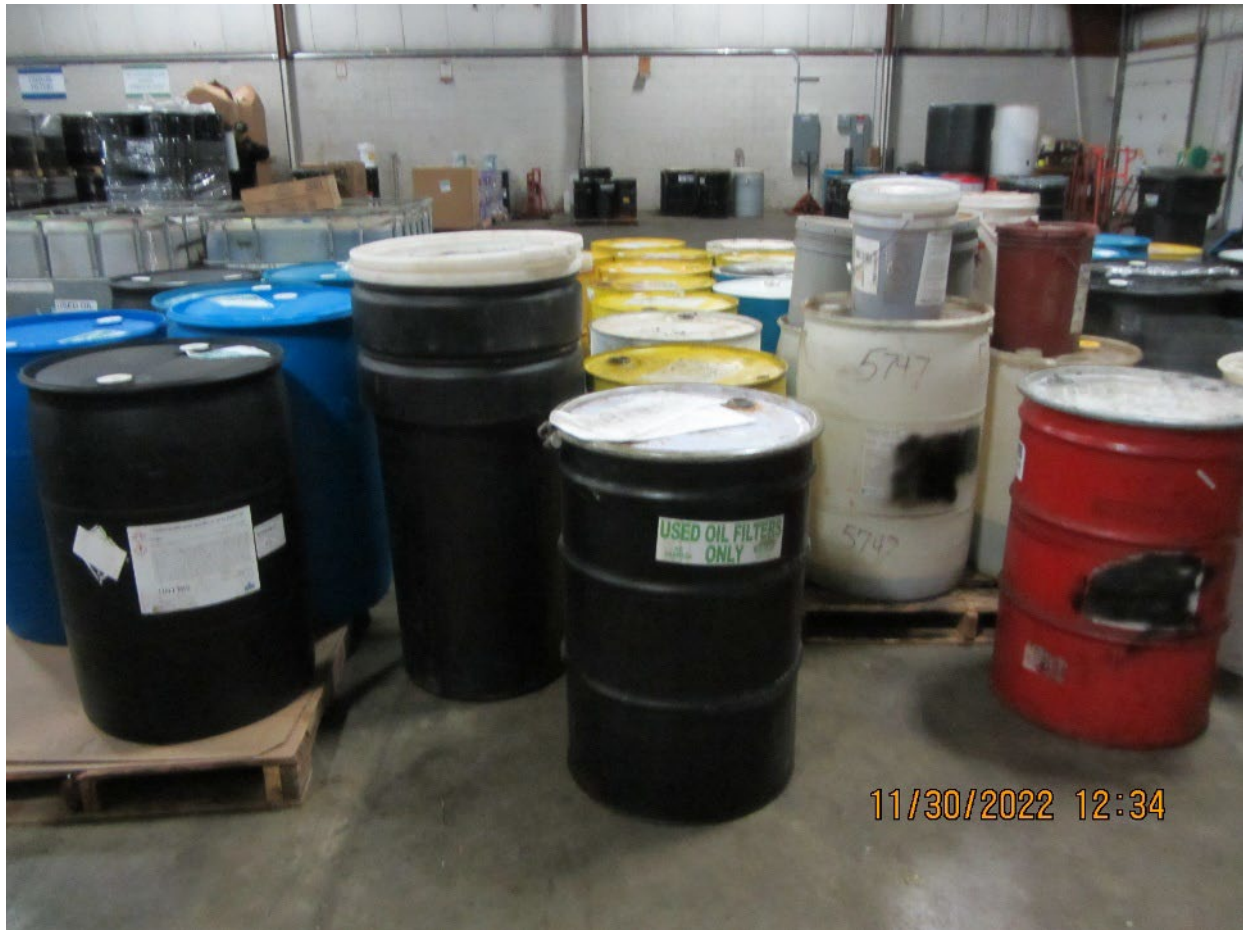
1: IMG\_0270

Near the loading area, I saw full drums of oily water waiting to be taken to the waste facility (Photo 1) and drums of gasoline ready to be transported to the underground tanks (Photo 2). Drums are offloaded into groups and stored near the loading area prior to processing (Photos 6-7).

Description: Drums of oily water located near the loading dock, waiting for transfer offsite to the contracted wastewater facility. One drum has a visible "USED OIL FILTERS ONLY" label.

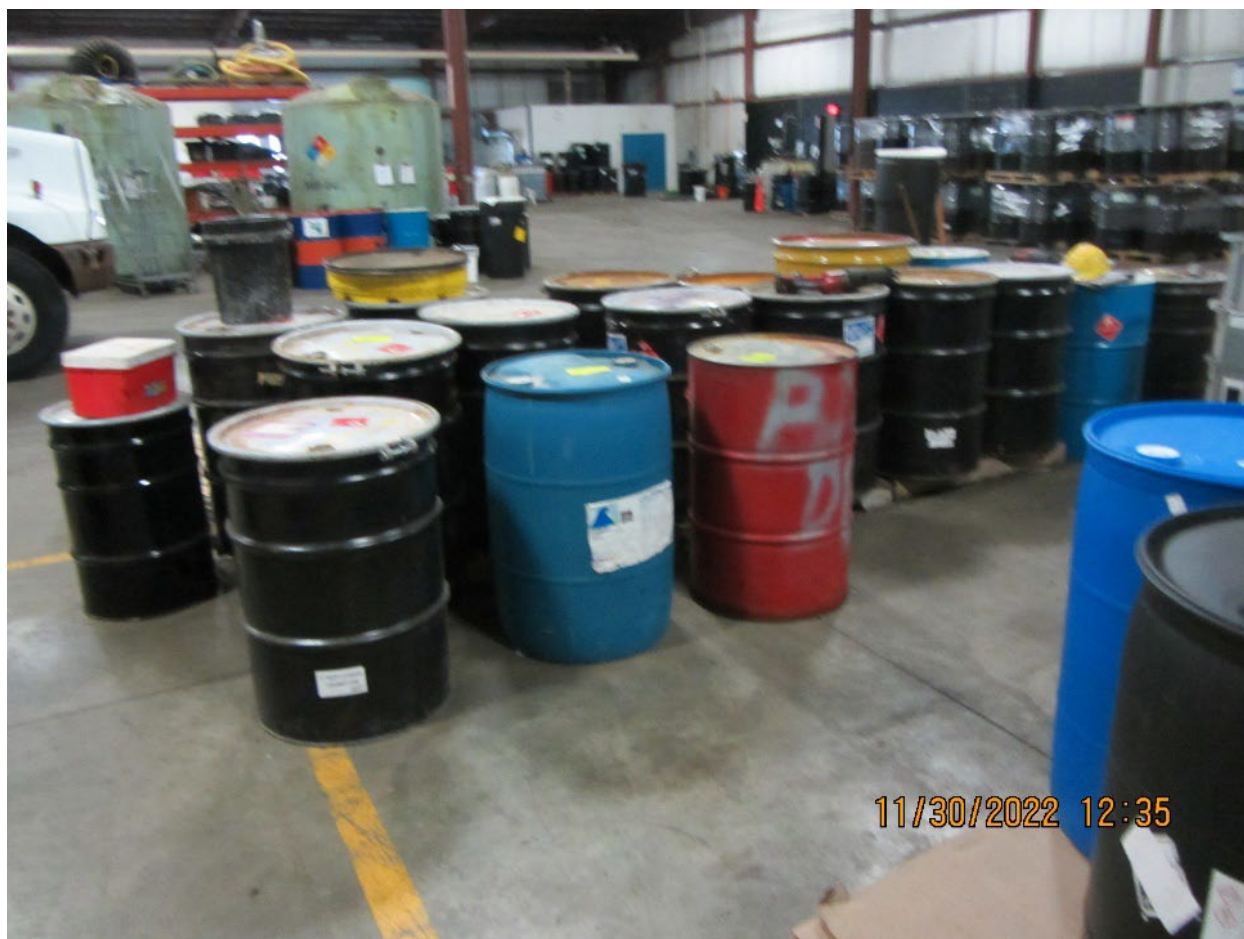
2: IMG\_0271

Description: Full drums of bad gasoline, situated near the loading dock, waiting to be transported to the underground tank.

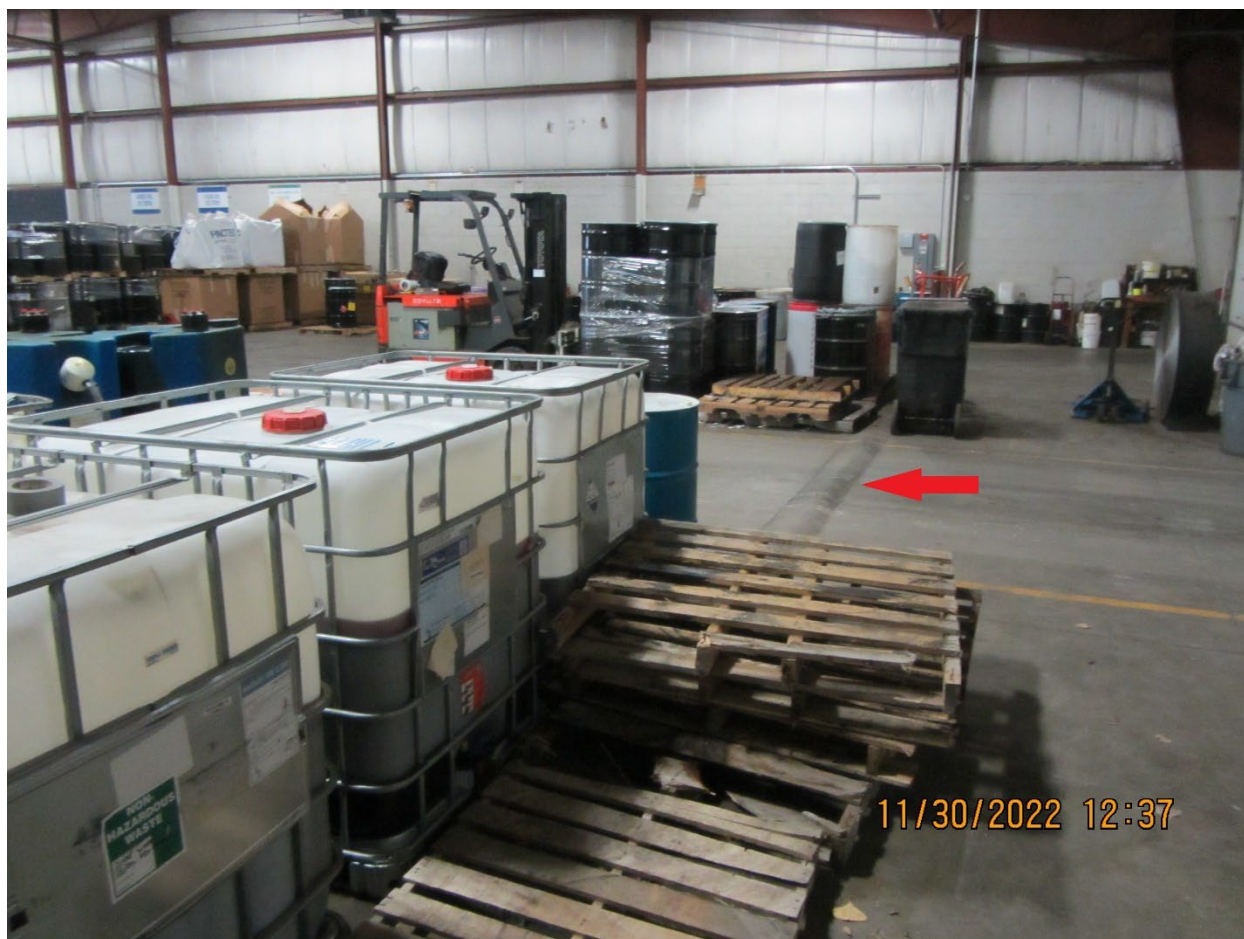
3: IMG\_0272

The warehouse area is an enclosed building with a concrete floor, no floor drains, and two loading docks. There is a berm surrounding the loading dock area (Photos 3 and 5), thus the floor of the warehouse is considered secondary containment for the petroleum stored onsite. The total petroleum storage onsite (including the tank farm and underground storage tank) is approximately 550,000 gallons, according to the Spill Prevention Control and Countermeasure plan prepared November 7, 2022 (SPCC).

Description: Two loading docks to the right of image. Red arrow (added by EPA to identify location) points to the berm that surrounds the loading dock.

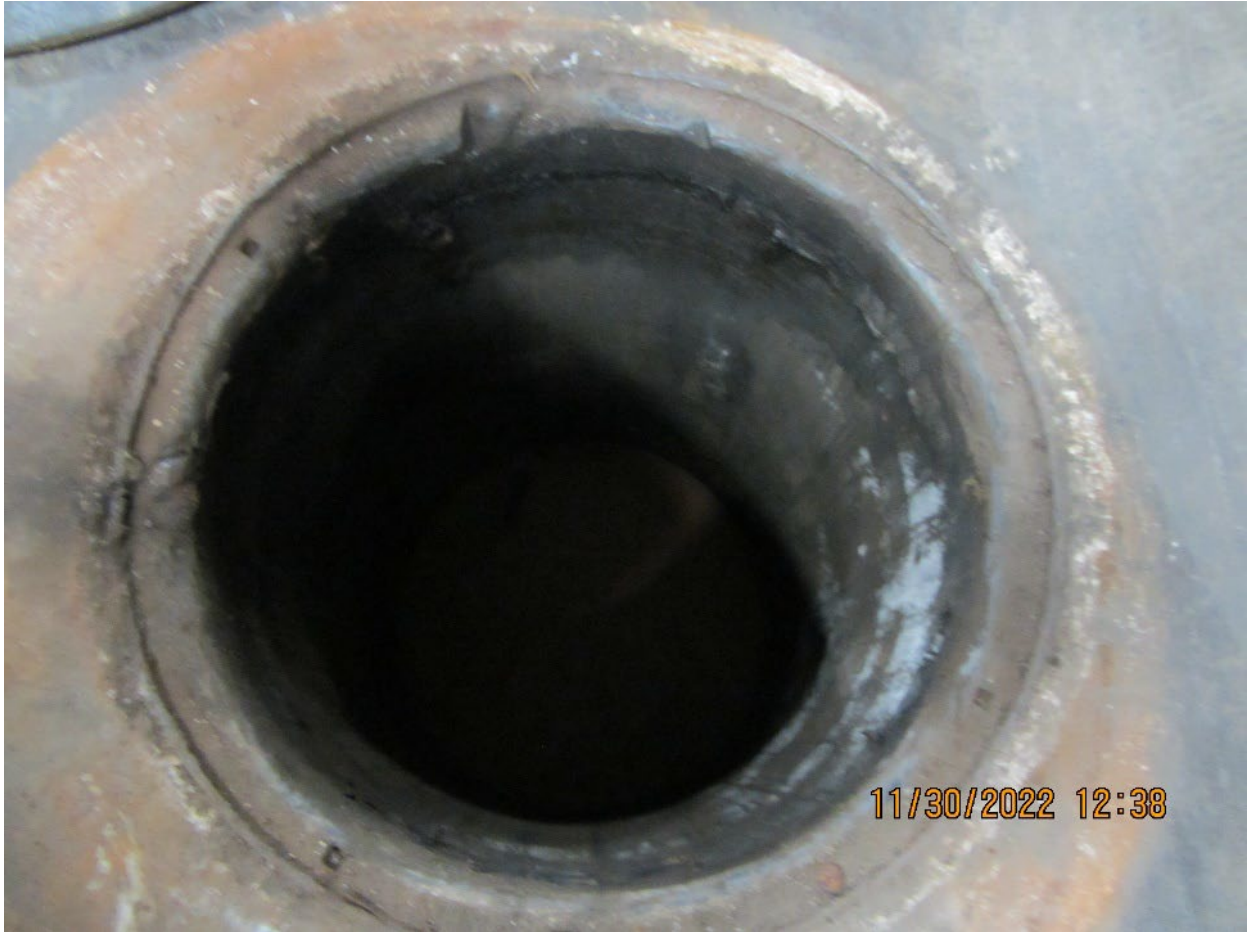
4: IMG\_0273

Description: View into open sump in concrete floor of warehouse that is used to collect melted snow off the vehicles and is not connected to a drain. Inspectors noted the sump was dry at the time of the inspection.

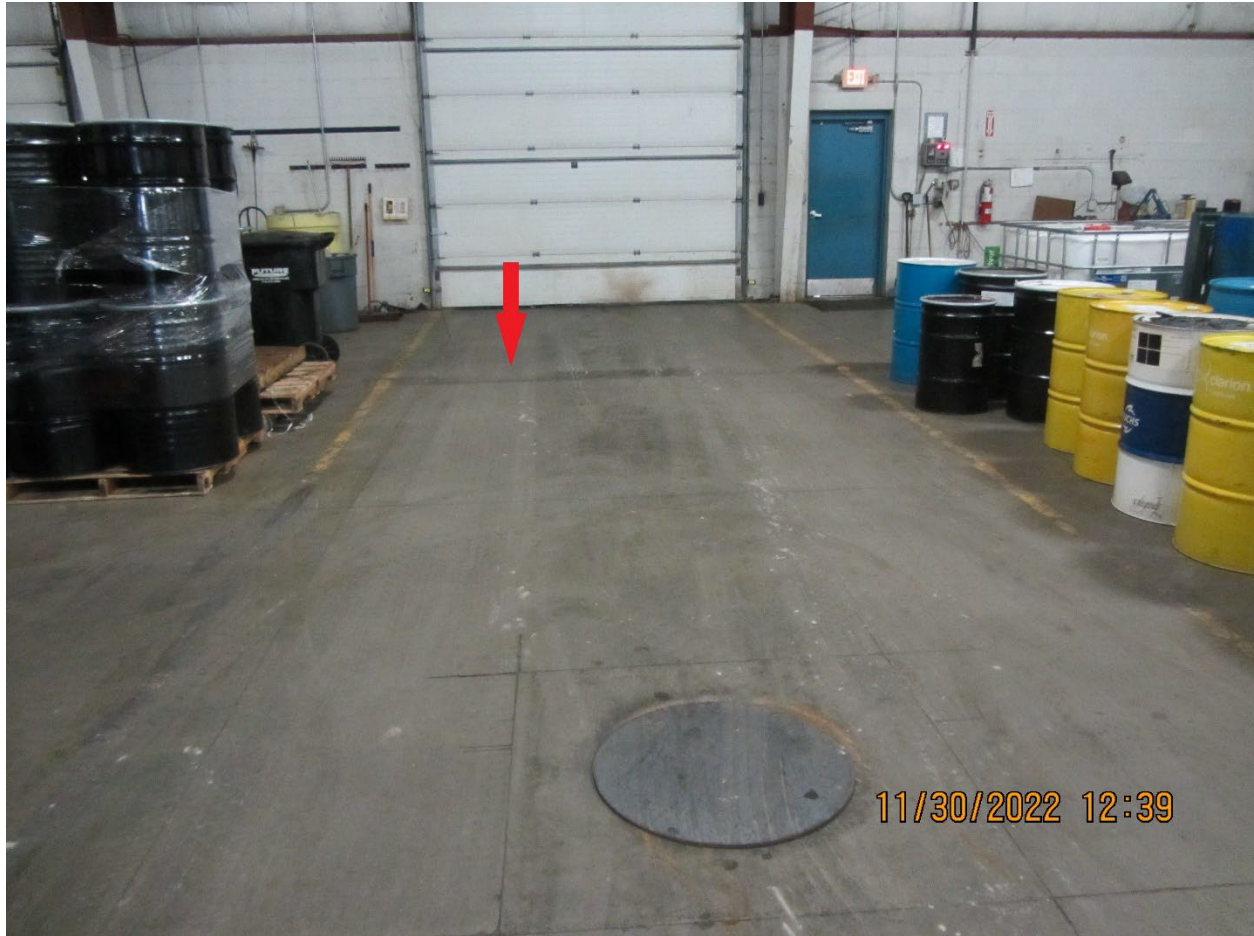
5: IMG\_0274

Description: Metal plate covering sump in loading dock area in foreground. Red arrow (added by EPA to identify location) points to the berm surrounding loading area that is in the same location as Photo 3.

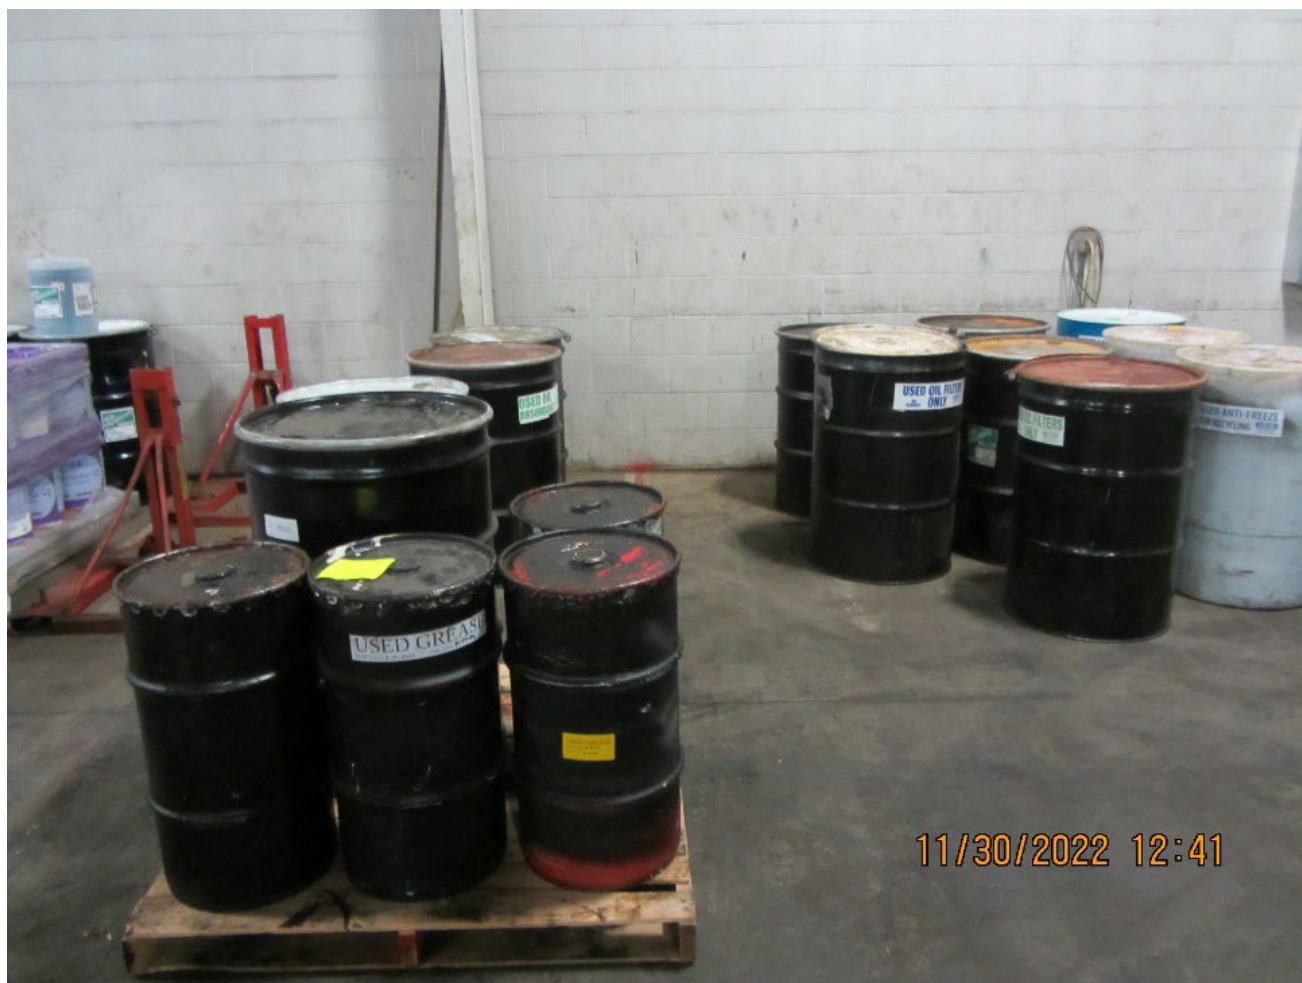
6: IMG\_0275

Description: Off loading area near the loading dock. Drums of similar wastes will be placed together prior to relocating and processing. Drums labeled "USED GREASE" on left and "USED ANTI-FREEZE" and "USED OIL FILTERS" on right.

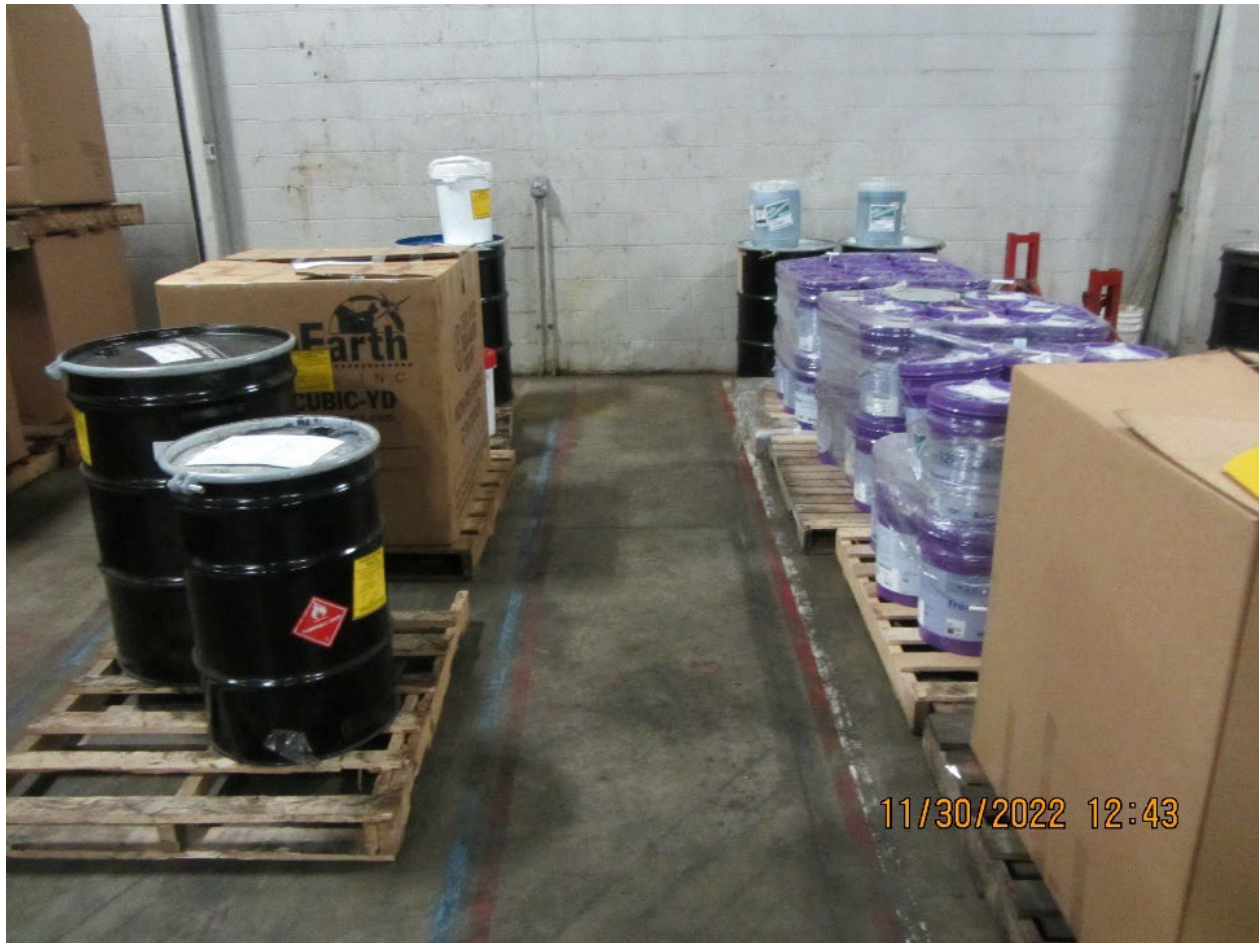
7: IMG\_0276

Description: Off loading area near the loading dock. Drums of similar wastes will be placed together prior to relocating and processing. Mr. Rosier stated that non-hazardous material is stored on the right.

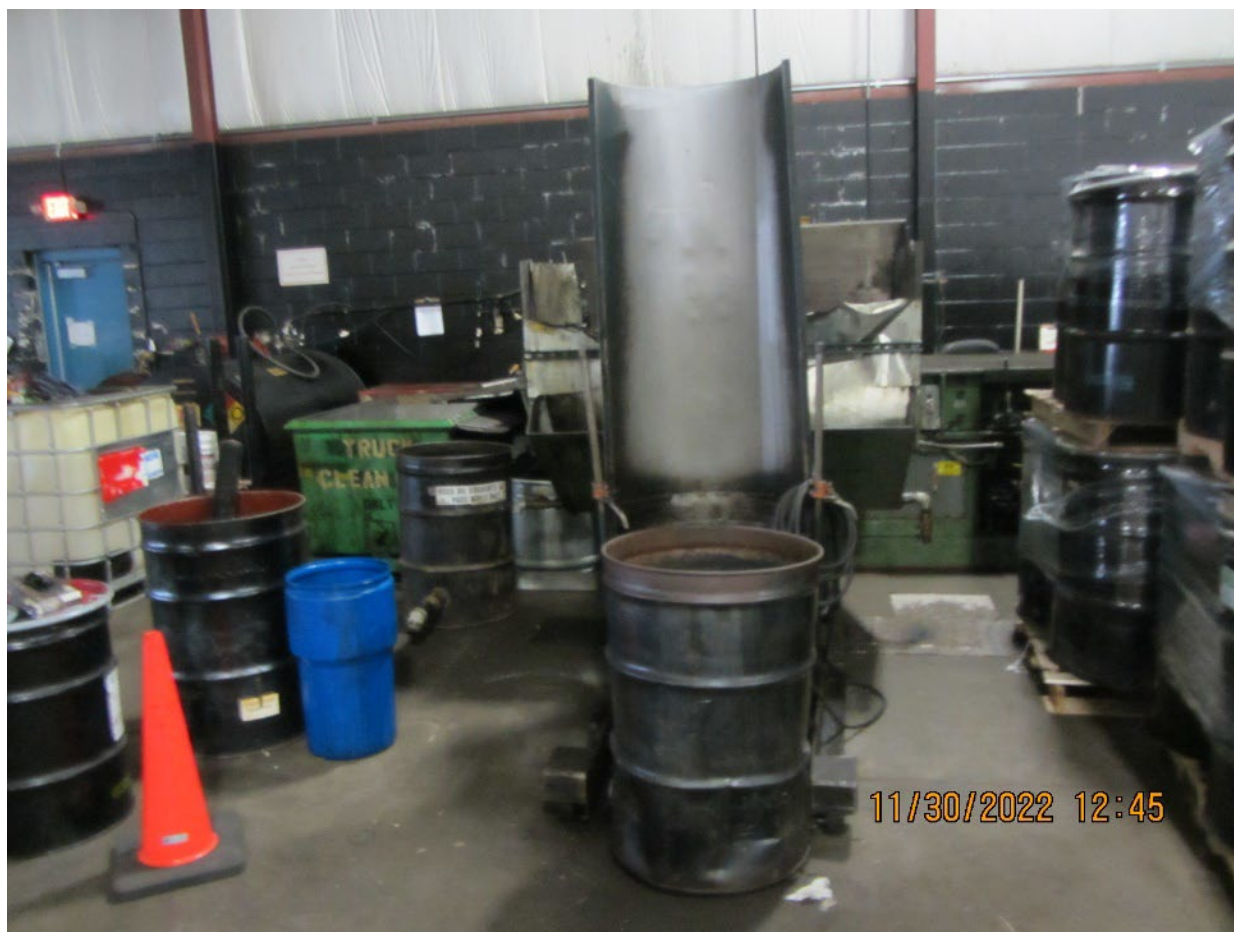
8: IMG\_0277

Description: Oil filter compactor which is not currently used, according to Mr. Rosier.

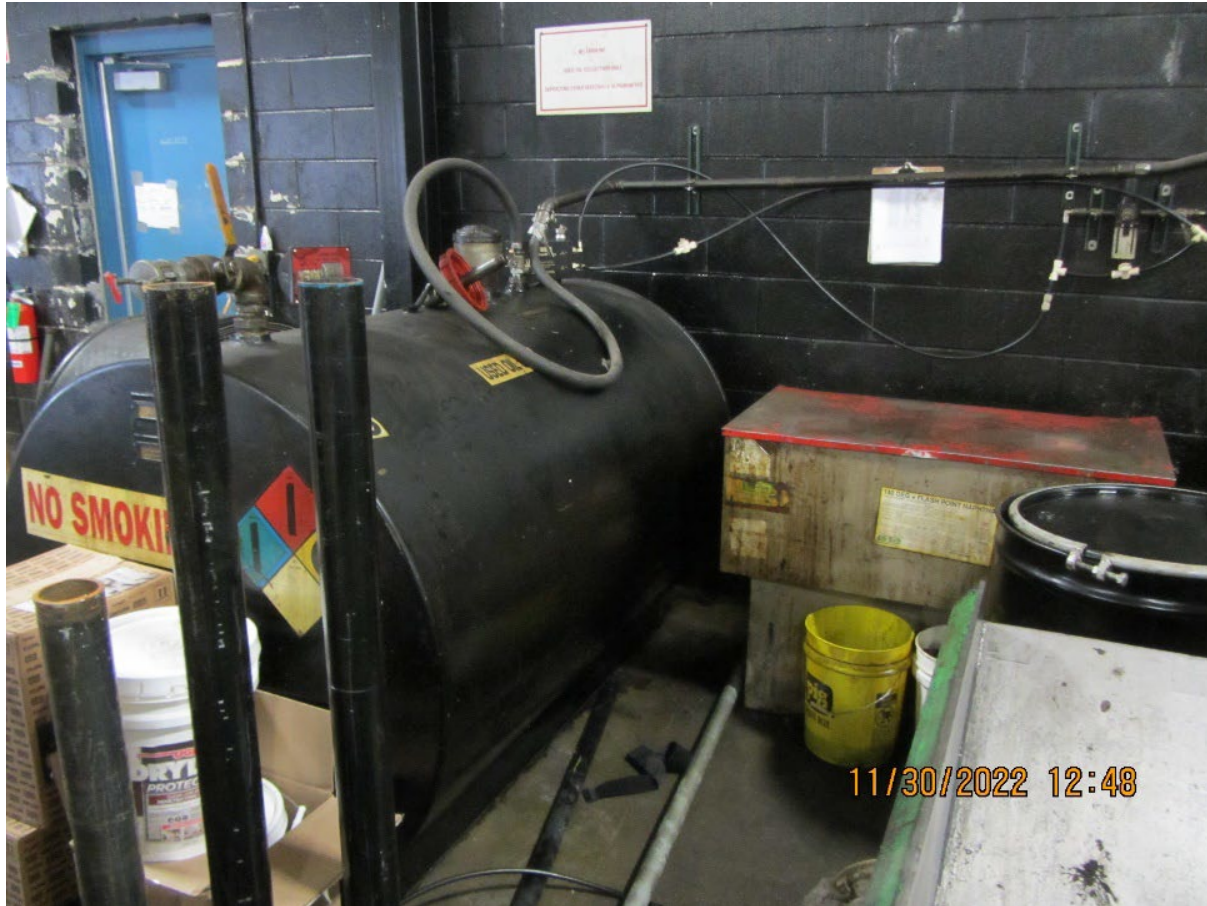
9: IMG\_0278

Description: Black used oil tank on left and part washer in rear which reads "140 flash Naptha". Clipboard (on the wall) documents tank inspections and inspectors note that the clipboard lists the current date. Mr. Rosier stated that it is required to be checked weekly but is usually checked daily.

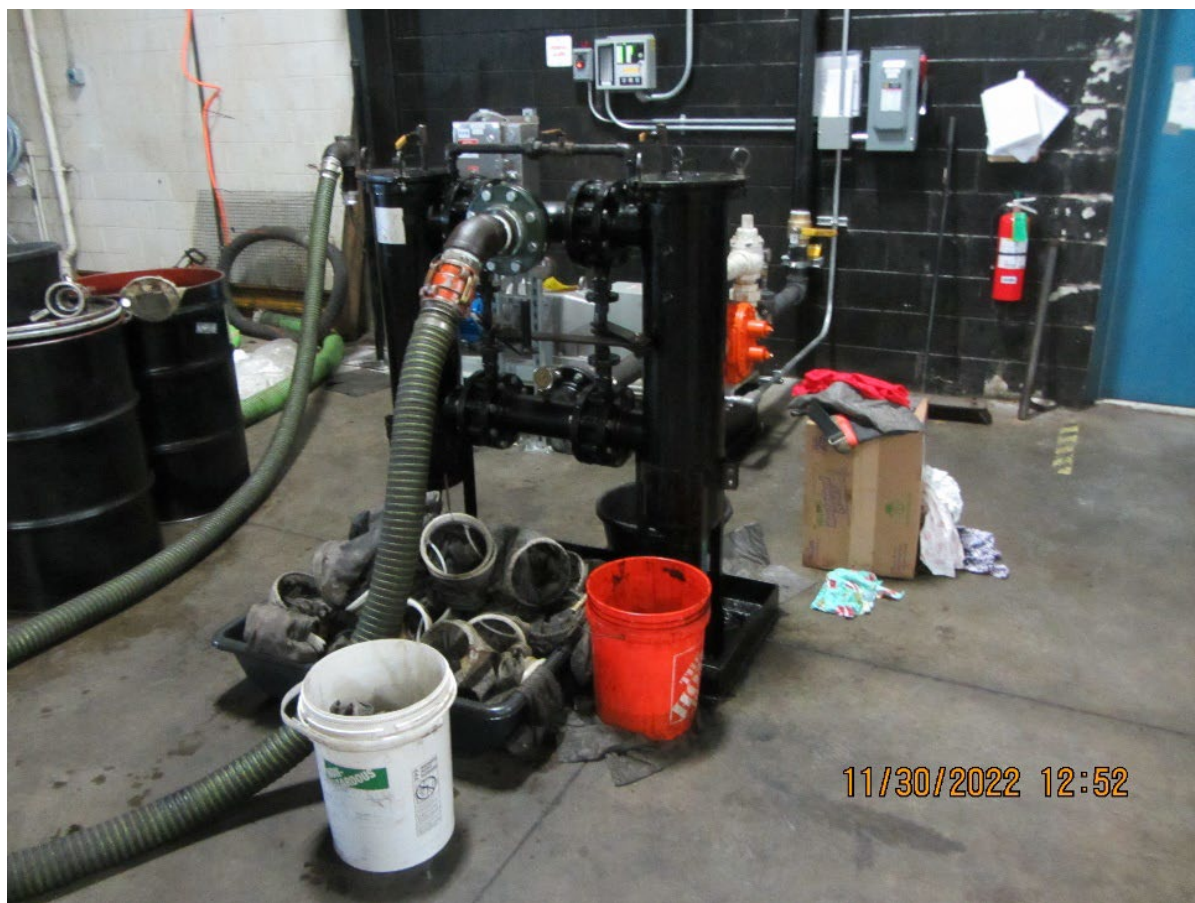
10: IMG\_0279

Description: Used oil offloading and filtration prior to sending oil to the tank farm. Used filters (white circles next to orange bucket) are stored under the filter prior to cleaning in parts washer and reuse.

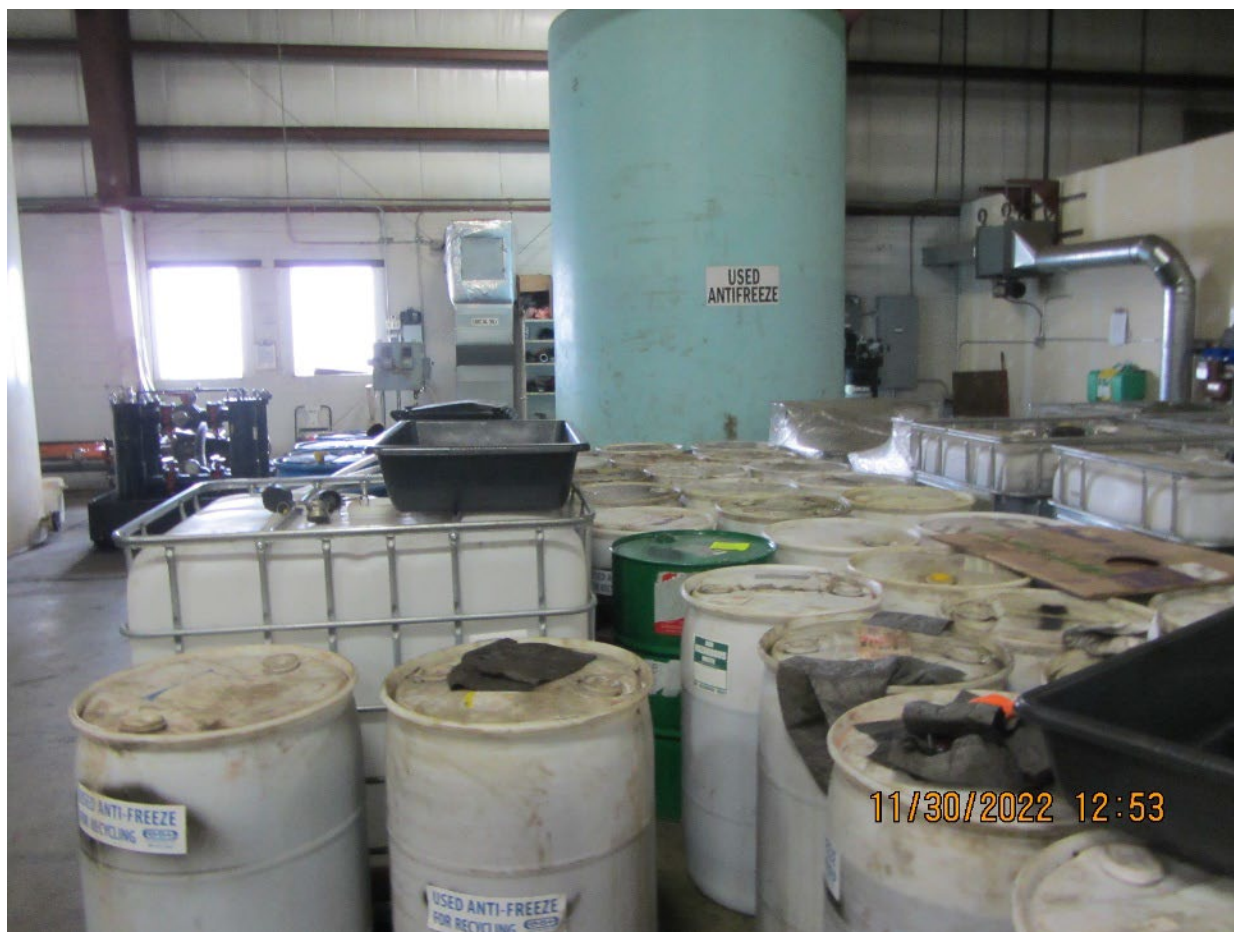
11: IMG\_0280

There were also drums stored near the antifreeze tank which are waiting to be consolidated to the larger tank (Photo 11) and same for the mineral oil tanks. I noted that some of the drums in the mineral oil area have two labels with different information. Mr. Rosier explained that the clients may not remove the old label from an empty drum before refilling and the OSI labels are the correct ones. Each of the mineral oil tanks has a clipboard that lists the contributing generators, shipping, and analytical results for all the oil in that tank (Photos 15-18).

Description: Drums and totes labeled “ USED ANTI-FREEZE” in foreground. Used antifreeze tank in background. A coarse filter is in left background below the window.

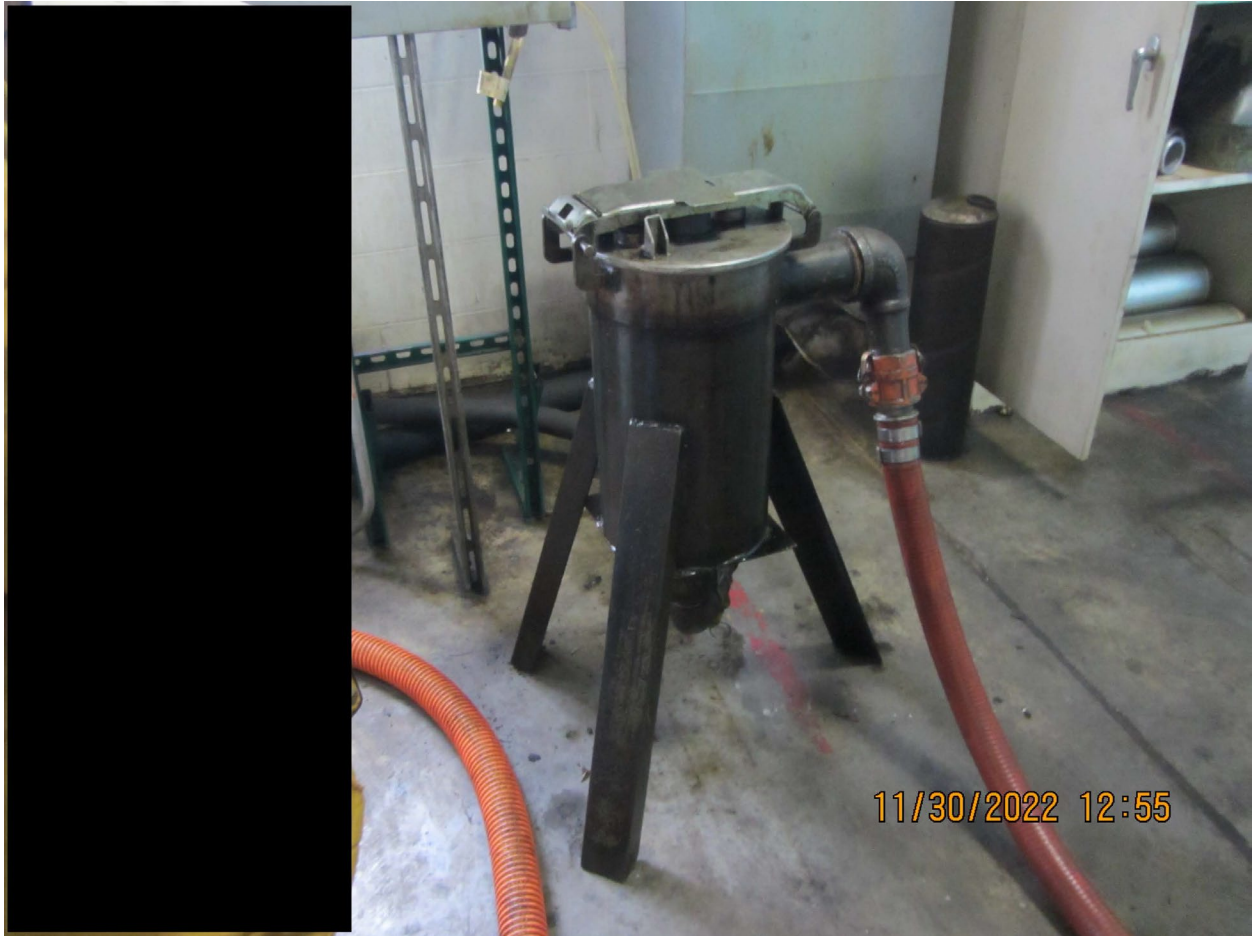
12: IMG\_0281\_redacted

Description: The coarse filter that is used for the antifreeze tank from Photo 11.

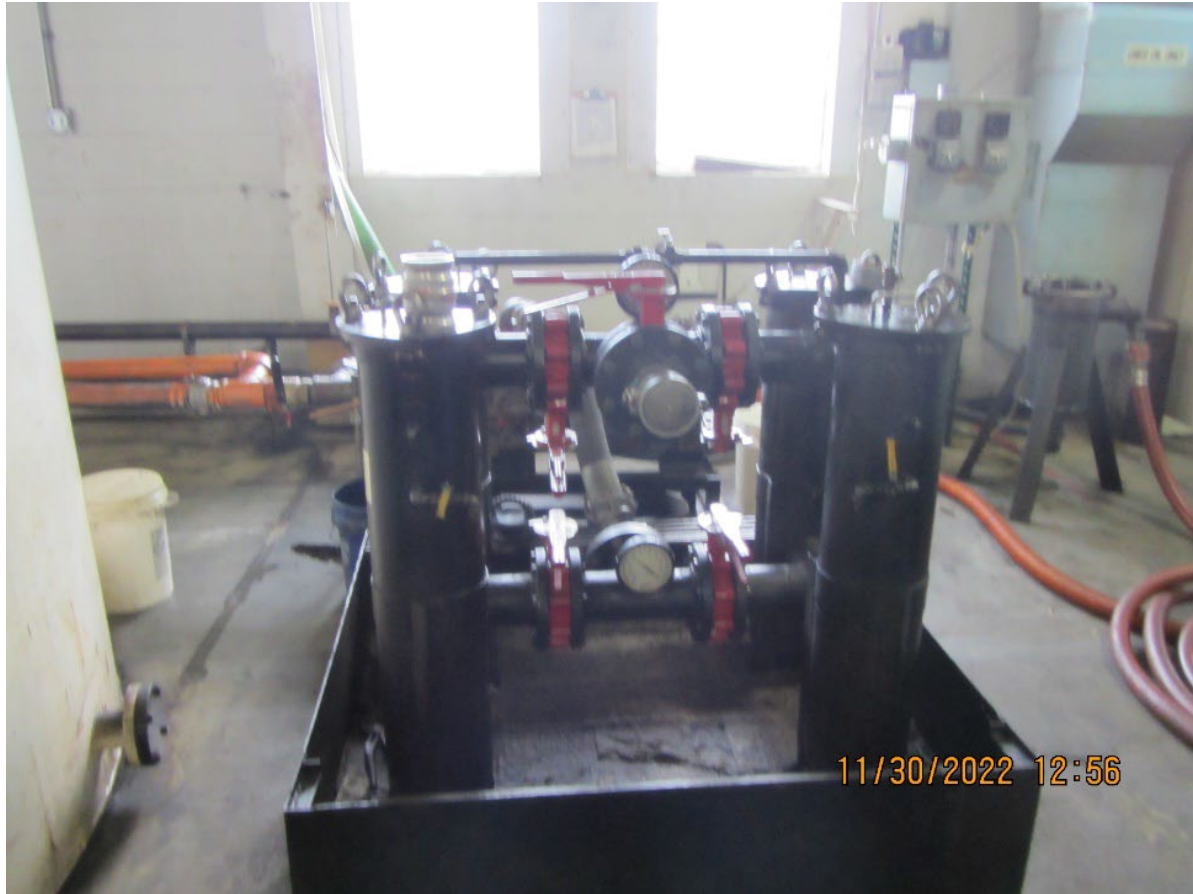
13: IMG\_0282

Description: Coarse filter that is used on the mineral oil tanks.

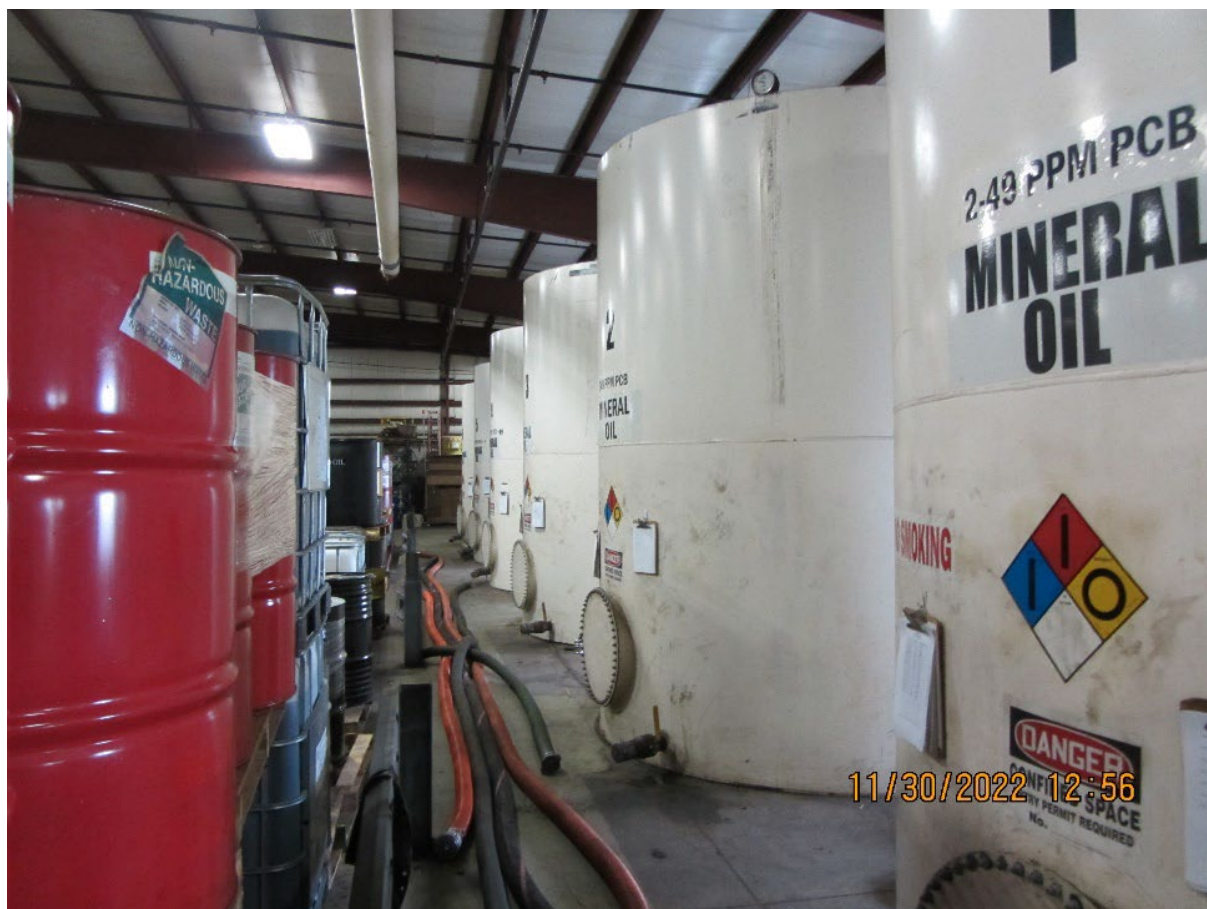
14: IMG\_0283

Description: Six 2-49 PPM PCB mineral oil tanks. Each tank has a separate clipboard that lists the products which have been pumped to the tank and their laboratory reports.

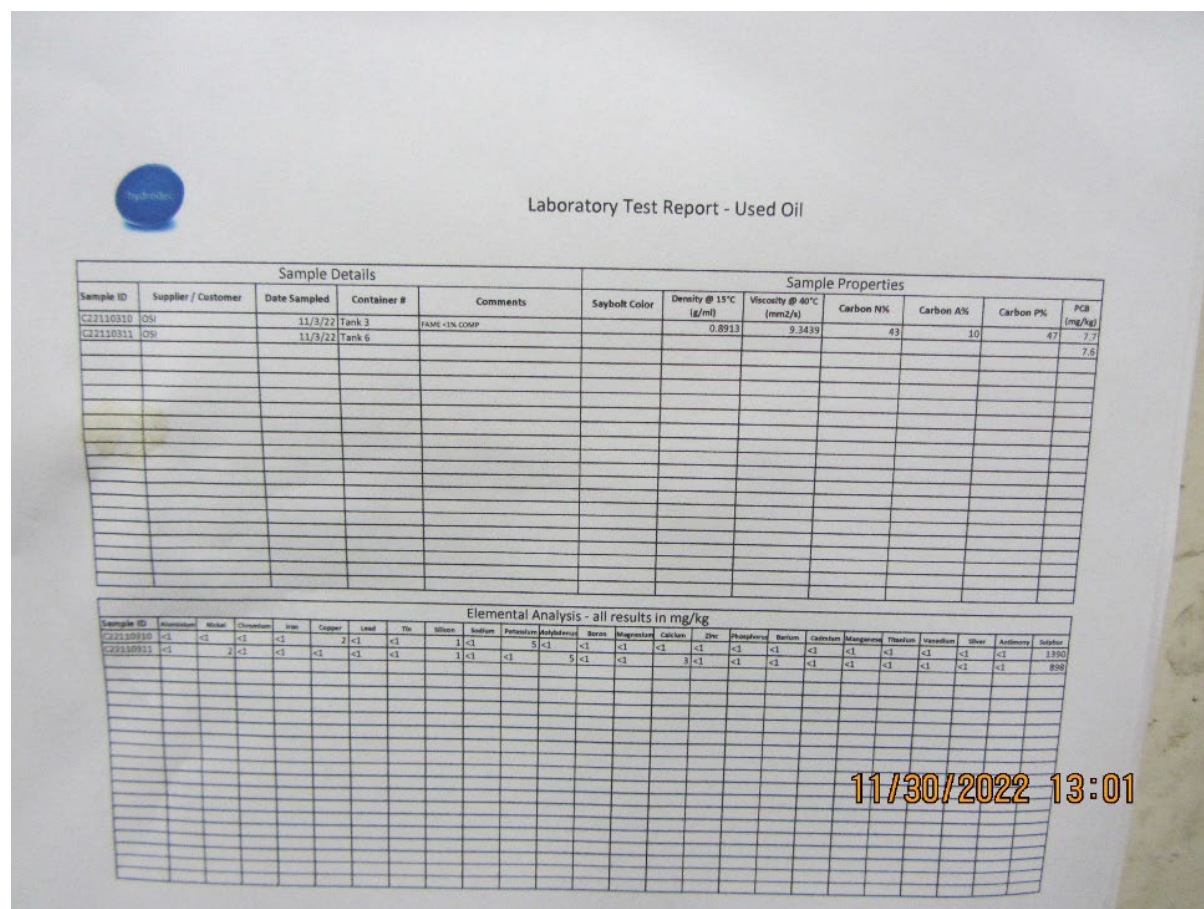
15: IMG 0284

Description: Page from Mineral Oil Tank 3 clipboard which states “Laboratory Test Report - Used Oil”. The report lists density, viscosity, PCB and elemental analysis for an oil sample that was pumped to the tank.

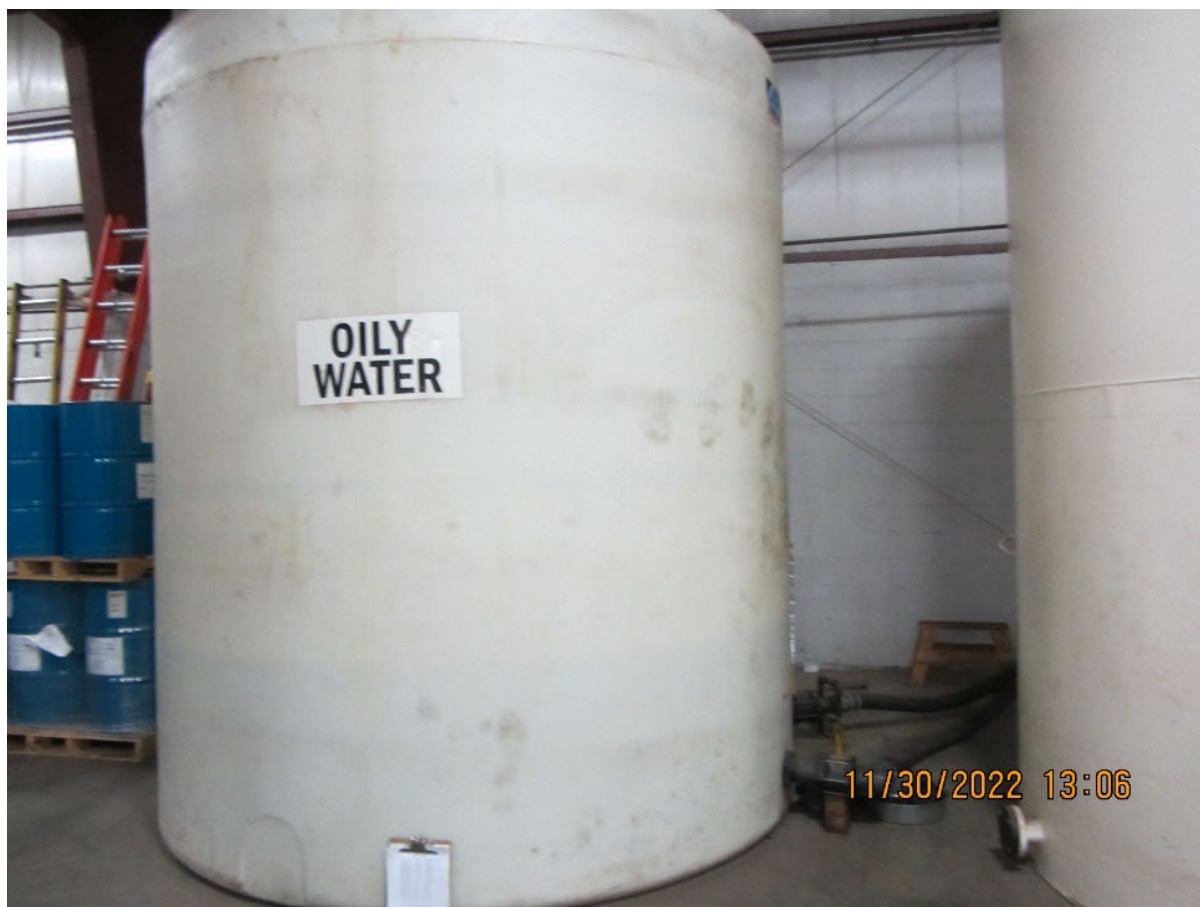
19: IMG\_0288

Description: Oily water tank that is located south of the mineral tanks.

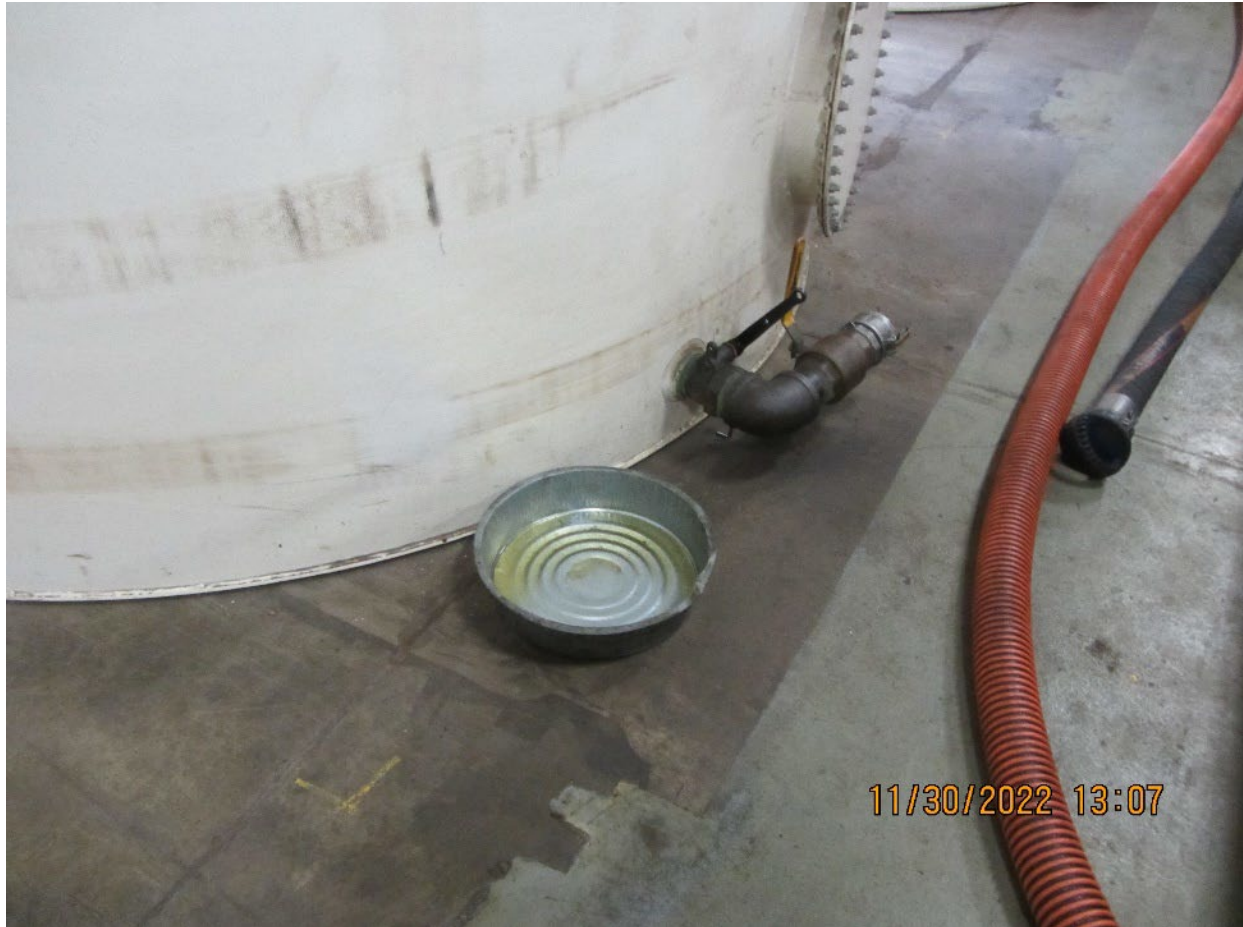
20: IMG\_0289

Description: Pan that is used for collecting drips when taking off hose fittings. A yellow liquid is visible in the pan.

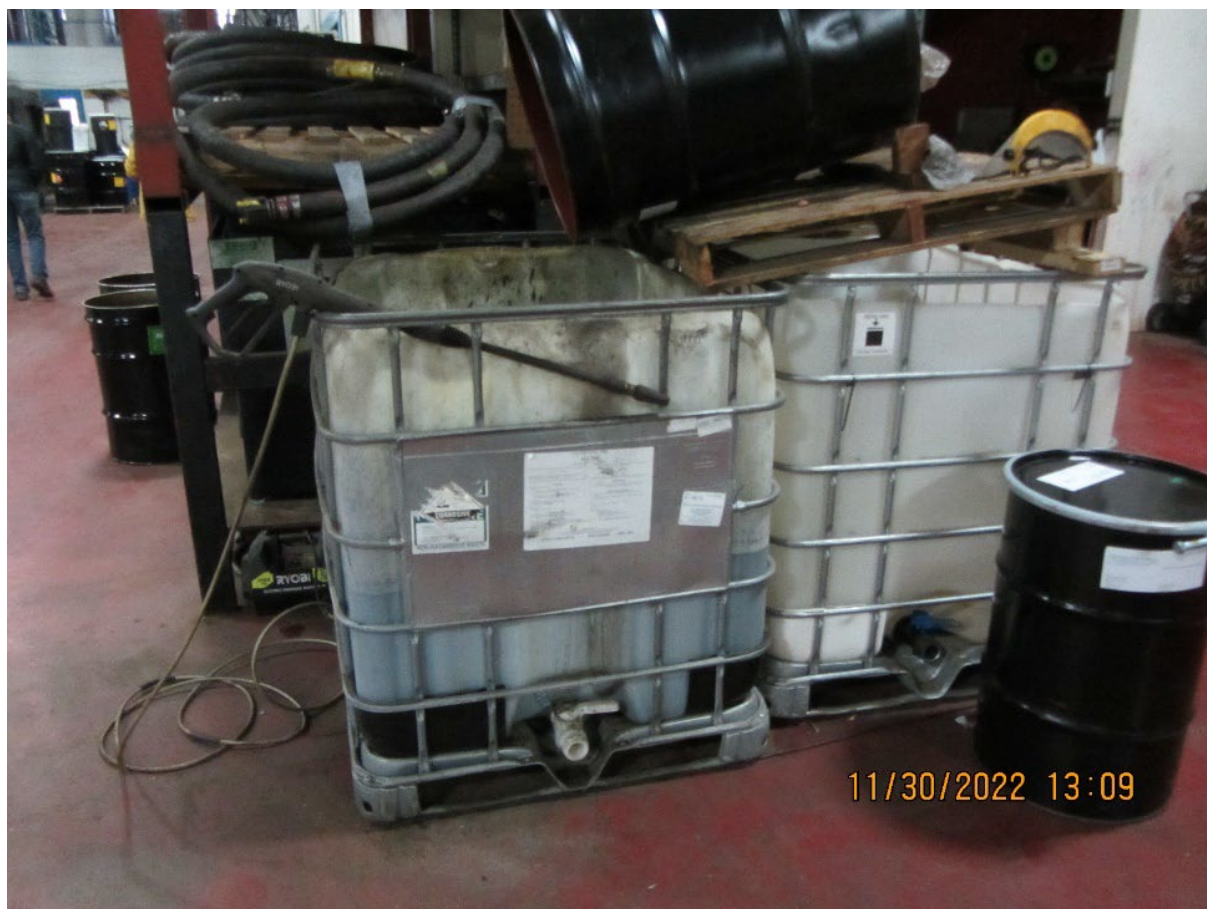
21: IMG\_0290

There is a maintenance area which has a parts washer, but this does not produce wastewater, according to Mr. Rosier. Drum cleaning is also done in this area. I saw an elevated drum that was draining into an open tote containing oily waste (Photos 21 – 22). Mr Rosier stated that the

Description: Inverted drum dripping into an open tote that is used as parts washer waste collection.

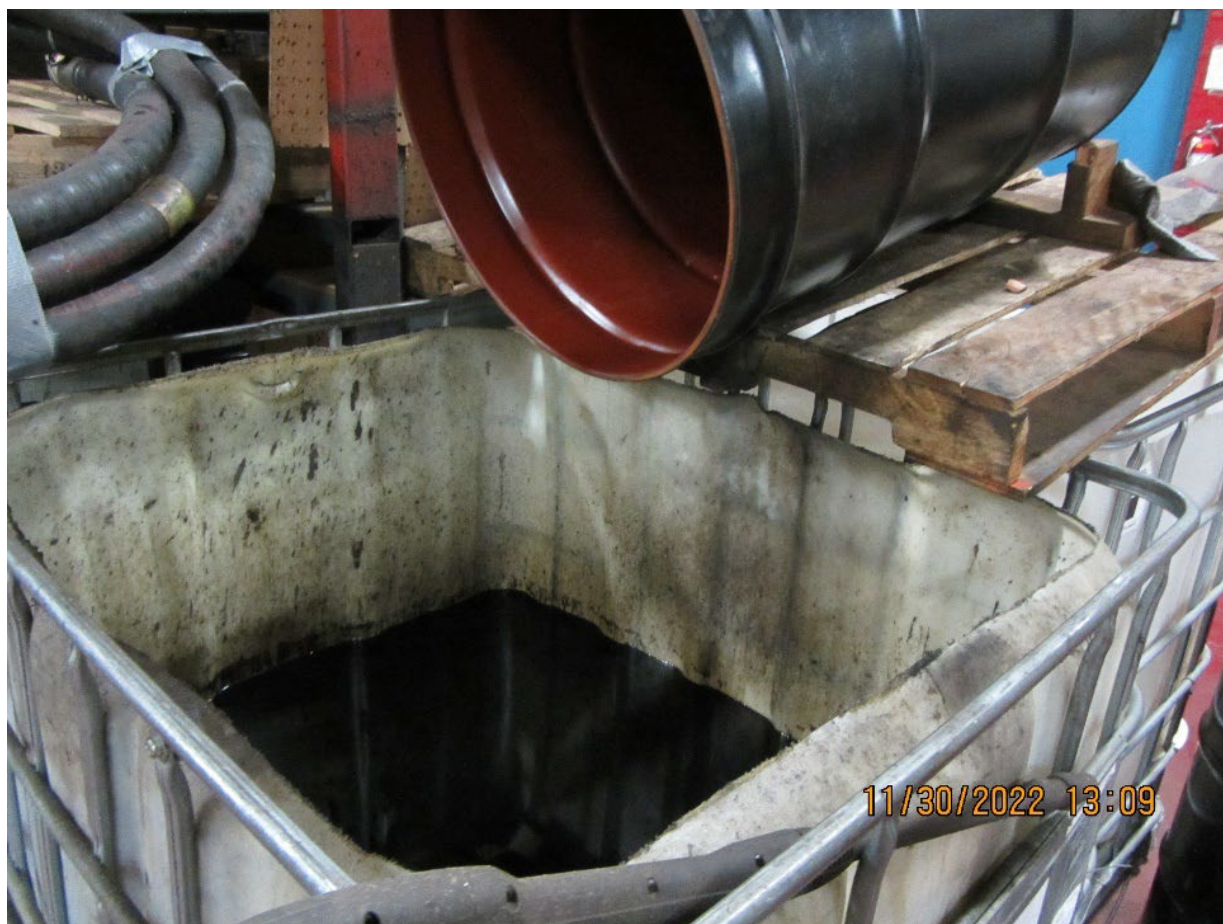
22: IMG\_0291

Description: Closer view of the open parts washer waste collection tote and inverted drum from Photo 21.
