COMPLIANCE EVALUATION INSPECTION REPORT  
U.S. ENVIRONMENTAL PROTECTION AGENCY, REGION 5

**Purpose:** NPDES Compliance Evaluation Inspection

**Facility:** OSI Environmental  
912 Tesch Court  
Waukesha, Wisconsin 53186

**Date of Inspection:** November 30, 2022

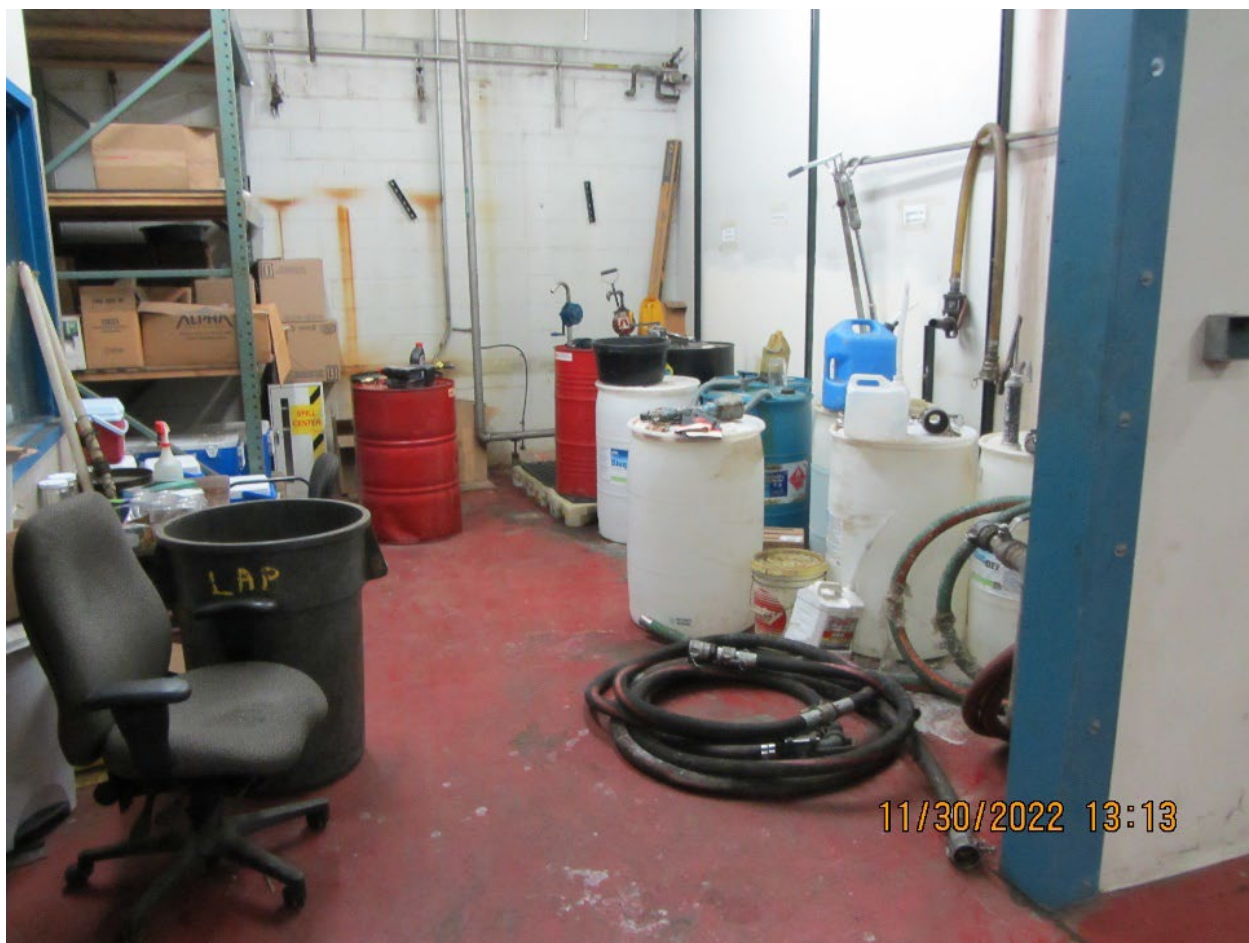
23: IMG\_0292

Description: Storage room for oil, antifreeze and washer fluid for trucks.

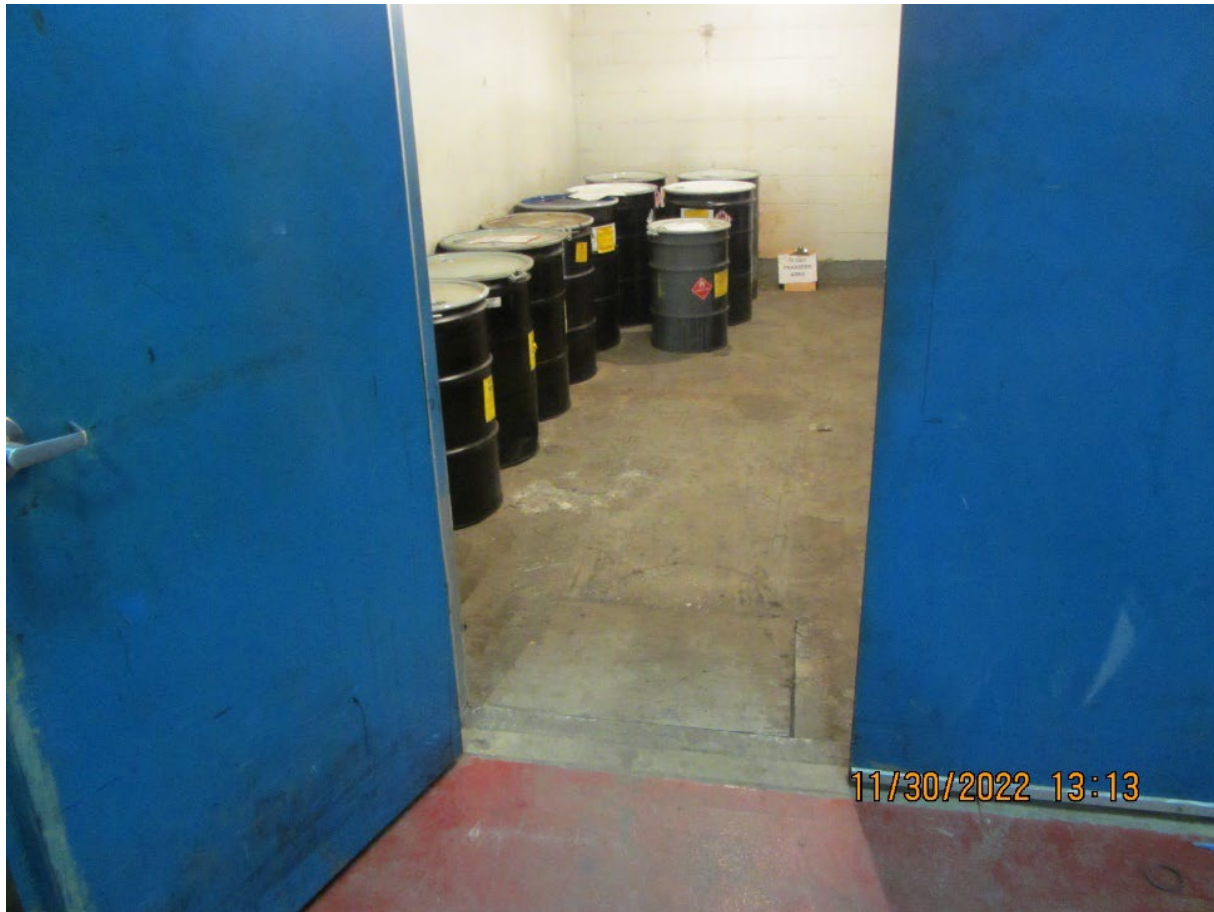
24: IMG\_0293

There is a hazardous waste room that has intrinsically safe lighting (Photo 24). Hazardous waste may be stored for up to 10 days. I noted some drums labeled as hazardous waste sitting outside the room waiting to be picked up for transfer.

Description: Hazardous waste drums stored in intrinsically safe hazardous waste room. Room is at a lower grade than the warehouse floor and a ramp leads into the room. Both blue doors are normally closed, but one was opened to take the photo.

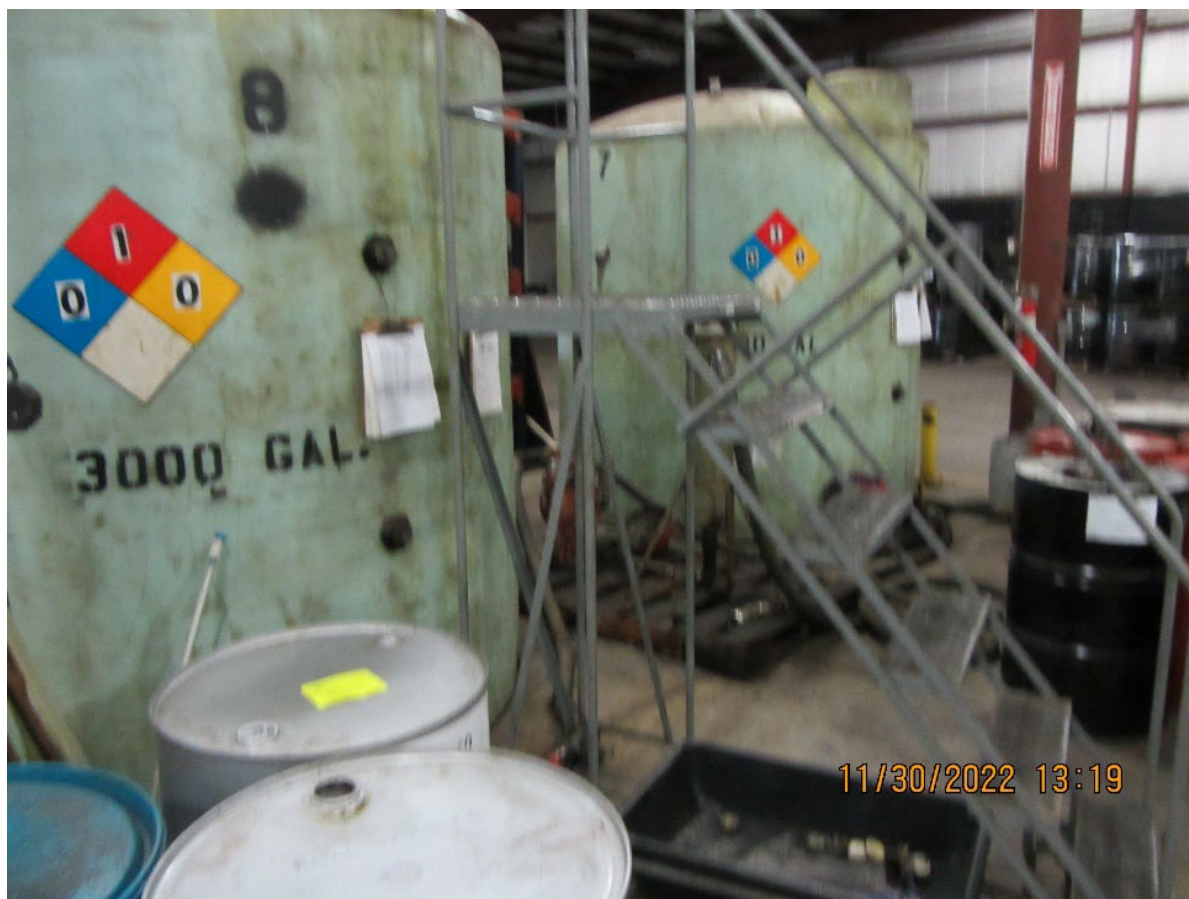
25: IMG\_0294

Description: Two 3000 gallon tanks that were not used at the time of the inspection, but are kept as backups.

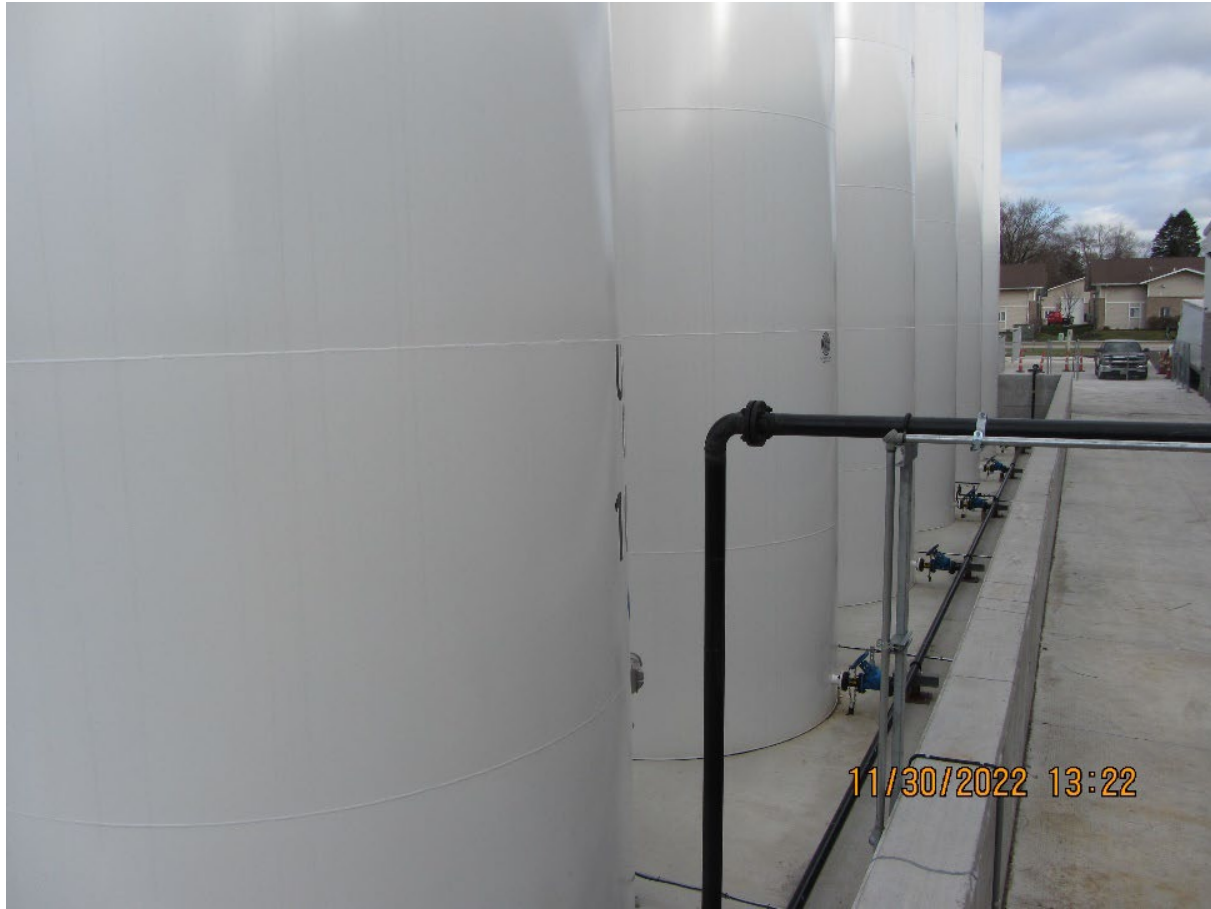
26: IMG\_0295

Description: Used oil tanks in recently constructed tank farm within a cement containment area.

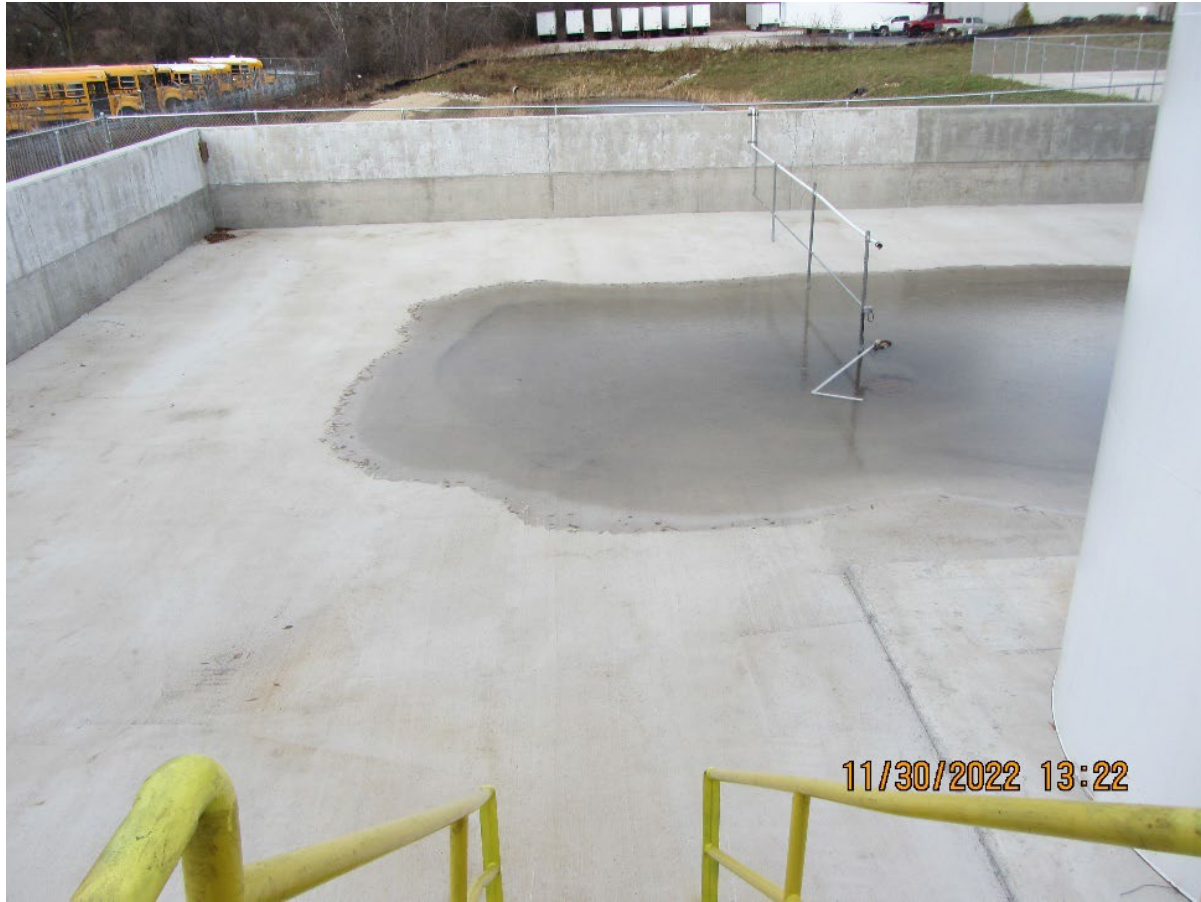
27: IMG\_0296

Description: View to the left of the six tanks from Photo 26 down into the cement containment area.

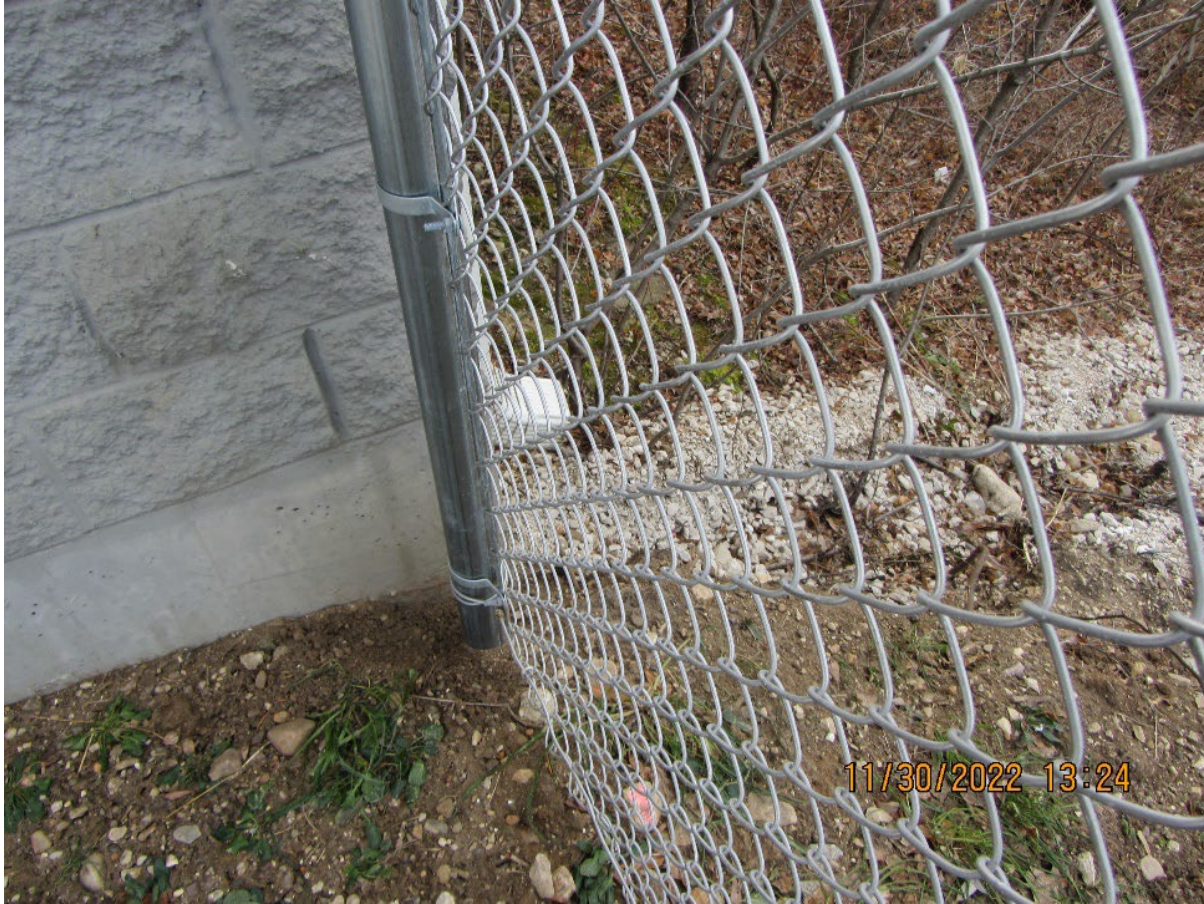
28: IMG\_0297

1. Flow from a roof drain flows behind the warehouse and towards a ditch area and not towards the stormwater pond. The drainage map (Appendix C) in the SWPPP dated

December 21, 2022 does not have the roof drains on the western side of the warehouse listed.

Description: Drain spout from roof of warehouse flows down west of warehouse.

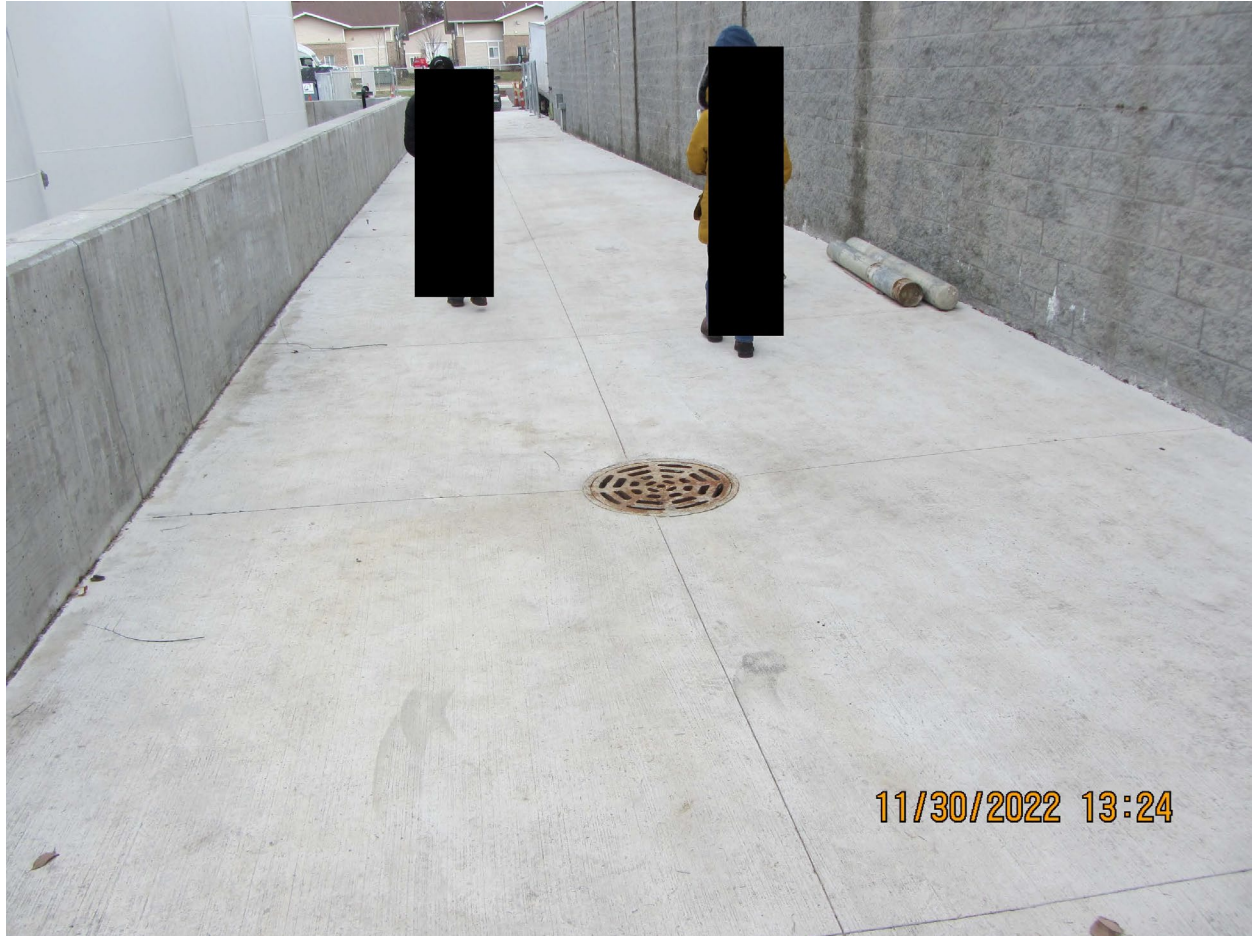
29: IMG\_0298\_redacted

Description: Stormwater drain built into the area between the warehouse and tank farm.  
Stormwater piping flows to the pond according to the SWPPP.

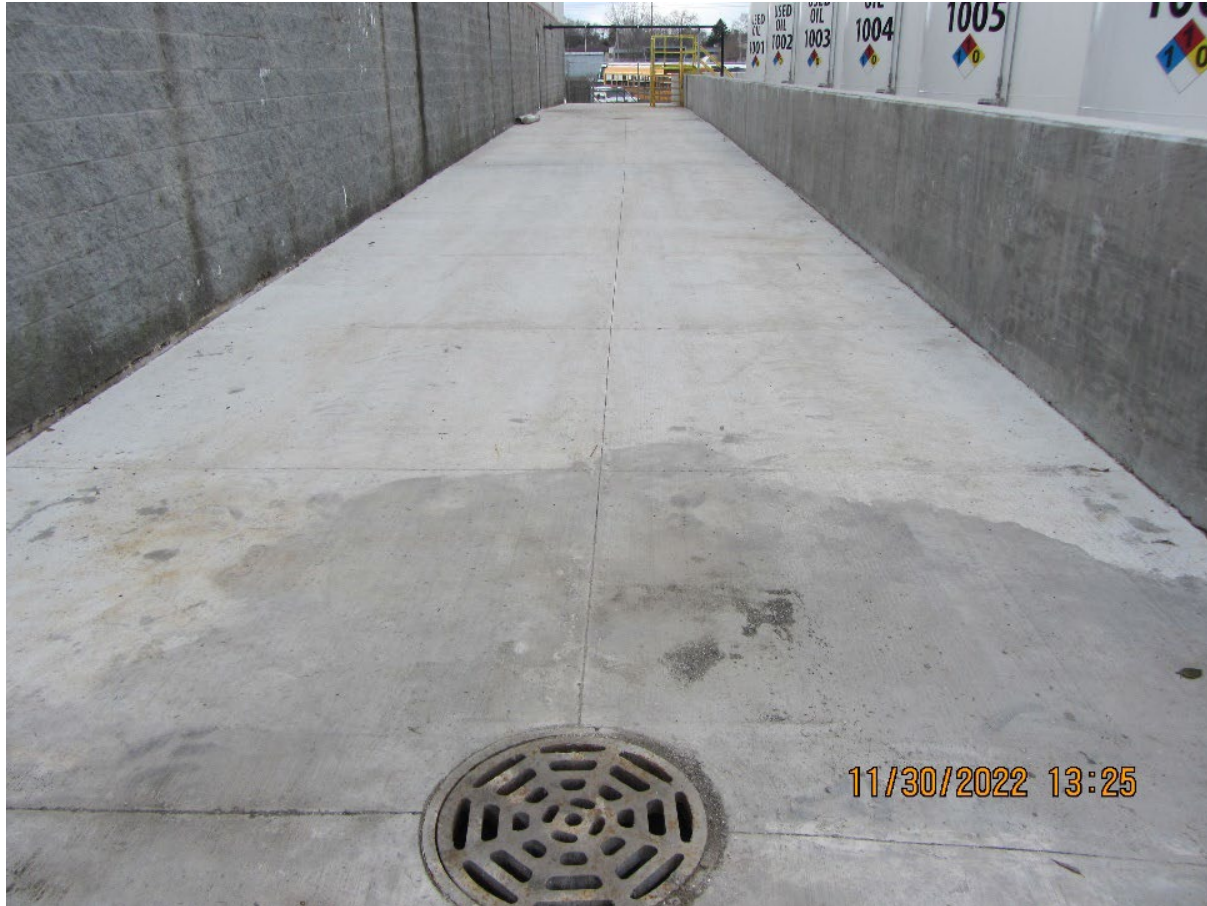
30: IMG\_0299

Description: Stormwater drain built into the area between the warehouse and tank farm. Stormwater piping flows to the pond. Same view as Photo 29 but looking in opposite direction.

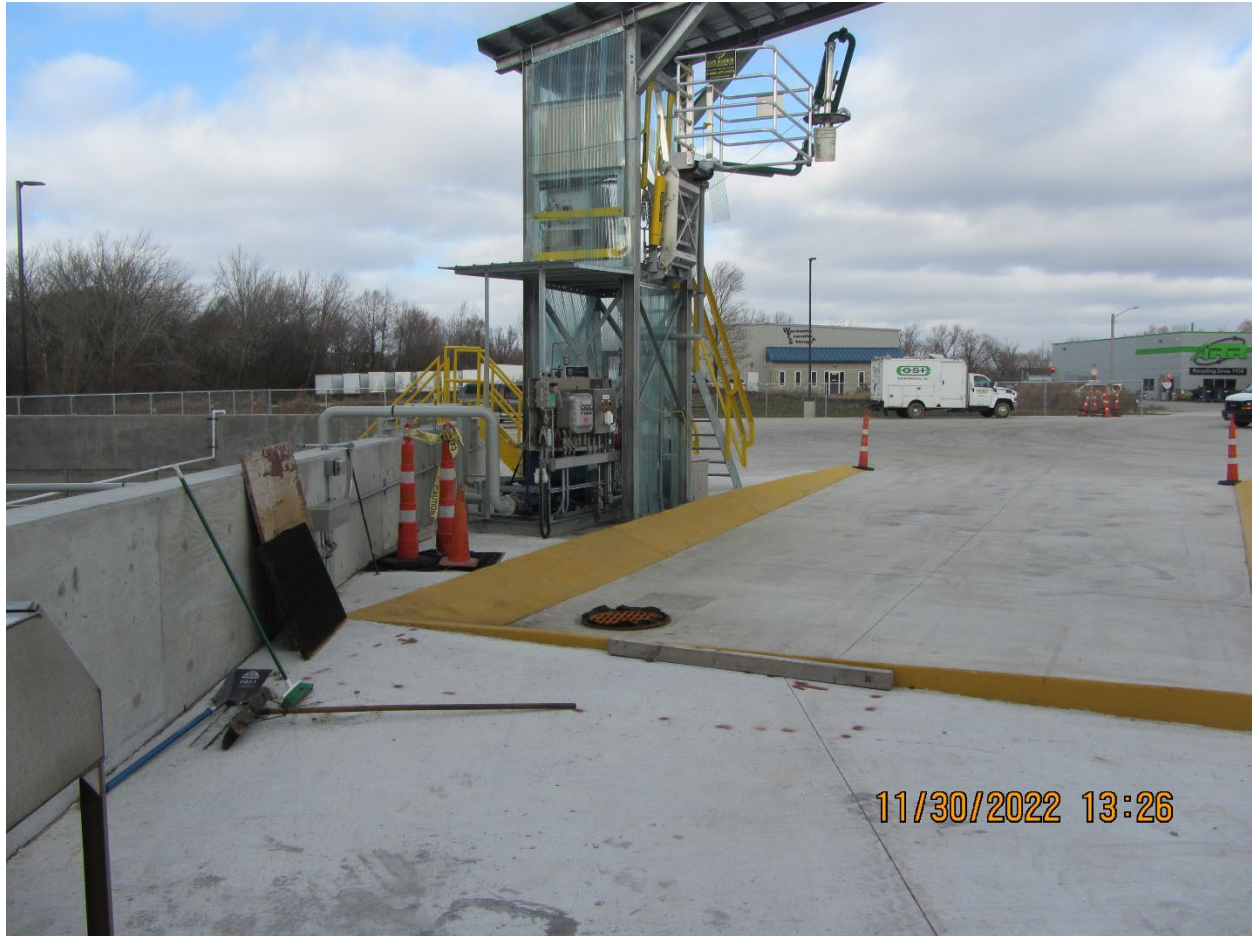
31: IMG\_0300

Description: Newly constructed loading area for vehicles purchasing used oil which is stored in the tank farm. Loading dock is at an incline and a drain is located at the lowest area. The drain flows into the containment area.

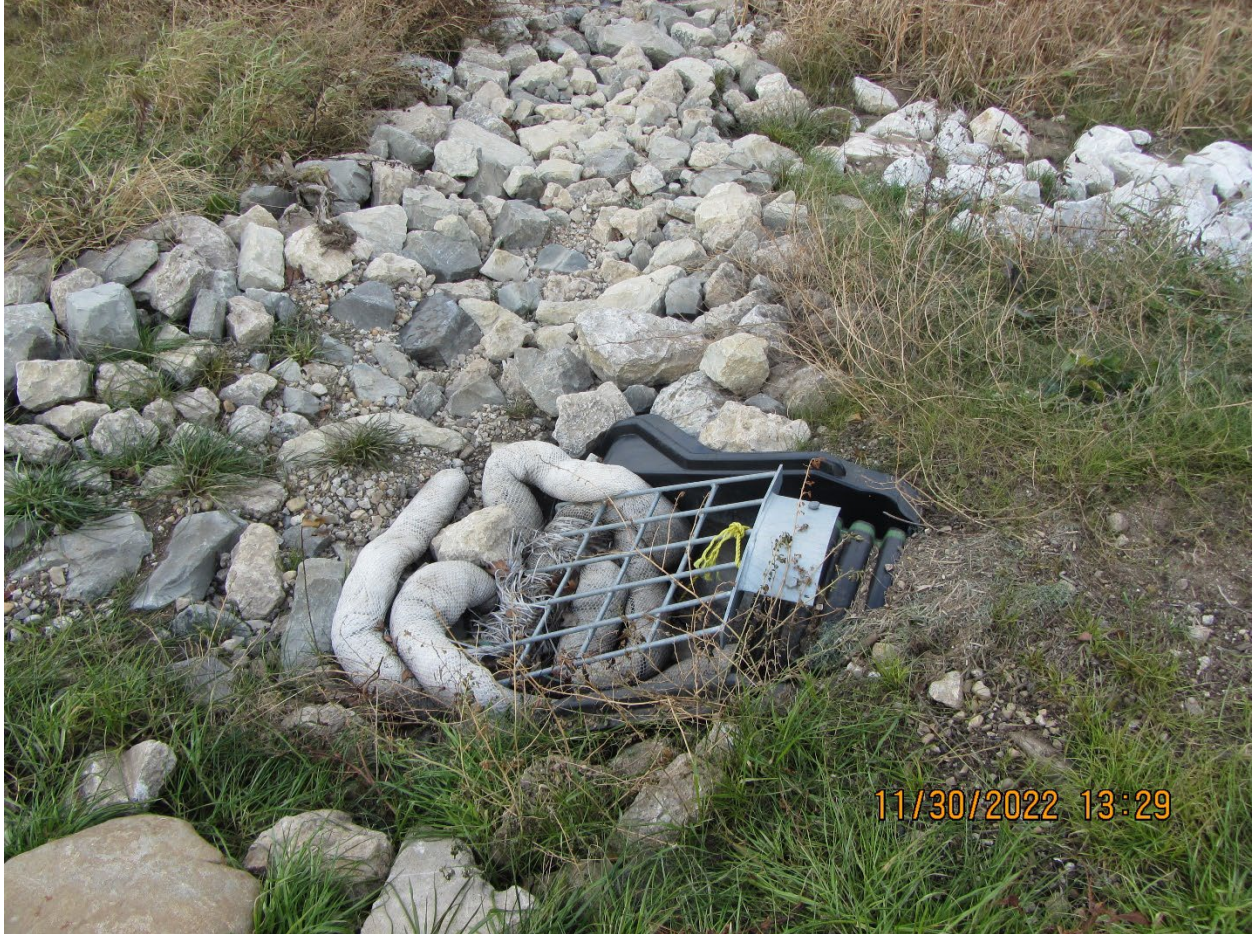
32: IMG\_0301

Description: Stormwater outfall which flows to the pond. At the time of the inspection, I did not observe any flow. The stormwater drains, shown in Photos 29, 30 and 34, are plumbed to discharge to this stormwater outfall.

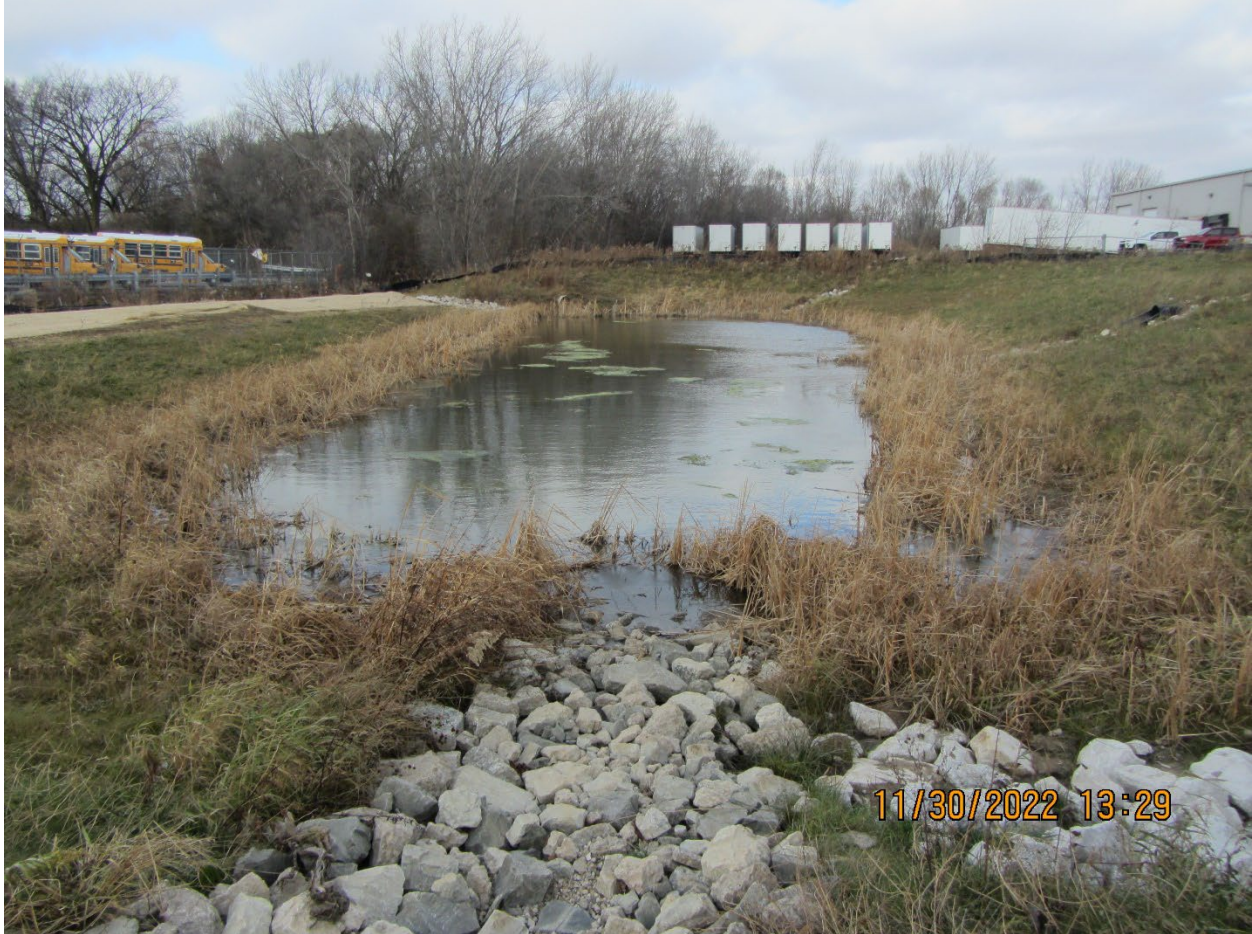
33: IMG\_0302

Description: View from the stormwater outfall looking towards the pond. The pond outfall to Fox Creek, visible at the far end of the pond, is located above the surface of the pond.

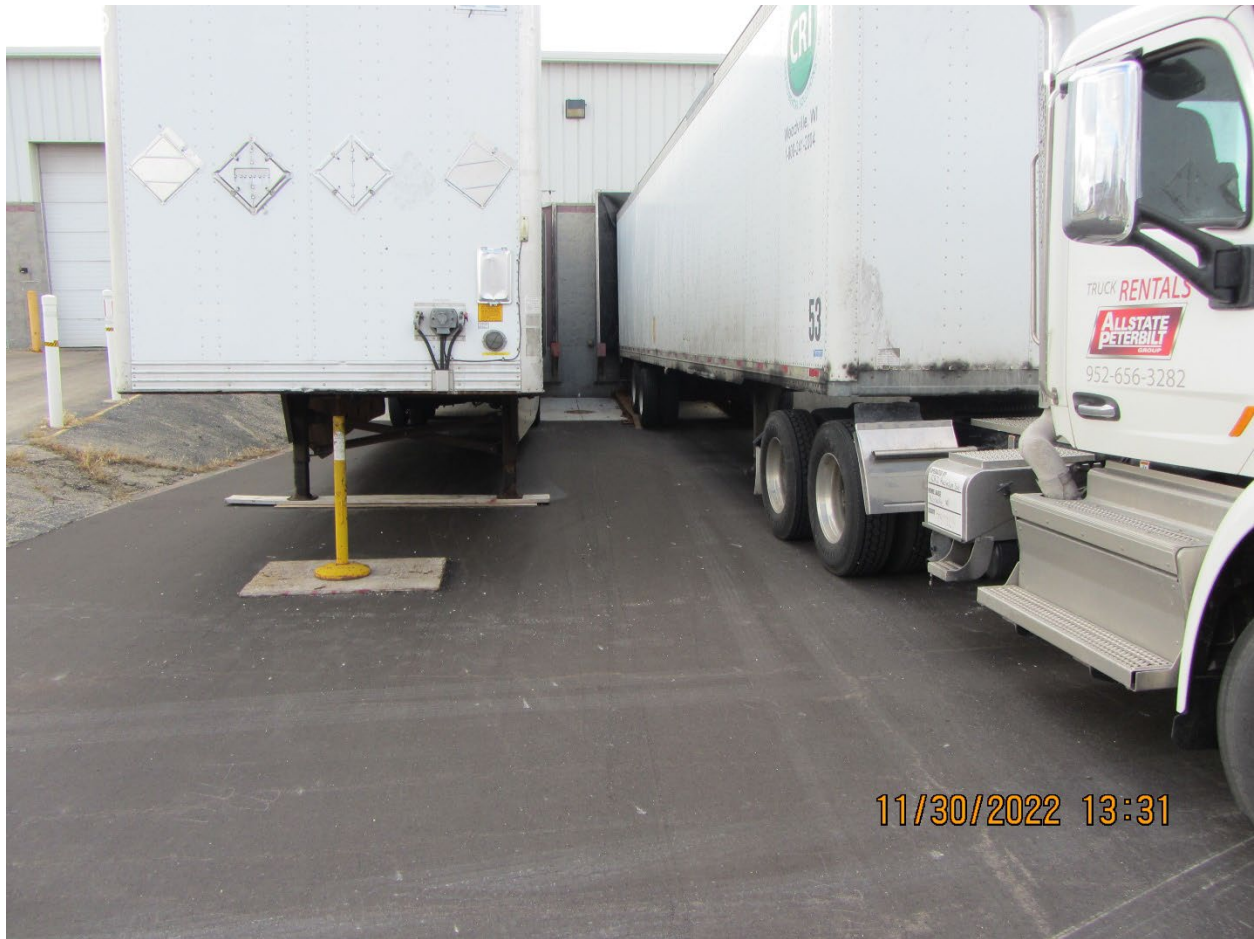
34: IMG\_0303

We walked towards the warehouse loading dock which has two sloped truck bays. A stormwater drain, which is plumbed to the stormwater pond, is located at the bottom of the bays. I noted that if a spill were to occur, it could enter the stormwater pond through this drain. Mr. Rosier stated that all drivers remain on site during loading or unloading and were a spill to occur, it would be noticed immediately and secured prior to entering the storm drain. We continued walking to the location of two underground storage tanks (Photo 35) at the side of the warehouse. These tanks total 14,000 gallons and store bad gasoline which will be sent to a re-refinery for processing.

2. A stormwater drain is located at the bottom of the sloped warehouse loading dock. There is a possibility that any spill could enter the stormwater drain and flow to the stormwater pond.
3. Waste products received from customers are stored in reused drums prior to consolidation. Some drums have two conflicting labels, one for the drum's previous use that does not match the product that is currently stored the drum, and a second label which OSI Environmental added that lists the current contents.

Description: Trucks parked at the two warehouse loading docks. The loading area is sloped and a stormwater drain, which leads to the pond, is located at the bottom of the slope.

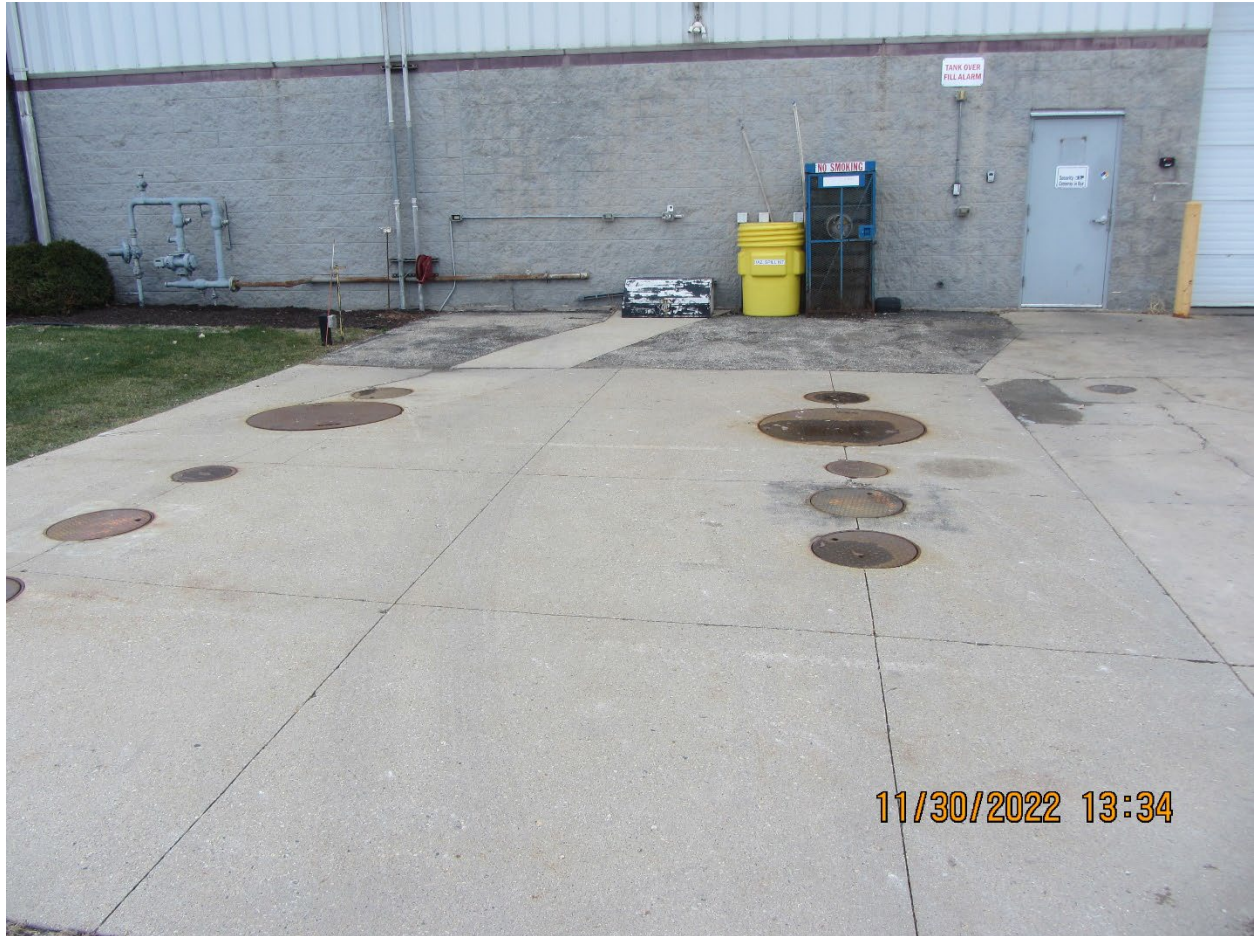
35: IMG\_0304

Description: Manhole plates are visible where two underground gasoline tanks are located. A yellow hazardous spill kit is located nearby against the building.

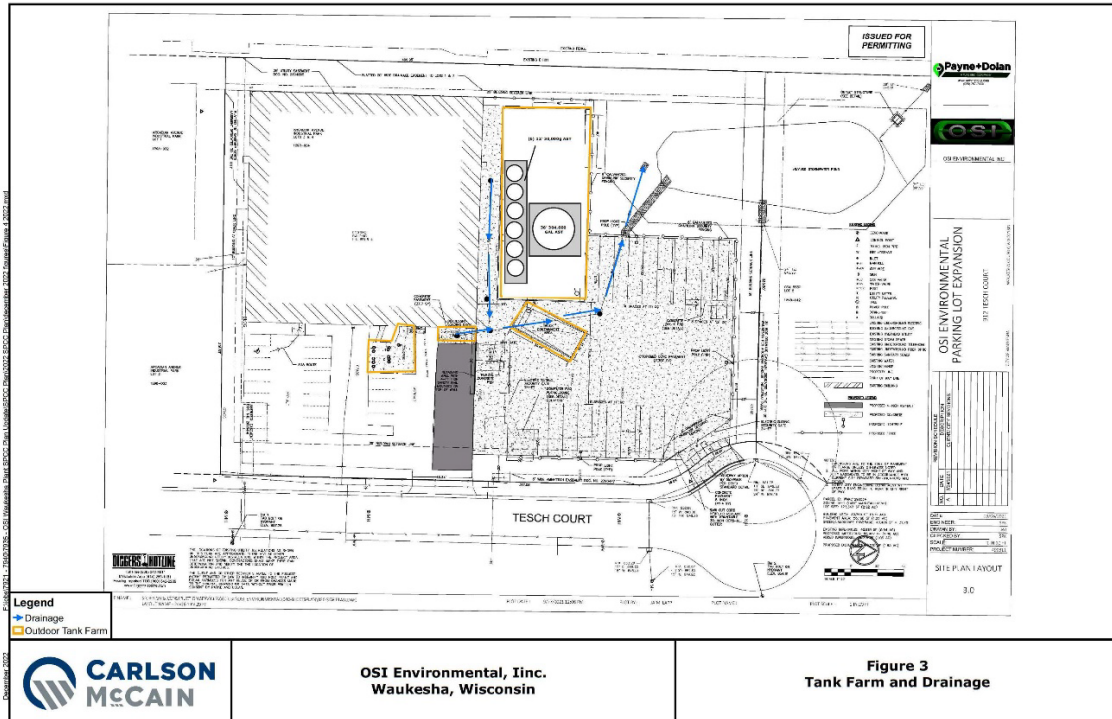
### Appendix C: Drainage Map from page 22 of Stormwater Pollution Prevention Plan dated December 21, 2022

Facility map shows flow from stormwater drains that enters the stormwater pond. This map omits northwestern roof drain which, according to Mr. Rosier, flows to a trench on the western side of warehouse and not to the stormwater pond.
