**UNITED STATES ENVIRONMENTAL PROTECTION AGENCY  
REGION 8  
RESOURCE CONSERVATION AND RECOVERY ACT**

**BASIC INFORMATION**

**Facility Name:** University of Colorado – Boulder **RCRA ID:** COD007431505

**Date of Inspection:** July 9, 2021

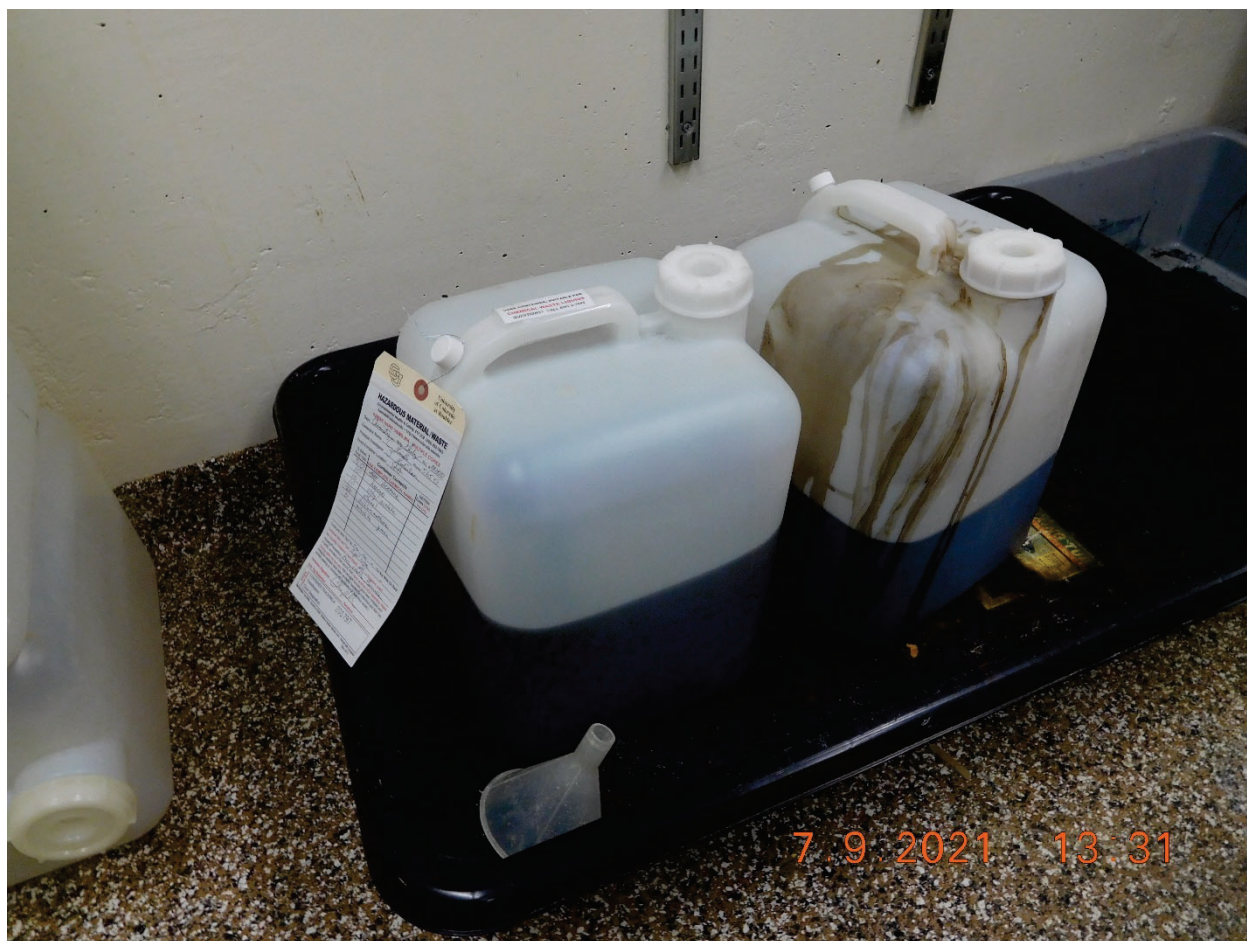
I observed an SAA for mixed solvents with two 5-gallon carboys in one tray for secondary containment (photo 1). One container was closed and labeled with the words “Hazardous Waste,” but was not labeled with an indication of the hazard. The other container was closed, but was not labeled with the words “Hazardous Waste” or an indication of the hazard.

1. In Ekeley Sciences M1B10, a 5-gallon SAA container was not labeled with the words “Hazardous Waste” or an indication of the hazard [6 CCR 1007-3 262.15(a)(5)(i) and 6 CCR 1007-3 262.15(a)(5)(ii)].

Photo 1: SAA in Ekeley Sciences storage room with two 5-gallon containers of solvent mix (DSCN1411.JPG)

- Properly labeling the 5-gallon SAA for mixed solvents in Ekeley Sciences M1B10
- Adding an indication of the hazard to the 90-day acetone containers in Ekeley Sciences M1B10
- Properly labeling the two 55-gallon and two 5-gallon SAAs in Ekeley Sciences M1B65
- Initiating new management practices for the small SAA containers in the hoods in Ekeley Sciences M1B65
- Properly labeling the 5-gallon SAA in Ekeley Sciences S1B25B
- Properly labeling and closing the container, and ordering a new lid for the SAA ceramics glaze container in VAC 156
- Properly labeling the four 30-gallon SAAs outside of VAC 1B60N
- Properly labeling the 5-gallon SAA in the hood in Benson 225A

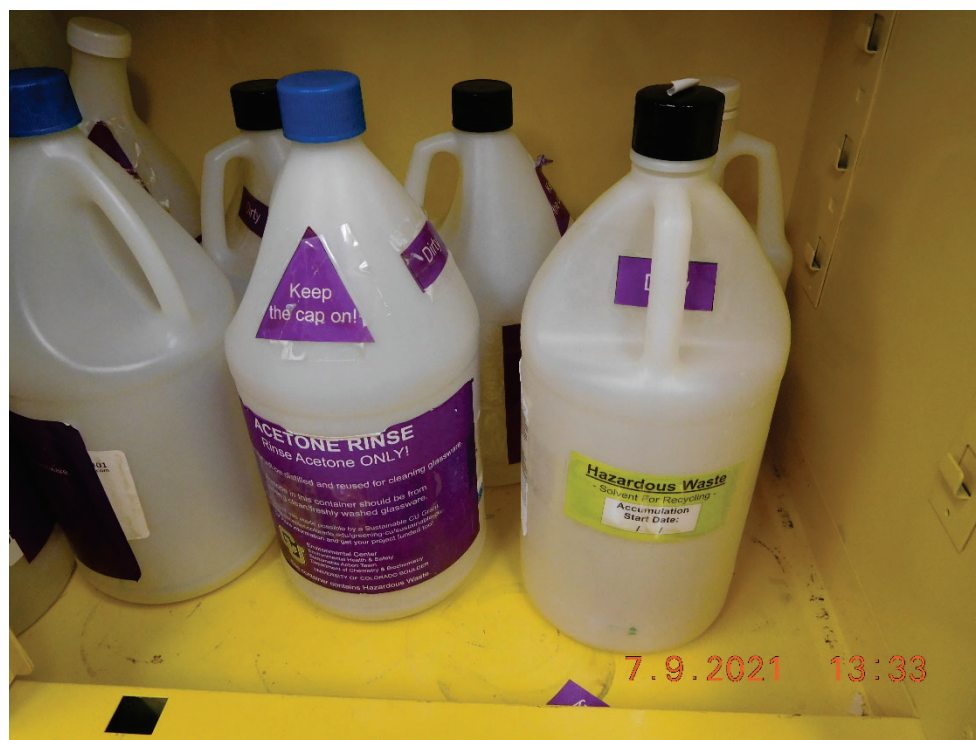
I also observed a small solvent distillation unit used to recover acetone. The unit produces hazardous waste sludge that is cleaned out when serviced. The unit was labeled with a service date of 3/9/21. There was no acetone waste present at the time of the inspection, but I observed containers in a flammable cabinet that had been prepared to hold acetone waste. The containers had been labeled with the words “Hazardous Waste” and a space for an accumulation start date, but there was no indication of the hazard (photo 2).

According to Mr. Browne, the acetone waiting to be processed is considered to be in 90-day storage because the distillation unit is not located at the point of generation, however the flammable cabinet was labeled as a satellite accumulation area (photo 3). I noted that weekly inspections were performed of the 90-day flammable cabinet and the SAA and recorded on a log on the flammable cabinet.

Photo 2: 90-day area for acetone waste in Ekeley Sciences storage room flammable cabinet (DSCN1412.JPG)

- In Ekeley Sciences room M1B10, the 90-day storage area in the flammable cabinet is labeled as a satellite accumulation area.
- In Cristol Chemistry 18, no correction was noted for the two small SAA containers with the tags on the benchtop under the containers.
- The training records were missing dates for contingency plan and emergency procedures on-the-job trainings.
- It is unclear if there is a contingency plan for the LQG areas.

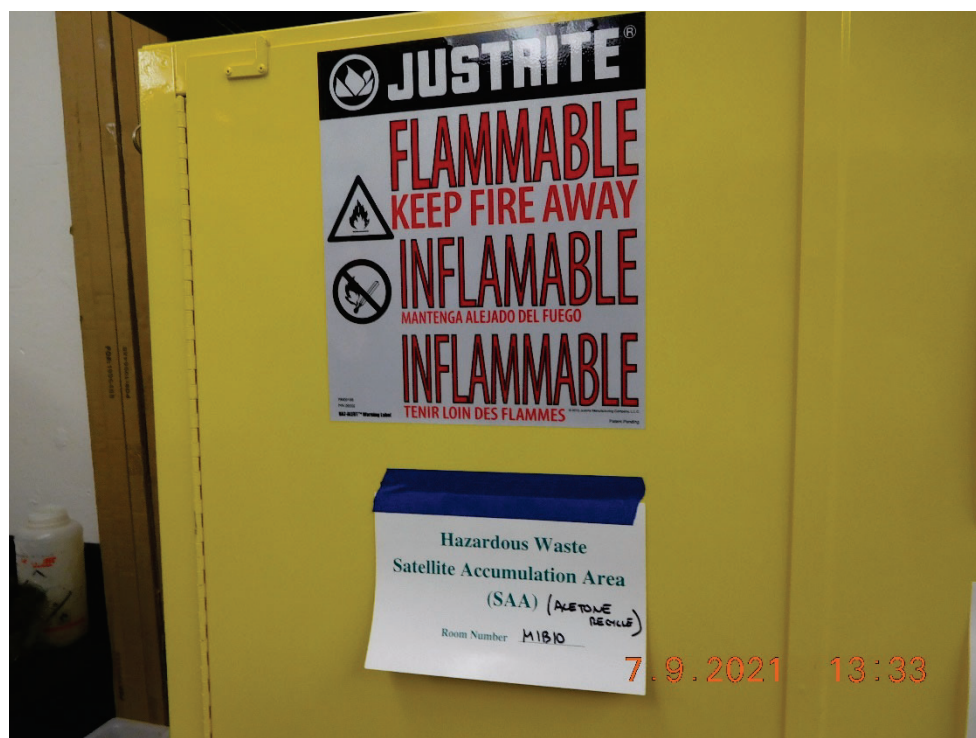
Photo 3: Flammable cabinet for acetone waste in Ekeley Sciences storage room (DSCN1413.JPG)

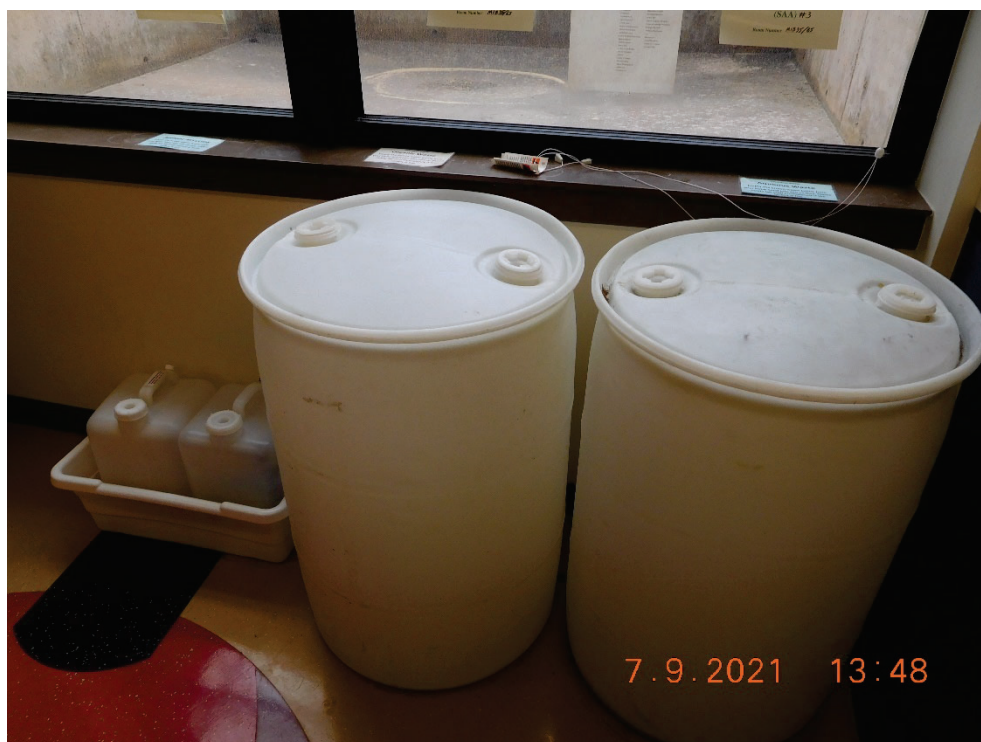
Mr. Wright stated that this was a teaching lab. I observed two 55-gallon and two 5-gallon SAA containers to collect lab waste (photo 5). The containers were closed and there were signs on the windowsills near the containers identifying one 55-gallon container as “hazardous waste – organic waste,” the other 55-gallon container as “hazardous waste – aqueous waste,” and the two 5-gallon containers as “hazardous waste – acetone recycling.” However, the two 55-gallon and two 5-gallon SAA containers themselves were not labeled with the words “Hazardous Waste” or an indication of the hazard (photos 6 and 7).

2. In Ekeley Sciences M1B65, two 55-gallon and two 5-gallon SAA containers were not labeled with the words “Hazardous Waste” or an indication of the hazard [6 CCR 1007-3 262.15(a)(5)(i) and 6 CCR 1007-3 262.15(a)(5)(ii)].

Photo 5: SAA in Ekeley Sciences room M1B10 with two 55-gallon containers and two 5-gallon containers of solvent waste. Containers are not labeled as hazardous waste; labels are on the signs on the windowsill. (DSCN1415.JPG)

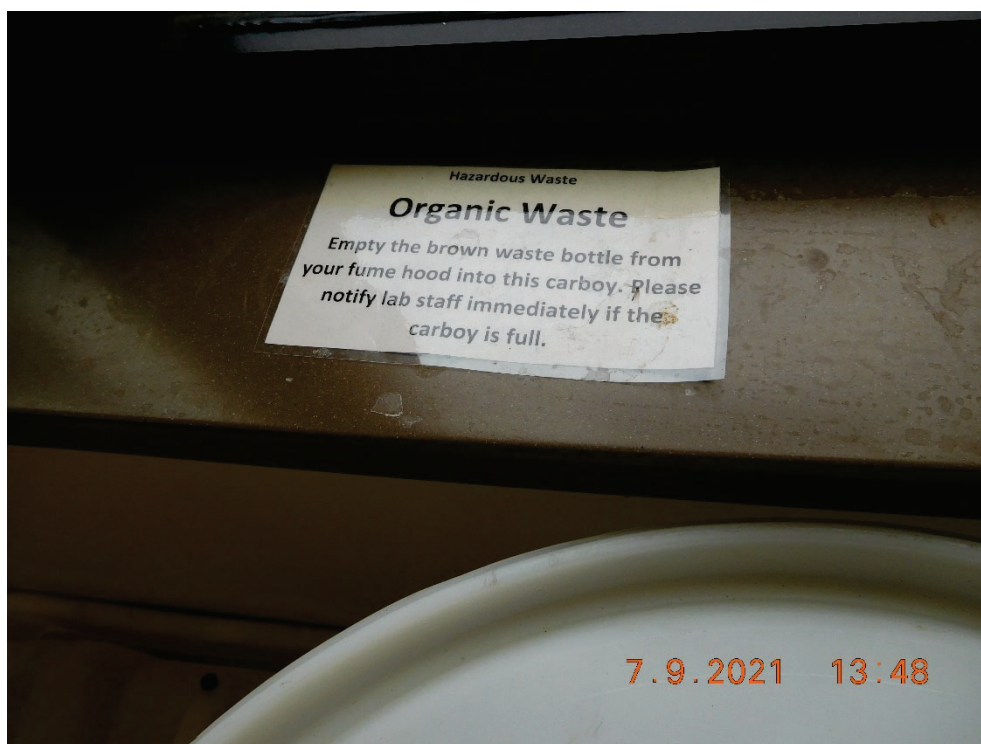
Photo 6: Sign for one of the 55-gallon SAA containers in Ekeley Sciences room M1B10 (DSCN1416.JPG)

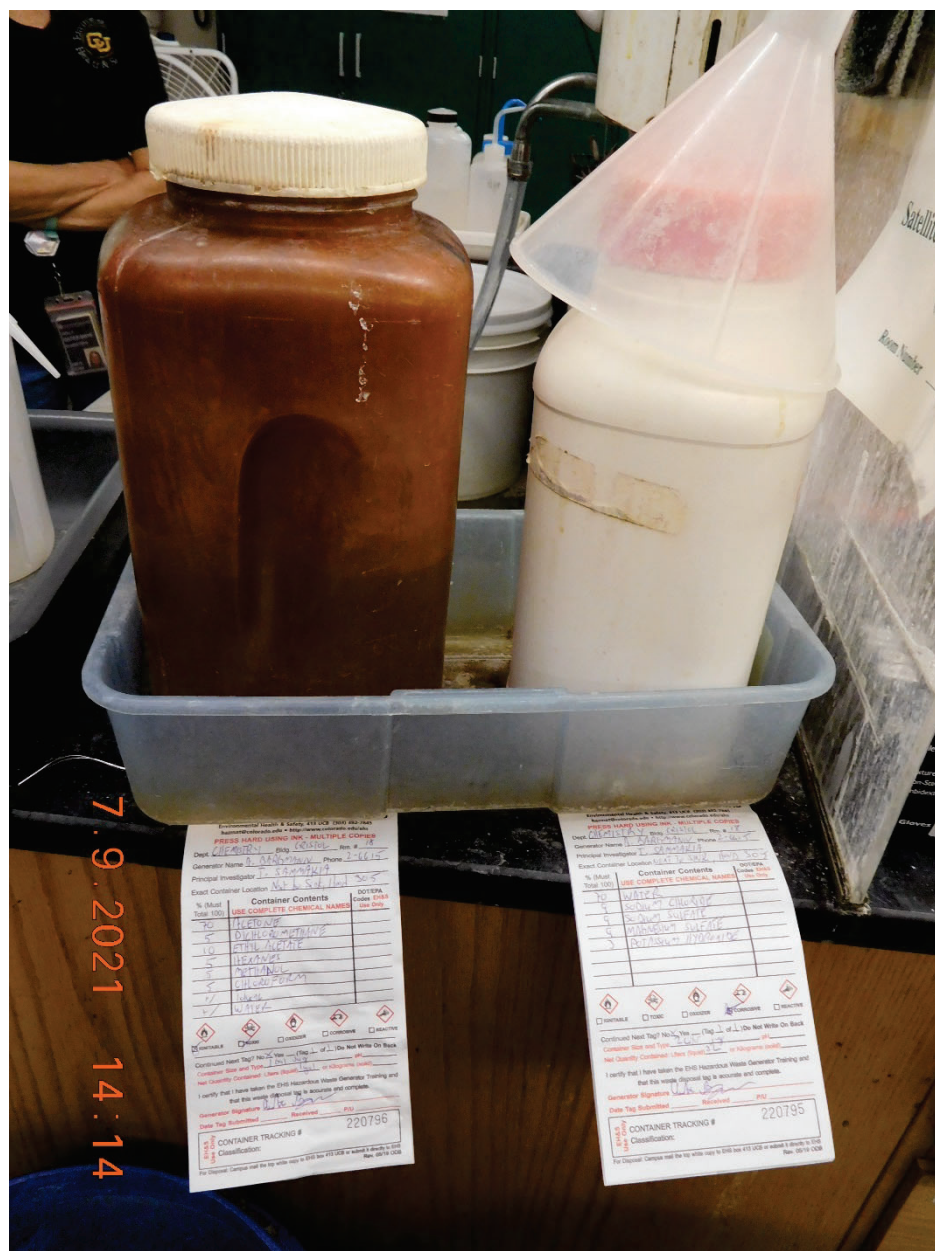
I observed an SAA designated as “bench top SAA” next to the sink near hood 305 with two small containers. One was labeled as containing acetone, dichloromethane, ethyl acetate, hexanes, methanol, chloroform, toluene, and water, and the other was labeled as containing water, sodium chloride, sodium sulfate, magnesium sulfate, and potassium hydroxide. The containers were closed, but the hazardous waste tags, containing the words “Hazardous Waste” and an indication of the hazards, were on the benchtop under the containers and were not attached to the containers (photo 9). The two SAA containers were not labeled with the words “Hazardous Waste” or an indication of the hazards.

Photo 9: Unlabeled SAA containers with unattached hazardous waste tags in Cristol Chemistry room 18 (DSCN1419.JPG)

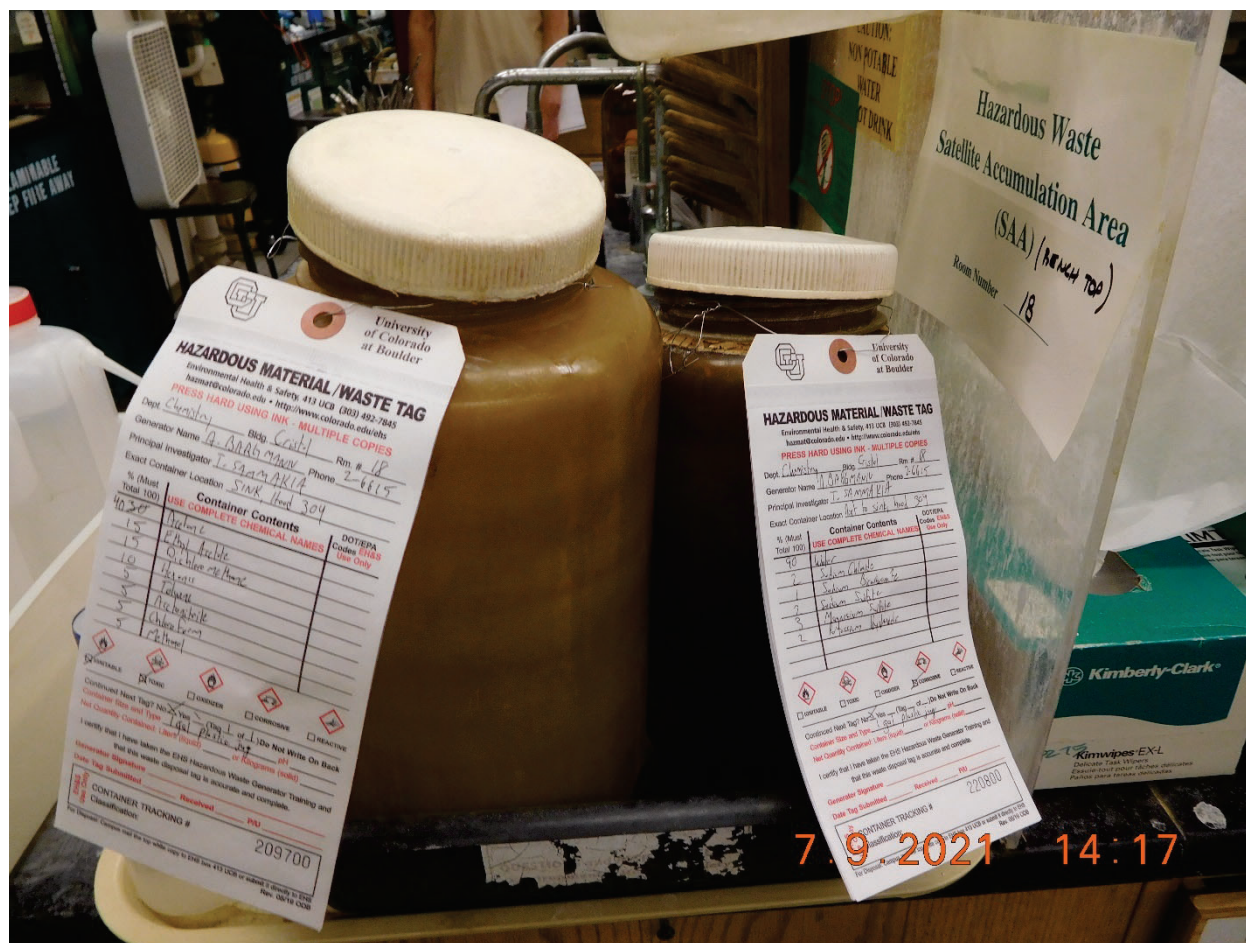
Photo 10: Open SAA containers being vented in Cristol Chemistry room 18 (DSCN1420.JPG)

as a temporary measure, and that the container is fully sealed once the off gassing stops and the hazard subsides. Return inspections by EH&S to the lab confirmed that the container is fully sealed.

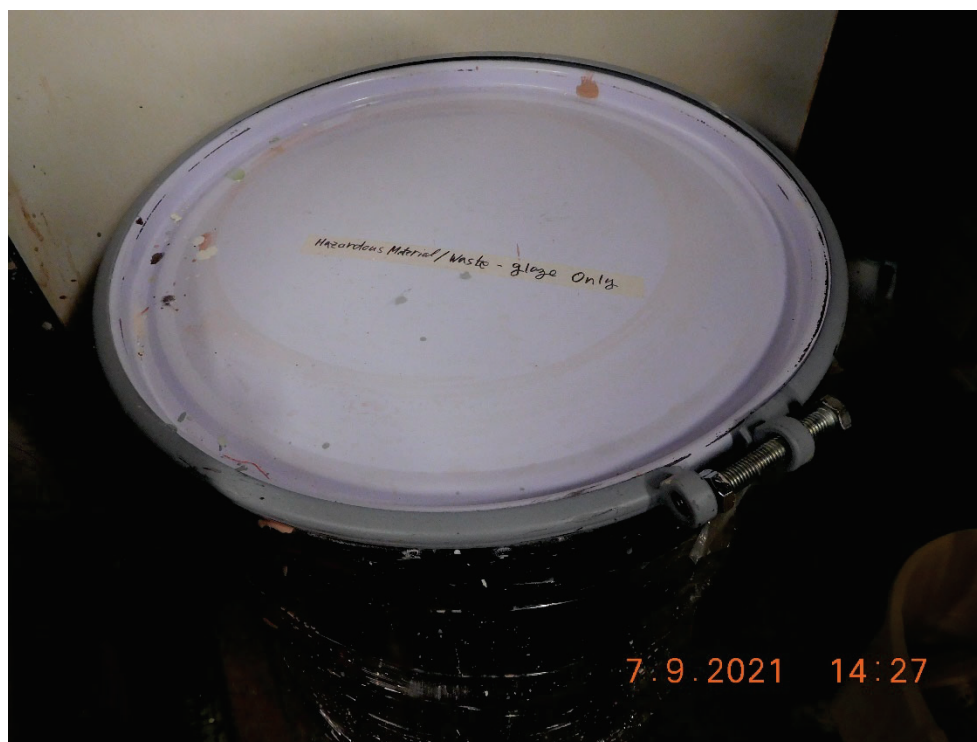
I observed a 55-gallon SAA container for hazardous waste ceramics glaze containing heavy metals that was labeled with the words “Hazardous Waste” but was not labeled with an indication of the hazard and was not closed (photo 12). At the time of the inspection, waste was not being added, removed or consolidated.

6. In VAC 156, a 55-gallon SAA was not closed [6 CCR 1007-3 262.15(a)(4)] and was not labeled with the words “Hazardous Waste” [6 CCR 1007-3 262.15(a)(5)(i)].

Photo 12: Open SAA container for ceramics glaze in Visual Arts Complex room 156 (DSCN1422.JPG)

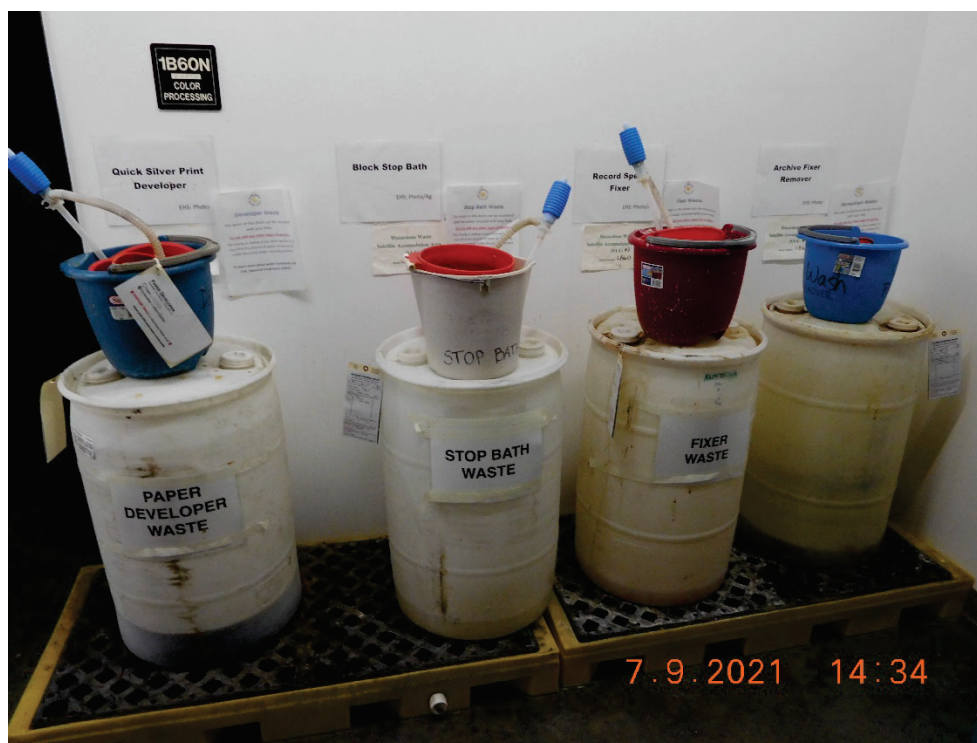
I observed an SAA that contained four 30-gallon poly containers to collect hazardous waste from the photo development process. These containers were labeled as “paper developer waste,” “stop bath waste,” “fixer waste,” and “archive fixer remover.” These four containers were closed and labeled with hazardous waste tags that contained the words “Hazardous Waste,” but were not labeled with an indication of the hazards (photo 13).

7. Outside of VAC 1B60N, four 30-gallon SAA containers were not labeled with an indication of the hazard [6 CCR 1007-3 262.15(a)(5)(ii)].
8. In Benson Earth Sciences 225A, one 5-gallon container was not closed [6 CCR 1007-3 262.15(a)(4)].
9. The training records were missing dates for contingency plan and emergency procedures on-the-job trainings, as required by the CU Boulder State RCRA Permit Section II.F.3, which refers to Permit Attachment 5, Table 1, number 5.

Photo 13: SAA containers for waste related to the photo development process in Visual Arts Complex outside of room 1B60N (DSCN1423.JPG)

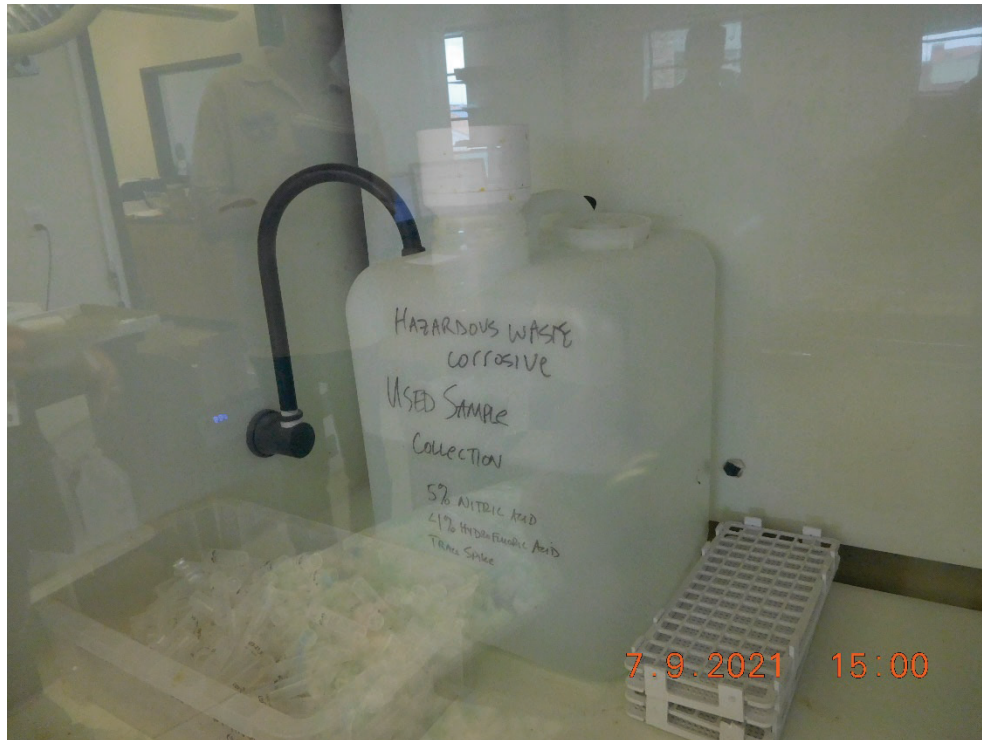
I observed a 5-gallon container in the hood for used sample collection waste containing 5% nitric acid and <1% hydrofluoric acid. The container was labeled with the words “Hazardous Waste” and an indication of the hazard (corrosive). It had an open white funnel in the hole with the cap sitting on top of the container, so was not closed (photo 14). At the time of the inspection, waste was not being added, removed, or consolidated.

Photo 14: Open SAA in hood in Benson room 225A (DSCN1424.JPG)

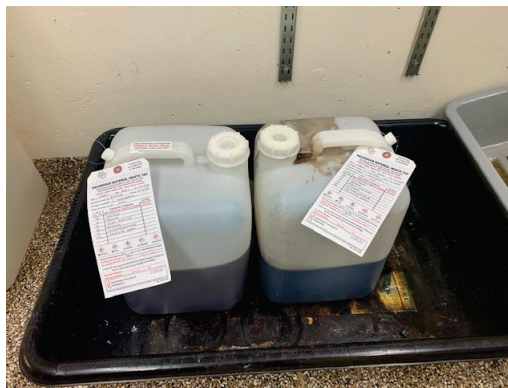
- a. Observed: Two carboys of presumed hazardous waste did not have full correct labeling to meet all hazardous waste requirements.
  - i. Response: The contents of the carboys were identified and confirmed to be waste. They were fully labeled with our hazardous waste disposal tags to meet all hazardous waste regulations.

*M1B10: Carboys fully identified and tagged*

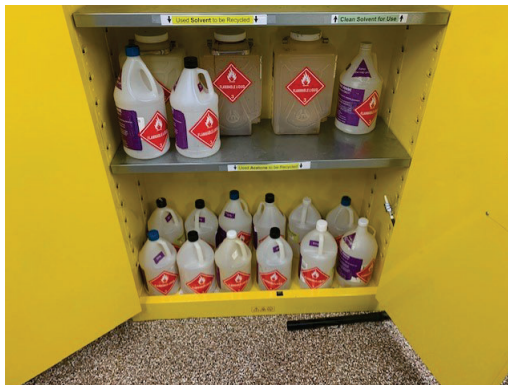
- b. Observed: In the 90-day storage area within the room, there are collection bottles that are pre-labeled and get used for storage of waste solvent to be recycled in our distillation unit. These bottles were all empty during the inspection, however they were lacking the required designation of its waste characteristic for when they will contain solvent waste.
- i. Response: All 90-day reuse bottles were applied with a “flammable” label, in order to ensure they meet labeling requirements when they eventually hold hazardous waste.

*M1B10: 90-Day storage area reuse solvent waste bottles with new characteristic labels*

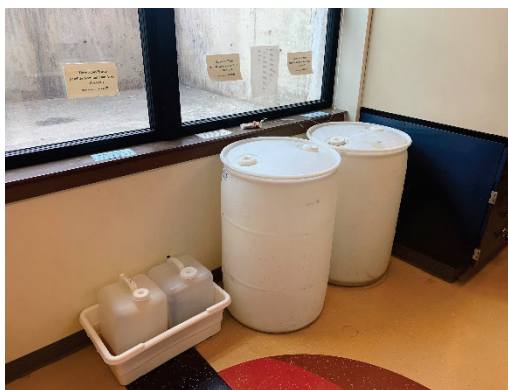
- a. Observed: Two 55-gal drums and two 5-gal carboys had their labeling and list of contents posted on the wall adjacent to the containers, instead of on the containers themselves. They were also lacking their labeling of hazard characteristic.

*EKLC M1B65: Drum and carboy SAAs pre-tagging.*

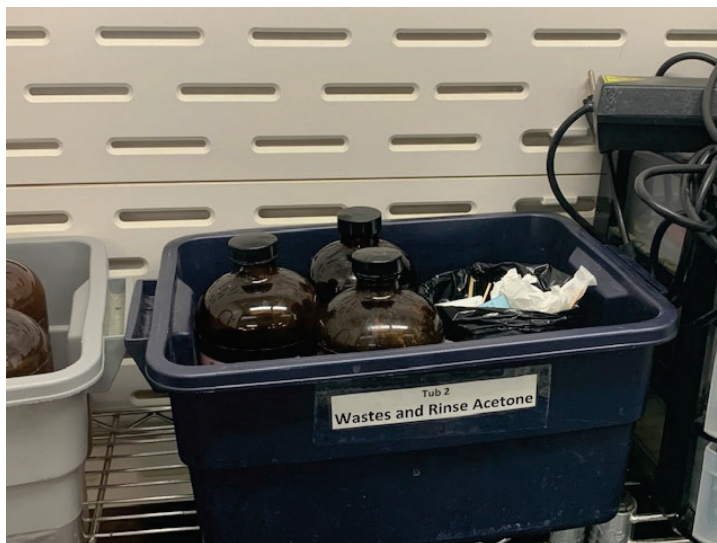
- b. Observed: Within the teaching lab fume hoods of this room, there are smaller 1-liter bottles that are filled during a class day, and should then be emptied into the main drums/carboys by the end of the day. It was observed that these waste bottles still contained some hazardous waste, most likely abandoned due to the pandemic ceasing in-person classes last year.

*EKLC M1B65: Teaching Lab hoods with leftover waste*

- i. Response: All waste containers throughout these teaching hoods have been emptied into their respective waste consolidation SAAs, and no waste remains in the hoods. To ensure this does not happen again, we are working with the teaching lab supervisor and are currently investigating new methods to ensure these containers are emptied into the SAA drums and carboys at the end of each work shift for the coming fall semester of in-person classes.”

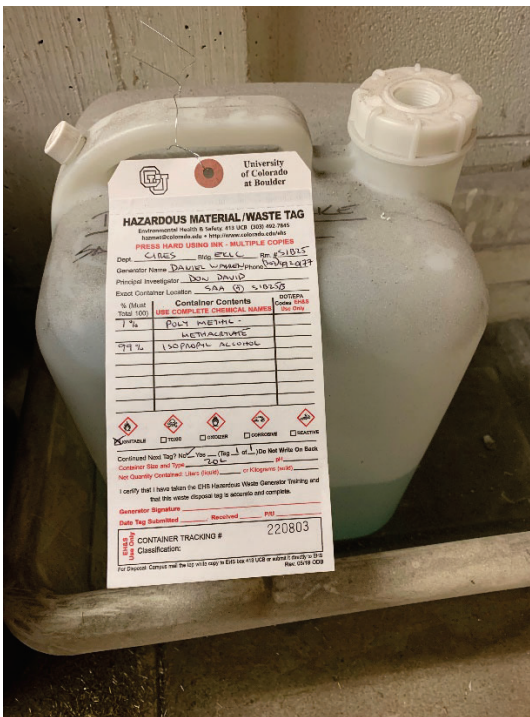
- a. Observed: There was a hazardous waste carboy observed in this SAA that was missing the labeling of its hazard characteristic.
  - i. Response: The carboy received a new tag and had its hazard characteristic labeled.

*EKLC S1B25B: Carboy with hazard characteristic marked on tag*

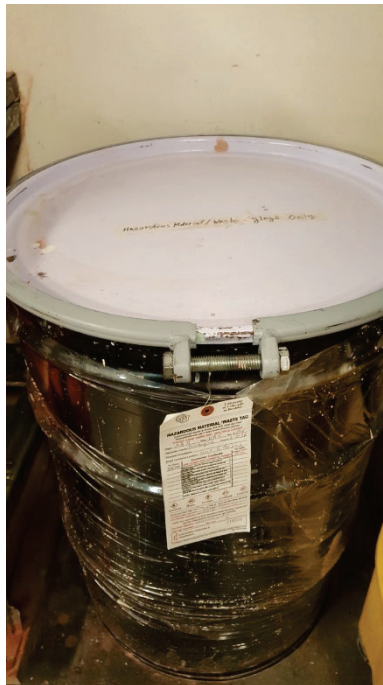
- a. Observed: There was a 55-gal drum of ceramic glaze hazardous waste in this SAA that was missing a detailed labeling of its contents, as well as its hazard characteristic. In addition, even though the drum did have its lid placed on top, it was not fully tightened down to completely seal it.
  - i. Response: The drum received a hazardous waste tag that completely lists its contents as well as its hazard characteristic. The drum also had its bolt-lock rim fully tightened to seal it.

We contacted the lab manager, and they expressed that this style of bolt locking mechanism is extremely difficult for them to do. This leads them to not fully tighten the rim every time they add to the drum like they should. EH&S is planning to purchase a lever-lock ring for the drum in this space, which is much easier to close and will help ensure the drum is fully sealed in the future.

*VAC 156: Drum with labeling tag attached and drum lid fully sealed.*

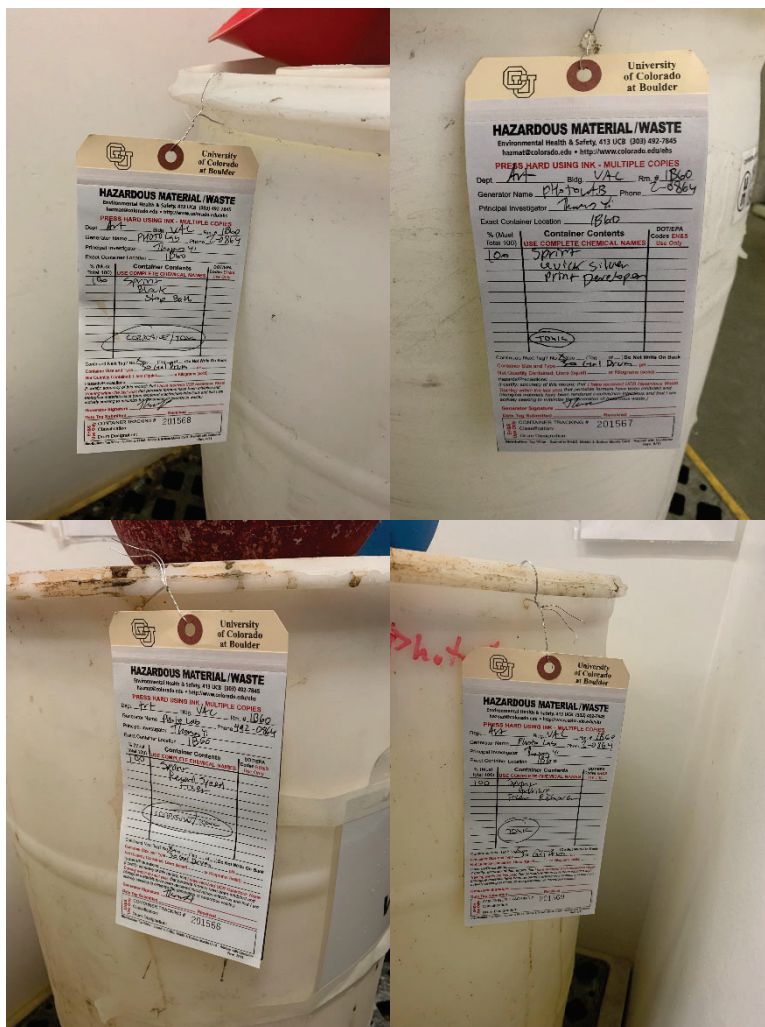
- a. Observed: There was a line of four 30-gal drums that were missing the labeling of its hazard characteristic.
- i. Response: All of the drums had its hazard characteristic clearly added to its labeling tag.

VAC 1B60: Drum tags with hazard characteristic marked.

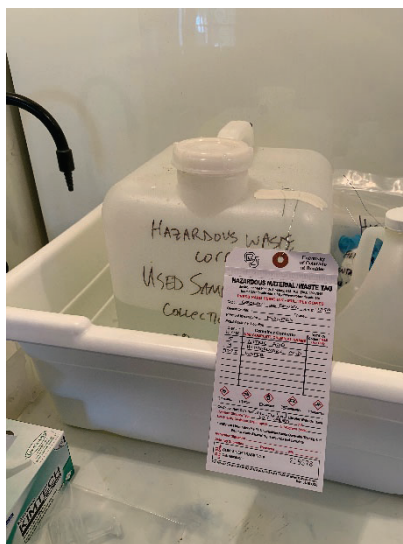
- b. Observed: There was a carboy of hazardous waste in the fume hood that was left open with a funnel placed in it.
- ii. Response: The carboy has had its funnel removed, and the carboy was sealed. We also attached a new hazardous waste tag to keep the

container labeling clearer. We spoke with lab members to remind them it must be closed when not actively being added to.

*BESC 225A: Carboy with funnel removed, lid sealed, and a new clear hazardous waste tag attached.*
