**U.S. ENVIRONMENTAL PROTECTION AGENCY  
REGION 5**

**Purpose:** Pretreatment and Industrial Storm Water Compliance Evaluation Inspection

**Facility:** Metalex North  
700 Liberty Drive  
Libertyville, IL 60048

**Date of Inspection:** December 14, 2022

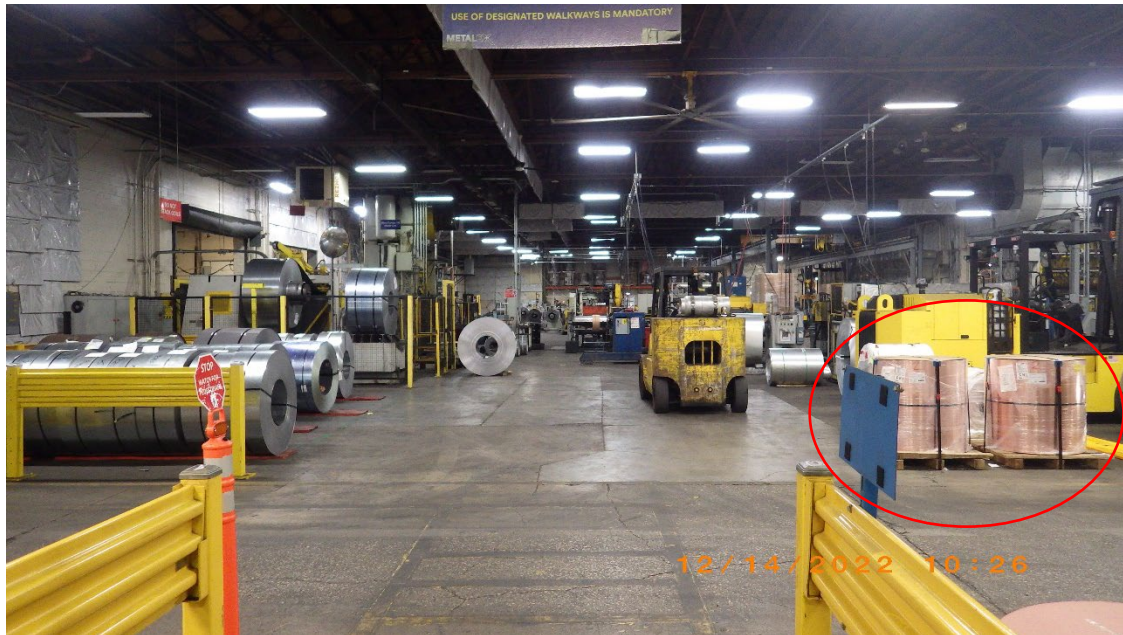
1: RIMG0105

Description: Overview of Stamping Department. Note copper spools of raw material in red circle.

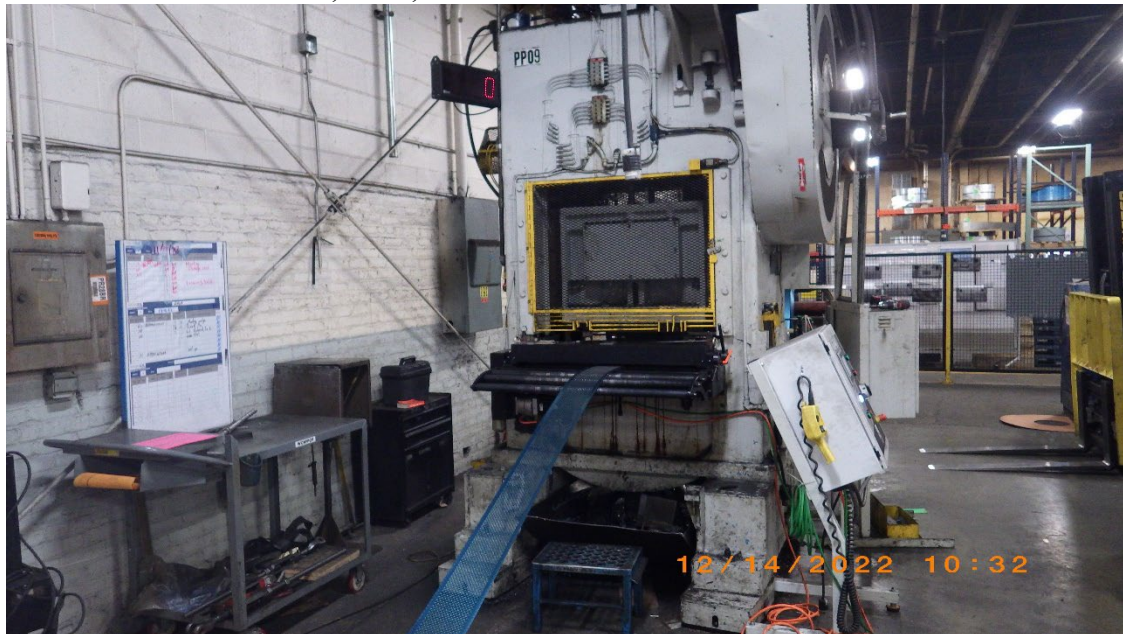
2: RIMG0106

Description: Perforation machine. Blue material in foreground is exiting the machine and is coated in vanishing oil.

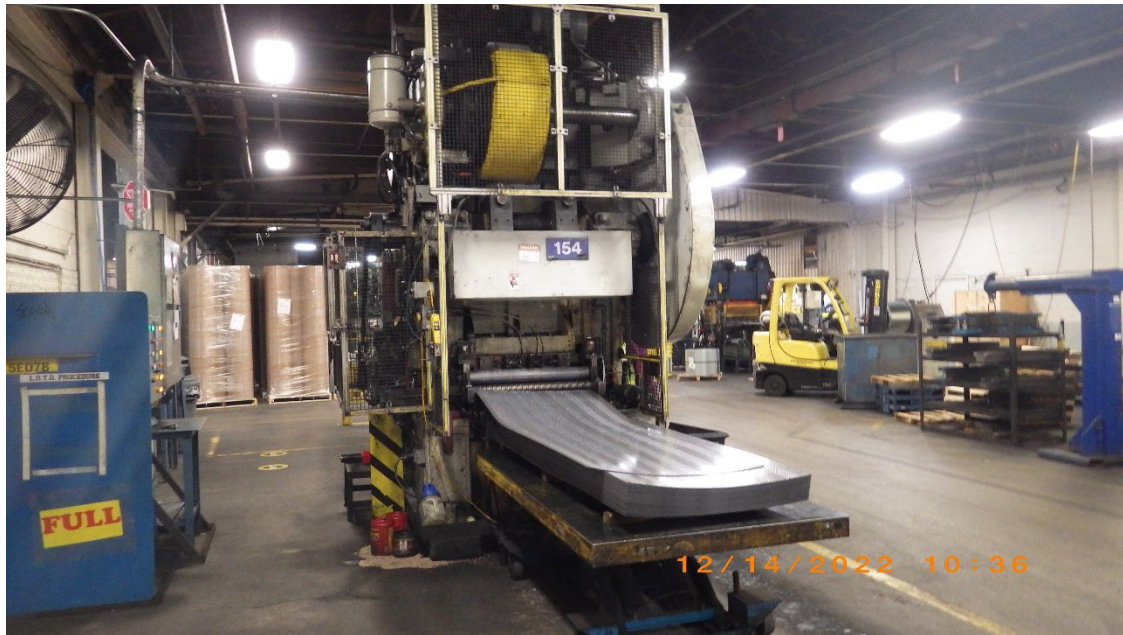
3: RIMG0107

Description: Stamping machine. Material in foreground is exiting the machine and is coated in vanishing oil.

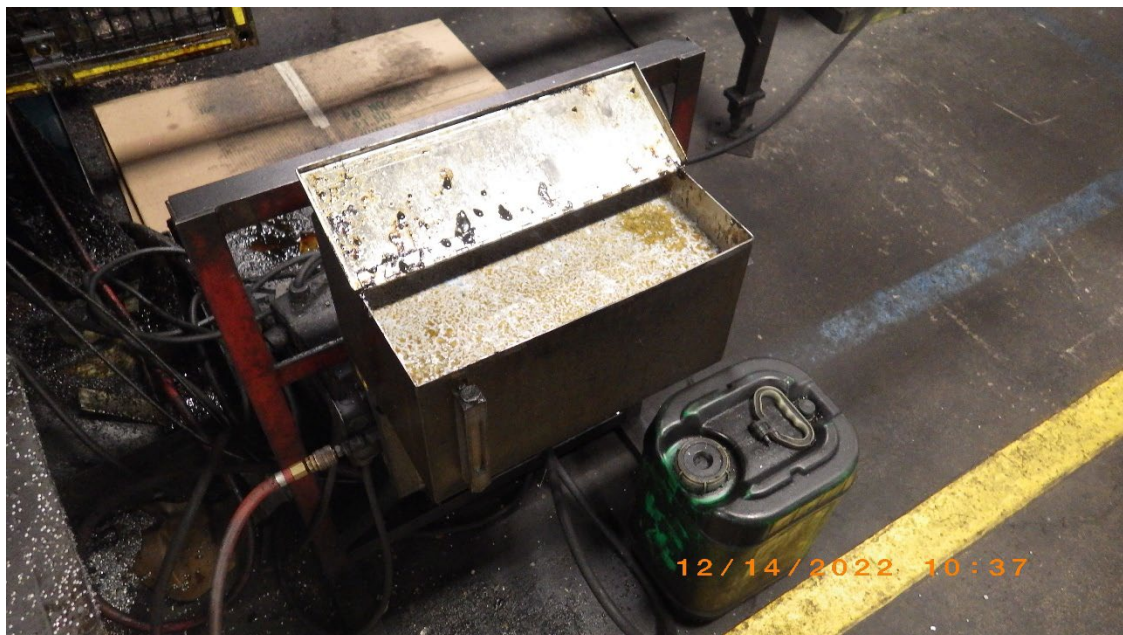
4: RIMG0108

Description: Vanishing oil reservoir for machine 154. Note container of additional vanishing oil on ground.

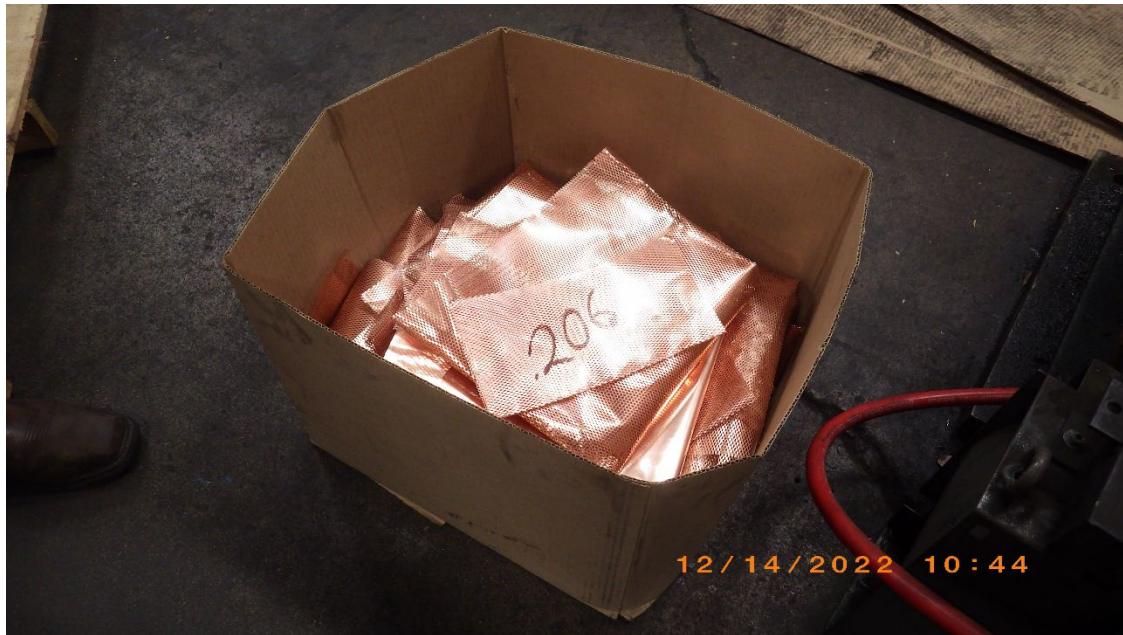
5: RIMG0109

Description: Box of engineered scrap copper.

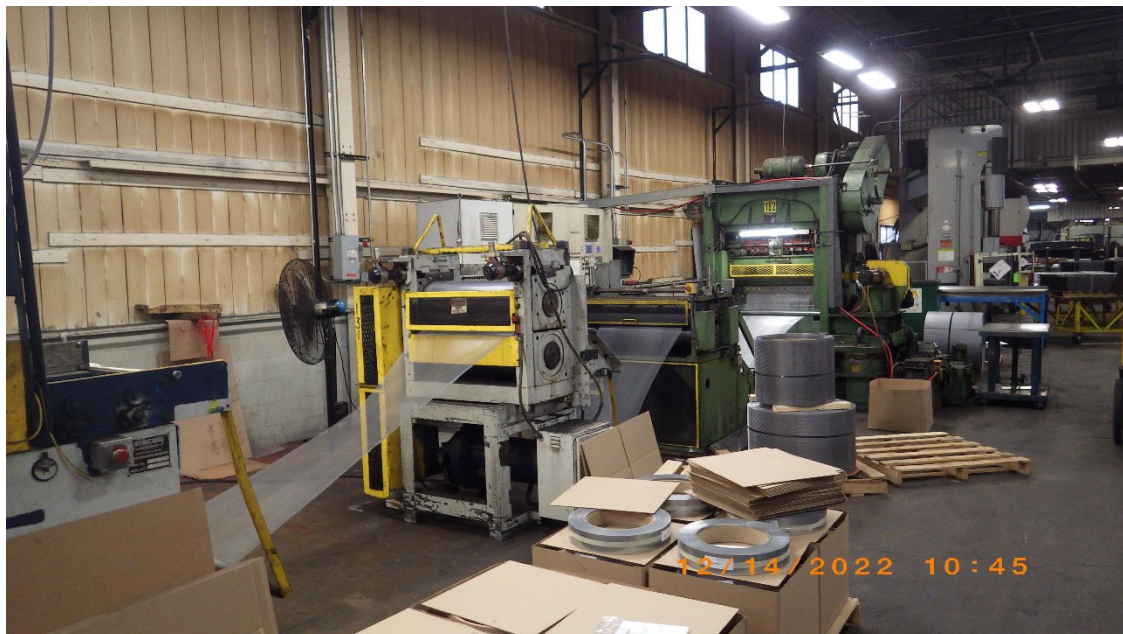
6: RIMG0110

Description: Expanded metal machine, producing a micromesh product. Material in foreground is exiting the machine and is coated in vanishing oil.

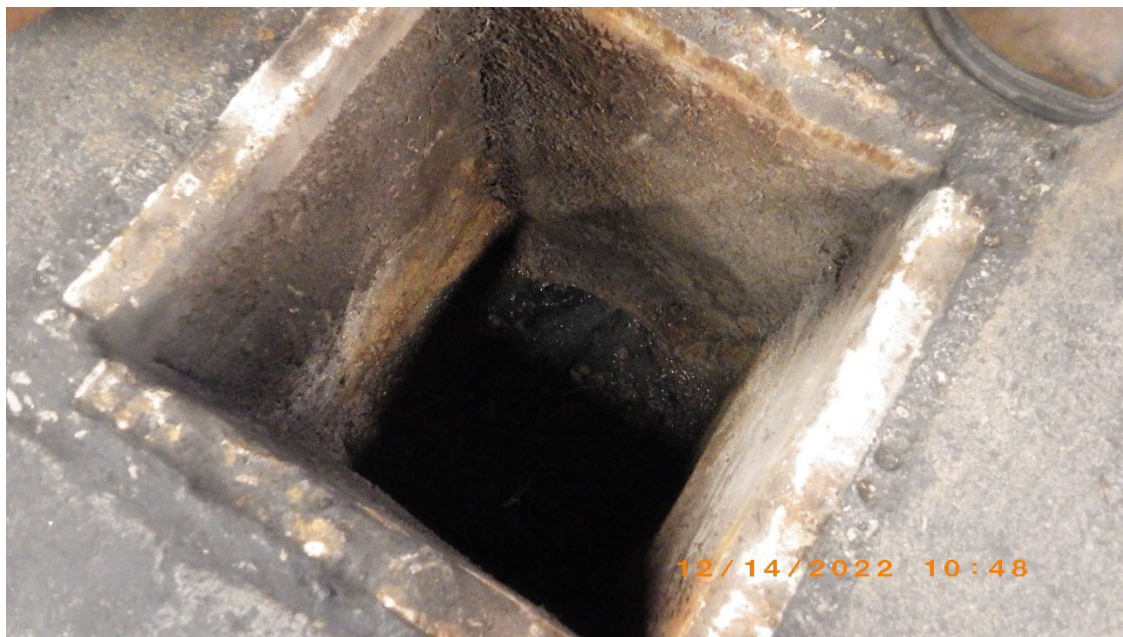
7: RIMG0111

Description: Sewer clean out with cap removed. Flash off. Depth is approximately 2 feet.

Location: Adjacent to Machine 182. Noted presence of oil and grease.

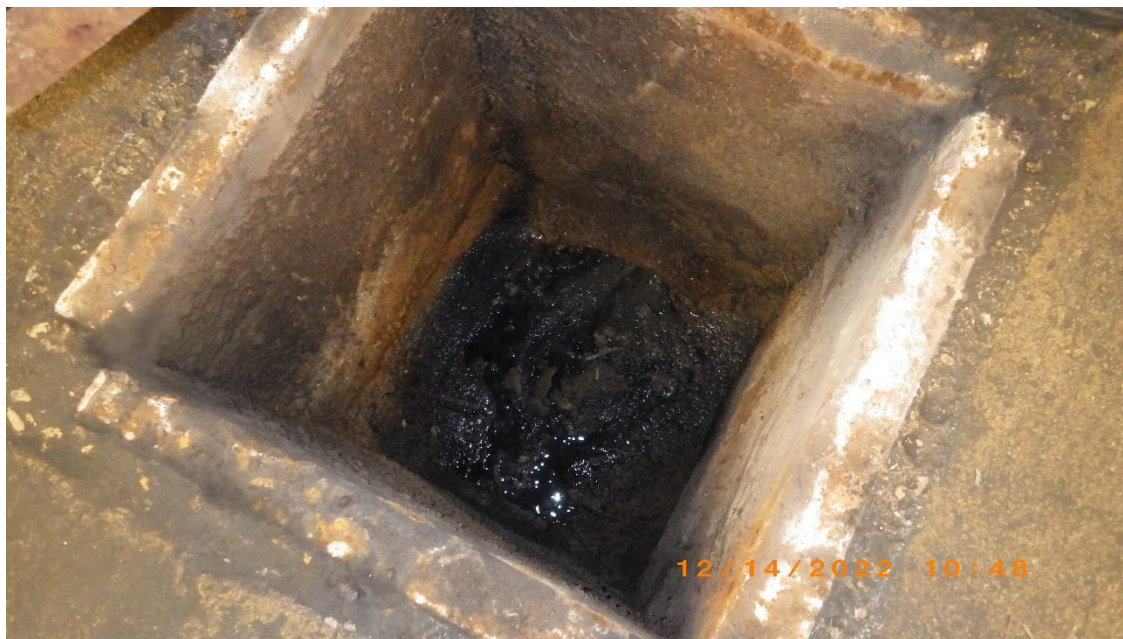
8: RIMG0112

Description: Additional photo of sewer clean out depicted in Photo 7 with cap removed. Flash on. Depth is approximately 2 feet. Note presense of oil and grease.

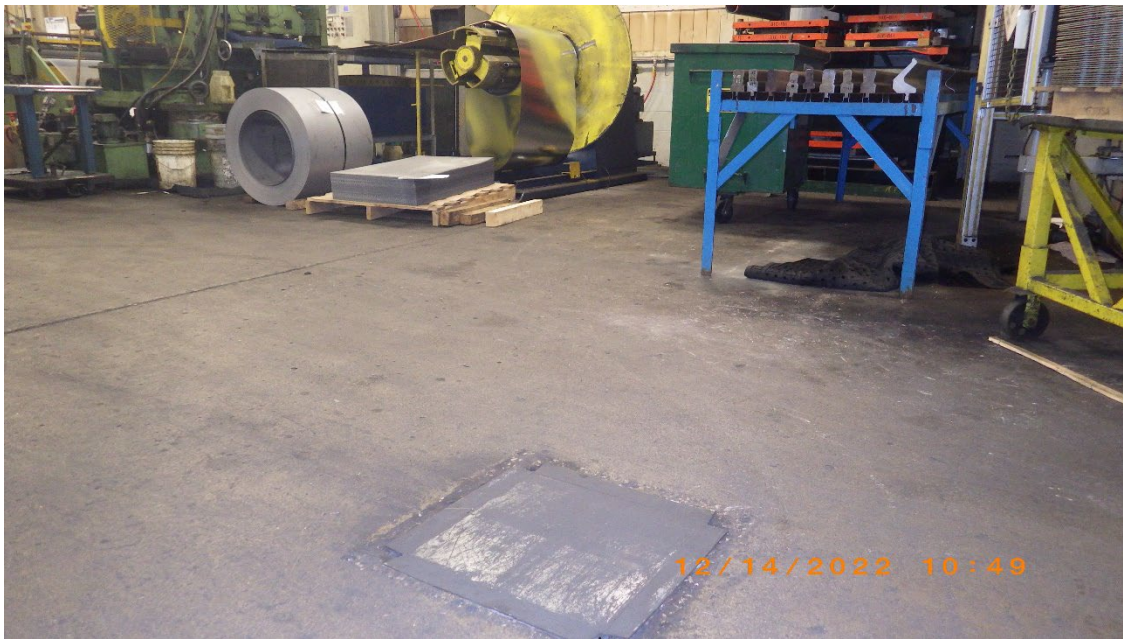
9: RIMG0113

Description: Overview of sewer clean out depicted in Photo 7 and 8 with cap installed.

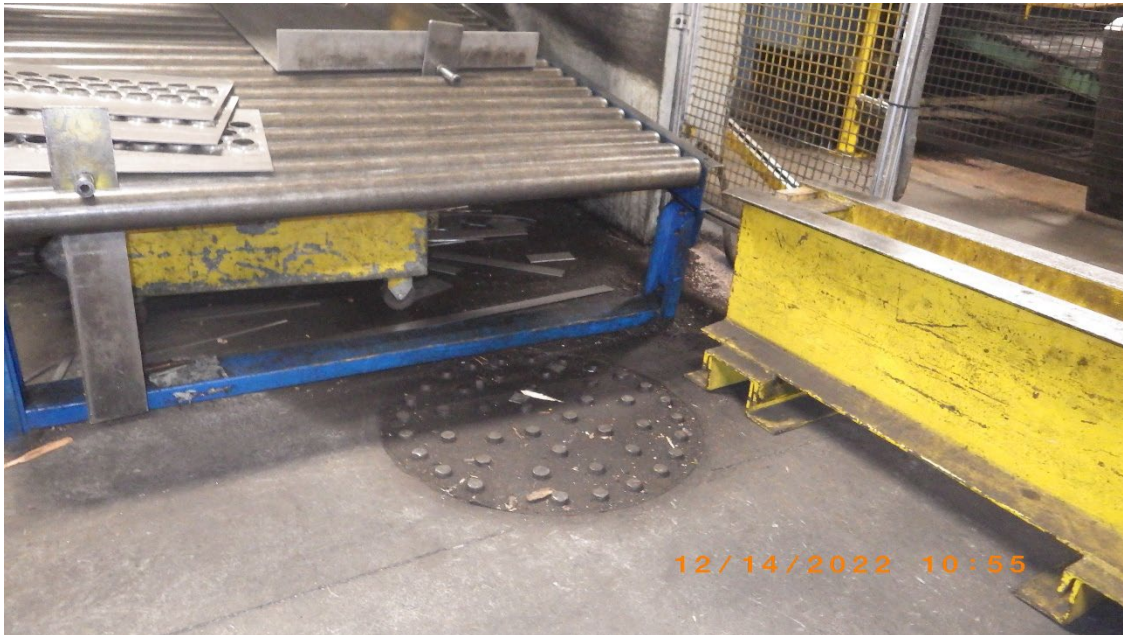
10: RIMG0114

Description: Manhole within production area. Manhole could not be opened due to equipment location.

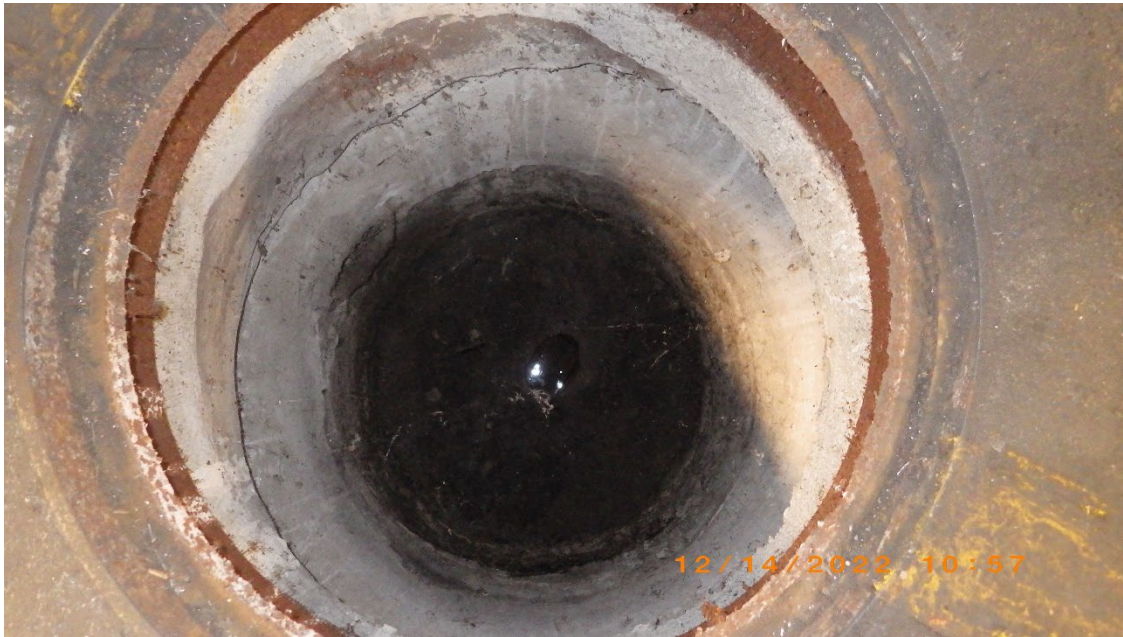
11: RIMG0115

Description: Opened manhole which was labeled "Sanitary Sewer". Depth was approximately 4 feet. Note presence of water in trough.

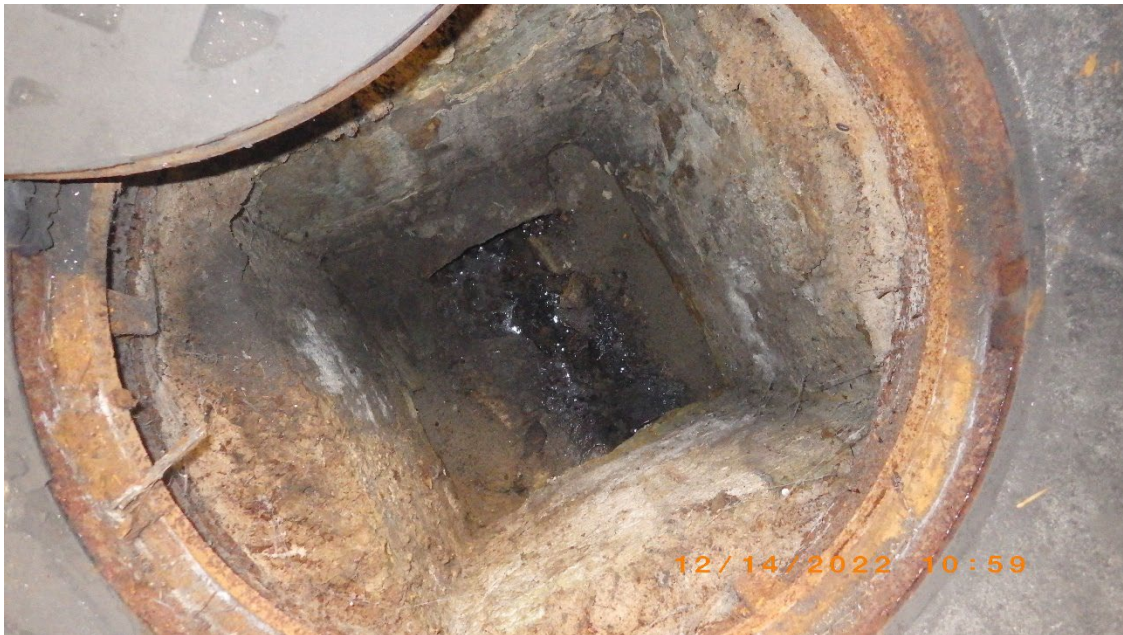
12: RIMG0116

Description: Opened manhole which was labeled "Sanitary Sewer." Depth was approximately 4 feet. Note presence of water in trough.

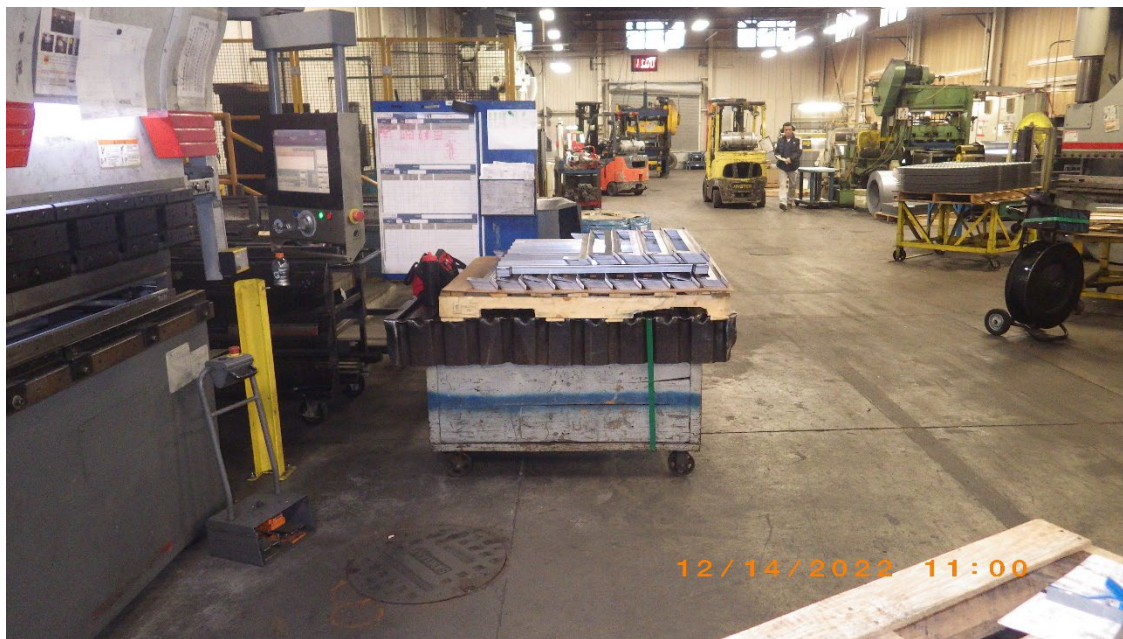
13: RIMG0117

Description: Overview of manhole which was labeled “Sanitary Sewer.”

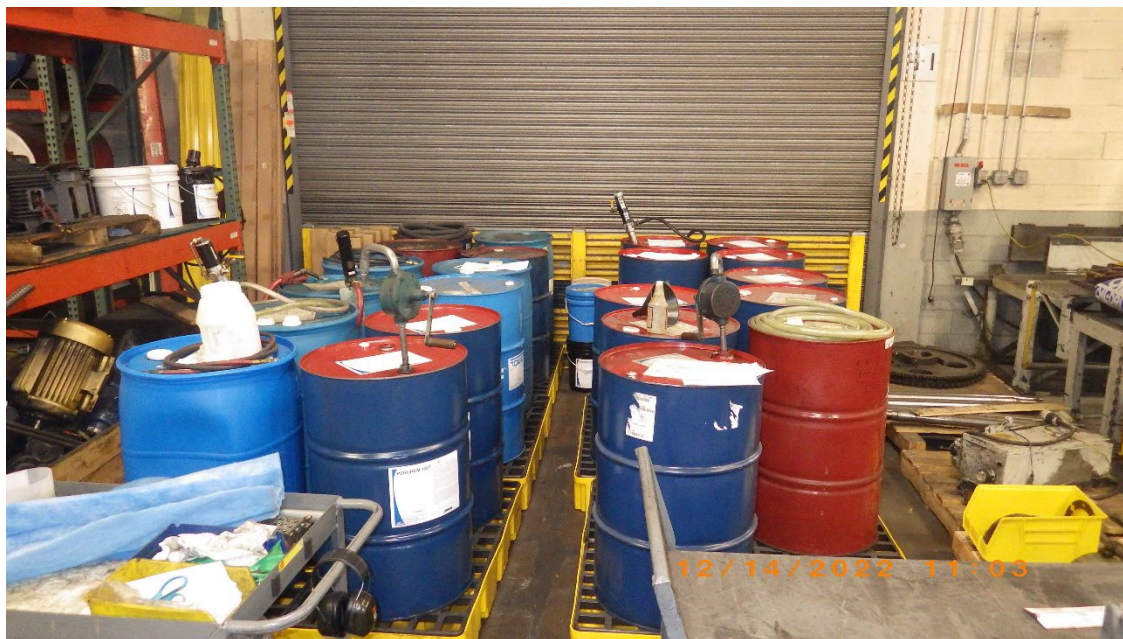
14: RIMG0118

Description: Overview of new oil storage 55 gal tanks with secondary containers.

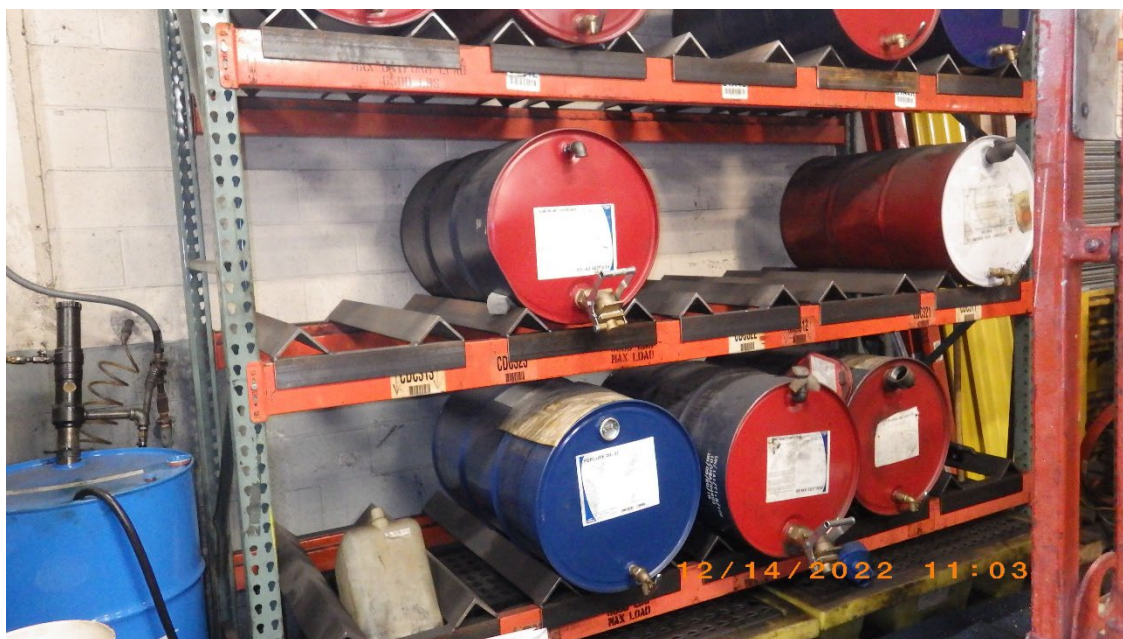
15: RIMG0119

Description: Overview of new oil storage of 55 gal tanks.

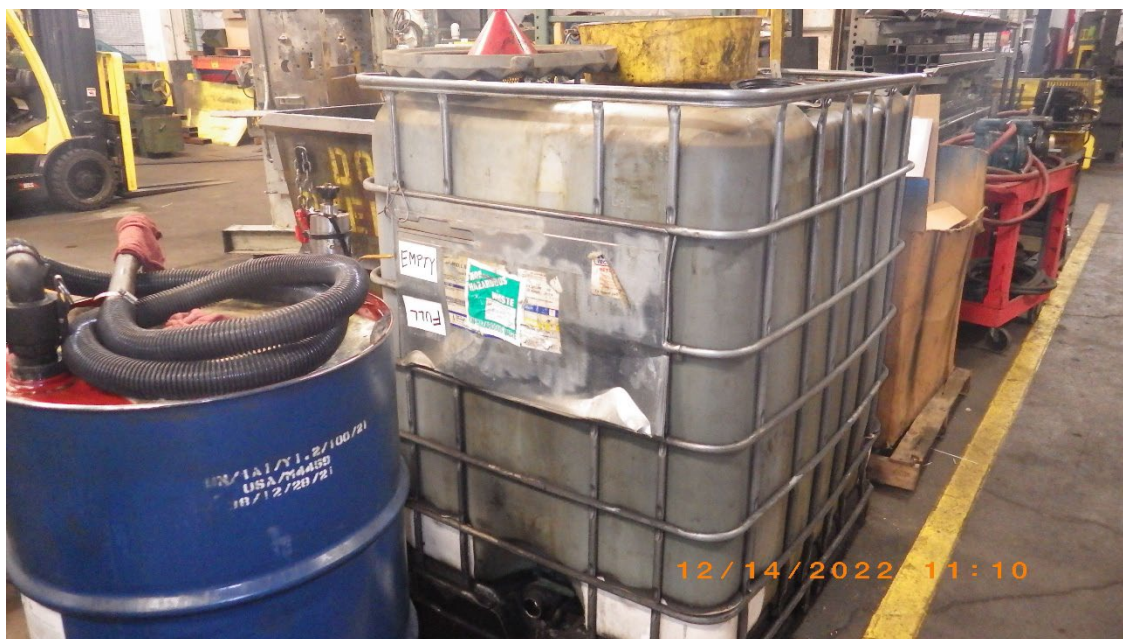
16: RIMG0120

Description: Tote full of used oil.

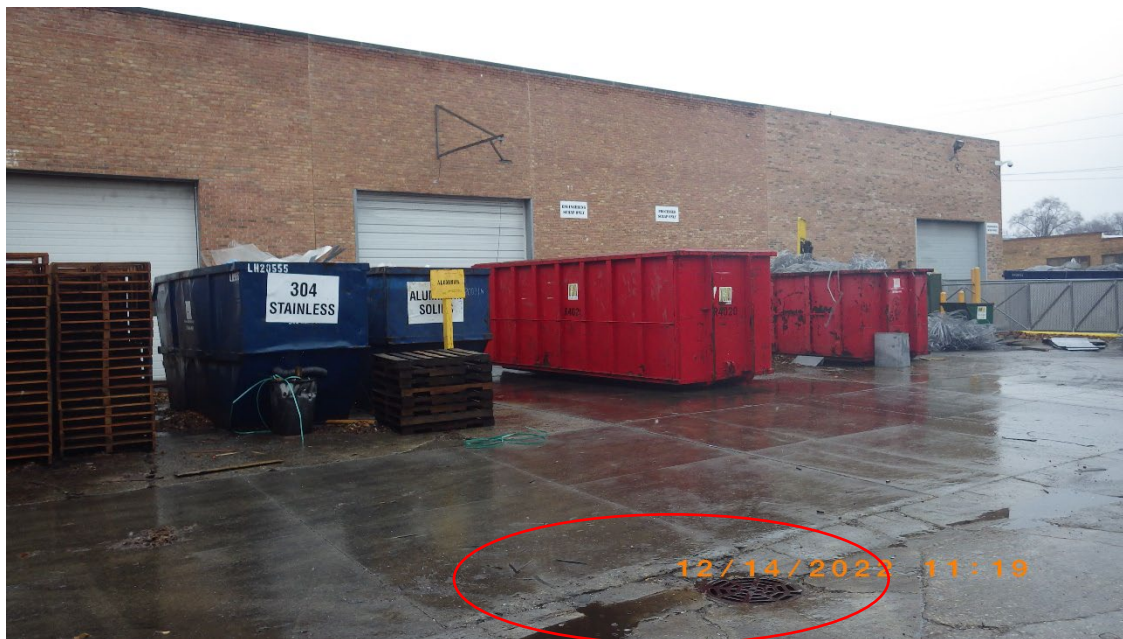
17: RIMG0121

EPA observed open dumpsters with scrap metal (waste materials associated with industrial activity), scrap metal on the ground exposed to stormwater, and flow of discolored storm water entering the storm drain (Photos #17 and #18).

Description: Overview of dumpsters used for engineered scrap metal storage. Note active rain during inspection and the flow of discolored storm water entering the storm drain in the red circle.

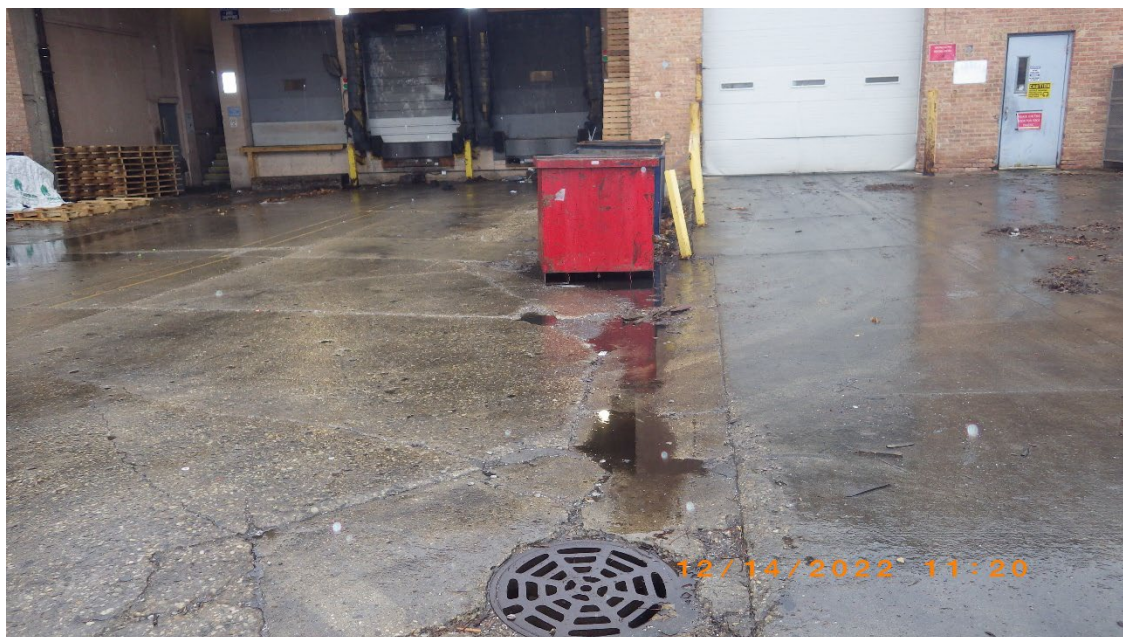
18: RIMG0122

Description: Discolored storm water entering storm drain adjacent to engineered scrap metal storage. Same storm drain depicted in Photo 17.
