**Well Inspection**  
**Osage DNR / Environmental Protection Agency**  
**1201 Elm Street, Suite 500**  
**Dallas, Texas 75270**

| <b>Operator Info</b> | McCann Resources, Inc<br>1613 West 6th Street<br>Bartlesville, OK 740033404<br>Phone: 918-337-4747 | <b>Inventory ID</b> | OS2221000 | | |
| | | <b>Lease Name</b> | Parker | | |
| | | <b>Well ID</b> | W-88 | | |

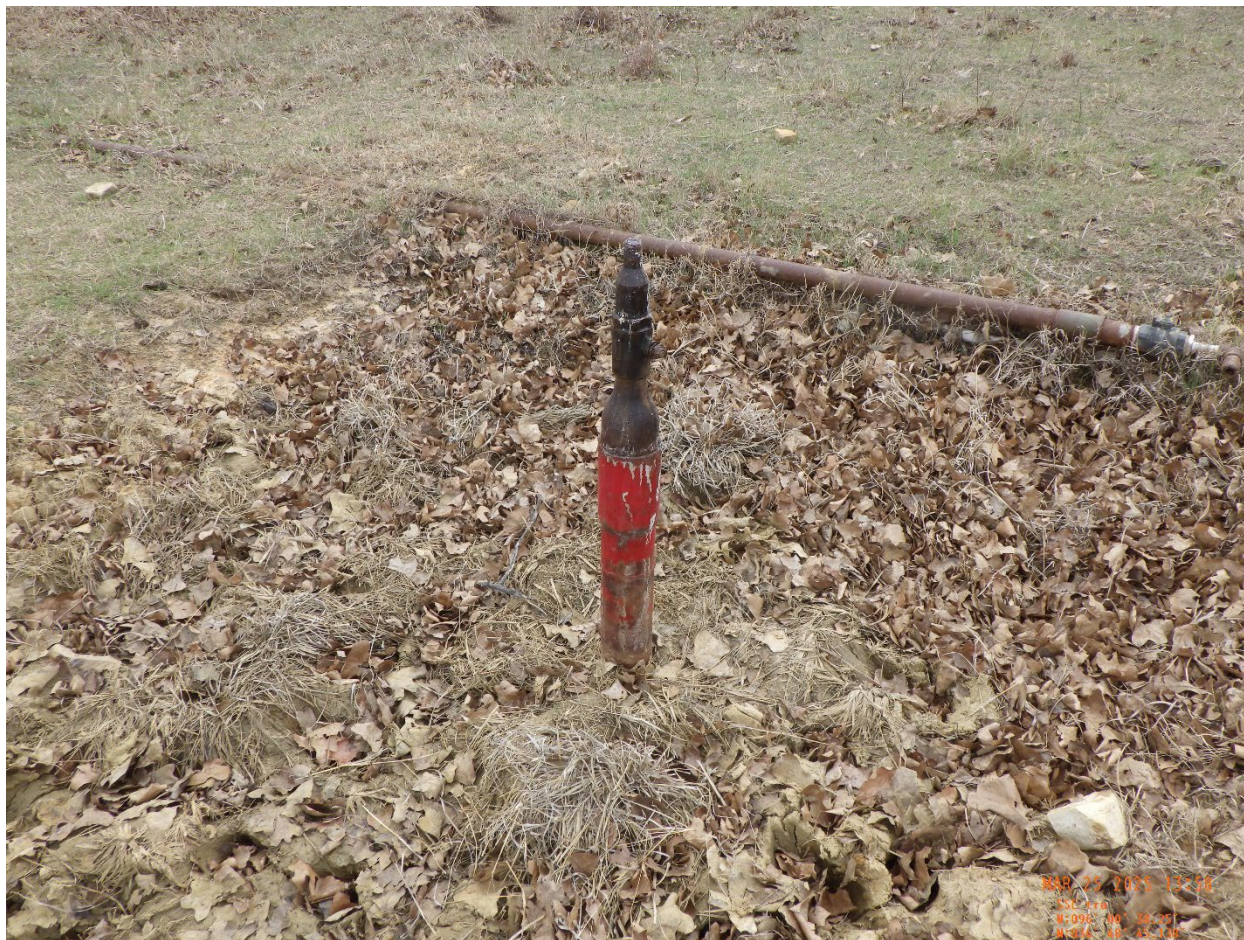
Photo No. 1

| <b>Inspection Comments</b> | Inspector observed well OS2221000. At the time of the inspection, the well was 4.5" casing reduced to 1" threads. The fluid level was observed at the surface by way of the leaking 2" cutoff valve which allowed saltwater to stand full inside the open piping. At the time of the inspection there was no well sign present identifying the well. | | | | |

**Description:** This was well OS2221000 at the time of the inspection. The well was casing reduced to 1-inch pin threads. The fluid level was observed at the surface by way of leaking valve.
