**UNITED STATES ENVIRONMENTAL PROTECTION AGENCY  
REGION III**

**Report Title:** Clean Water Act, Section 404 Inspection Report for 342 Girl Scout Drive  
**Inspection Date(s):** 10/06/2022  
**Start Time:** 9:00 am **End Time:** 10:35 am  
**Regulatory Program(s):** Inspections authorized pursuant to Clean Water Act, Sections 308 and 404 (33 U.S.C. §§ 1318 and 1344)  
**Site Name:** Harry Ridgely  
**Site Location:** 342 Girl Scout Drive  
Hedgesville, West Virginia 25427  
**Latitude:** 39.3836 N **Longitude:** -78.1662 W  
**County/Parish:** Berkeley  
**Site Owner:** Harry Ridgely  
**Mailing Address:** 342 Girl Scout Drive  
Hedgesville, West Virginia 25427  
**Unique Project #:** N/A  
**Site Contact(s):**  
Harry Ridgely  
Phone: 719-480-9299 Email: ridgelyharry@gmail.com  
Landowner  
**EPA Inspector:**  
Katelyn Almeter  
Phone: 215-814-2797 Email: almeter.katelyn@epa.gov

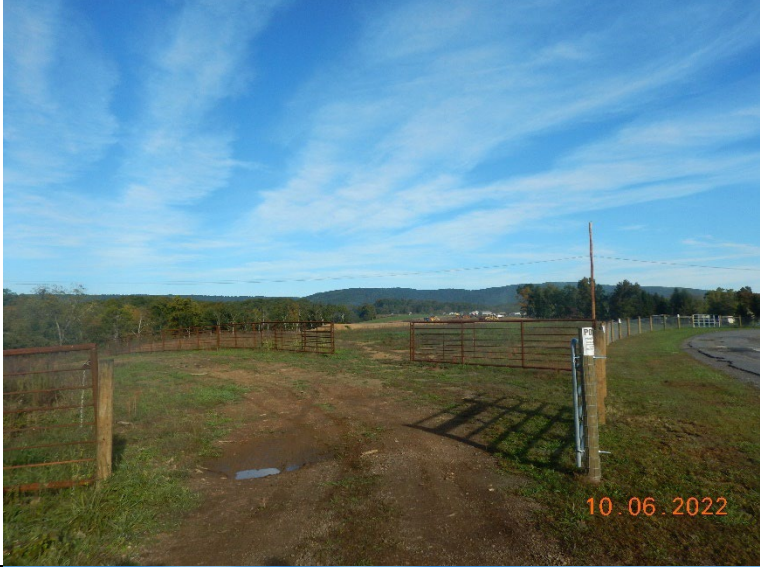
The inspection walkthrough began in the northern portion of the Site at approximately 39° 23' 4.548" N, 78° 9' 58.944" W (refer to Attachment 2 – Photographic Log; DSCN3985). The attendees walked to the upper portion of a topographic valley running east to west downslope towards the Unnamed Tributary to Back Creek ("UNT to Back Creek"). The valley was cleared and grubbed and was observed to contain concrete debris and dirt fill material within it (DSCN3987 to DSCN3989). Mr. Ridgely stated that he was bringing in the material to fill the valley with the goal of bringing the area up to grade with the surrounding hillside. According to Mr. Ridgely, some of the fill material (i.e. the concrete debris) for the valley was being sourced from waste material from local projects of the West Virginia Division of Highways. The valley was followed downslope. Approximately halfway down the valley, a silt fence was placed across the valley bottom (DSCN3990). Below the silt fence, pooling water and saturation were

| | <p>Ridgely<br/>Photo ID: DSCN3985<br/>Date: October 6, 2022</p> <p>Notes: taken near Site entrance looking at equipment in northern portion of Site; facing north</p> |

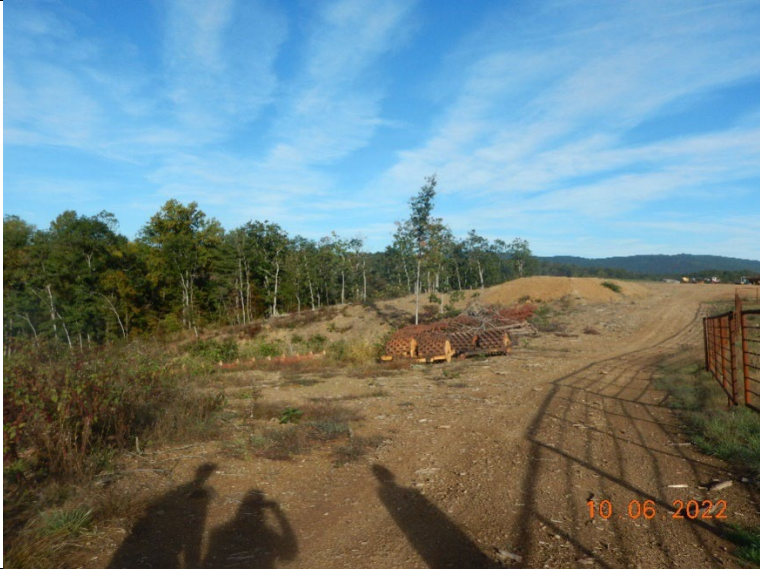
| | <p>Ridgely<br/>Photo ID: DSCN3986<br/>Date: October 6, 2022</p> <p>Notes: unimproved equipment access road; facing north</p> |

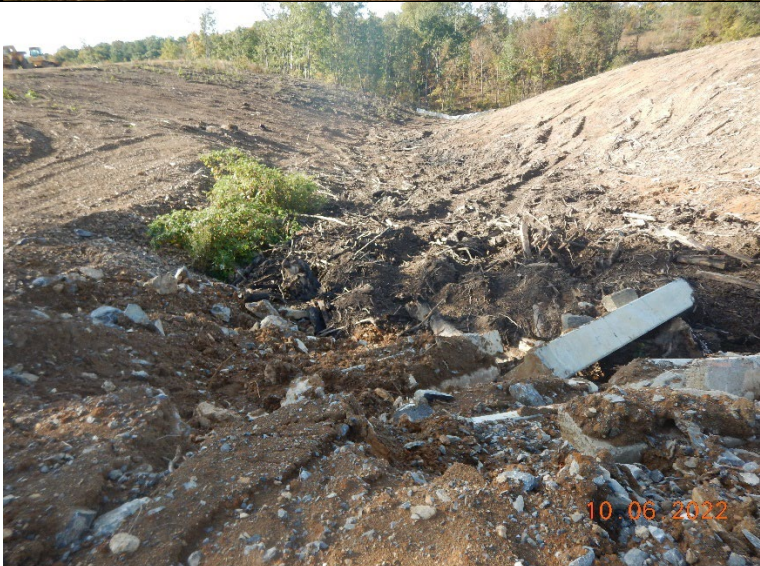
| | <p>Ridgely<br/>Photo ID: DSCN3987<br/>Date: October 6, 2022</p> <p>Notes: concrete debris and dirt placed in cleared valley; facing west</p> |

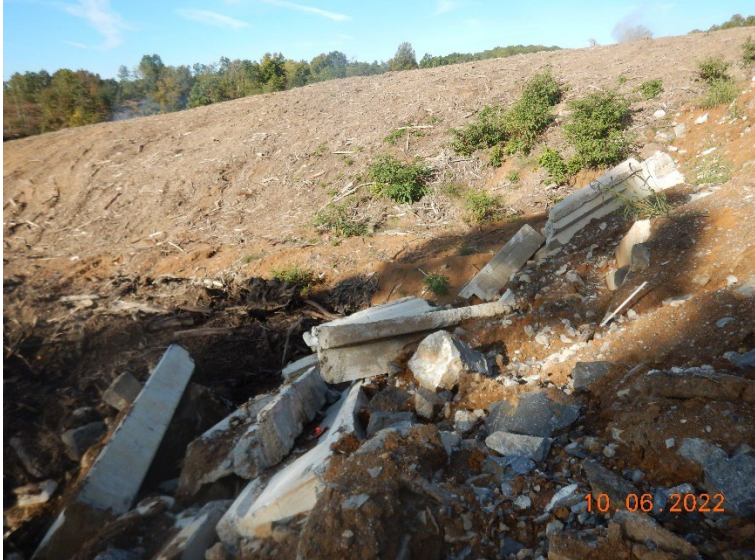
| | <p>Ridgely<br/>Photo ID: DSCN3988<br/>Date: October 6, 2022</p> <p>Notes: concrete debris and dirt placed in cleared valley; facing northeast</p> |

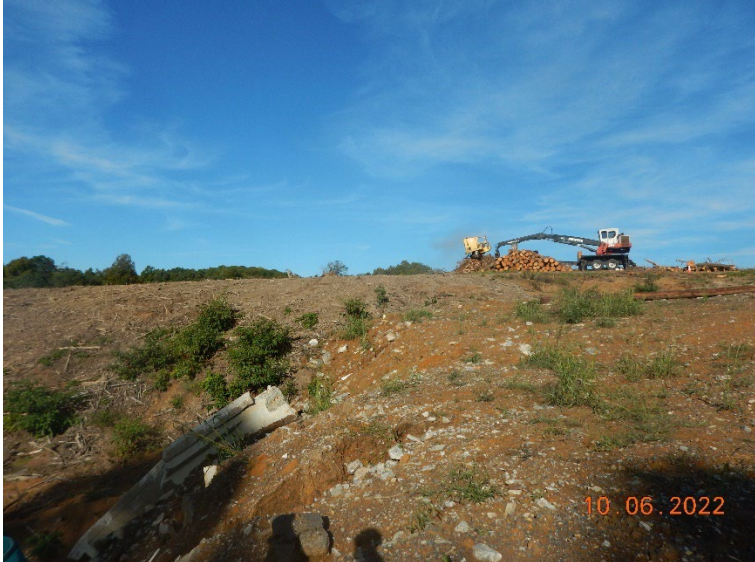
| | <p>Ridgely<br/>Photo ID: DSCN3989<br/>Date: October 6, 2022</p> <p>Notes: overview of cleared area to the north of the valley; facing north</p> |

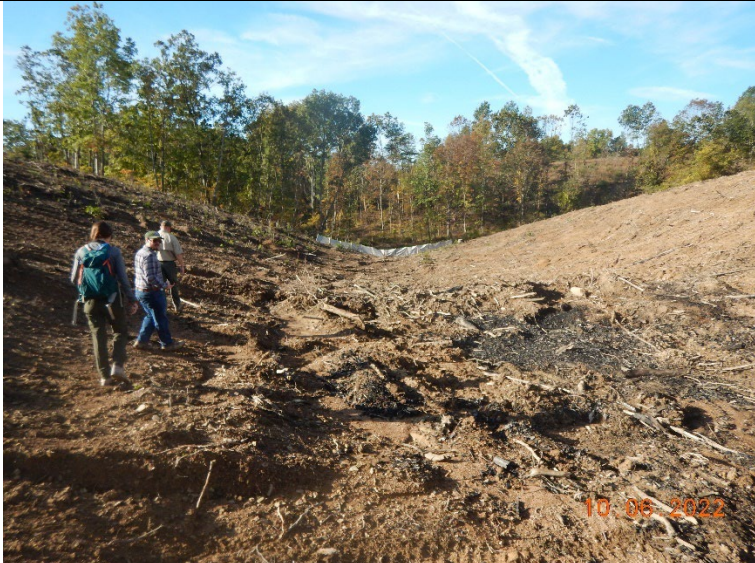
| | <p>Ridgely<br/>Photo ID: DSCN3990<br/>Date: October 6, 2022</p> <p>Notes: cleared valley looking towards UNT to Back Creek; facing west</p> |

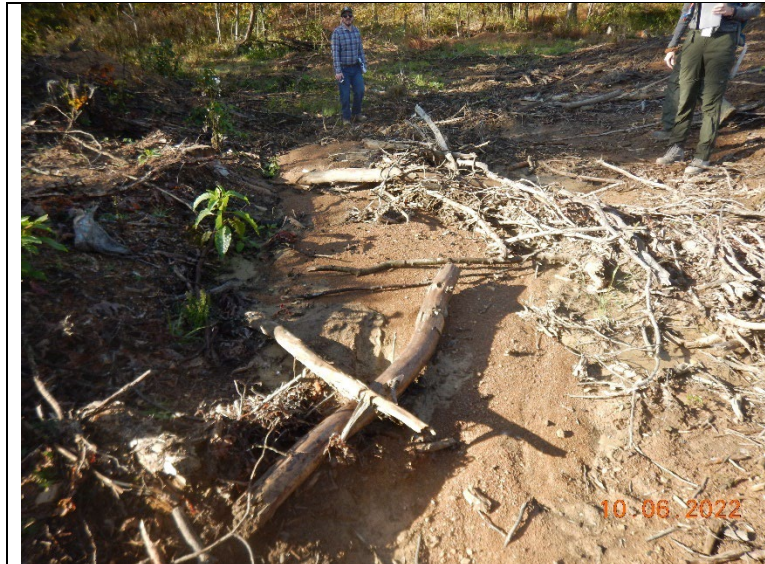
Ridgely  
Photo ID: DSCN3991  
Date: October 6, 2022

Notes: bottom of cleared valley  
near UNT to Back Creek; facing  
west

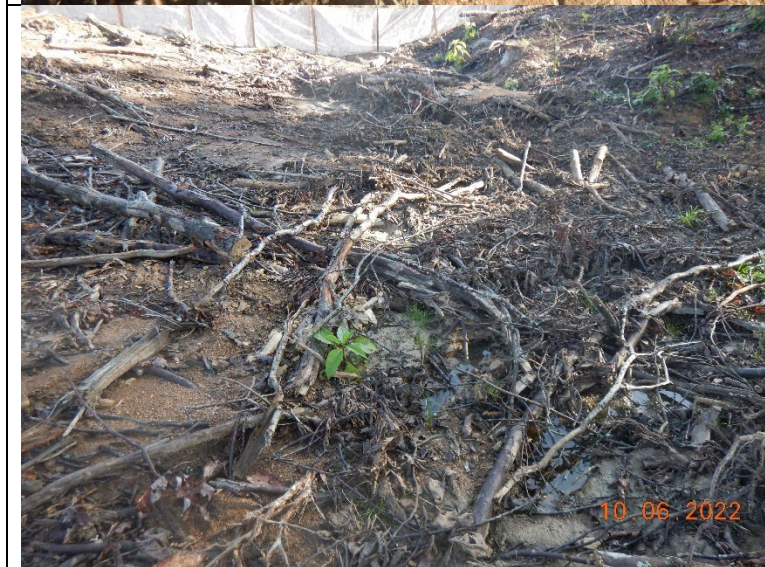
Ridgely  
Photo ID: DSCN3992  
Date: October 6, 2022

observed in the valley bottom adjacent to the UNT into Back Creek (DSCN3992 and DSCN3993). At the bottom of the valley, there was limited herbaceous vegetation present along the left descending bank, and the right descending bank was forested. The UNT to Back Creek was flowing at the time of the inspection. The stream had an Ordinary High Water Mark and bed and banks.

Notes: bottom of cleared valley  
near UNT to Back Creek; facing  
east

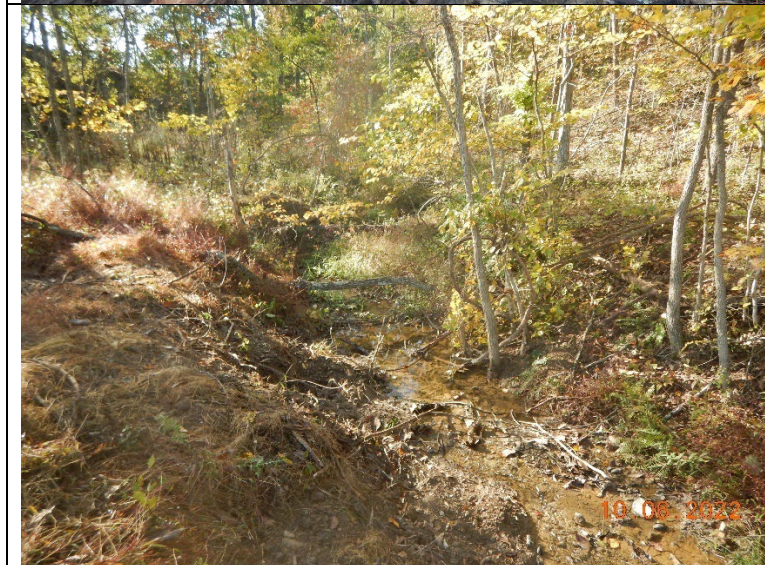
Ridgely  
Photo ID: DSCN3993  
Date: October 6, 2022

Notes: UNT to Back Creek;  
facing south

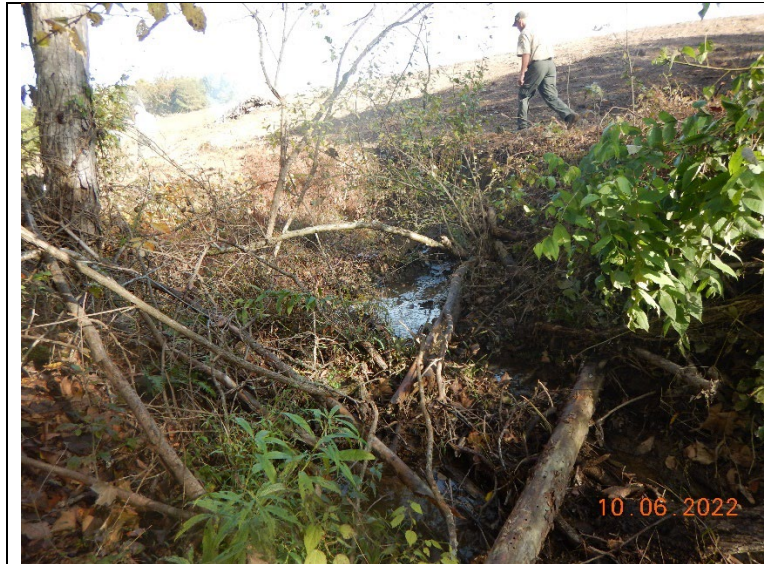
Ridgely  
Photo ID: DSCN3994  
Date: October 6, 2022

The walkthrough continued upstream along the left descending bank of the UNT to Back Creek (DSCN3994). Land-clearing and grubbing activities were observed to have taken place along the left descending stream bank (DSCN3995 and DSCN3996). Vegetation had been removed to the stream edge. Bare ground was present, and encroachment below the Ordinary High Water Mark was observed (DSCN3997 to DSCN4000).

Notes: UNT to Back Creek;  
facing north

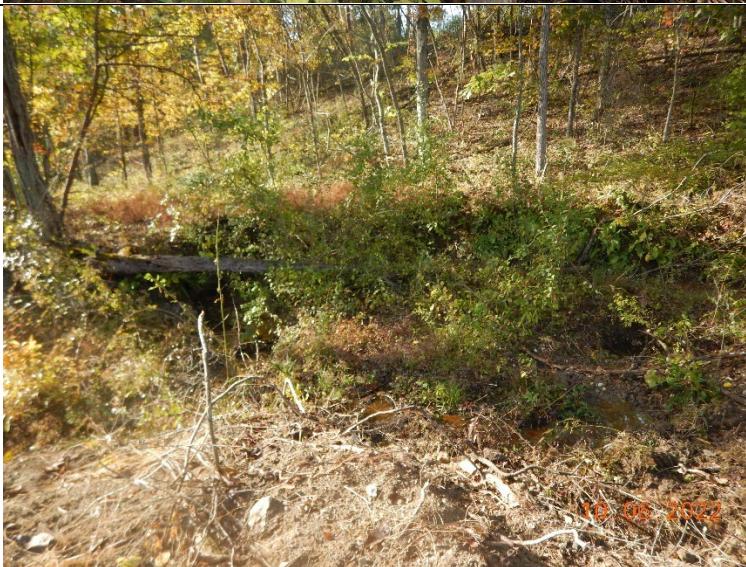
Ridgely  
Photo ID: DSCN3995  
Date: October 6, 2022

Notes: UNT to Back Creek with  
clearing occurring on left  
descending bank; facing west

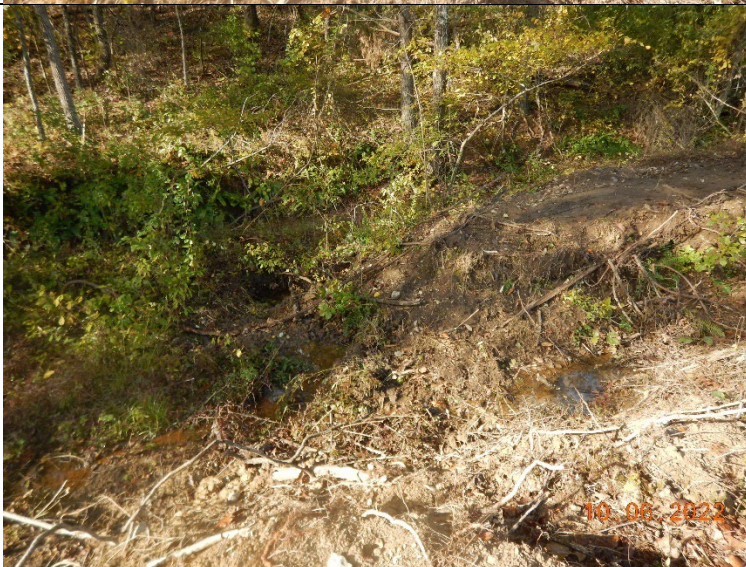
Ridgely  
Photo ID: DSCN3996  
Date: October 6, 2022

Notes: UNT to Back Creek with  
equipment activity/clearing  
occurring along both banks;  
facing west

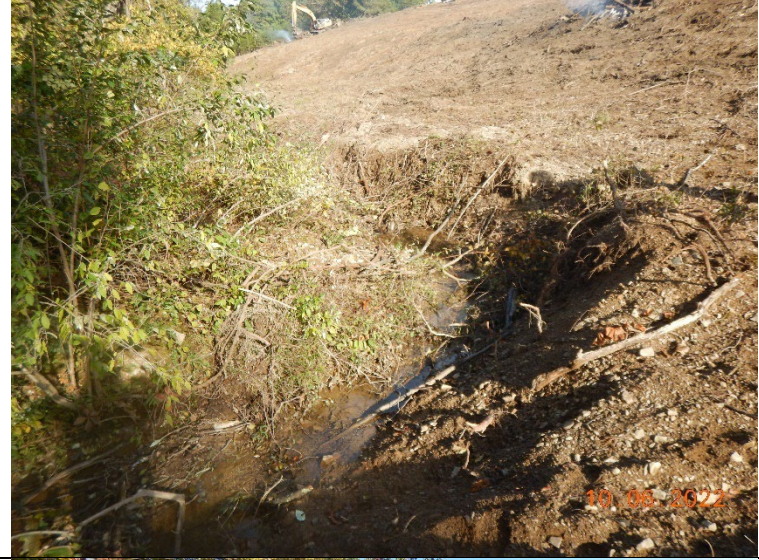
| | <p>Ridgely<br/>Photo ID: DSCN3997<br/>Date: October 6, 2022</p> <p>Notes: UNT to Back Creek with equipment activity/clearing occurring on left descending bank; facing north</p> |

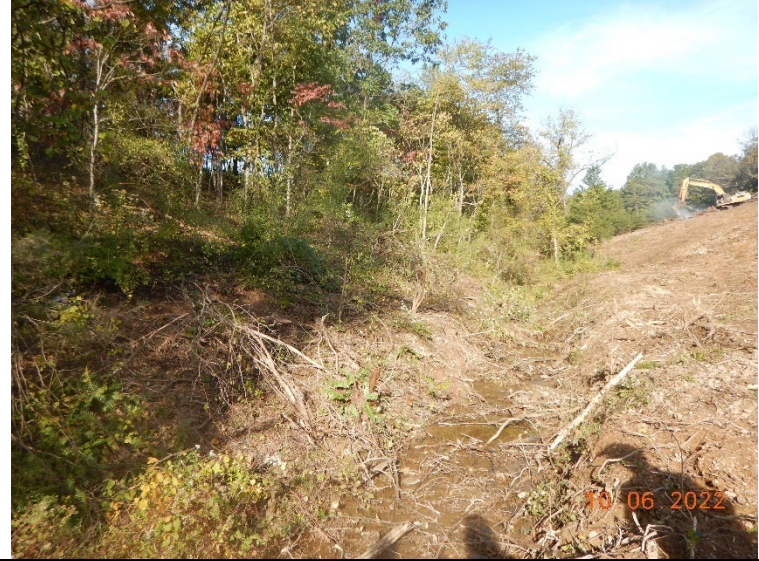
| | <p>Ridgely<br/>Photo ID: DSCN3998<br/>Date: October 6, 2022</p> <p>Notes: UNT to Back Creek with equipment working in the background; facing north</p> |

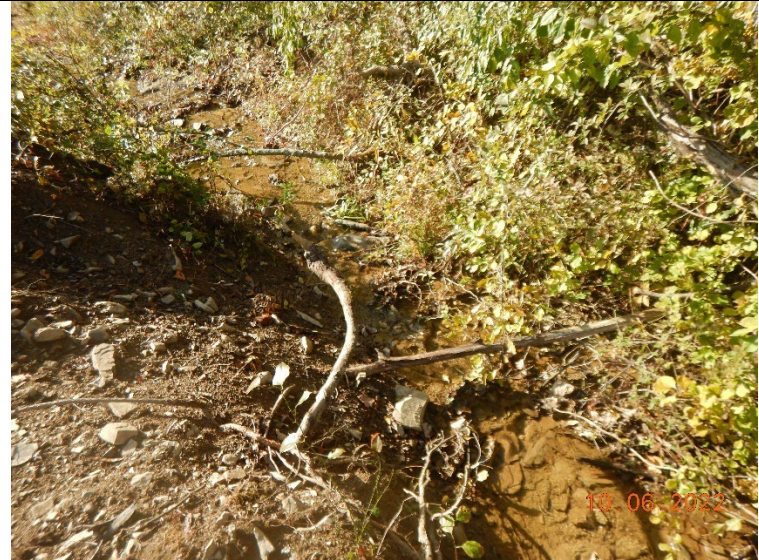
| | <p>Ridgely<br/>Photo ID: DSCN3999<br/>Date: October 6, 2022</p> <p>Notes: UNT to Back Creek</p> |

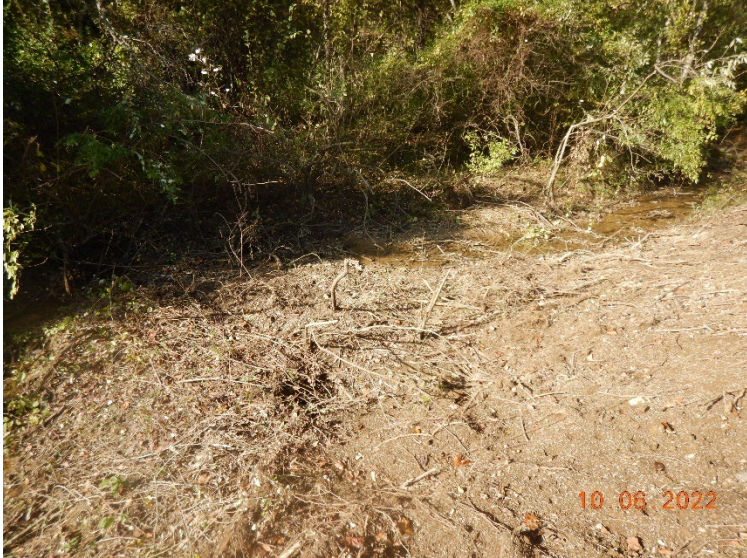
The walkthrough continued upstream along the UNT to Back Creek. An area was observed along the left descending bank that was cleared and grubbed, with bare ground observed to the stream channel (DSCN4000 to DSCN4006). The area was a wider, low-lying riparian zone at the toe of the hillslope. There were pockets of remaining vegetation, which was a hydrophytic community dominated by jewelweed (*Impatiens capensis*) and smartweed (*Polygonum persicaria*) (DSCN4004). Soils in the area were observed to have a 60% matrix color of 10YR6/2 with 40% redoximorphic features as prominent concentrations (DSCN4003). The soils were observed to meet the hydric soil indicator of F3- depleted matrix. The area abutted the UNT to Back Creek, and encroachment of dirt below the Ordinary High Water Mark was observed.

| | <p>Ridgely<br/>Photo ID: DSCN4000<br/>Date: October 6, 2022</p> <p>Notes: UNT to Back Creek and<br/>cleared wetland area; facing<br/>north</p> |

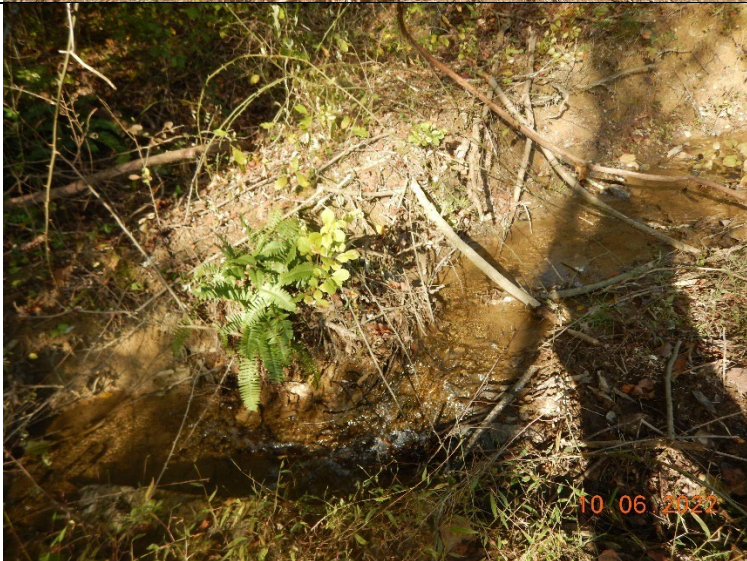
| | <p>Ridgely<br/>Photo ID: DSCN4001<br/>Date: October 6, 2022</p> <p>Notes: UNT to Back Creek</p> |

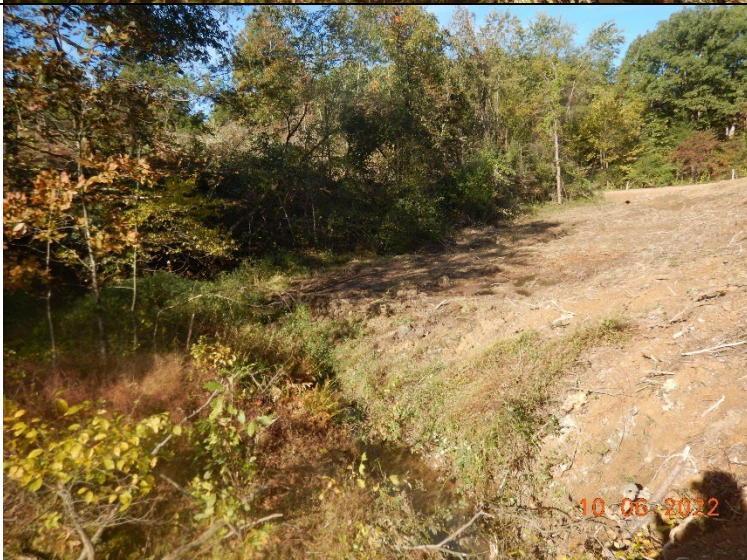
| | <p>Ridgely<br/>Photo ID: DSCN4002<br/>Date: October 6, 2022</p> <p>Notes: UNT to Back Creek<br/>looking towards stream crossing<br/>for equipment access road;<br/>facing north</p> |

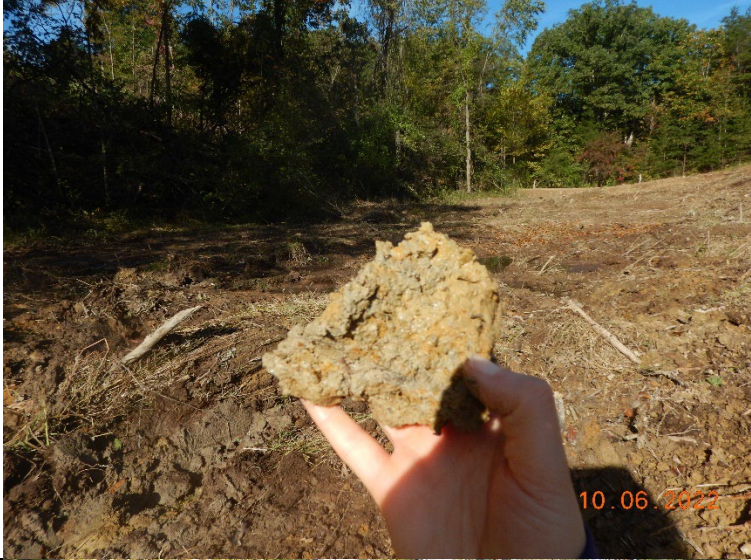
| | <p>Ridgely<br/>Photo ID: DSCN4003<br/>Date: October 6, 2022</p> <p>Notes: soil from wetland area</p> |

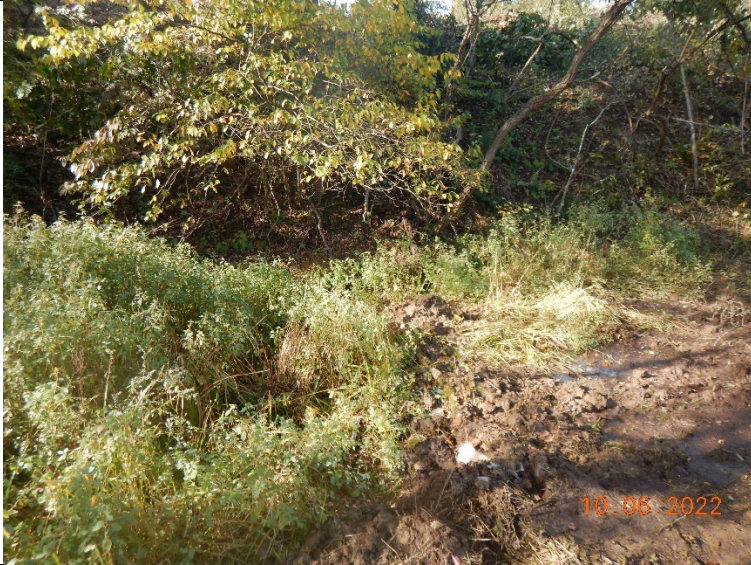
| | <p>Ridgely<br/>Photo ID: DSCN4004<br/>Date: October 6, 2022</p> <p>Notes: equipment activity/<br/>clearing in wetland area along<br/>UNT to Back Creek with<br/>remaining vegetation dominated<br/>by <i>Impatiens capensis</i>; facing<br/>southwest</p> |

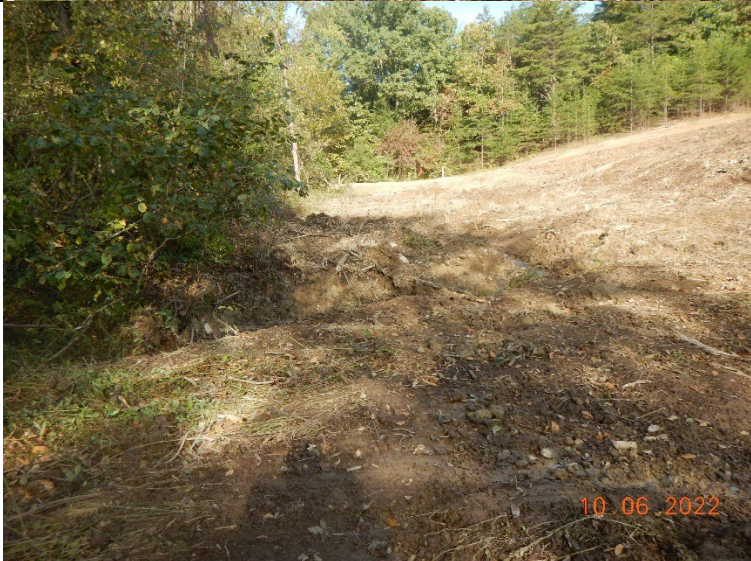
| | <p>Ridgely<br/>Photo ID: DSCN4005<br/>Date: October 6, 2022</p> <p>Notes: cleared area of UNT to<br/>Back Creek and wetland; facing<br/>north</p> |

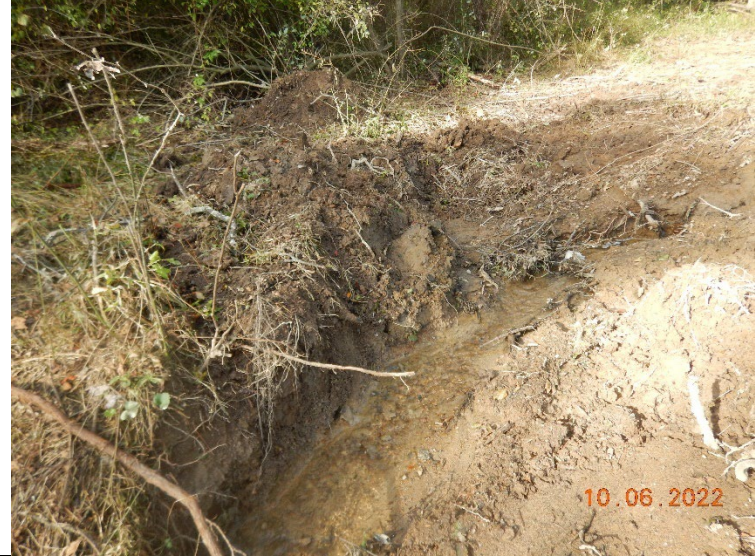
| | <p>Ridgely<br/>Photo ID: DSCN4006<br/>Date: October 6, 2022</p> <p>Notes: UNT to Back Creek;<br/>facing north</p> |

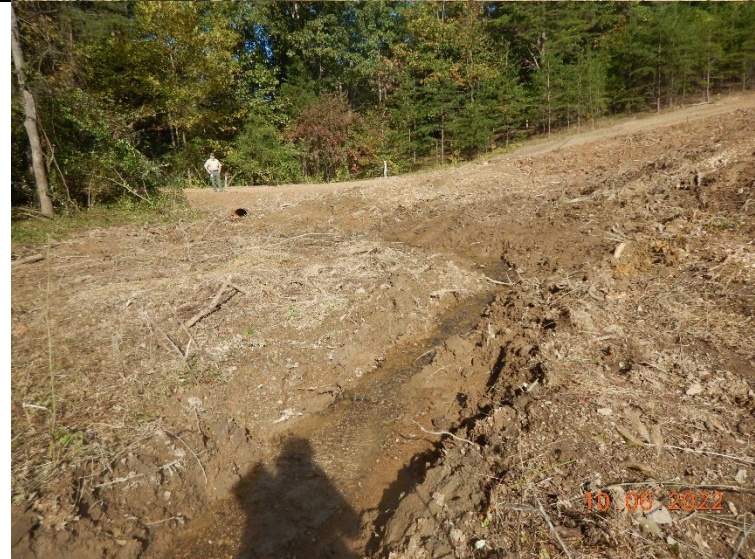
| | <p>Ridgely<br/>Photo ID: DSCN4007<br/>Date: October 6, 2022</p> <p>Notes: UNT to Back Creek;<br/>facing north</p> |

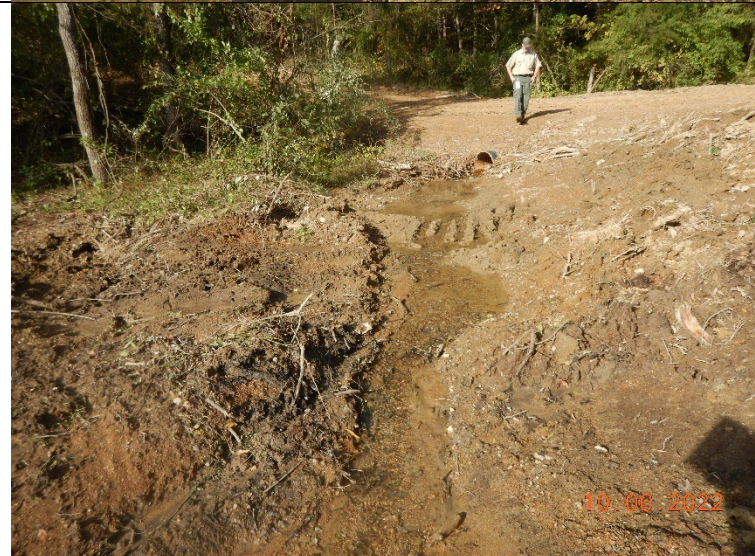
| | <p>Ridgely<br/>Photo ID: DSCN4008<br/>Date: October 6, 2022</p> <p>Notes: UNT to Back Creek;<br/>facing north</p> |

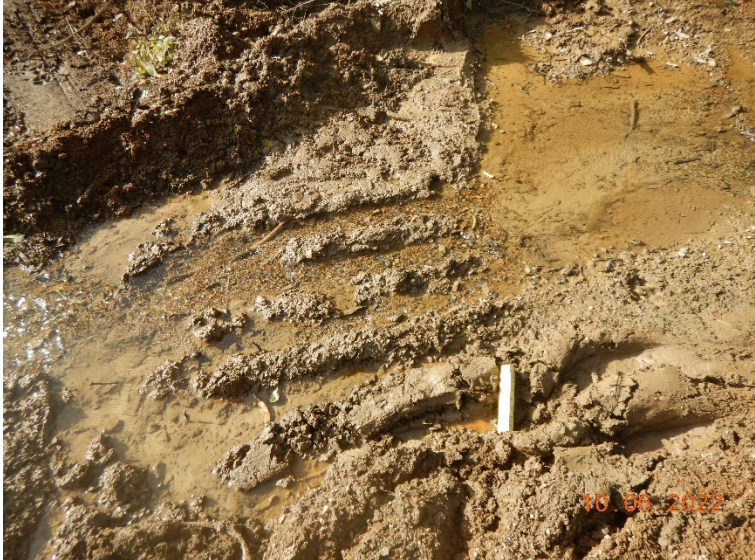
| A close-up photograph of a muddy stream bed. The water is murky brown, and the surrounding soil is dark brown and uneven. There are some small, light-colored marks on the soil, possibly from equipment. A white object, possibly a marker or a piece of equipment, is visible in the center of the frame. The date '10.06.2022' is printed in orange in the bottom right corner. | <p>Ridgely<br/>Photo ID: DSCN4009<br/>Date: October 6, 2022</p> <p>Notes: equipment marks in bed<br/>of channel of UNT to Back<br/>Creek</p> |

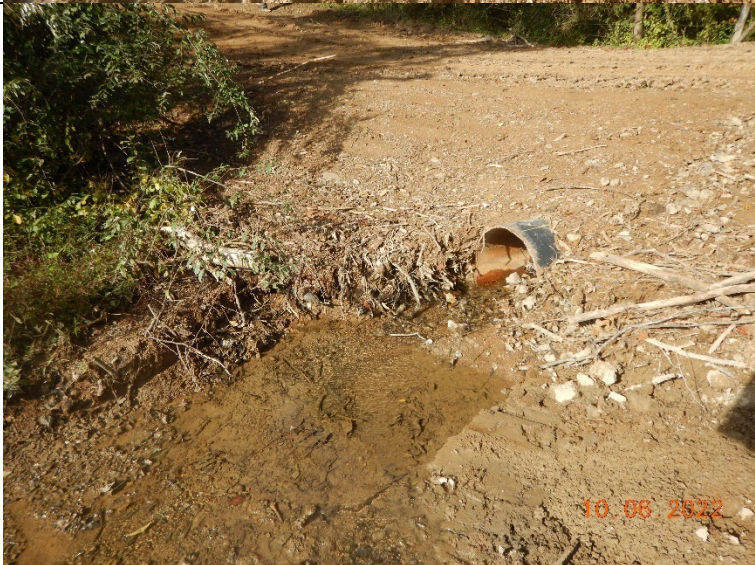
| A photograph showing the outlet of a culvert for a stream crossing. The culvert is a large, dark, cylindrical pipe that has been partially buried in the ground. The surrounding area is a mix of dirt, rocks, and some sparse vegetation. The date '10.06.2022' is printed in orange in the bottom right corner. | <p>Ridgely<br/>Photo ID: DSCN4010<br/>Date: October 6, 2022</p> <p>Notes: outlet of culvert for<br/>stream crossing of equipment<br/>access road; facing north</p> |

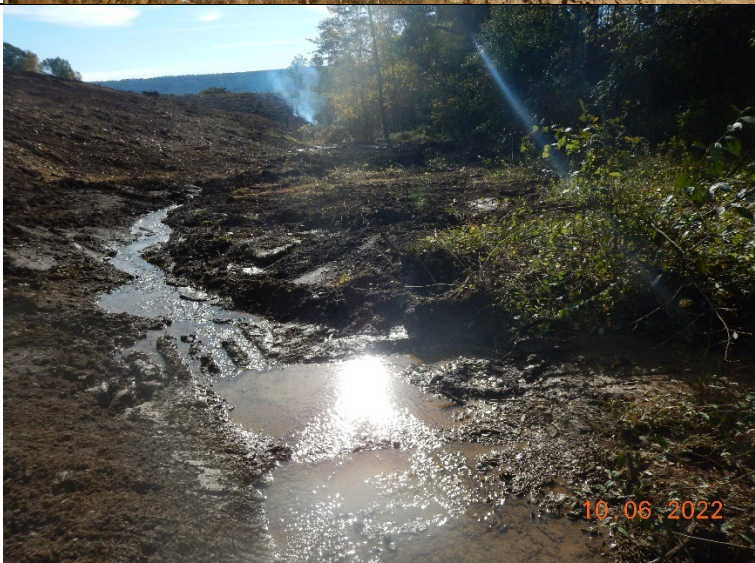
| A photograph of a stream flowing through a wooded area. The water is clear and reflects the sunlight. The surrounding area is covered in trees and vegetation. The date '10.06.2022' is printed in orange in the bottom right corner. | <p>Ridgely<br/>Photo ID: DSCN4011<br/>Date: October 6, 2022</p> <p>Notes: UNT to Back Creek;<br/>facing south</p> |

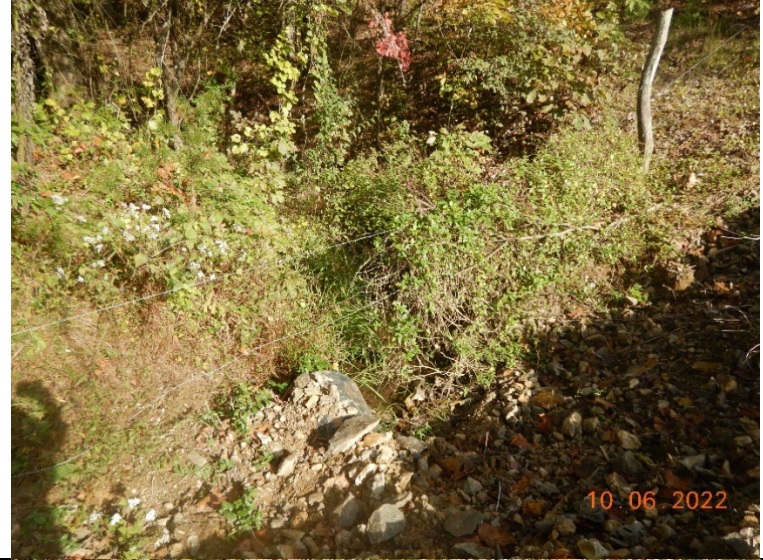
| | <p>Ridgely<br/>Photo ID: DSCN4012<br/>Date: October 6, 2022</p> <p>Notes: inlet of culvert for stream crossing of equipment access road; facing north</p> |

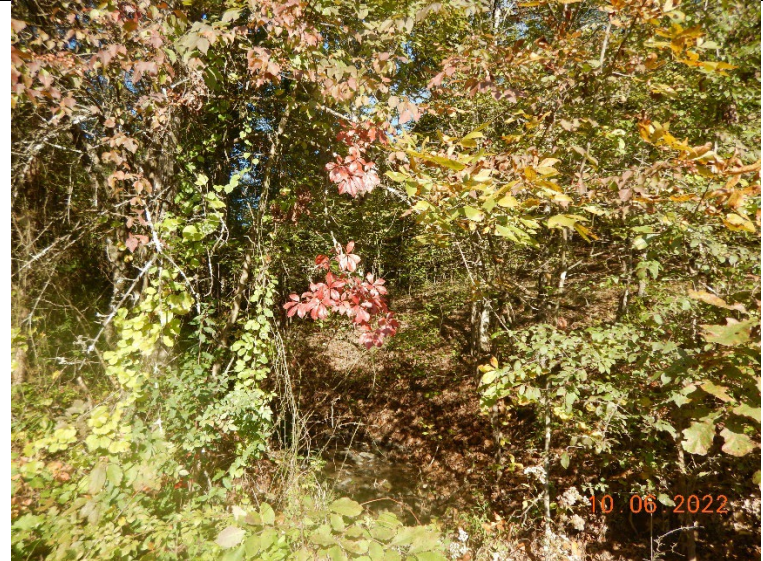
| | <p>Ridgely<br/>Photo ID: DSCN4013<br/>Date: October 6, 2022</p> <p>Notes: upstream portion of UNT to Back Creek; facing north</p> |

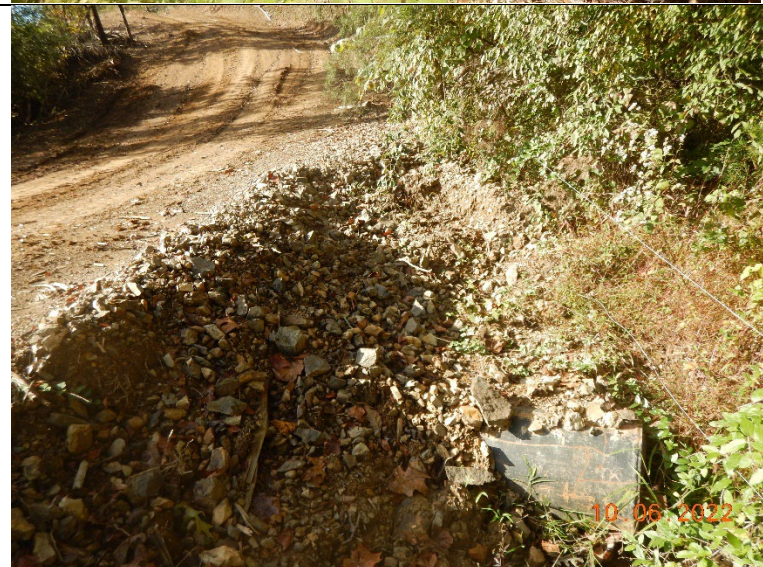
| | <p>Ridgely<br/>Photo ID: DSCN4014<br/>Date: October 6, 2022</p> <p>Notes: inlet of culvert; facing west</p> |

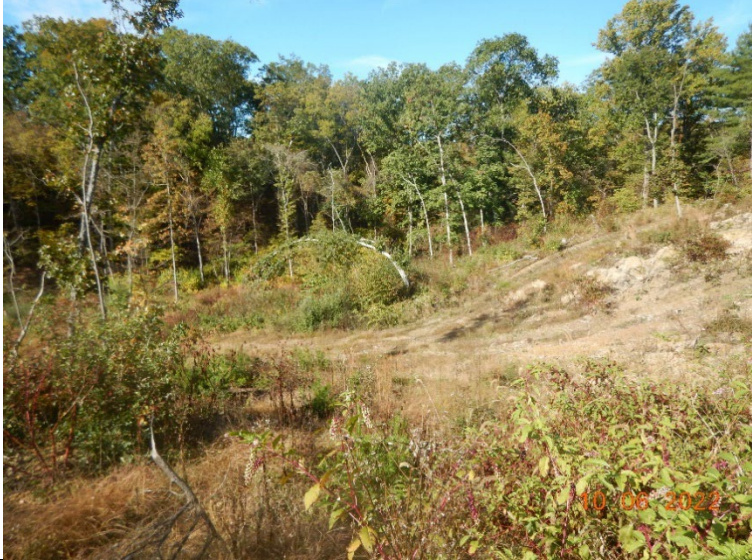
The walkthrough then left that part of the Site and the inspectors walked to the area near the house. On the way, a second topographic depression was observed (DSCN4015 and DSCN4016). The area near the house where the yard had been expanded by bringing fill material in and building up the hillside was also observed (DSCN4017 to DSCN4019). The area appeared to be stable and well-vegetated based on a visual observation. A few boulder-sized rocks were observed in the forest from the previous construction activities. The section of UNT leading to Back Creek, located in the forest below the yard, was observed. There were no visual obstructions or encroachments in that section. That concluded the inspection walkthrough.

| | <p>Ridgely<br/>Photo ID: DSCN4015<br/>Date: October 6, 2022</p> <p>Notes: topographic depression<br/>located in central portion of site;<br/>facing west</p> |

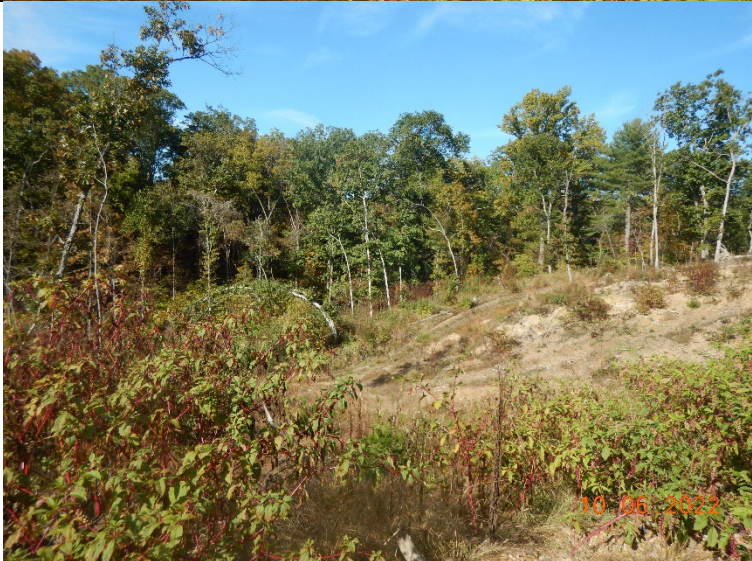
| | <p>Ridgely<br/>Photo ID: DSCN4016<br/>Date: October 6, 2022</p> <p>Notes: topographic depression<br/>located in central portion of site;<br/>facing west</p> |

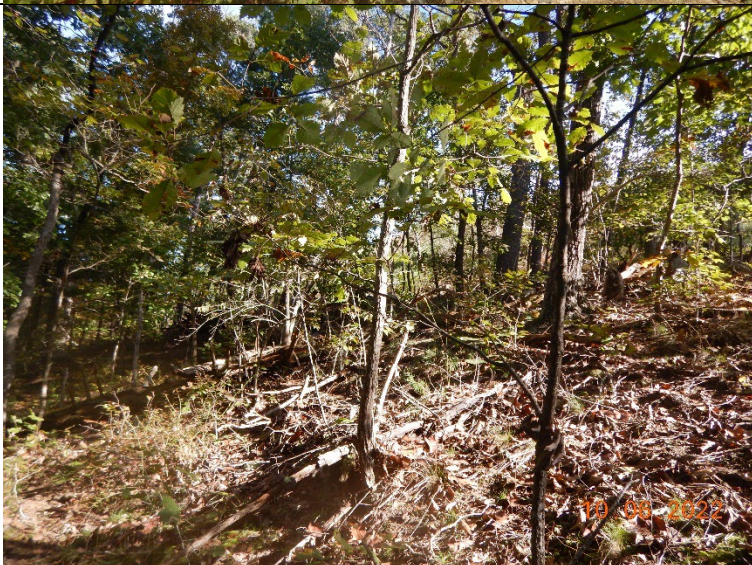
| | <p>Ridgely<br/>Photo ID: DSCN4017<br/>Date: October 6, 2022</p> <p>Notes: hillslope behind house;<br/>facing north</p> |

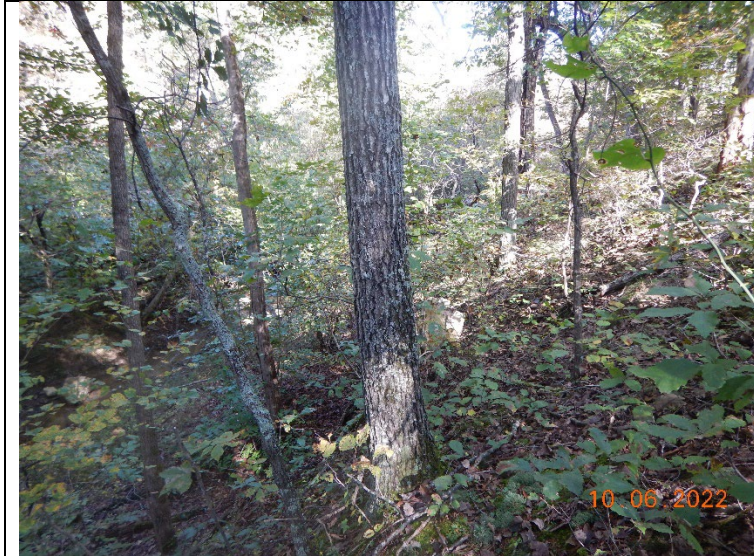
Ridgely  
Photo ID: DSCN4018  
Date: October 6, 2022

Notes: hillslope behind house  
with boulders visible; facing  
north

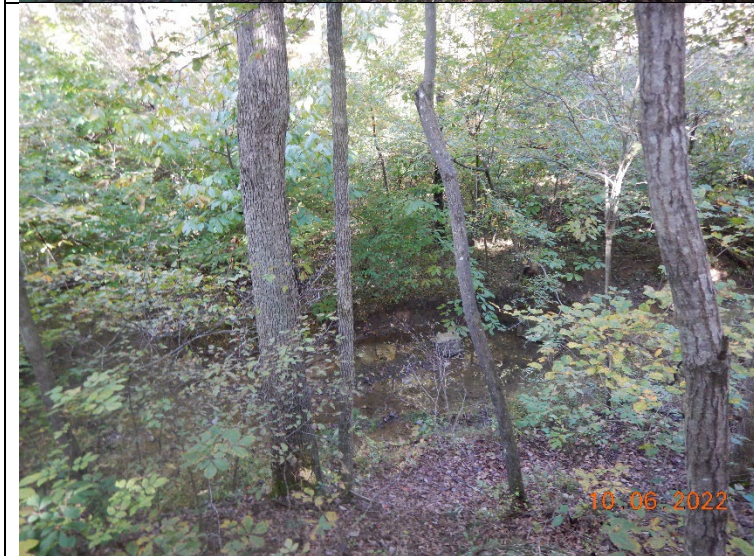
Ridgely  
Photo ID: DSCN4019  
Date: October 6, 2022

Notes: UNT to Back Creek  
behind the house; facing west
