**Region 6 Compliance Assurance and Enforcement Division  
INSPECTION REPORT**

| Company Name: | Tyson Poultry, Inc. | | |
| Facility Name: | Tyson Poultry, Inc. – Dardanelle Processing Facility | | |

EPA Region 6 inspectors Juan Ibarra and Paul Juarez began an unannounced Industrial Storm Water inspection at the Tyson Poultry, Inc. / Dardanelle Processing Facility at 1107 on March 21, 2018. We met with Dave Evans (Tyson Environmental Manager), and Wayne Spencer (Tyson Wastewater Manager) at the Opening Conference. I presented my credentials to the Tyson Managers and informed them that this was an EPA inspection to determine compliance with the facility's ADEQ Industrial Storm Water General Permit and the Clean Water Act. The scope of the inspection was a full compliance evaluation inspection (CEI) and included an evaluation of the facility's physical site conditions and applicable records as required by the ADEQ Industrial Storm Water General Permit. Dave Evans and Wayne Spencer accompanied the EPA inspectors throughout the course of the inspection.

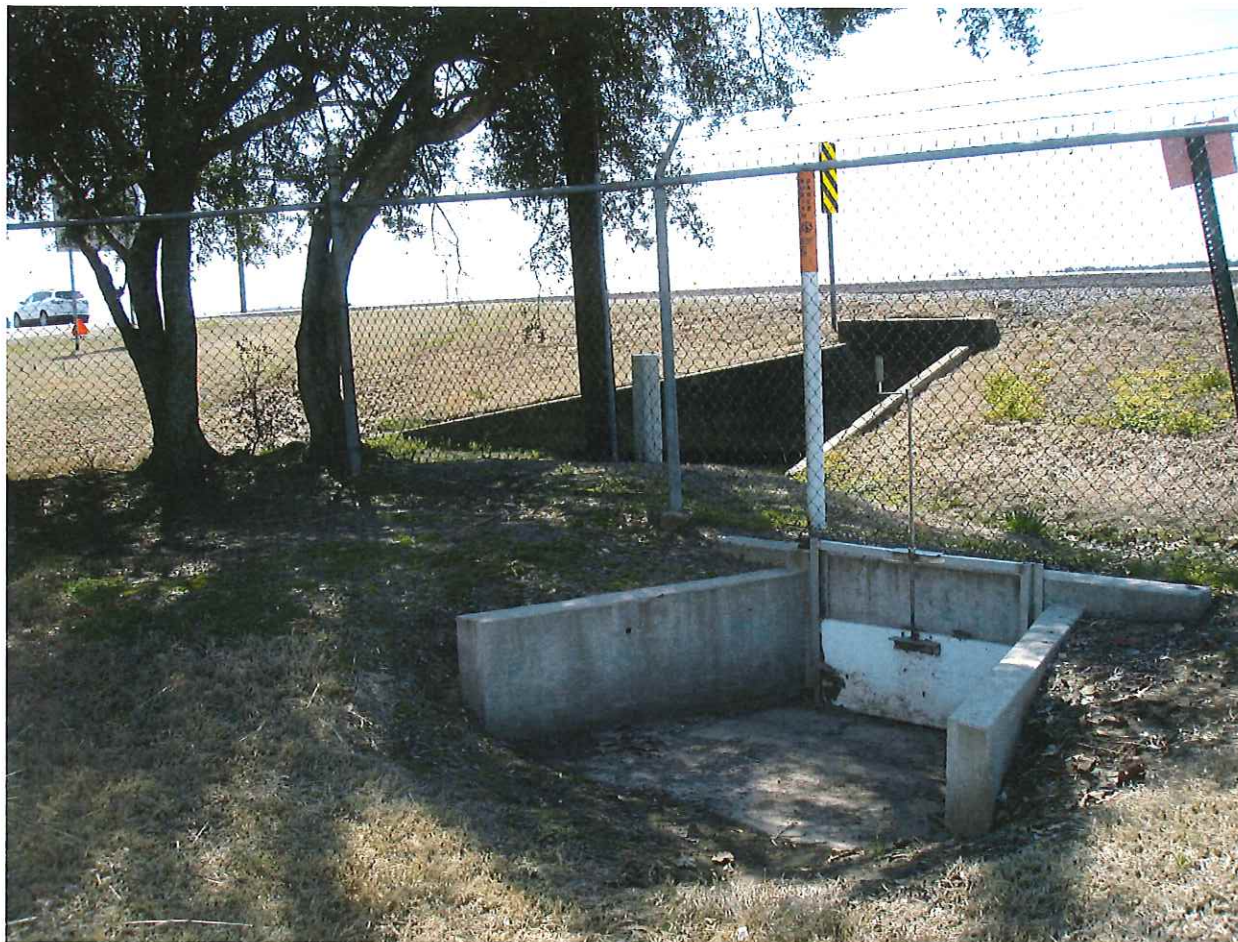
Photo No. 1

Additionally, the required analyses were being performed as required by the General Permit at the required frequency, and the facility was meeting their benchmark requirements with one exception in November, 2015. The facility determined that this benchmark exceedance for COD at OTFL 002 probably occurred due to crushed berries that fell from a 100' row of densely clustered yaupon trees located adjacent to the OTFL. However, the facility was taking the Oil and Grease sample in a plastic container which violated the container requirement for Oil and Grease sample collection found in 40 CFR 136.3.

Description: Looking southwest at storm water OTFL 002, located on the southwest side of the wastewater treatment plant. The yaupon trees that were believed to have been the cause of a COD benchmark exceedance in November, 2015, are seen in the background. Also, a sluice gate was used to control when a discharge would occur.

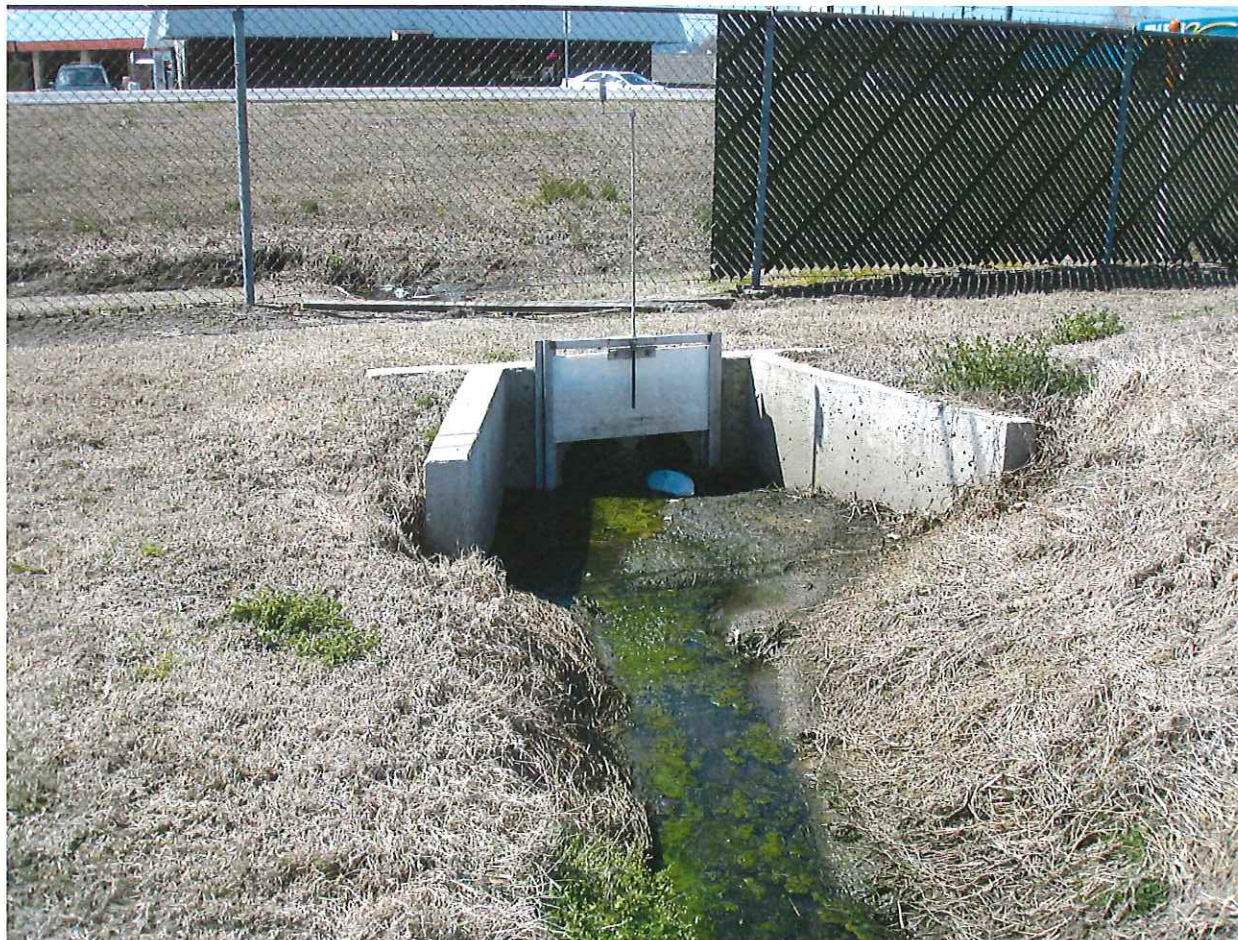
Photo No. 2

Description: Looking west at storm water OTFL 001, located on the northwest side of the wastewater treatment plant. This OTFL was also equipped with a sluice gate.

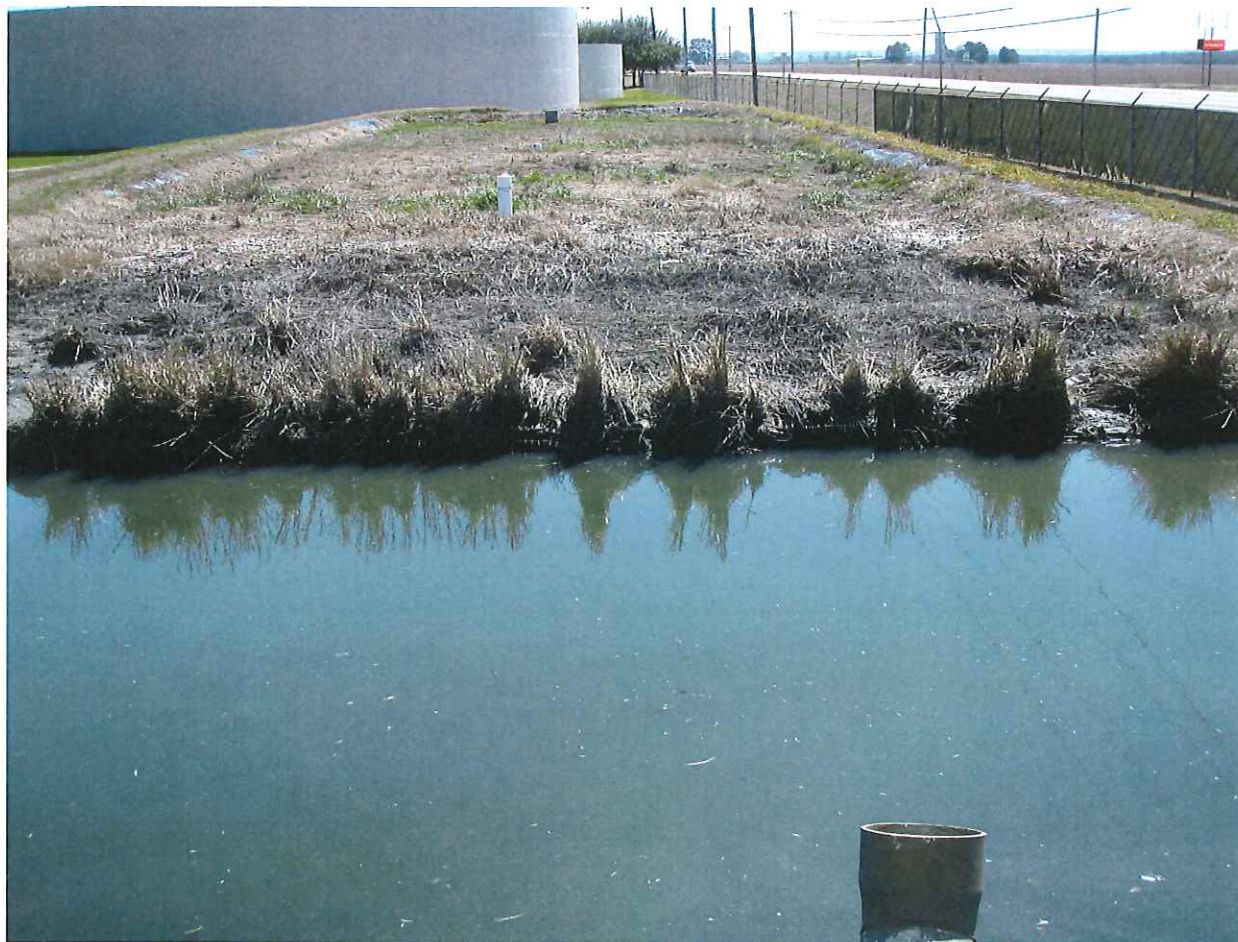
Photo No. 3

Description: Looking south at the storm water bio-retention pond. This vegetated pond would catch an estimated 60% of the storm water generated at the plant site (according to the Tyson staff) that comes from the northwest side of the facility.

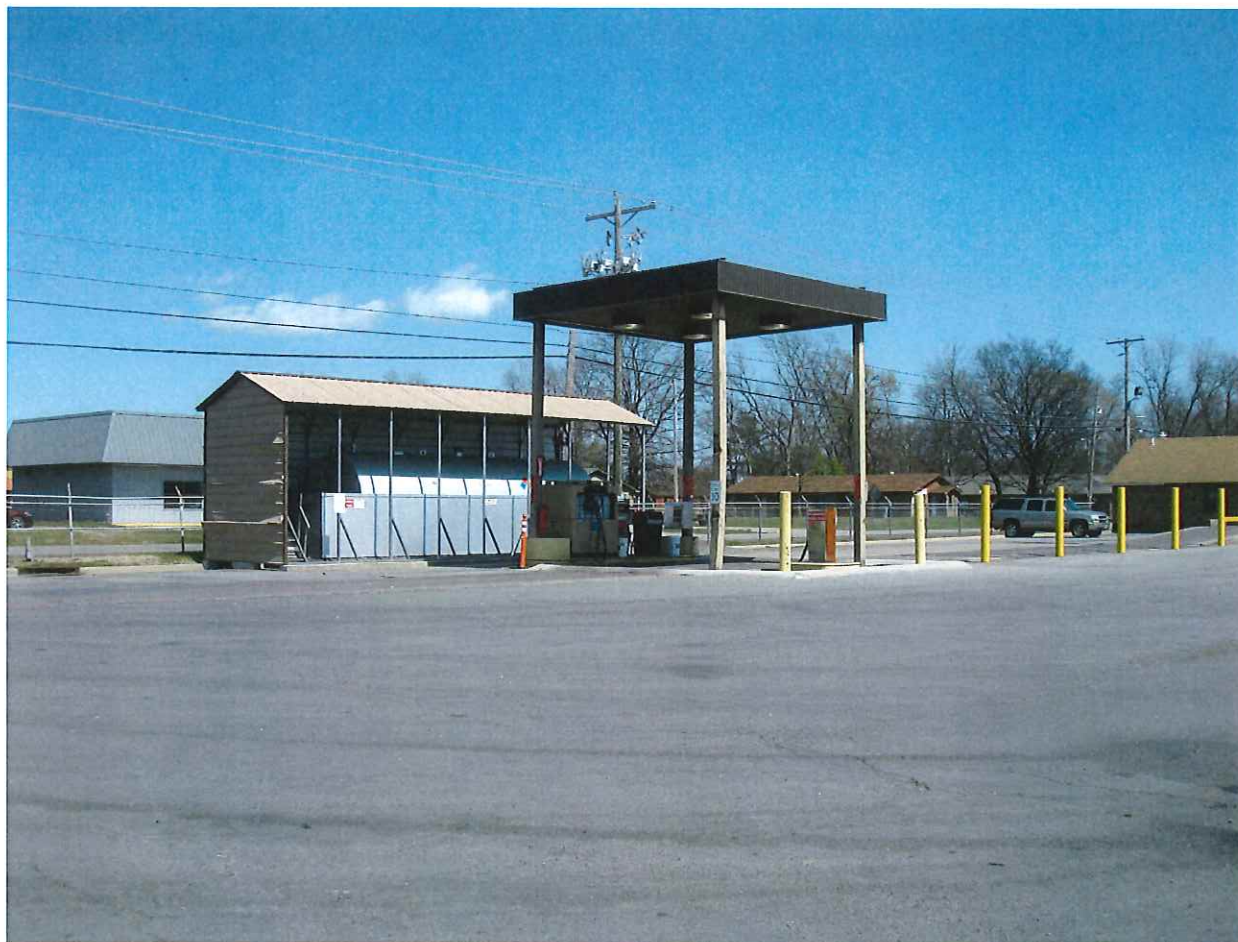
Photo No. 4

Description: Looking northeast at the covered fuel station at the north side of the facility. The fuel pumps were covered and had concrete curbing, and the above ground fuel tank had secondary containment (with no drain plug discharge potential) and a roof covering.

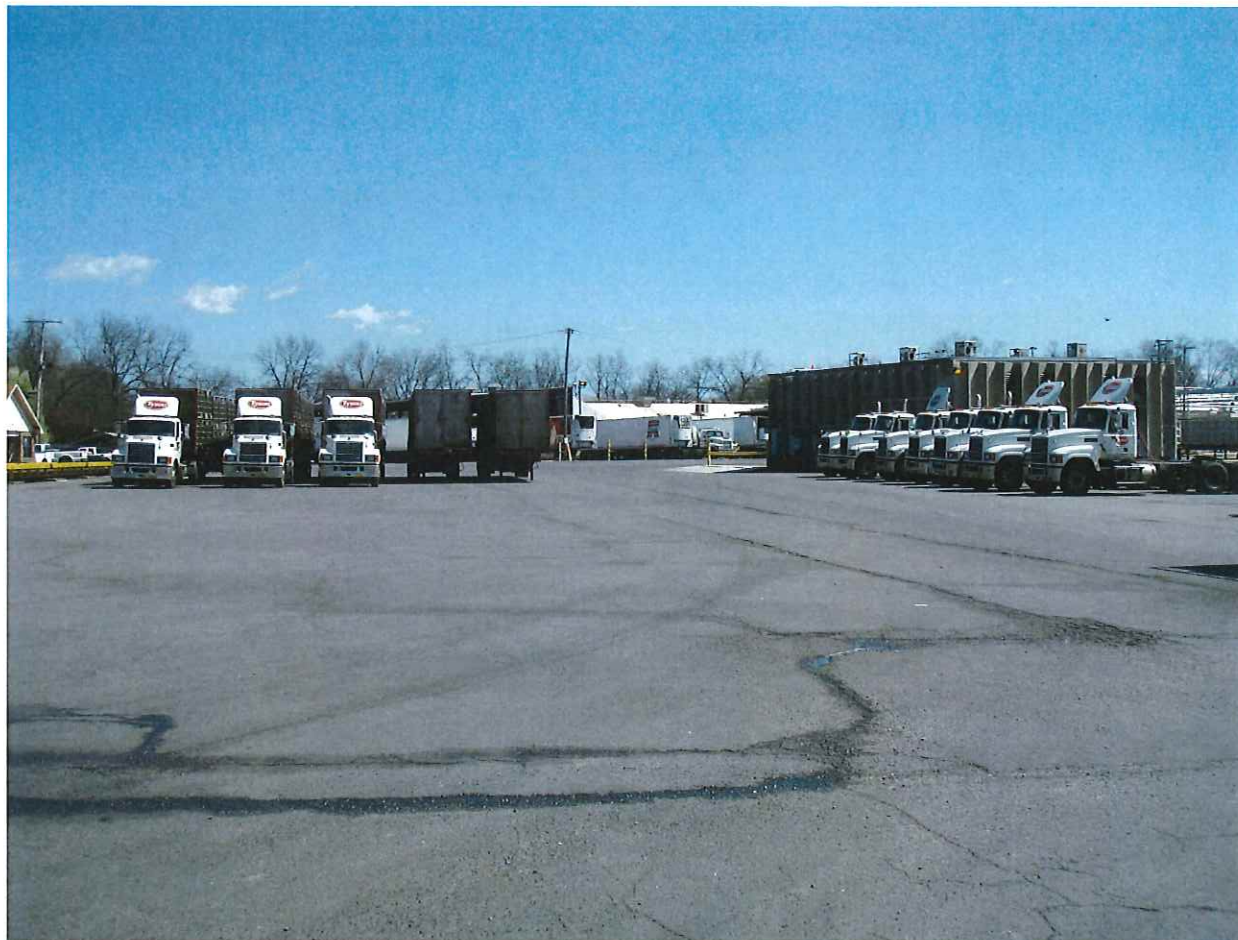
Photo No. 5

Description: Looking east at the site conditions at the truck and trailer area at the northeast area of the plant grounds. Note the cleanliness and good housekeeping that was representative of the plant site. No vehicle oil spills were noted during the inspection.

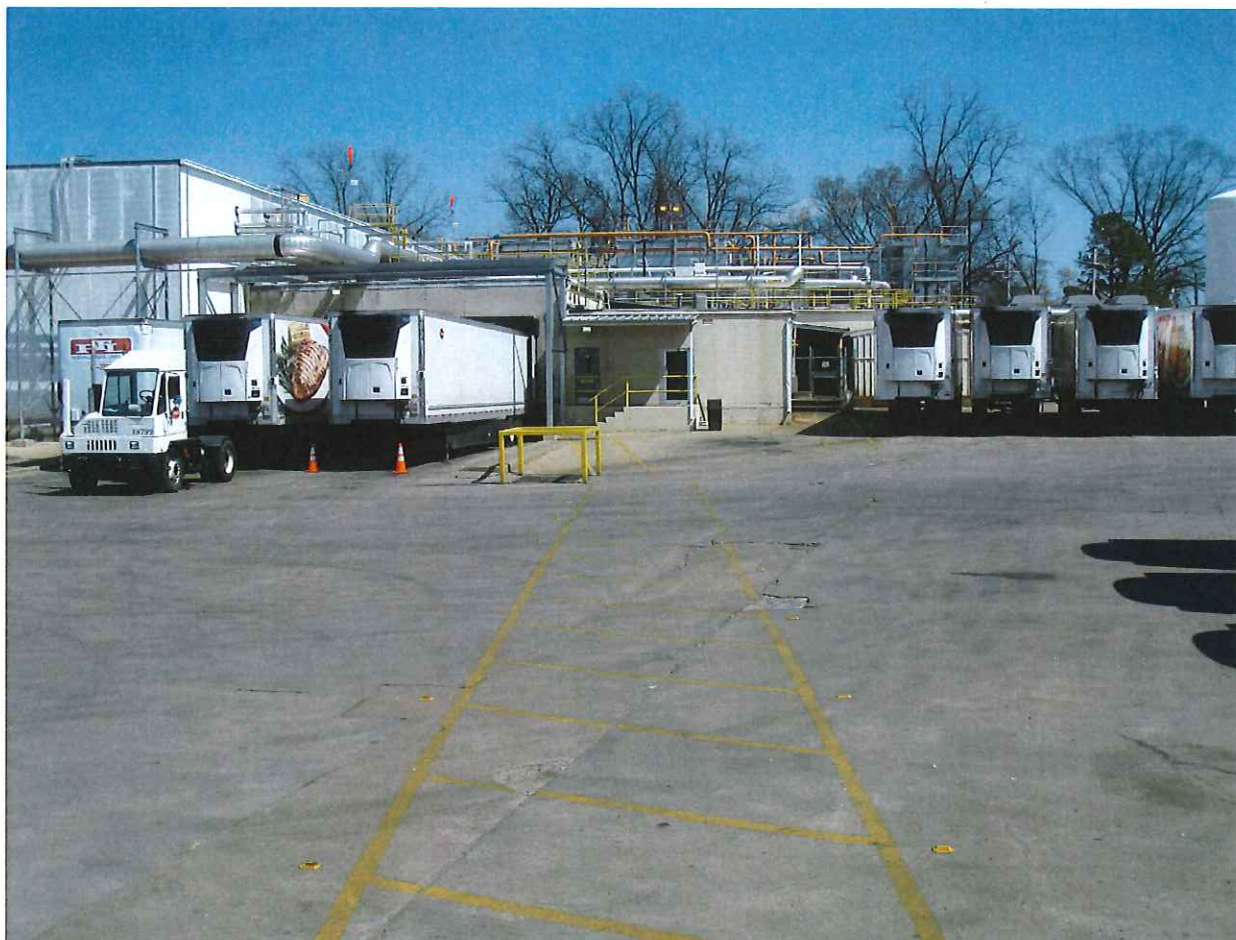
Photo No. 6

Description: Looking east at storm water OTFL 004 (below the yellow railing). Storm water from this OTFL enters the City of Dardanelle storm sewer system, and commingles with the WWTP effluent before discharging at the Arkansas River.
