**Region 6 - Enforcement & Compliance Assurance Division**  
**INSPECTION REPORT**

| Company Name: | <b>4D Oil &amp; Gas, LLC</b> | |
| Facility Name: | <b>Nellie Noble Lease Tank Battery</b> | |
| Identification/Permit Number: | OKU002212 | |

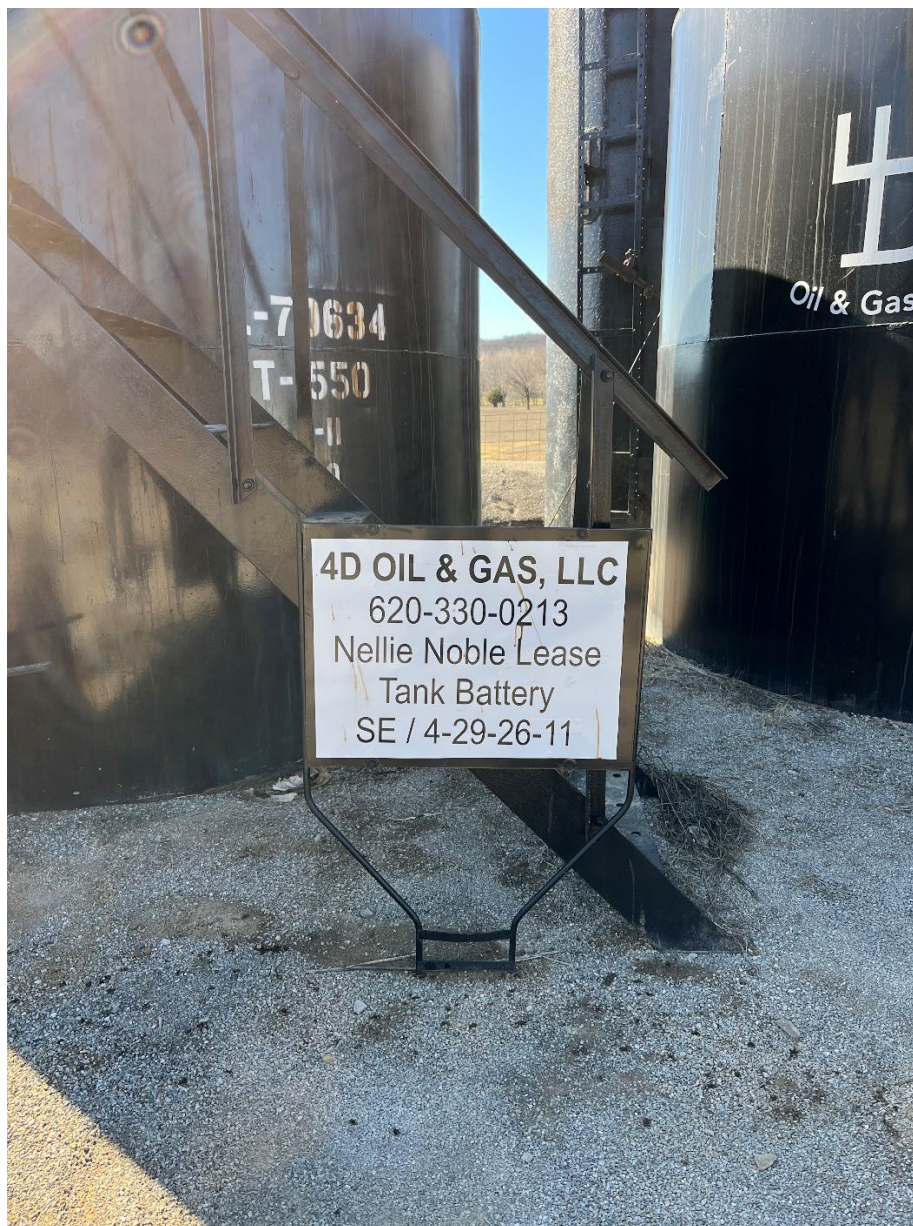
Photo No. 1

I observed the Nellie Noble Lease tank battery facility signage. A recent spill inside the Nellie Noble tank battery was the source of the citizen complain. See photo No. 1, of Appendix 1 (photo log). For additional GPS location information and photo metadata, see the attached photo log.

**Description:** This was the facility sign for the 4D Oil & Gas, LLC, Nellie Noble lease tank battery at the time of the inspection.

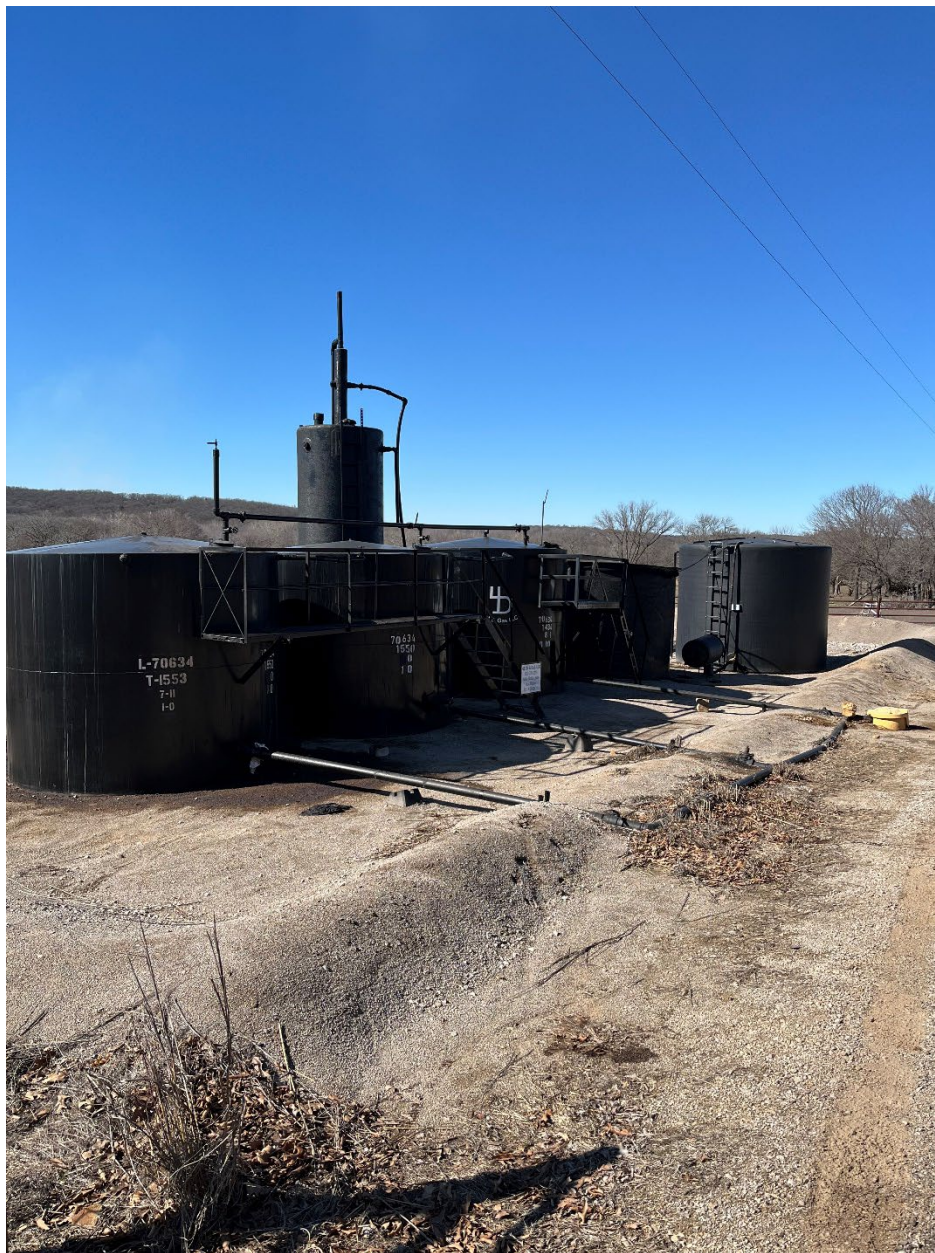
Photo No. 2

I observed the Nellie Noble tank battery along the east side of the facility, this facility overview can be seen in photo No. 2.

**Description:** This was an overview of the facility facing northwest.

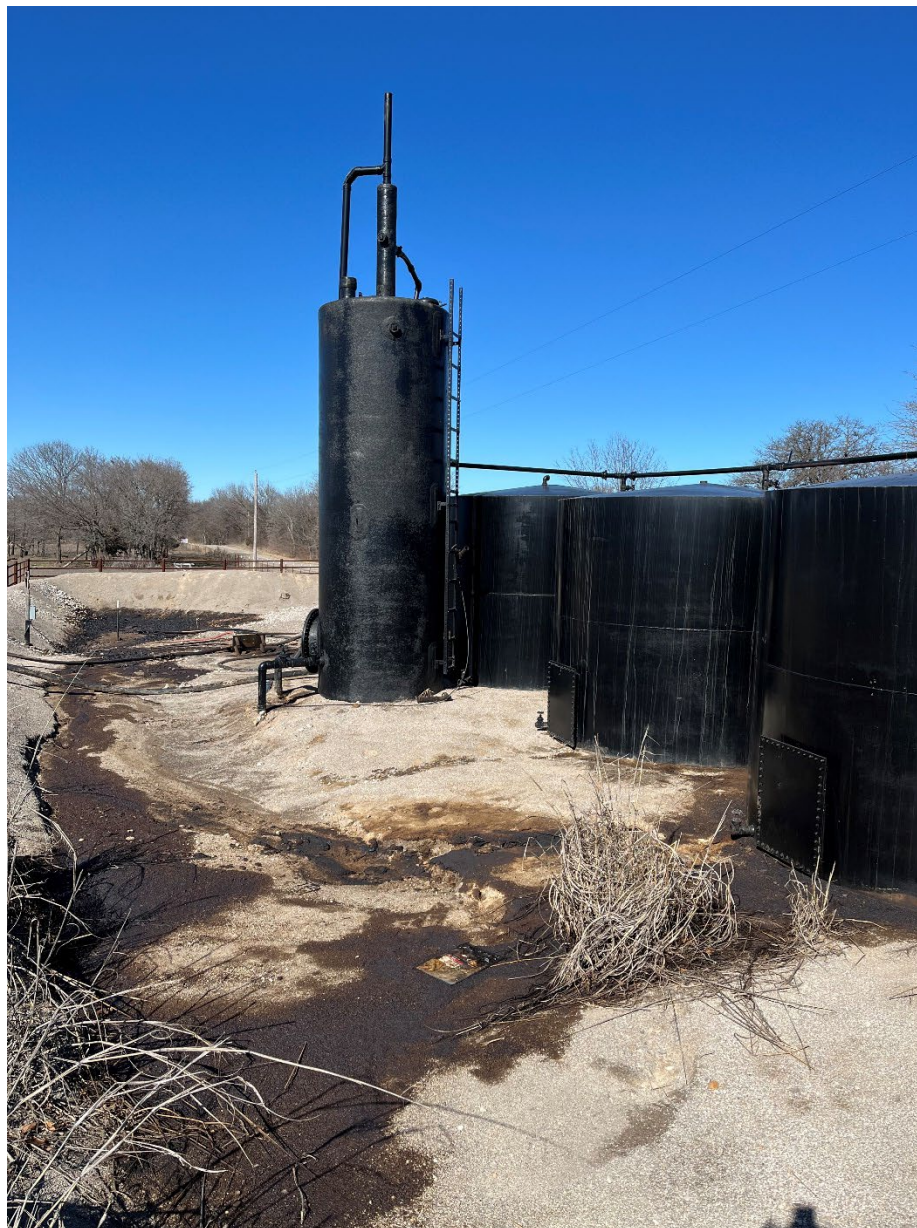
Photo No. 3

I observed the west side of the facility. At the time of the inspection, there was significant oil staining on the soil, gravel and vegetation inside the facilities' secondary containment. This facility overview and oil staining can be seen in photo No. 3.

**Description:** This was a view down the west side of the facility showing the oil-stained floor of the facility.

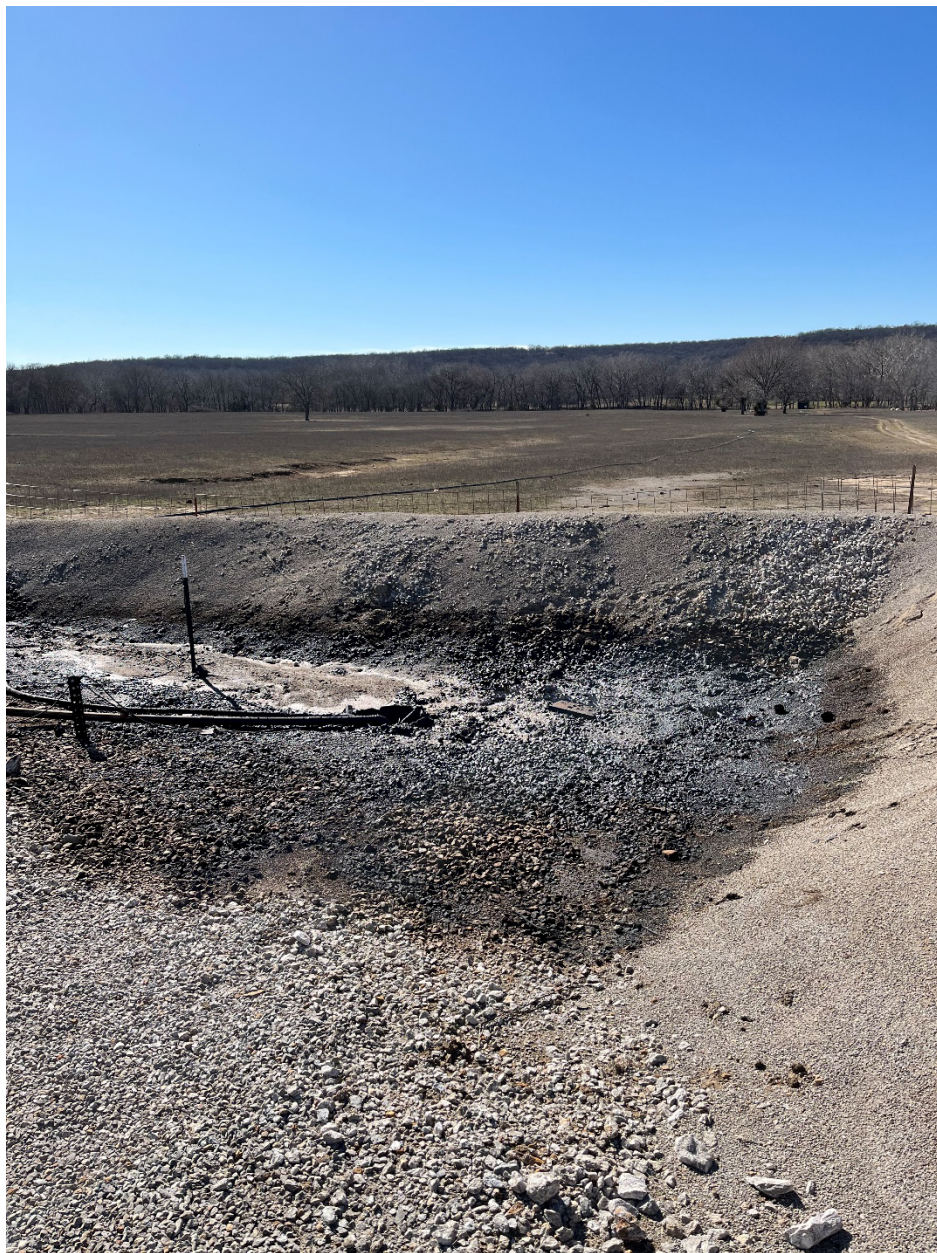
Photo No. 4

I observed the oil-stained sump/pit area at the northwest corner of the facility. See photo No. 4.

**Description:** This was a view of the sump/pit area with oil-stained soil/gravel present.

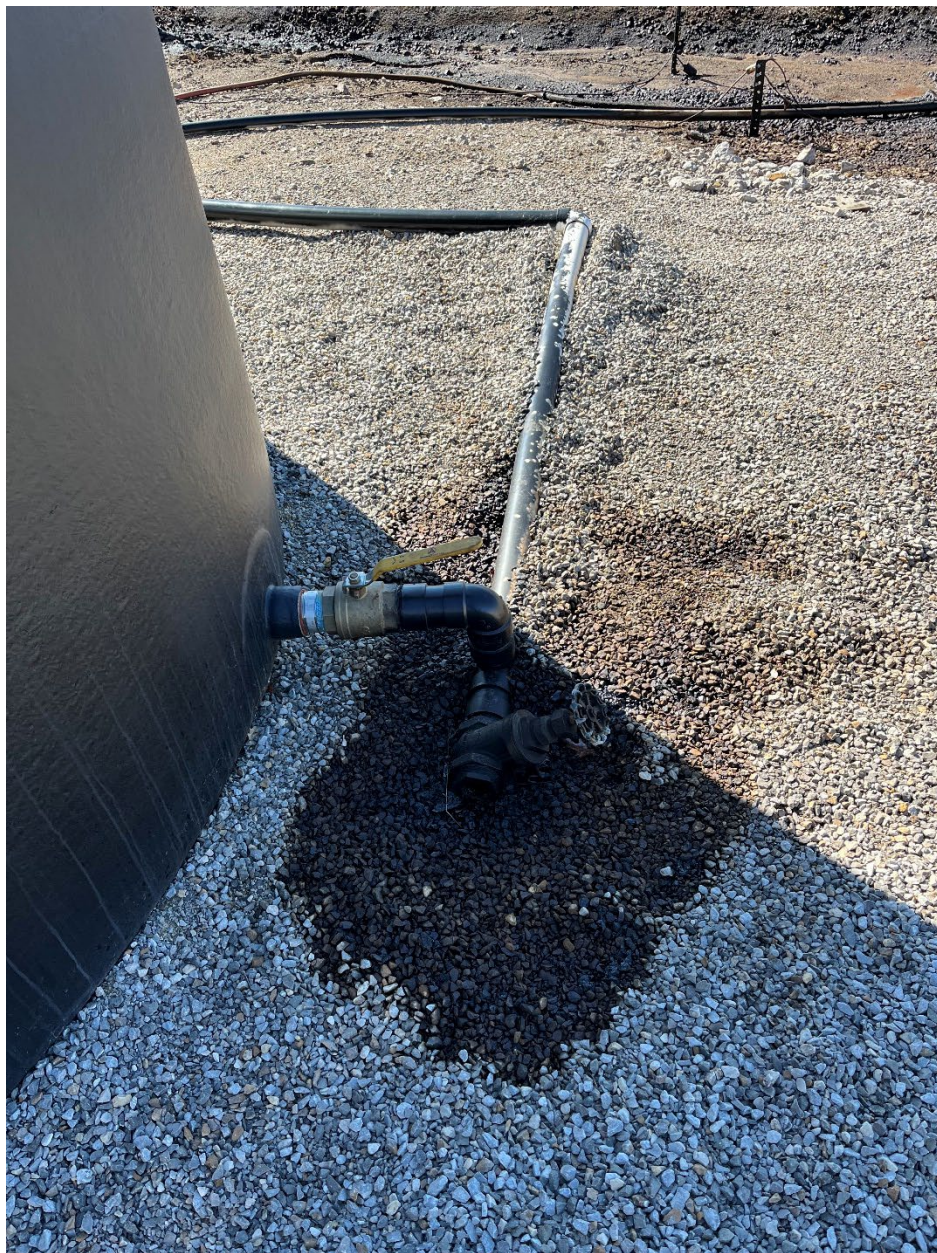
Photo No. 5

I observed an oil-stained area immediately north of the northernmost tank at the facility. This area appeared to be caused by leaking piping or valves. See photo No. 5.

**Description:** This was an oil-stained area inside the facility.

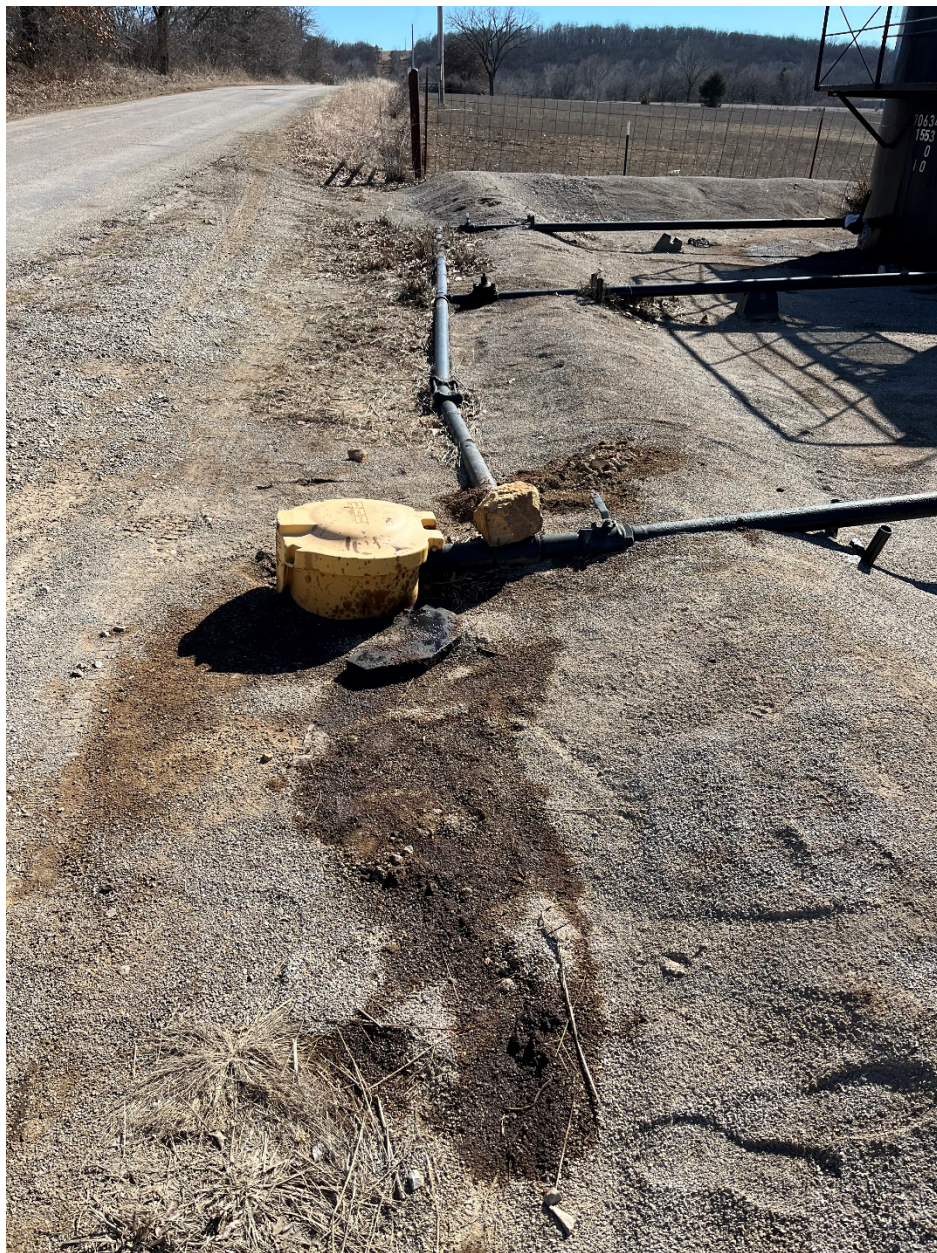
Photo No. 6

I observed the facilities' loading area, which was located outside of the secondary containment. There was oil-stained soil/gravel present at the time of the inspection. See photo No. 6.

**Description:** This was an oil-stained area, outside the secondary containment, at the loading area.
