**Region 6 - Enforcement & Compliance Assurance Division**  
**INSPECTION REPORT**

| Inspection Date(s): | 01/20/2022 | |
| Company Name: | <b>Village of Taos Ski Valley</b> | |
| Facility Name: | <b>Taos Ski Valley WWTP</b> | |

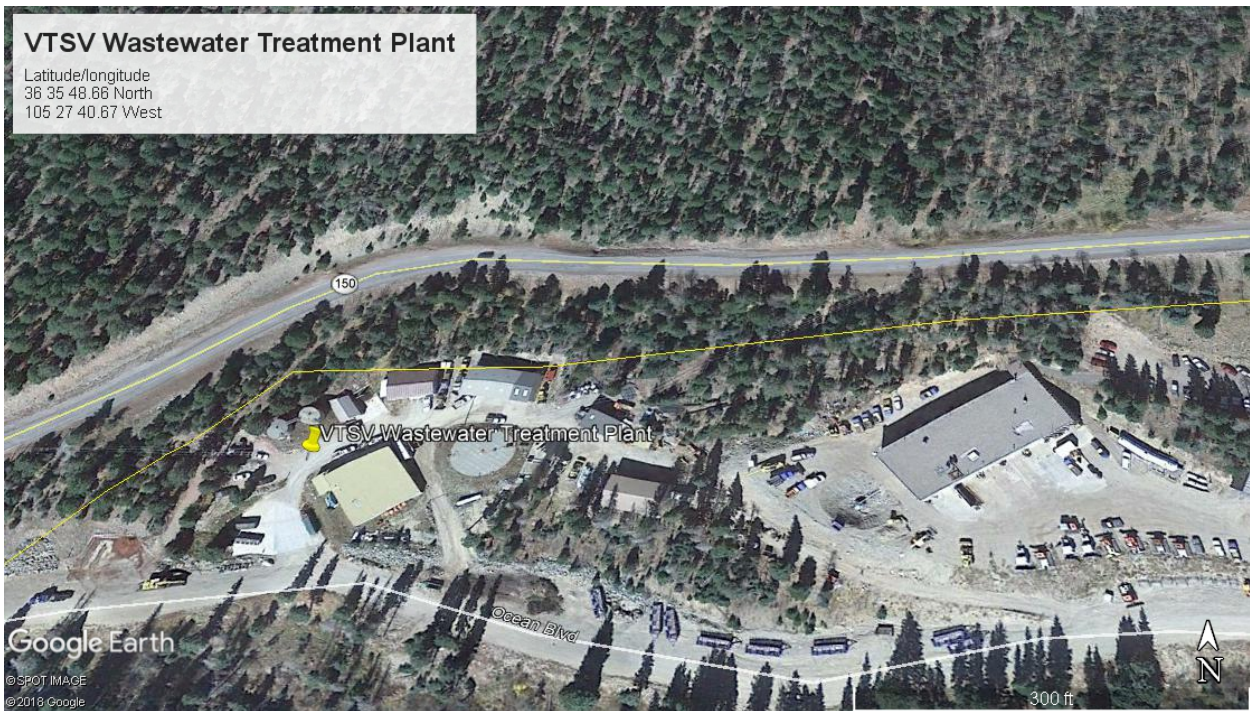
**Aerial Image #1:** Overall view of the Village of Taos Ski Valley's Wastewater Treatment Plant. Aerial from Google Earth maps.

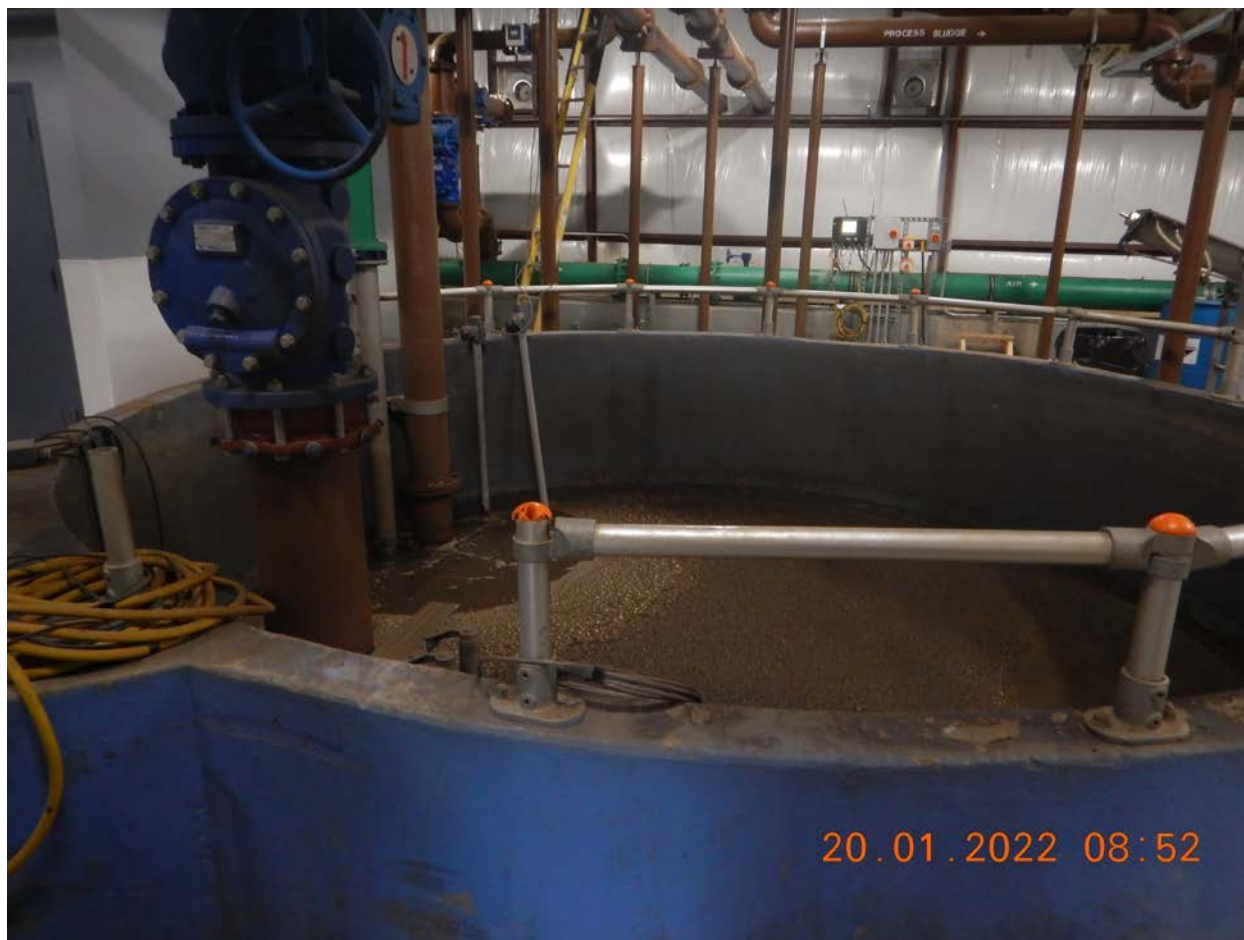
Photo No. 1

View of one (1) of the two (2) in-ground equalization (EQ) basins, i.e., an anoxic EQ basin with mixers and a steel EQ basin after receipt of flow from the headworks. (DSCN2108). Photographed by D. Esparza

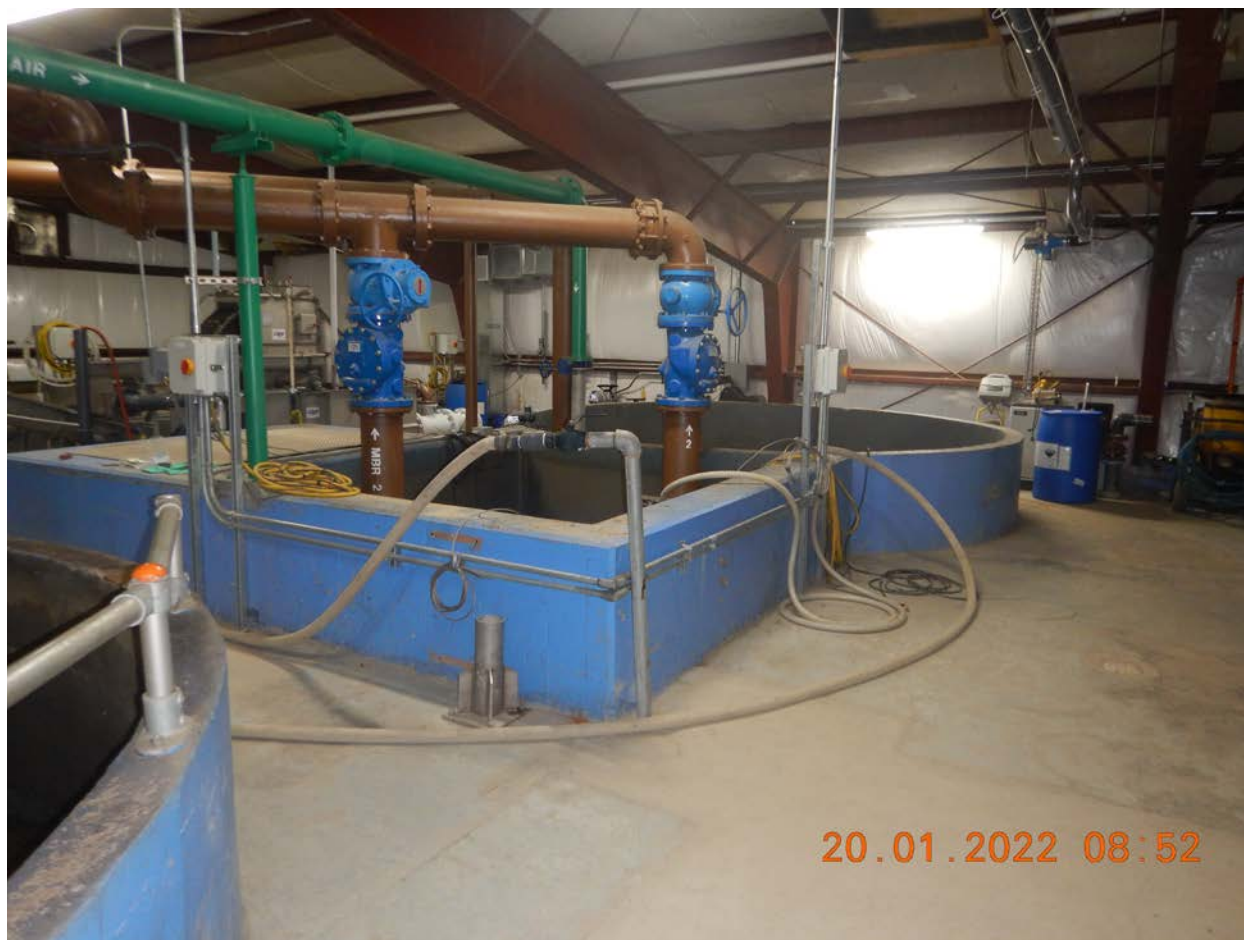
Photo No. 2

Another view of the in-ground equalization (EQ) basins. (DSCN2109). Photographed by D. Esparza

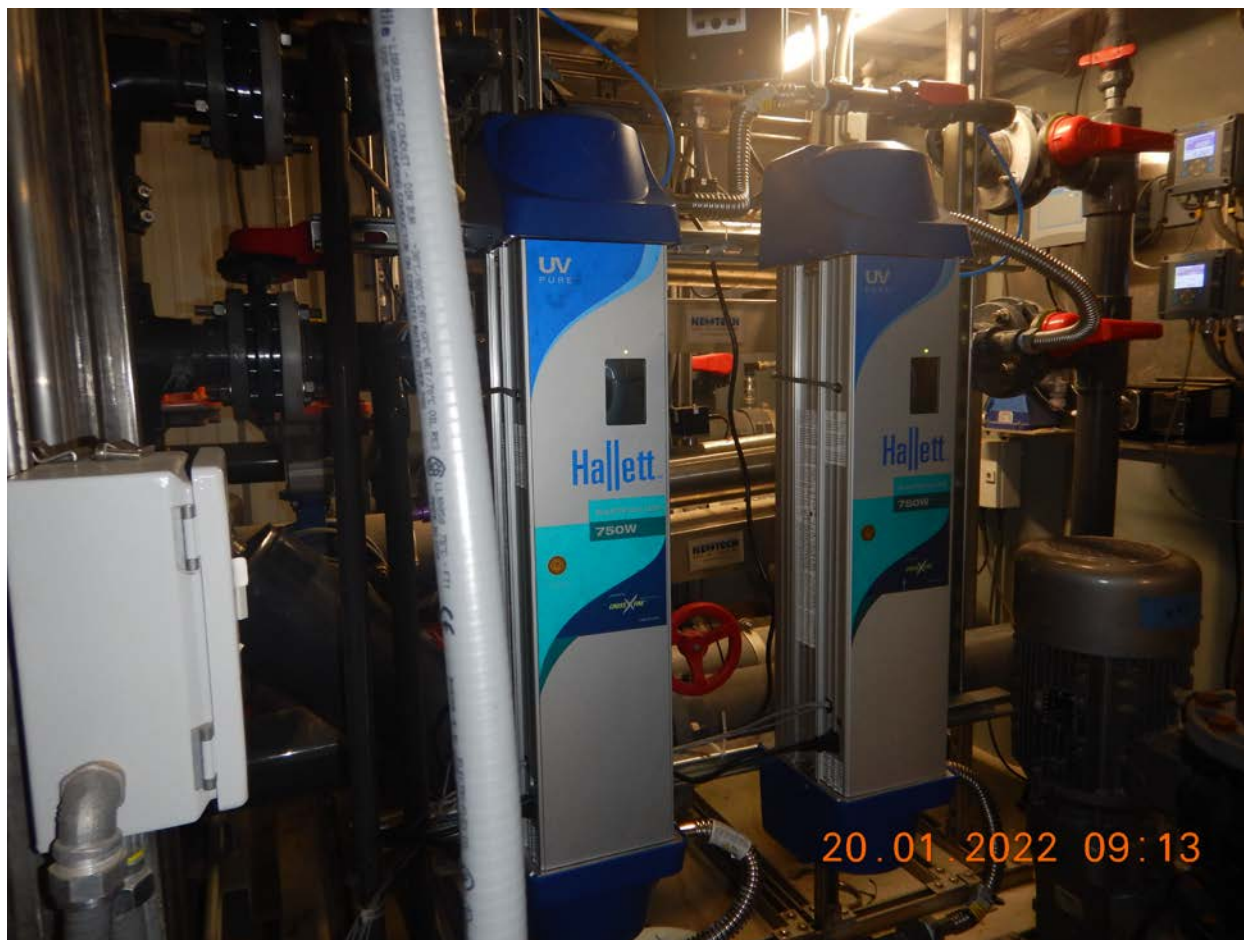
Photo No. 3

- The June 2019 improvements included upgrades to the WWTP UV disinfection system, a Supervisory Control and Data Acquisition (SCADA) instrumentation and placement of an Ovivo Membrane Bioreactor (MBR) system(Appendix 1 Photograph #3 and Photograph #4).
- The WWTP maintains an on-site generator for back up that is exercised every two (2) weeks.
- At the time of the inspection, I was informed that a Sanitary Sewer Overflow (SSO) had occurred in November 2021 and was duly reported.
- Overall maintenance and operation of the WWTP appeared to be satisfactory. All equipment looked to be running properly.

View of the upgraded UV disinfection system in conjunction with the Ovivo Membrane Bioreactor (MBR) system. (DSCN2113). Photographed by D. Esparza

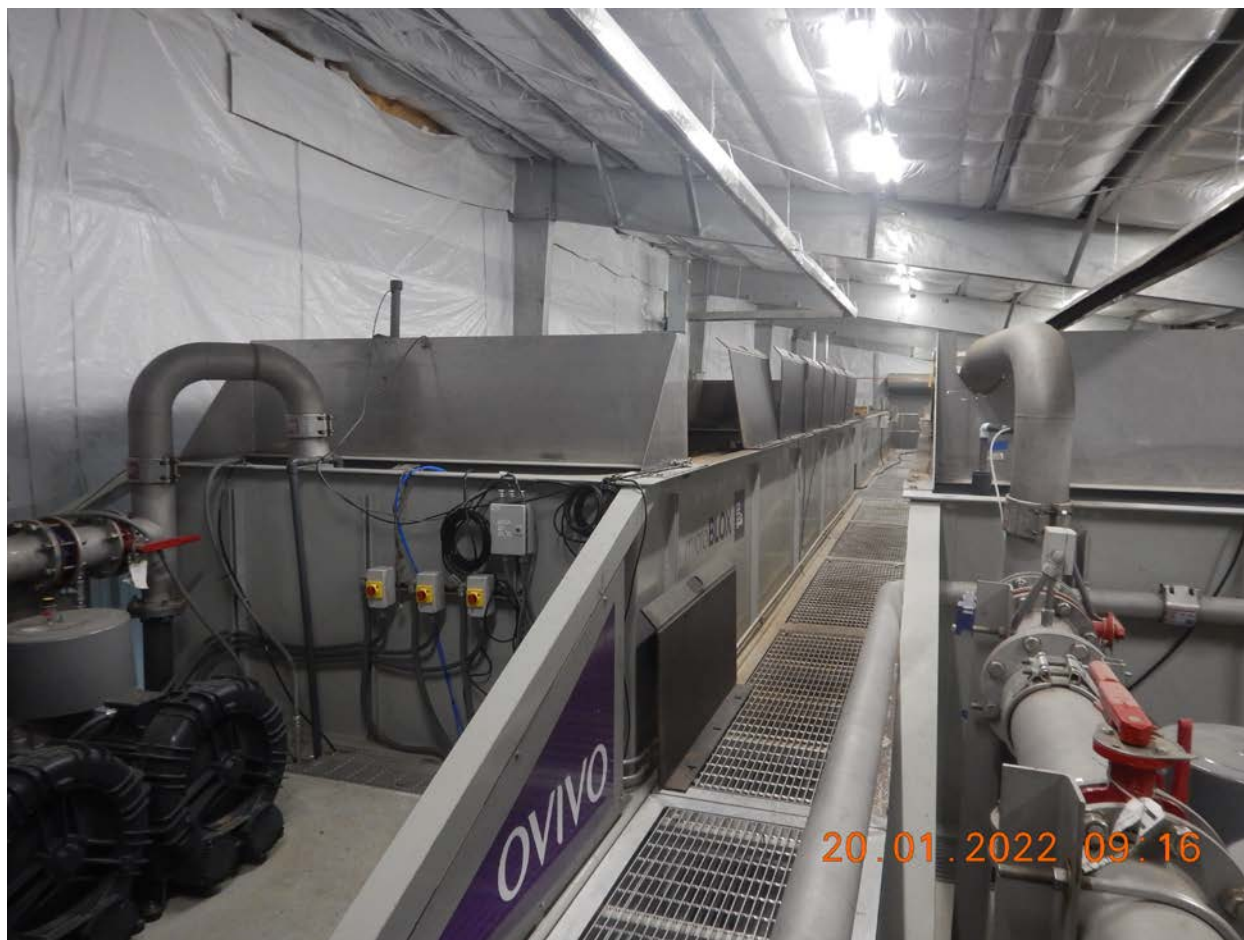
Photo No. 4

A view of a portion of the Ovivo Membrane Bioreactor (MBR) system. (DSCN2114). Photographed by D. Esparza

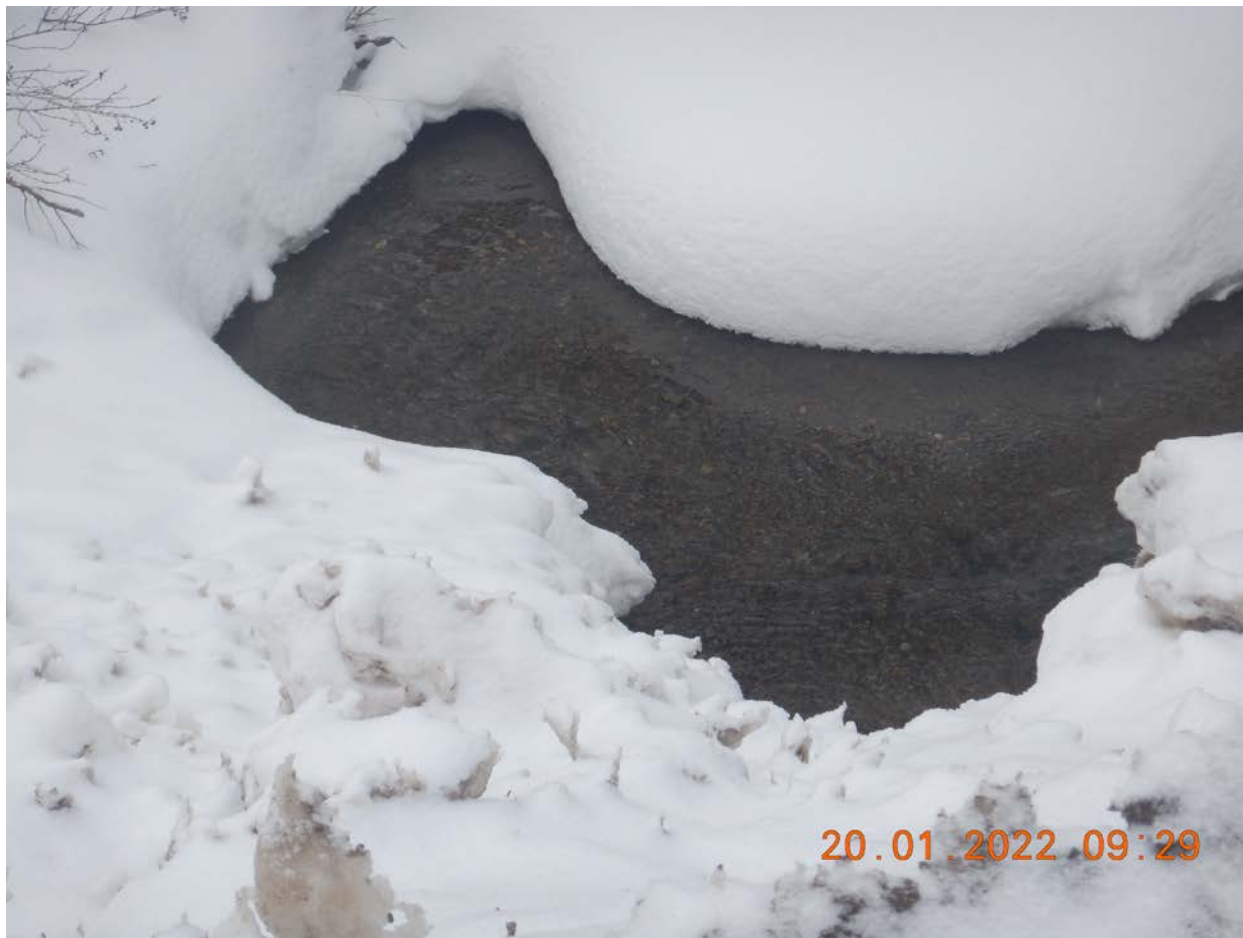
Photo No. 5

View of the WWTP's Outfall into the Rio Hondo a tributary to the Rio Grande. Note: no visible staining, aromatics or stressed vegetation was observed. (DSCN 2118). Photographed by D. Esparza
