**Region 6 - Enforcement & Compliance Assurance Division**  
**INSPECTION REPORT**

| Inspection Date(s): | 03/05/2025 | |
| Company Name: | <b>Randall County Feedyard</b> | |
| Identification/Permit Number: | TXG920456 | |

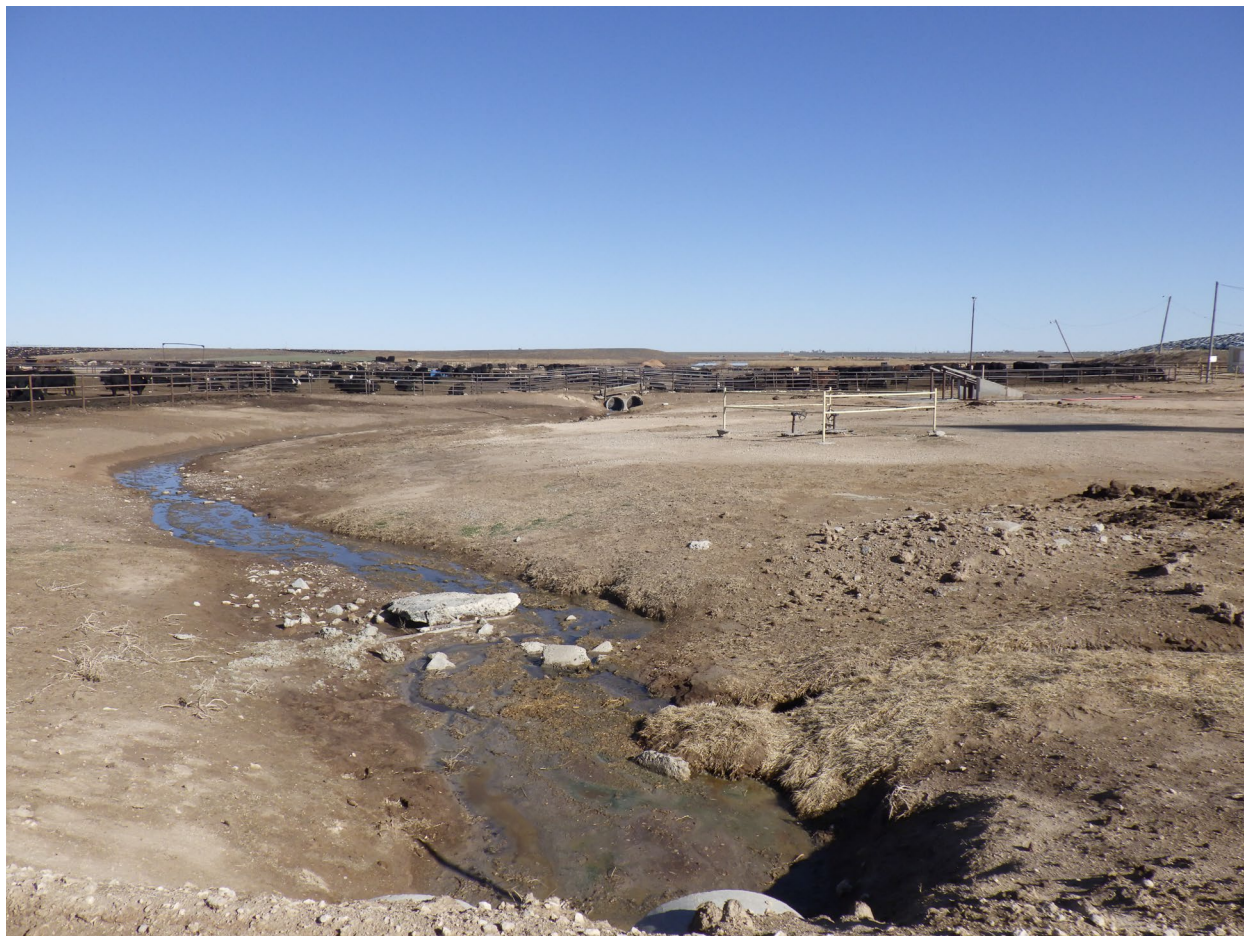
Photo No. 1

All the berms on-site were in good condition. Drainage channels were properly routing runoff to the playa during the inspection without any signs of problems (Appendix 1, Photos 1, 3, 5, & 11).

Description: View to the north. Drainage channel through the open lot pens routed to the playa.

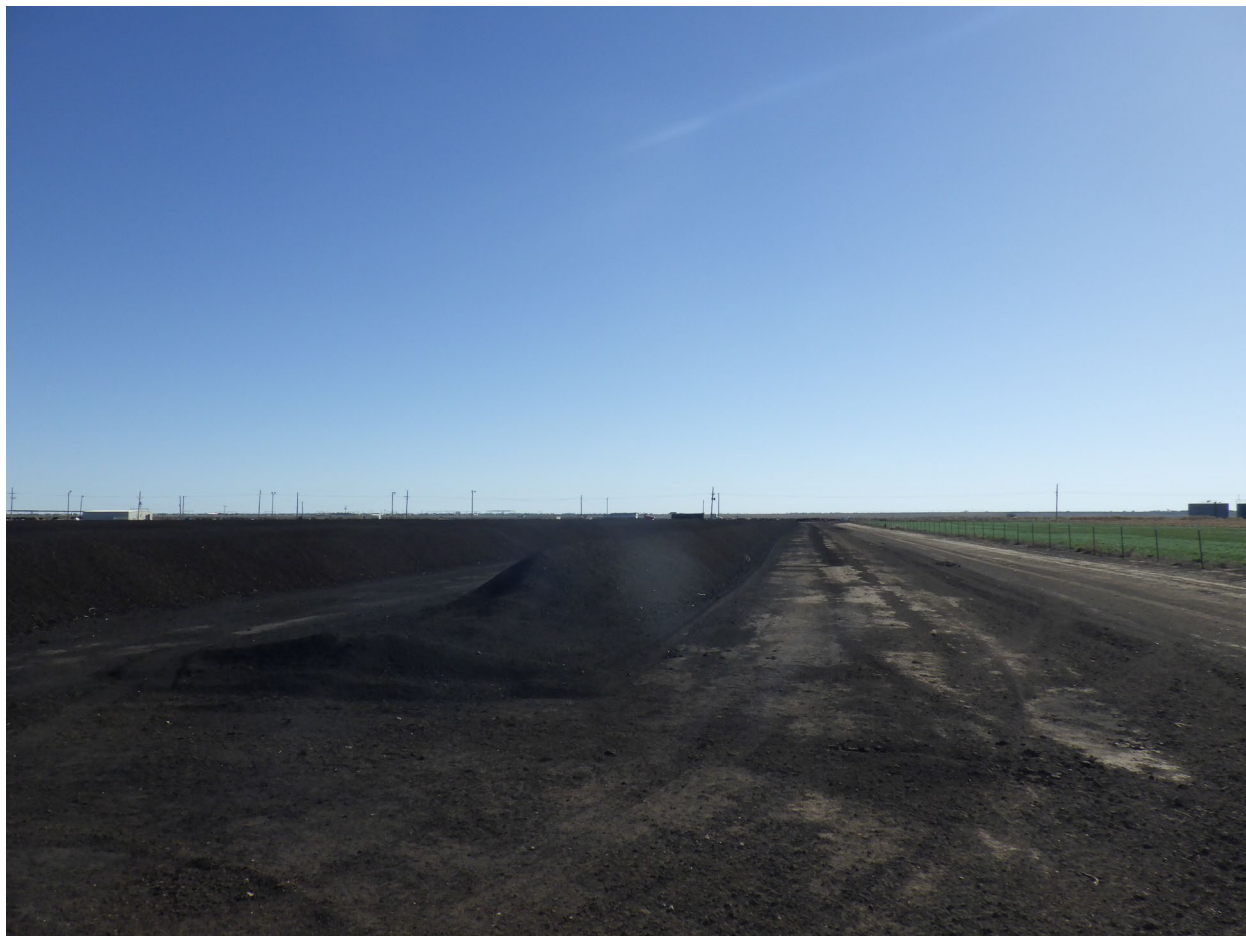
Photo No. 2

Randall County Feedyard has the requirements to meet the large CAFO regulatory definition. The open lot pens were clean and without any visible manure piles inside the pens. All manure stockpiles and composting on-site were within the drainage of an RCS (Appendix 1, Photos 2 & 3).

Description: View to the east. Manure compost with pens in background.

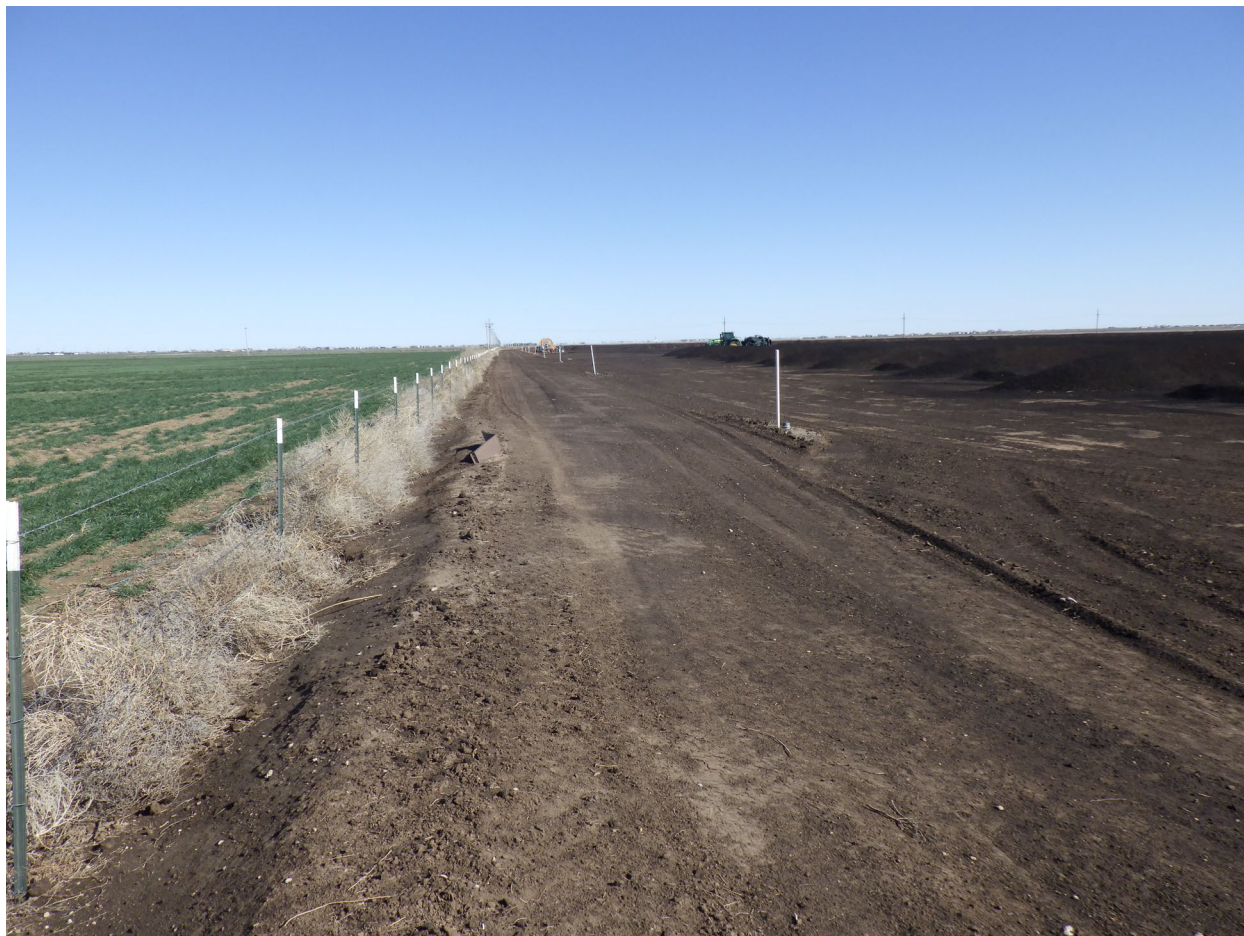
Photo No. 3

Description: View to the north. Berm on the perimeter of the manure compost site.

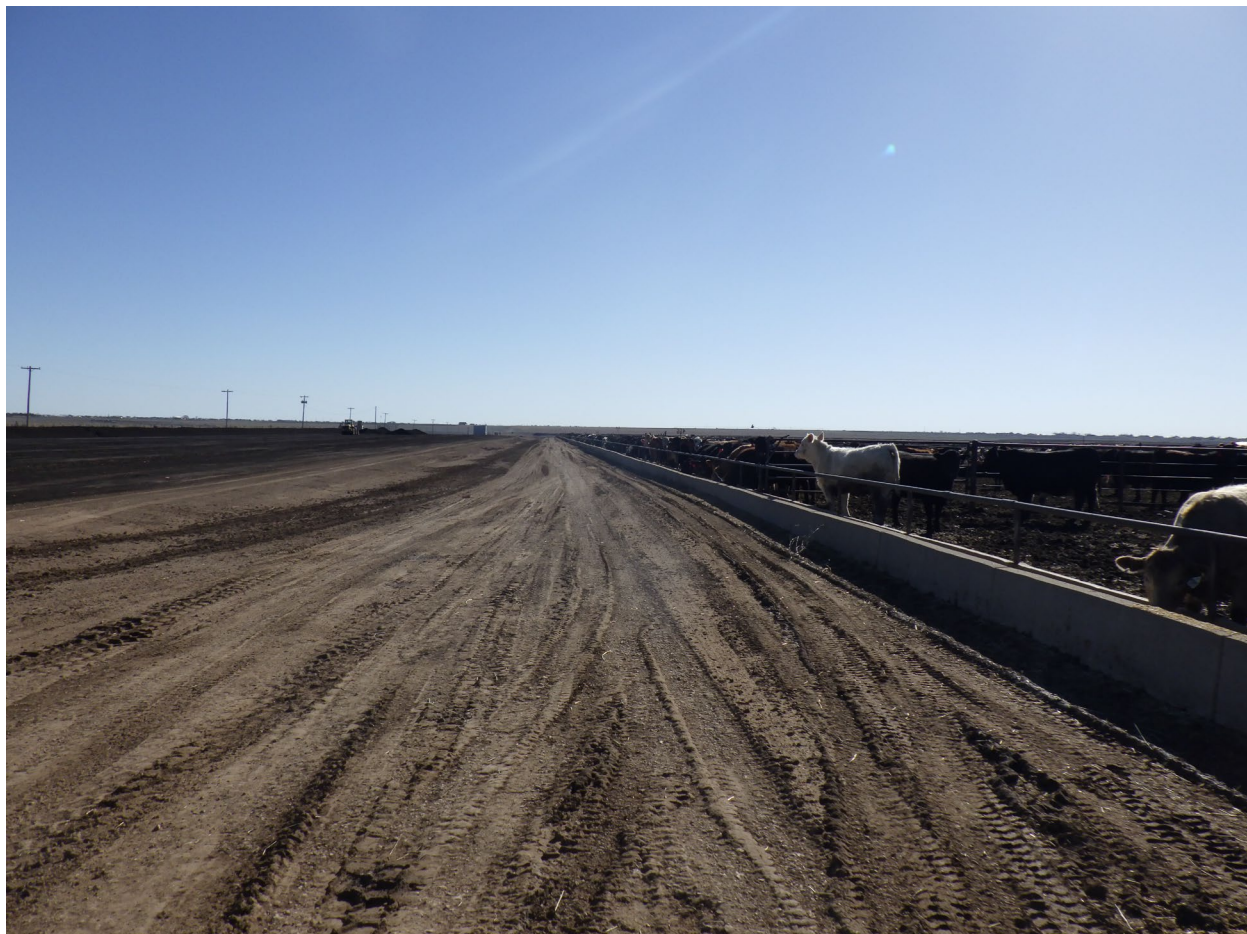
Photo No. 4

Description: View to the east. Northern perimeter of the open lot pens with concrete barrier.

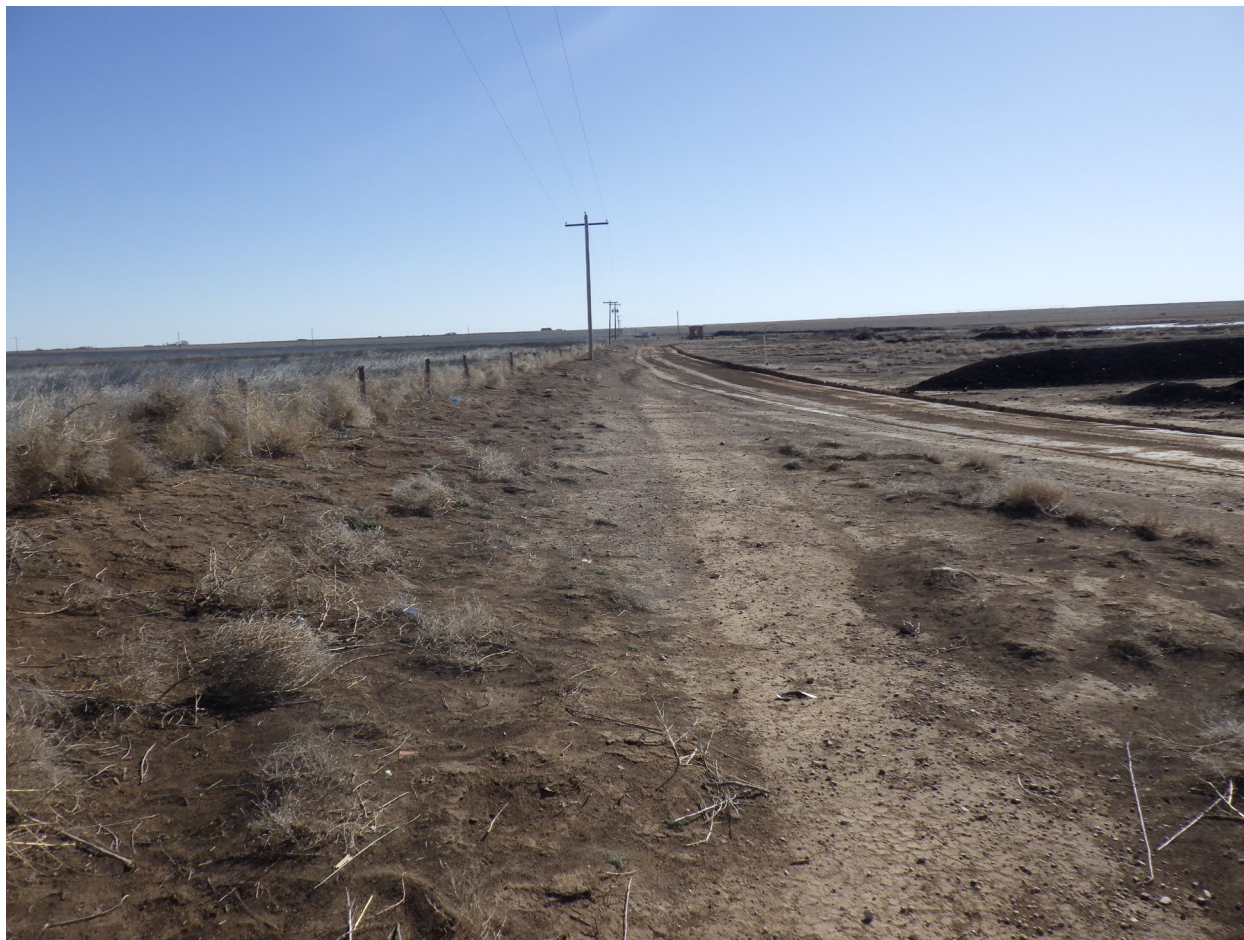
Photo No. 5

The mortality composting site was bermed on the perimeter, in the drainage of the RCS, and not built in a floodplain (Appendix 1, Photos 5 & 6).

Description: View to the east. Berm around the mortality compost site.

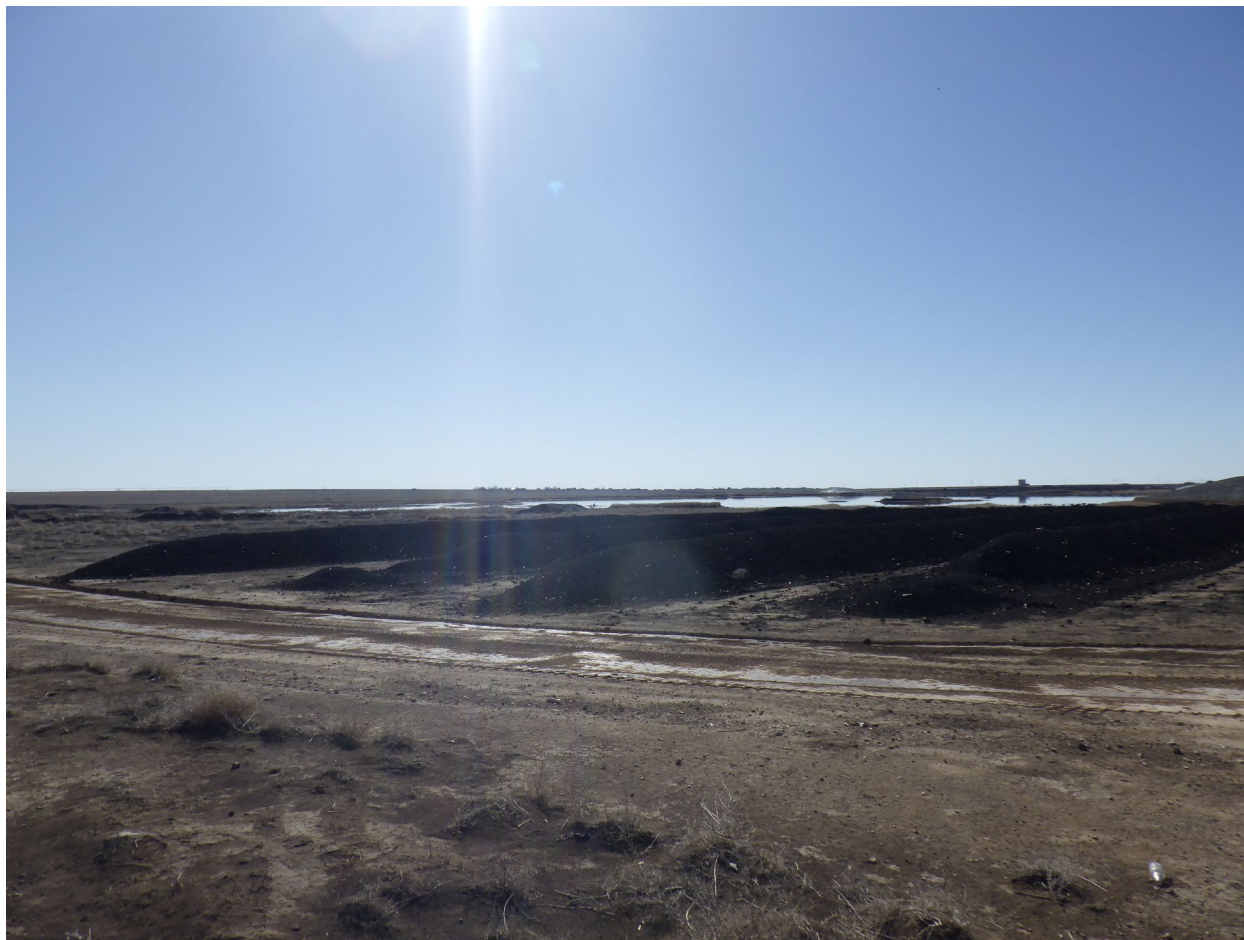
Photo No. 6

Description: View to the southeast. Mortality compost site with the playa in the background.

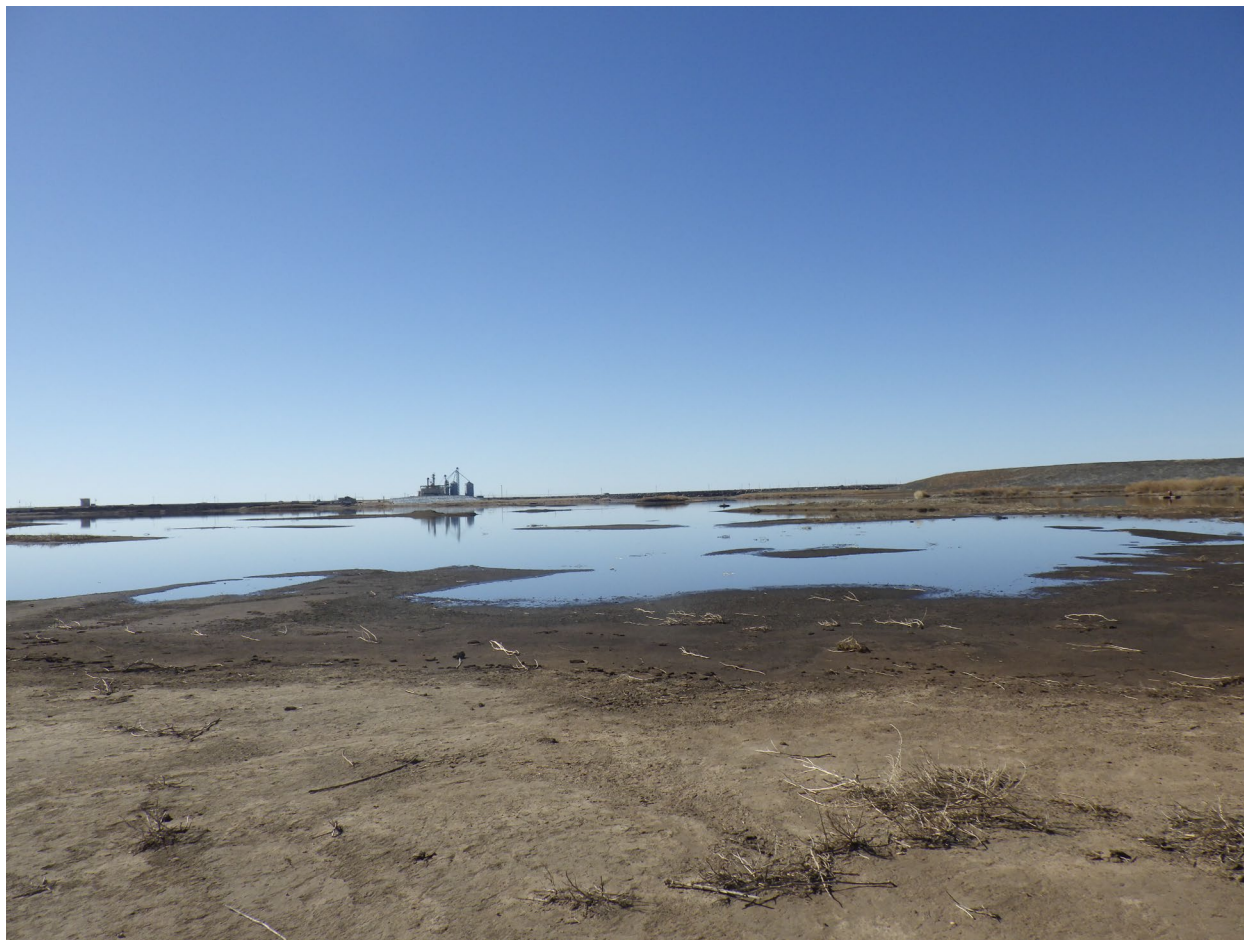
Photo No. 7

A check of the playa design and as-builts showed adequate storage for the production area and 25-year/24-hour rain event. Minimum required capacity is 807.95 ac/ft (acre-feet), and the playa capacity is 1,055.80 ac/ft. The playa is clay lined and certified by Norman Mullin from Enviro Ag Engineering on 10/25/1994. Infiltration tests were all shown to be above the minimum requirement of hydraulic conductivities no greater than  $1 \times 10^{-7}$  centimeters per second performed 12/14/1993. A visual check of the playa was conducted and there was adequate freeboard, pole marker, lack of erosion, no solids overloading, and no evidence of unauthorized discharge (Appendix 1, Photos 7, 8, 9, & 10).

Description: View to the southwest. Playa with the commodity storage silos in the background.

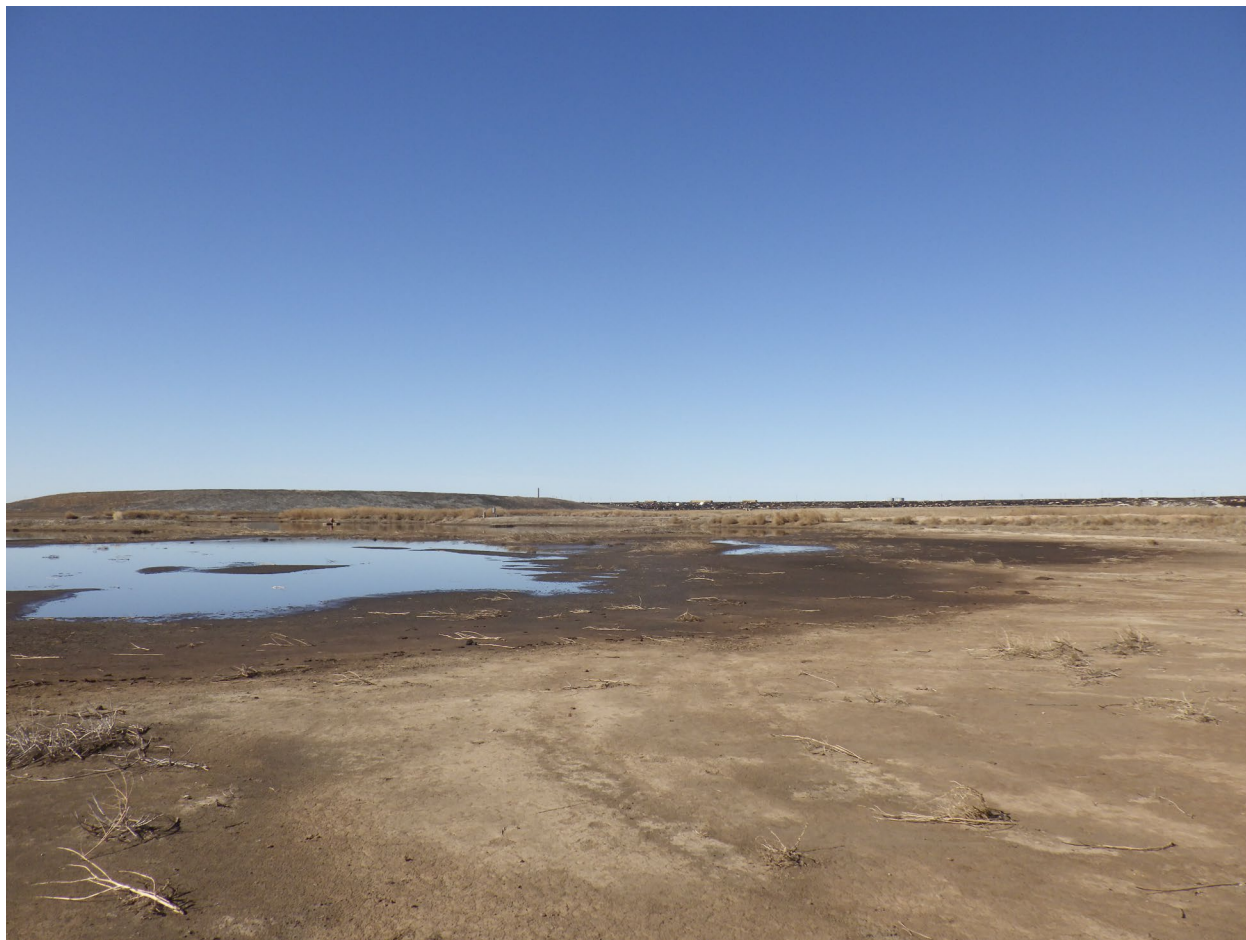
Photo No. 8

Description: View to the northwest. Playa with pens and mortality composting in background.

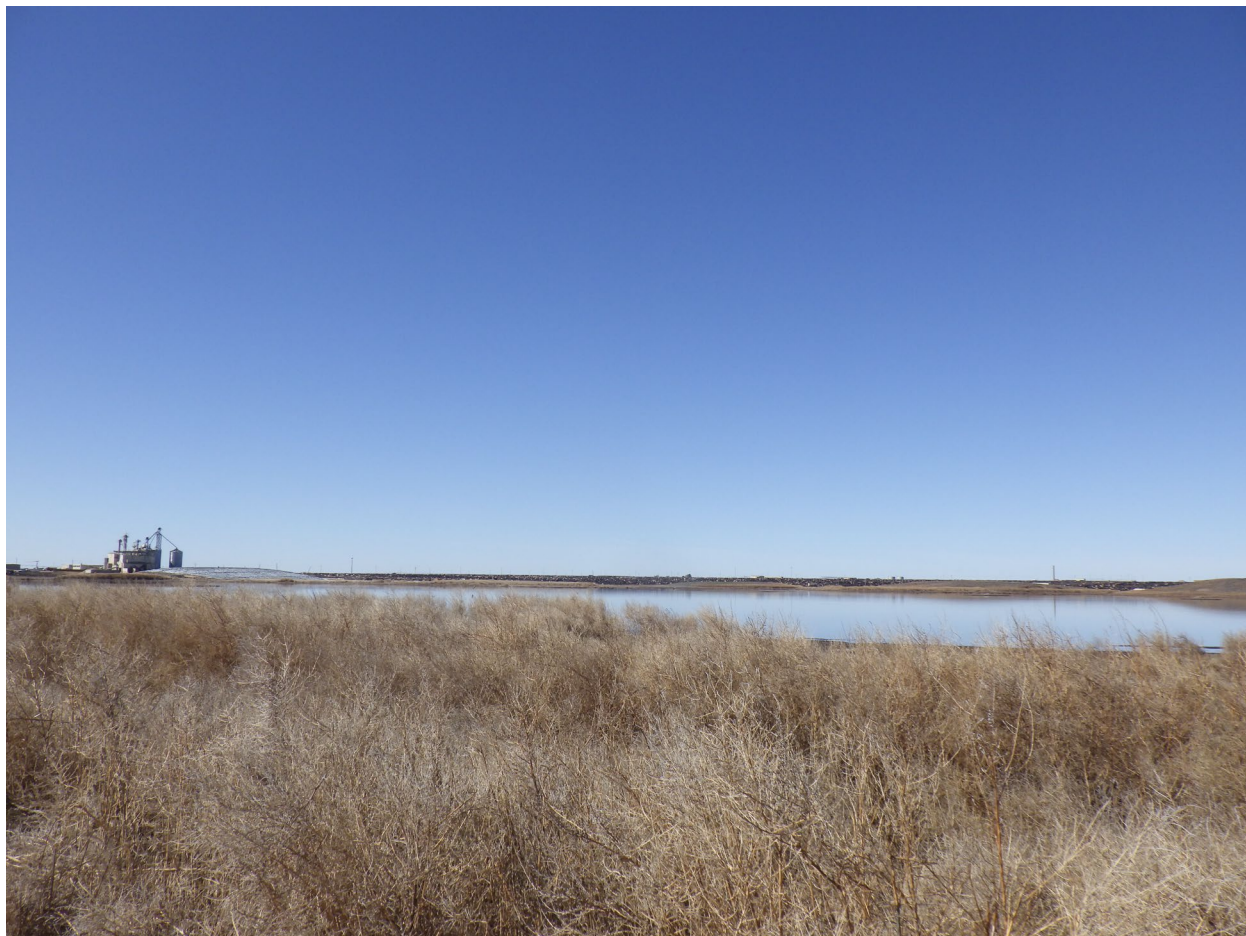
Photo No. 9

Description: View to the west. Playa with pens and commodity storage silos in background.

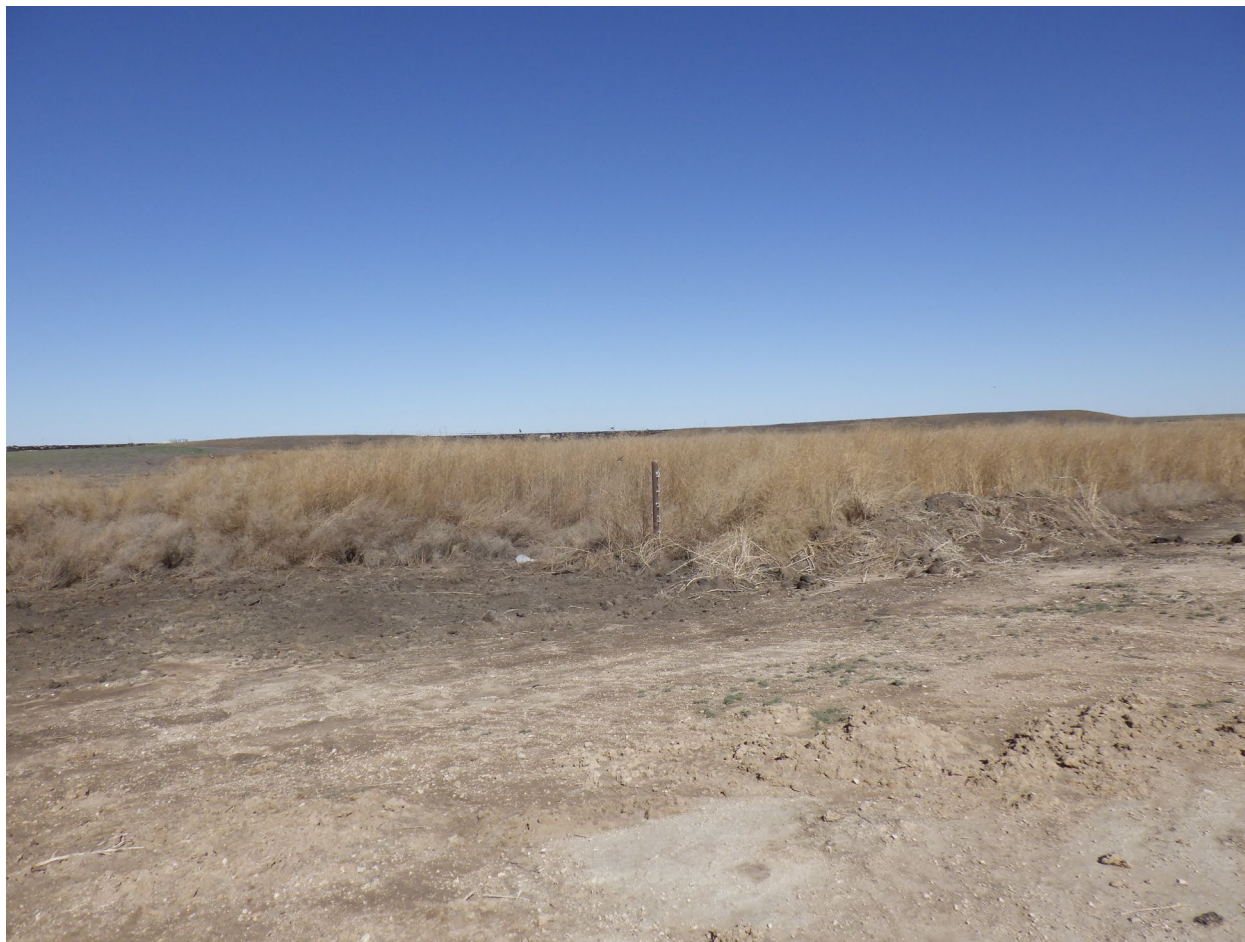
Photo No. 10

Description: View to the west. Pole marker for the playa.

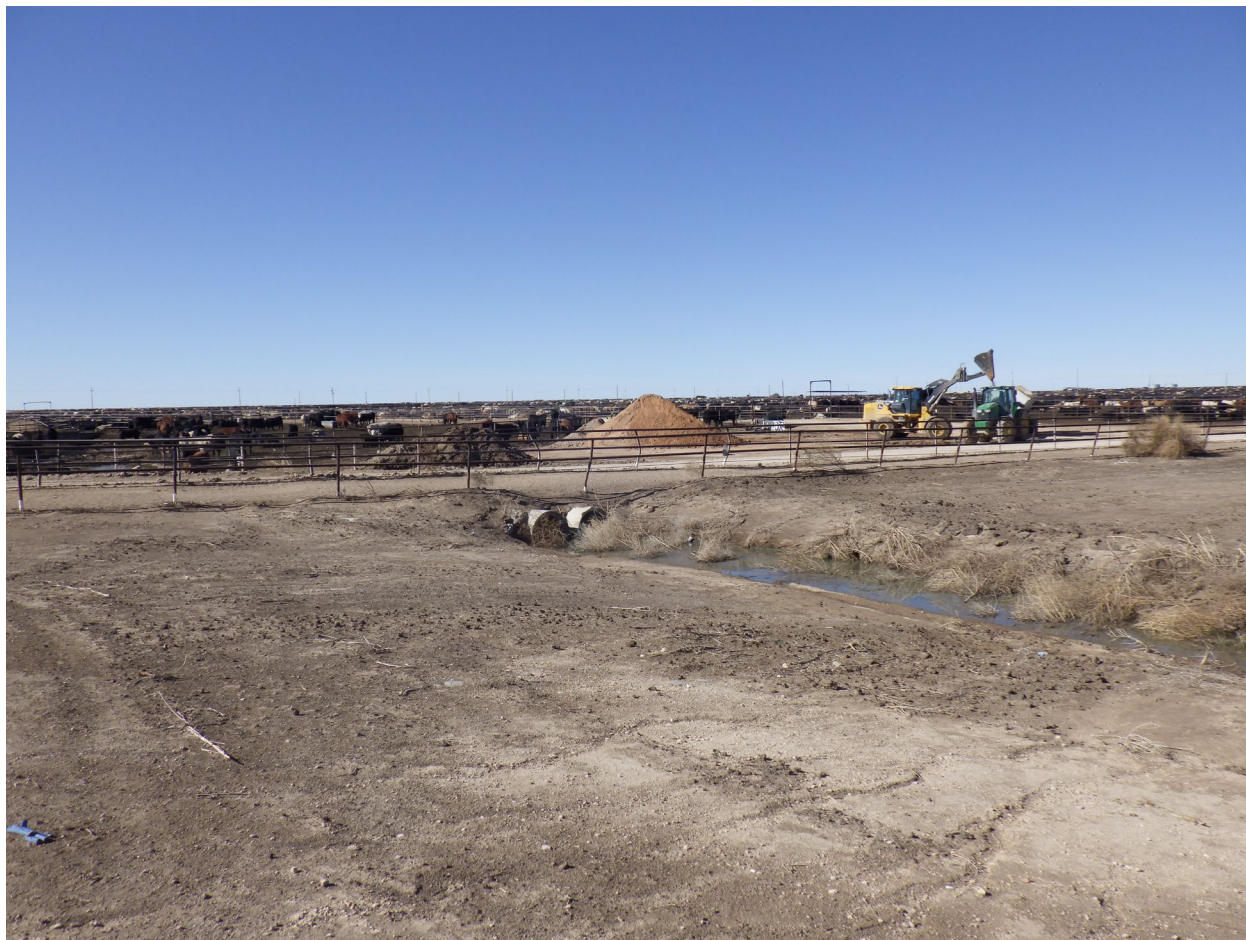
Photo No. 11

Description: View to the southwest. Drainage channel coming from open pens that is routed to playa.

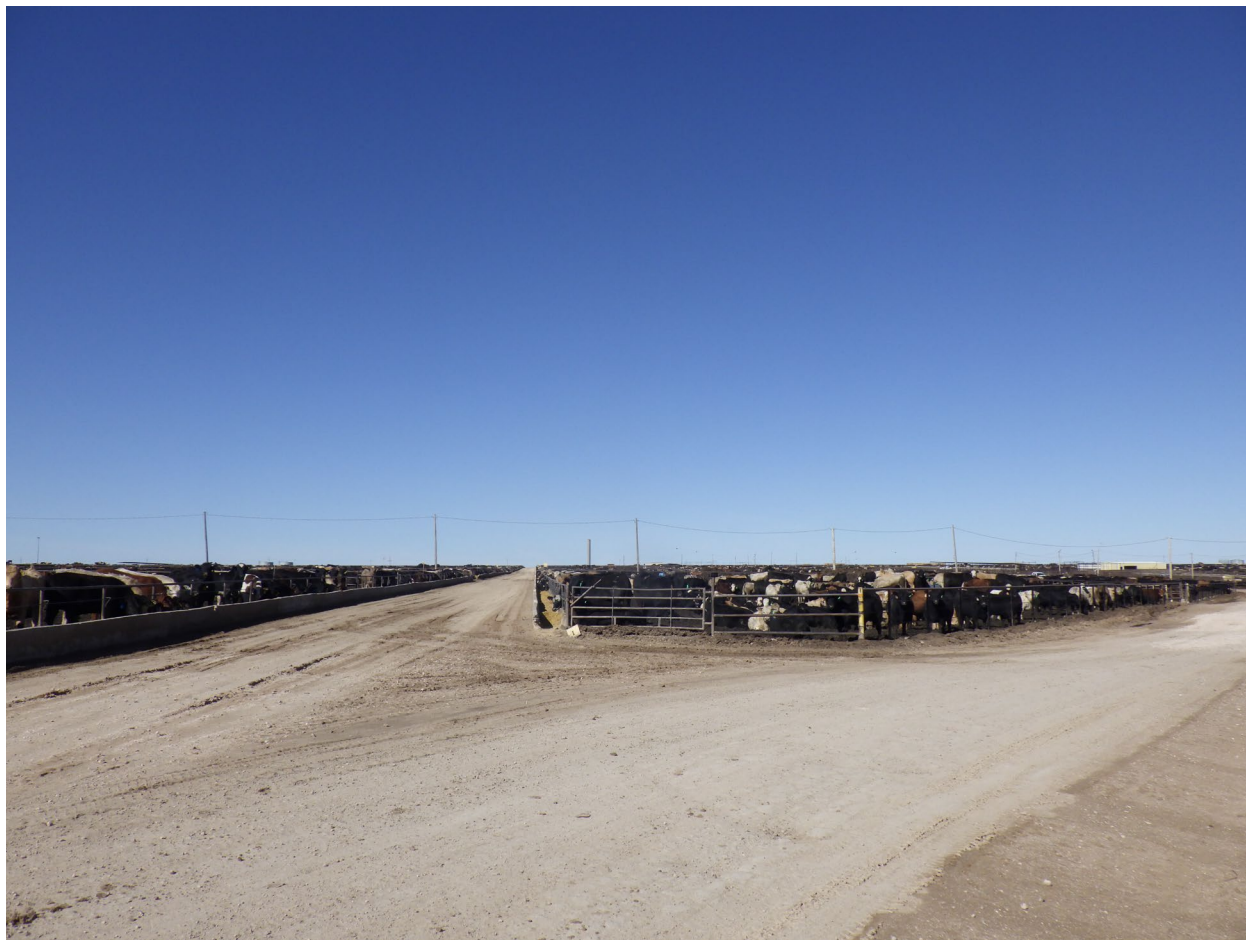
Photo No. 12

Description: View to the west. Shot of the open lot pens showing grading of pens toward the playa.
