**UNITED STATES ENVIRONMENTAL PROTECTION AGENCY  
REGION 8  
RESOURCE CONSERVATION AND RECOVERY ACT**

**Facility Name:** Calpet - La Barge COWDF      **Facility Location:** 42.393747, -110.273988

**Date of Inspection:** May 16, 2023

**Type and Purpose of Inspection:** Compliance Evaluation Inspection

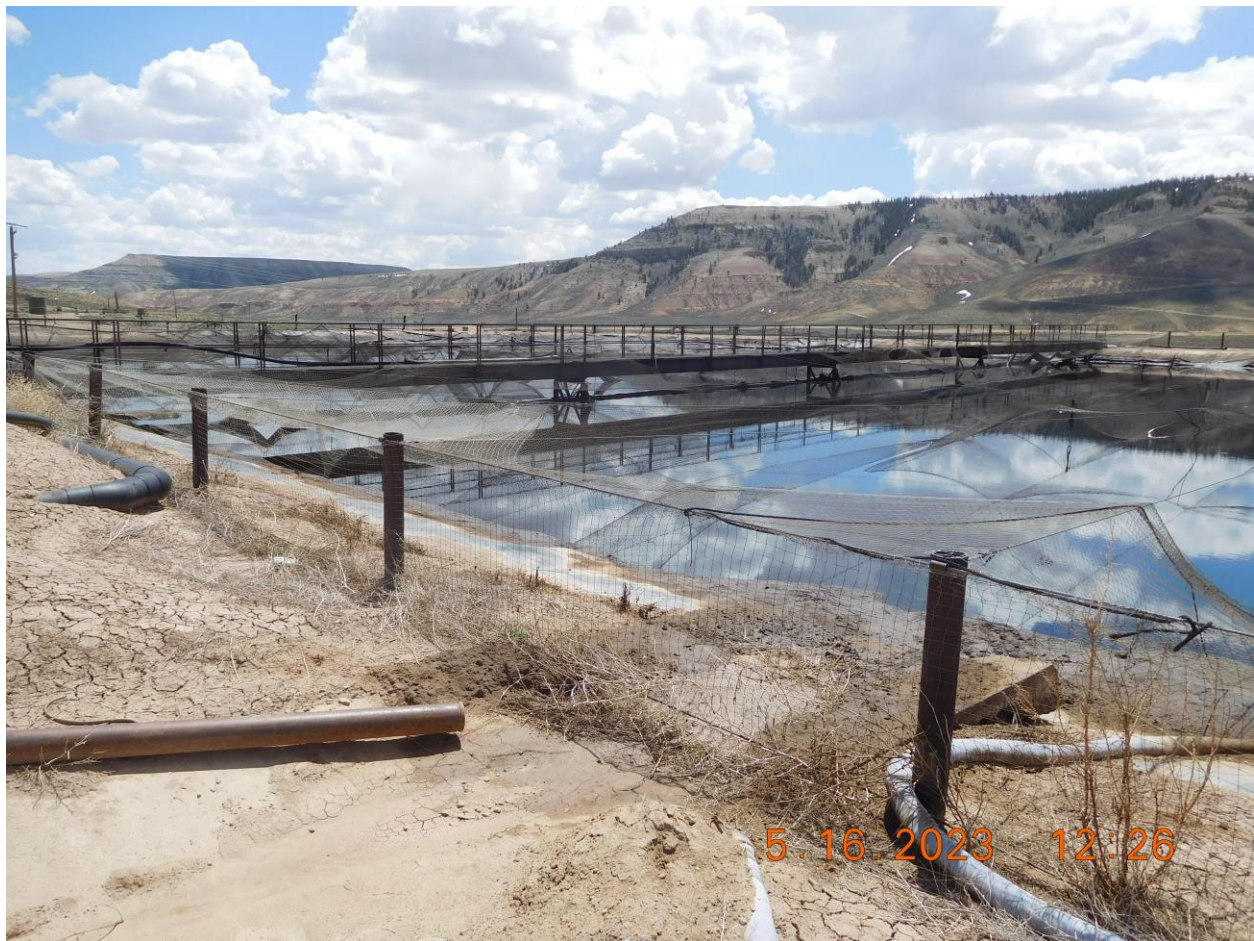
During the inspection, I observed that netting over the slop/skim pit, referred to as Pond 4, was sagging into the oily waste with oil exposed above the extent of the netting on the east side of the pond. Significant bad weather in the weeks and months before the inspection appeared to be the cause. Mr. Merritt stated that the ponds had only recently thawed out. Mr. Ellingford stated that the entire section of netting would be pulled down and replaced. See photos 2012-2014 and 2021. All inspection photos are included in a photo log attached as Appendix 2.

Photo 2012, DSCN2012.JPG, photo of the netting over pond 4, the slop/skim pit, facing south/southeast. The netting was very degraded and dipped into the pond on the eastern portion of the pond.

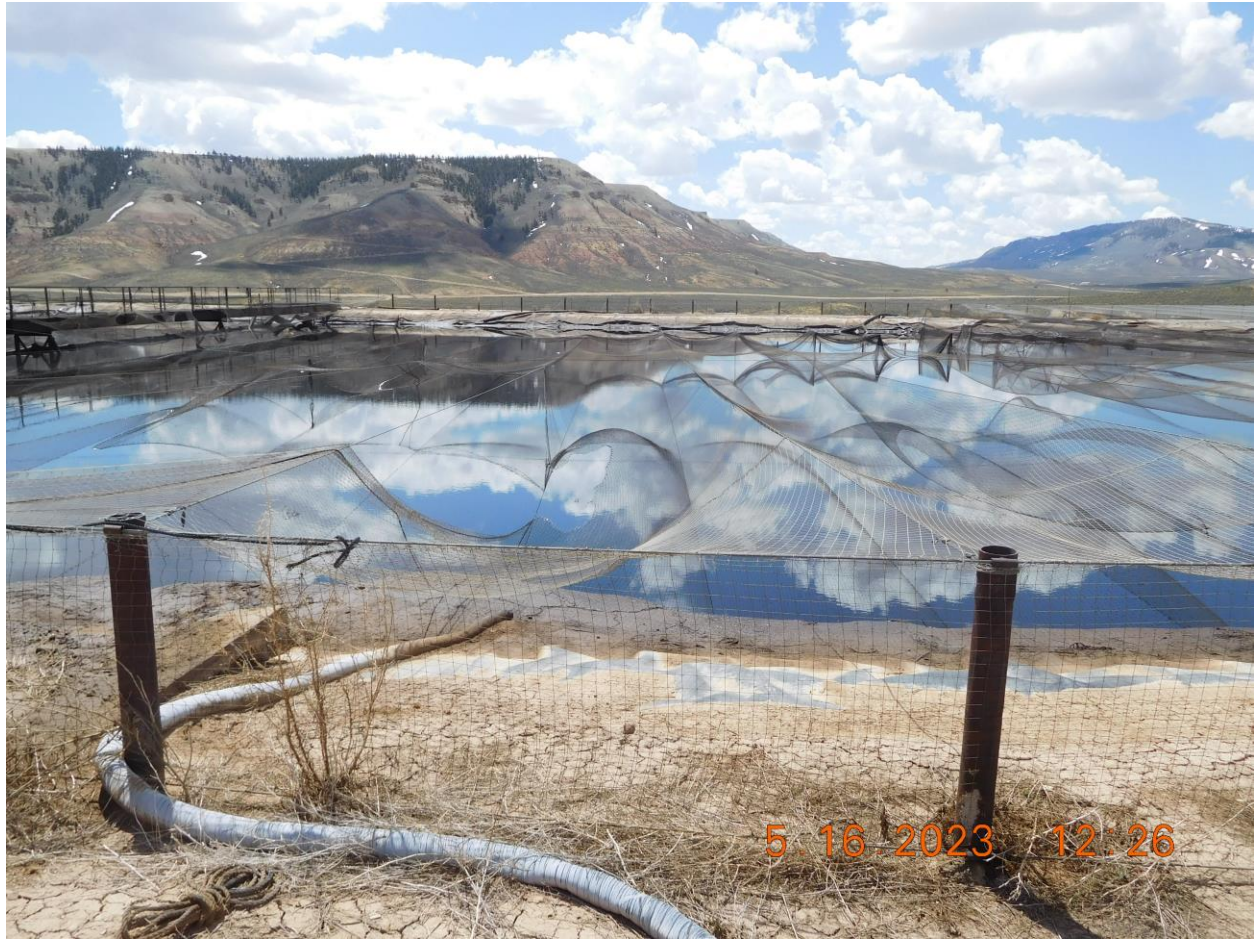
Photo 2013, DSCN2013.JPG, photo of the same area shown in photo 2012, panned right.

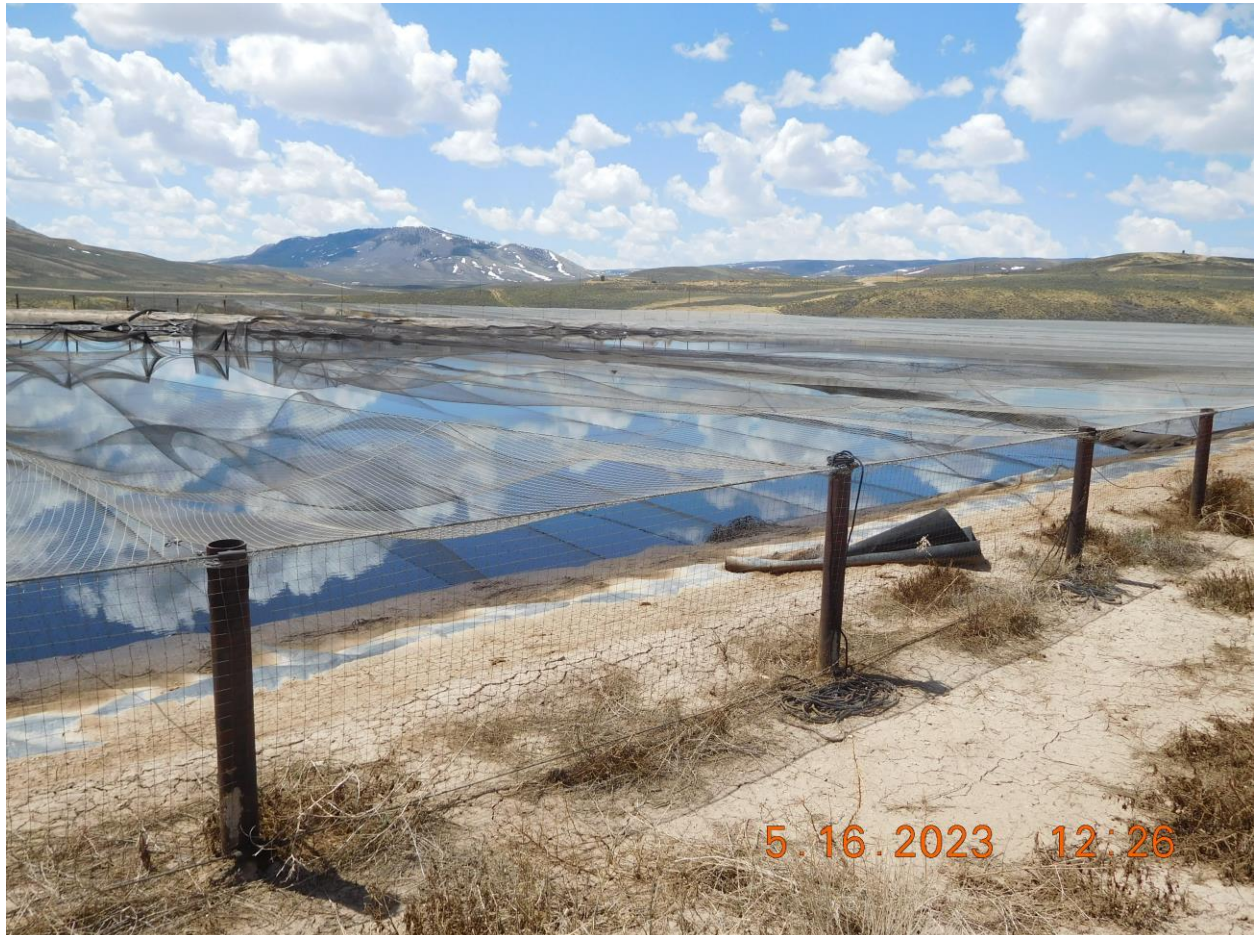
Photo 2014, DSCN2014.JPG, photo of the same area as that shown in photos 2012 and 2013, panned right.

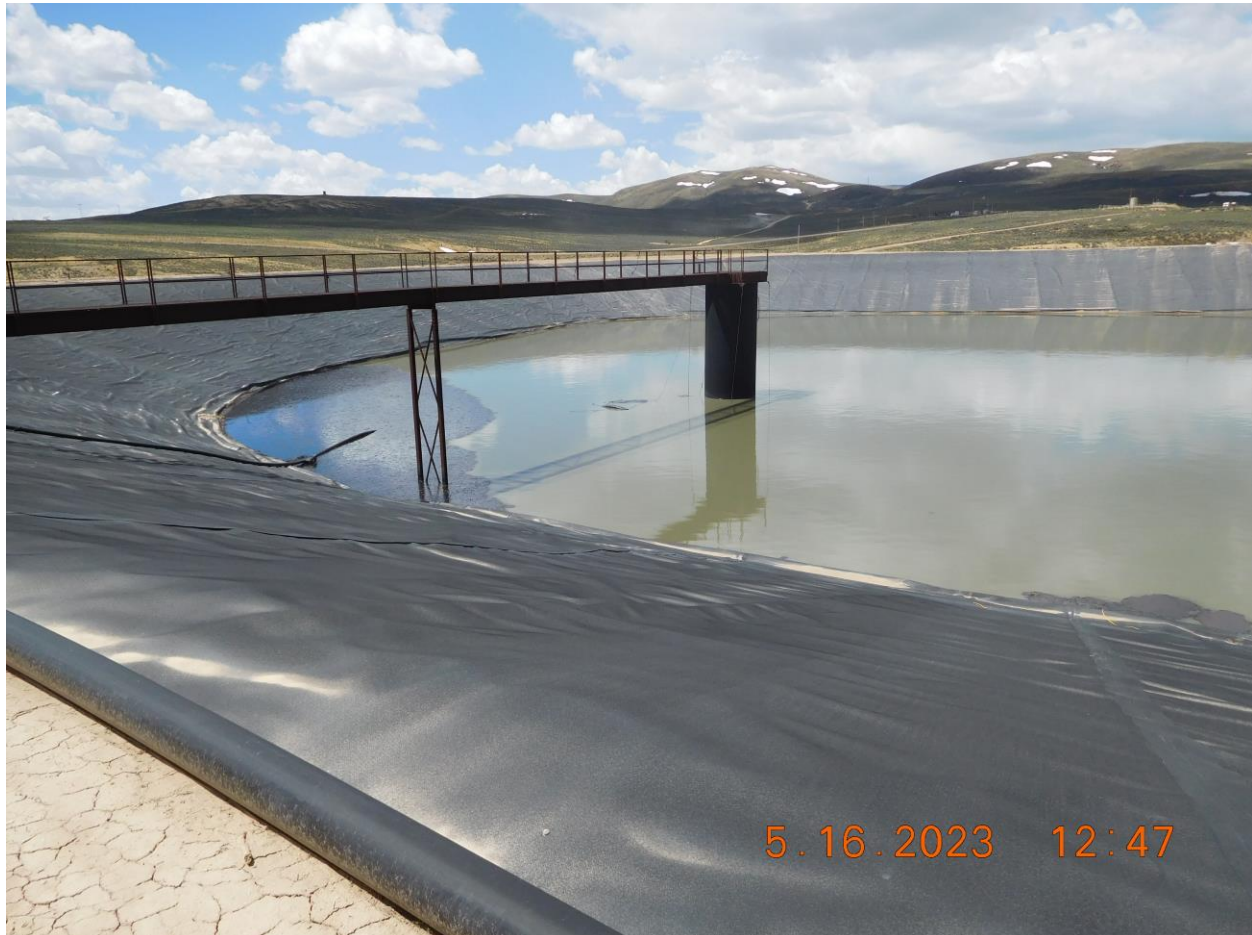
On the south end of Pond 9, I observed what appeared to be floating algae at the southeast portion. At the north end, I observed oil floating on the surface that was contained by a hydrocarbon boom. Mr. Merritt stated that work would begin to remove the oil later that week and would include drawing down the water to allow the oil and algae to dry out. Photos 2015-2018.

Photo 2015, DSCN2015.JPG, photo of pond 9 near the southeast portion, facing south/southwest. Material floating on the surface appeared to be an algae.

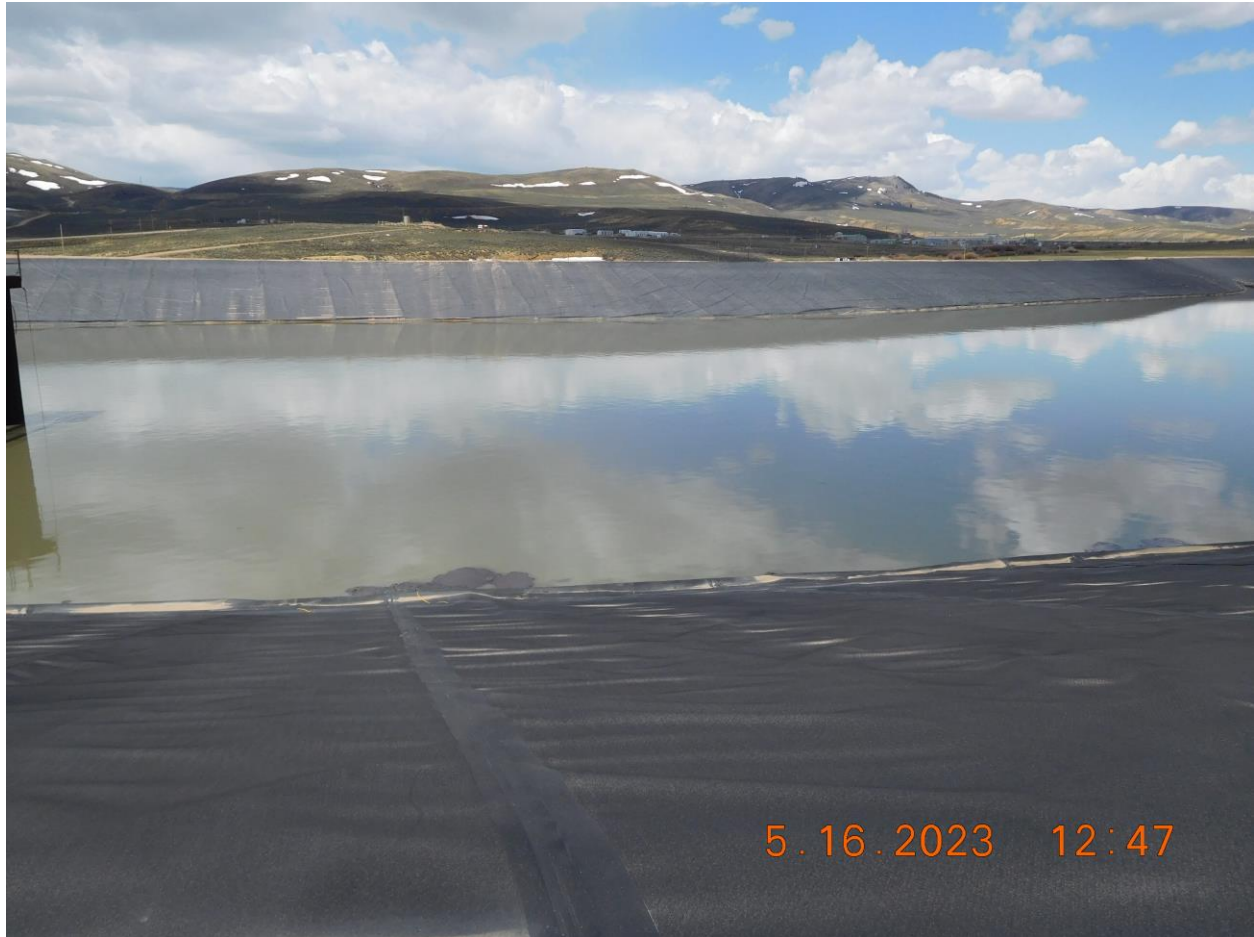
Photo 2016, DSCN2016.JPG, photo of the same area as that shown in photo 2015, panned right.

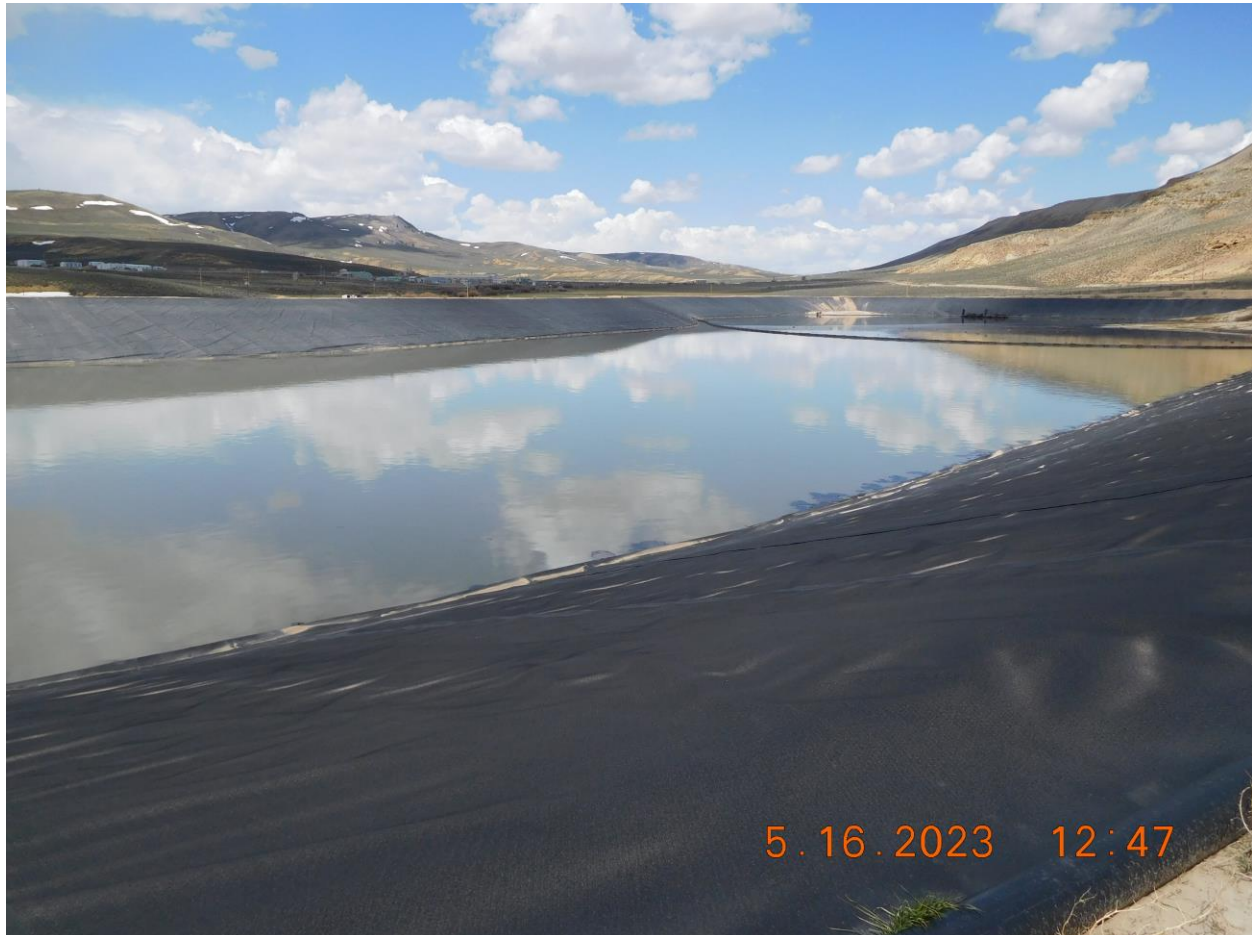
Photo 2017, DSCN2017.JPG, photo of the same area shown in photo 2015 and 2016, panned right.

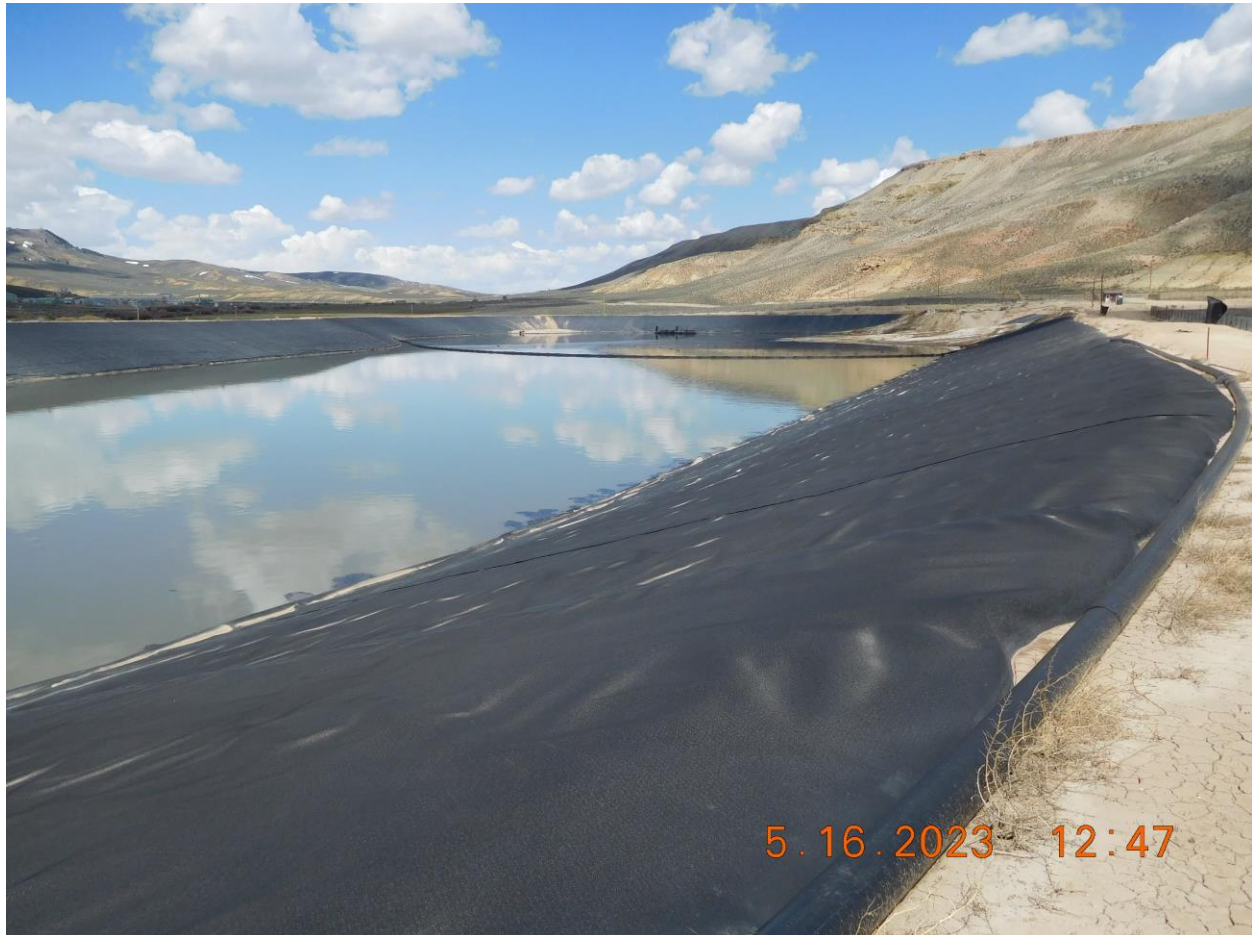
Photo 2018, DSCN2018.JPG, photo of the same area shown in photos 2015-2017, panned right. Oil on the surface of the pond was contained inside a hydrocarbon boom.

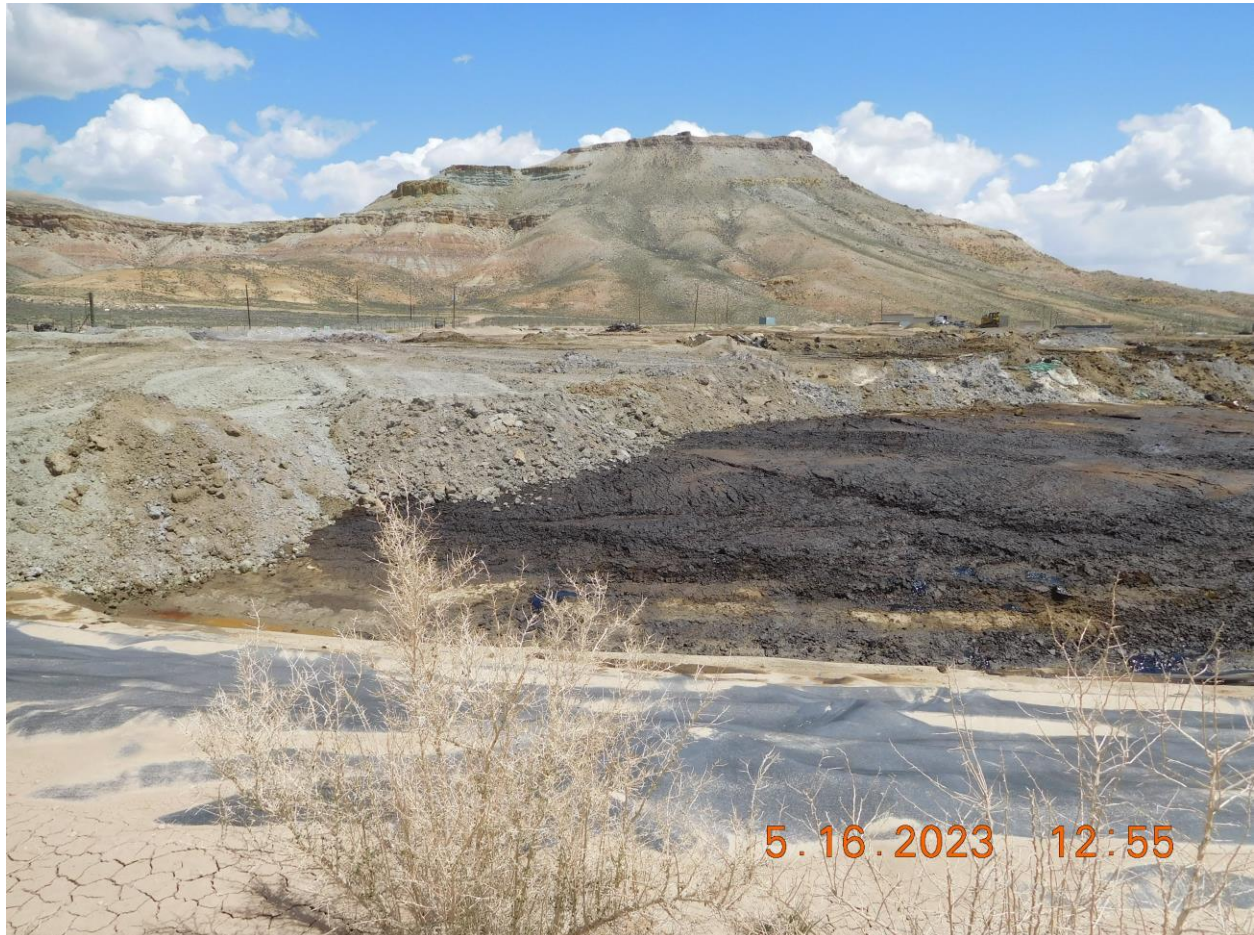
At Pond 6, which has largely, but not yet completely, converted to a waste solids landfill, I observed that very limited standing water was present. Filters and other debris were present in the landfill, and Mr. Ellingford stated that they are checked for radioactivity before disposal into the landfill. For photos of the landfill, see photos 2019-2020 and 2022-2024.

Photo 2019, DSCN2019.JPG, photo of the cell 6 landfill facing north/northeast from southwest area of the landfill.

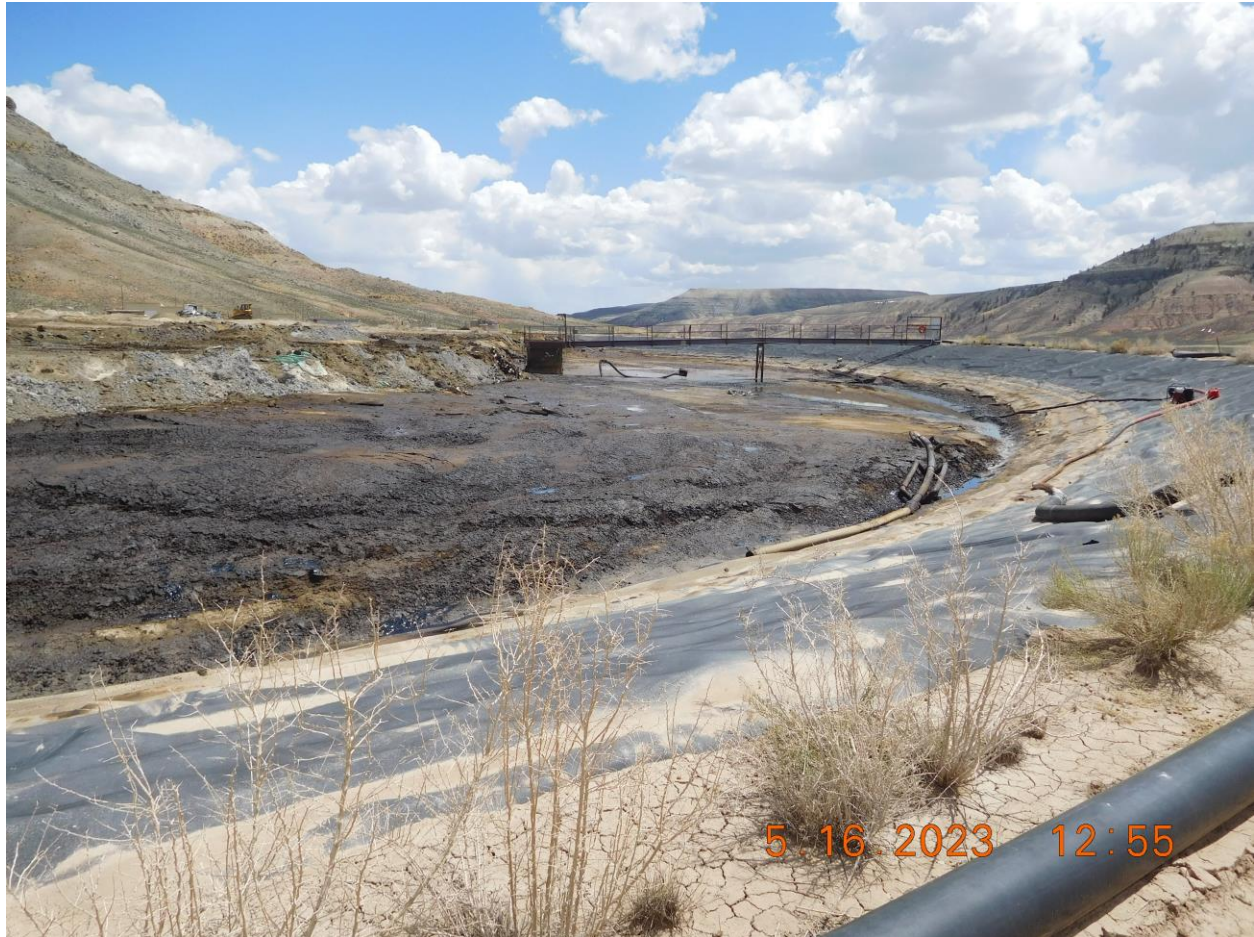
Photo 2020, DSCN2020.JPG, photo of the same area shown in photo 2019, panned right.

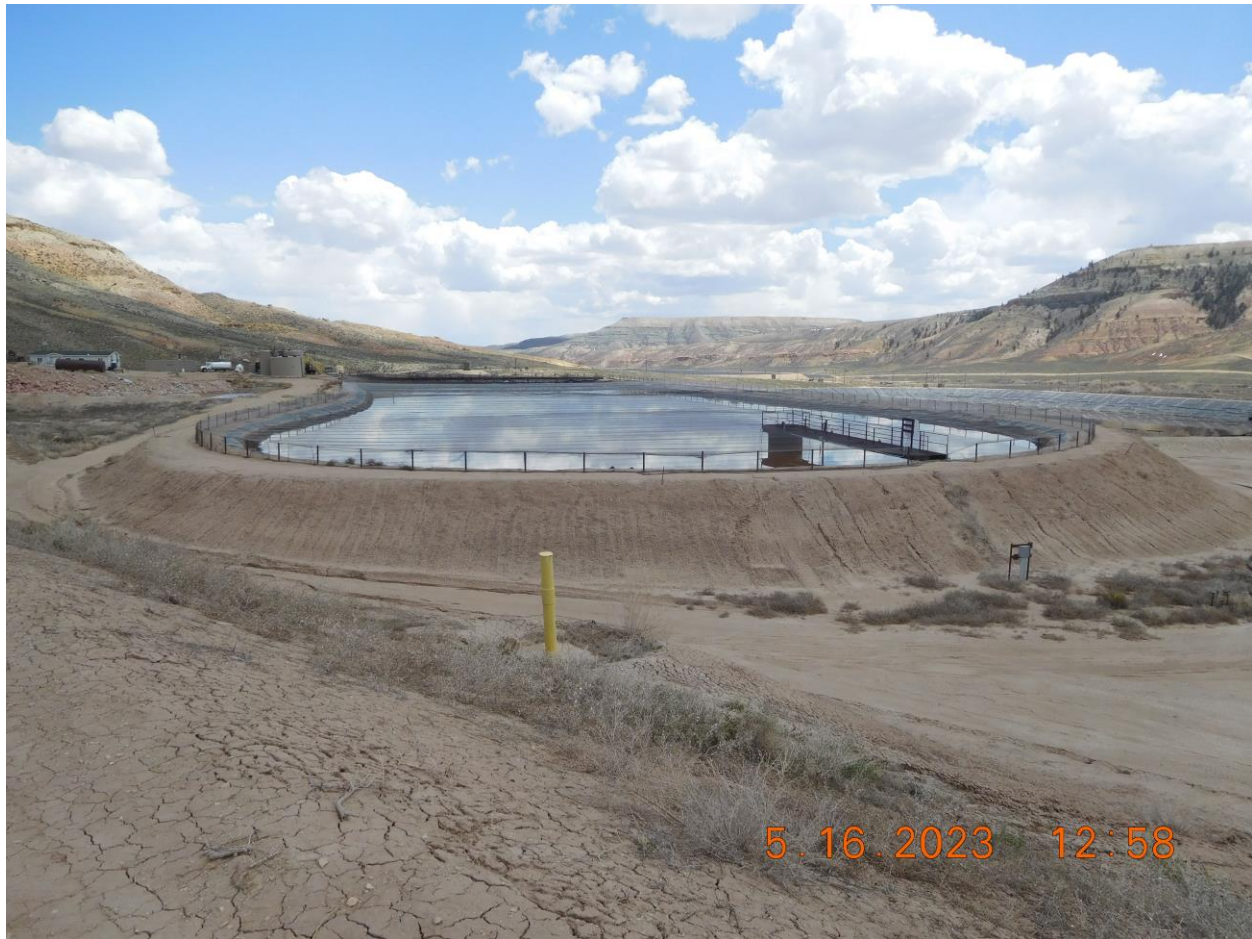
Photo 2021, DSCN2021.JPG, photo of pond 4, the slop/skim pit, facing east.

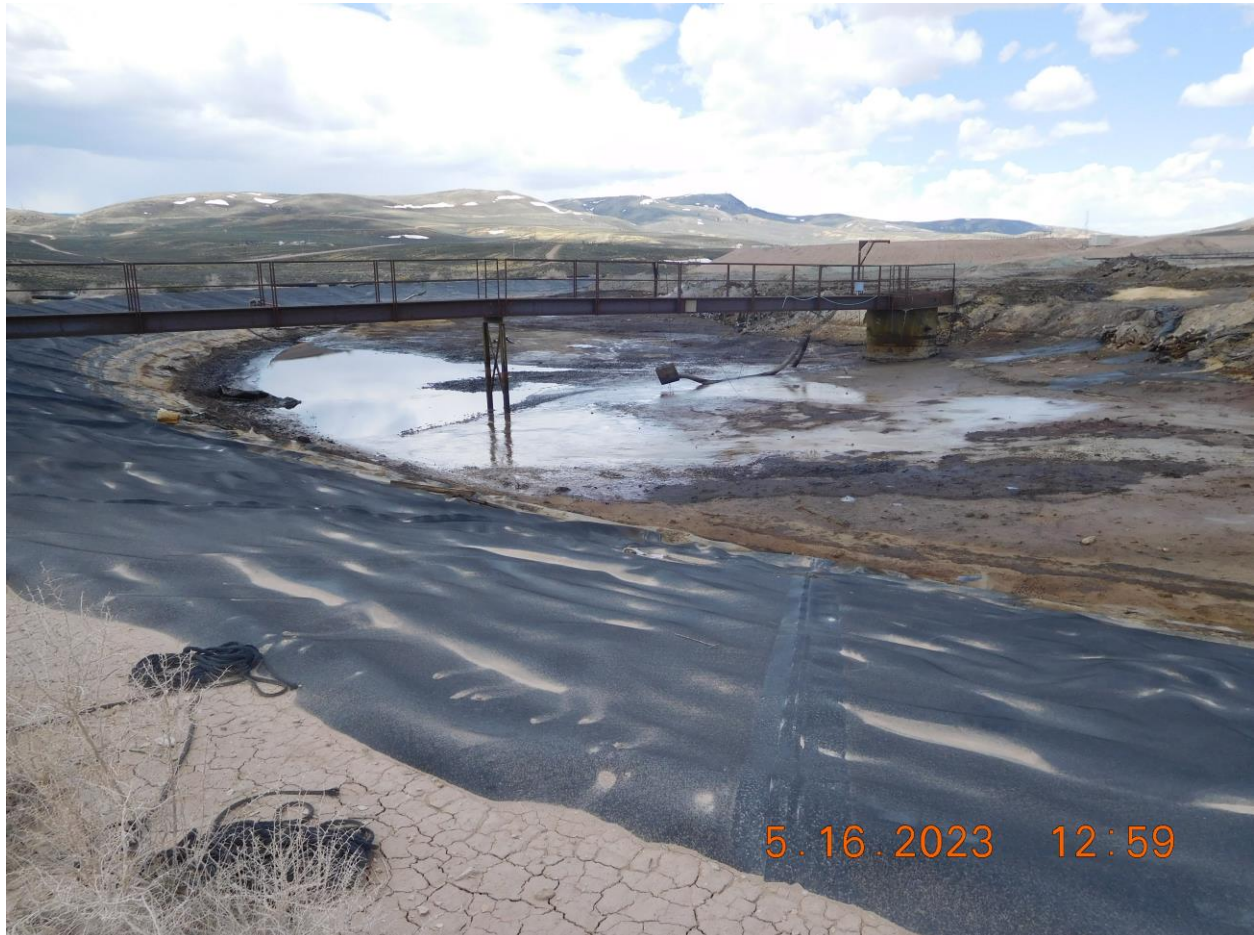
Photo 2022, DSCN2022.JPG, photo of the cell 6 landfill taken from the south side of the landfill facing west.

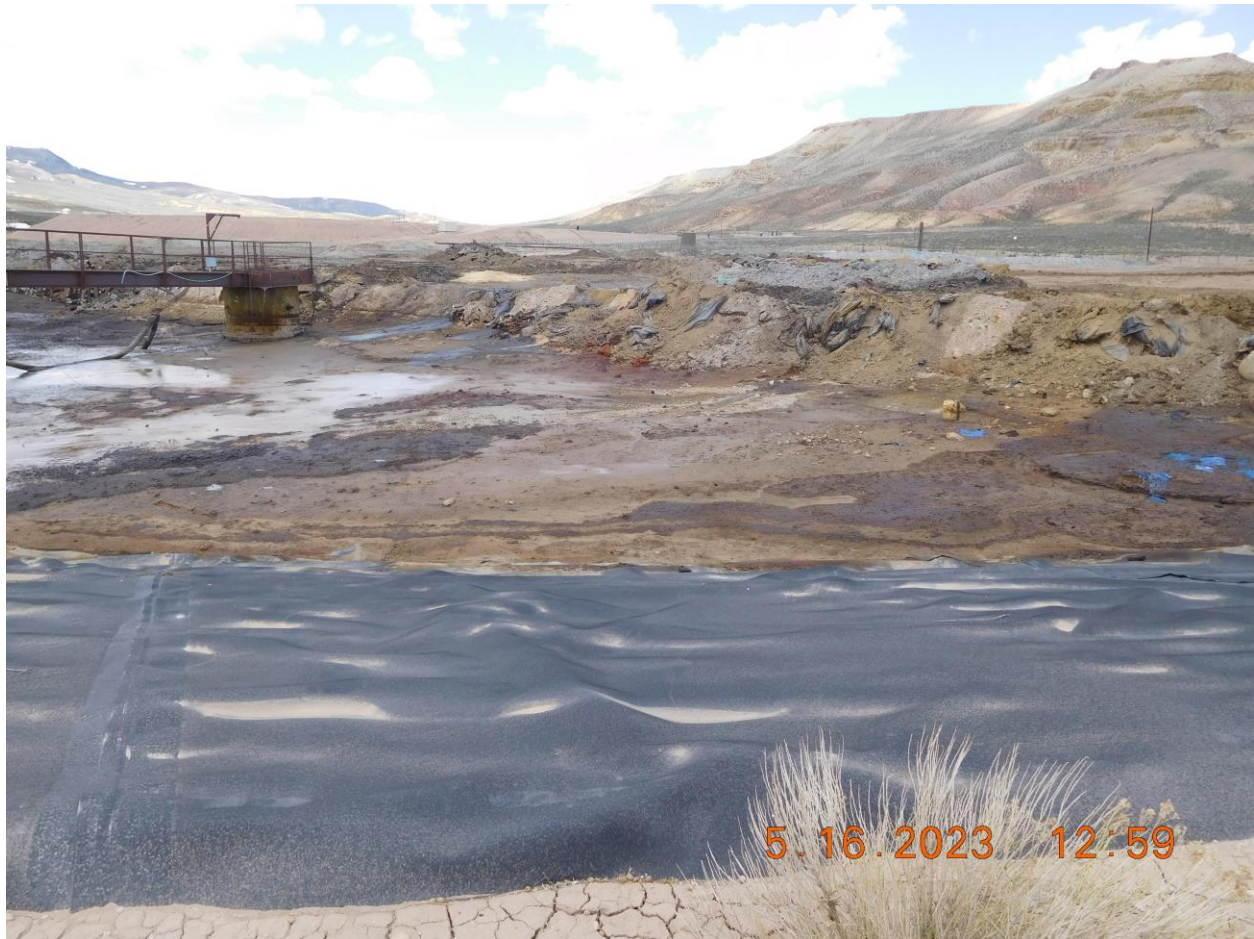
Photo 2023, DSCN2023.JPG, photo of the same area shown in photo 2022, panned right.

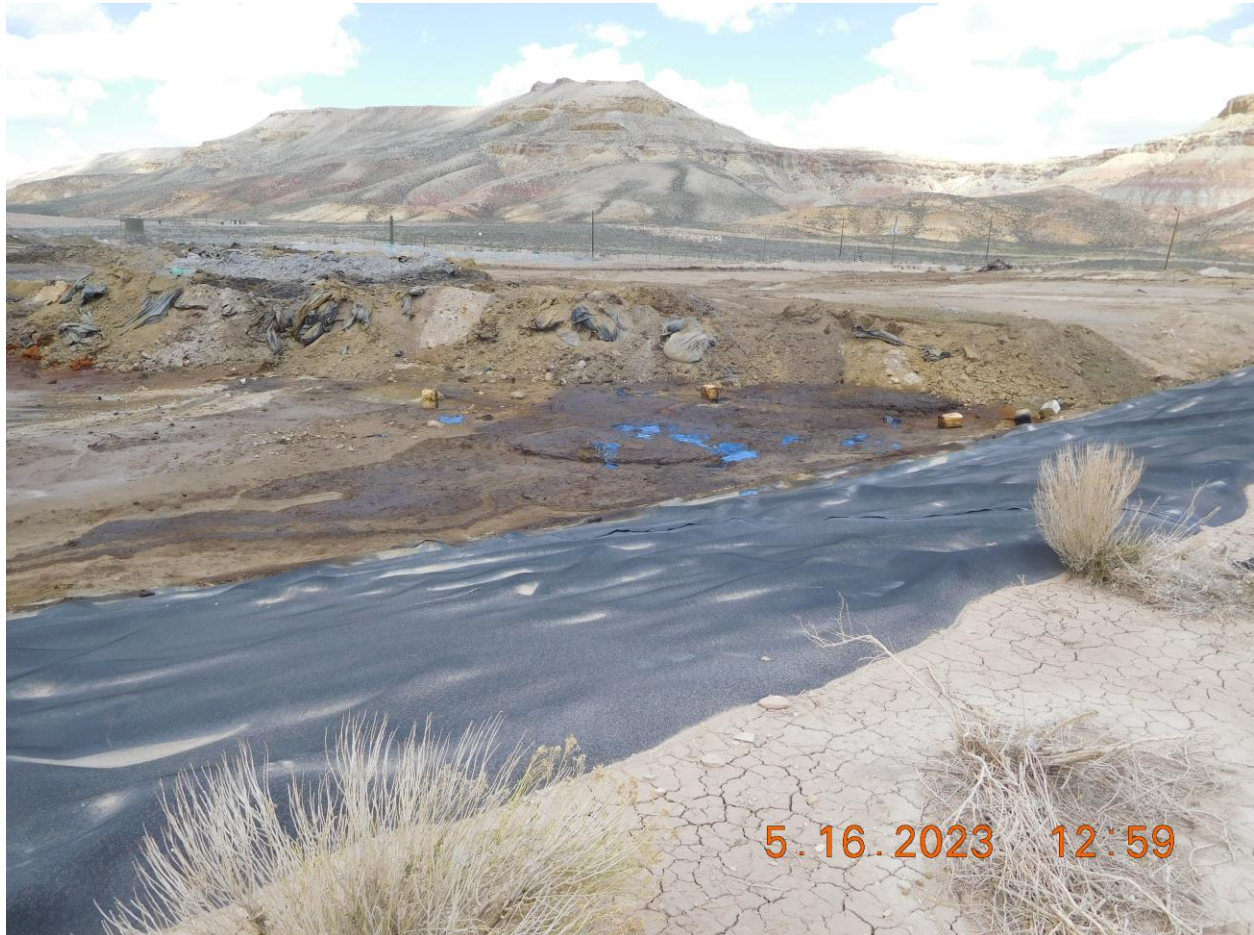
Photo 2024, DSCN2024.JPG, photo of the same area shown in photos 2022 and 2023, panned right.

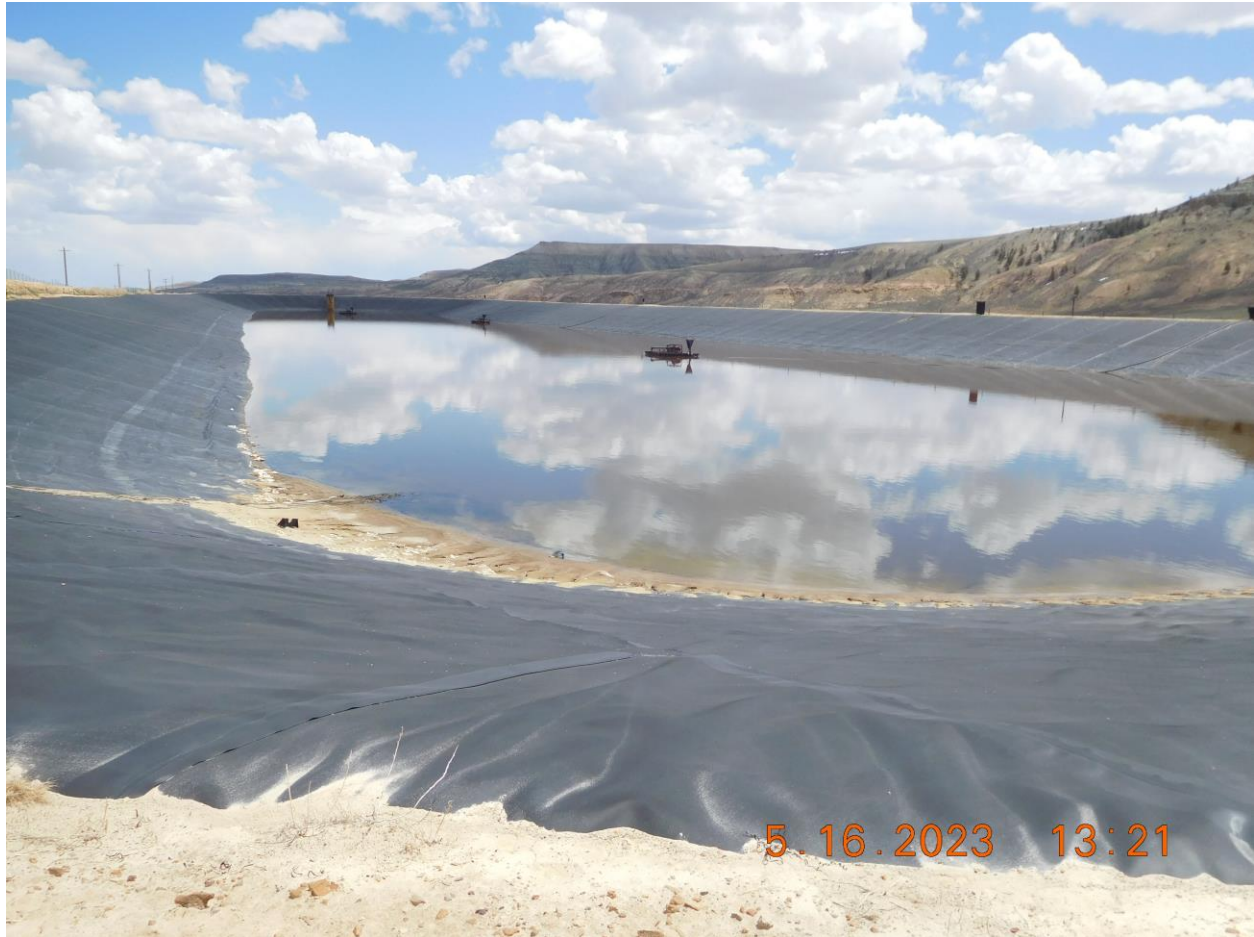
No other oil was observed on pond surfaces. A photo of pond 7 is included in Attachment 2, photo 2025. I did not observe pond 5 during the inspection.

Photo 2025, DSCN2025.JPG, photo of pond 7.
