# NPDES Compliance Inspection Report

## Parker Hannifin – Enumclaw

**NPDES Permit Tracking Number  
# WAR004622**

**Inspection Date: 01/18/2023**

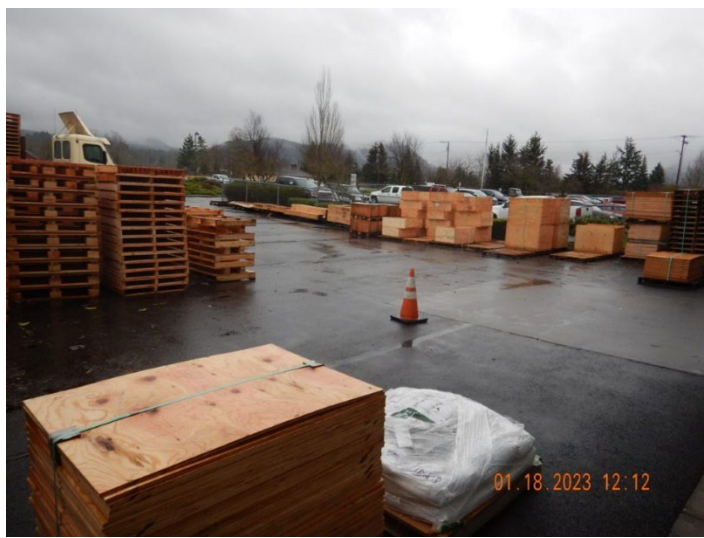
Photo: #01 (DSCN0458.JPG)

We began just outside the main entrance and moved north to the shipping area. We saw many new pallets and blocking and bracing material stored outside (**Photo 1**). In the same area we saw a pallet of recently delivered garnet material used inside the Facility in their abrasive process.

Description: Facing east, an overview of the outside of the shipping department showing a mix of old and new pallets.

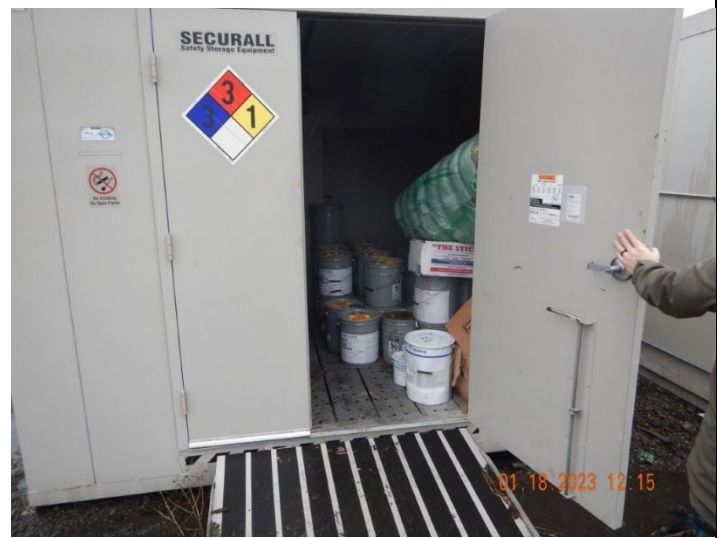
Photo: #02 (DSCN0459.JPG)

Description: Facing east, the inside of one of two outdoor storage containers holding product paints.

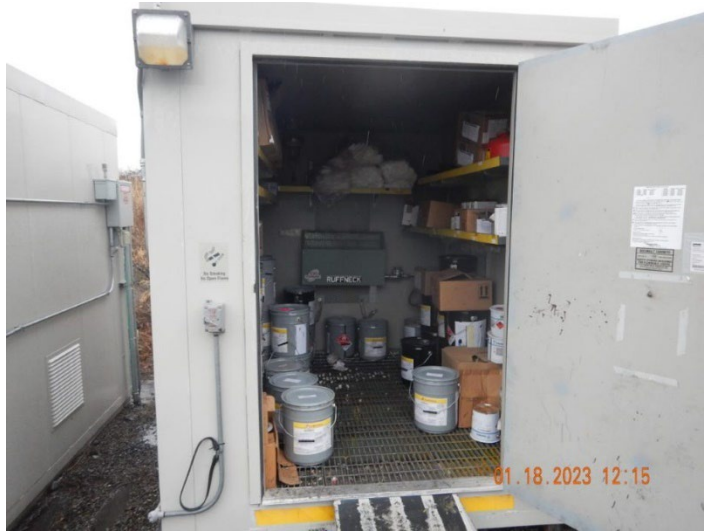
Photo: #03 (DSCN0460.JPG)  
Description: Facing east, the inside of the second outdoor storage container holding products.

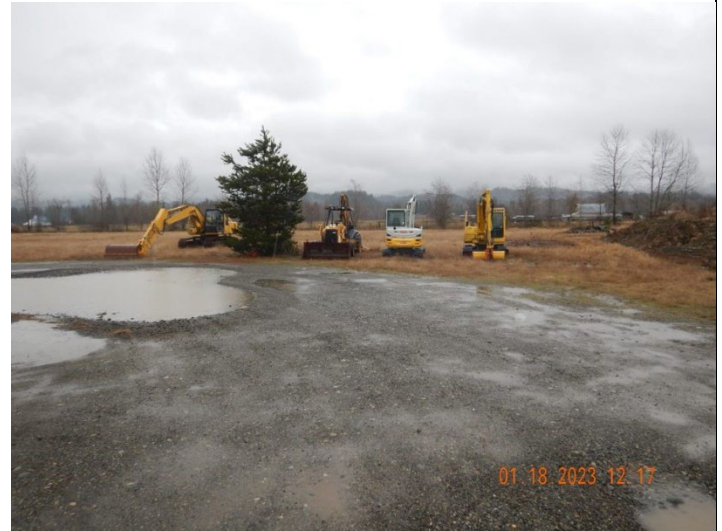
Northeast of the lockers we saw four large industrial machines, three excavators and a front-end loader, stored on pervious land (**Photo 4**). Mr. Clark told us they keep these machines on-site to test new actuators. Just north of the lockers we saw five red dumpsters holding mostly scrap metal for recycling, and east of those, approximately 12 bales of compressed cardboard and paper (**Photo 5**). We observed the dumpsters labeled "Seattle Iron and Metals Corp." Three smaller dumpsters, approximately four feet wide sat closed, though the two longer dumpsters, approximately 10-12 feet long, sat open. I looked inside the southernmost open dumpster and saw a small accumulation of water freely draining through an open seam on the bottom of the dumpster (**Photo 6**). To the west of the smaller dumpsters, we saw some metal shavings and fines on the ground (**Photo 7**). Mr. Clark told us they accumulate steel in the larger dumpsters, and the smaller ones usually hold more valuable metals. He said he thought the observed fines looked to be brass.

Photo: #04 (DSCN0461.JPG)  
Description: Facing east, four large earthmoving pieces of equipment stored on-site to test new products manufactured at the Facility.

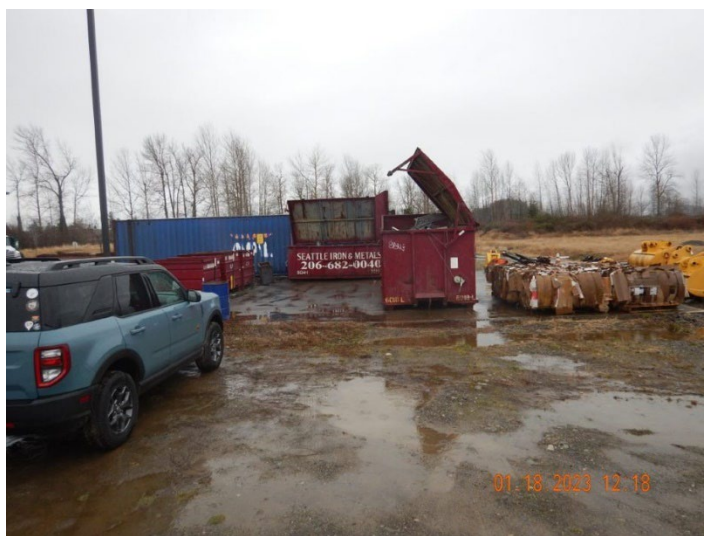
17. We noted three large, approximately 12-15-foot-long dumpsters, open during the inspection (**Photos 5 and 11**).

Photo: #05 (DSCN0462.JPG)  
Description: Facing north, standing due east of the Facility, three large dumpster holding scrap metal stand open. To the right, bales of paper stored outside.

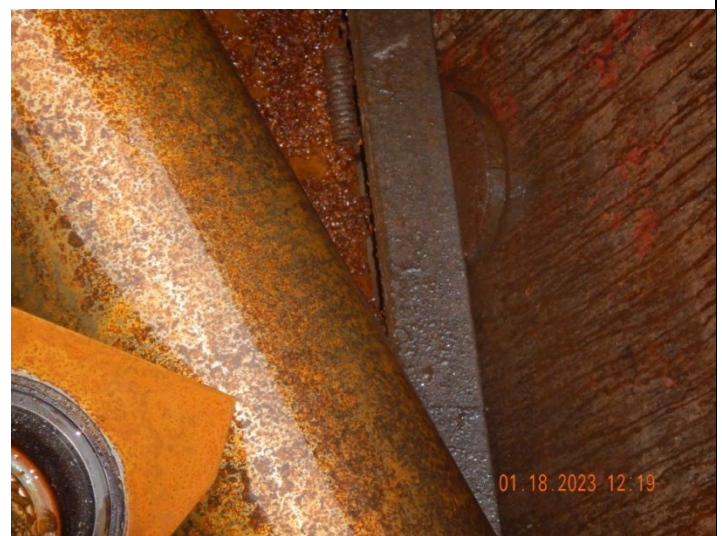
Photo: #06 (DSC0463.JPG)  
Description: Interior of rightmost dumpster in Photo 5, showing steel scrap and fines, with an open seam at the bottom. Beneath the dumpster appeared rust colored water (pool visible in Photo 5).

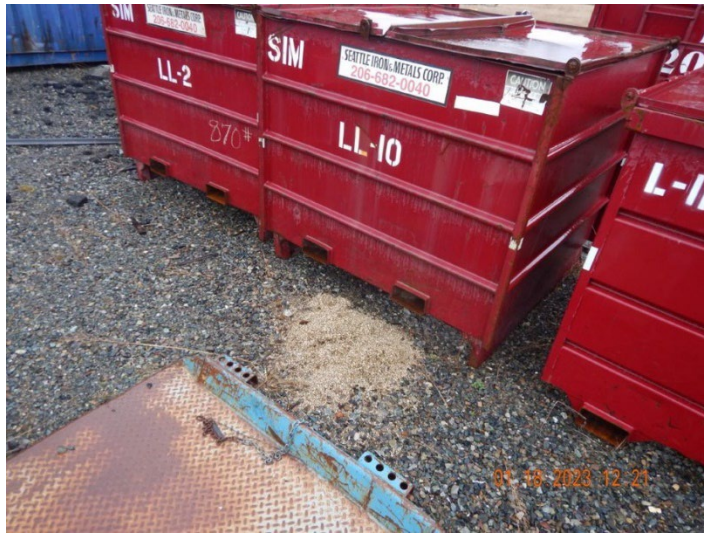
Photo: #07 (DSCN0464.JPG)

16. Section 4.1.1.1 of the SWPPP states the facility sweeps paved areas regularly and as needed. Section 4.5 of the SWPPP states the Facility’s catch basins contain filter inserts assist in sediment control. We observed an excess of sediment built up over a catch basin (**Photo 10**), and a significant amount of brass fines on the ground (**Photo 7**). No catch basin filters were apparent during our inspection.

Description: Facing northeast, backside of smaller dumpsters visible on the left of Photo 5; with large accumulation of brass fines on the ground.

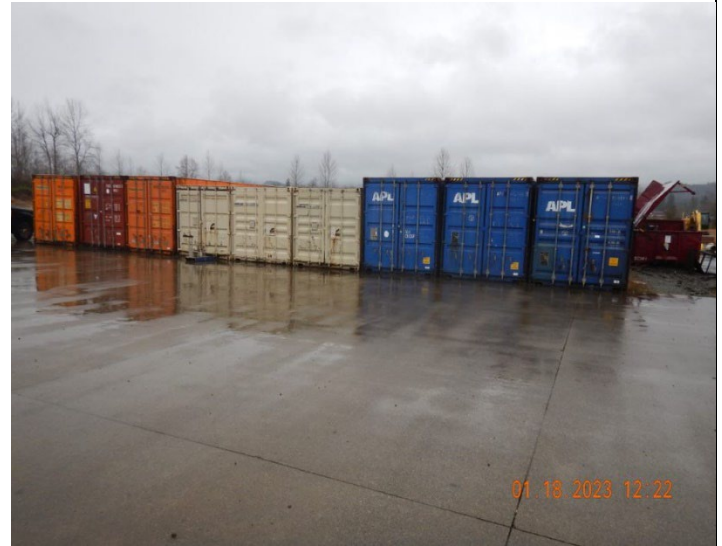
Photo: #08 (DSCN0465.JPG)

Description: Facing east, large impervious concrete pad holding nine shipping containers used to store products.

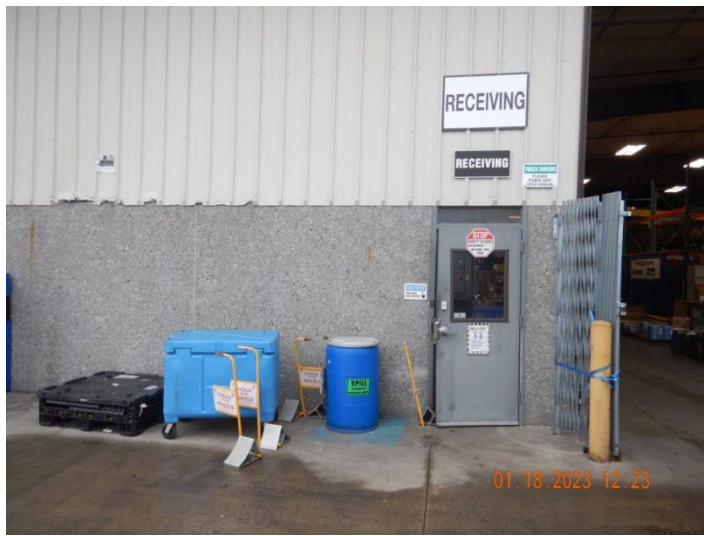
Photo: #09 (DSCN0466.JPG)

Description: Facing west, photo of spill kit outside Receiving Department. Spill kit is due west of containers in Photo 8.

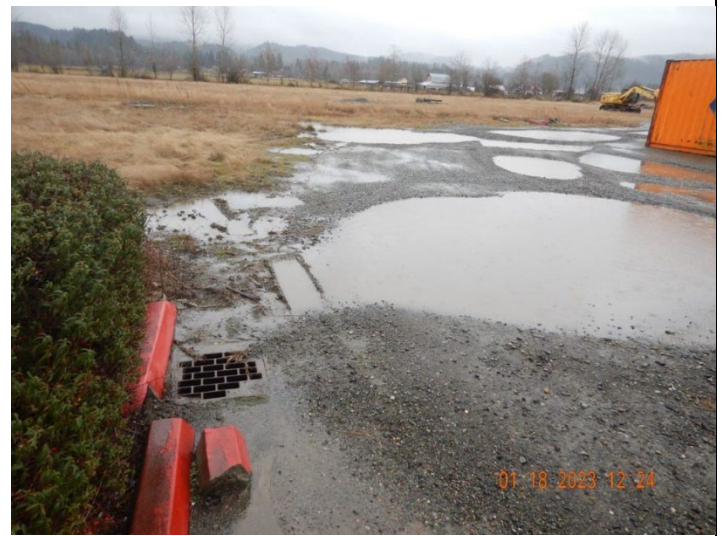
Photo: #10 (DSC0467.JPG)

Description: Facing east, just north of containers in Photo 8, graveled area meets pervious grassland, with a perimeter of catch basins catching stormwater run-off from impervious area.

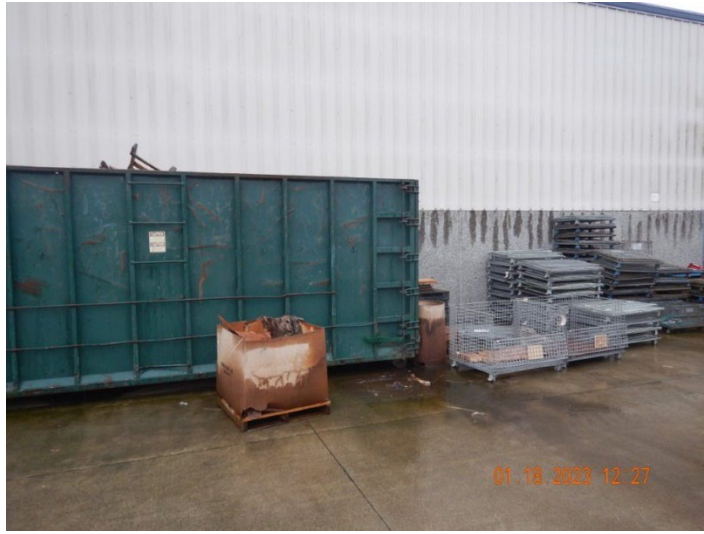
Photo: #11 (DSCN0468.JPG)

Description: Facing south, and the northern side of the Facility, a large dumpster holding wood debris stood open. Also visible, metal bins and wheeled carts.

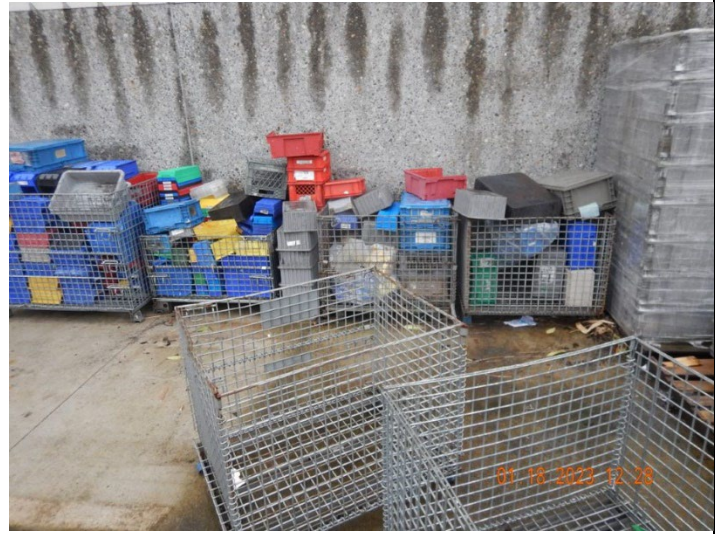
Photo: #12 (DSCN0469.JPG)

Description: Facing south, west of Photo 11, additional bins holding plastic trays.

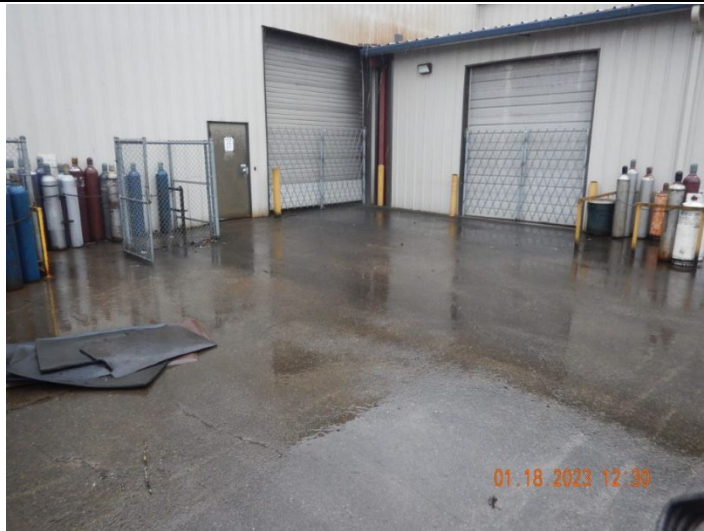
Photo: #13 (DSCN0470.JPG)

Description: Facing southeast, photo of northwest corner of Facility, showing many compressed gas cylinders stored outside.

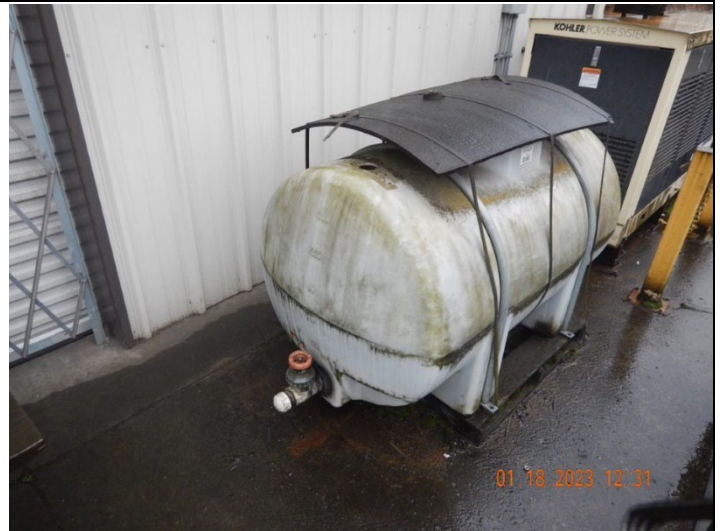
Photo: #14 (DSC0516)

Description: Facing south, one capped tank standing west of cylinders in photo 13, and a secondary generator. The tank has a secondary lid strapped on, but the cut hole appeared only part covered, and the tank appeared to hold a water mixture.

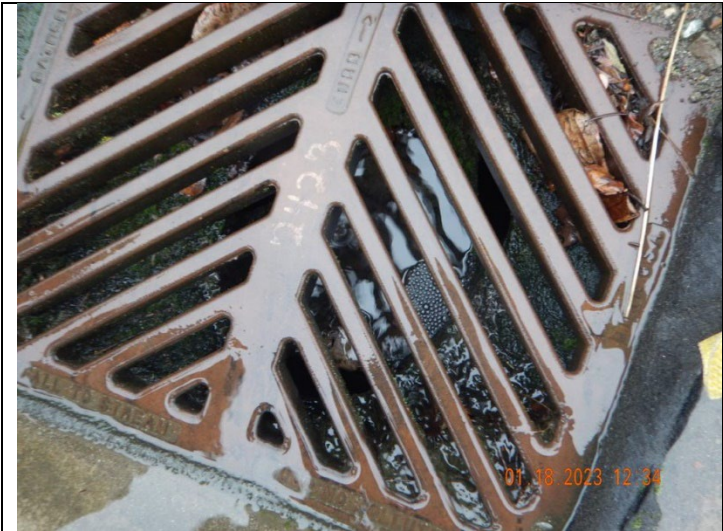
Photo: #15 (DSC0472.JPG)

Nearby, to the west, we saw catch basin holding water with bubbles, possibly from a surfactant or an additional source (**Photo 15**). The Facility representatives stated they did not know the source of the bubbling. We continued south noting additional catch basins (**Photo 16**), and where the ring of perimeter catch basins ended, a large pooling of water (**Photo 17**). It appeared the neighboring property had been built up with rock, and water accumulated along the property line, or flowed just into property owned by the Facility.

Description: Another of the series of catch basins circling the perimeter of the Facility. Water inside bubbled, possibly indicating the presence of a surfactant.

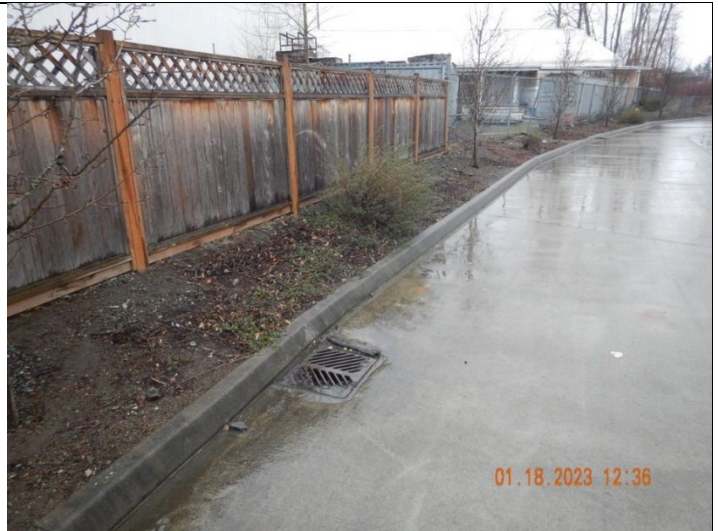
Photo: #16 (DSC0473.JPG)

Description: Vicinity of preceding catch basin. Area beyond the catch basin and curbed boundary of the Facility belongs to neighboring Facility.

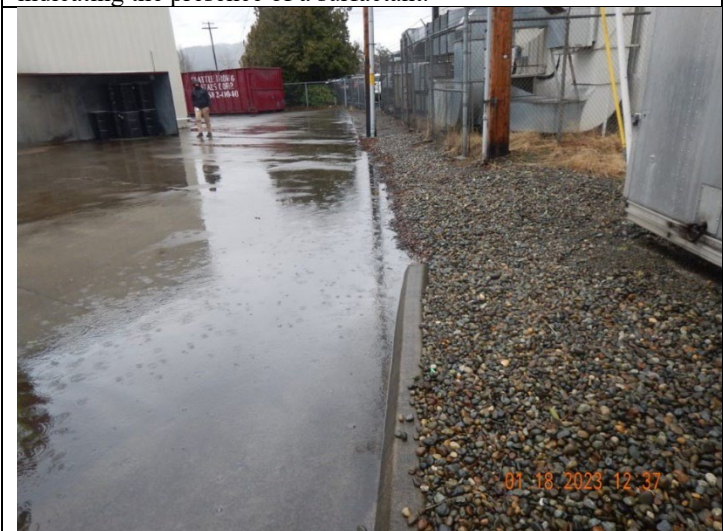
Photo: #17 (DSC0474.JPG)

Description: Facing south, apparent pooling along edge of property. Boundary between properties appeared built-up with rocky aggregate.

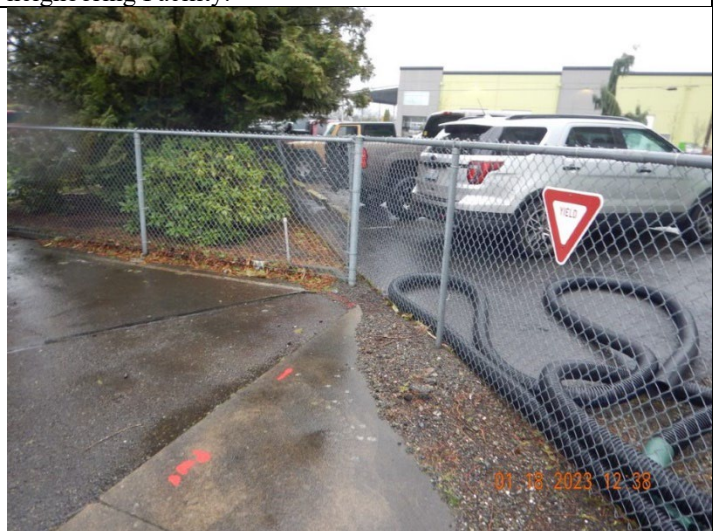
Photo: #18 (DSC0475.JPG)

Description: Facing south, at the fence-line visible in background of Photo 17. The boundary between properties continues to appear built-up with an aggregate mixture.

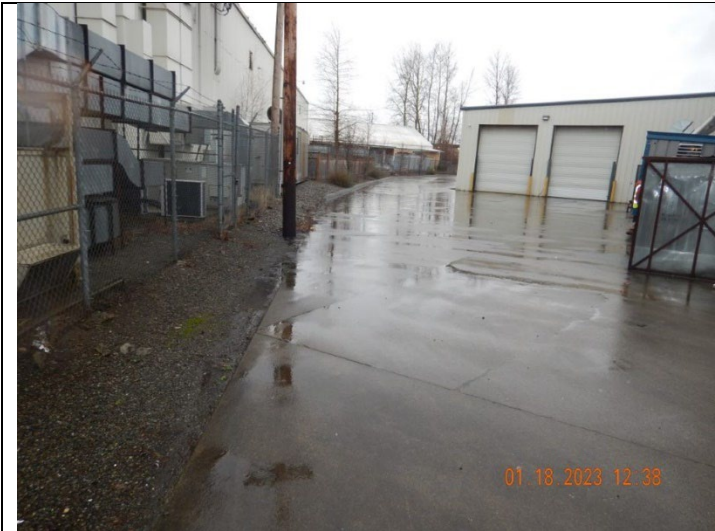
Photo: #19 (DSC0476.JPG)  
Description: Facing north, turned opposite from vantage in Photo 18, pooling water in previous photos does not appear flowing towards the street.

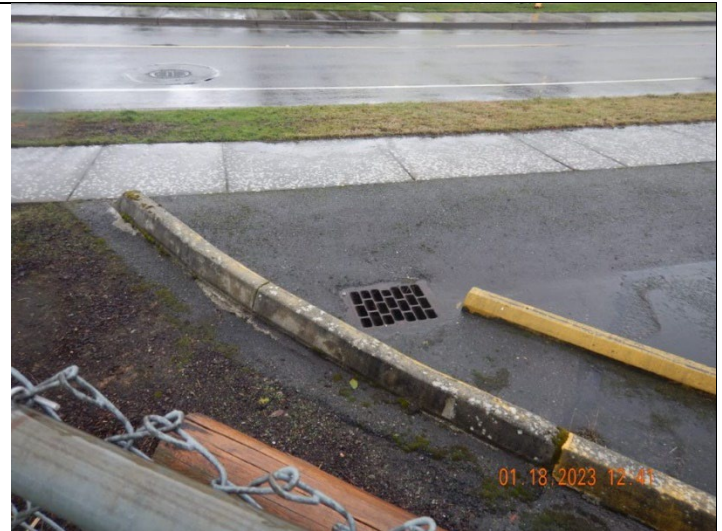
Photo: #20 (DSC0477.JPG)  
Description: Facing south, catch basin next to Battersby Avenue, located on neighboring property, did not appear to receive stormwater flow.

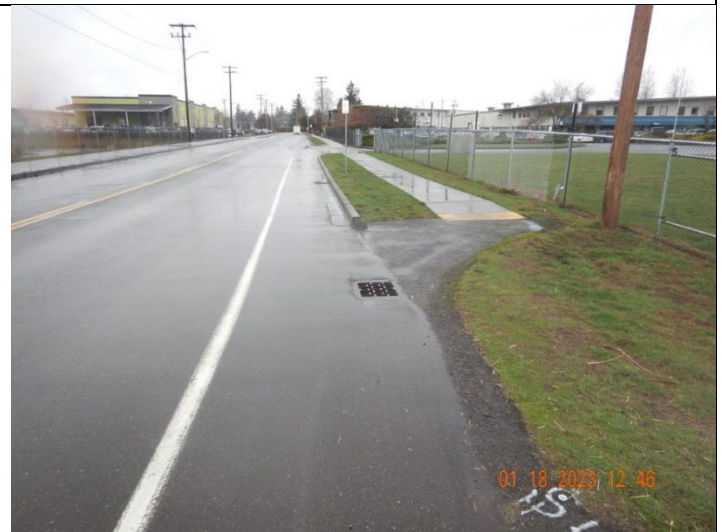
We walked across the southern perimeter to a catch basin at the southwest corner of land leased by the Facility, also by Battersby Avenue (**Photo 22**). Mr. Myron said he thought this might belong to the City of Enumclaw's municipal separate storm sewer system. Inside the catch basin appeared to be a receiving pipe from the east, and an outfall pipe to the north (**Photo 23**). North of the catch basin, we saw the apparent discharge point from the catch basin (**Photo 24**). We observed water to the north of this point, possibly infiltrating as we did not see an apparent flow (**Photo 25**).

Photo: #22 (DSC0479.JPG)  
Description: Facing west along Battersby Avenue, looking towards the Facility. Image shows a catch basin along the right of way.

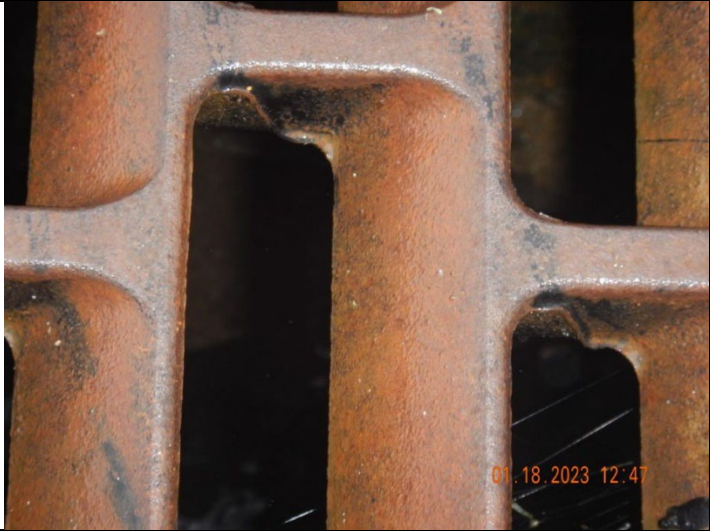
Photo: #23 (DSC0480.JPG)  
 Description: Close-up of catch basin in Photo 22. We noted a pipe leading north from the catch basin back to land owned by the Facility.

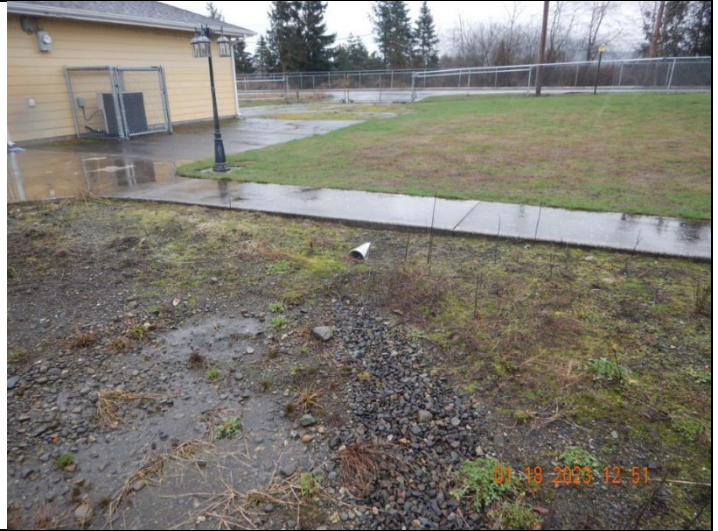
Photo: #24 (DSC0481.JPG)  
 Description: Facing south, with Battersby Avenue in background. Exposed pipe appears to serve as discharge point from the catch basin in Photo 22. Land around pipe appeared slightly lower in elevation, and we saw some standing water.

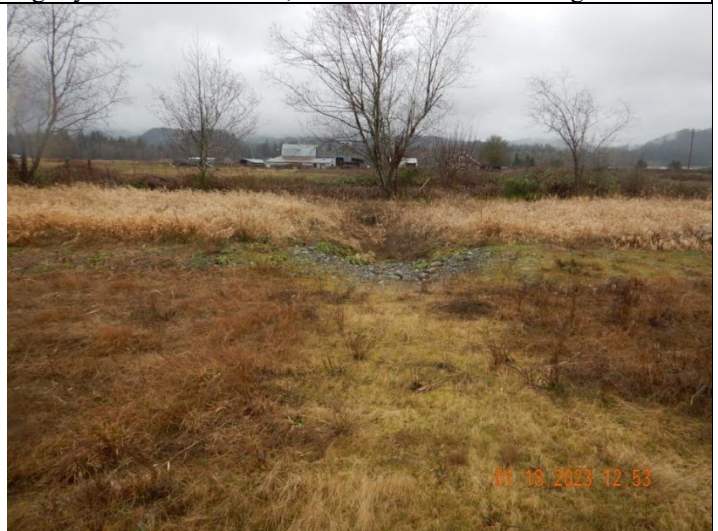
Note: The site in **Photo 26** generally corresponds with the "Emergency Overflow" identified in the Facility's site map. Facility representatives did not describe it as such.

Photo: #26 (DSCN0483.JPG)  
 Description: Facing east, north of Photo 25 photo shows raised dike separating lands leased by Facility from the Drainage District 5 lateral.

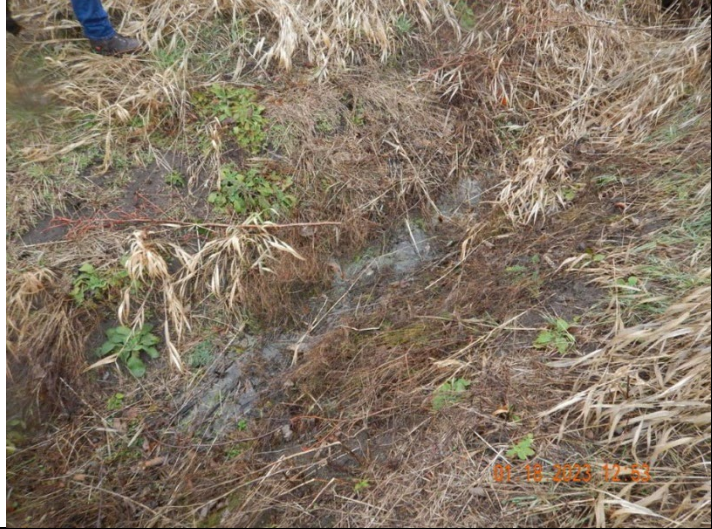
Photo: #27 (DSCN0484.JPG)  
 Description: Surface water flowing north across lands leased by Facility. Water appeared to flow in small channel.

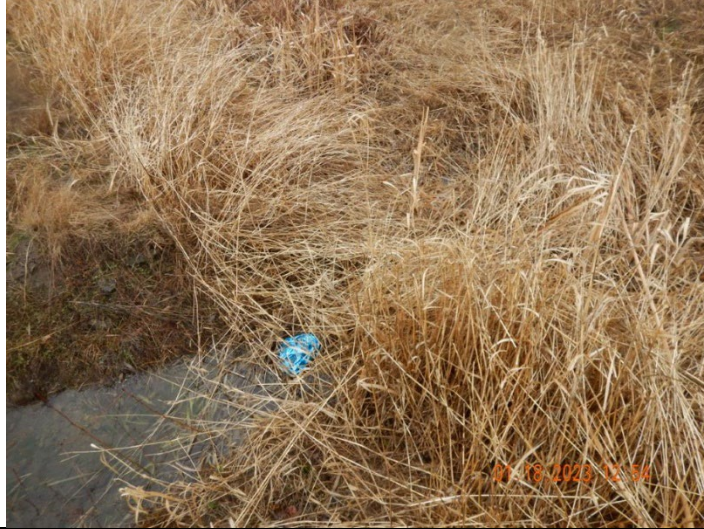
Photo: #31 (DSCN0488.JPG)

Description: Photo of surface water in channel, with some floating trash, flowing generally east and north across lands leased by the Facility.

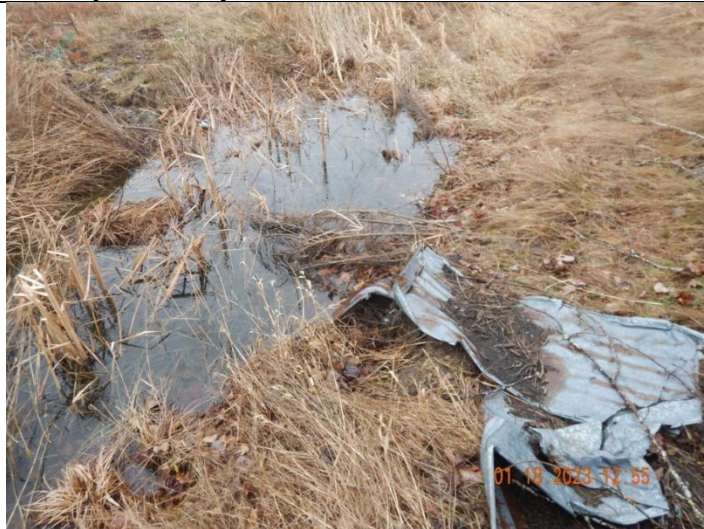
Photo: #33 (DSCN0490.JPG)

Description: Photo of surface water in a swale flowing generally north across lands leased by the Facility, with large piece of metal debris.

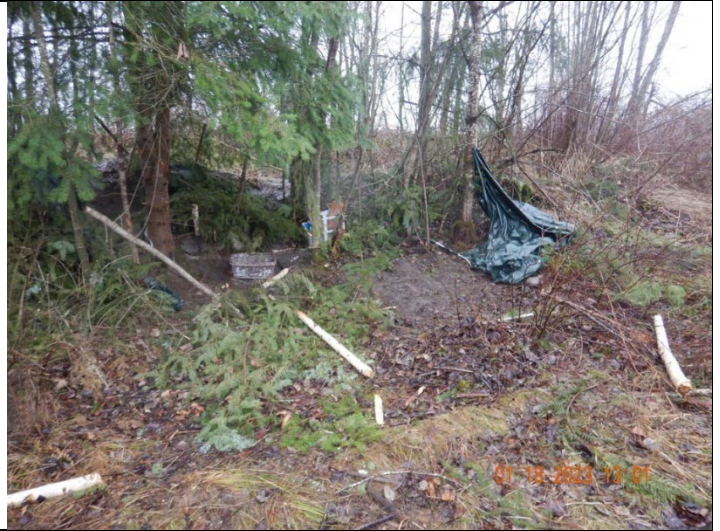
Photo: #36 (DSCN0493.JPG)

As we approached the Facility's pond, we saw signs of temporary human habitation (**Photo 36**). Mr. Clark said they had occasionally cleaned up the area and found large amounts of solid waste left behind. He also said he was aware of a historic spill record which may have led to a life die-off in and around the pond. He said he thought the spill stemmed from chemical waste left behind by trespassers.

Description: Facing south, sign of temporary human occupancy on lands leased by the Facility. Site of photo just south of Facility's stormwater pond.

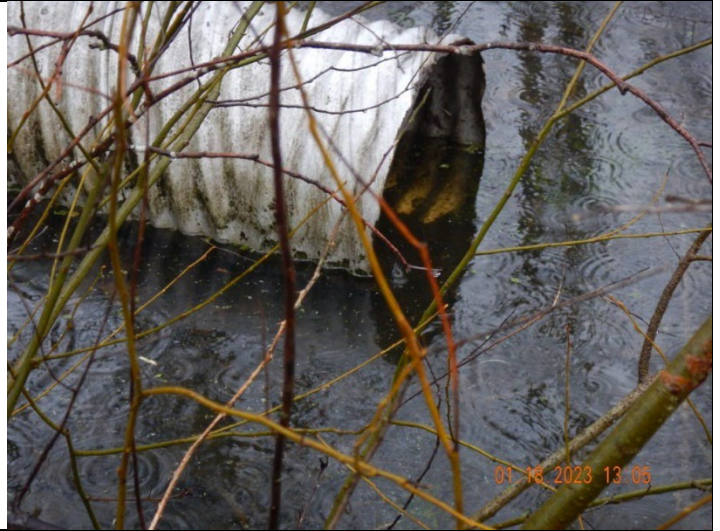
Photo: #40 (DSCN0497.JPG)  
Description: Close-up of pipe in background of Photo 39. Pond's water level crosses threshold of pipe's lower lip. The pipe appeared to slant up, above stormwater pond level.

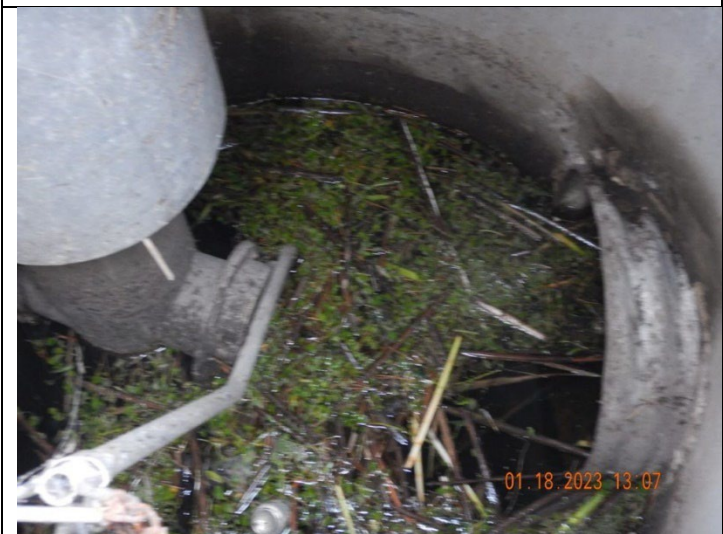
Photo: #41 (DSCN0498.JPG)  
Description: Interior view of a Type 2 catch basin situated between stormwater pond and drainage district lateral. Facility representatives referred to this as a stand pipe assembly; waters flow from pond through pipe (right) and would flow up through metal assembly (left) before discharging. Representatives stated they would sample here in the event the basin filled.

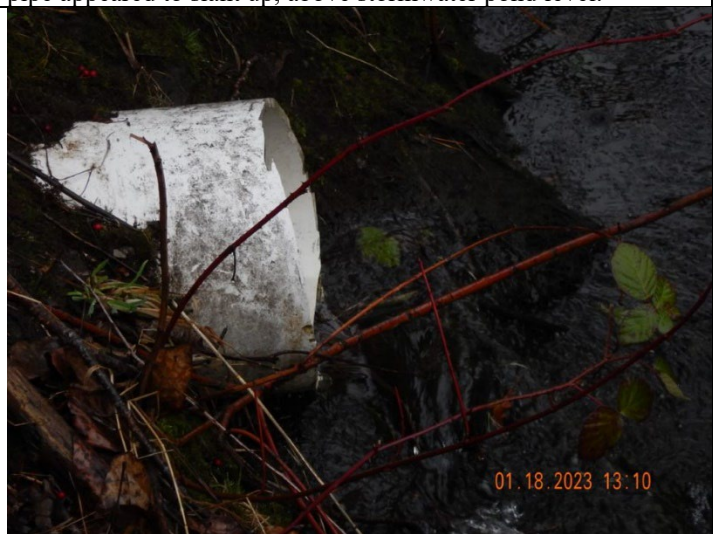
2. As noted above, since 2020 the Facility recorded “no discharge” on their DMRs. However, during the inspection, we saw water discharging from a pipe next to the on-site retention pond into the Drainage District 5 lateral (**Photos 42, 43**). Mr. Myron stated in a March 2, 2023, email the Facility sampled its discharge on February 28.

Photo: #42 (DSCN0499.JPG)  
Description: Image of pipe with water discharging into Drainage District 5 lateral. This outfall sat directly between Facility's stormwater pond and the lateral. Pipe appeared made from PVC or a similar material.

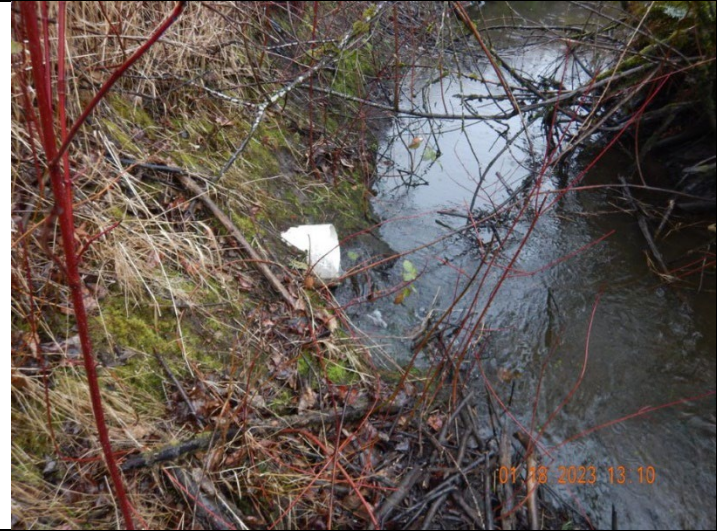
Photo: #43 (DSCN0500.JPG)

Description: Zoomed out image of pipe from Photo 44. Pipe appeared to cross from Facility stormwater pond, through the berm, to the lateral.

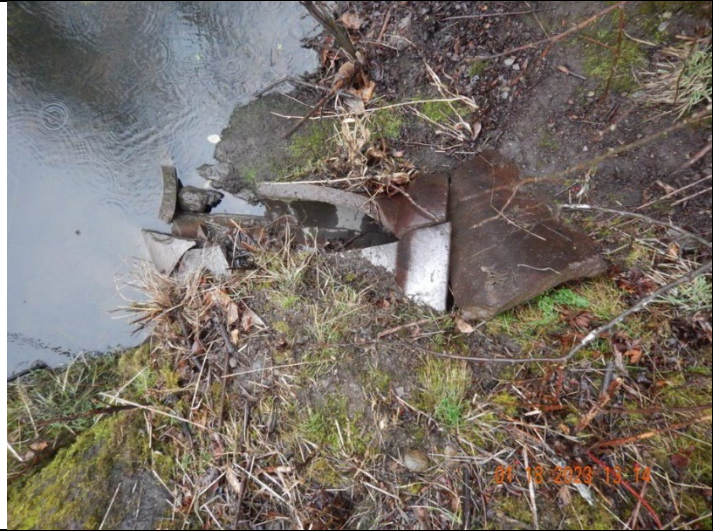
Photo: #44 (DSCN0501.JPG)

Description: Second pipe leading to the lateral. This pipe appeared constructed of concrete, or similar material. Facility representatives stated they believed this pipe served as their pond's discharge point. Interior of the pipe appeared dry, though the case had cracked.
