**Region 6 - Enforcement & Compliance Assurance Division**  
**INSPECTION REPORT**

| Inspection Date(s): | 02/05/2024 | |
| Company Name: | BASF Corporation | |
| Facility Name: | BASF Beaumont Agro Plant | |

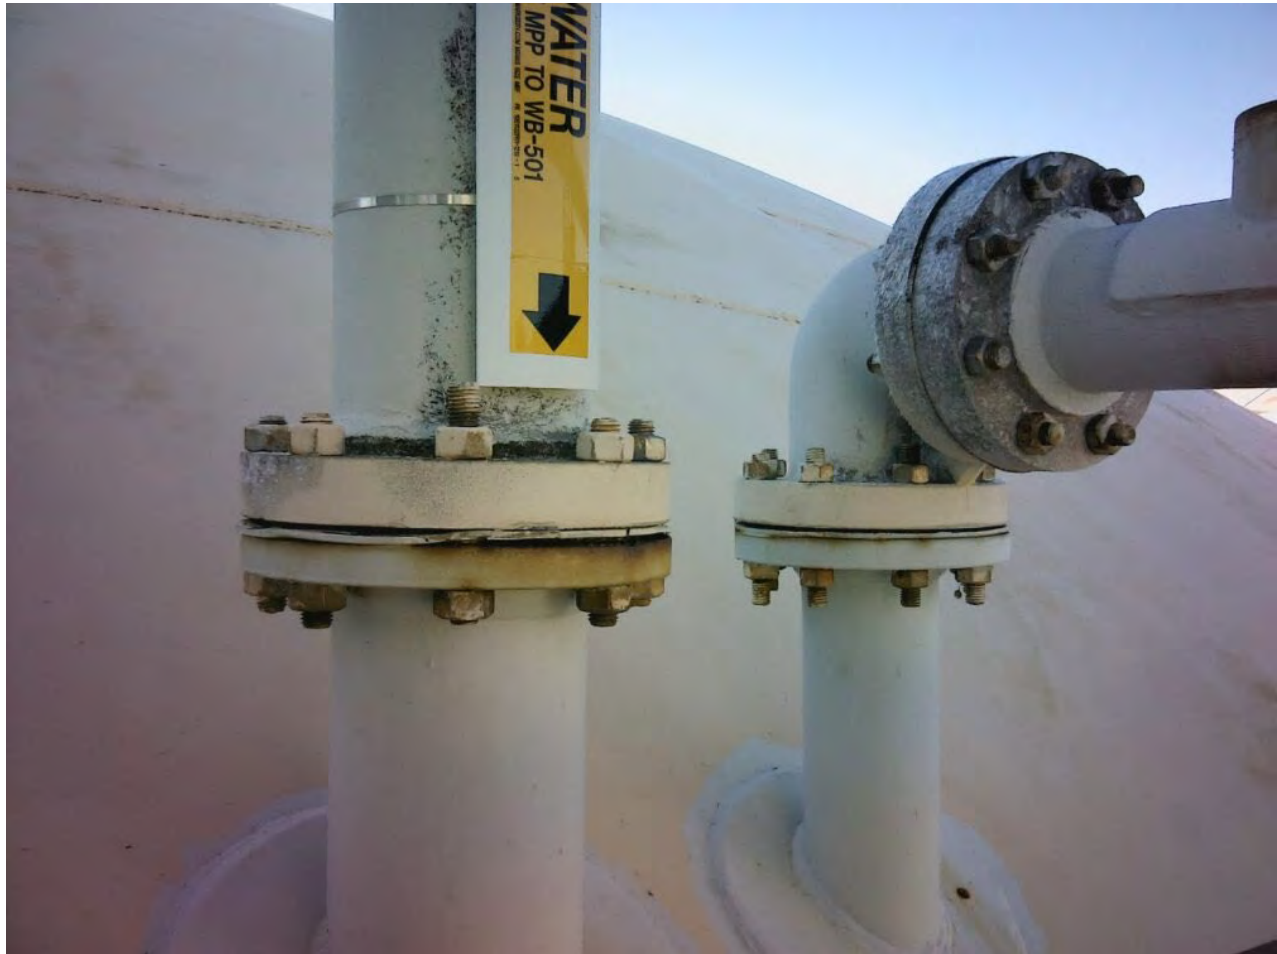
Photo No. 1

Ms. McCarthy and Mr. McPherson climbed Tank WB-501 with Ms. Wilder. EPA's photoionization detector measured VOCs up to 10 parts per million. Inspectors observed piping and components that had recently been repaired. They also observed visual defects and gaps at flange gaskets along feed lines to the tank (see Photo 1 in Appendix 1.) No hydrocarbons were detected using the optical gas imaging camera.

Description: Tank WB-501 feed lines observed with visual defects and gaps at flange gaskets.
