**Subj:** Inspection Report  
Clean Water Act  
Northeast Biodiesel

- A. *Facility Name:* Northeast Biodiesel
- B. *Facility Location:* 179 Silvio O Conte Dr  
Greenfield, MA 01301
- C. *Facility Contacts:* Rick Durepo  
(413) 214-9017, rickd@northeastbiodiesel.com
- D. *NPDES ID No(s):* 3400086959 (ICIS ID for pretreatment)  
MAD000283 (stormwater)

- A. *Date(s) of inspection:* November 29, 2022
- B. *Weather Conditions:* Clear, cool
- C. *US EPA Representative(s):*  
John (Jack) Melcher  
Damian Bednarz
- D. *State/Local Representative(s):*  
None

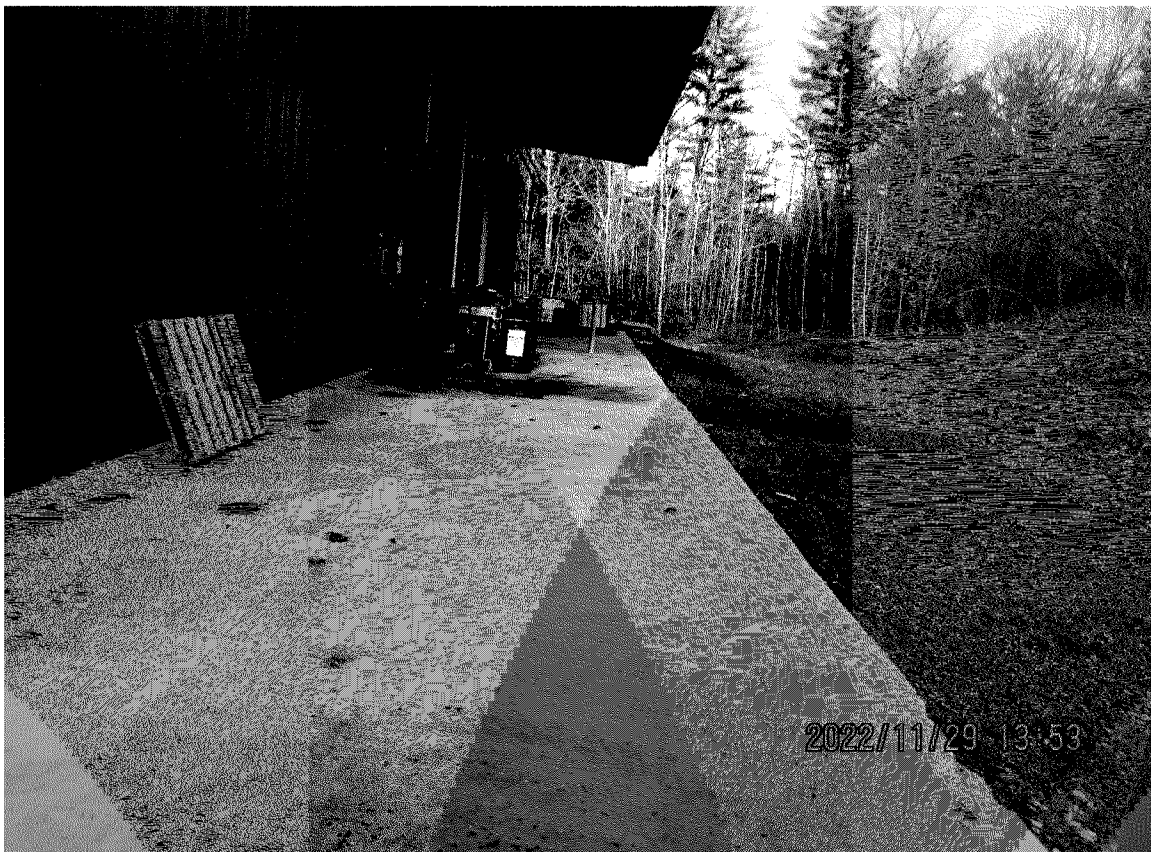
Mr. Durepo, Mr. Bednarz, and I viewed the area behind the Facility, shown in the photo below:

The area behind the building was covered by the roof, but open on the sides. The concrete pad was graded inwards towards three catch basins. Mr. Durepo said that he did not

believe that any pipes were connected to the catch basins. I looked in a catch basin and saw a small chamber below with a depth of one to two feet.

I observed a dark stain on the ground near the building. Mr. Durepo said that he did not know why the soil was stained. I did not observe a connection between the stain and surface water.
