## Region 6 - Enforcement & Compliance Assurance Division

### INSPECTION REPORT

| Company Name: | <b>Box L Operating</b> | |
| Facility Name: | <b>Lynn Lease</b> | |

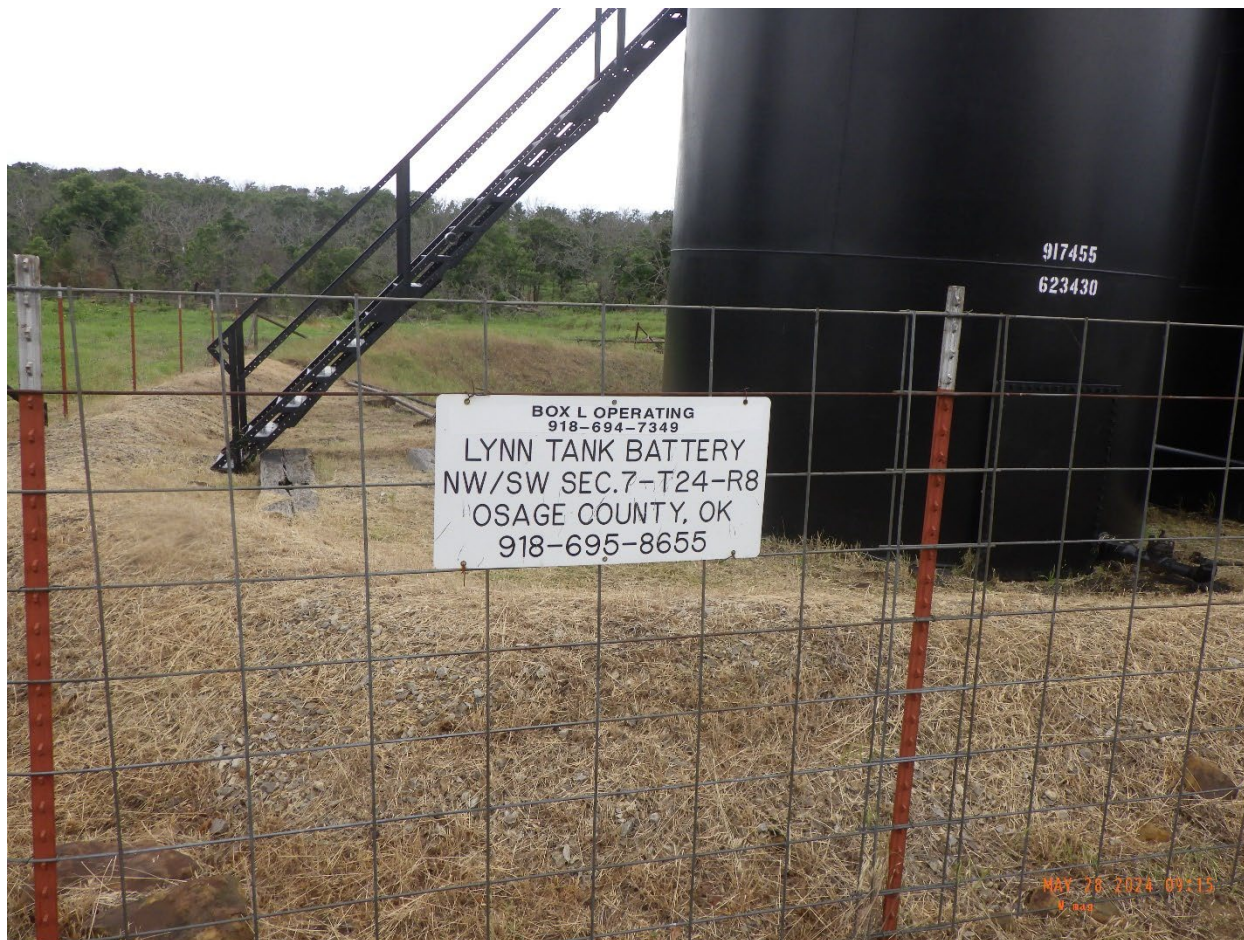
Photo No. 1

I observed the Box L Operating, Lynn Lease tank battery and facility signage. The overall facility maintenance and appearance indicated the facility was well managed except for the recent spill impacts which were not fully cleaned at the time of the inspection. See Appendix 1 (photo log) photos No. 1 and 2. For GPS location information and additional meta data, please see the photo log.

**Description:** This was the Box L Operating, Lynn Lease tank battery facility signage.

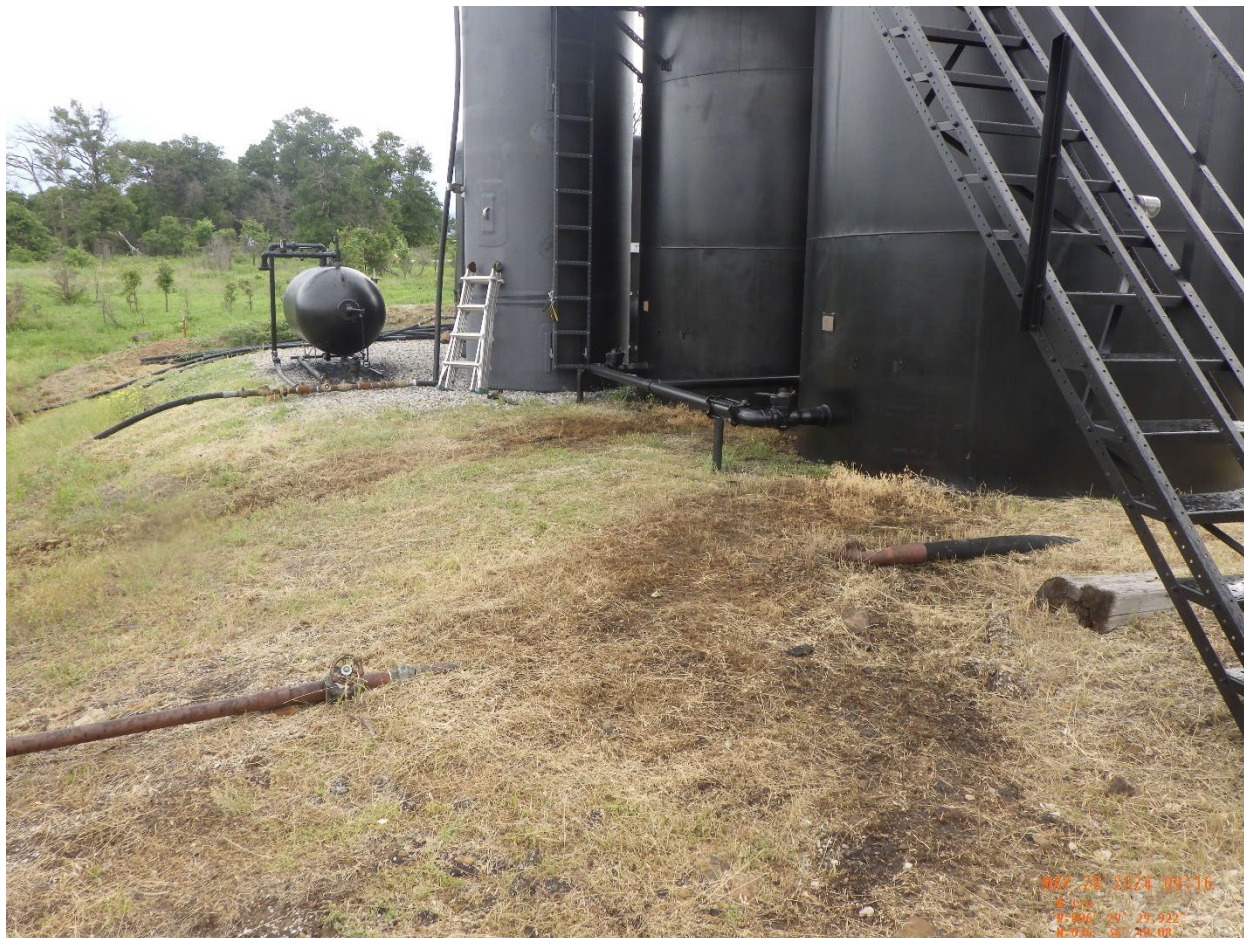
Photo No. 2

The Box L Operating, Lynn Lease tank battery consisted of 2 oil storage tanks, 2 oil/water separators, 1 saltwater storage tank and 1 saltwater disposal pump. The spill occurred when one of the oil storage tanks experienced an integrity failure, resulting in the release of crude oil into the facilities secondary containment. Released oil migrated out of the secondary containment through a previously unknown plastic pipe conduit, through the secondary containment berm, then into an unnamed tributary of Hominy Creek.

**Description:** This was an overview of the Lynn Lease tank battery, looking along the west side of the facility. The oil leak occurred from the tank nearest the photographer in the photo.

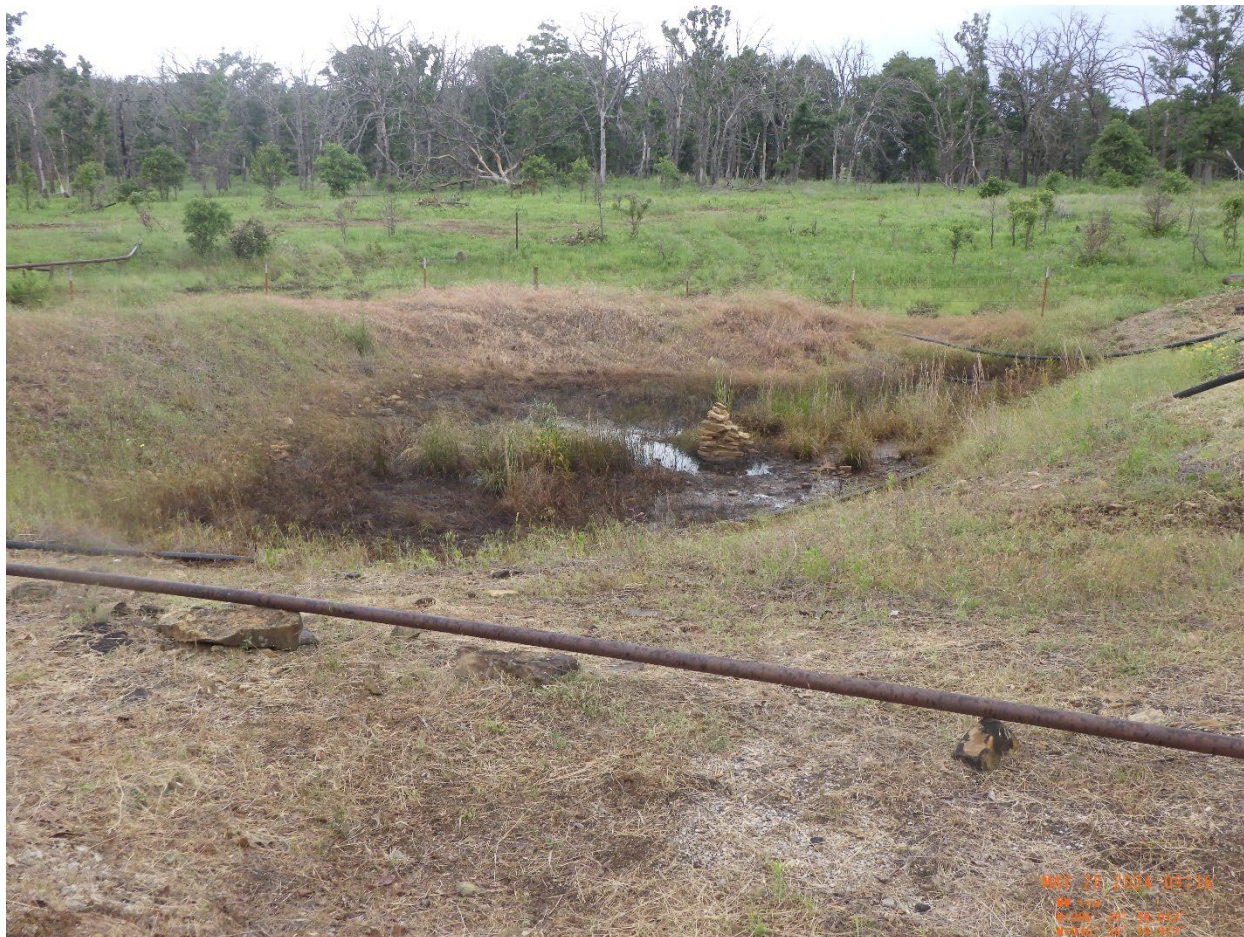
Photo No. 3

I observed the pit or sump area of the facility (inside secondary containment) where spilled oil initially pooled upon release. At the time of the inspection there was free oil, oil-stained grass, soil, and rocks in the sump area. See photo No. 3.

**Description:** This was the "pit" or "sump" area of the facility where the oil pooled before migrating through the secondary containment. Free oil and oil-stained soil/vegetation were present at the time of the inspection and can be seen in the photo.

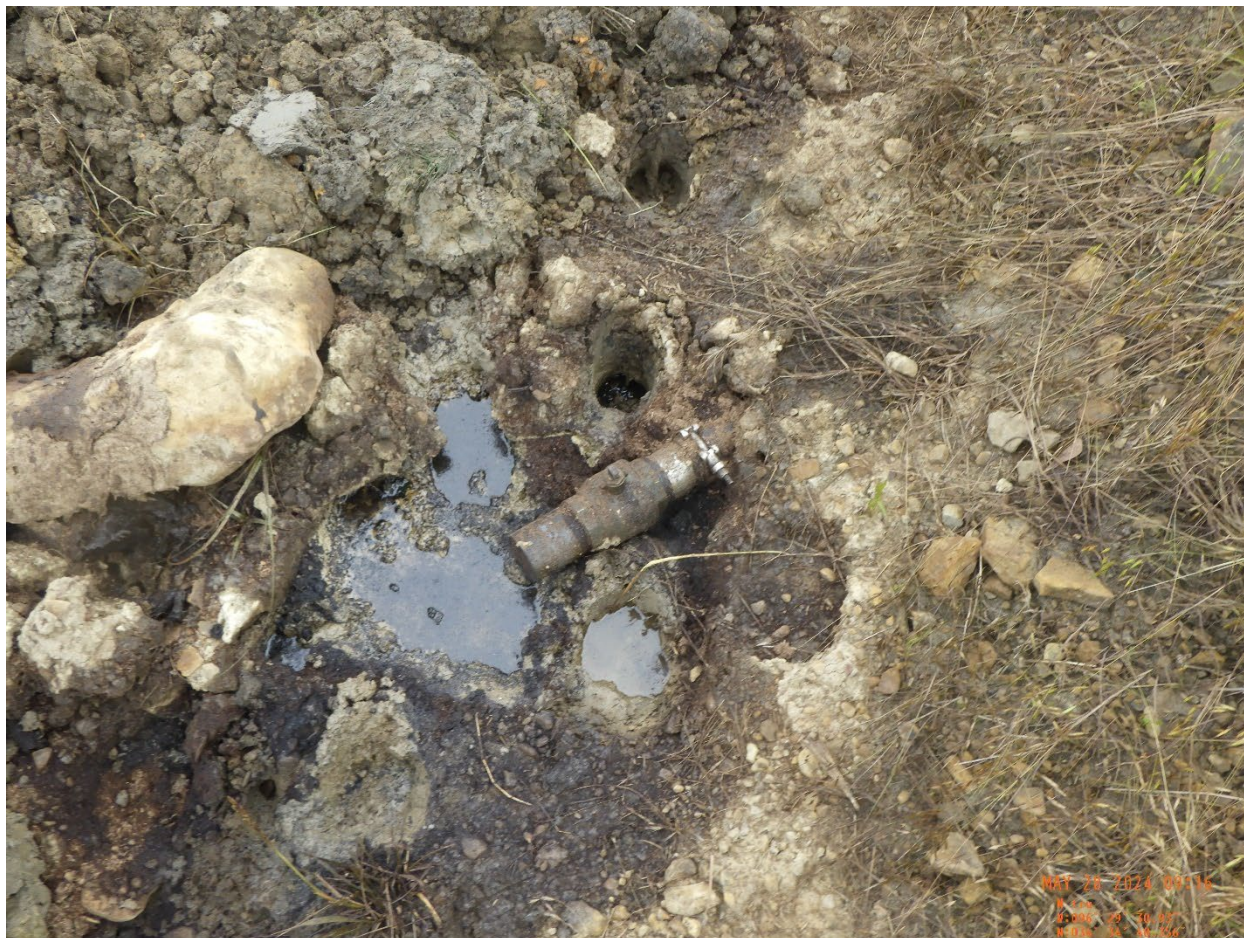
Photo No. 4

I observed the 2" pipe conduit which allowed the spill to escape the secondary containment. At the time of the inspection, the operator had installed a cap on the line to prevent future releases. It was not determined whether this was a sump area drain line used to remove excess rainwater from the facility or if the line was an abandoned flowline which had been left behind by a previous operator. See photo No. 4.

A final area of concern was the conduit/flowline/drain line which allowed the oil to escape the secondary containment.

**Description:** This was the "drain line" which transported the spilled oil through the secondary containment. This photo is taken on the west side of the facility, outside of the berm. At the time of the inspection, the line had been capped by the operator.

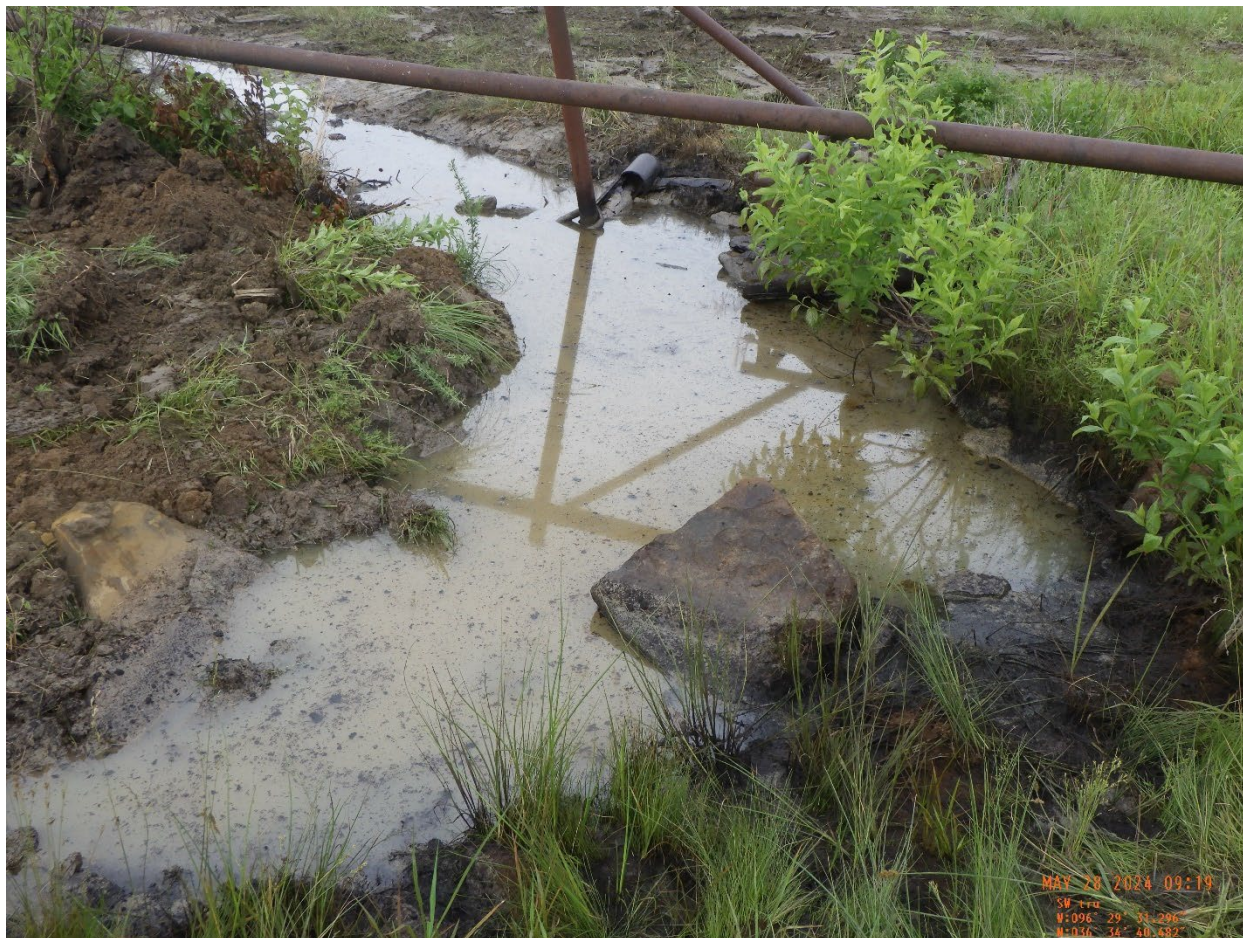
Photo No. 5

I observed the Point of Entry (POE) into the unnamed tributary of Hominy Creek. At the time of the inspection there was free oil floating on the water in the main channel of the tributary. I also observed oil-stained soil, rocks, and vegetation at and around to POE. See photo No. 5.

**Description:** This was the Point of Entry into the unnamed tributary of Hominy Creek. Loose oil and oil-stained soil and vegetation were present at the time of the inspection.

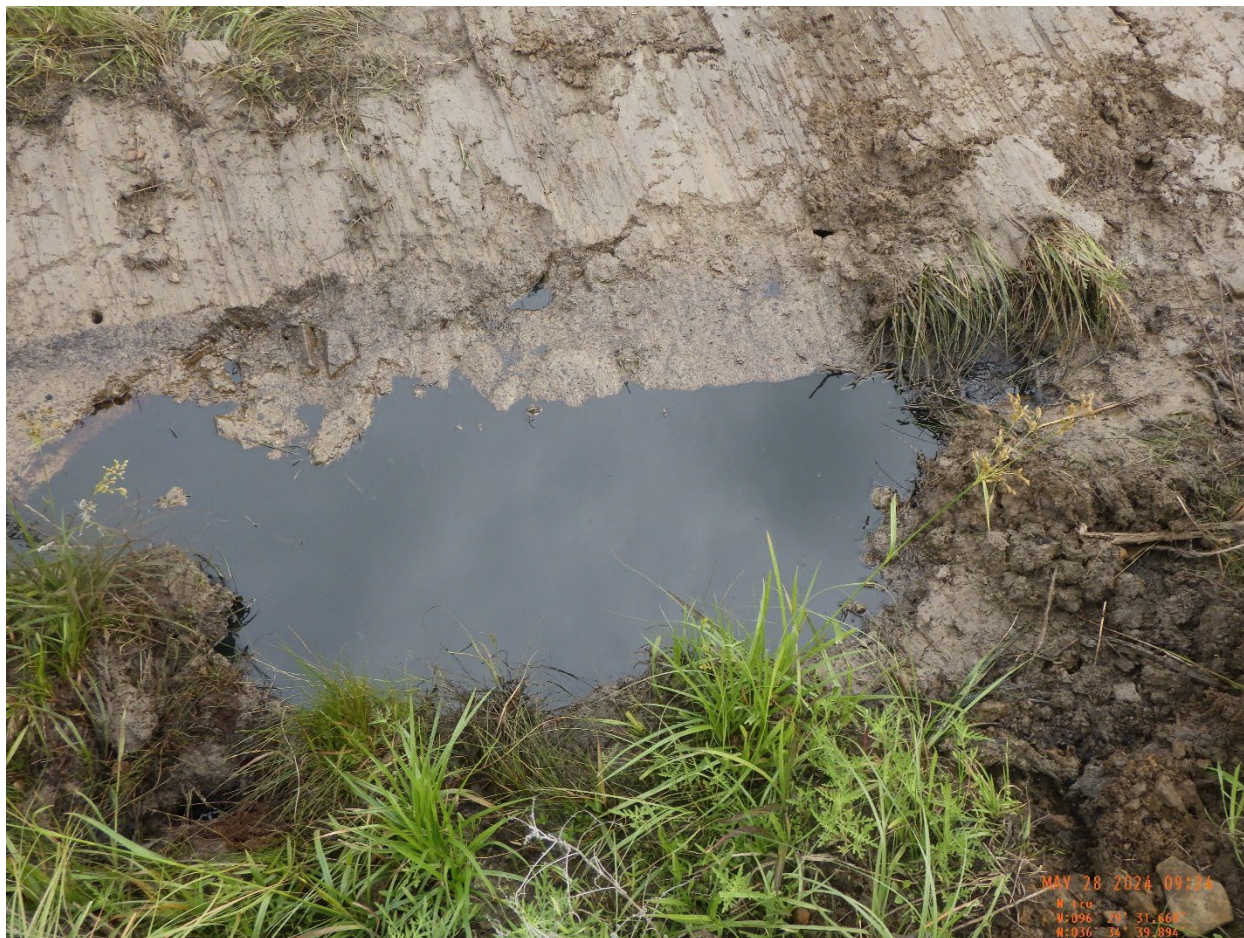
Photo No. 6

I observed free oil along the impacted tributary in an area where the operator was working to remove oil from the tributary. See photo No. 6.

**Description:** This was a photo of loose oil along the unnamed tributary.

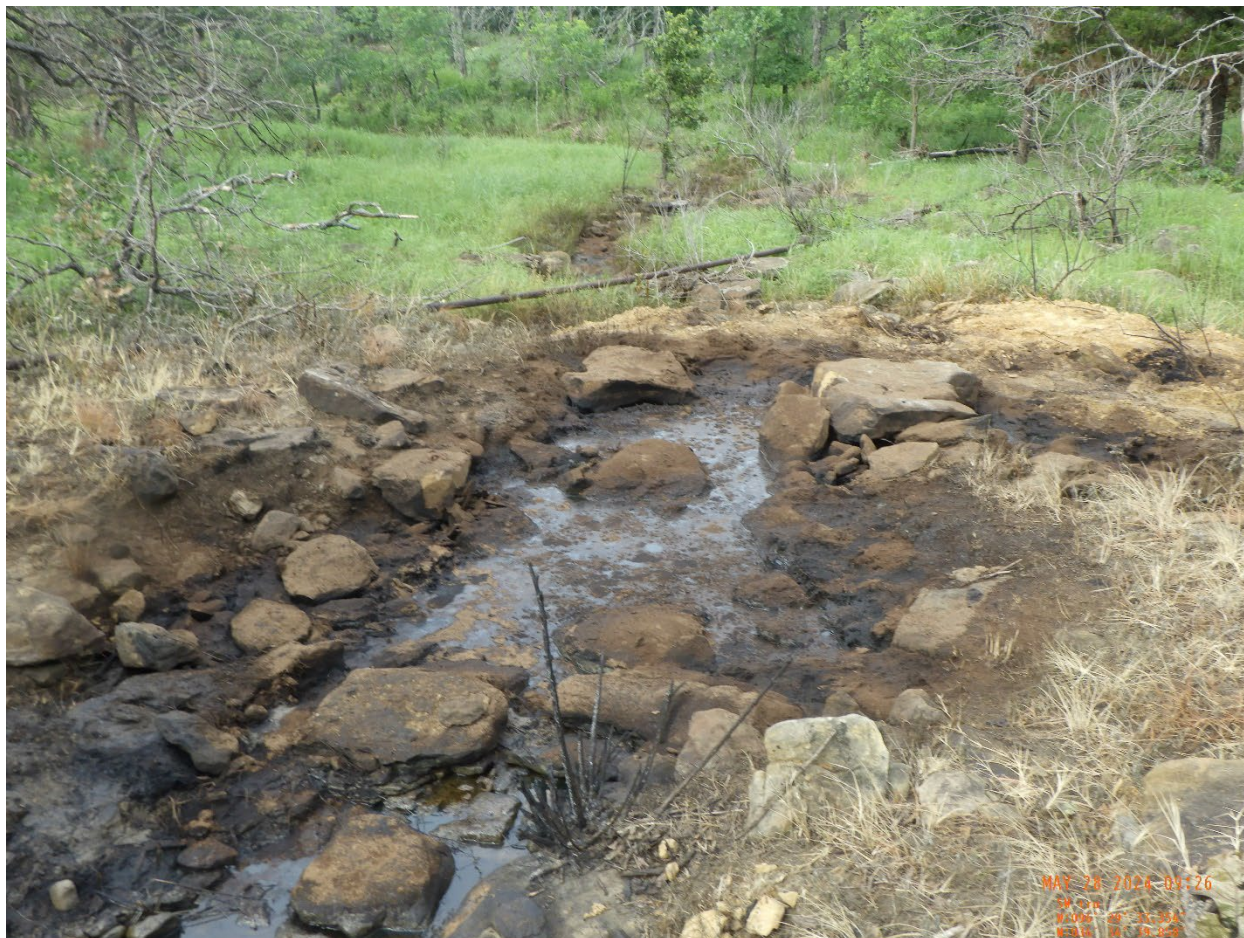
Photo No. 7

Continuing downstream, I observed multiple consecutive locations with oil-stained rocks, vegetation, and soil. These same locations included scorched and burned vegetation in and along the impacted tributary, evidence the oil along this section of the impacted tributary had burned prior to the inspection. The operator stated the oil was not burned when they left just ahead of a significant thunder/lightning storm the prior night. When the operator returned the following morning, oil along this section of the tributary had already burned. See photos No. 7, 8, 9 and 10.

**Description:** This was photo of oil-stained rock and soil along the impacted tributary. The oil in this area had burned prior to the inspection. The black and ash covered sticks in the bottom middle of the photo were evidence of the oil burning. The tributary was covered in "sphag sorb" (an industrial oil absorbent) at the time of the inspection.

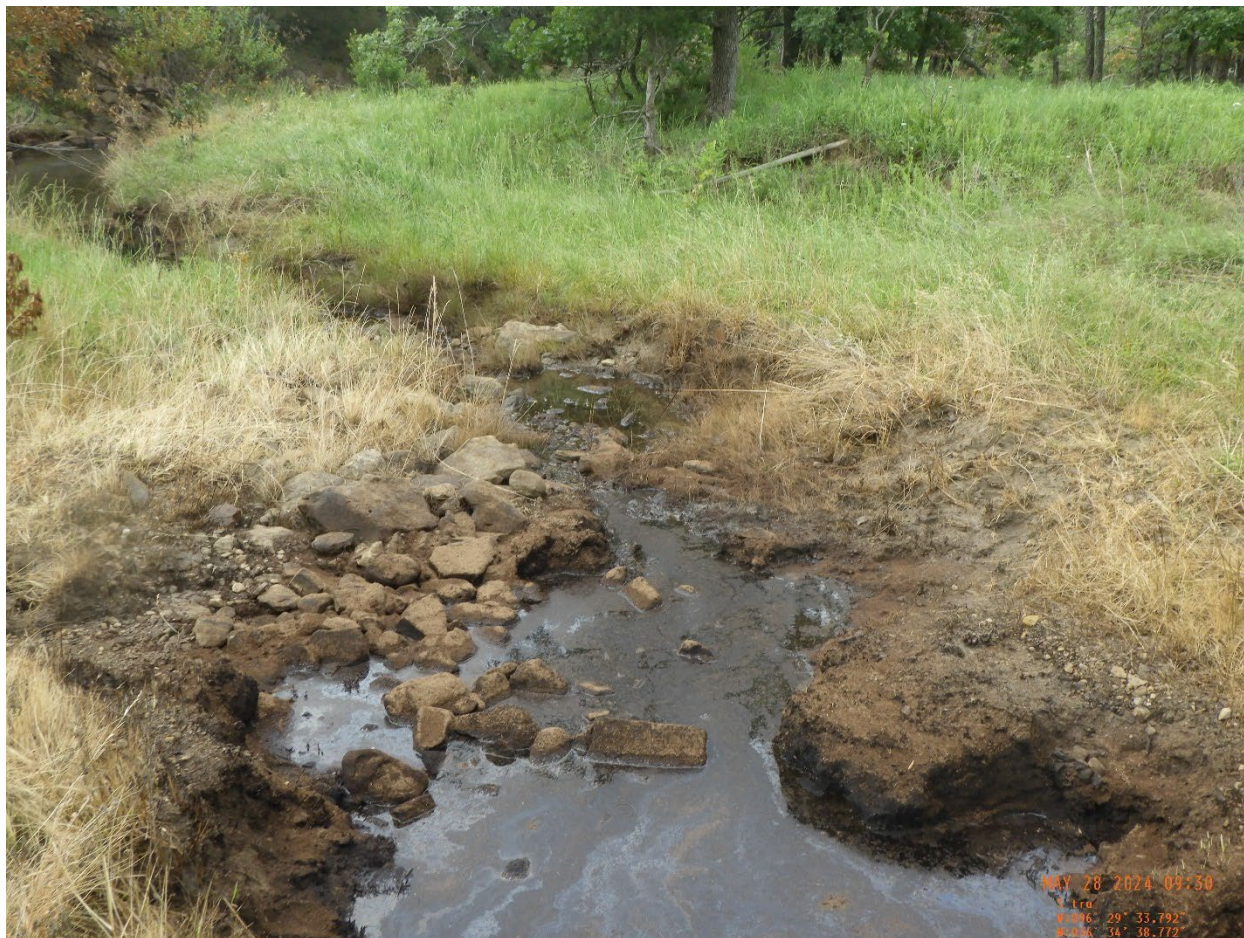
Photo No. 8

**Description:** This was a photo showing oil sheen, spahg sorb and burned oil along the impacted tributary.

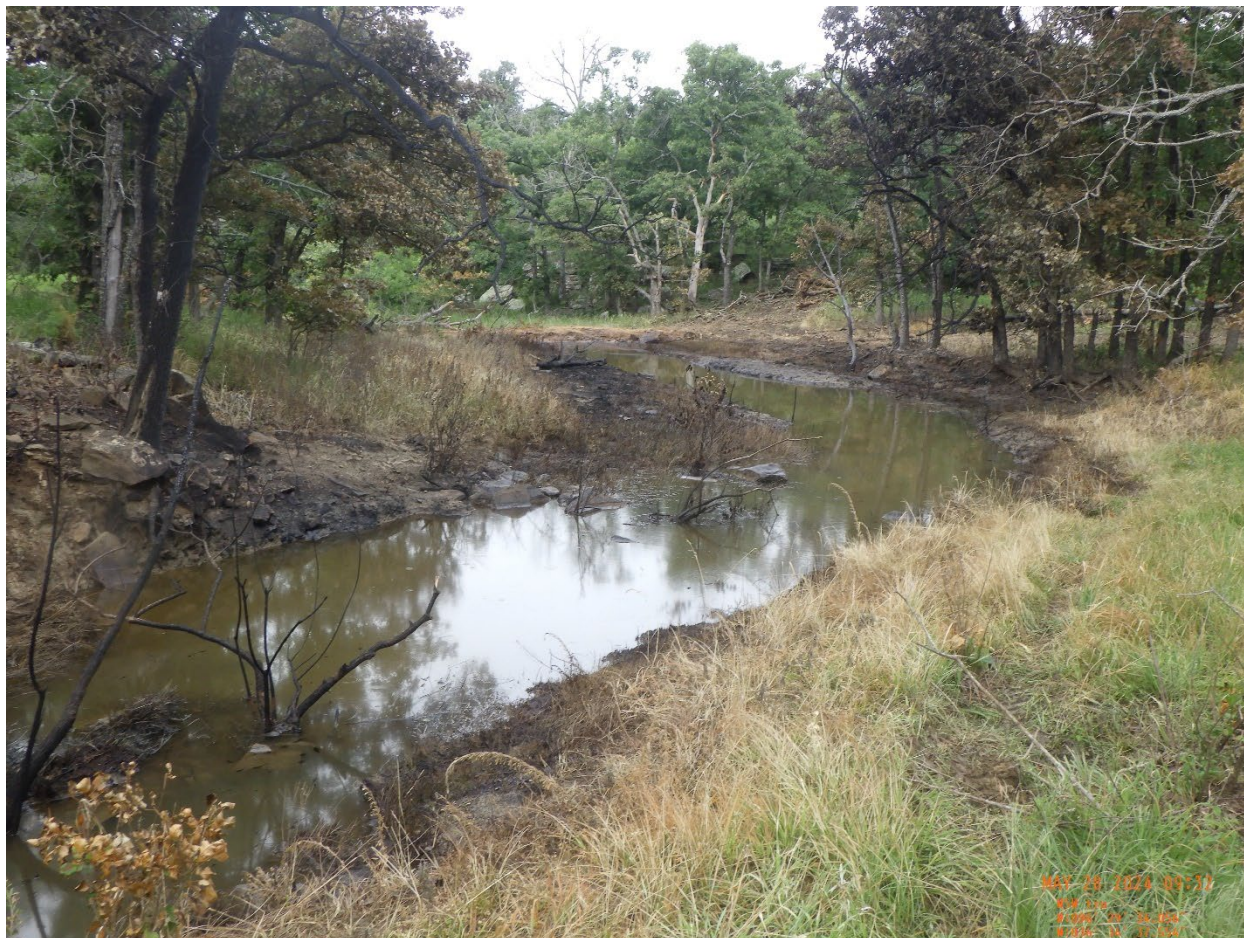
Photo No. 9

**Description:** This was an area upstream from the first temporary containment berm where a significant amount of oil burned.

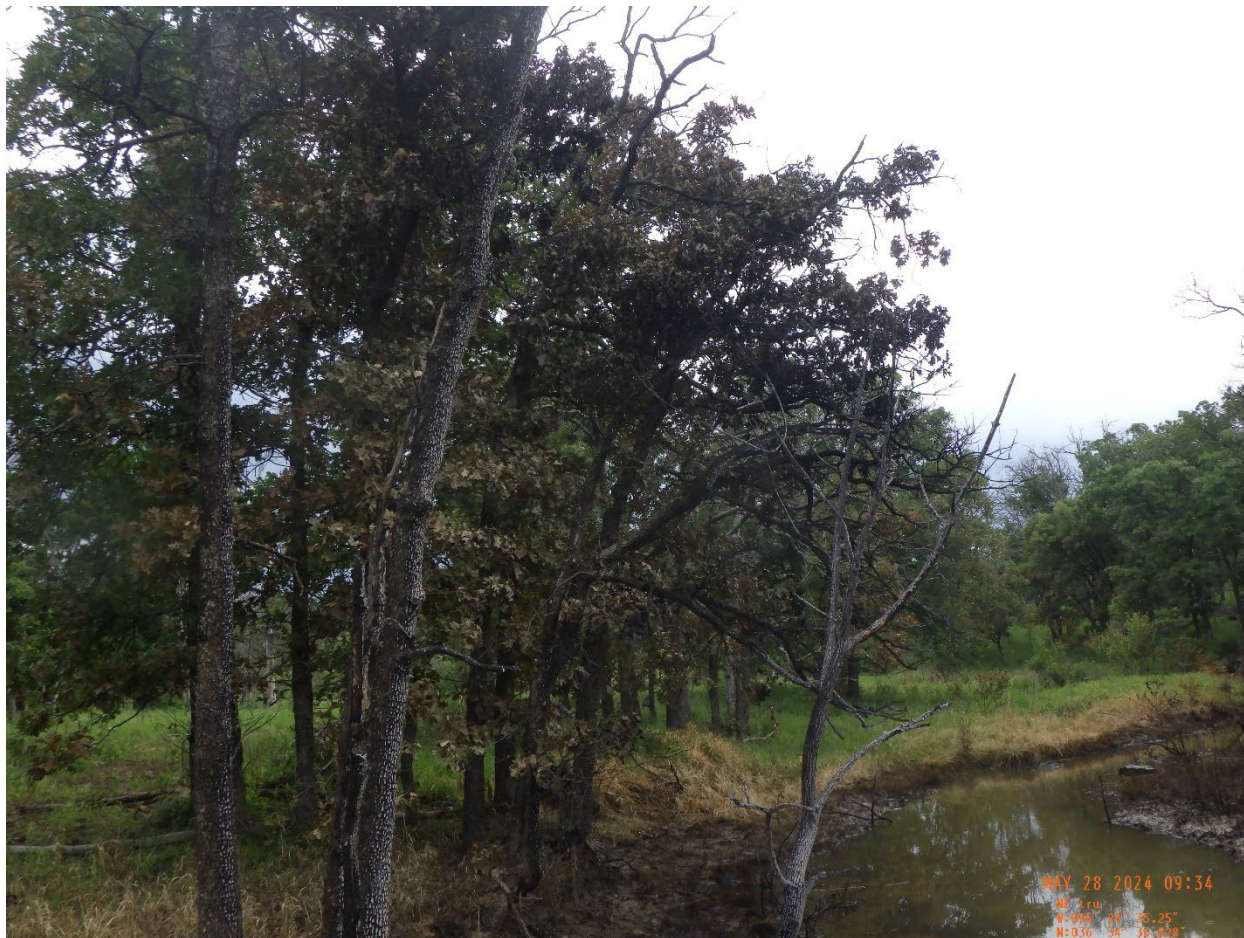
Photo No. 10

**Description:** This photo showed charred trees approximately 15-20 feet above the impacted tributary.

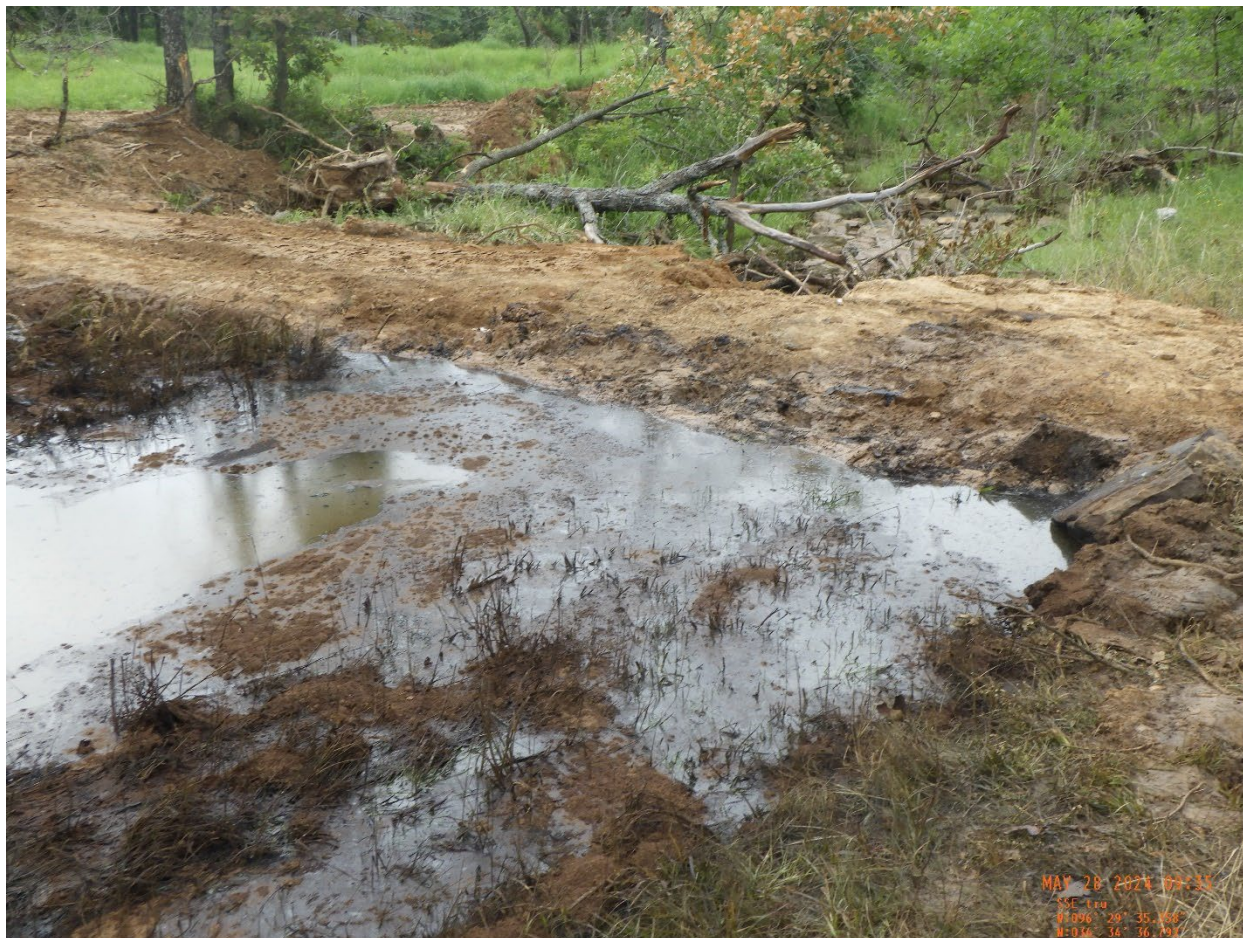
Photo No. 11

I observed a temporary containment dam which had been placed by the operator to prevent downstream migration of oil. At this same location there was oil-stained rocks, soil, and vegetation. There was also a significant amount of "sphag sorb" (an industrial, peat moss based industrial oil absorbent) present on the banks and in the main channel of the tributary. See photo No. 11.

**Description:** This was the first temporary containment dam which had been placed by the operator to prevent downstream migration of the spilled oil. Oil-stained soil, rock and vegetation were present along the banks and dam. Significant amounts of sphag sorb were present on the tributary at this location.

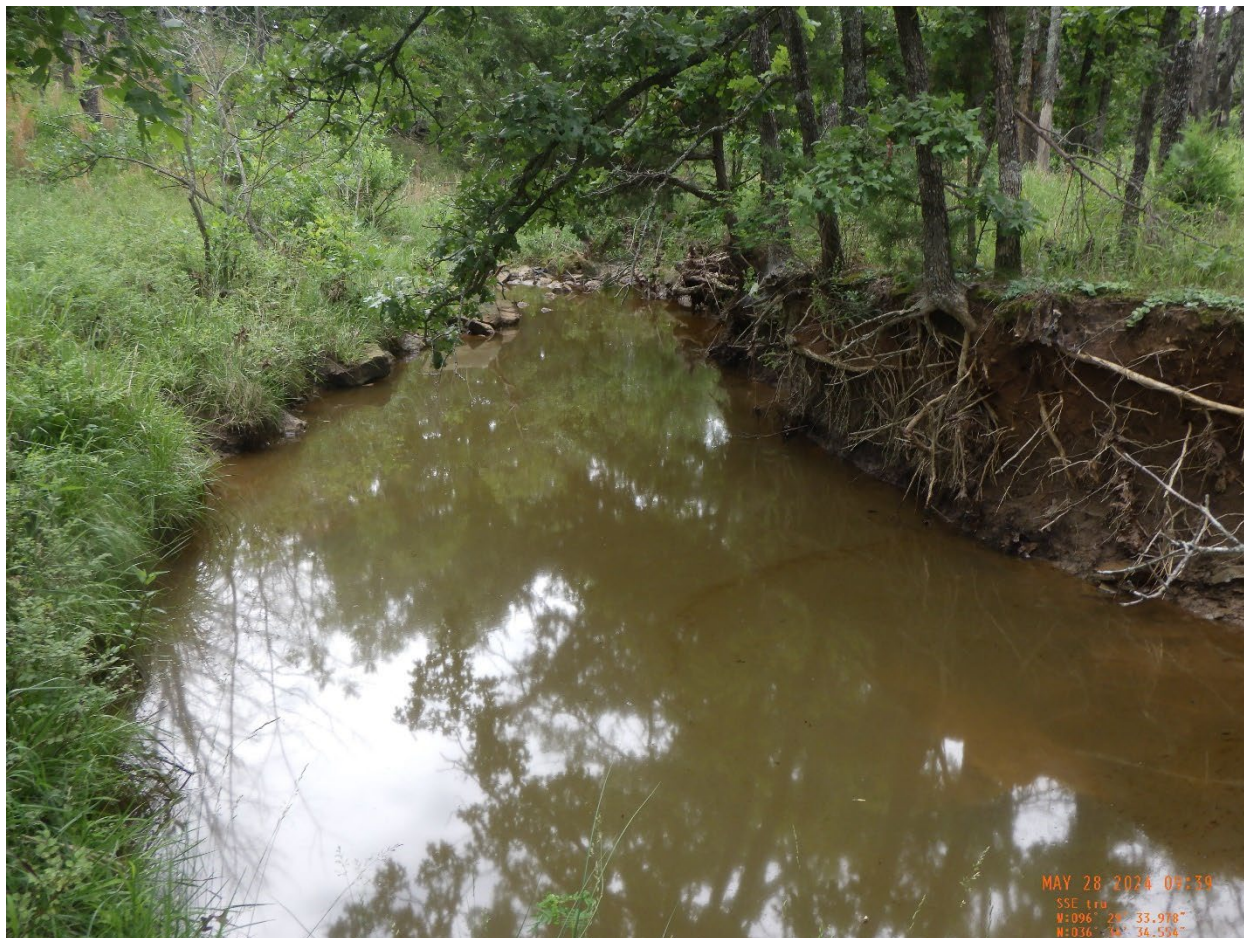
Photo No. 12

Continuing downstream from the containment dam, I observed continuing oil impacts along the banks as well as free oil floating on the water. The bed and bank features of the tributary were also captured in photos No. 12, 13, 14, 15, 16, 17 and 18.

**Description:** This was a photo showing oil floating on the impacted tributary as well as oil staining along the banks.

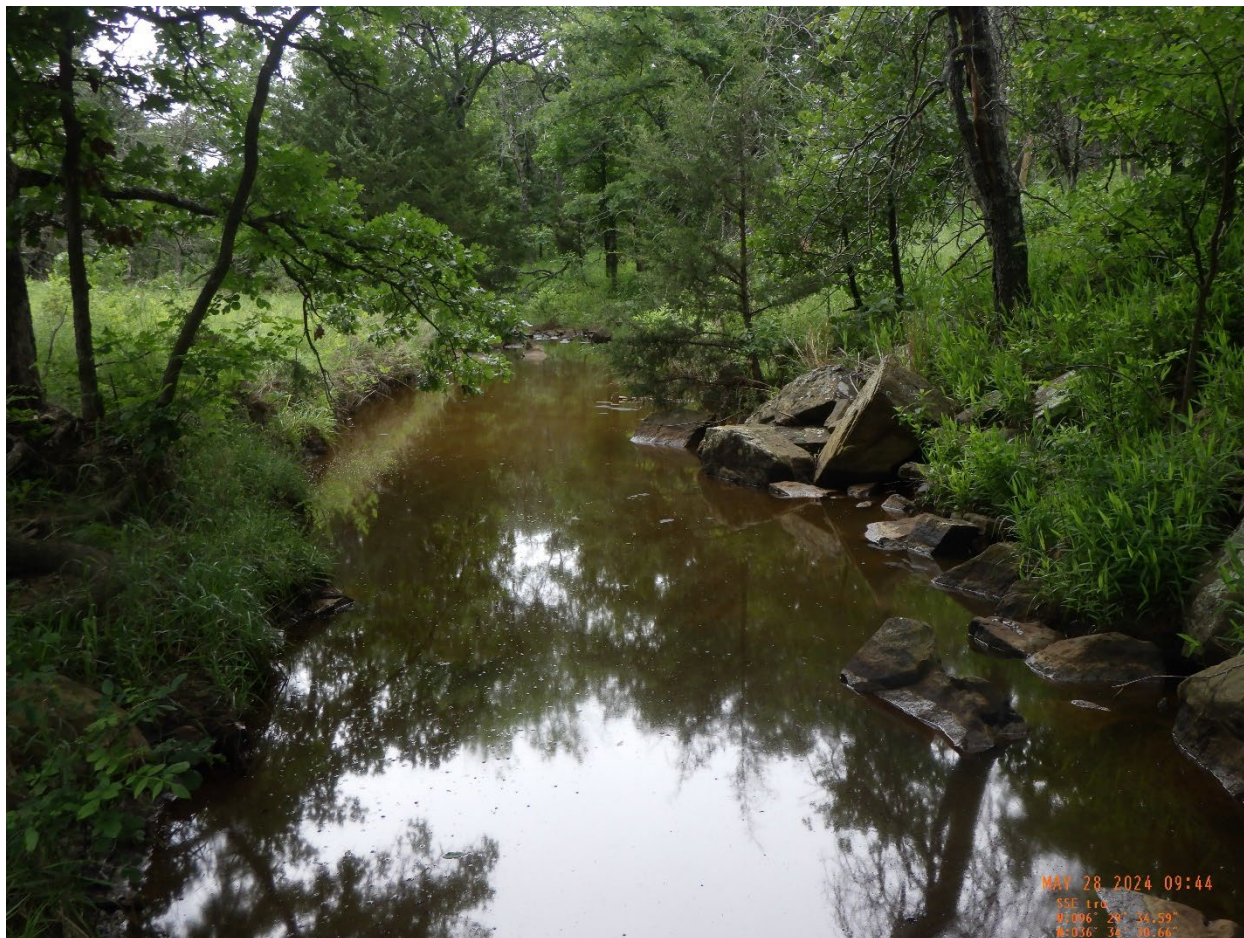
Photo No. 13

**Description:** This was a photo showing the bed and bank features of the unnamed tributary. This location was approximately 1300 feet downstream from the POE.

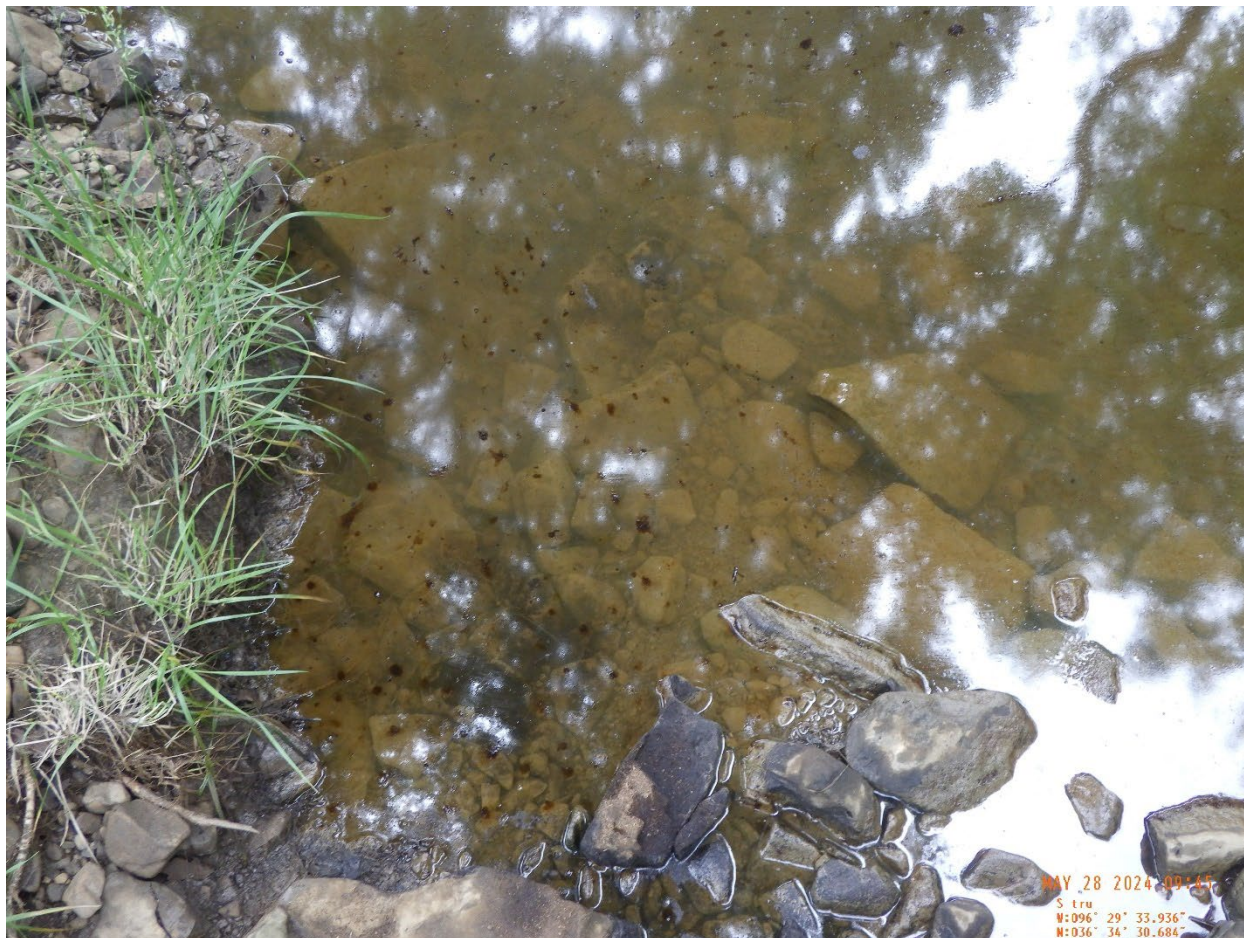
Photo No. 14

**Description:** This was a photo of oil floating on the water as well as oil-stained soil and rocks along the impacted tributary. This was at the same location as photo No. 13.

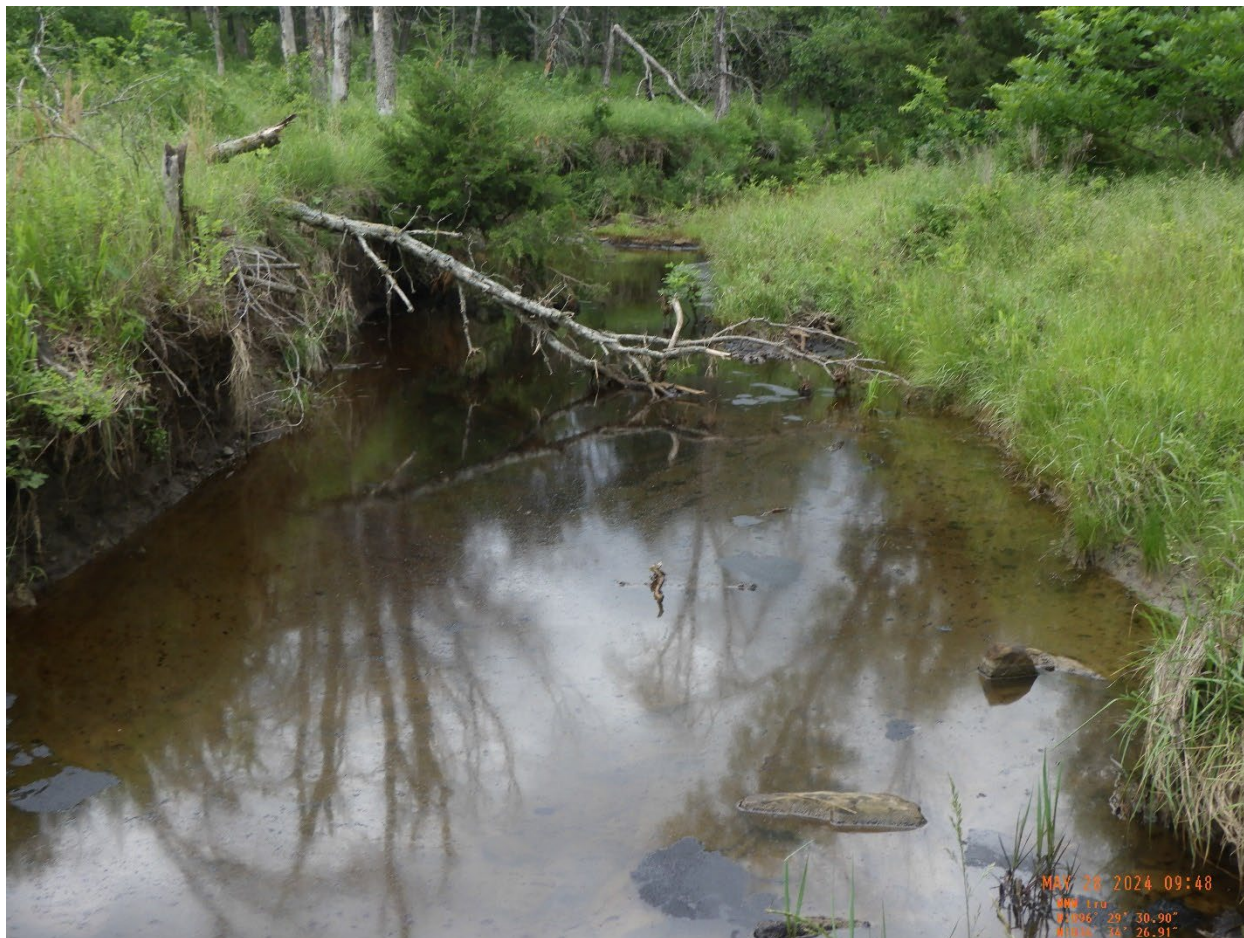
Photo No. 15

**Description:** This was a photo of oil floating on the impacted tributary.

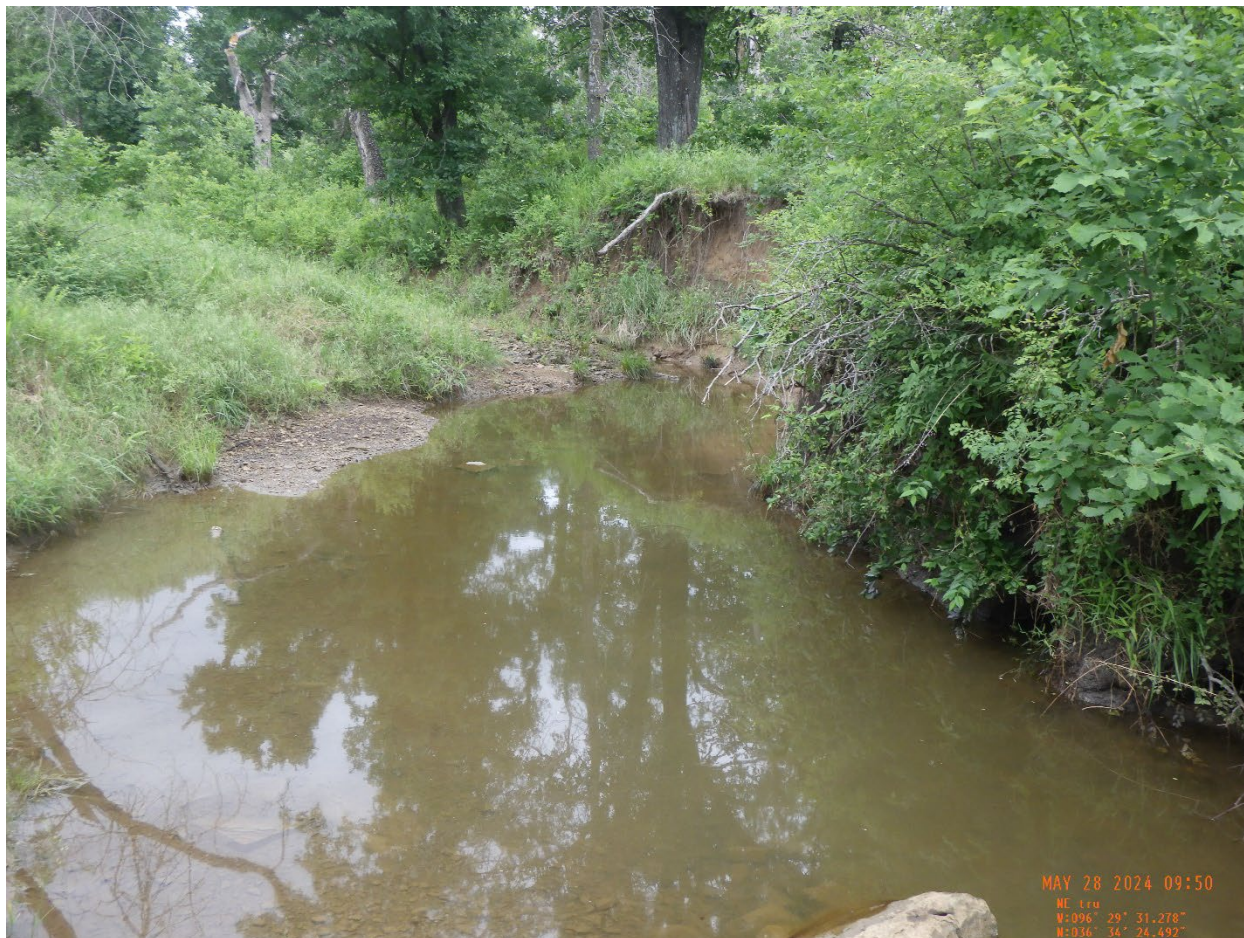
Photo No. 16

**Description:** This was a photo showing the bed and bank features of the impacted tributary.

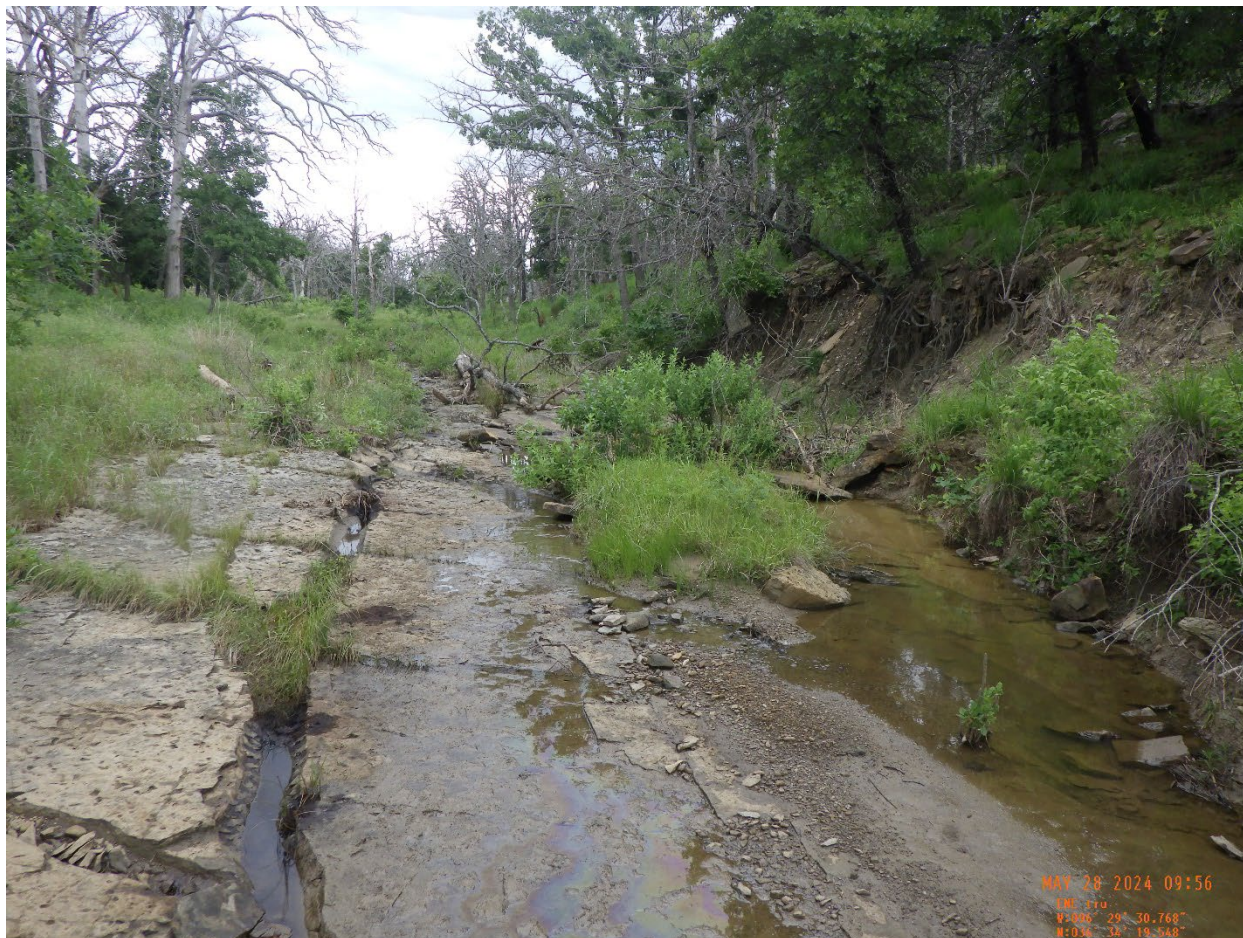
Photo No. 17

**Description:** This was a photo of sheen on the water as well as the bed and bank features of the tributary along the impacted tributary. This was a view upstream from the location.

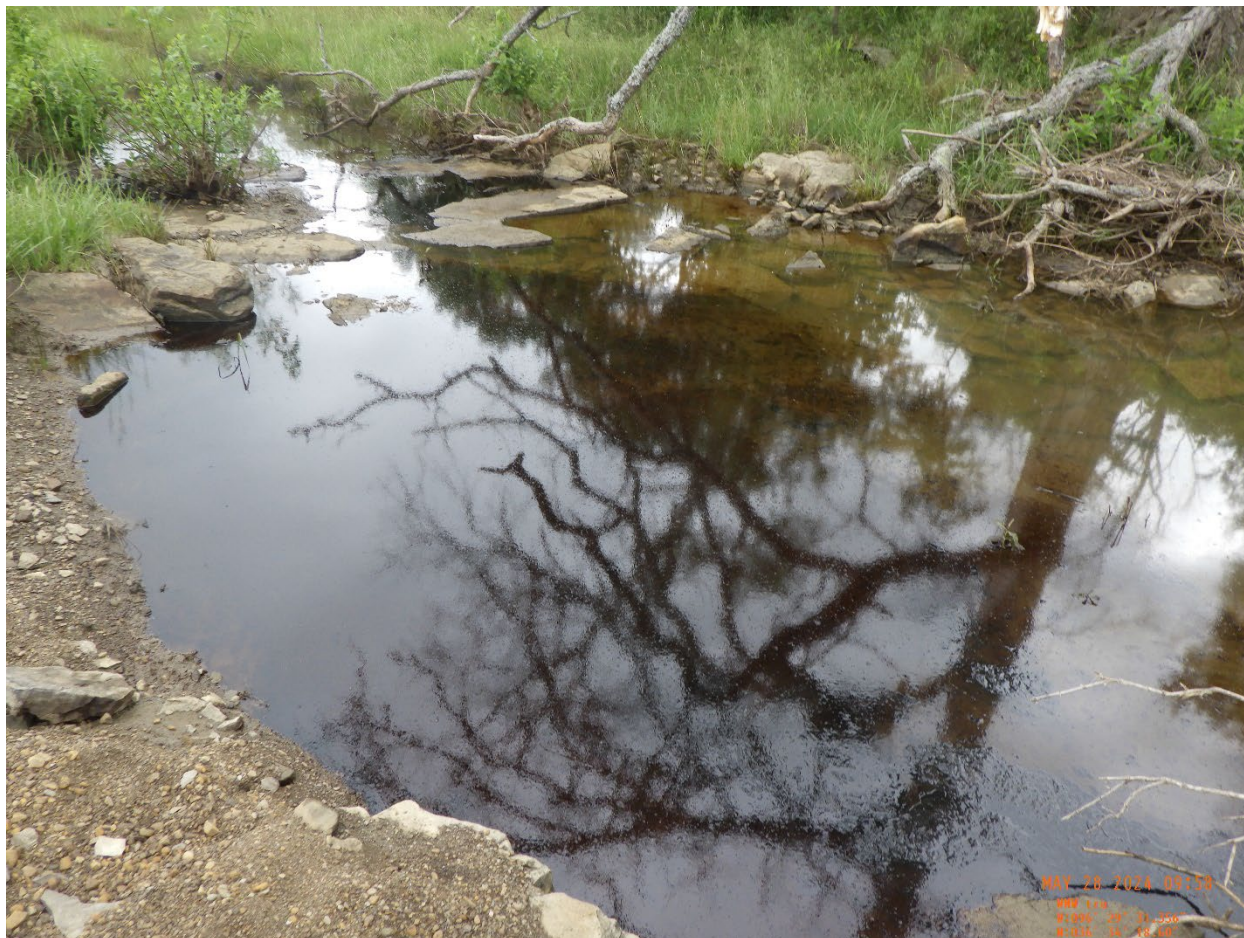
Photo No. 18

**Description:** This photo showed oil on the water along the impacted tributary. This was a downstream view from the same location as photo No. 17.
