## Region 6 - Enforcement & Compliance Assurance Division

### INSPECTION REPORT

| Company Name: | <b>Box L Operating</b> | |
| Facility Name: | <b>Lynn Lease</b> | |

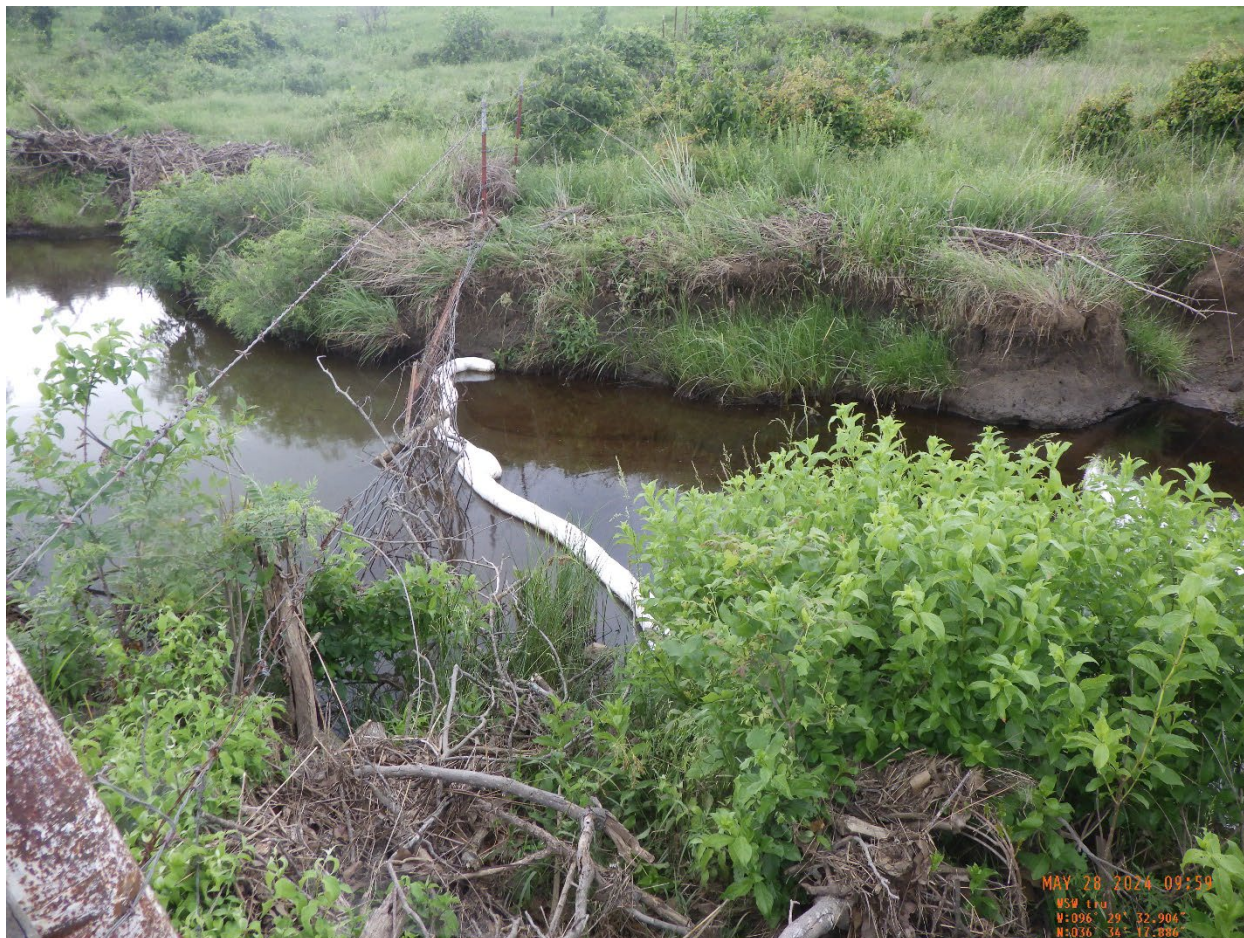
Photo No. 19

I observed oil-staining, free oil and a floating, oil absorbent containment boom at the point where spill impacts crossed onto a second landowner. See photo No. 19.

**Description:** This was a photo of oil on the water at the point where the spill crossed onto a second landowner.

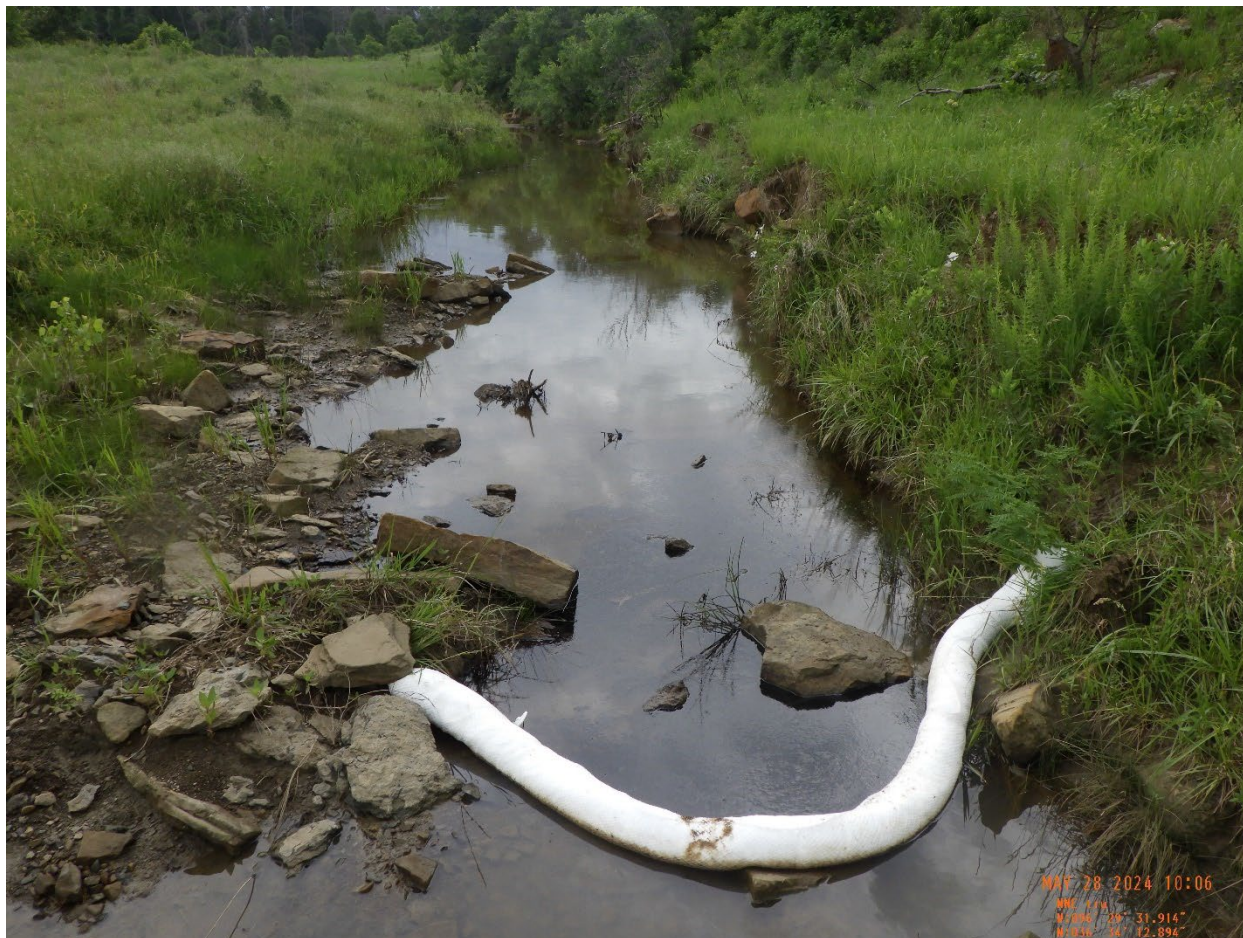
Photo No. 20

I observed an additional floating, absorbent, containment boom as well as contained oil floating on the surface of the impacted tributary. See photo No. 20.

**Description:** This was an oil absorbent containment boom installed across the tributary to prevent downstream migration of spill impacts. This photo was taken with an upstream view from the location.

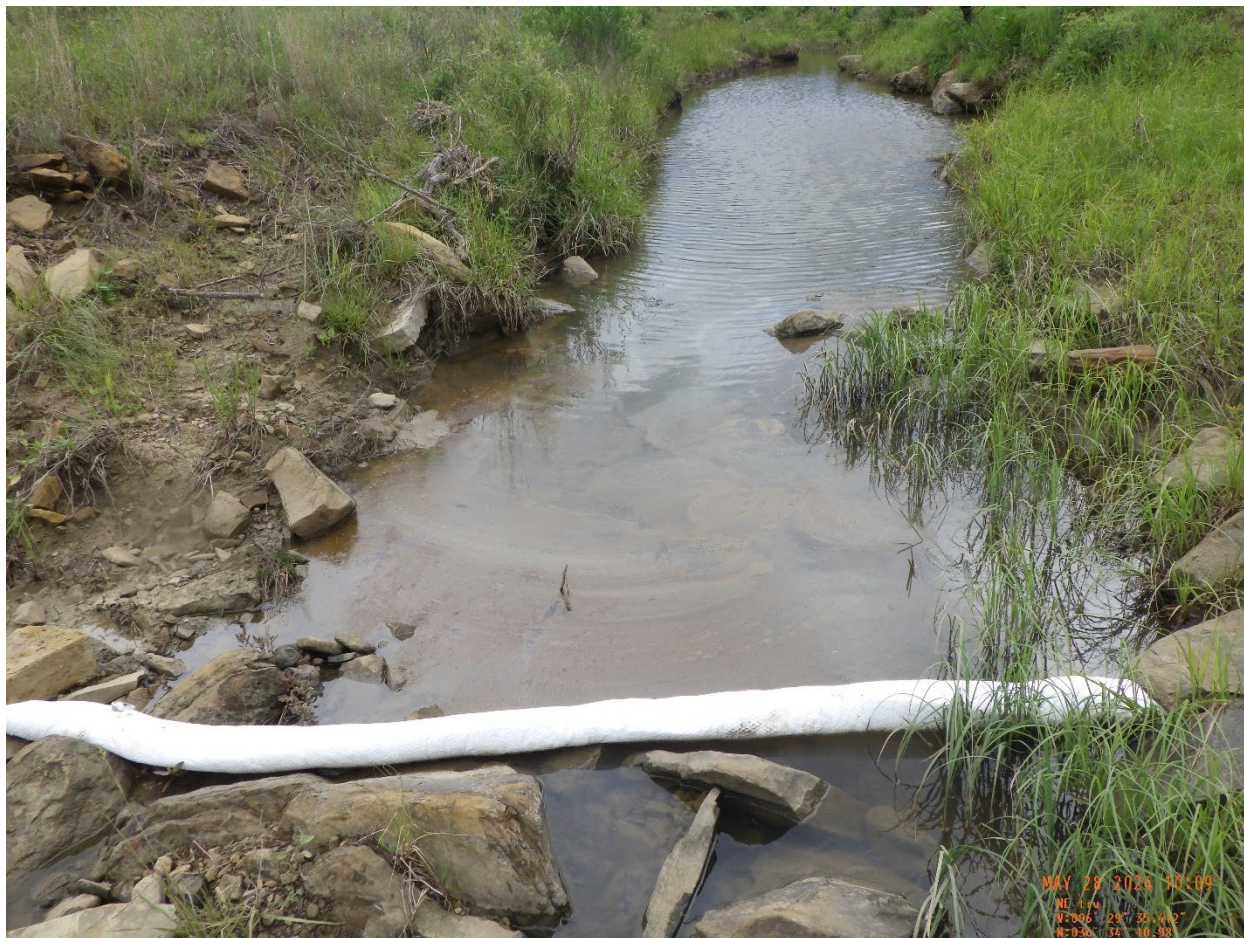
Photo No. 21

I observed the end of spill impacts and the final/lowermost, downstream, floating, oil absorbent, containment boom. At the time of the inspection, the spill was effectively contained by proper placement of the final containment boom. See photo No. 21.

**Description:** This was the lowermost, downstream containment boom with a small amount of oil sheen trapped on the upstream side of the boom. This was the furthest downstream location where spill impacts were observed. At the time of the inspection, the spill was effectively contained.
